Use Attainability Analysis

WBID 2582 Howell Creek

Submitted by
SES Inc.

Missouri Department of Natural Resources
Water Protection Program

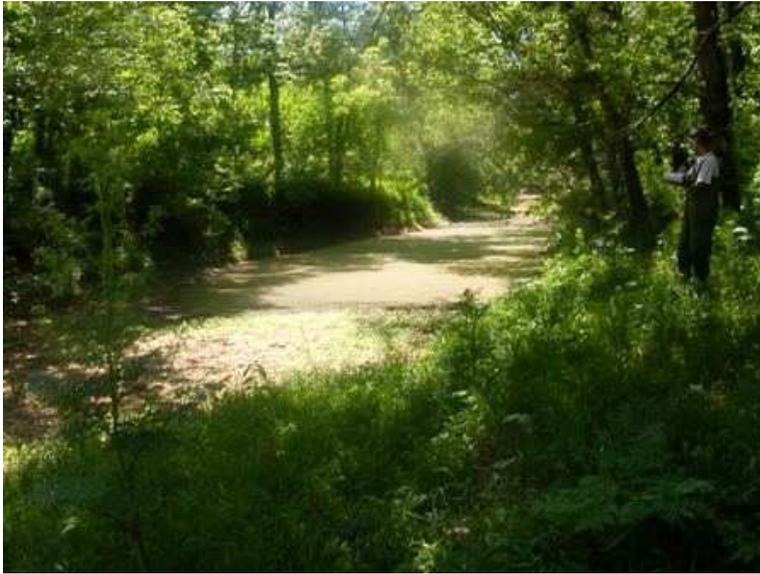
Site# 1 Photo ID# 66, Upstream

Upstream Photo 66 Downstream Photo 65

Depth (m)
Transect 1	0.00
Substrate:	0.00
gravel/cobble	0.00
Water Clarity:	0.00
	0.00
Channel Feature:	0.00
	0.00
Channel Width:	0.00
	0.00
0.00	0.00
Transect 2	0.00
Substrate:	0.00
cobble/gravel	0.00
Water Clarity:	0.00
	0.00
Channel Feature:	0.00
	0.00
Channel Width:	0.00
	0.00
0.00	0.00
Transect 3	0.25
Substrate:	0.45
mud/cobble	0.50
Water Clarity:	0.50
murky	0.45
Channel Feature:	0.40
pool	0.40
Channel Width:	0.65
13 yards	0.60
0.45	0.30
Transect 4	0.25
Substrate:	0.25
mud/cobble	0.30
Water Clarity:	0.30
murky	0.45
Channel Feature:	0.50
pool	0.35
Channel Width:	0.30
12 yards	0.30
0.30	0.30

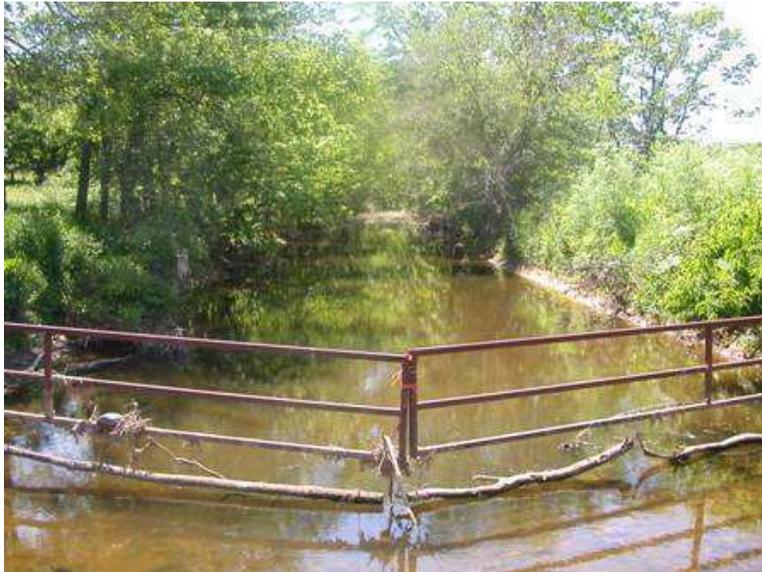
Site# 2 Photo ID# 67, Upstream

Upstream Photo 67 Downstream Photo 68

Roads	Rope swings	Foot paths/prints	Dock/platform
Livestock Watering	RV/ATV Tracks	Camping Sites	Fire pit/ring
NPDES Discharge	Fishing Tackle	Other: Gate across stream; See Pics 67&68

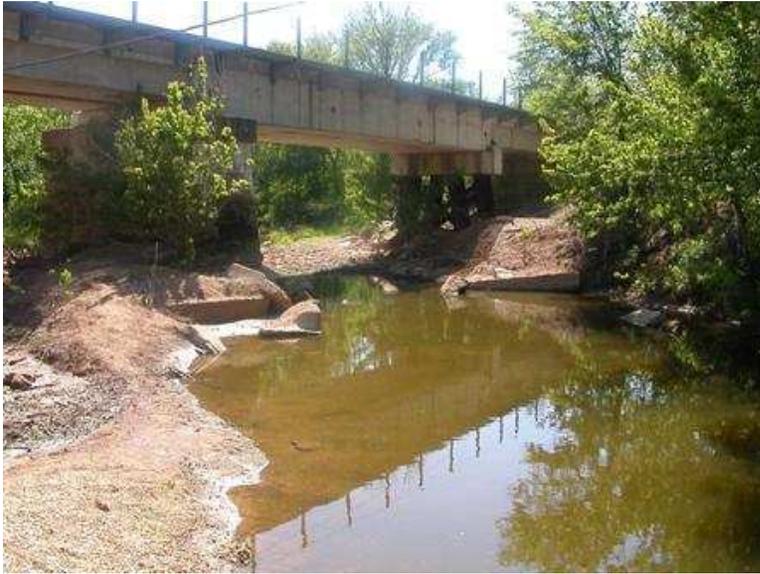
Site# 3 Photo ID# 69, Upstream

Upstream Photo 69 Downstream Photo 70

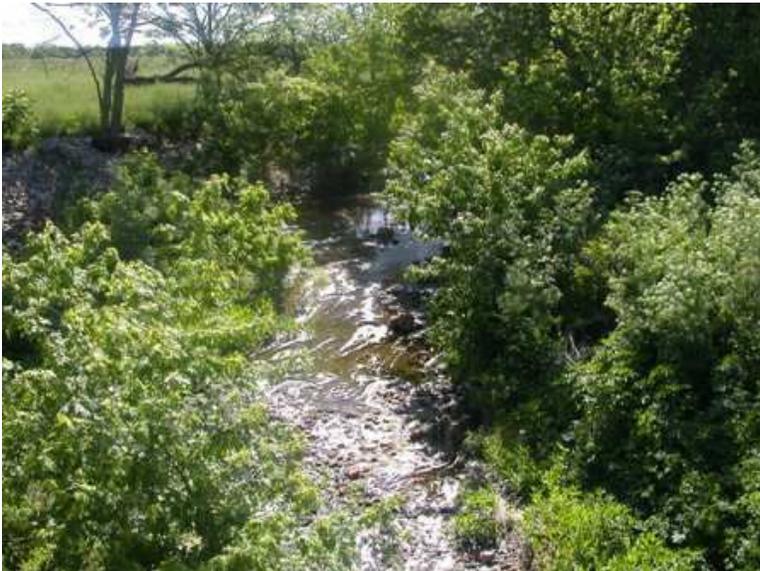
Site# 4 Photo ID# 71, Upstream

Upstream Photo 71 Downstream Photo 72

% of Channel Feature				
Riffle	0				
Run	0				
Pool	100

Filamentous green algae. Vegetation along banks. Algae on rocks. Floating algae.

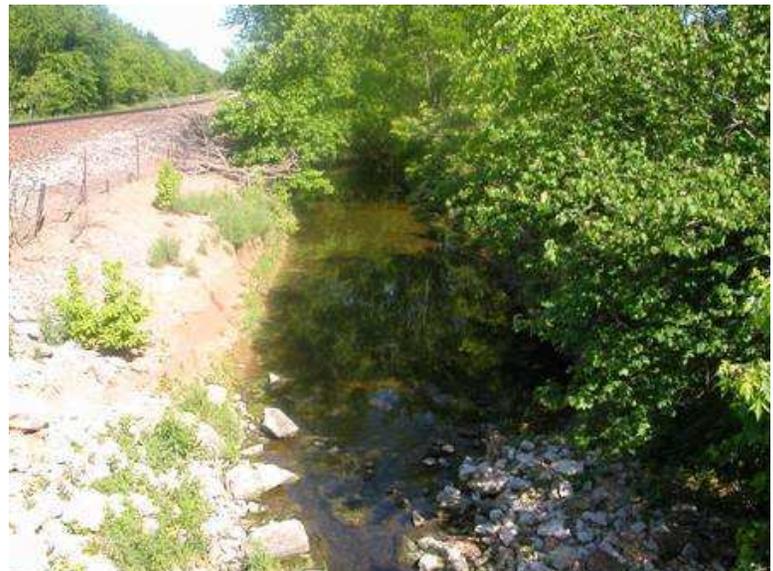
Site# 4 Photo ID# 72, Downstream

% Cobble	% Gravel	% Sand	% Silt
35	35	0	20
% Mud/Clay	% Bedrock		
10	0

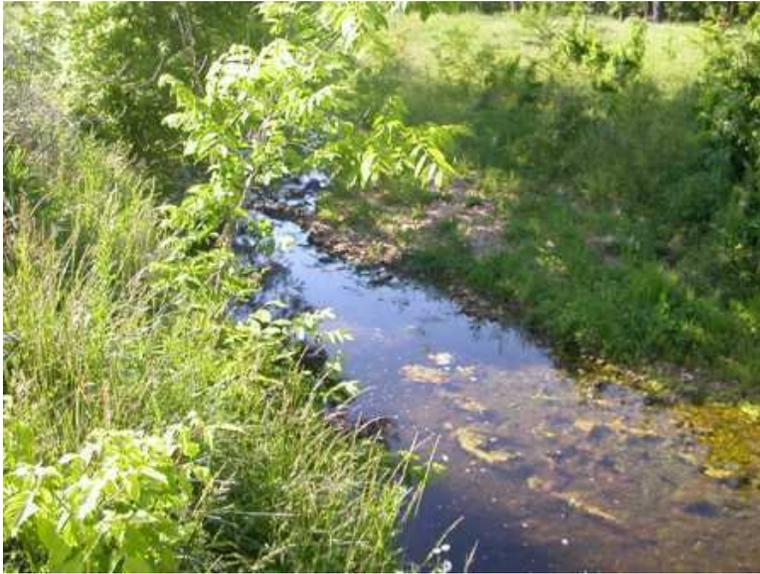
Site# 5 Photo ID# 75, Upstream

Upstream Photo 75 Downstream Photo 74

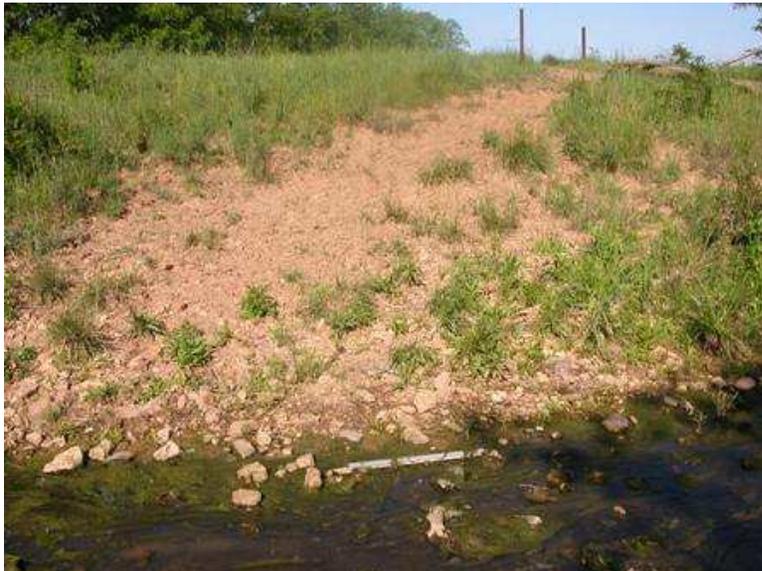
Site# 5 Photo ID# 73, Livestock watering

Roads	Rope swings	Foot paths/prints	Dock/platform
Livestock Watering:	RV/ATV Tracks	Camping Sites	Fire pit/ring
Pic # 73			
NPDES Discharge	Fishing Tackle	Other:

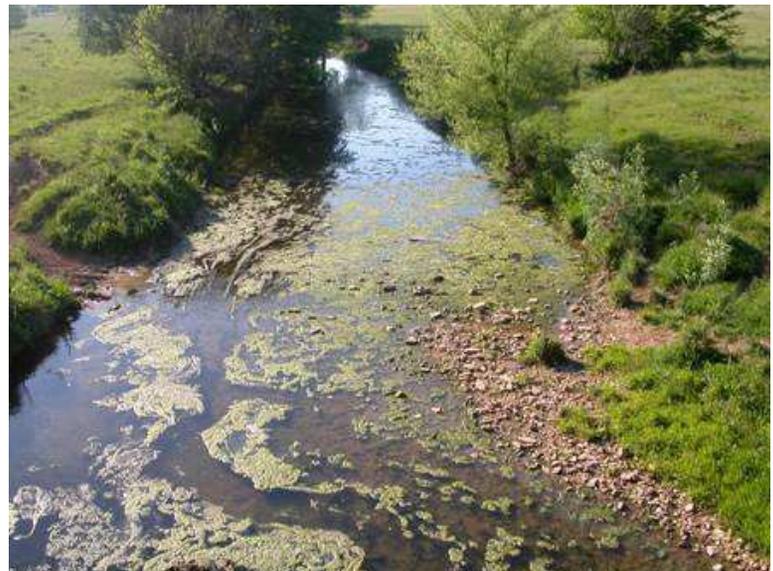
Site# 6 Photo ID# 77, Upstream

Upstream Photo 77 Downstream Photo 76

Riffle	18				
Run	0				
Pool	82

Floating algae. Algae on rocks. Vegetation along banks.

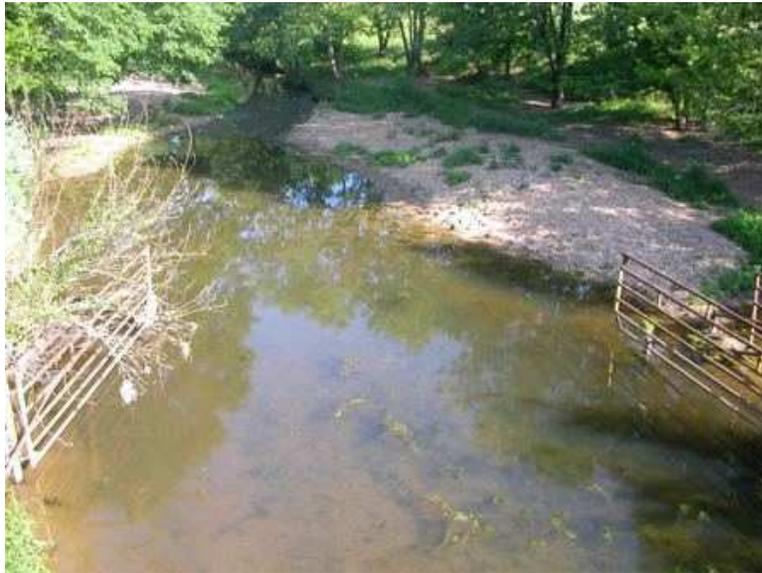
Site# 6 Photo ID# 76, Downstream

% Cobble	% Gravel	% Sand	% Silt
33	34	0	33
% Mud/Clay	% Bedrock		
0	0

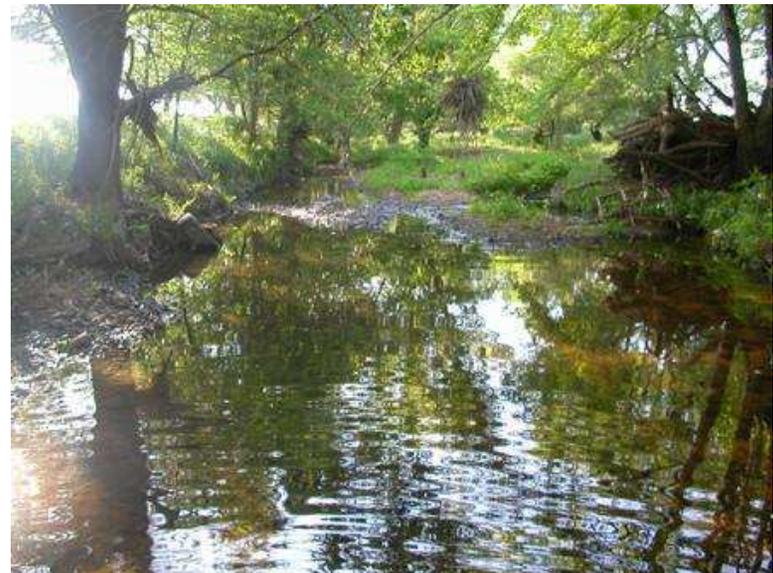
Site# 7 Photo ID# 79, Upstream

Upstream Photo 79 Downstream Photo 78

% of Channel Feature				
Riffle	10				
Run	0				
Pool	90

Algae on rocks. Some filamentous algae. Vegetation along banks.

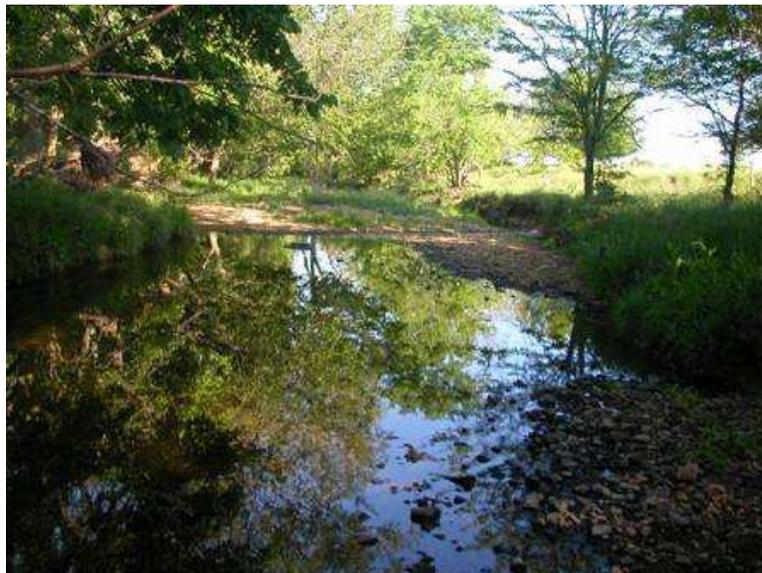
Site# 7 Photo ID# 78, Downstream

% Cobble	% Gravel	% Sand	% Silt
25	35	0	29
% Mud/Clay	% Bedrock		
0	11
