# North Central Missouri Locust Creek Watershed Study Final Report

Section 22 WRDA  
Planning Assistance to States

November 2013

**HDR Engineering, Inc.**

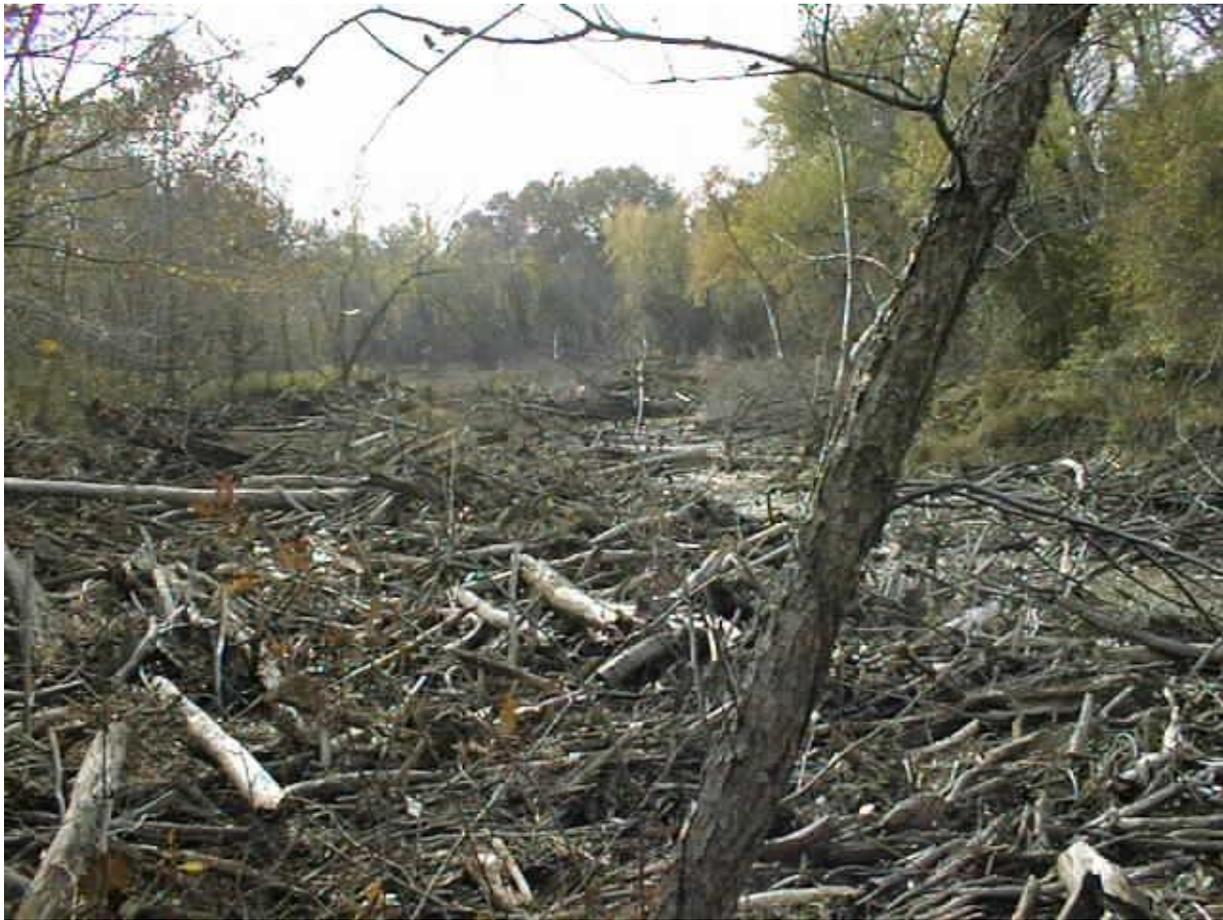
**Figure 2: Typical Log Jam in LC**

For nearly 20 years, Missouri Department of Natural Resources (MDNR) staff have encountered and removed multiple log jams in the Lower LC (LLC) channel running through PSP upstream and downstream of U.S. Hwy 36 (Hwy 36). Winter ice jams are also a problem in PSP. Figure 2 is a photo of a typical log jam in LC and Figure 3 shows mapped PSP log jam locations and extents. The U.S. Geological Survey (USGS) reported that since the Great Flood of 1993 and succeeding floods, LC has been repeatedly choked with log jams in or near PSP (USGS, 1997). Files (2012) reported that as result of the Great Flood of 1993, much upstream bank erosion and tree loss occurred and began to accumulate in the LC stream meanders inside PSP. The earliest detailed log jam information available for review was a log jam in 1999 in PSP that was reported to have been over 6,000 feet long. U.S. Army Corps of Engineers (USACE) Regulatory Branch memos indicate Section 404 permits were issued prior to 1999 for log jams in PSP just south of Hwy 36. In addition to MDNR issues at PSP, Missouri Department of Conservation (MDC) staff at nearby Fountain Grove Conservation Area (FGCA) dealt with a log jam and sediment aggradation problem in LC and Hickory Branch (HB). Between MDNR and MDC, over one dozen Clean Water Act Section 404 permits for log jam/sediment removal have been issued.

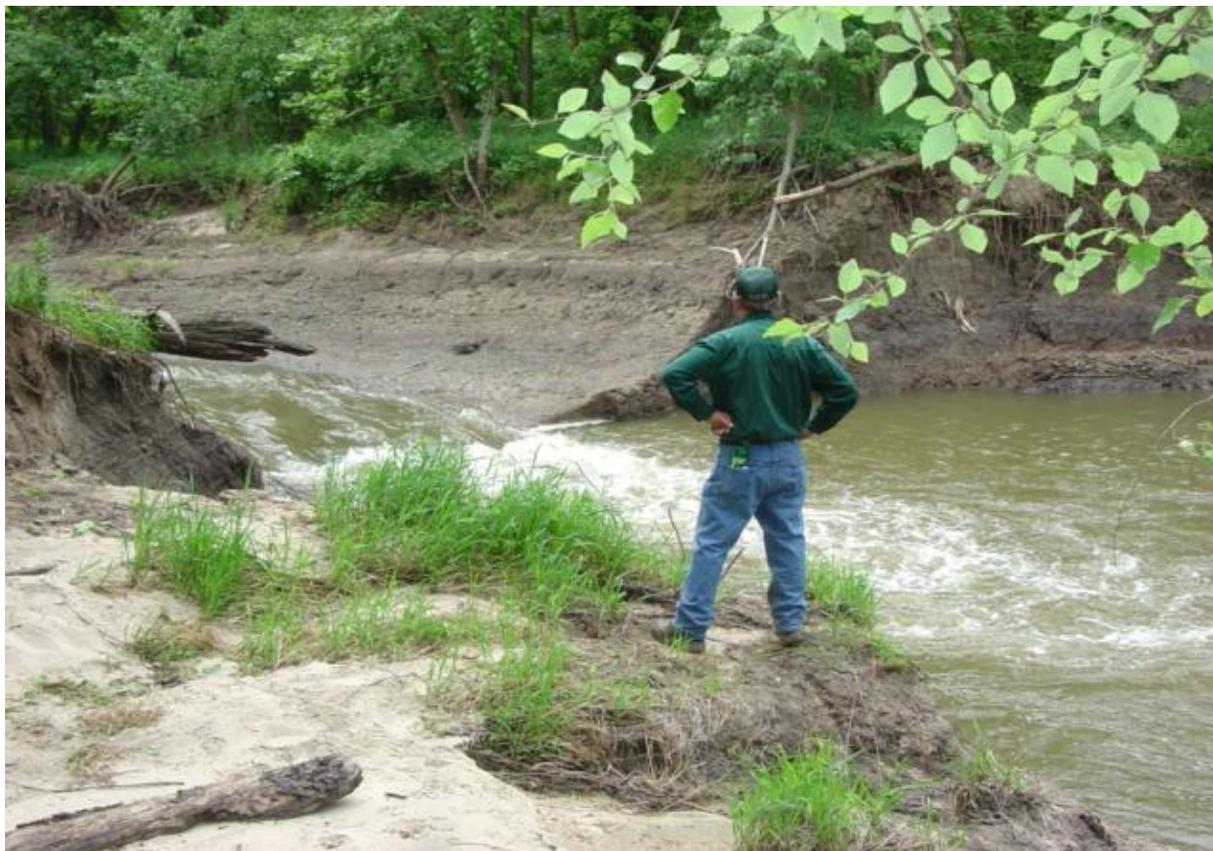
**Figure 15: Representative Headcuts in the Locust Creek Watershed**

Active Headcut: Note waterfall effect over the knick point above the head cut channel, abrupt channel bed elevation changes, and downstream bank failure below the knick point. Photo taken on main avulsion between LC and HD.

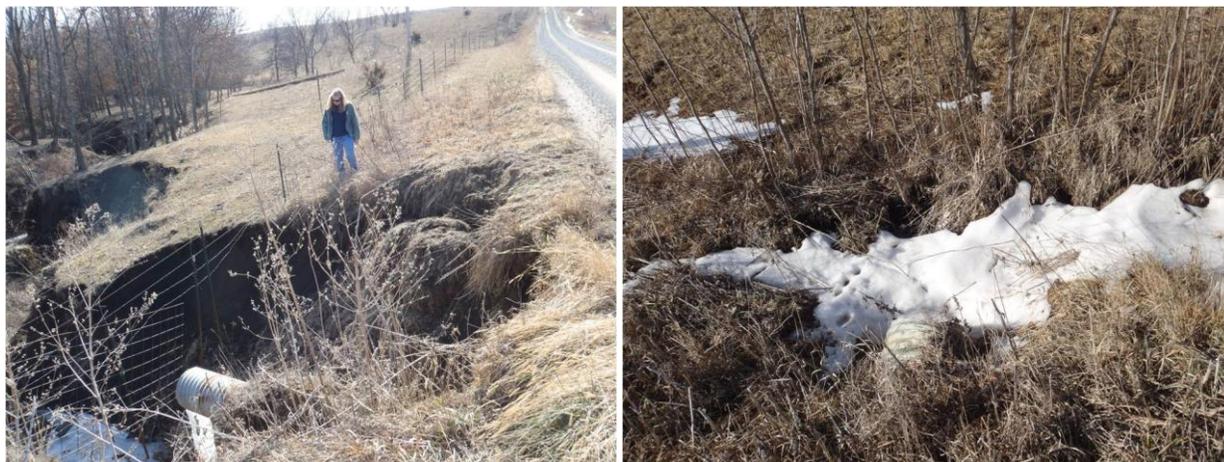
Inactive Headcut: Headcut in upland area has migrated to a county road culvert and has temporarily stopped or is inactive, as demonstrated by lack of a defined eroded channel on the opposite side of the road. Photo from 220<sup>th</sup> Road, Putnam, County.

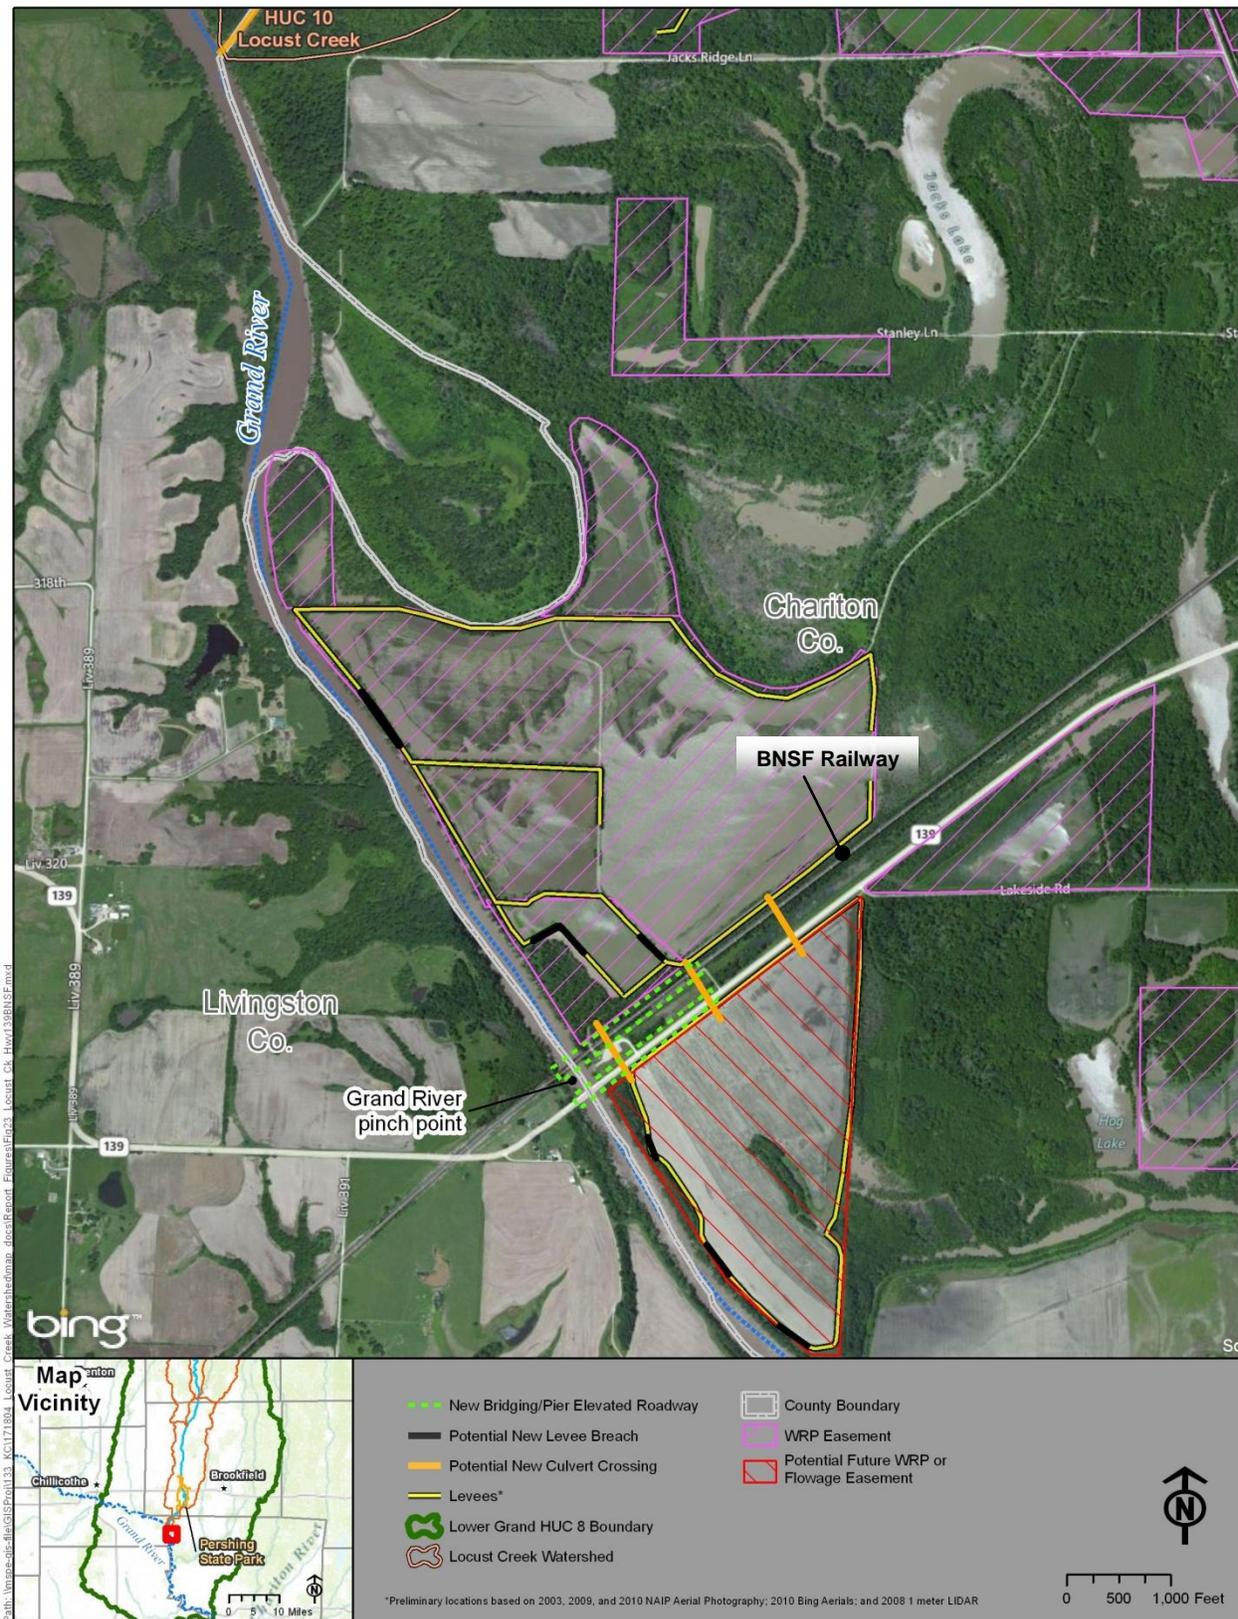
Figure 33: Hwy 139/BNSF Railroad Floodway Drainage Improvements

This restoration action consists of improving floodway sediment transport and drainage capacity through the bridge openings and fill embankments of Hwy 139 and the BNSF Railway running across and constricting the Grand River floodway west of Sumner, Missouri. This constricting location is one of several pinch points on the LGR floodway that could be constricting flood drainage and sediment transport on the LGR and LLC, and causing upstream channel bed aggradation. New bridge structures and/or the addition of pier elevated road and track structures would potentially be highly effective in increasing sediment transport. Levee modifications and flowage easements may also be necessary on adjacent properties for this action as shown in Figure 33 to help convey floodwater. Private lands would be needed for a flowage easement. This action, though outside the LCW, but within the Lower Grand watershed containing LC, is considered a potentially highly important restorative action. This action would require further detailed hydrology & hydraulics analysis to determine whether it could create meaningful benefits to LC and the LGR. Currently there is a WRP easement on the north side of these transportation corridors, which is reported by MDNR to capture floodwater primarily from LC flooding. This WRP easement appears to be providing substantial floodway benefits. Consideration for other floodway improvements should be investigated to see if additional modifications would be necessary. If constricting bridges exist, then focus should be first placed on remedying restoring sediment transport in the LGR channel. This action would likely be technically feasible, but extremely expensive, but could produce high system wide benefits. This practice would be difficult to gain acceptance from MoDOT, BNSF Railway, adjacent private landowners, and local taxing and governing jurisdictions.

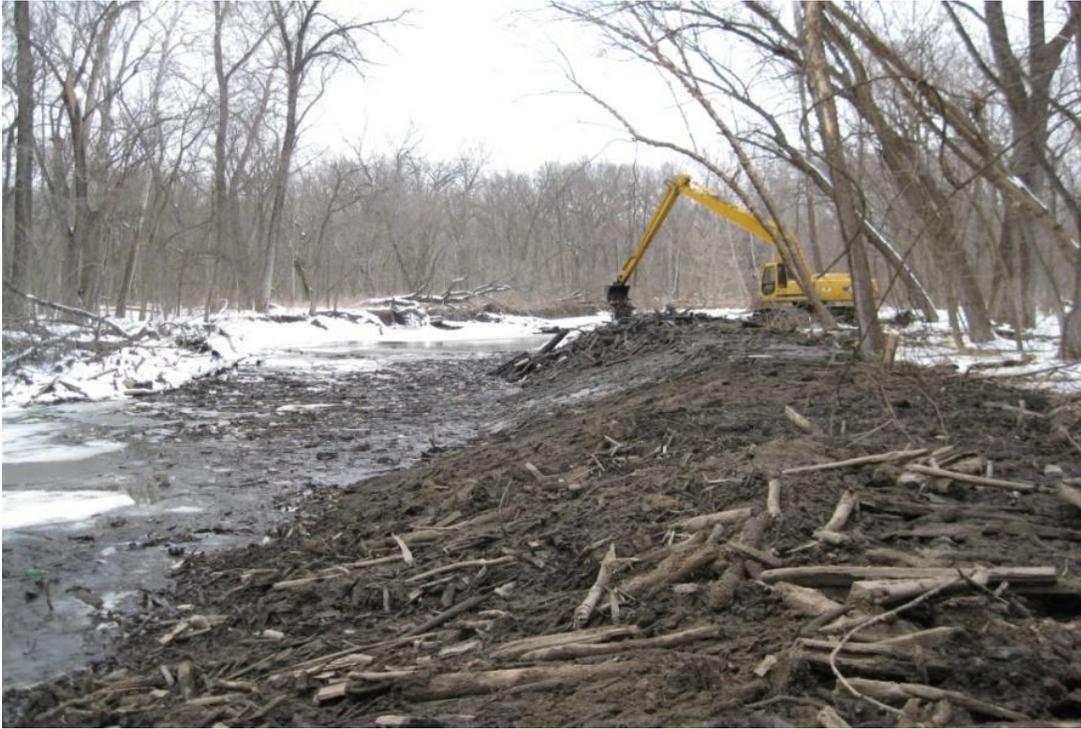
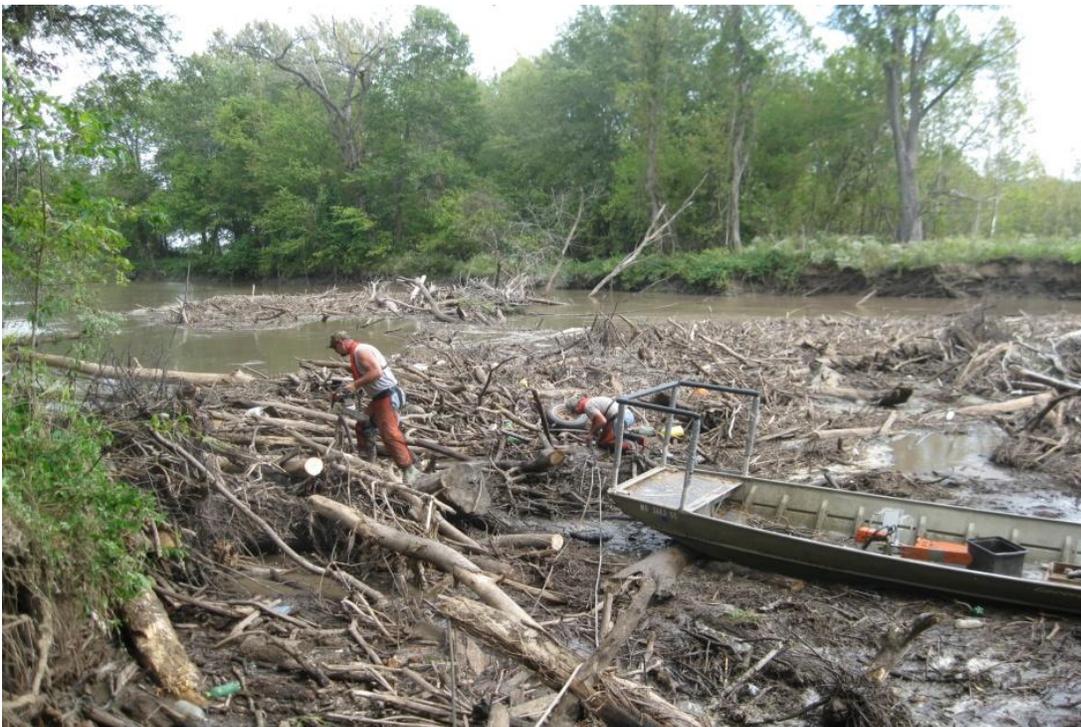
**Figure 35: On-going Natural Resource Management – Log Jam Removal**

This restoration action consists of on-going resource management practices that are necessary or desired in order to continue providing natural resources functions in the watershed. Current natural resource management practices include log jam removal and management on LC in PSP and at bridges and culverts throughout the watershed. Potential new natural resource management practices include invasive plant species management (prescribed burning, etc.) and native plantings for restoration purposes. Functional results of log jam management include restoring flows to pass sediments and reduced flooding issues. Functional results of invasive plants species management and native plantings are to restore native biological plant diversity key to supporting ecosystem health. Costs can vary widely on individual resource management practices. Land owner and public concerns are expected to be neutral to fully supporting. Figure 35 below depicts log jam removal on LC in PSP.

Personnel from PSP conduct low impact log jam management (Figure 35). Personnel at PSP do actively watch for early log jam formations during high flow events to try to catch and eliminate log jams early on before they become sizable. PSP personnel use two low impact methods for removal. Low impact methods are necessary due to the sensitive nature of adjacent floodplain wetlands and permitting considerations. One method involves operating a motor boat up to a log jam and using chainsaws and winches to cut up, move and re-mobilize woody debris to float downstream. The second and preferred method is to place woody material with an excavator on inside channel bends during low flow to form instant point bars, which collect sediment and lock into place. These bars natural re-vegetate over time with tree

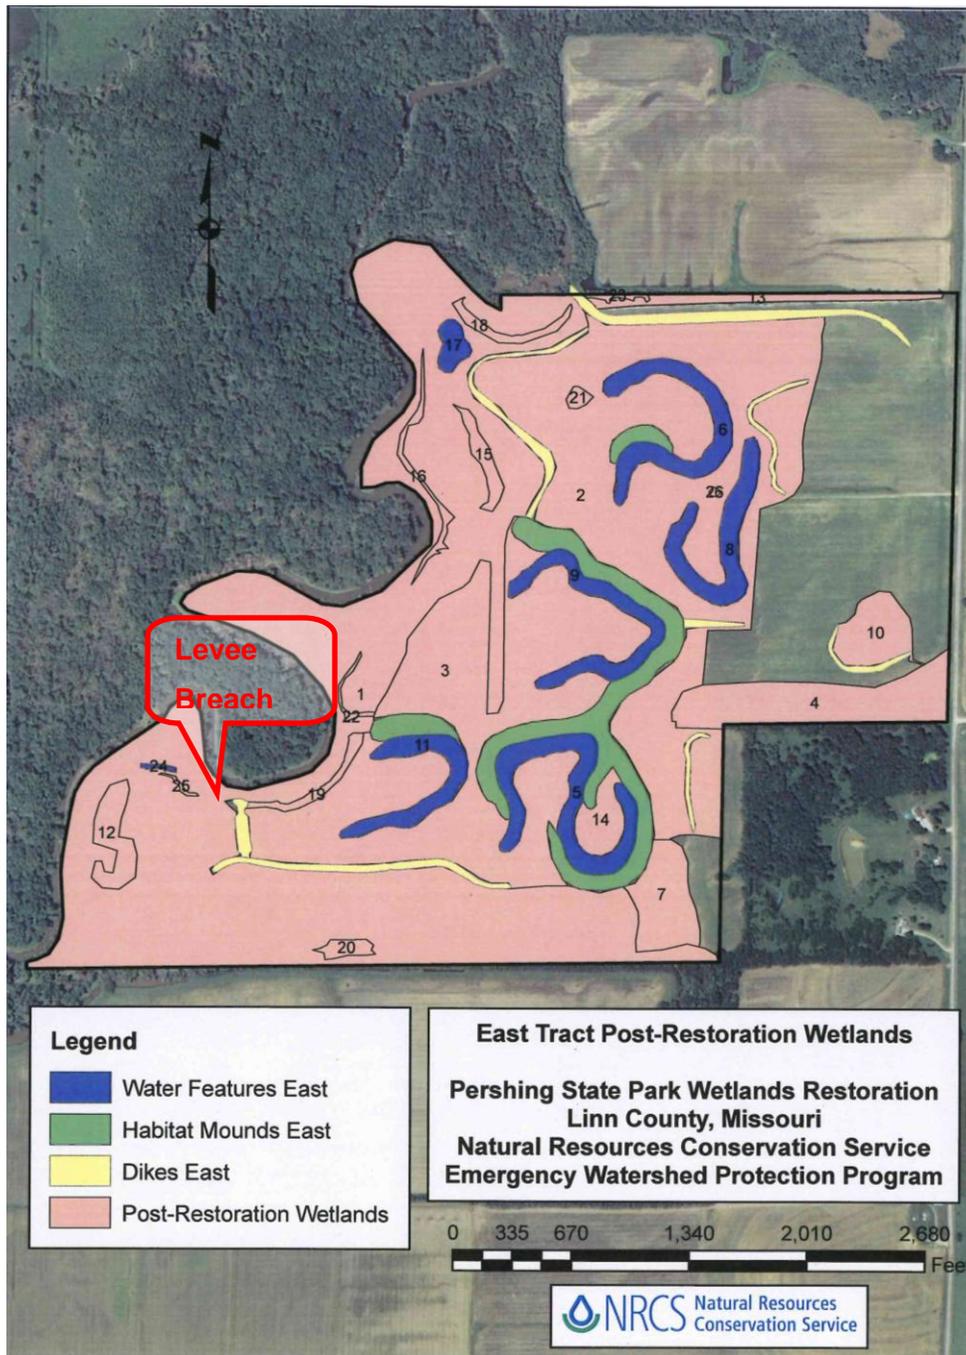
Figure 41: Pershing State Park – Zell Tract East Wetland Restoration Plans

Figure taken from NRCS geospatial analysis of West Zell Tract wetlands restoration (NRCS, ca. 2011).

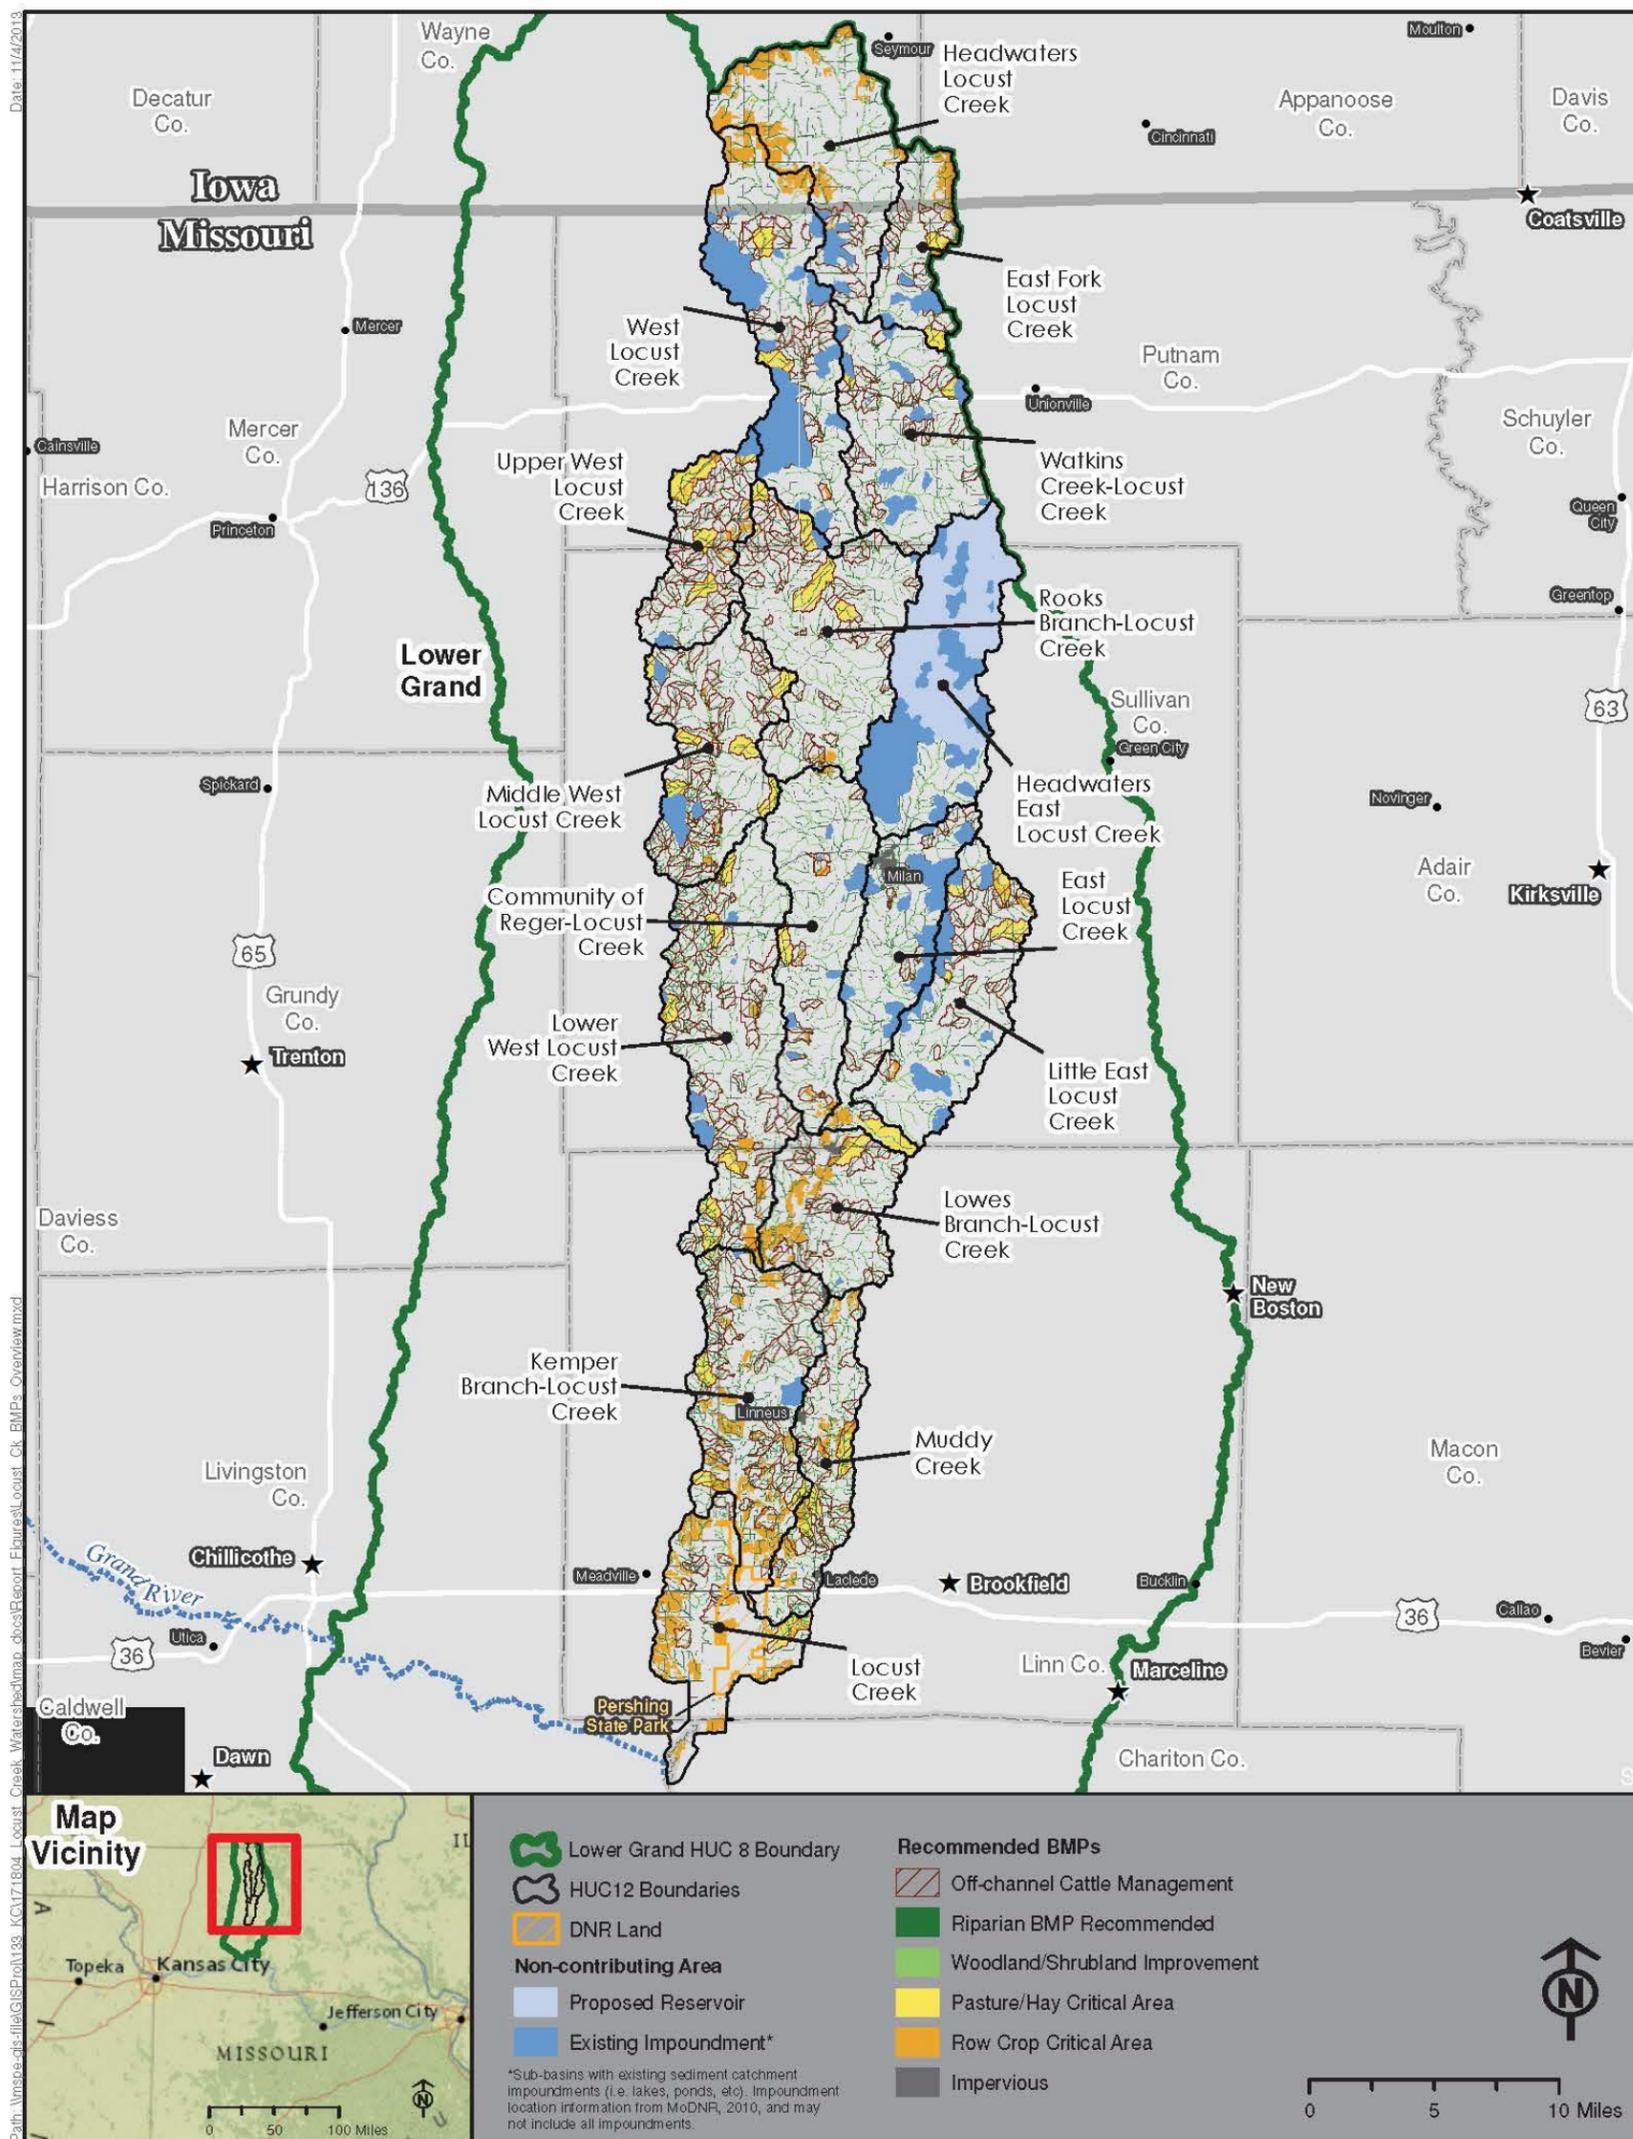
Figure 42: Landscape Level Recommended BMPs Locations within the LCW

Table 8 below and sited in the LCW as shown in Figure 42. These land cover/use BMPs are Off-channel Shade (Cattle Management), Riparian (Buffer), Riparian Woodland/Shrubland Improvement, Row Crop Critical Area, and Pasture/Hay Critical Area. They were developed based on potential CSA's with high and very high RPLs, impervious areas, limited riparian buffer areas, and/or those pastures with limited off-channel shade for cattle (and other livestock) more than 100 feet away from streams. The BMP locations identified in Figure 42 are also detailed by sub-watershed in the Appendix C map book (sheets 1 – 16). Combining off-channel shade with off-channel livestock water sources could add even more benefit of reducing riparian and channel bank erosion through reduced use and behavioral changes of cattle. Little to no future BMP work should be conducted in areas of existing and/or future impoundments/reservoirs as shown on Figure 42 and in Appendix C. For example, several of the ELC HUC-12 sub-watersheds in Figure 42 have extensive existing and proposed future impoundments/reservoirs which would function as sediment catchment and thus BMPs implemented in those would do little to aid in downstream sensitive reach sediment loads.

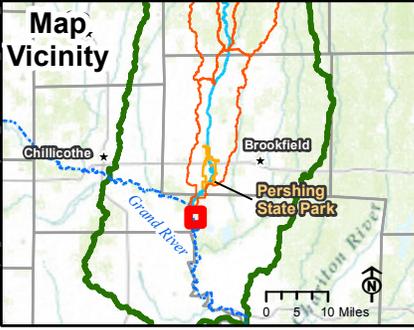
**Lower Grand River Hwy 139/BNSF Drainage Improvements Alternative**

- New Bridging/Pier Elevated Roadway
- Potential New Levee Breach
- Potential New Culvert Crossing
- Levees\*
- Lower Grand HUC 8 Boundary
- Locust Creek Watershed
- County Boundary
- WRP Easement
- Potential Future WRP or Flowage Easement

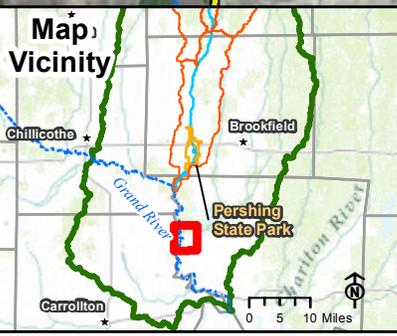
### Lower Grand River Floodway and Levee System Modifications Alternative

- Lower Grand HUC 8 Boundary
- Garden of Eden Proposed Setback Levee
- Existing Levee Takedown
- Existing Levees\*
- National Wildlife Refuge
- WRP Easement
