**National Register of Historic Places  
Registration Form**

historic name Richland Christian Church

Richland Christian Church  
Callaway County, MO

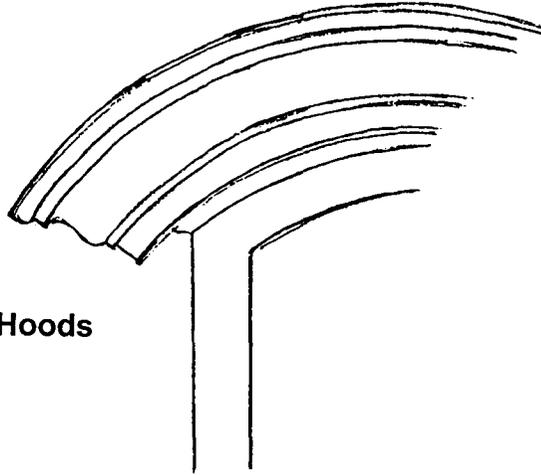
Figure 1. Window Hoods

The window and door hoods consist of five visible elements on a base frame. Their total height is approximately five inches. Layers of quarter inch wood serve as tops and bottoms. Beginning at the

bottom is a 1¼" plain board, a 1¾" crown mold, and a ½" quarter round. All parts are curved to match the segmental arches. (Figure 1)

The minimal ornamentation on the Richland Christian Church is in the Italianate style, and is expressed in the rounded hoods over windows and the primary entrance. Because the building is otherwise relatively plain, the impact of the hoods—a hallmark of Italianate architecture regardless of whether they are highly elaborated or relatively plain—is amplified. These hoods are unique in Callaway County. Of 33 rural 19<sup>th</sup> century religious properties in the county, Richland is the only one with segmentally arched windows and hoods. Most vernacular church buildings in Missouri either have flat head or, perhaps, Gothic windows. A circular window is sometimes present in the upper front gable end of Italianate buildings, and the jigsawed trefoil in the front gable of the Richland Christian Church is suggestive of such a window. Except for its shaped windows with hoods and a trefoil, the Callaway County building exemplifies the majority of rural church buildings of its period in appearance as well as size.

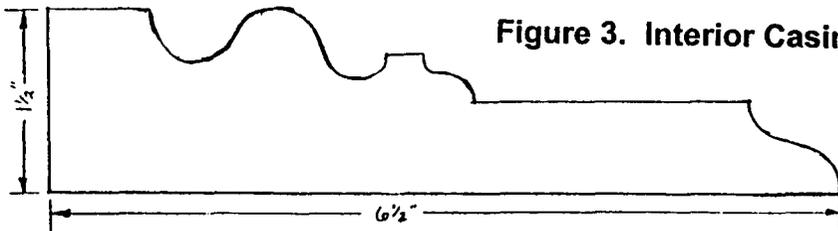
Figure 3. Interior Casing

Original 6" pine boards run the length of the room from north to south. The millwork and window enframements have been painted dark brown. Interior window tops and transoms are rectangular with segmental upper glass panes. The space between the rectangular sash and the segmental panes is filled with wood. The original 6½" window and door casings are intact. (Figure 3) The front door has been clad on both sides with ¼" plywood. Its casing has an additional 1" x 2-1/2" flat board attached at the outside edge, making the casing 7½" wide and 3½" thick. This deeper casing allows for some of the extra depth of the door jamb for the small framed panels.

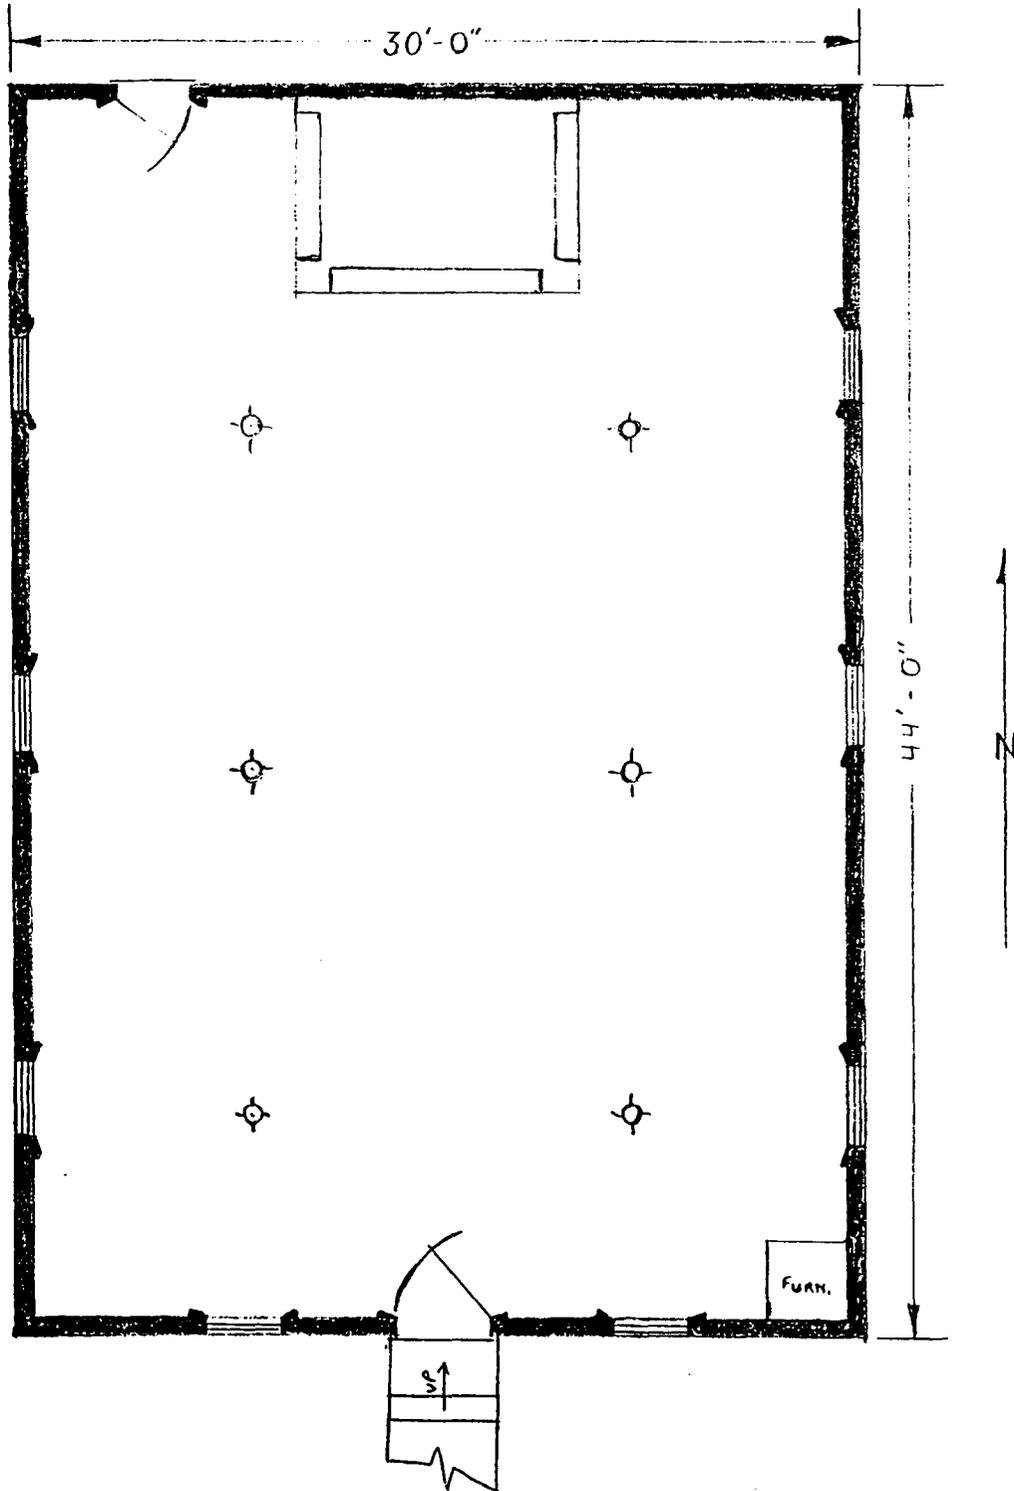
Figure 4. Floor Plan

**Interior:** The church interior consists of a single rectangular room with an arched ceiling. By design or coincidence, the arched ceiling complements the segmental windows and transom. In the middle of the room, two stove pipe hole covers in the ceiling indicate where the original heating stoves had been vented. The stoves were removed in the 1940s and a propane gas furnace was added in the southeast corner.<sup>2</sup> A red carpet runner extends from the entrance door to the pulpit area. Similar carpet upholsters the approximately one foot high rostrum platform at the north end.

The ceiling consists of 4'x4' framed panels of a Masonite-type material which also covers the walls above a chair rail just below the windows. Paneling has been added over the original wainscot. (Floor plan - Figure 4)

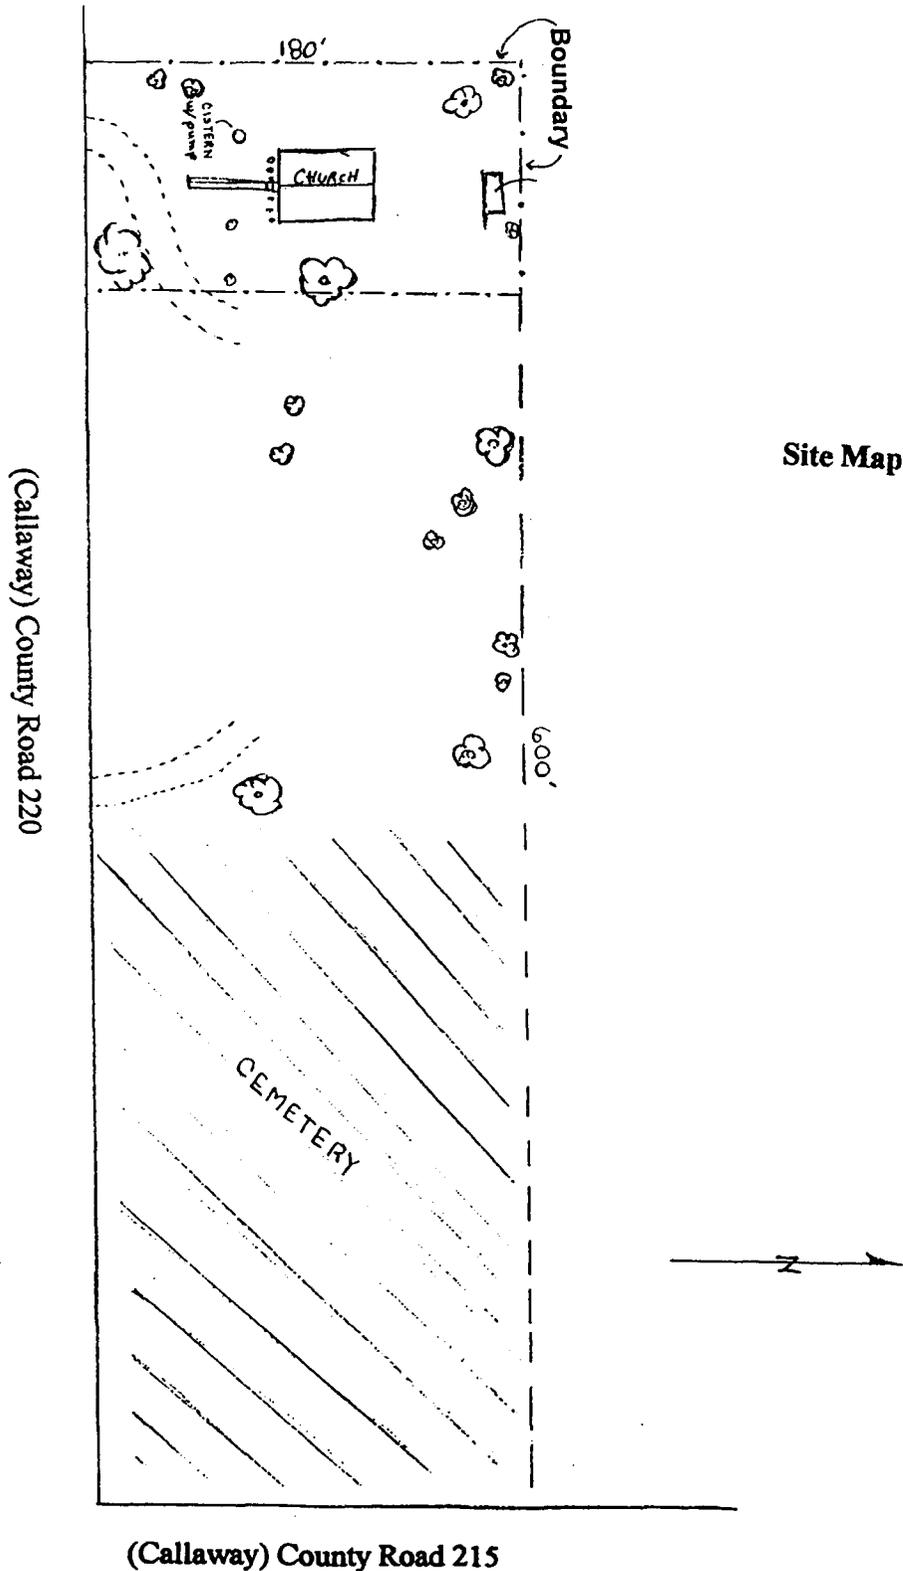
Site Map

The setting of Richland Christian Church remains relatively pastoral. The church is associated with a small cemetery that predates it. The yard contains several mature trees. In addition to the outhouse, a cistern with a hand pump is also nearby. To the south, Richland Creek from which the church takes its name flows through a landscape of gentle hills. Ultimately, the owner plans to let the buildings be moved as the last option to assure their continued preservation.

Constructed in 1912, the outhouse is a small, shed-roofed building measuring 9½' east-west by 5' north-south. A privacy wall attached to the southeast corner extends eastward. Another privacy wall (no longer intact) was attached to the southwest corner and extended westward. The outhouse is constructed from six primary tree-posts of which four are located in the corners of the west compartment and two in the northeast and southeast corners of the east compartment. Horizontal 2x4s are attached to the posts. The building is clad with vertical wide tongue and groove boards. Rafter ends are visible on the north and south sides below the corrugated metal roofing. Doors are made of planks held together by interior “z” braces. Simple diamond-shaped pieces of wood hold the doors shut; hooks are on the inside. Two small window openings are in the south elevation; the west opening has a single light sash attached on the interior. The front and top boards with square holes and modern style toilet seats are intact in both compartments.

The cistern and pump were added near the southwest corner of the church in the same year that the outhouse was built, 1912.
