**National Register of Historic Places  
Registration Form**

historic name Wallendorf, Joseph and Elizabeth, House

Other: 2-story log dogtrot

**Wallendorf, Joseph and Elizabeth House**  
**Cole County, MO**

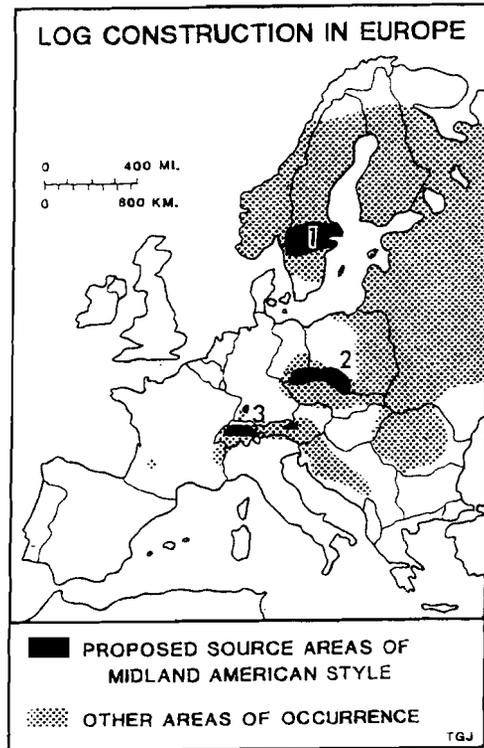
Figure 4: Log Construction in Europe<sup>23</sup>

Figure 1.3. The three potential source areas of Midland American log construction are (1) central Sweden, (2) the Czech-Polish-East German borderland, and (3) portions of the Alpine-Alemannic region in southern central Europe.

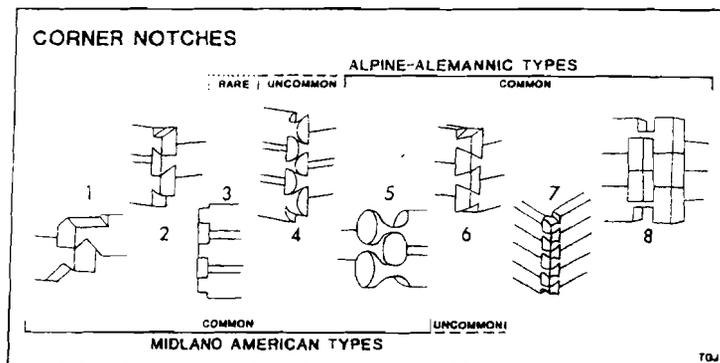
Figure 6: Corner Notches<sup>34</sup>

Figure 4.7. The types shown are (1) V notch, (2) half-dovetail, (3) square, (4) semilunate, (5) saddle, (6) full-dovetail, (7) flared full-dovetail, and (8) double.

The logs are joined at the corners using a half-dovetail joint. The logs are squared on the sides, so the exterior and interior walls are as straight as possible. The space between the logs is partially filled by wooden slabs placed on a slant, or blocking, which is covered by chinking. (A small section of wooden blocking material remains visible in both first floor rooms, for educational purposes.) At door and window locations, a wooden board covers the exposed ends of the logs, forming a frame for the door or window. All of the chinking in the house is new, and is a soft lime mortar. In order to make the house as comfortable as possible for visitors, insulation was placed between the logs. Then wire mesh was installed between the logs so that it curved inward. Chinking mortar was installed over the wire mesh, to ensure proper adhesion to the logs. The same process was used on the exterior and the interior. None of the insulation or wire mesh is visible once the chinking is in place. The mortar is already beginning to darken and appear more natural.

The notching technique used in the Wallendorf House is a half-dovetail, with the ends of the log planks trimmed to be flush with the exterior wall. Corner notchings traditionally used by German builders were designed so that moisture would drain away from the joint, preventing wood rot in this critical joint. The butts of the notches were trimmed to be flush with the wall.<sup>31</sup> The logs of the Wallendorf House are oak, the favorite wood used for walls of log houses in Missouri.<sup>32</sup> Except for smaller houses, the logs were dressed on two sides to form a wood plank 6 to 8 inches thick, with vertical surfaces of 10 to 18 inches. The planks were easier to raise into position than full logs, and provided necessary structural support when well notched at the corners. Further stability was provided by door and window frames, as well as the ceiling joists that were notched into the wall logs.<sup>33</sup>
