Draft Interim Report

Voluntary Lead Remediation of Smile Learning Center and Residential Properties in the Vicinity of Midwest Recycling

MW Recycling Inc.

AMEC Environment & Infrastructure, Inc.
15933 Clayton Road, Suite 215
Ballwin, MO 63011

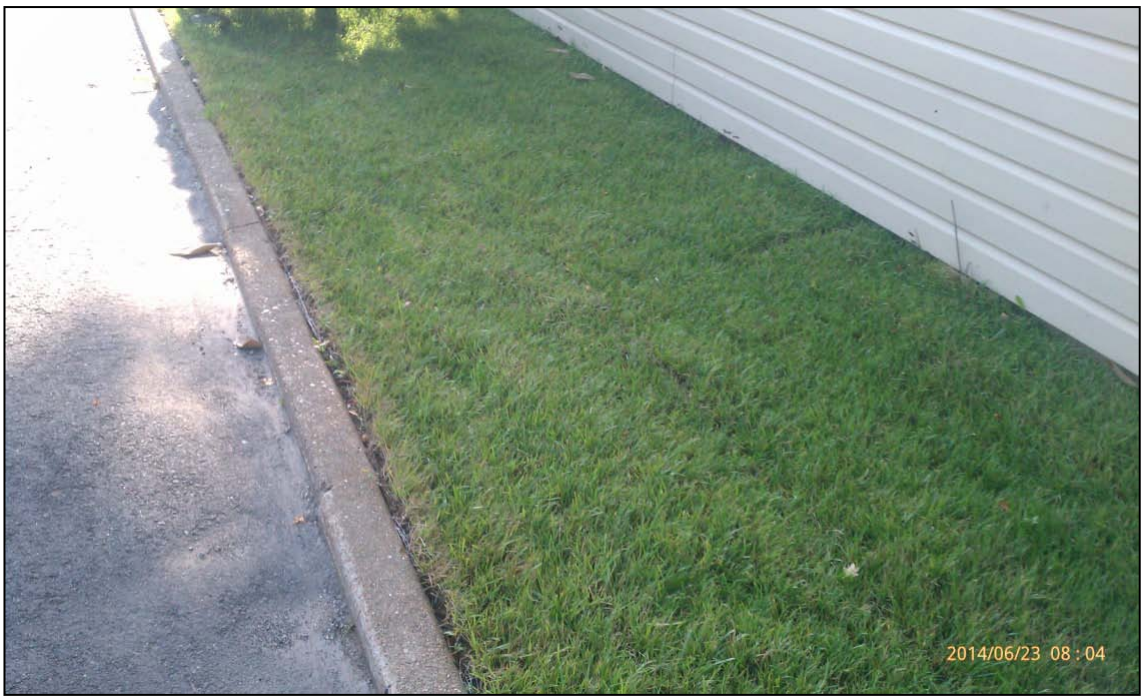
106.1 MDNR Parcel ID 106 – Front Yard Backfill.

106.2 MDNR Parcel ID 106 – Side Yard Restored.

106.3 MDNR Parcel ID 106 – Front Yard Restored.

Depth of Surface Soil Removed:	6 inches
Volume of Lead-Impacted Soil Removed:	10.78 yd^3
Volume of Clean Soil Replaced:	11 yd^3
Square Feet of Sod:	637 ft^2

Horticultural Summary
Sod was placed on backfilled areas, fungicide was applied, rye grass seed was applied for growth enhancement, and a watering schedule adhered to. No additional special vegetation replacement was required.

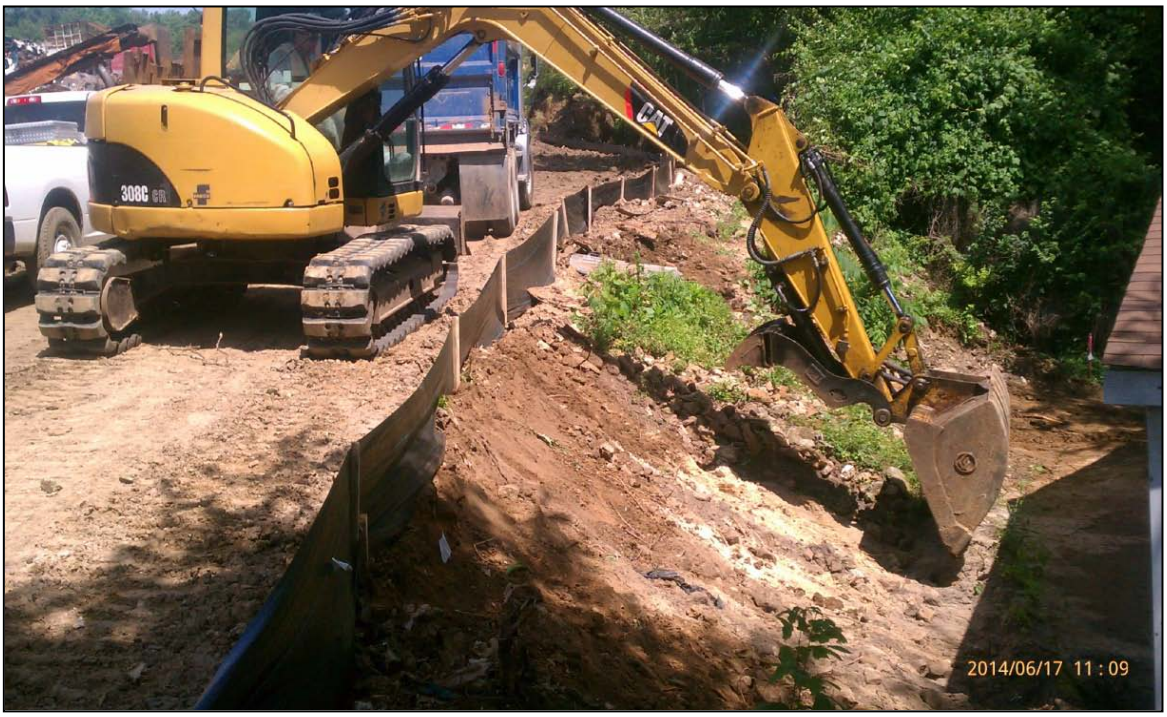
An Environmental Land Use Control (ELUC) barrier was placed at 12 inches below ground surface at area SU1.3 bordering the MWR facility due to final lead concentrations being greater than 400 ppm.

120.1 MDNR Parcel ID 120 – Back Yard Garage Area Remediation.

120.2 MDNR Parcel ID 120 – Back Yard Slope Area Remediation.

120.3 MDNR Parcel ID 120 – Back Yard Slope ELUC Barrier Placed at SU3.

As per change order, an additional 608 square feet (15 cubic yards) of soil, gravel, and rock were excavated and replaced with backfill and capped with rip rap.
