Bridgeton Landfill, LLC

Weekly Data Submittal

Week of May 31, 2020 – June 06, 2020

Required by Section IX.33.g of Final Consent Judgment, Case No. 13SL-CC01088-01
Effective June 29, 2018

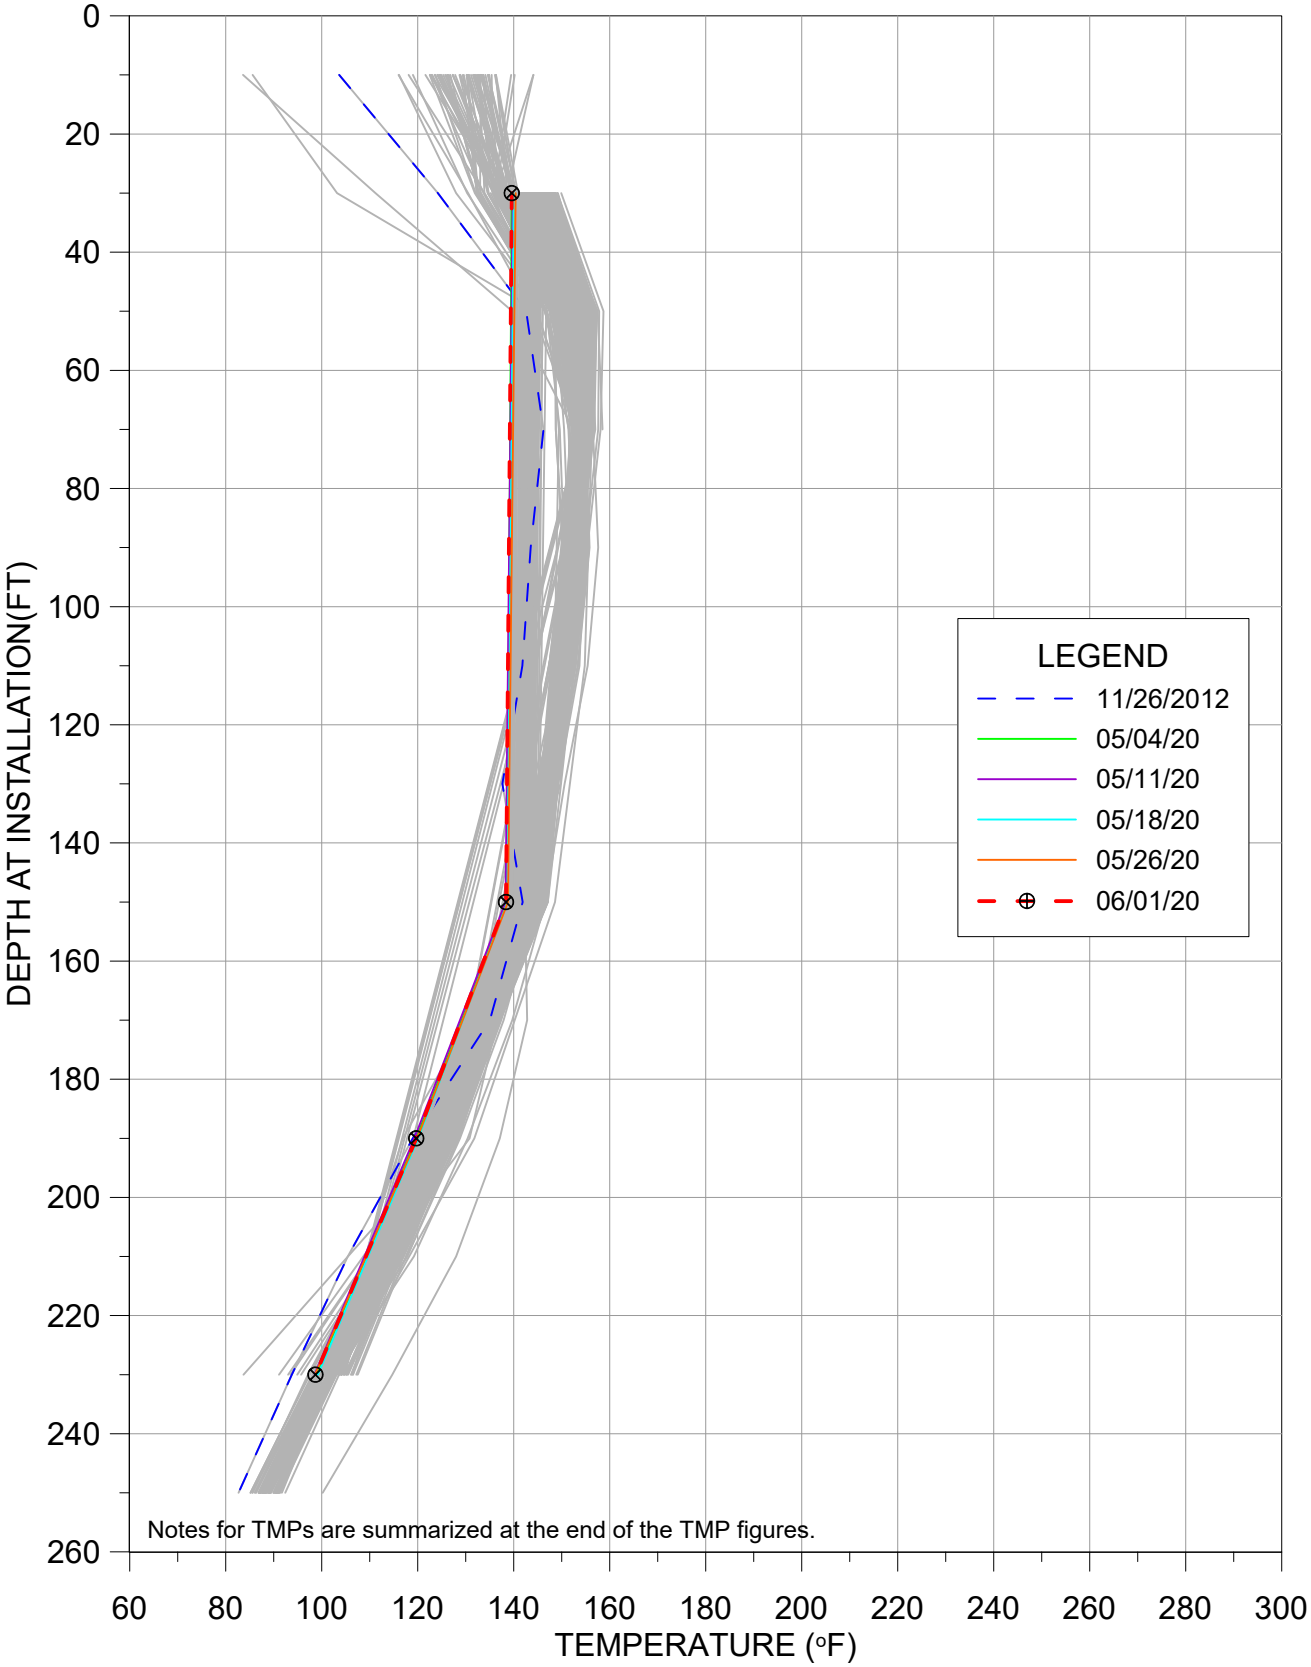
TMP-3

1. No reliable temperature readings have been obtained at 170 ft depth since 1/29/2014, except on 3/13/2014.
2. The connectivity tests on 4/11/2014 conducted by CEC showed that units at 10, 90, 130, 210 and 250 ft depths are no longer reliable.
3. The connectivity tests on 10/28/2014 conducted by Feezor Engineering showed that units at 10, 90, 110, 130, 210 and 250 ft depths are not reliable.
4. The unit at 50 ft depth was fluctuating resistance since 10/1/2018. Therefore the temperature is determined to be unreliable.
5. No temperature reading could be obtained at 70 ft depth since 10/22/2018.

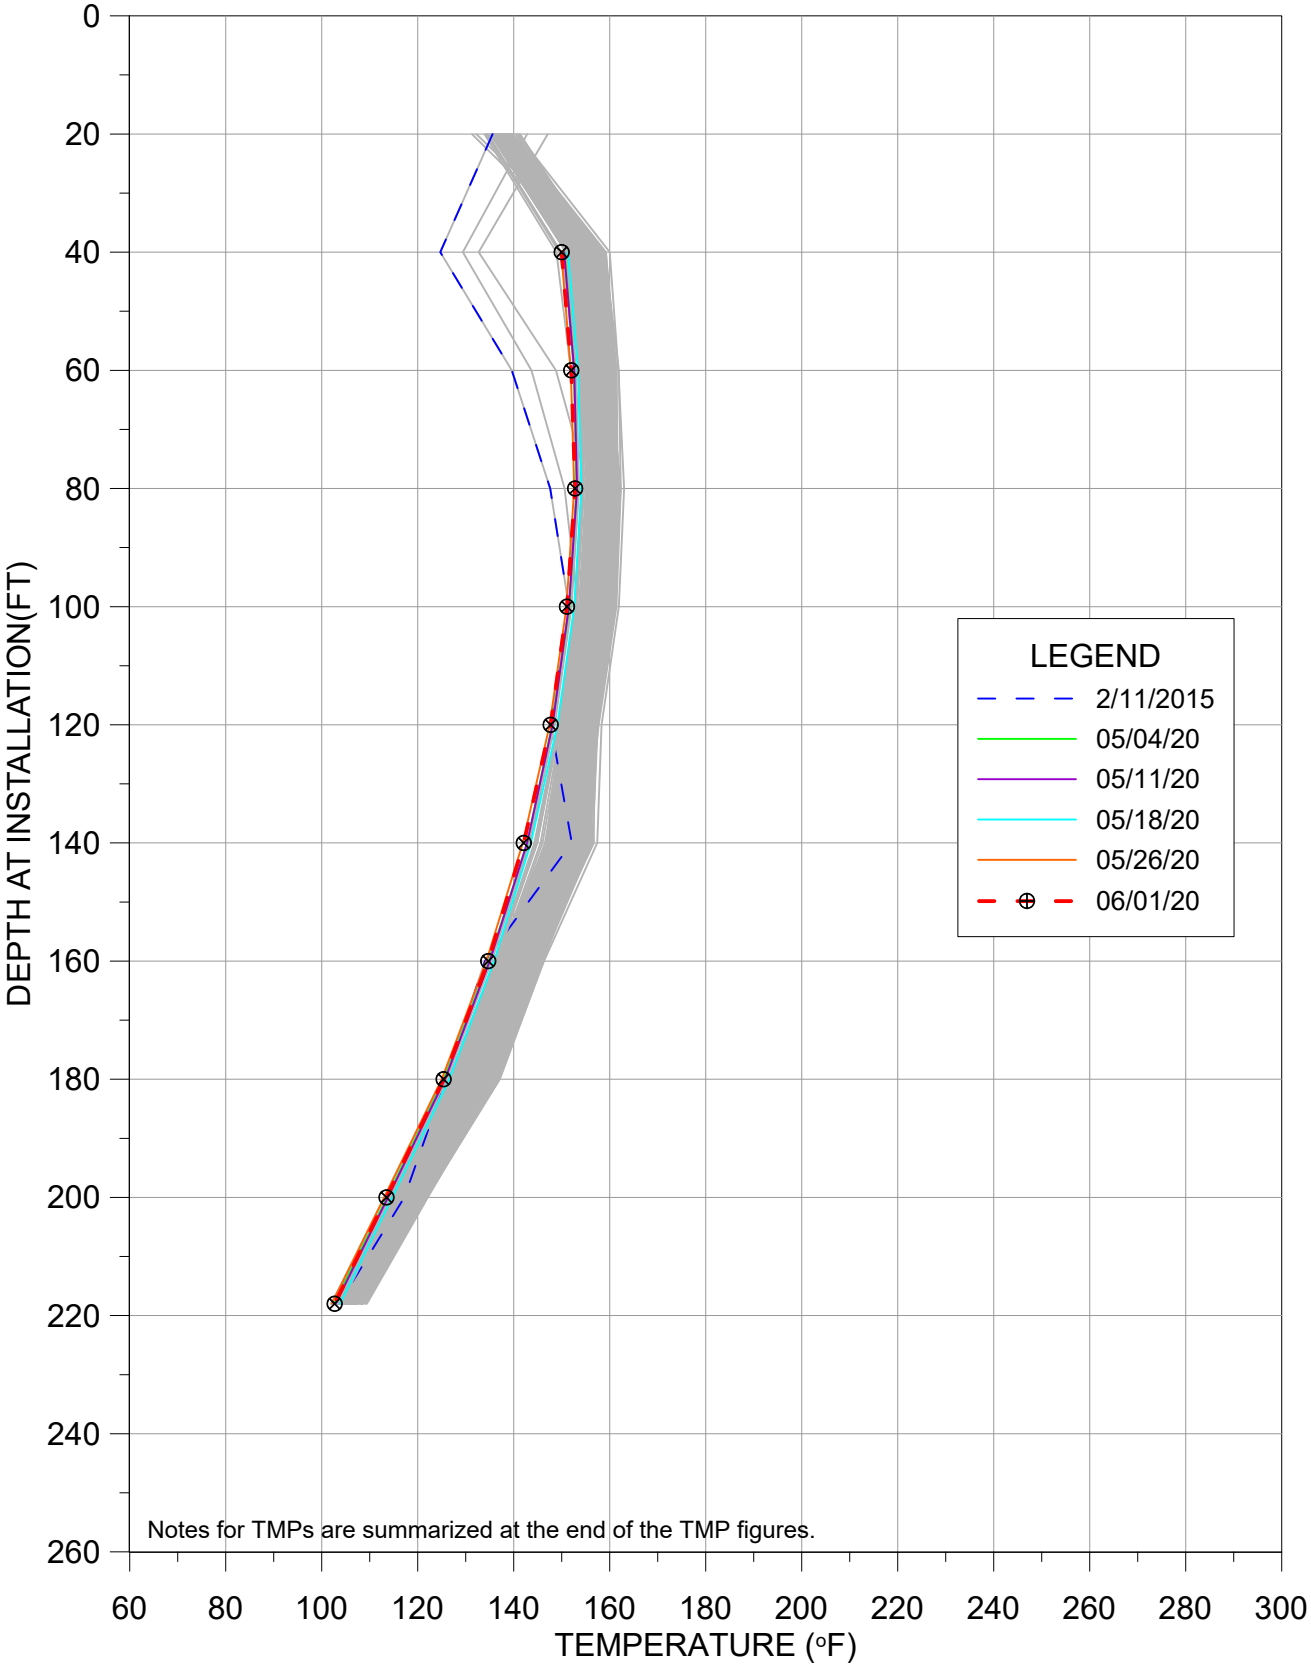
TMP-3R

1. The unit at 20 ft depth had a fluctuating resistance since 9/25/2017. Therefore the temperature is determined to be unreliable.

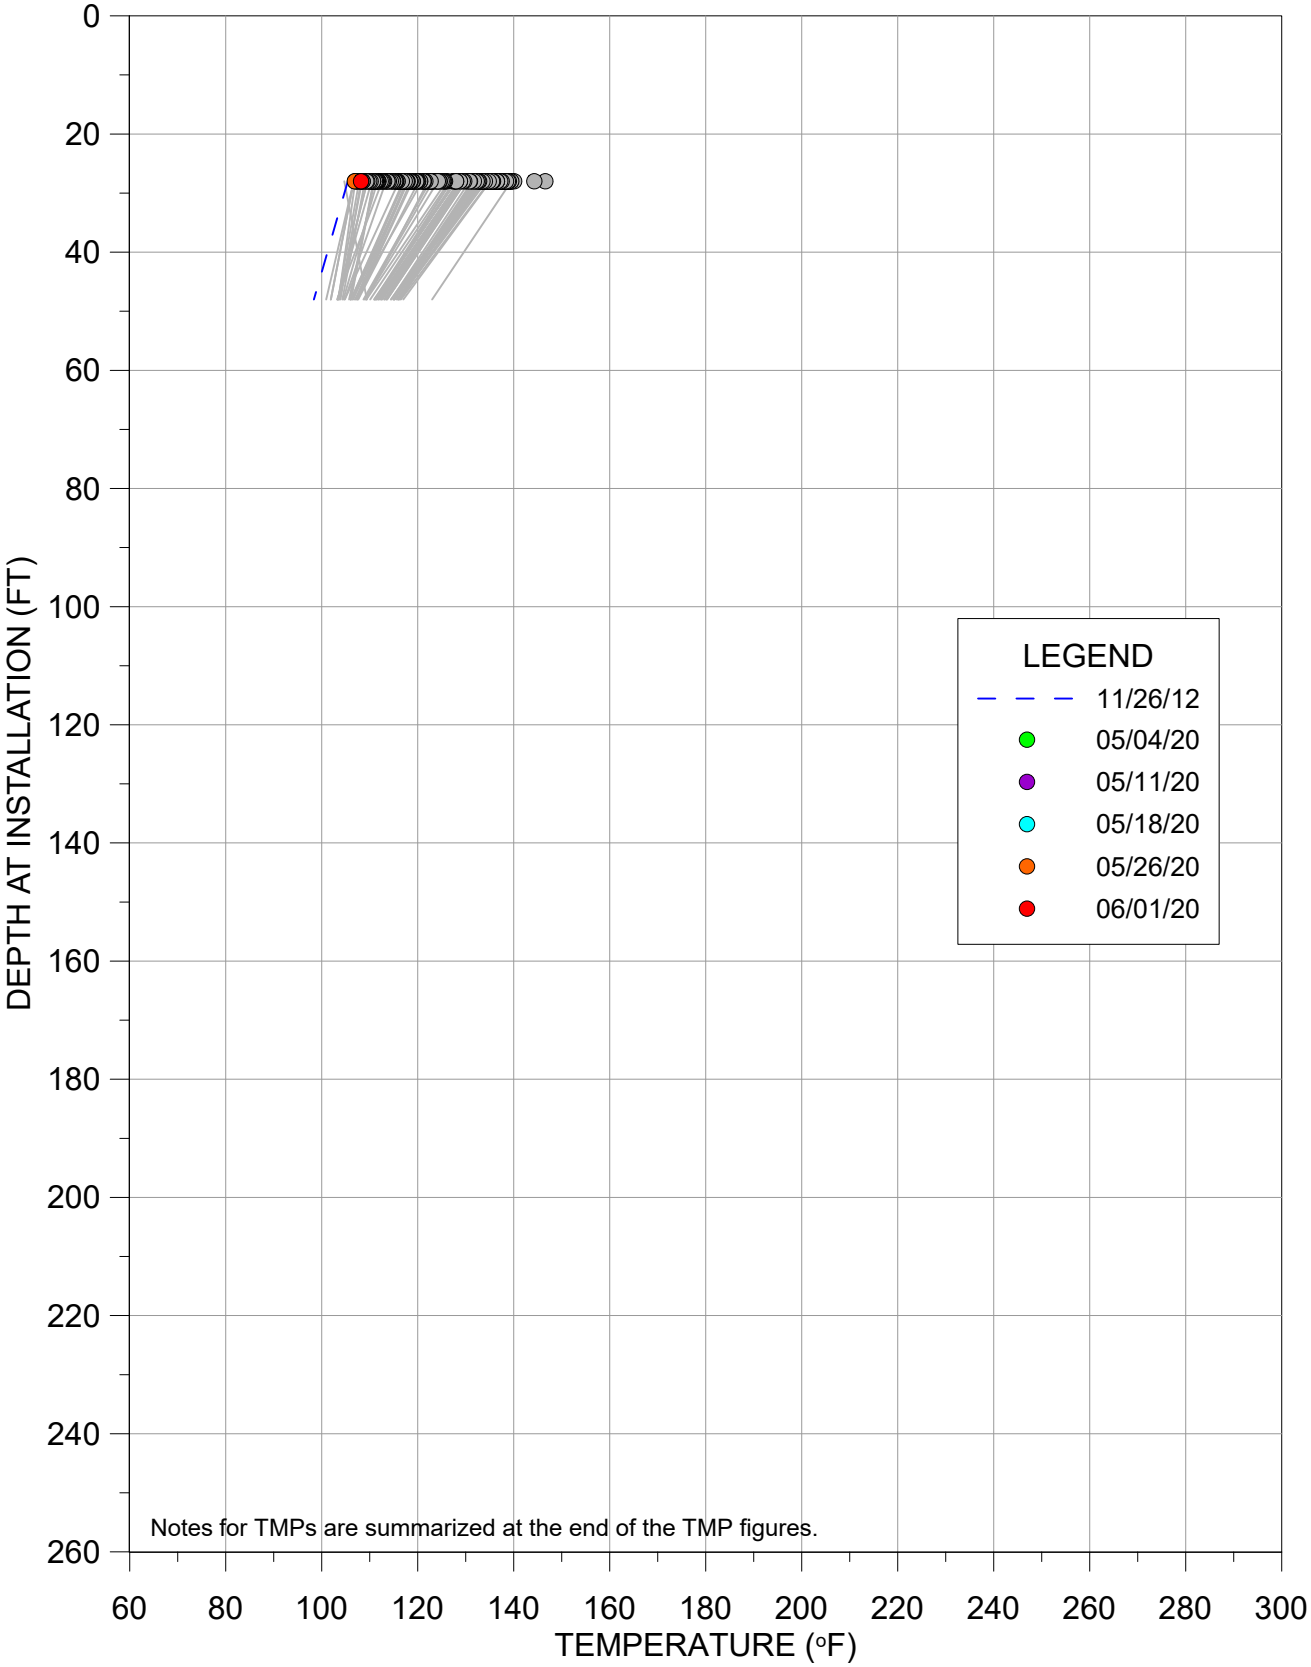
TMP-4

1. The connectivity tests on 4/11/2014 conducted by CEC showed that the unit at 48 ft depth is no longer reliable.

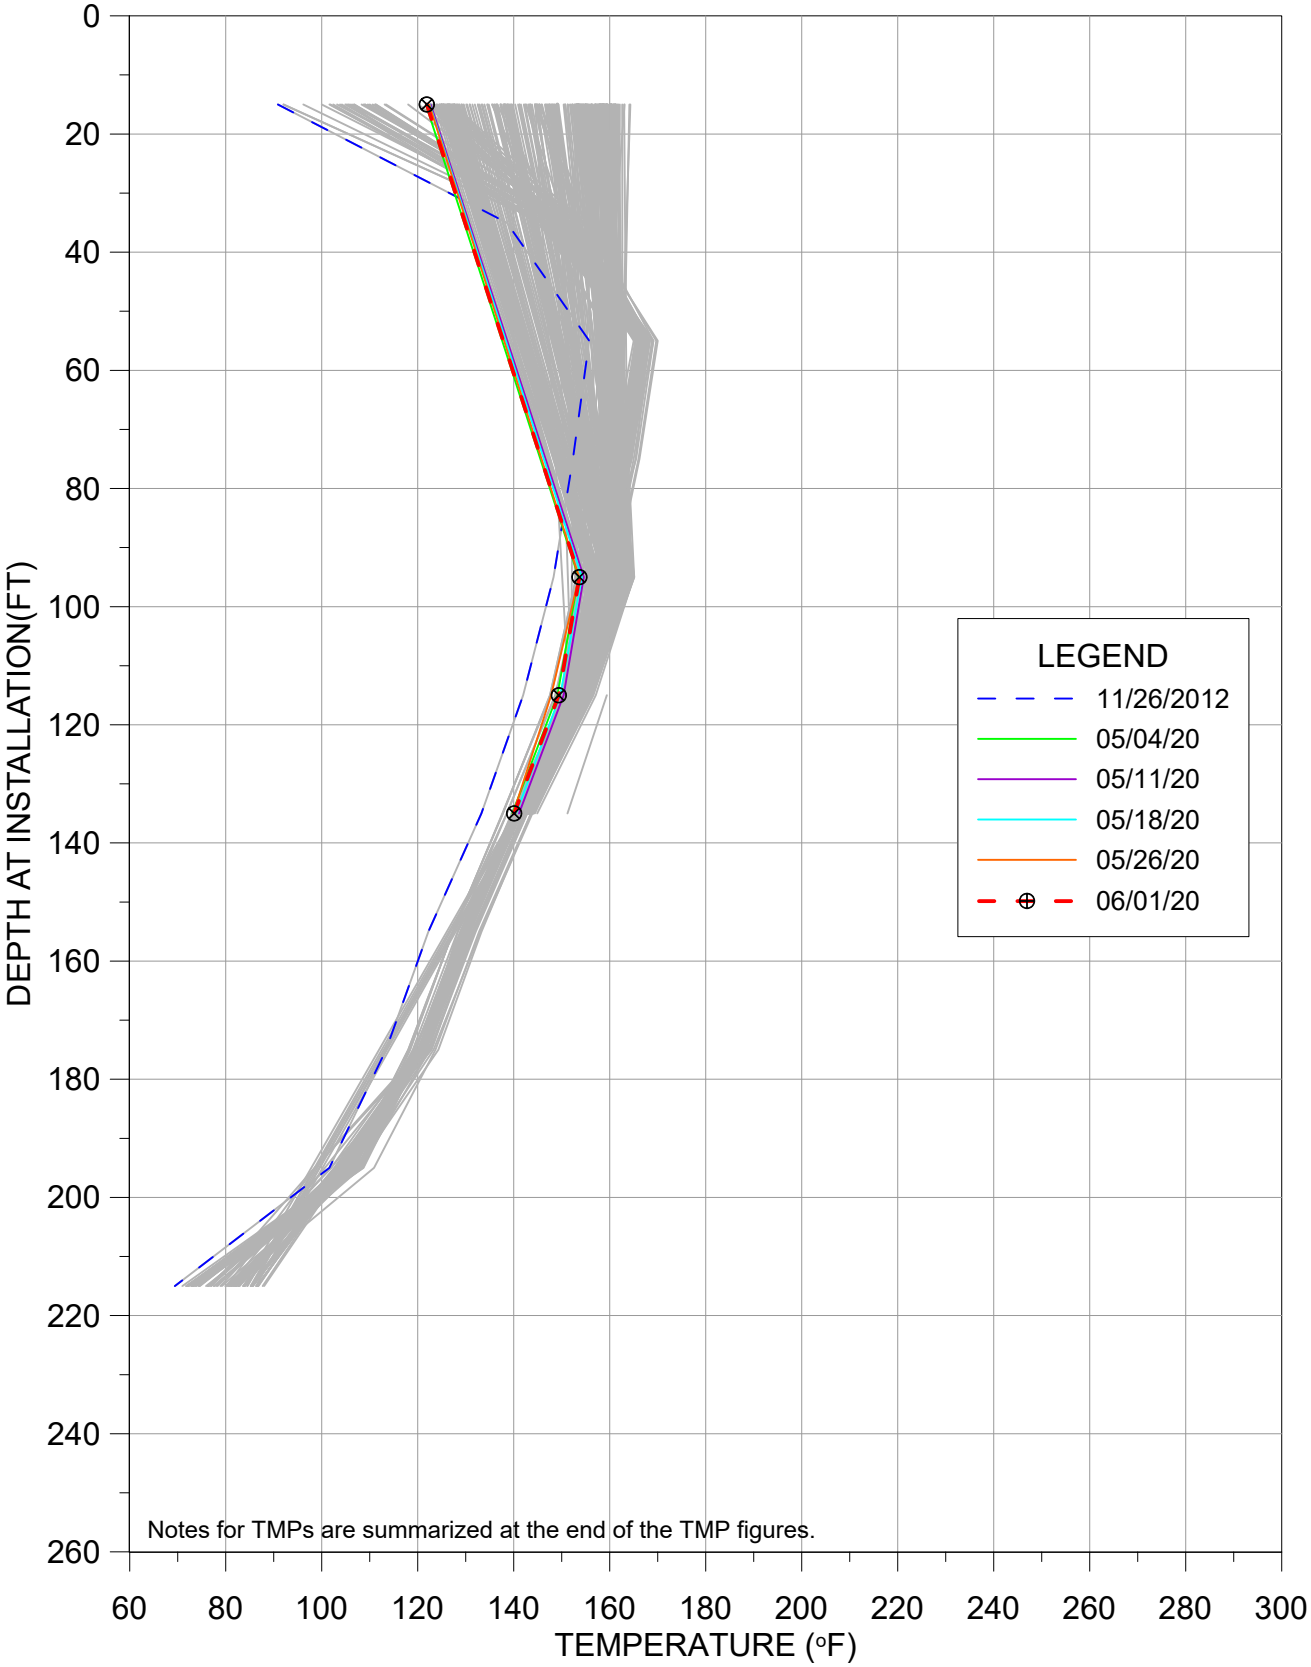
TMP-6

1. The connectivity tests on 4/11/2014 conducted by CEC showed that units at 35, 55, 75, 155, 175, and 195 ft depths are no longer reliable.
2. No reliable temperature readings have been obtained at the unit at 215 ft depth since 6/13/2014.

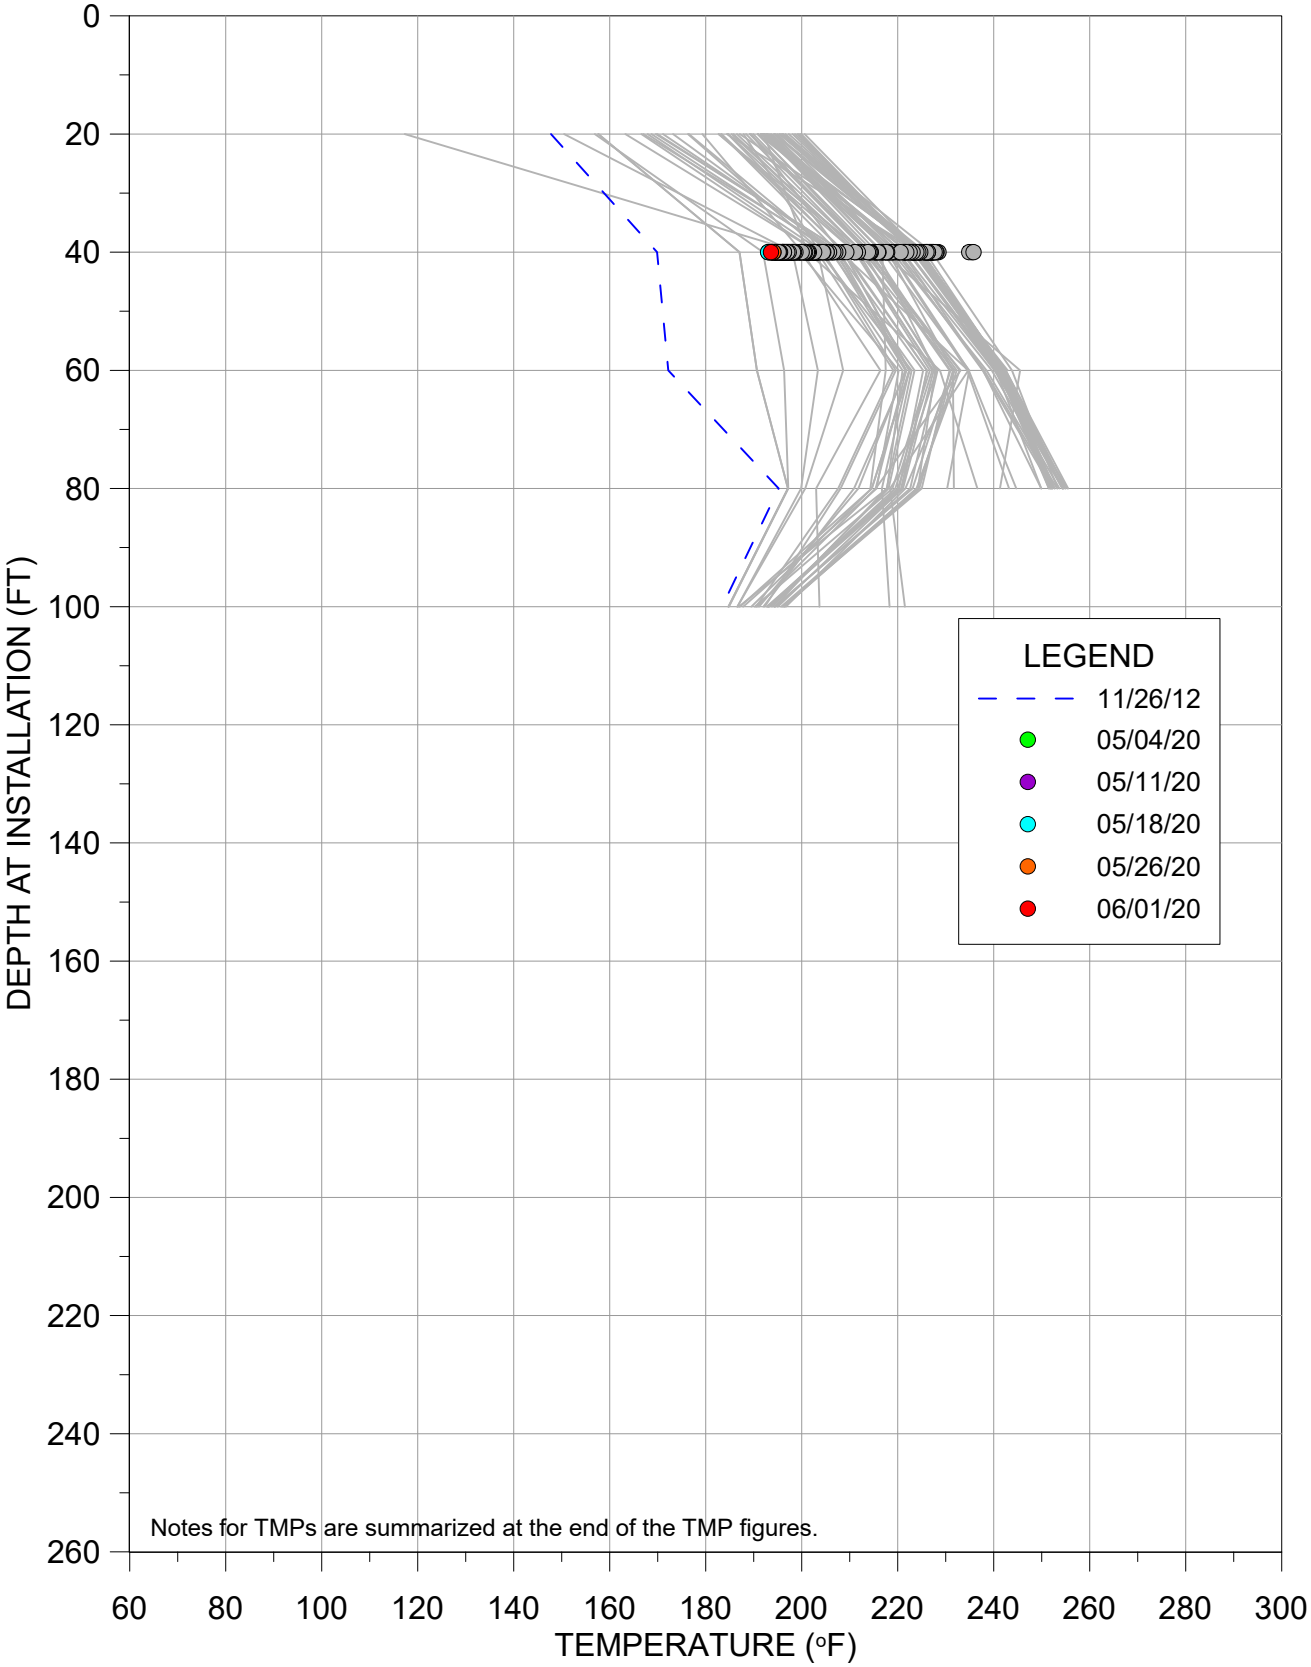
TMP-9

1. Unit at 100 ft depth had an inaccurate temperature reading on 8/1/2013 and no reading since 8/6/2013.
2. The connectivity tests on 4/11/2014 conducted by CEC showed that units at 20, 60, 80, and 100 ft depths are no longer reliable.

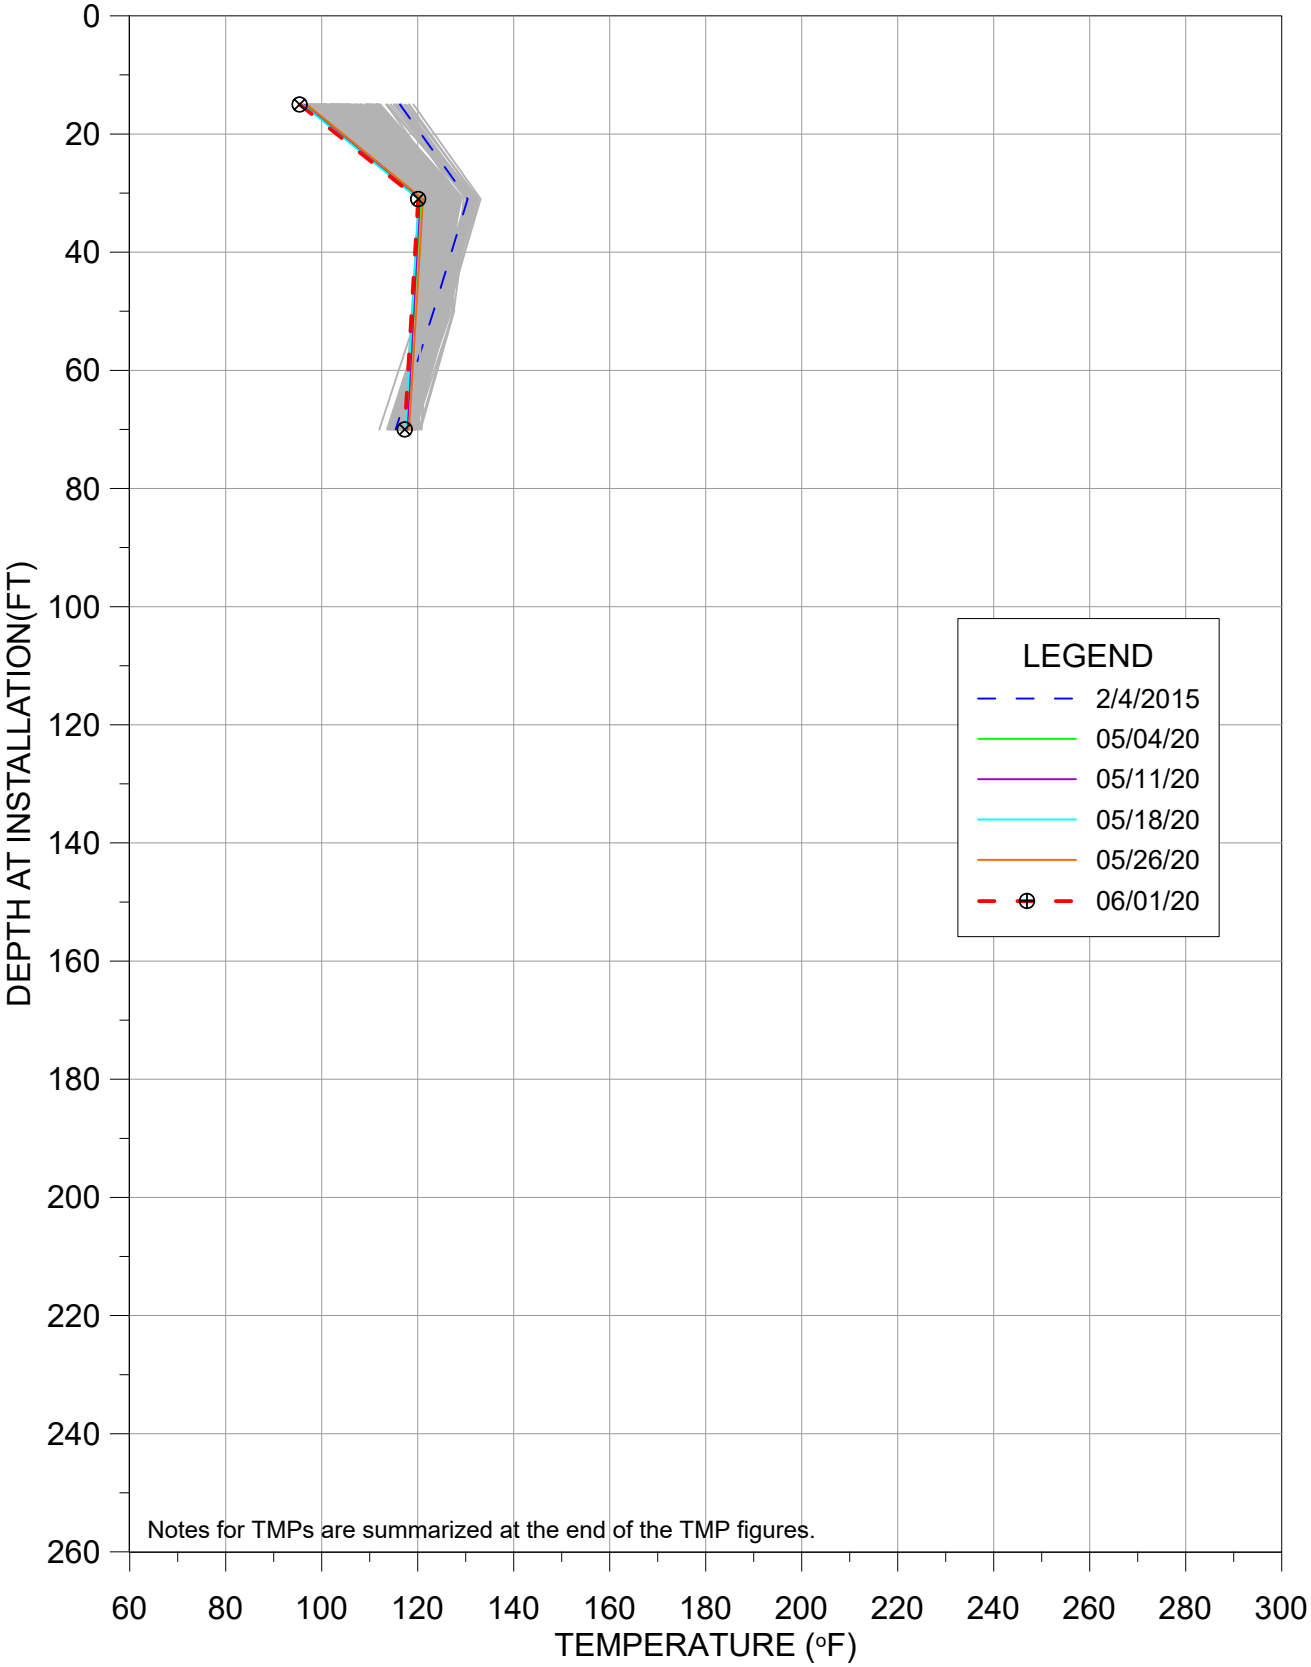
TMP-22

1. No temperature reading could be obtained and resistivity was fluctuating at the unit at 50 ft depth since 4/2/2018.

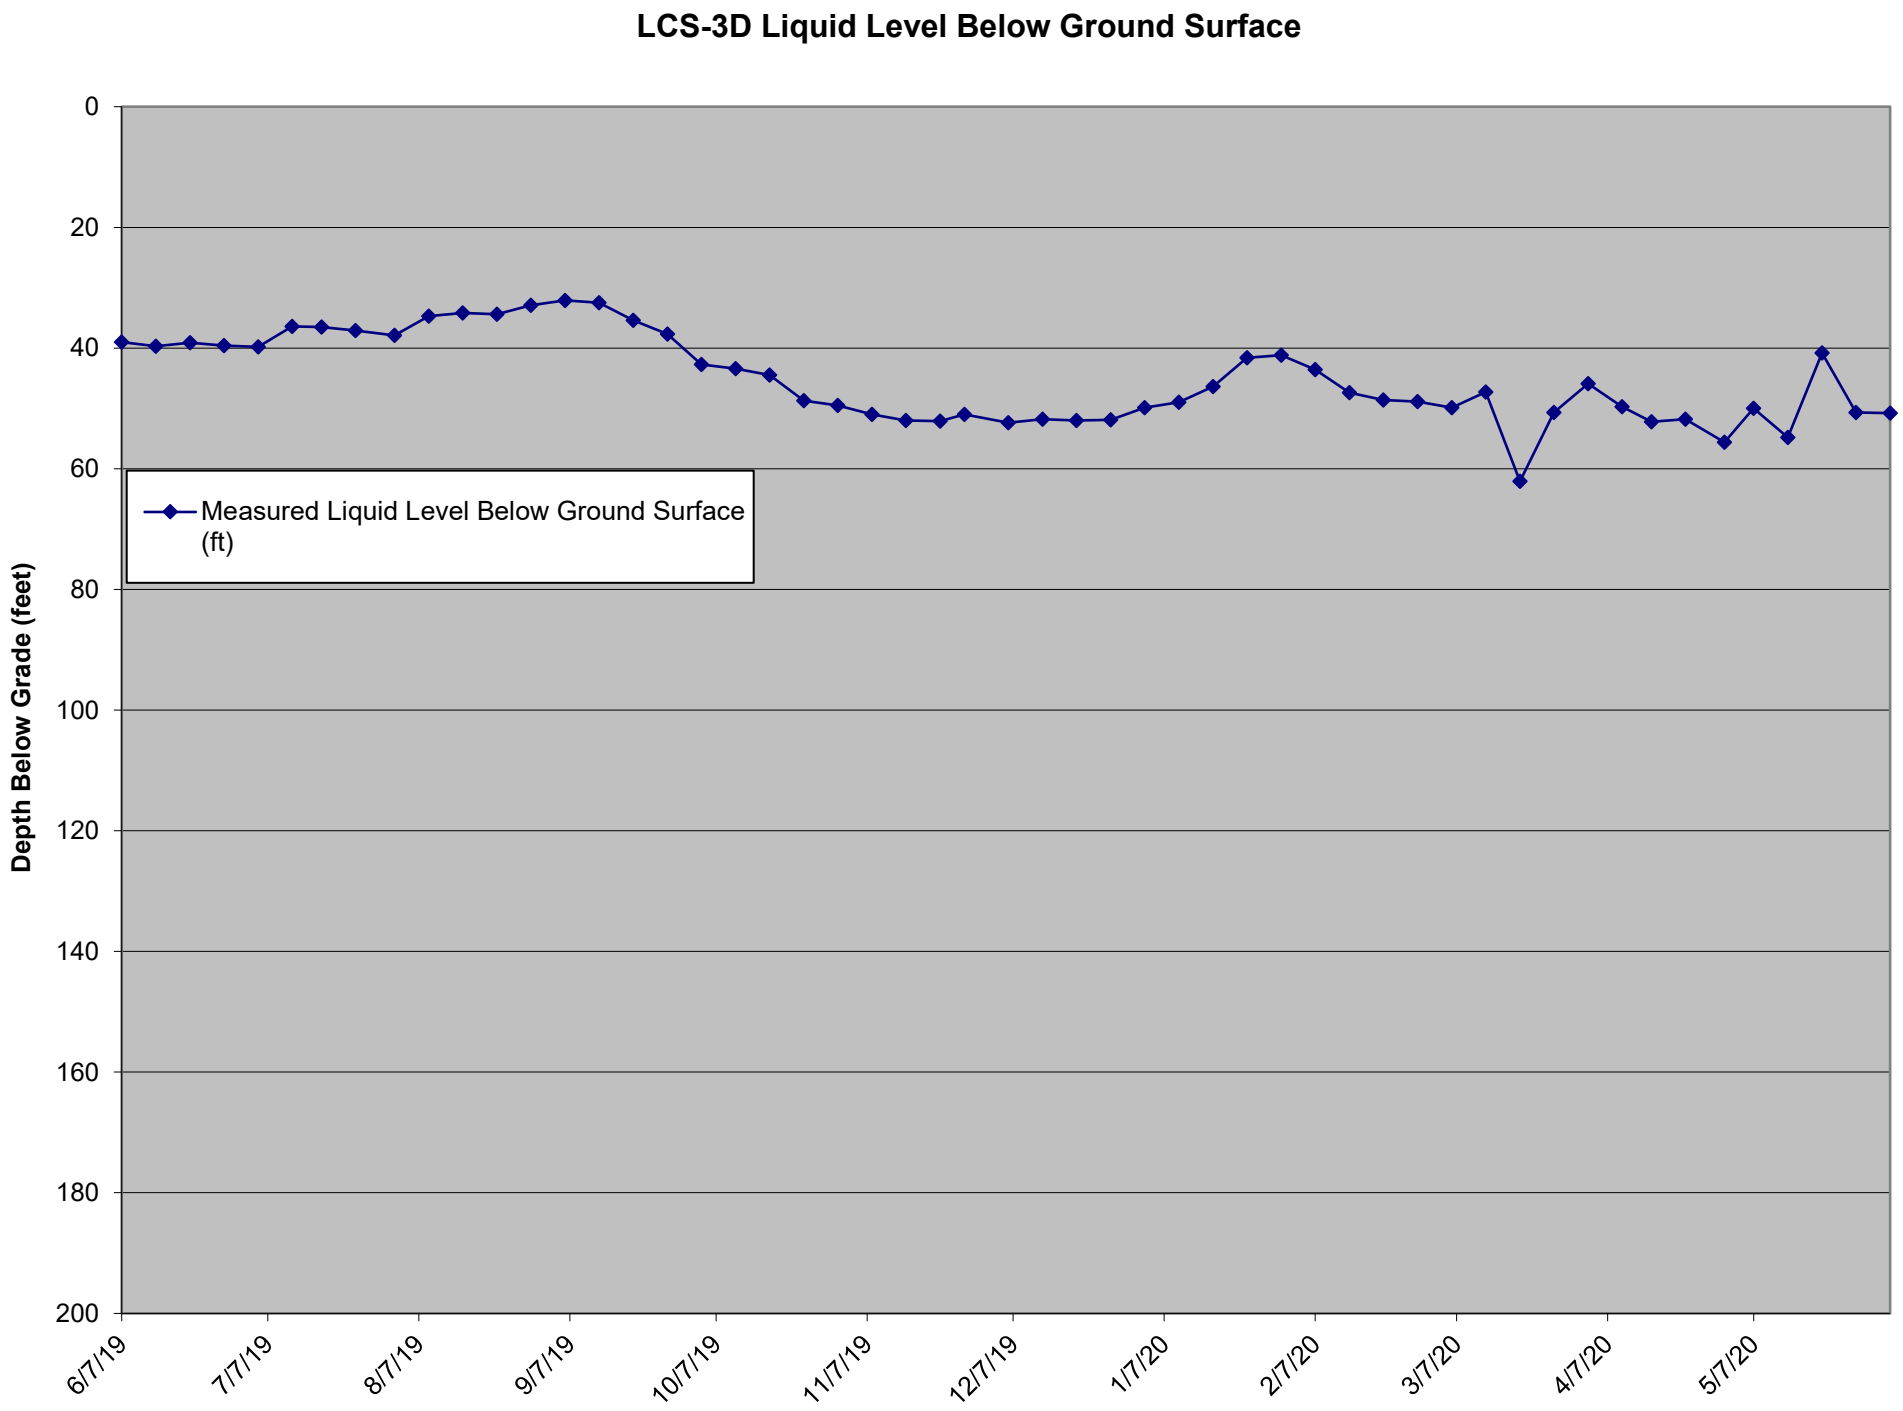
A Blackhawk pneumatic pump was installed in LCS-3D on 2/14/19 and was fully operational during the weekly reporting period. Liquid level was measured manually.

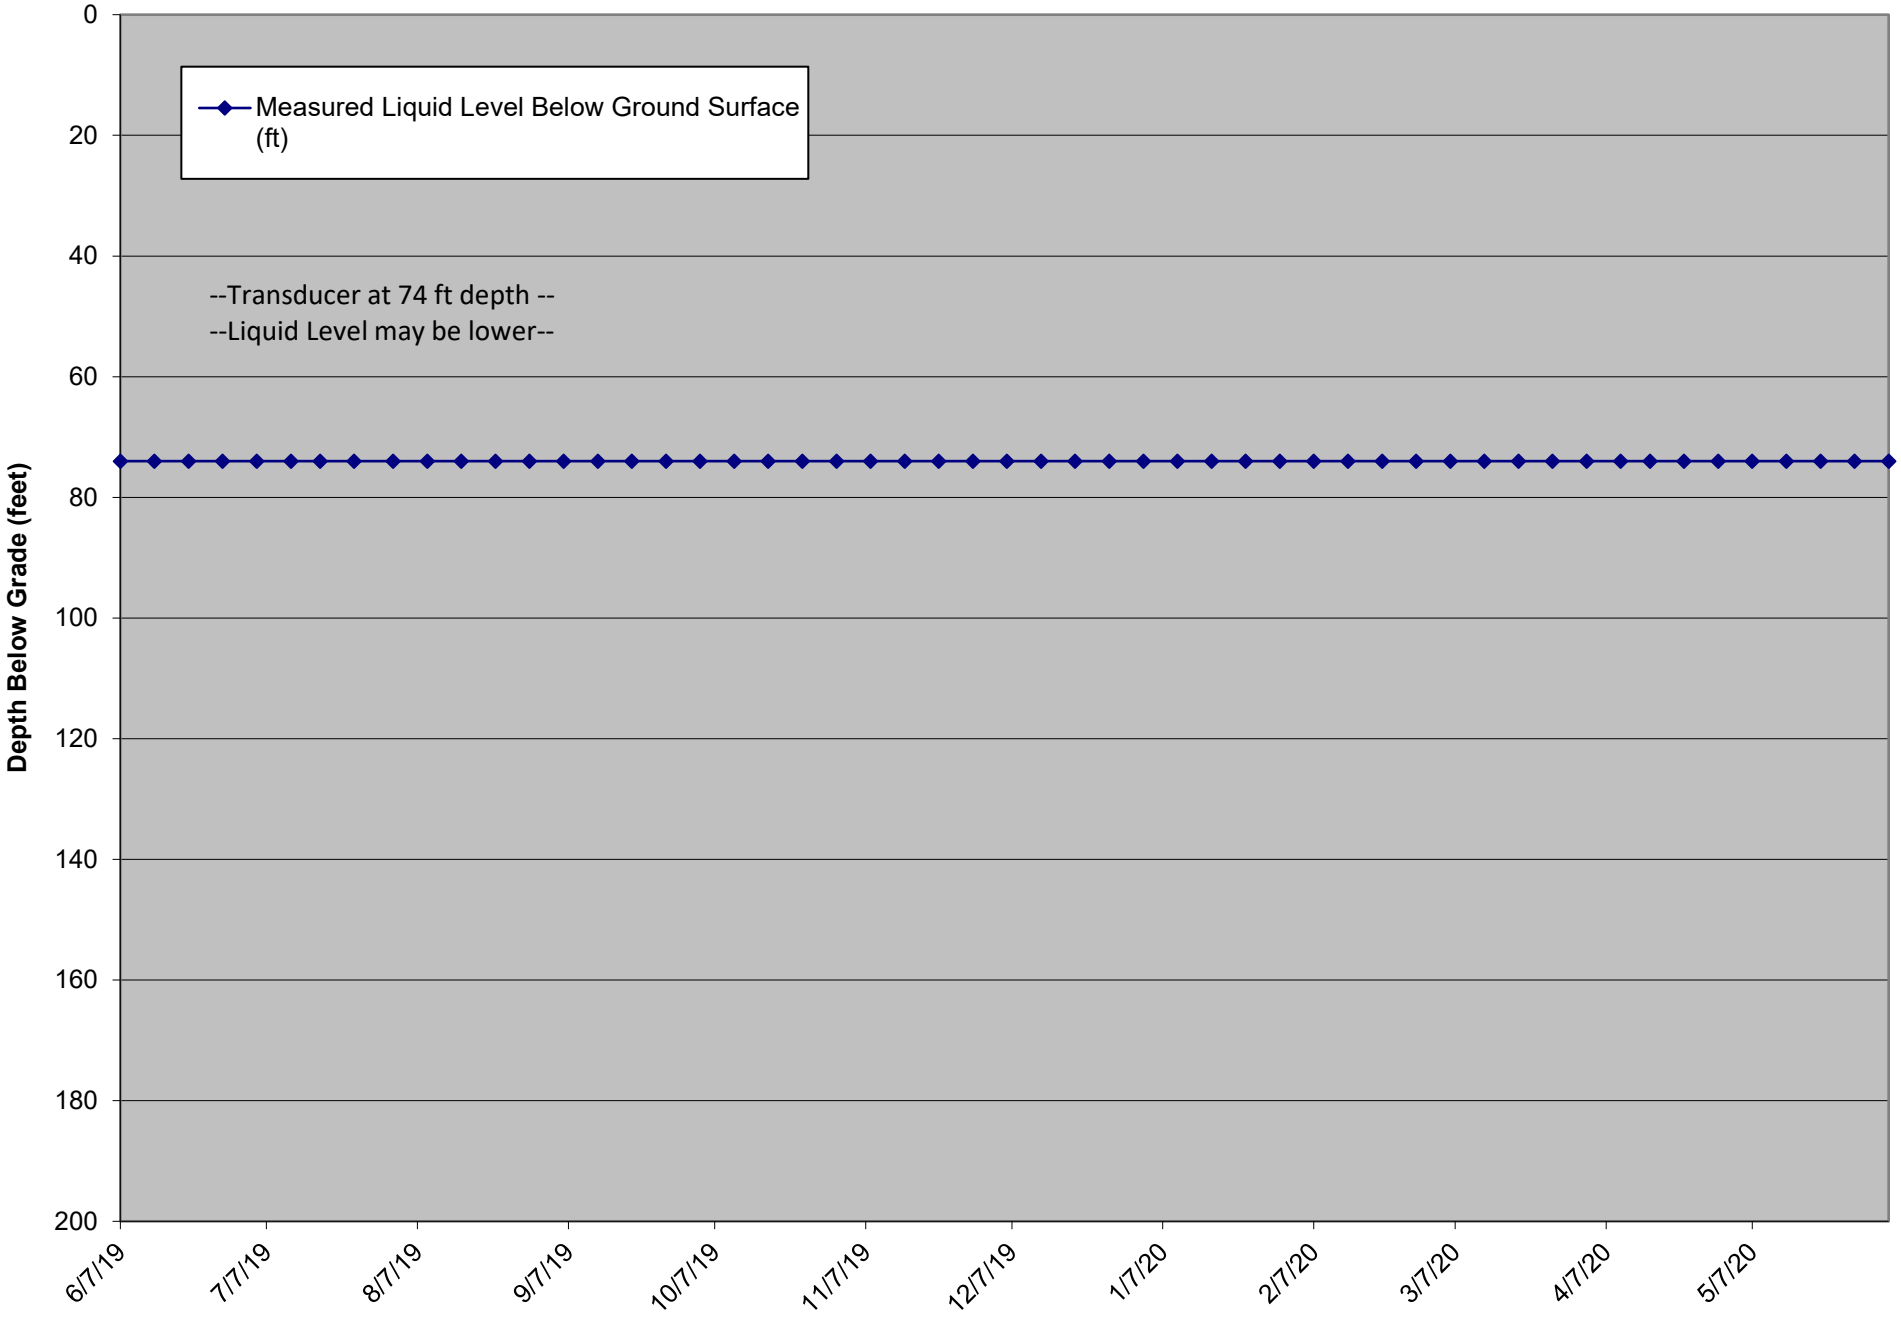
LCS-4B Liquid Level Below Ground Surface

The level sensor in LCS-4B is currently operational and responsive. Liquid level was not recorded by the level sensor during the weekly reporting period. LCS-4B is equipped with a flow meter that displayed no flow during the weekly reporting period. Therefore, it can be concluded that the liquid level was below the bottom of the pump and level sensor in LCS-4B.

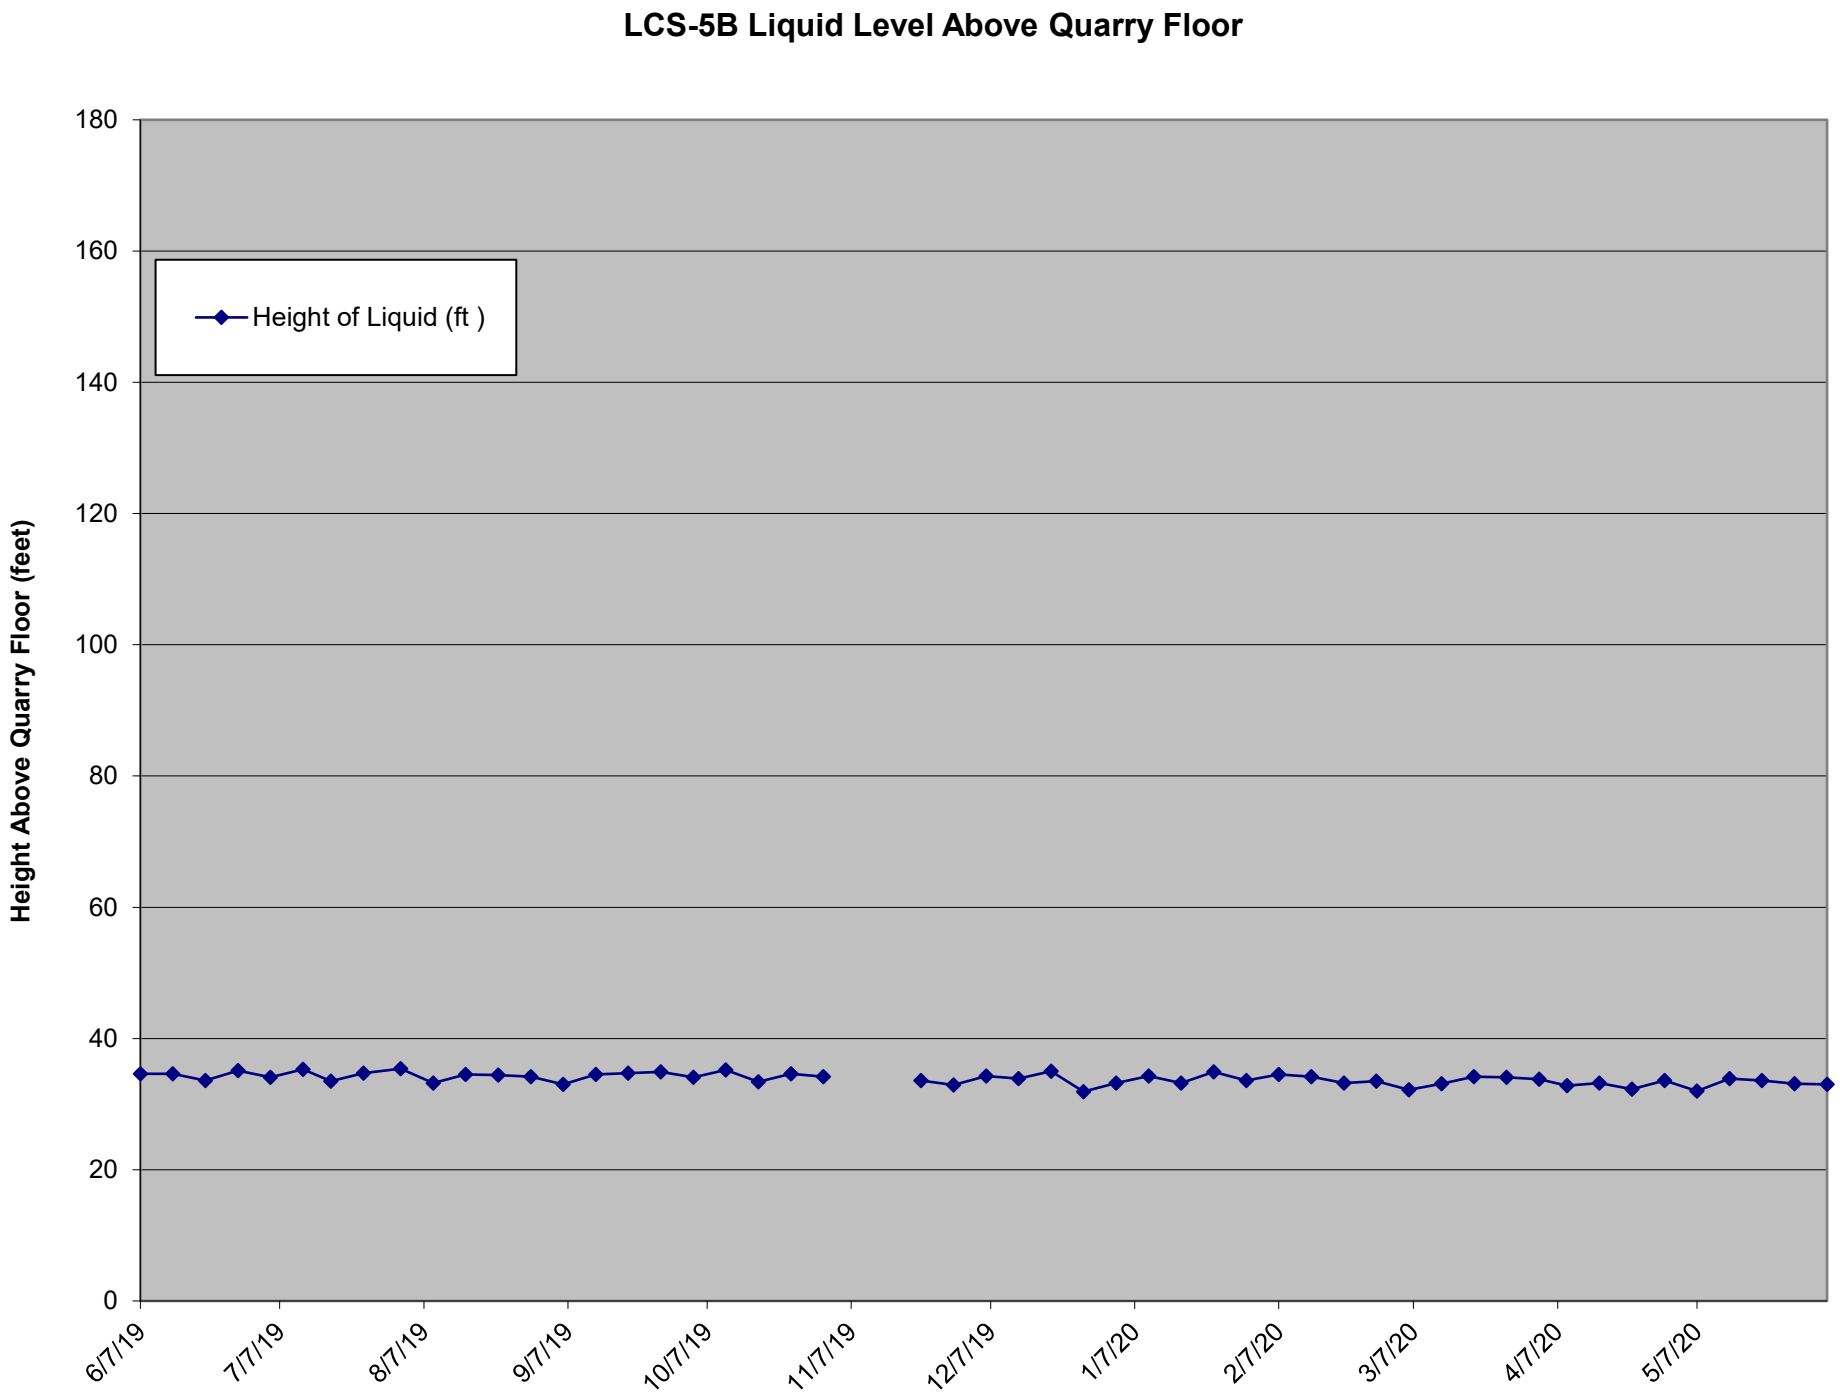
*The transducer in LCS-5B was down from 11/6/19 to 11/19/19.
