Bridgeton Landfill, LLC

Weekly Data Submittal

Week of May 31, 2020 – June 06, 2020

Required by Section IX.33.g of Final Consent Judgment, Case No. 13SL-CC01088-01
Effective June 29, 2018

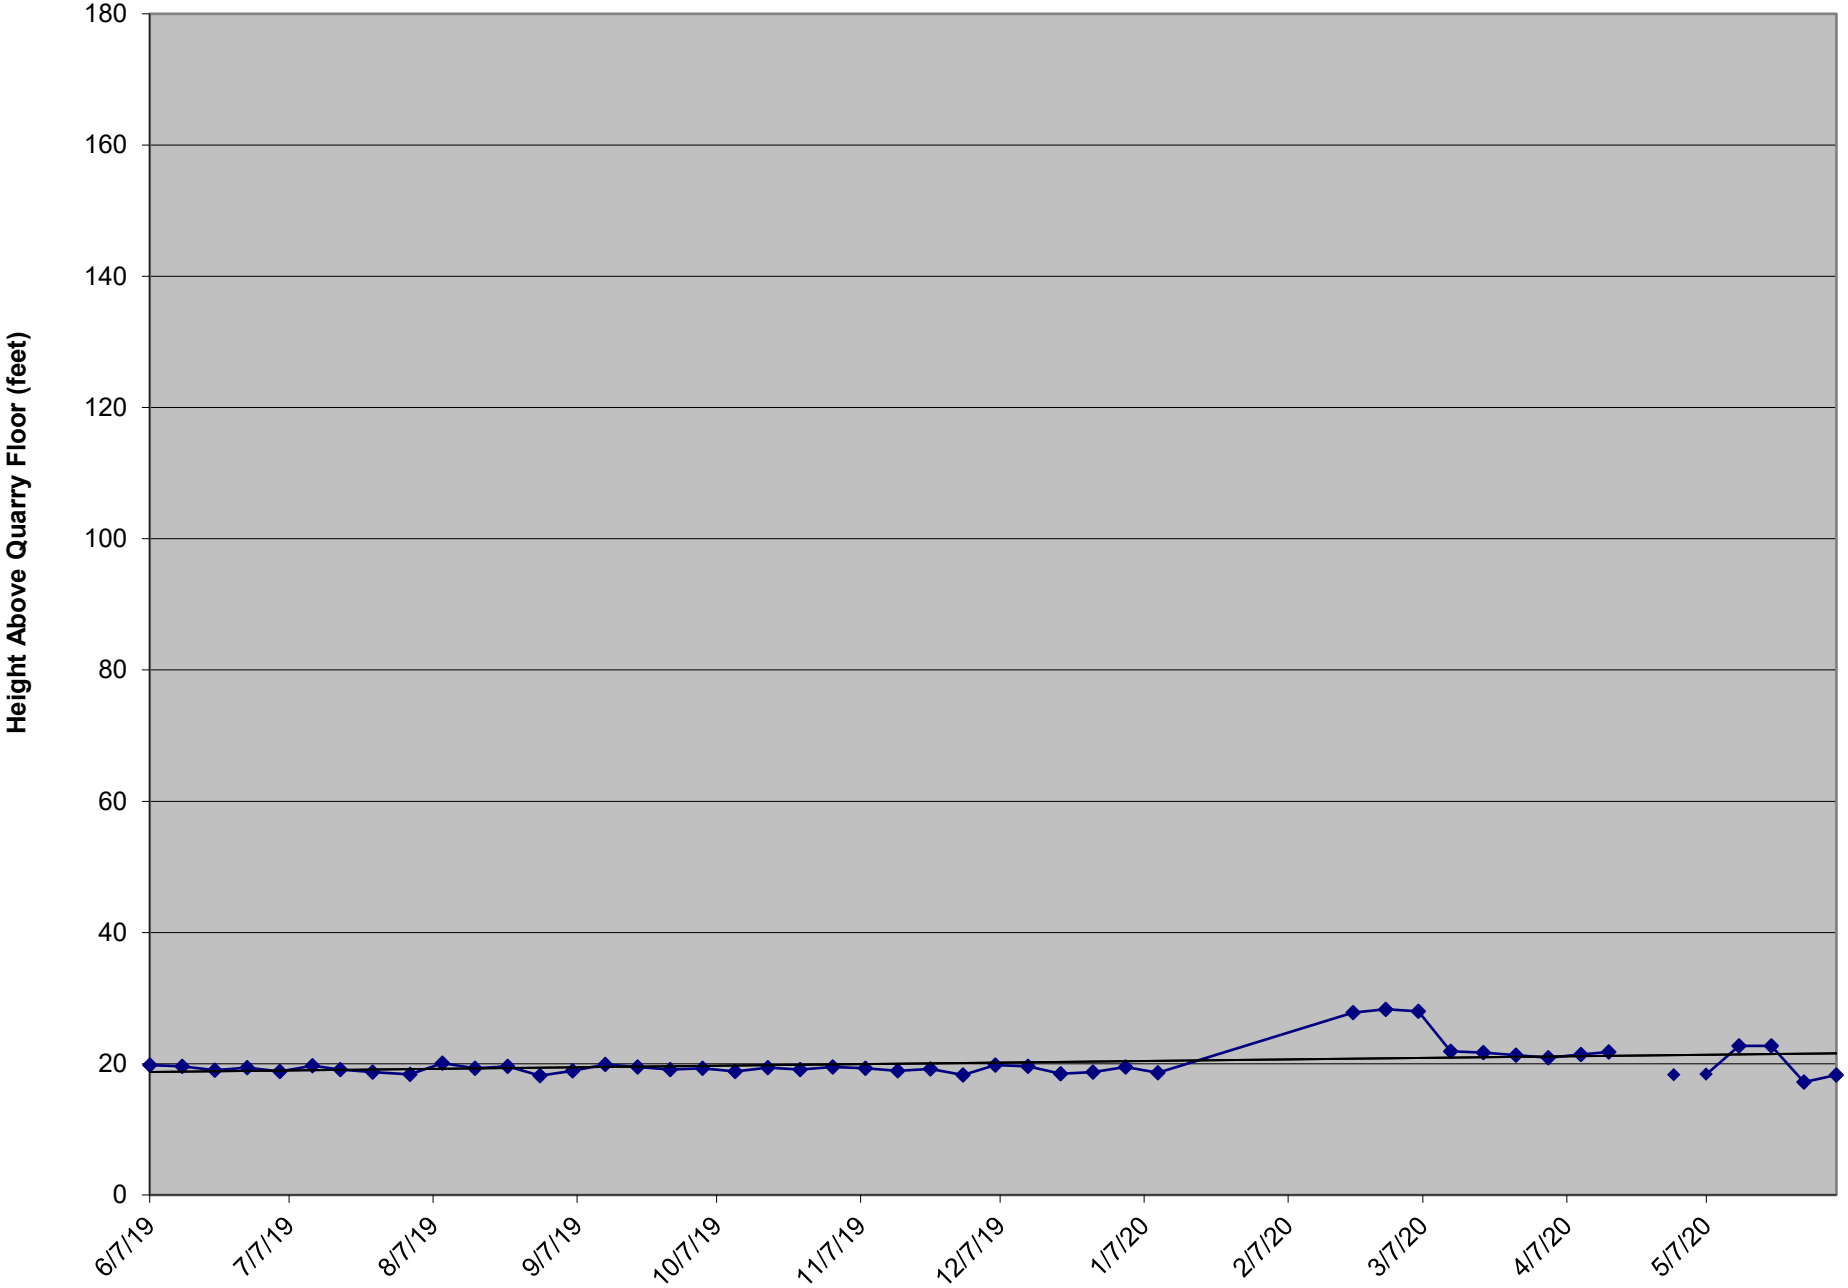
LCS-6B Liquid Level Above Quarry Floor

The transducer became non-operational on 1/13/20. Liquid level was measured manually on 2/21/20, 2/28/20 and 3/6/20. The transducer became operational on 3/13/20. The VFD was observed to be non-operational on 4/23/20, it was replaced on 4/23/20, however the level sensor reading was not taken due to VFD communication loss with SCADA.
