Memorandum

To: File 1010C5A – Storm Sewer
From: M. E. Stites, D/SE1, OC48
Date: December 15, 2011
Re: **OUTFALL 002 INSPECTION**

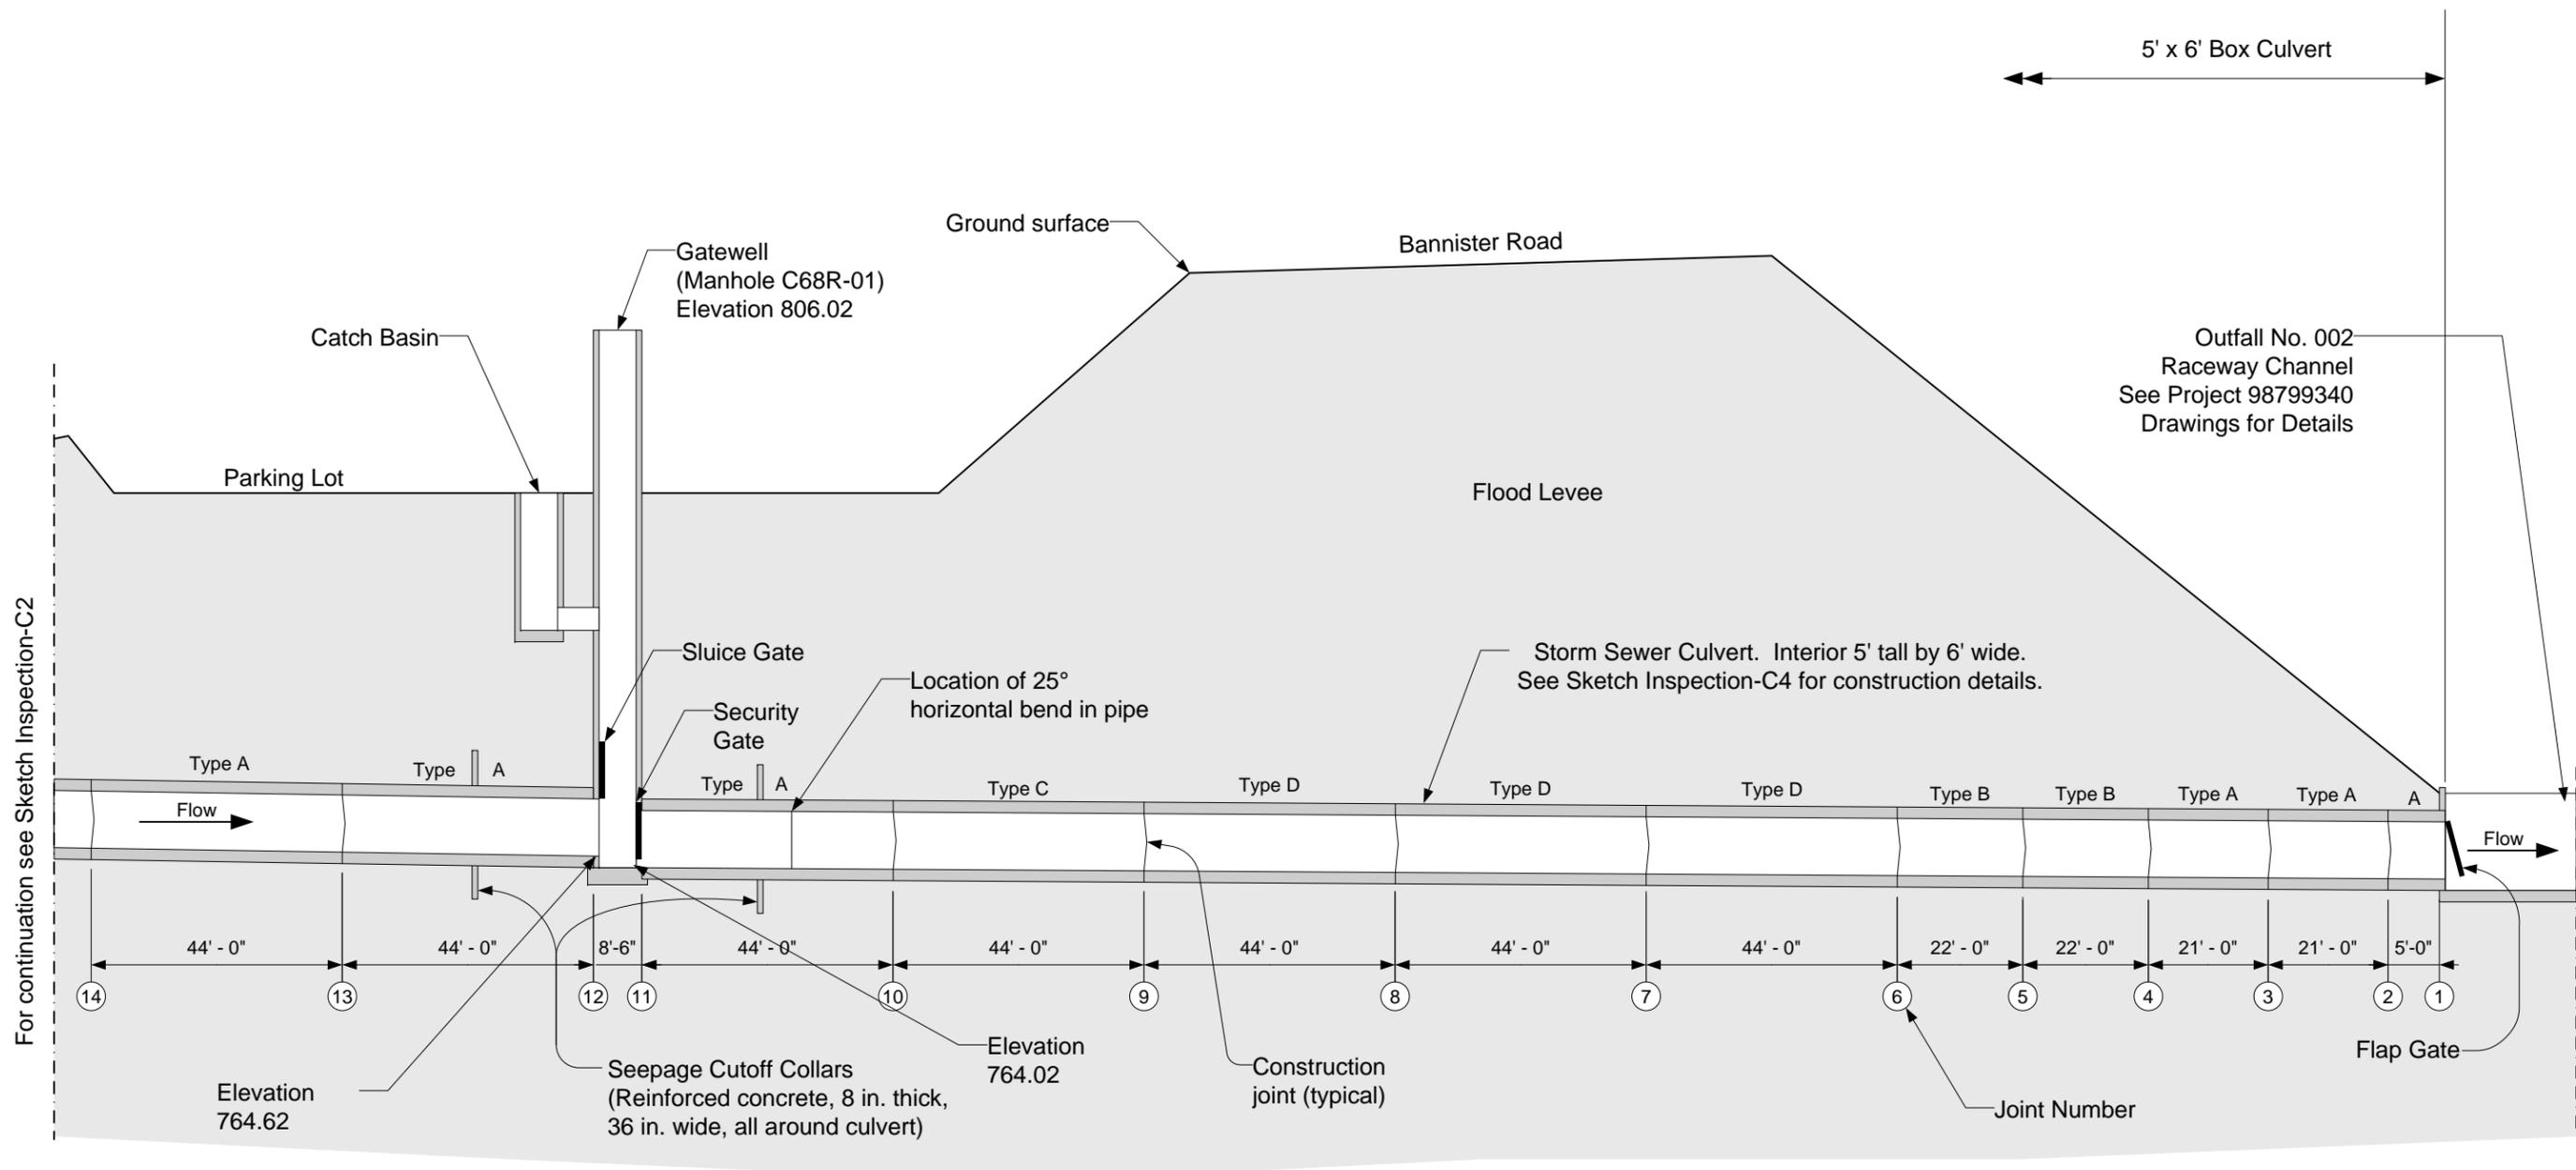
| DDB Project N.O. Inspection | WORK ORDER NO. Inspection | SKETCH NO. Inspection-C2 |

Minor flaking of patching material was observed at Joint 16 in the box culvert section and a crack was observed at Joint 7. No infiltration is observed at these joints. These joints will be evaluated for repair.
