Final Middle Fork Water Treatment Plant and Reservoir Condition Technical Memorandum

**U.S. Army Corps of Engineers
Kansas City District**

**Northwest Missouri Regional Water
Supply Transmission System Study
Phase V**

June 2012

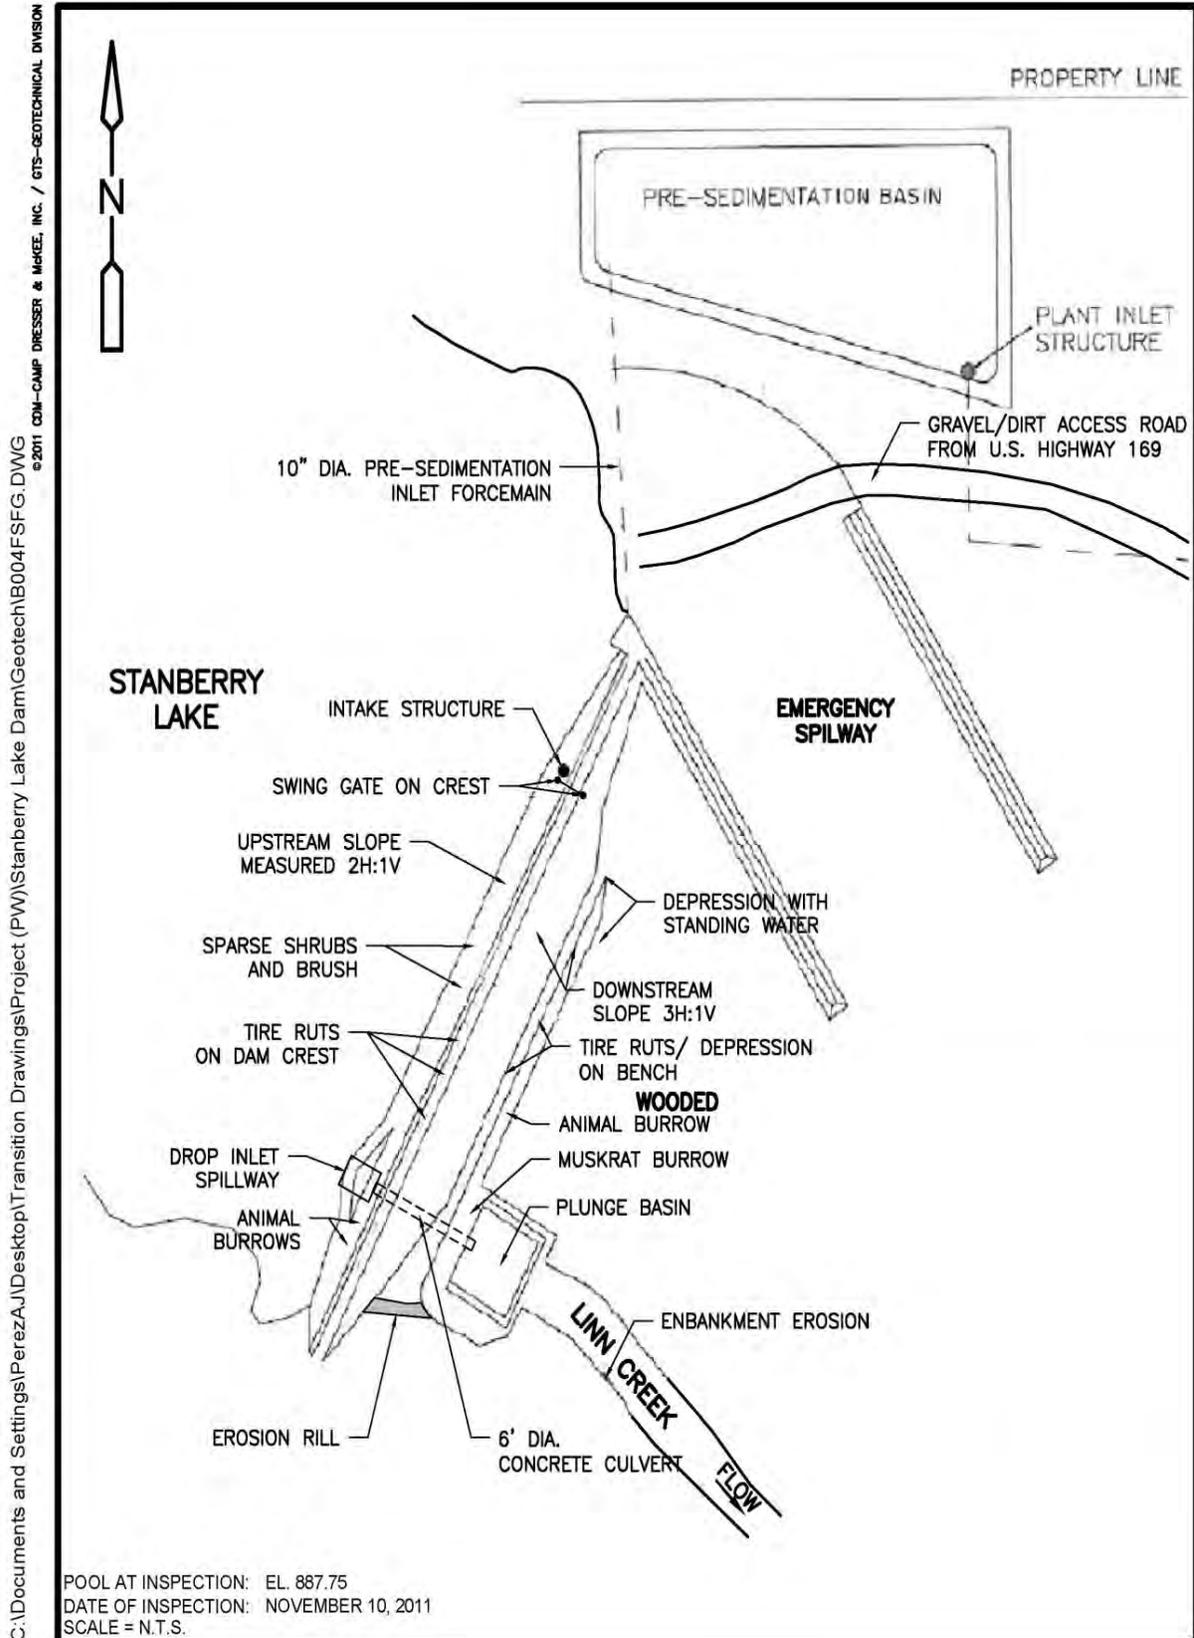
Figure 3.2 Field Sketch and Notes - Stanberry Lake Dam

Stanberry Lake Dam was inspected on November 10, 2011. At the time of the inspection, the weather was clear and the temperature was approximately 45 degrees Fahrenheit (°F). A site sketch and notes are shown on Figure 3.2. Photographs to document the current conditions of the dam were taken during the inspection and are included in Appendix B. The locations of the photographs are shown in Figure 3.3. Underwater areas were not inspected. A copy of the inspection checklist is included in Appendix E.

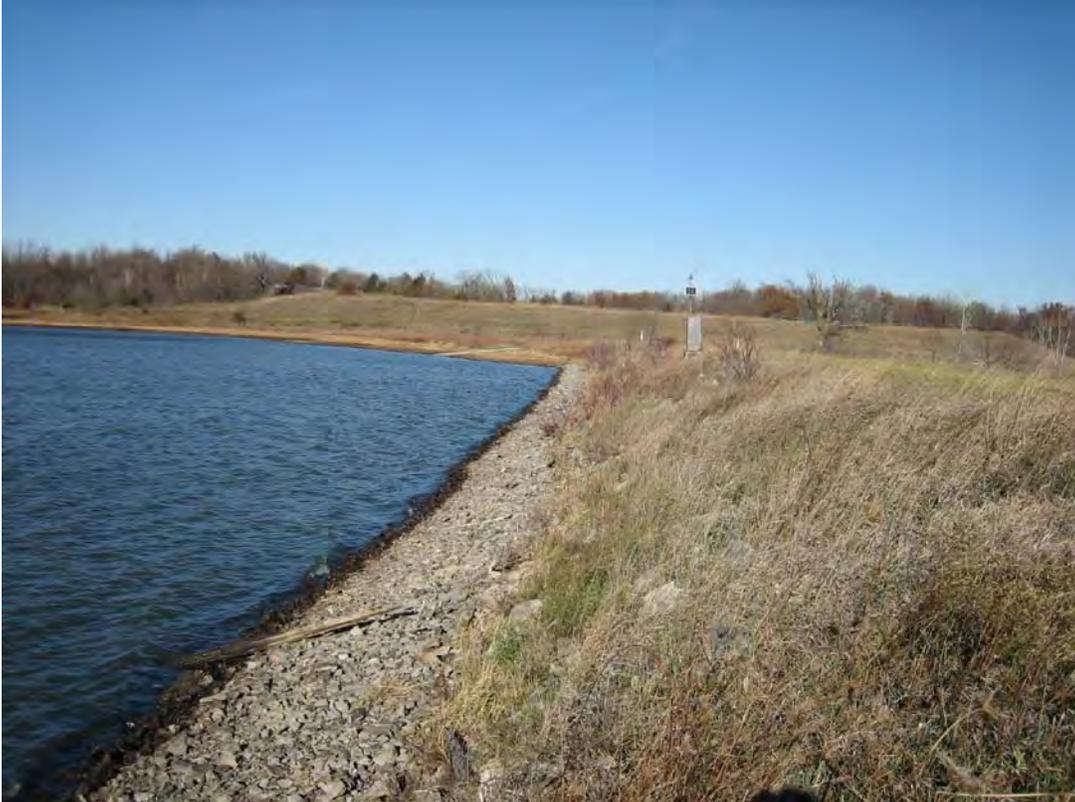
Photograph 8: Upstream slope looking north

The majority of the crest (Photographs 5, 6, and 7) of the dam was straight with no signs of misalignment, sloughing, or settlement. The upstream slope (Photographs 8, 9, 12, and 15) generally appeared to be stable. Some brush was observed on the upstream slope, but it did not obstruct viewing the slope. The downstream slope (Photographs 4, 16, and 17) above El. 876.8 appeared to be approximately 3H:1V and was covered predominantly with tall brush and grass. A 15-foot-wide bench, at about El. 876.8, had extensive tire ruts, approximately 8 inches deep (Photographs 4, 18, 19, and 22). Otherwise, the bench was generally covered with well established grass. The downstream slope, below El. 876.8 was approximately 3H:1V and was generally overgrown with tall brush, grass, and trees up to 4 inches in diameter (Photograph 20). Several animal burrows were observed on the lower slope (Photograph 21).

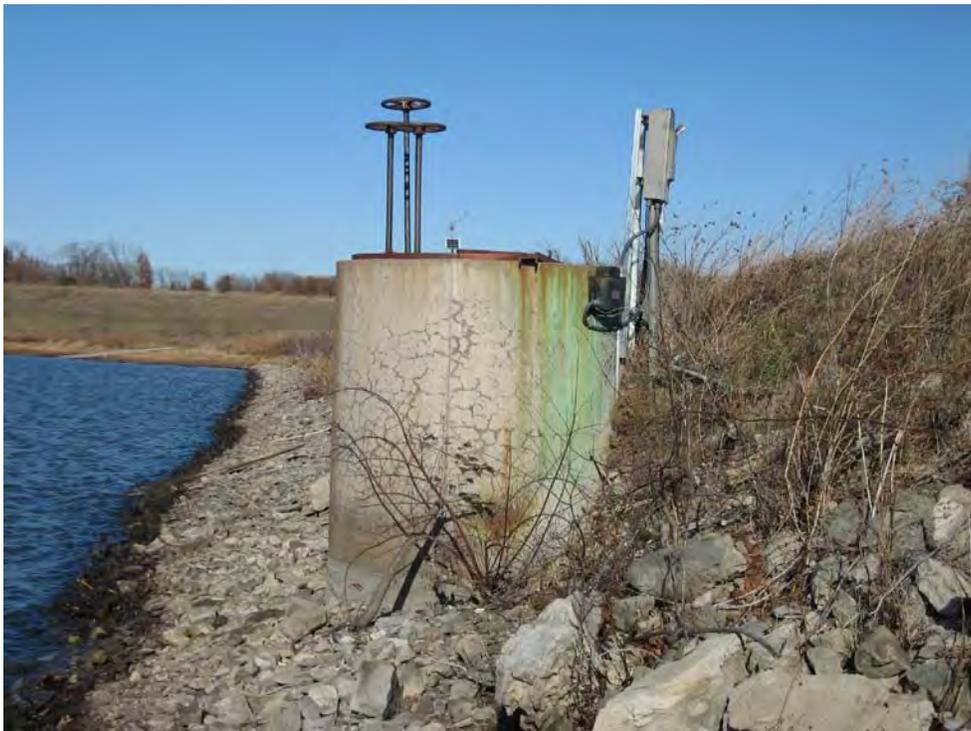
Photograph 10: Intake structure

The water supply intake structure, located on the upstream slope of the dam, is approximately 400 feet from the left abutment (Photograph 10). Concrete near the base of the intake has cracked to a depth of approximately 3 inches. It appears as though efforts have been made to patch the damaged area, however the attempted repairs have also failed (Photograph 11).

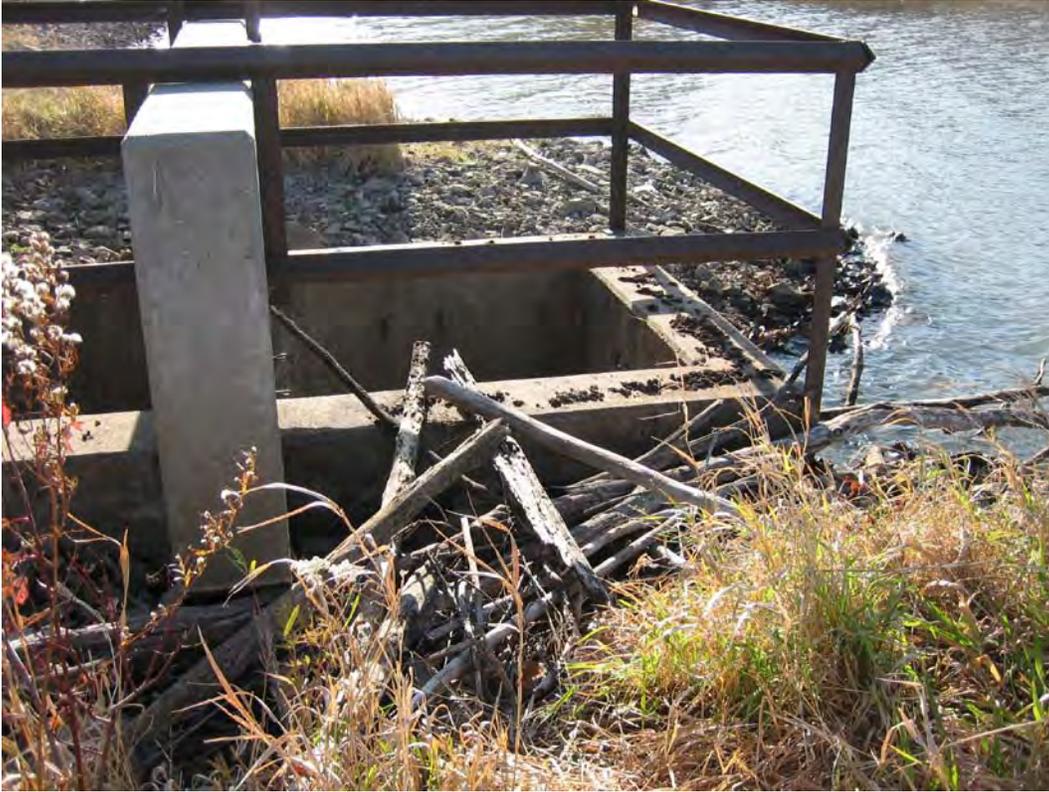
Photograph 13: Primary spillway looking south

The concrete primary spillway on the upstream slope of the dam was in good condition (Photographs 13, and 14). The water level at the time of the inspection was approximately El. 887.75.

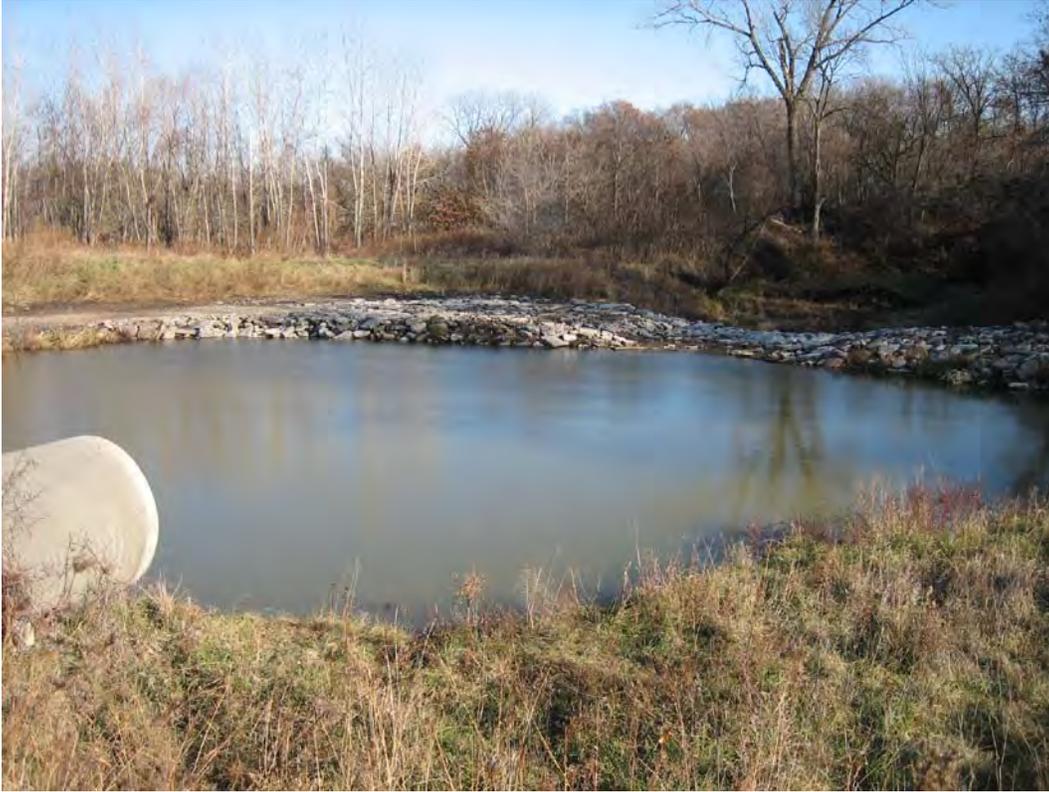
An erosion rill was observed on the downstream embankment slope, to the right of the primary spillway outlet (Photograph 26). In addition, a 6-inch-diameter animal burrow was observed on the slope left of the 6-foot-diameter primary spillway outlet pipe (Photograph 23 and 24). The abutment contacts appear to have a good transition into the natural topography (Photographs 1 and 7).

Photograph 23: Restored plunge basin embankment and outlet channel

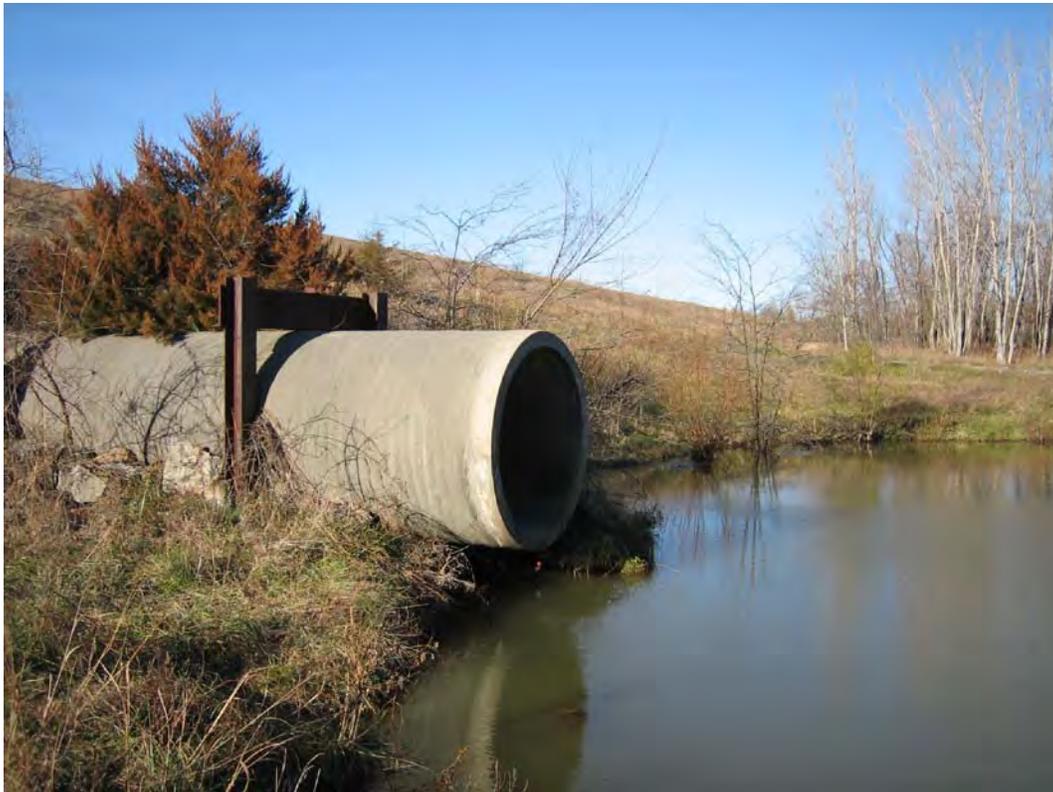
Photograph 24: Primary spillway outlet to plunge basin

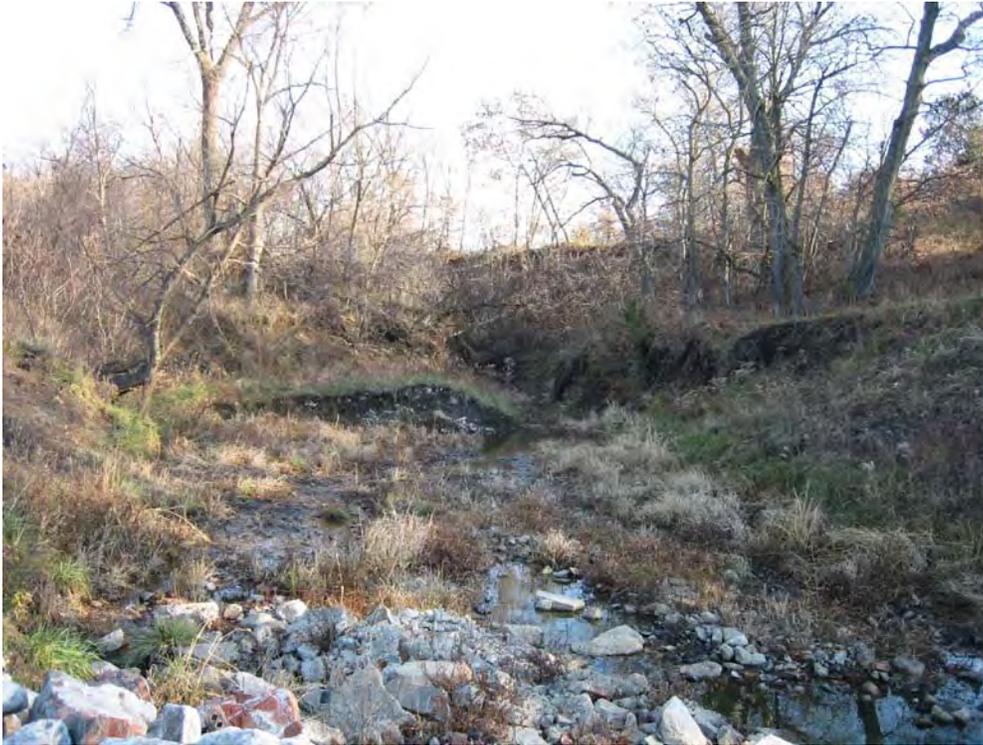
Photograph 26: Erosion rill in downstream slope above plunge basin
