Client: Westinghouse Electric Company
 Location: Hematite, MO
 Project: Hematite Remedial Investigation
 Date Started: 07/19/04
 Date Finished: 07/28/04
 Geologist: T. Calhoun
 Drilling Contractor: Geotechnology

Client: Westinghouse Electric Company
 Project: Hematite Remedial Investigation
 Location: Hematite, MO
 Borehole: BR-9-JC
 Sheet: 2 of 2

Client: Westinghouse Electric Company
 Project: Hematite Remedial Investigation
 Location: Hematite, MO
 Borehole: BR-10-JC
 Sheet: 2 of 2

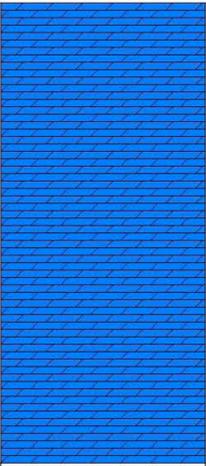
Elevation (ft)	Depth (ft)	Core Recovery (Pen/Rec)	RQD	Fracture Frequency	Lithology	Lithology Description	Well Construction	Well Construction Desc.
50

DOLOMITE: gray, very hard, sandy, pitted/vuggy		
	3.0/2.8	81	1					
365								
	55

4.0/4.0	94	1					
360								
	60

3.0/2.8	89	1					
60								
						Bottom of Hole 60.0'		
355								
	65							
350								
	70							
345								
	75							
340								
	80							
335								
	85							
330								
	90							
325								
	95							
320								
	100

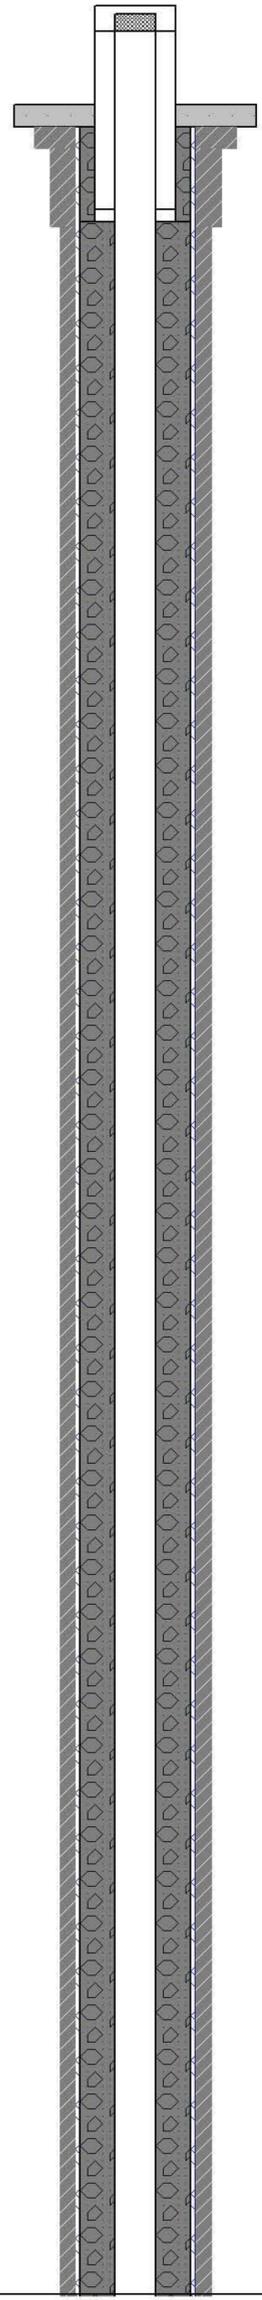
Boring: BR-11-JC

Elevation (ft)	Depth (ft)	Core Recovery (Pen/Rec)	RQD	Fracture Frequency	Lithology	Lithology Description	Well Construction	Well Construction Desc.
430	0					OVERBURDEN: Drilled without sampling

Protective Casing (4") 2.0' x 2.0' x 0.5' Concrete Pad 2" Sch 80 PVC Riser 6" Steel Isolation Casing Portland Cement High Solids Bentonite Grout (Tremied)
425	5							
420	10							
415	15							
410	20							
405	25							
400	30							
395	35							
390	40	4.1/4.1	70	0		Top of Bedrock 39.1' DOLOMITE: gray, hard to very hard, micritic wavy gray shale laminae 41.4-41.8' slightly weathered to weathered 47.6-49.7' vertical fracture 49.1-49.7'		
385	45	5.0/5.0	46	0				
50	50
