**BRIDGETON LANDFILL LLC.**

**CONSTRUCTION QUALITY ASSURANCE  
ACCEPTANCE REPORT**

**2019 GCCS IMPROVEMENTS**

**BRIDGETON, ST. LOUIS COUNTY, MISSOURI**

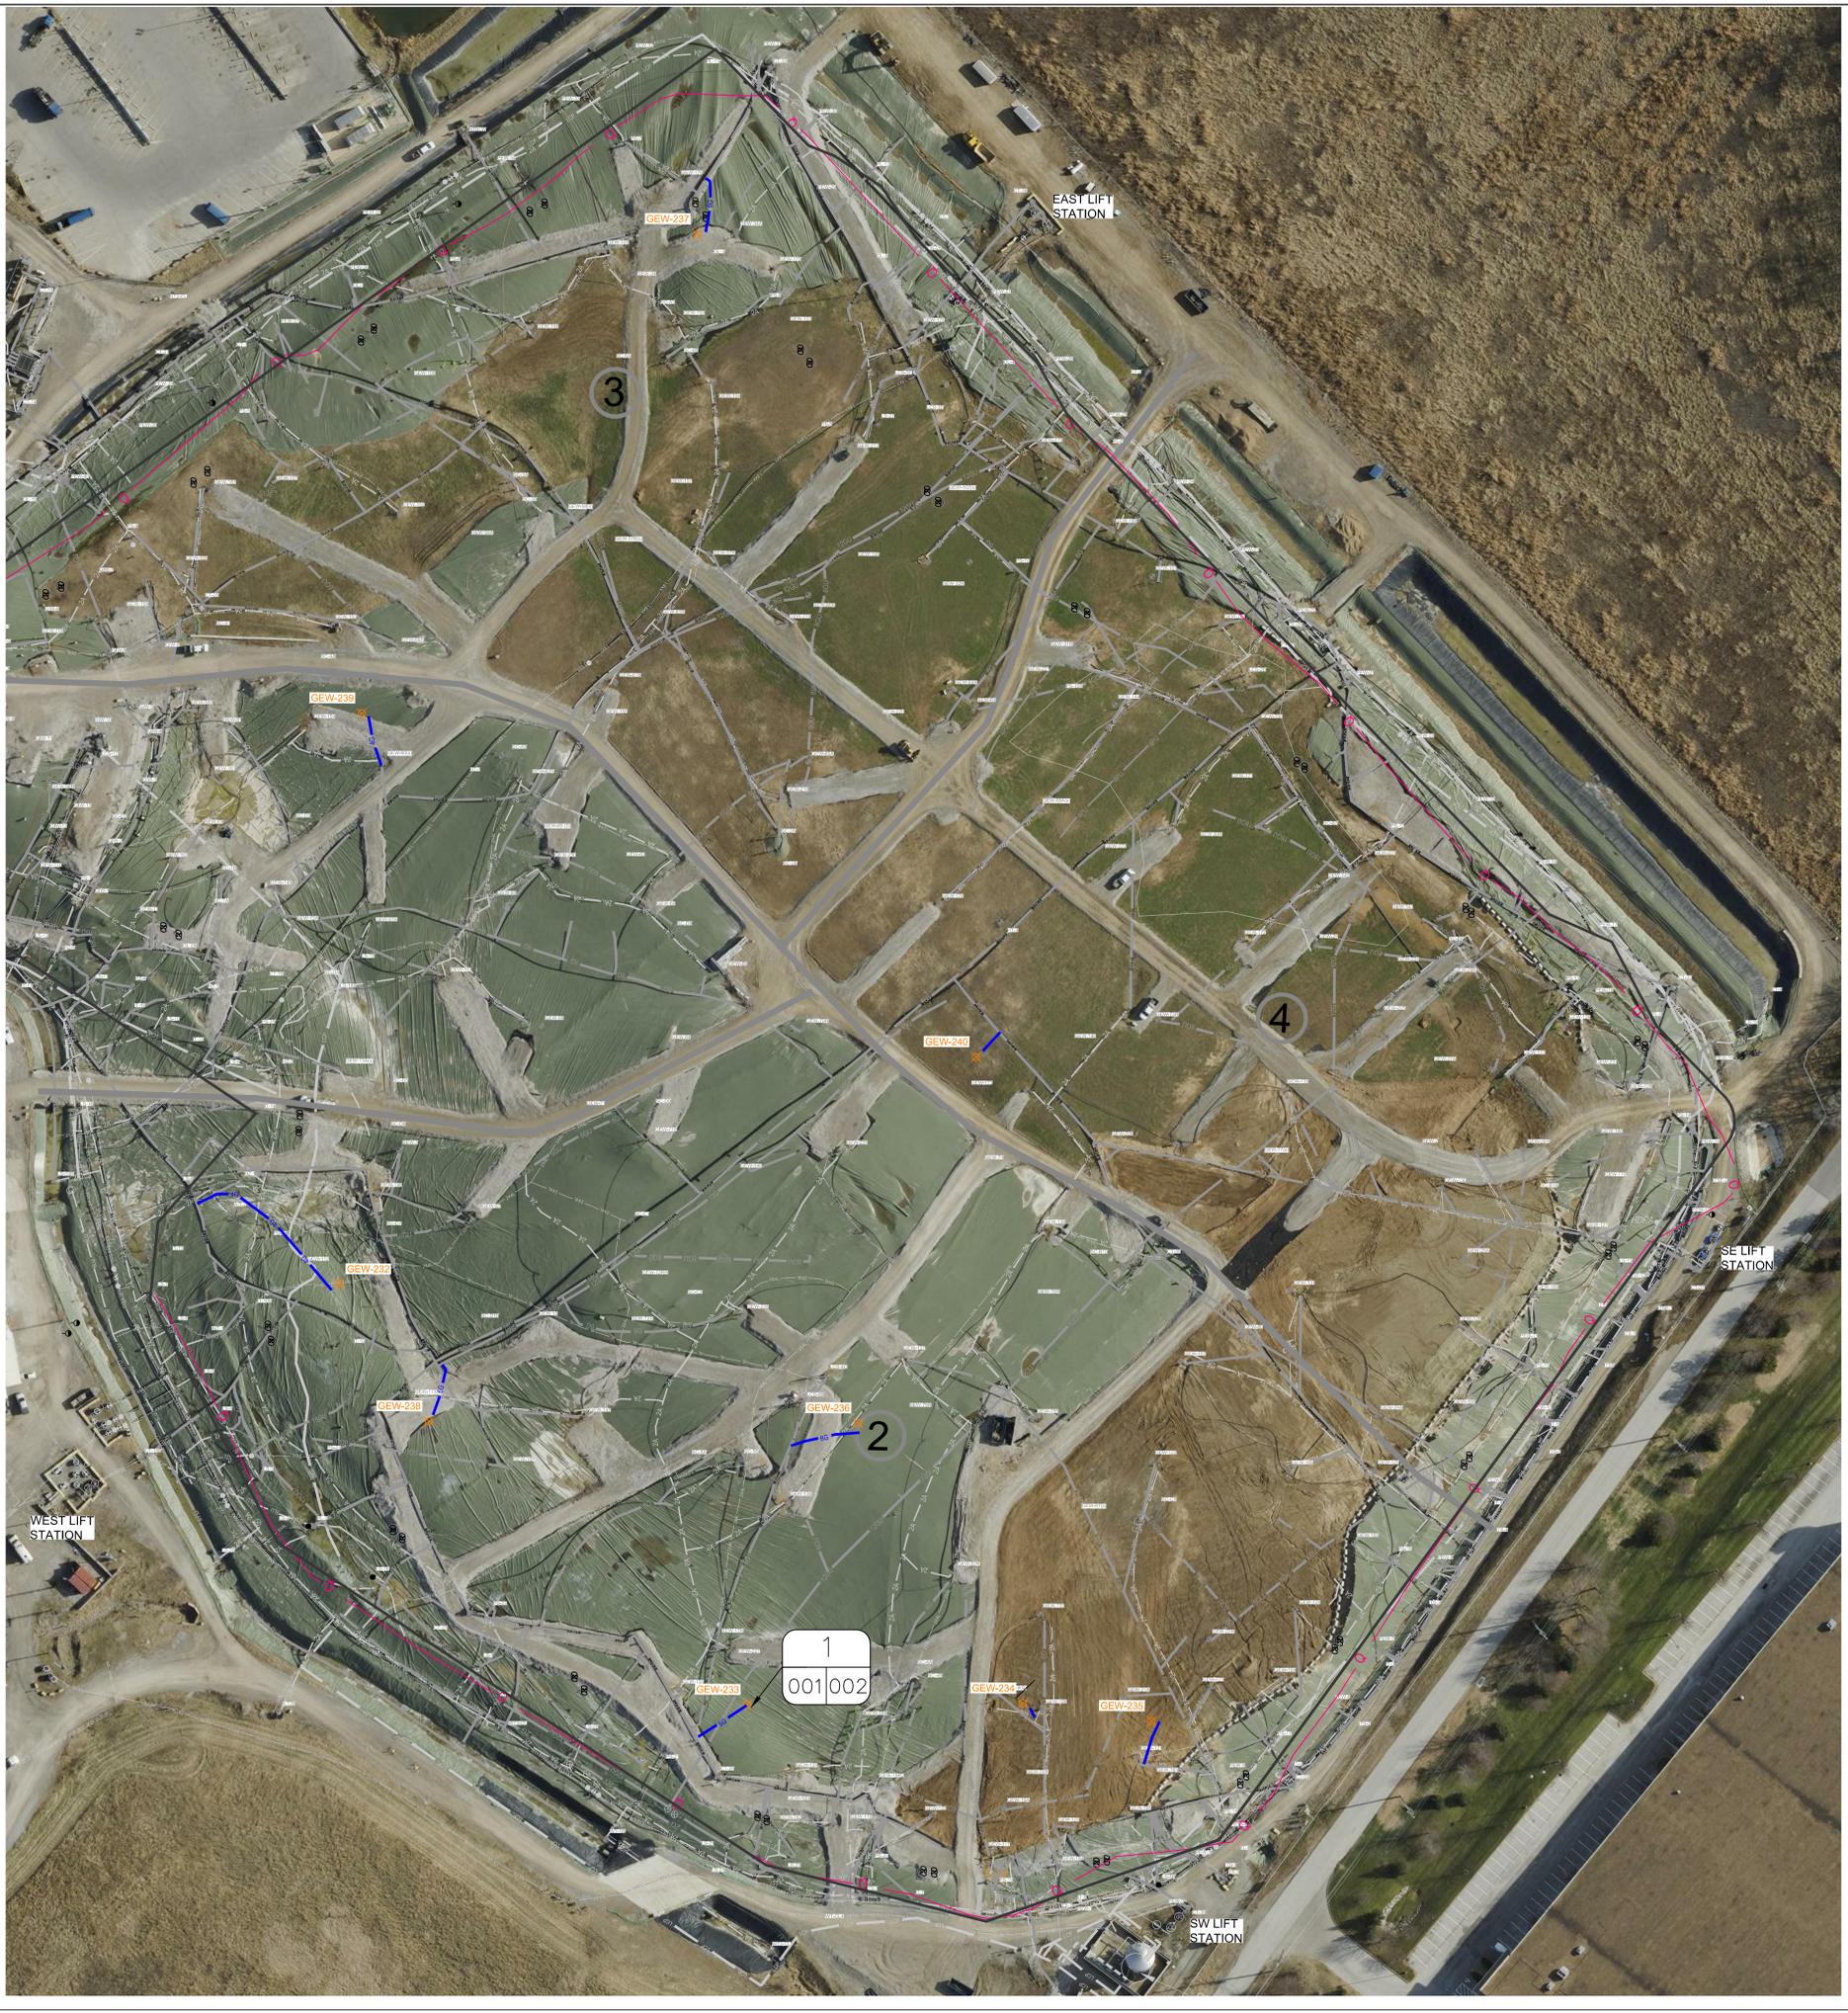
TITLE PAGE
001	GCCS PLAN VIEW
002	DETAILS

- C. Construction Certification Drawings (Reduced Set)**
  - Drawing 000** Title Page
  - Drawing 001** GCCS Plan View
  - Drawing 002** Details
