**BRIDGETON LANDFILL, LLC.**

**CONSTRUCTION QUALITY ASSURANCE  
ACCEPTANCE REPORT**

**NORTH QUARRY SURFACE COLLECTOR**

**BRIDGETON, ST. LOUIS COUNTY, MISSOURI**

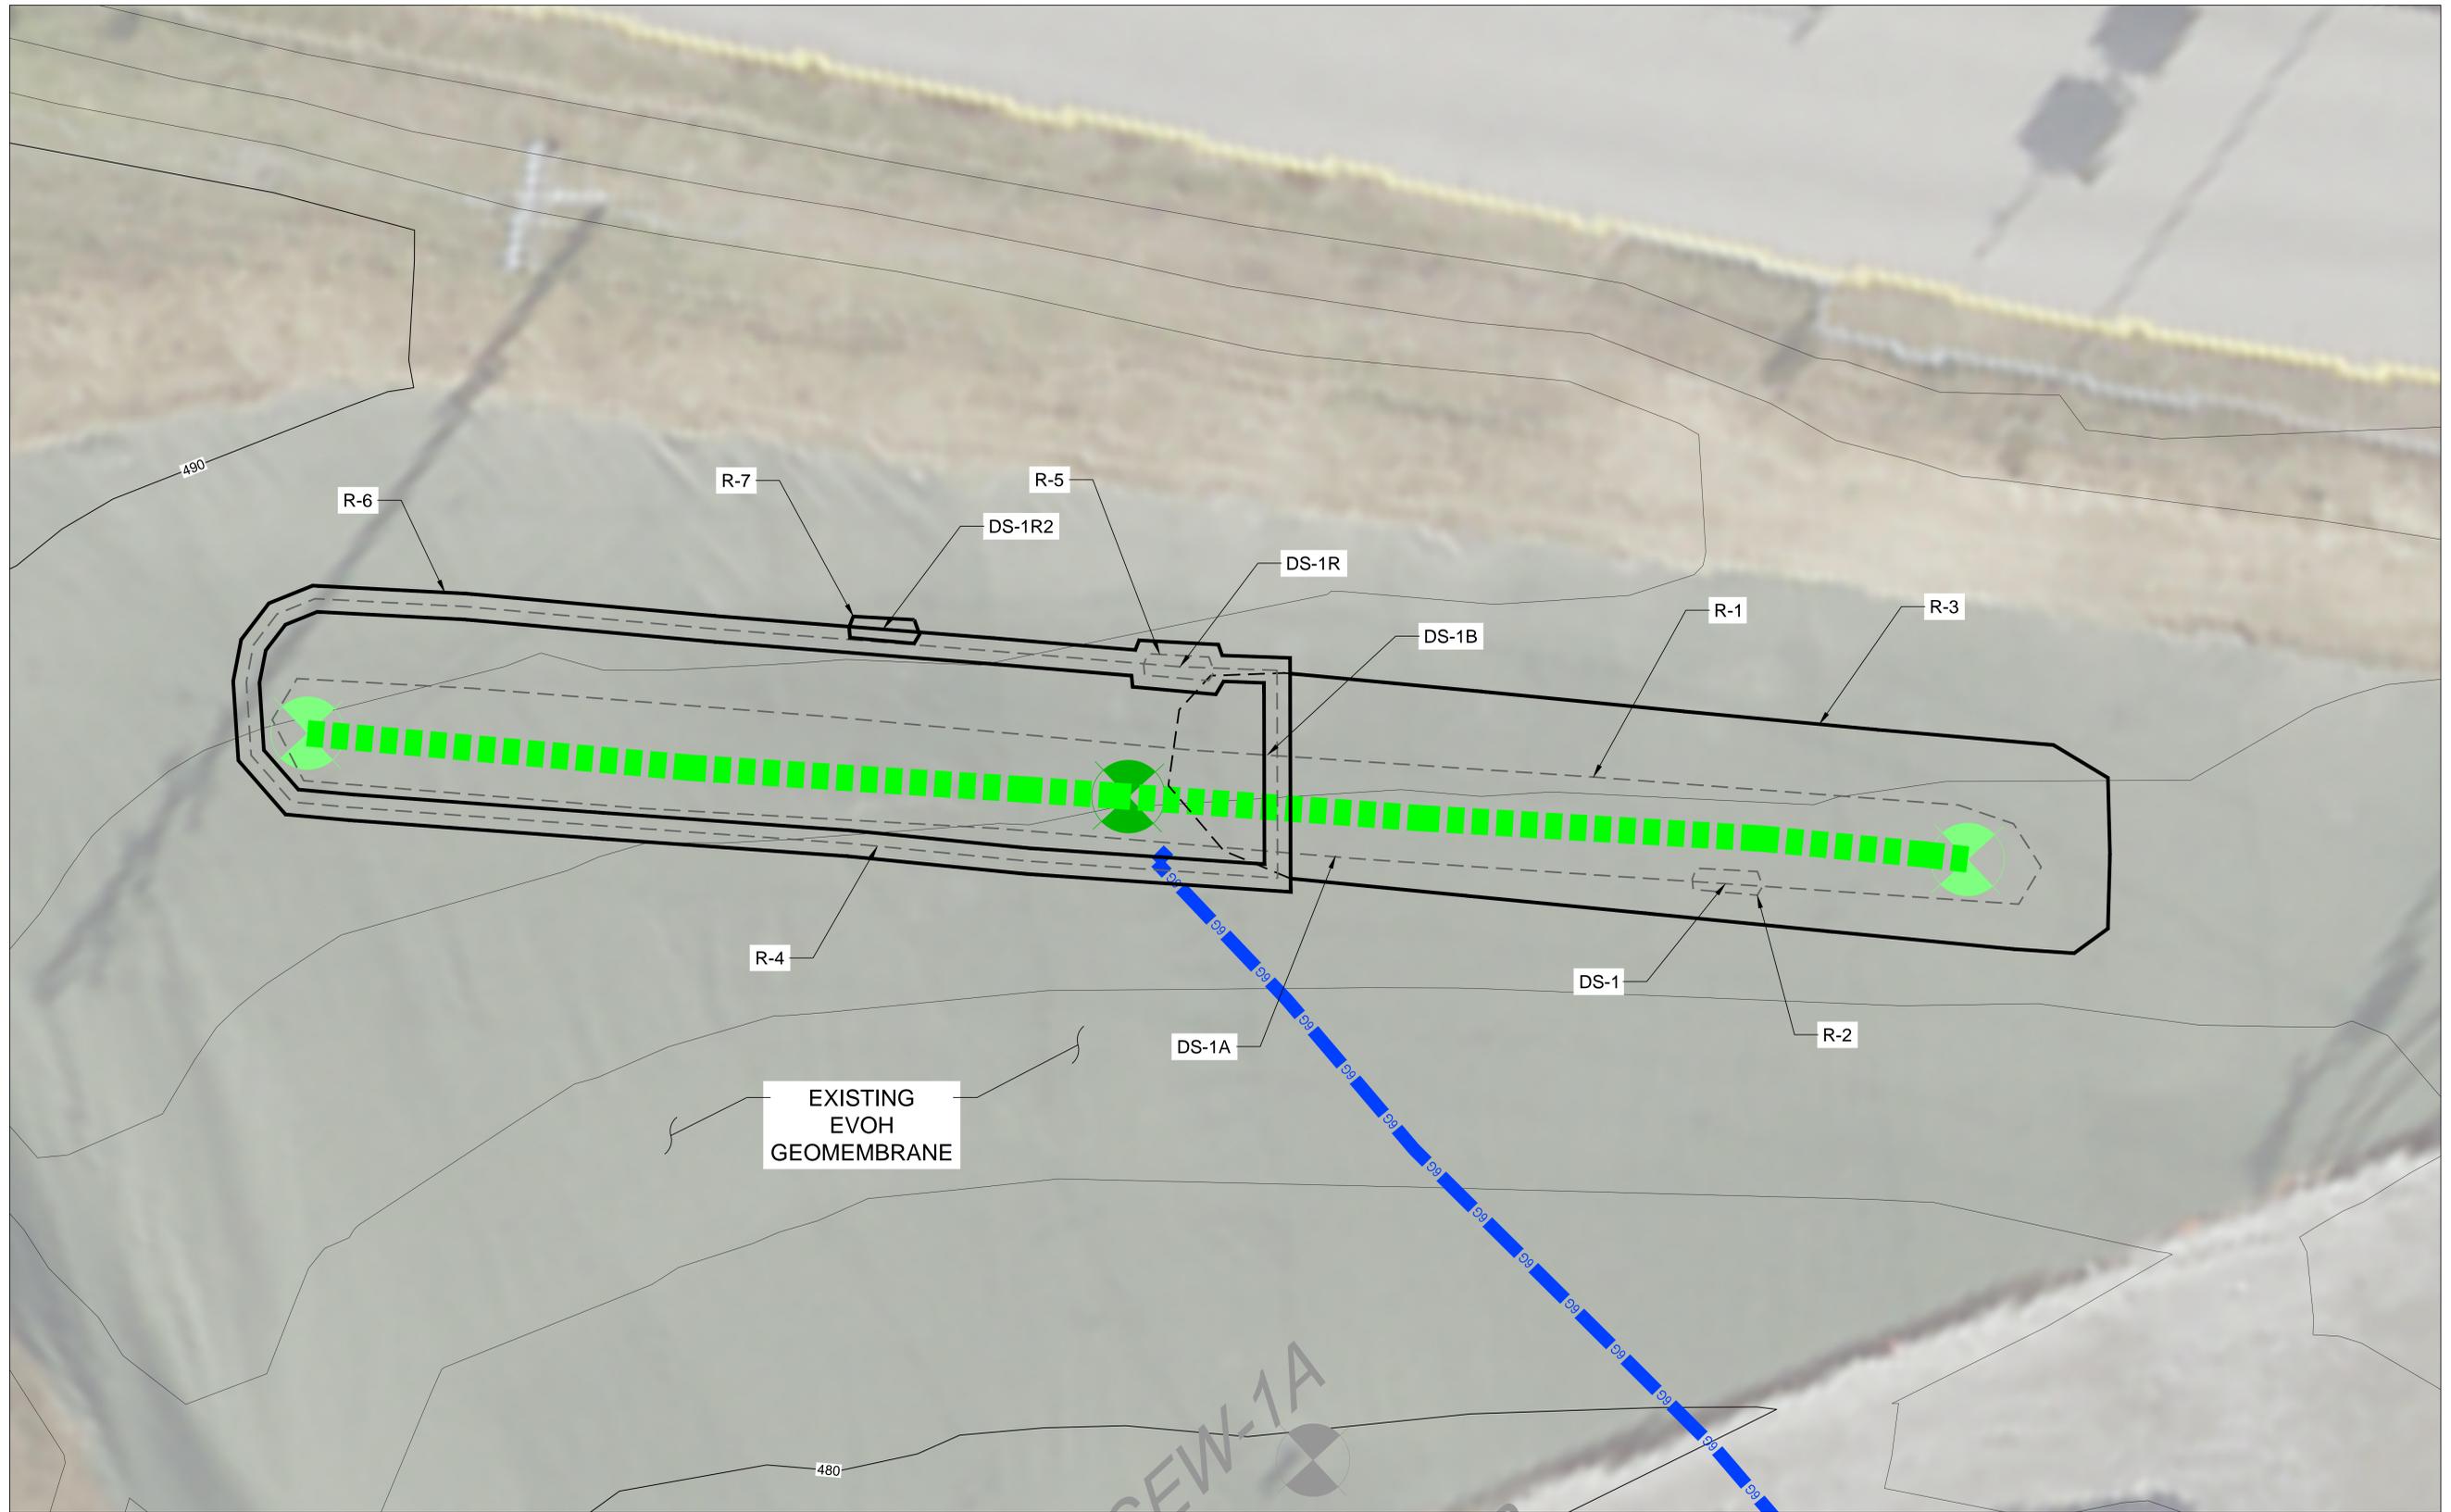
EXISTING  
EVOH  
GEOMEMBRANE

Fusion and Mid-America installed a repair strip of geomembrane by hand over the installed surface collector. The orientation of the geomembrane repair is depicted on **Drawing #2 of Appendix D**.

A summary of repair activity for the project are presented in **Appendix C.5** and **Drawing #2 of Appendix D**.
