Westinghouse Electric Company Hematite Facility

Well Inspection Report

Well Number: WS-9	Date Installed: Unknown	Project Number: SAHEM00136
Coordinates (MO State Plane NAD83): Northing/Easting 864406.938 827302.683		Elevation (TOC): 432.69
Total Depth (feet BTOC): 26.97	Riser Height (feet above grade): 0.88	Water Level (feet BTOC): 23.61
Well Construction Material: PVC	Well Casing Diameter (inches): 4	Screen Length (feet): 21.0
Hydrostratigraphic Zone: Unconsolidated	Inspected By: R. Tubbs	Date Inspected: 8/13/2004

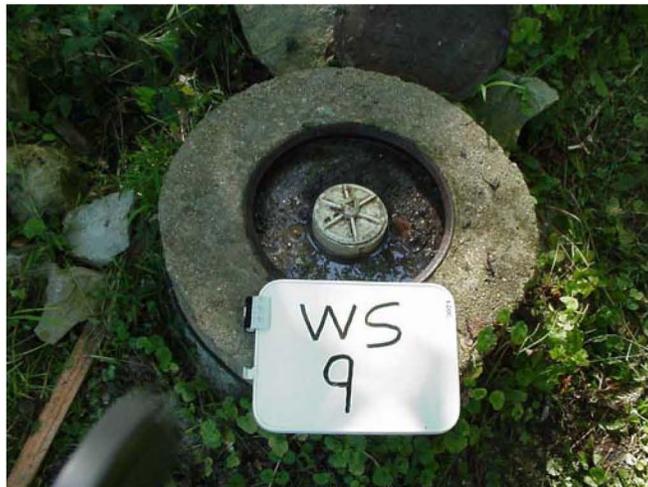
Visual Observations:

- Well condition noted as poor
- No outer protective casing
- Well pad construction – 24 inch round concrete (loose)
- No guard posts in place
- Well needs numbering/labeling
- Loose concrete pad recommended to be replaced
- Rehabilitation not required

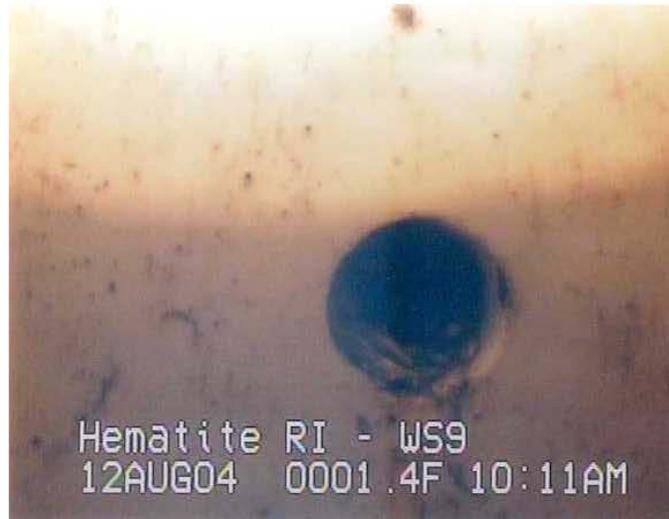
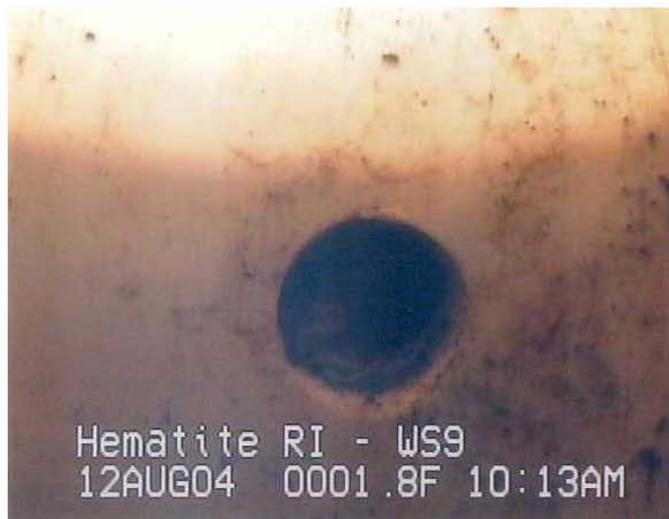
Video Observations:

- Beginning at 6 ft below top of casing, holes (approximately ¼ in. diameter) are present on the same side of the “screen”. Holes are spaced approximately 6 inches apart vertically to the bottom of the well.
- Wire mesh is visible on the outside of the casing covering the holes

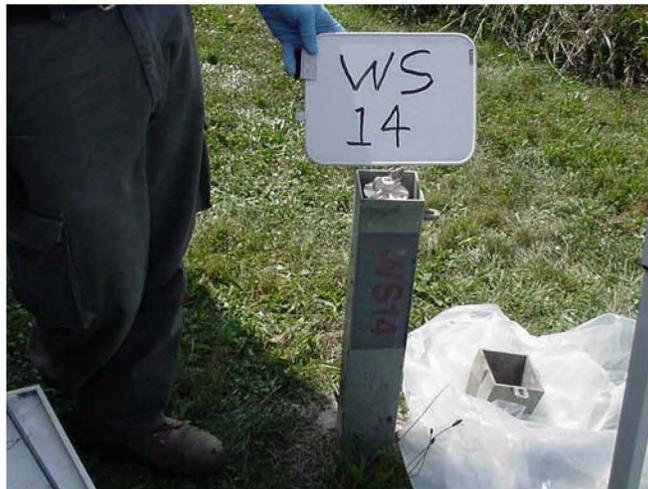
Visual Observations:

- Well condition noted as good
- Protective outer casing constructed of 4 inch square aluminum
- Well pad construction – 12 inch round concrete
- No guard posts in place
- Water-tight cap in place with dedicated bailer
- During redevelopment, well purged dry, small gravels present in bottom of well
- Rehabilitation and/or maintenance not required
