Use Attainability Analysis

WBID 1683 Long Branch (formerly Trib. To St. Johns Creek #3)

Submitted by
SES, Inc.

November 4, 2008

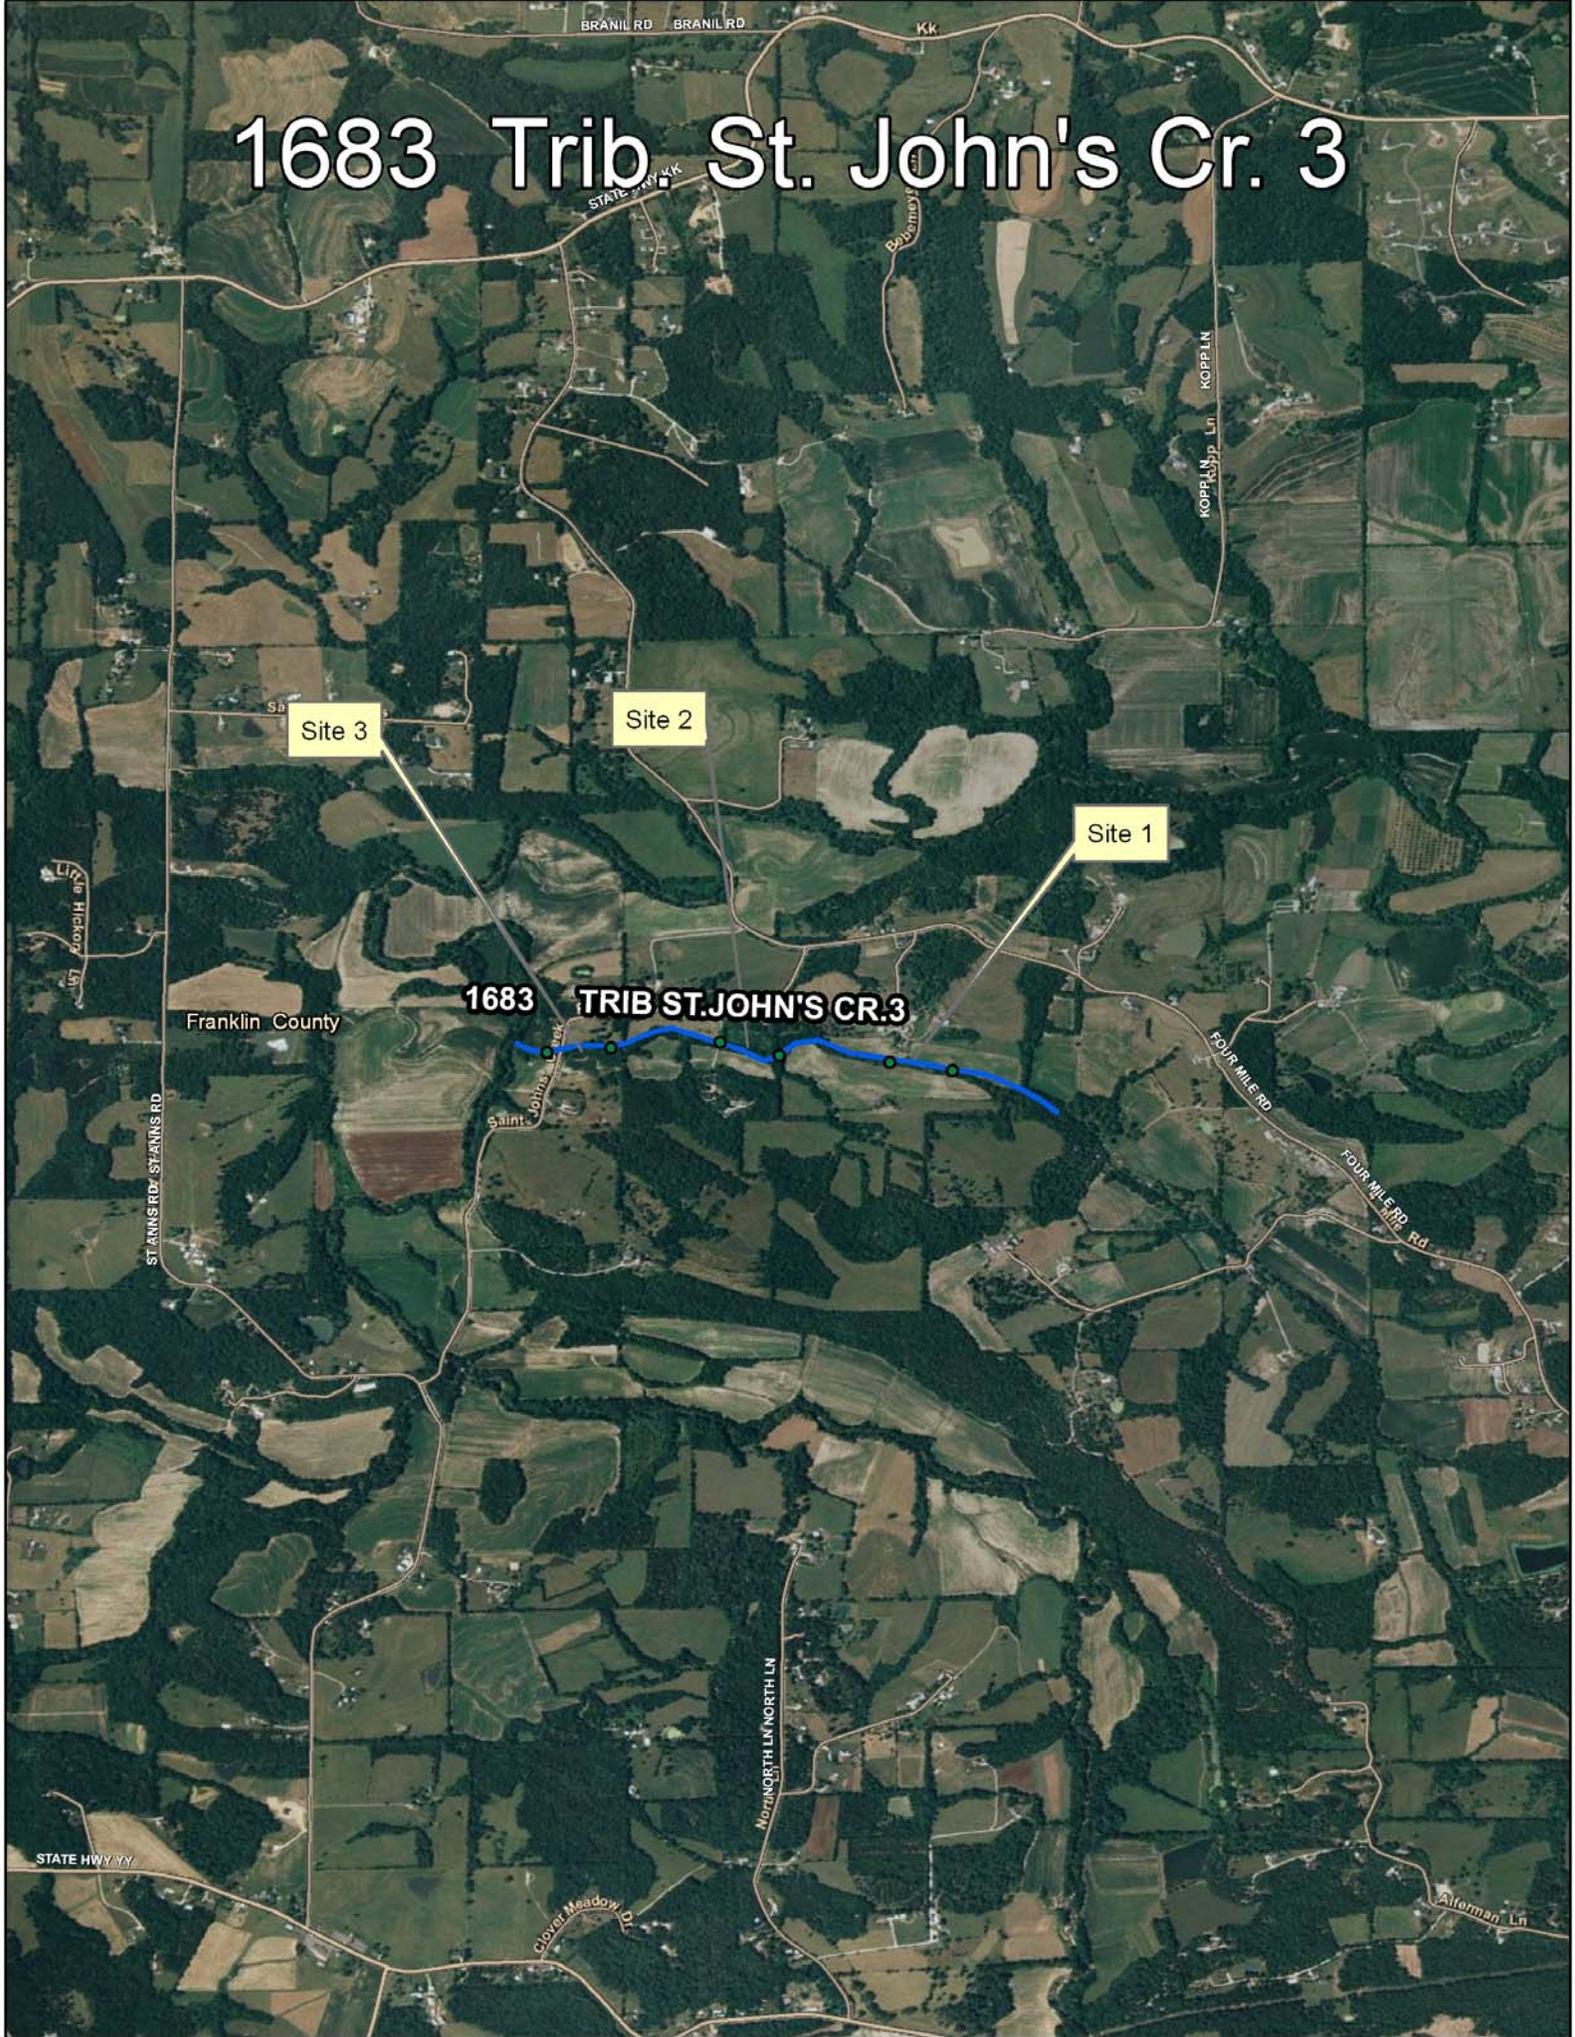
1683 Trib. St. John's Cr. 3

Site 3

Site 2

Site 1

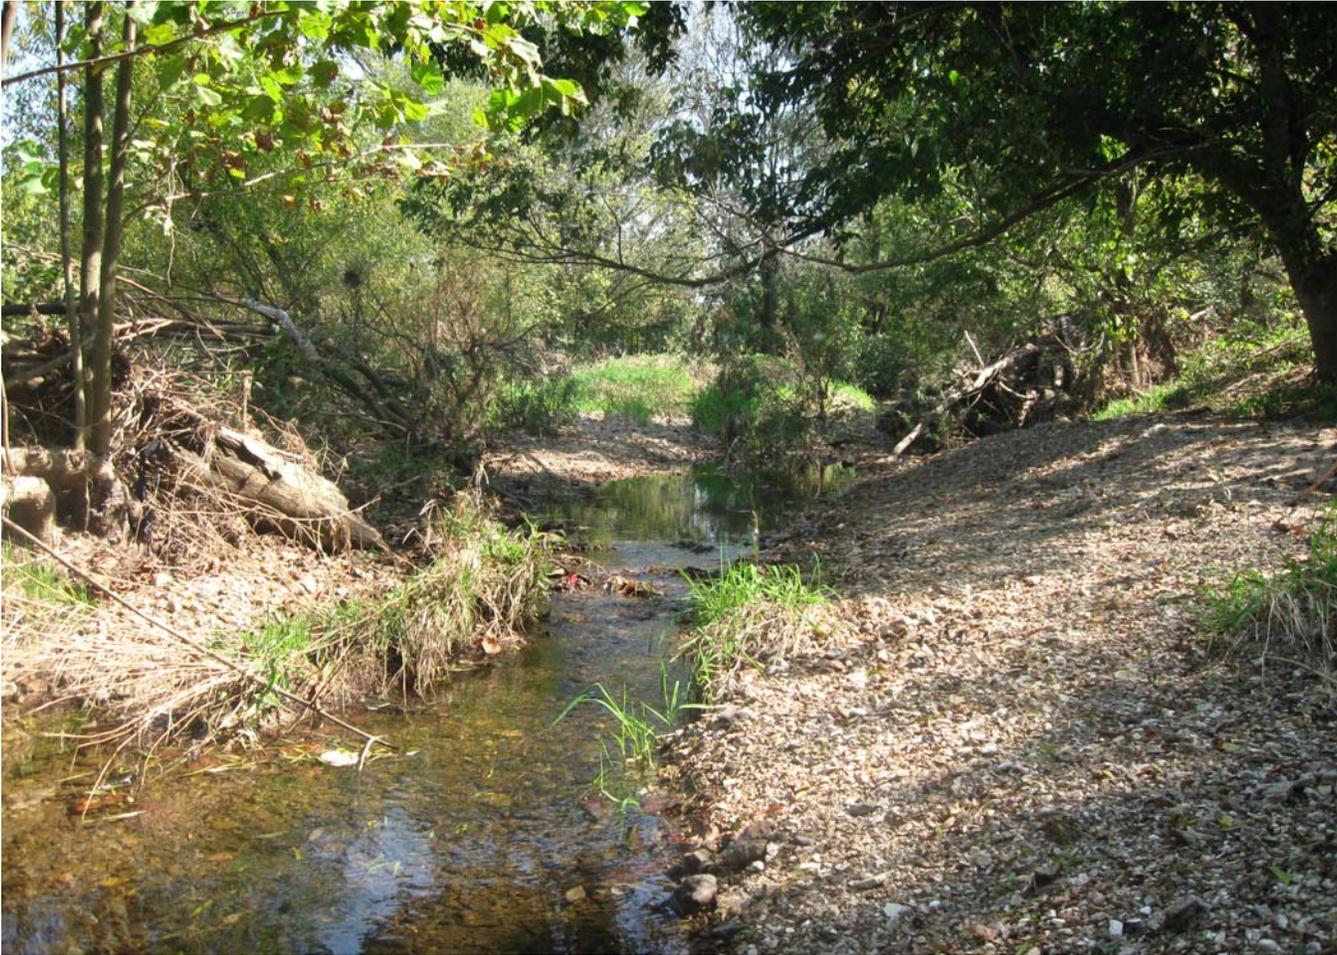
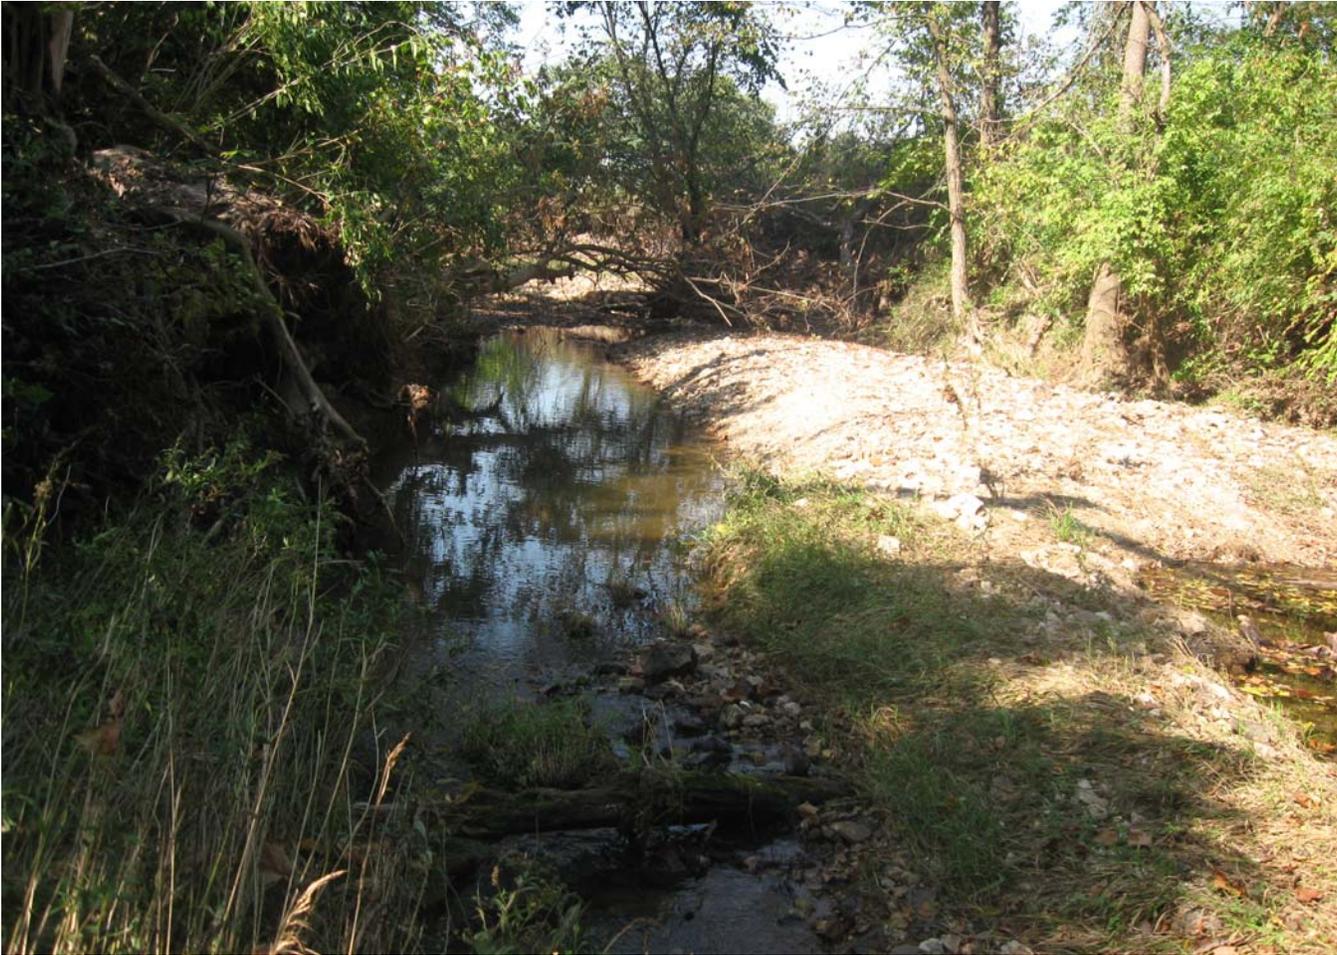
Photo ID#	Photo Purpose	Photo ID#	Photo Purpose	Photo ID#	Photo Purpose
97	upstream	98	downstream		
Photo ID#	Photo Purpose	Photo ID#	Photo Purpose	Photo ID#	Photo Purpose
Photo ID#	Photo Purpose	Photo ID#	Photo Purpose	Photo ID#	Photo Purpose

% Cobble	40% Gravel	60% Sand	% Silt	% Mud/Clay	% Bedrock
----------	------------	----------	--------	------------	-----------

None

Stream Name: <u>Trib. To St. John's Cr. 3</u> Waterbody ID: <u>1683</u> Site #: <u>1</u> Estimated Channel Incision: <u>2</u> (m) (height between low bank width and water) GPS Location - Easting (UTM X), Northing (UTM Y), Horizontal Accuracy Estimate (EPE / PDOP / FOM) 01 UTM X: <u>0665633</u> UTM Y: <u>4266391</u> +/- <u>6</u> (meters) 11 UTM X: <u>0665462</u> UTM Y: <u>4266418</u> +/- <u>7</u> (meters) Average Stream Width: <u>5</u> (meters) Length of Survey Segment: <u>150</u> (meters) (To determine Length of Reach) (20x average stream width) Field Staff: <u>David Bender, Chris Schuler</u>	Dissolved Oxygen Date: <u>10/5/2008</u> Time: <u>12:45</u> Dissolved Oxygen: <u>12.2</u> (mg/L) Dissolved Oxygen: _____ (% sat) Specific Cond: _____ (µS/cm) Water Temperature: <u>16.3</u> (°C)
--	--

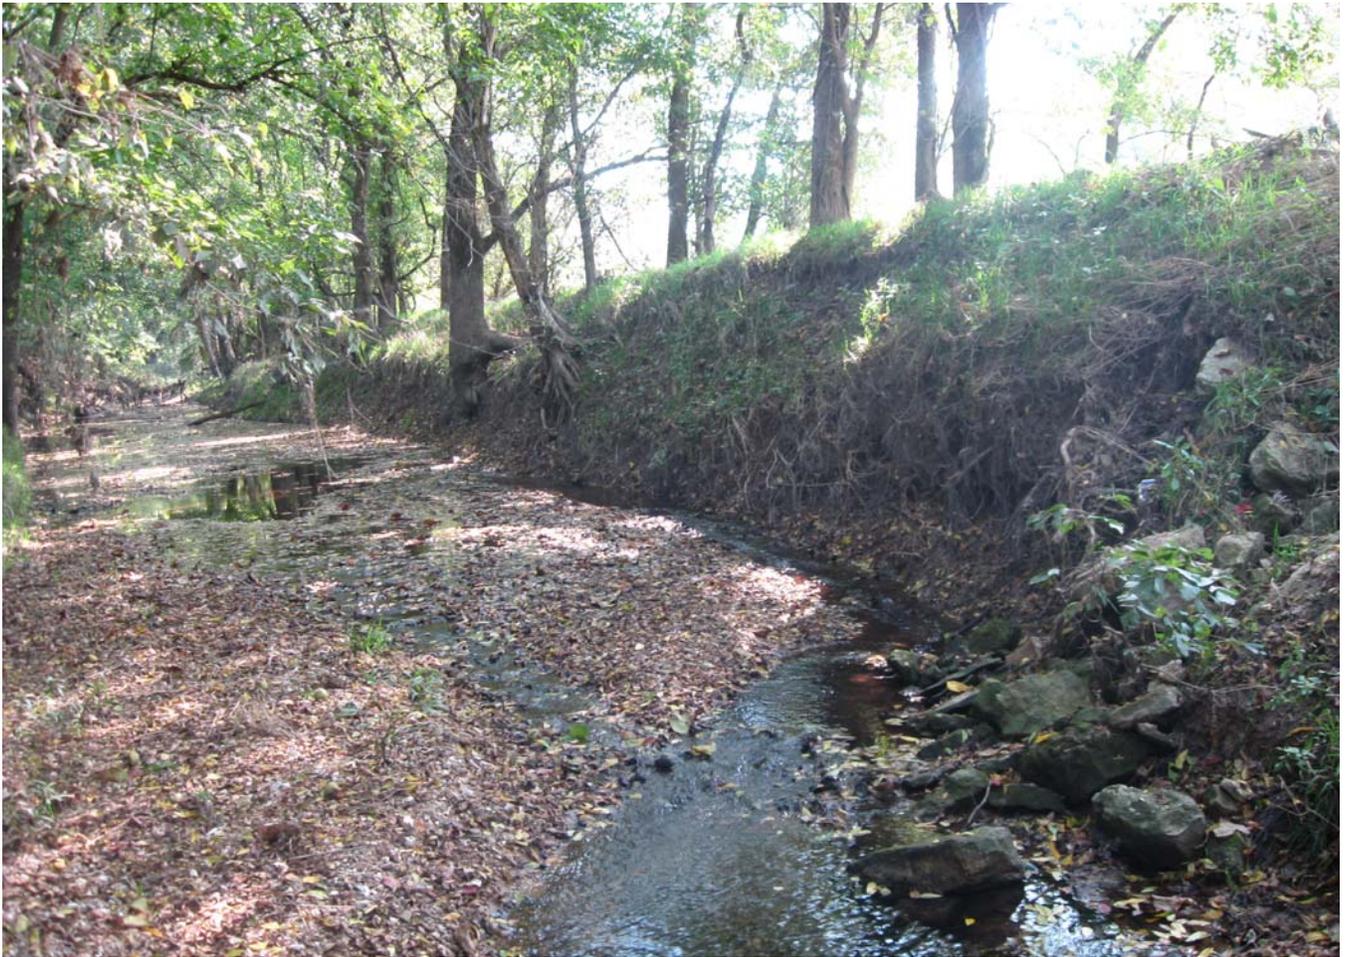
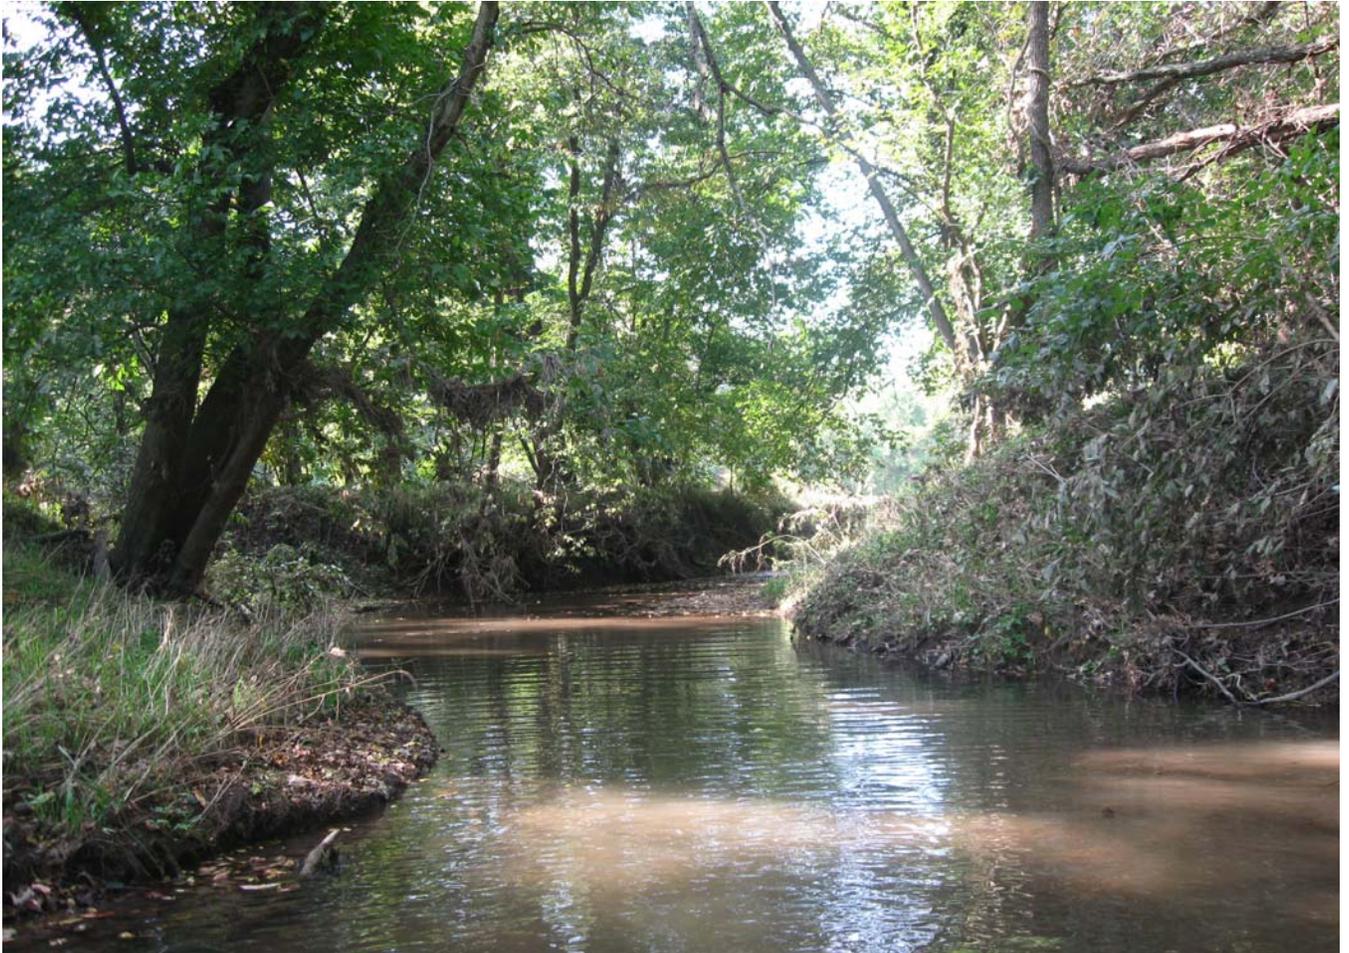
Photo ID#	Photo Purpose	Photo ID#	Photo Purpose	Photo ID#	Photo Purpose
95	upstream	96	downstream		
Photo ID#	Photo Purpose	Photo ID#	Photo Purpose	Photo ID#	Photo Purpose
Photo ID#	Photo Purpose	Photo ID#	Photo Purpose	Photo ID#	Photo Purpose

% Cobble	20% Gravel	80% Sand	% Silt	% Mud/Clay	% Bedrock
----------	------------	----------	--------	------------	-----------

None

Stream Name: <u>Trib. To St. John's Cr. 3</u> Waterbody ID: <u>1683</u> Site #: <u>2</u> Estimated Channel Incision: <u>3</u> (m) (height between low bank width and water) GPS Location - Easting (UTM X), Northing (UTM Y), Horizontal Accuracy Estimate (EPE / PDOP / FOM) 01 UTM X: <u>0665160</u> UTM Y: <u>4266437</u> +/- <u>6</u> (meters) 11 UTM X: <u>0665000</u> UTM Y: <u>4266471</u> +/- <u>8</u> (meters) Average Stream Width: <u>4</u> (meters) Length of Survey Segment: <u>150</u> (meters) (To determine Length of Reach) (20x average stream width) Field Staff: <u>David Bender, Chris Schuler</u>	<h4 style="text-align: center; margin: 0;">Dissolved Oxygen</h4> Date: <u>10/5/2008</u> Time: <u>11:35</u> Dissolved Oxygen: <u>11.0</u> (mg/L) Dissolved Oxygen: _____ (% sat) Specific Cond: _____ (µS/cm) Water Temperature: <u>15.5</u> (°C)
--	--

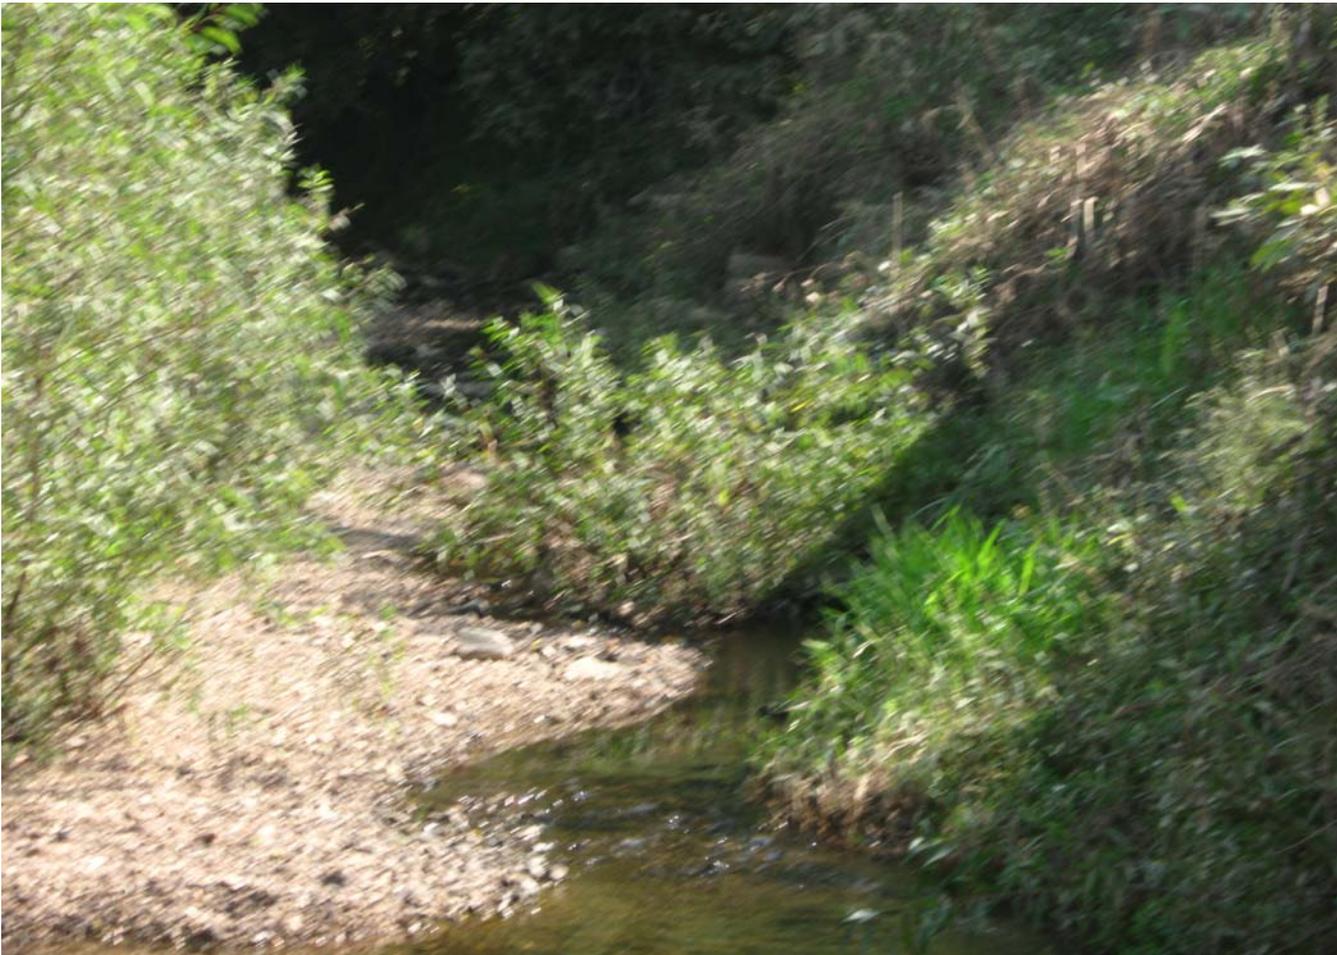
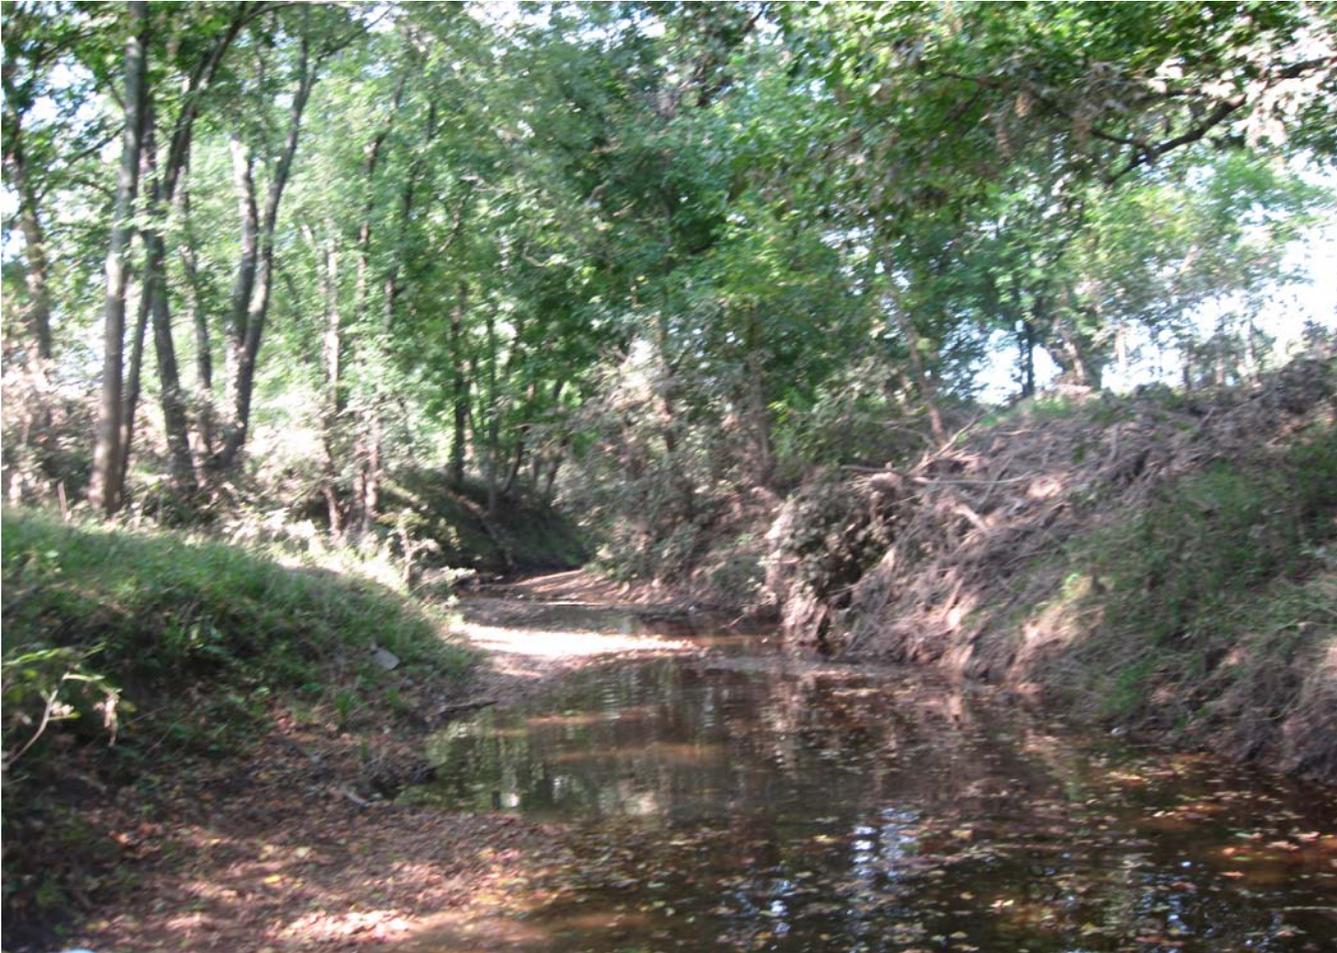
Photo ID#	Photo Purpose	Photo ID#	Photo Purpose	Photo ID#	Photo Purpose
93	upstream	94	downstream		
Photo ID#	Photo Purpose	Photo ID#	Photo Purpose	Photo ID#	Photo Purpose
Photo ID#	Photo Purpose	Photo ID#	Photo Purpose	Photo ID#	Photo Purpose

% Cobble	20% Gravel	70% Sand	% Silt	10% Mud/Clay	% Bedrock
----------	------------	----------	--------	--------------	-----------

Algae on 5% of substrate.

Stream Name: <u>Trib. To St. John's Cr. 3</u> Waterbody ID: <u>1683</u> Site #: <u>3</u> Estimated Channel Incision: <u>5</u> (m) (height between low bank width and water) GPS Location - Easting (UTM X), Northing (UTM Y), Horizontal Accuracy Estimate (EPE / PDOP / FOM) 01 UTM X: <u>0664691</u> UTM Y: <u>4266445</u> +/- <u>7</u> (meters) 11 UTM X: <u>0664533</u> UTM Y: <u>4266431</u> +/- <u>3</u> (meters) Average Stream Width: <u>4</u> (meters) Length of Survey Segment: <u>150</u> (meters) (To determine Length of Reach) (20x average stream width) Field Staff: <u>David Bender, Chris Schuler</u>	<h4 style="text-align: center; margin: 0;">Dissolved Oxygen</h4> Date: <u>10/5/2008</u> Time: <u>11:05</u> Dissolved Oxygen: <u>7.4</u> (mg/L) Dissolved Oxygen: _____ (% sat) Specific Cond: _____ (µS/cm) Water Temperature: <u>15.0</u> (°C)
--	---
