Use Attainability Analysis

WBID 1695 Tributary to Labadie Creek

Submitted by
SES, Inc.

November 4, 2008

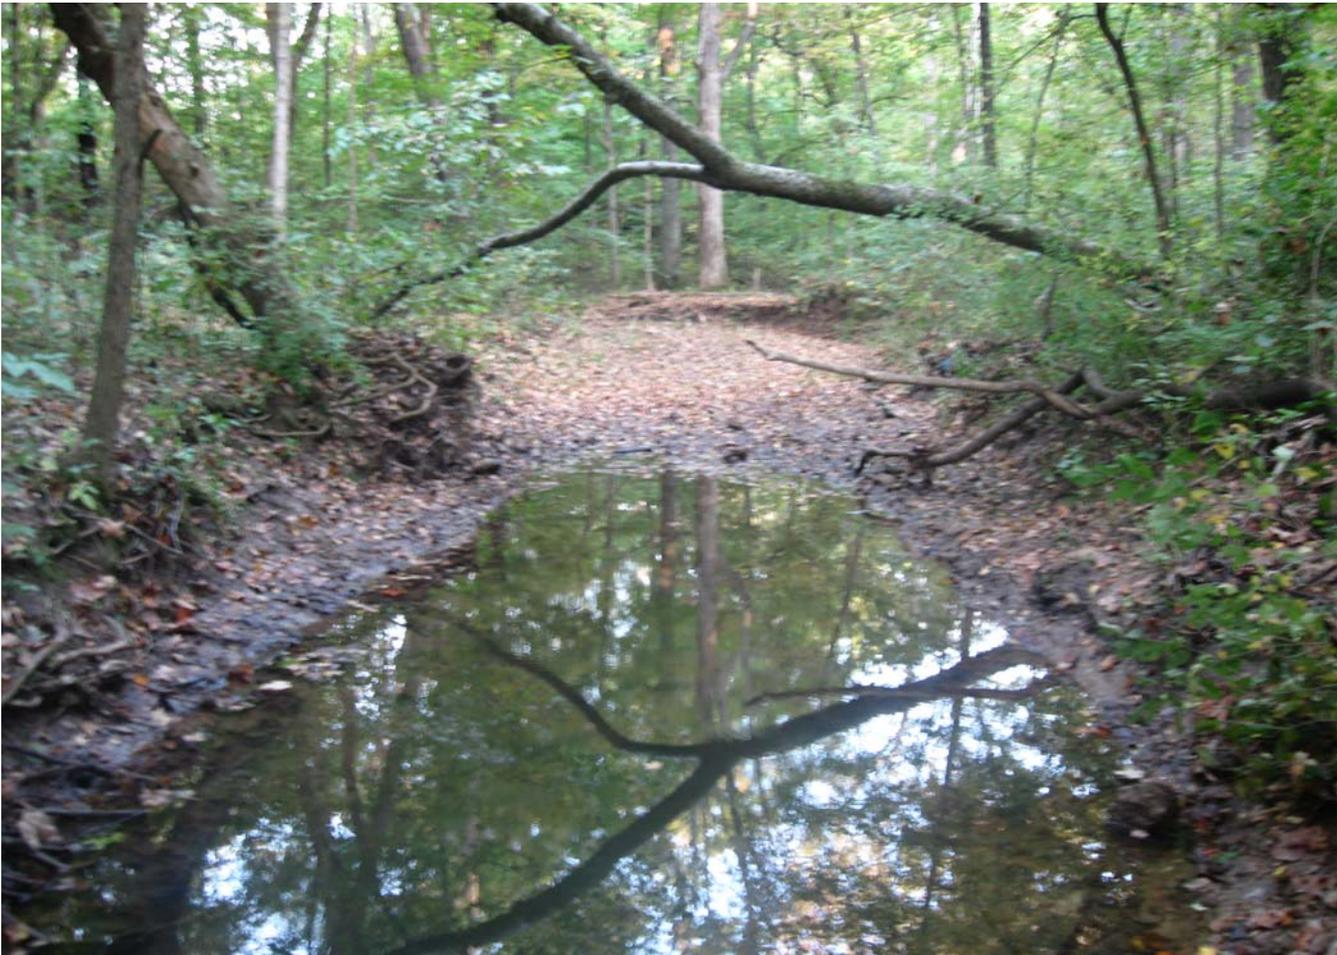
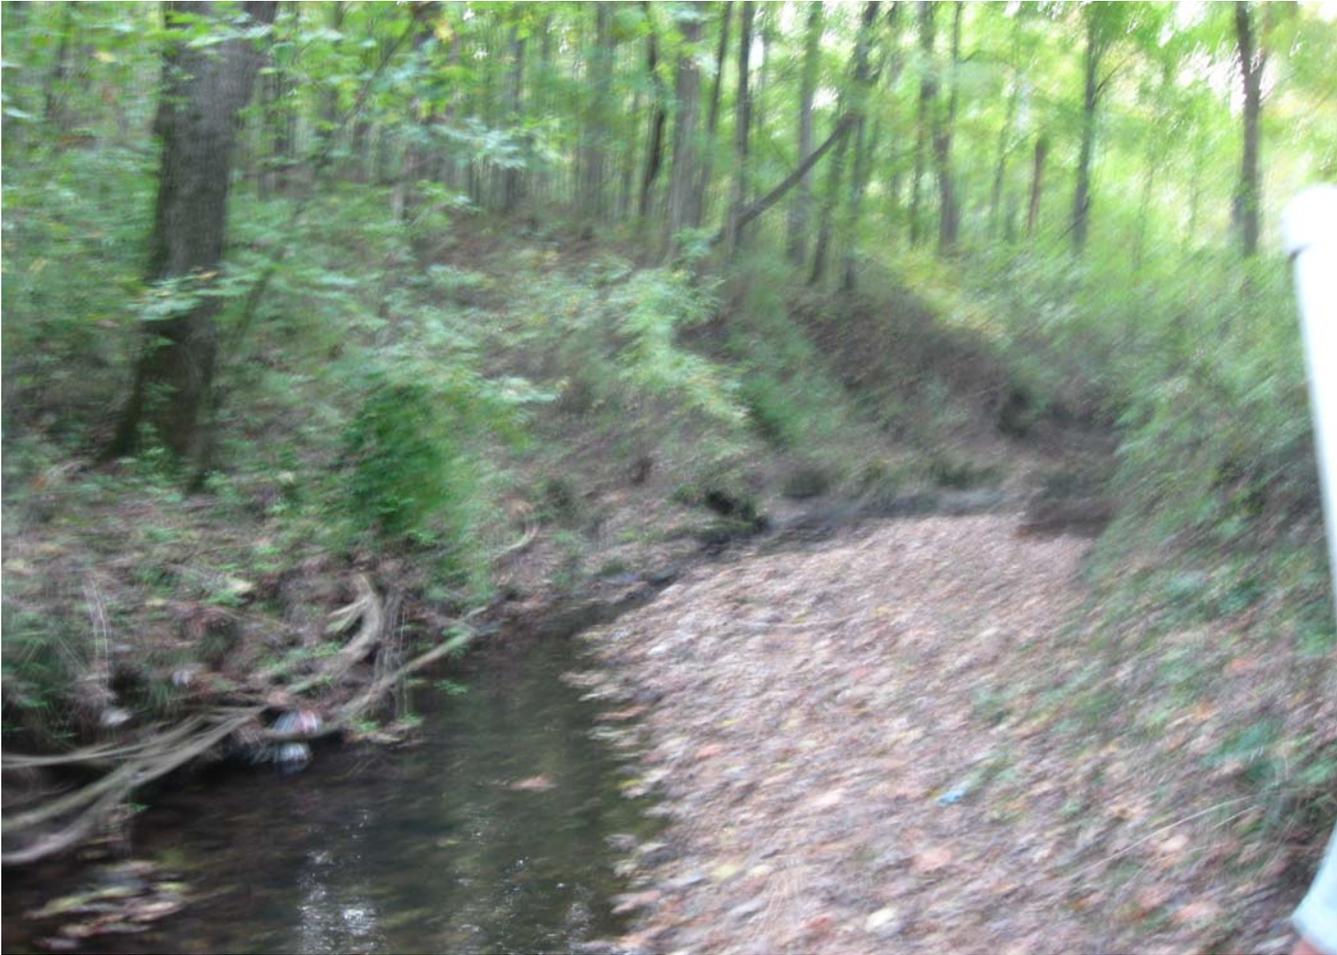
Photo ID#	Photo Purpose	Photo ID#	Photo Purpose	Photo ID#	Photo Purpose
84	Downstream	85	Upstream		
Photo ID#	Photo Purpose	Photo ID#	Photo Purpose	Photo ID#	Photo Purpose
Photo ID#	Photo Purpose	Photo ID#	Photo Purpose	Photo ID#	Photo Purpose

No flow

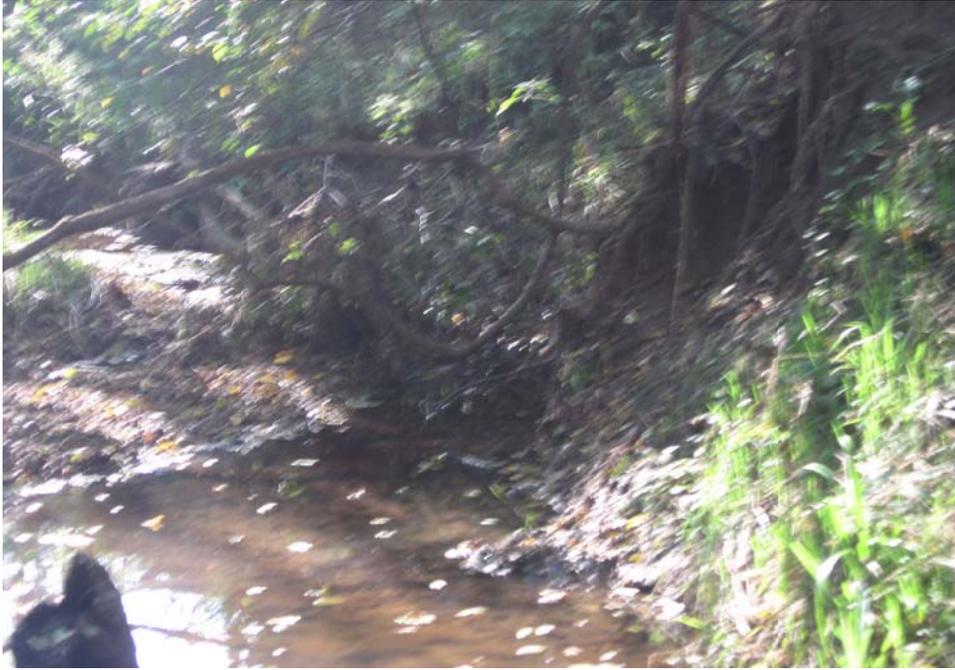
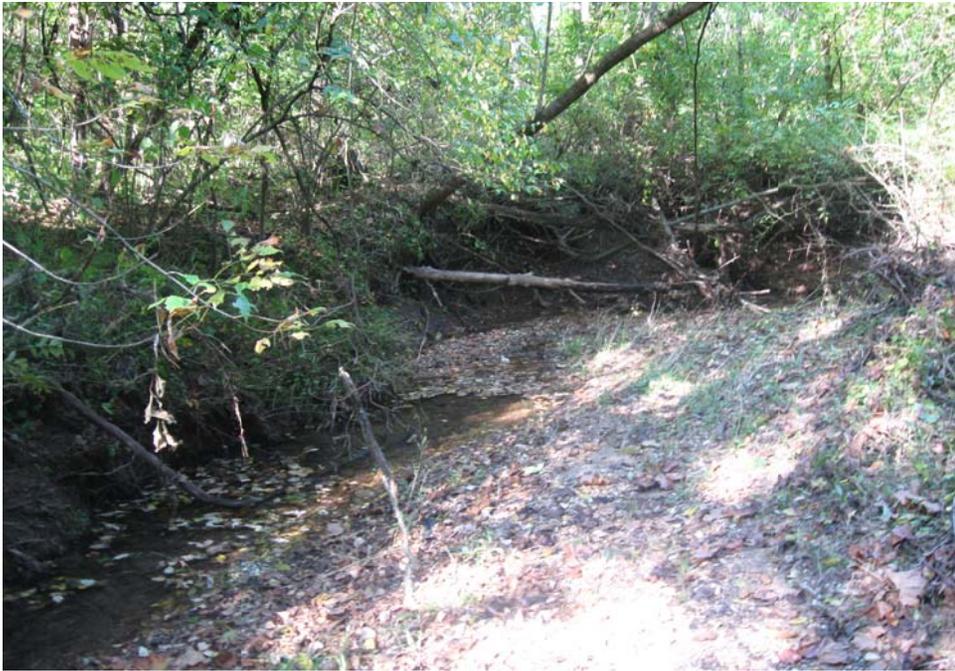
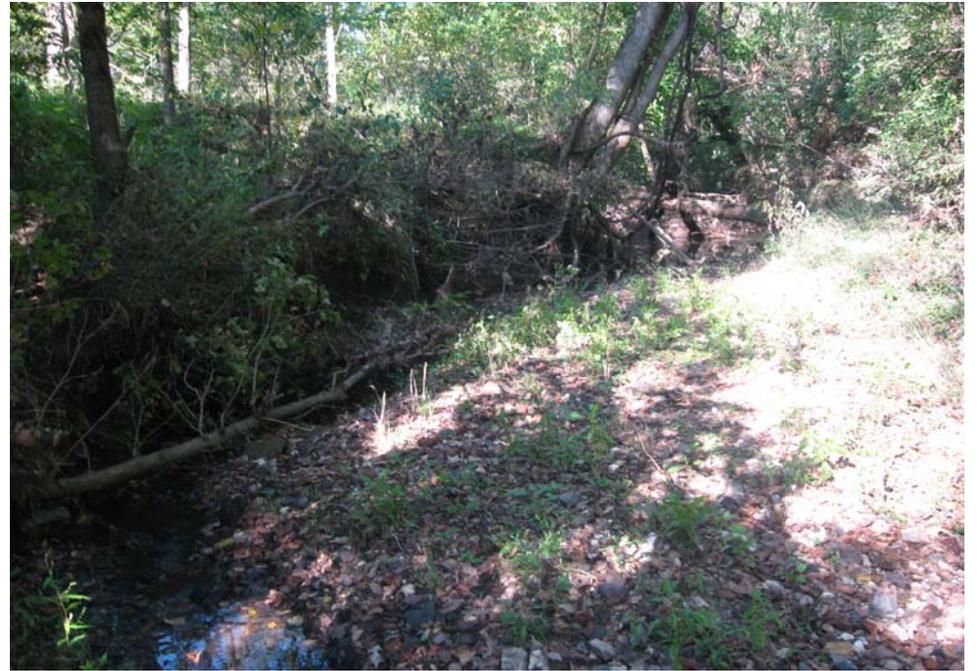
Photo ID#	Photo Purpose	Photo ID#	Photo Purpose	Photo ID#	Photo Purpose
79	Downstream	80	ATV Tracks	81	downstream
Photo ID#	Photo Purpose	Photo ID#	Photo Purpose	Photo ID#	Photo Purpose
Photo ID#	Photo Purpose	Photo ID#	Photo Purpose	Photo ID#	Photo Purpose

Picture 79 contains a cable in the stream bed.

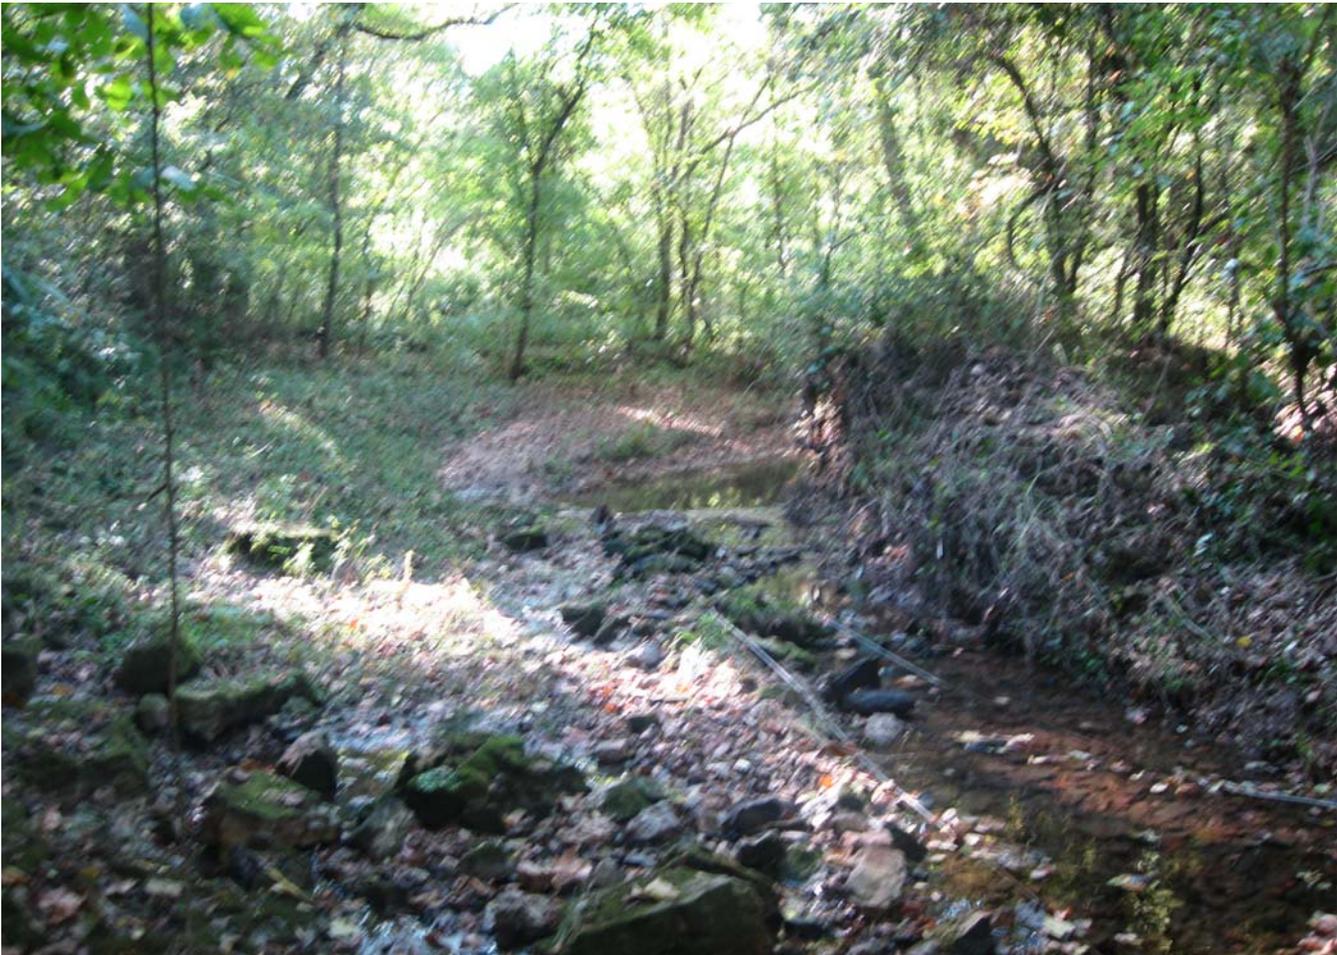
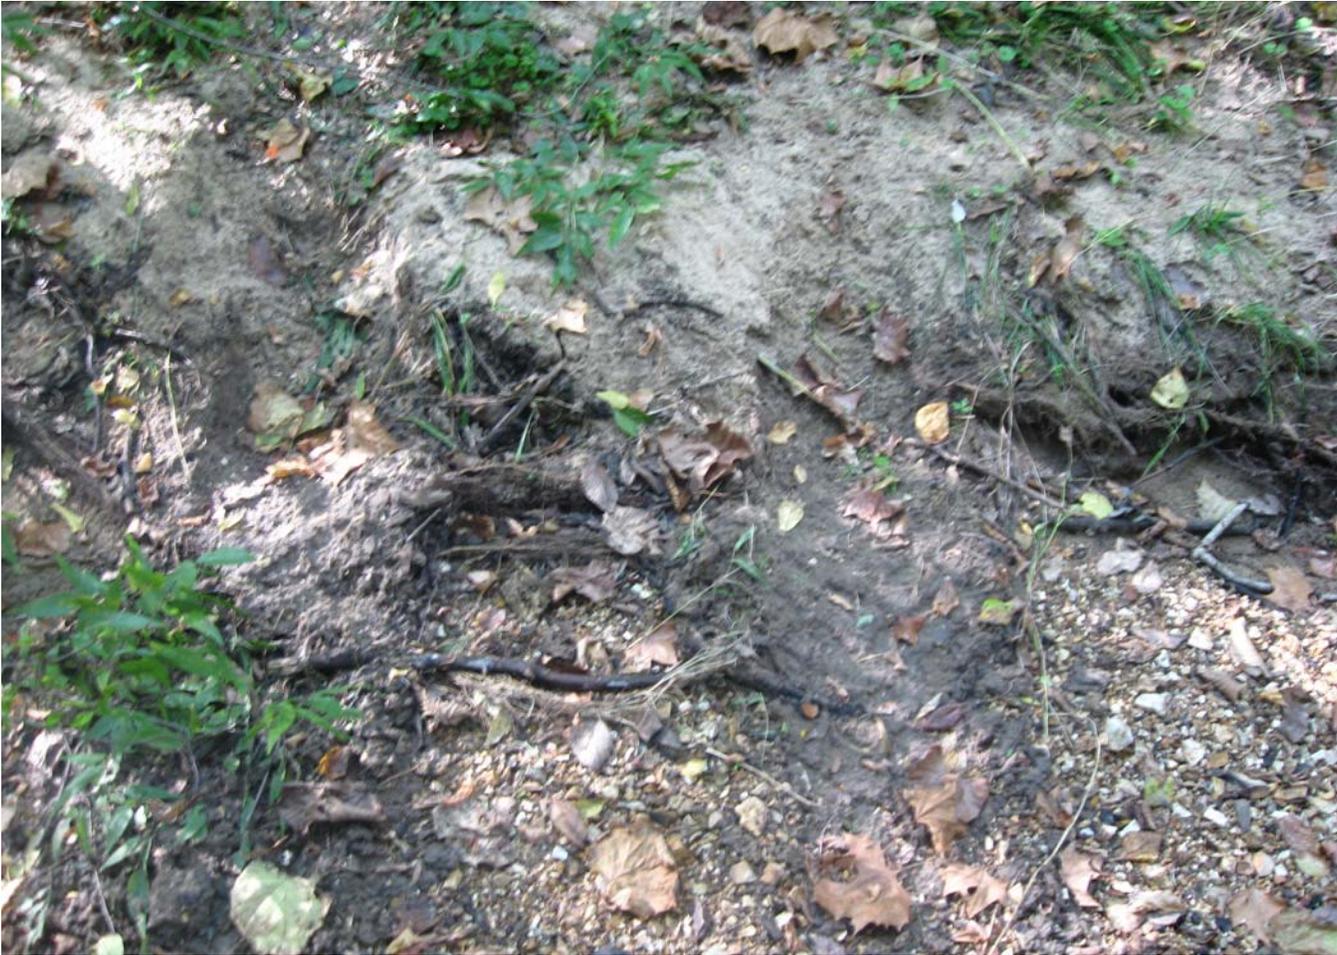
Photo ID#	Photo Purpose	Photo ID#	Photo Purpose	Photo ID#	Photo Purpose
82	upstream	83	downstream		
Photo ID#	Photo Purpose	Photo ID#	Photo Purpose	Photo ID#	Photo Purpose
Photo ID#	Photo Purpose	Photo ID#	Photo Purpose	Photo ID#	Photo Purpose
