Use Attainability Analysis

WBID 1701 Bonhomme Creek

MEC Water Resources

Field Data Sheets for Recreational Use Stream Surveys

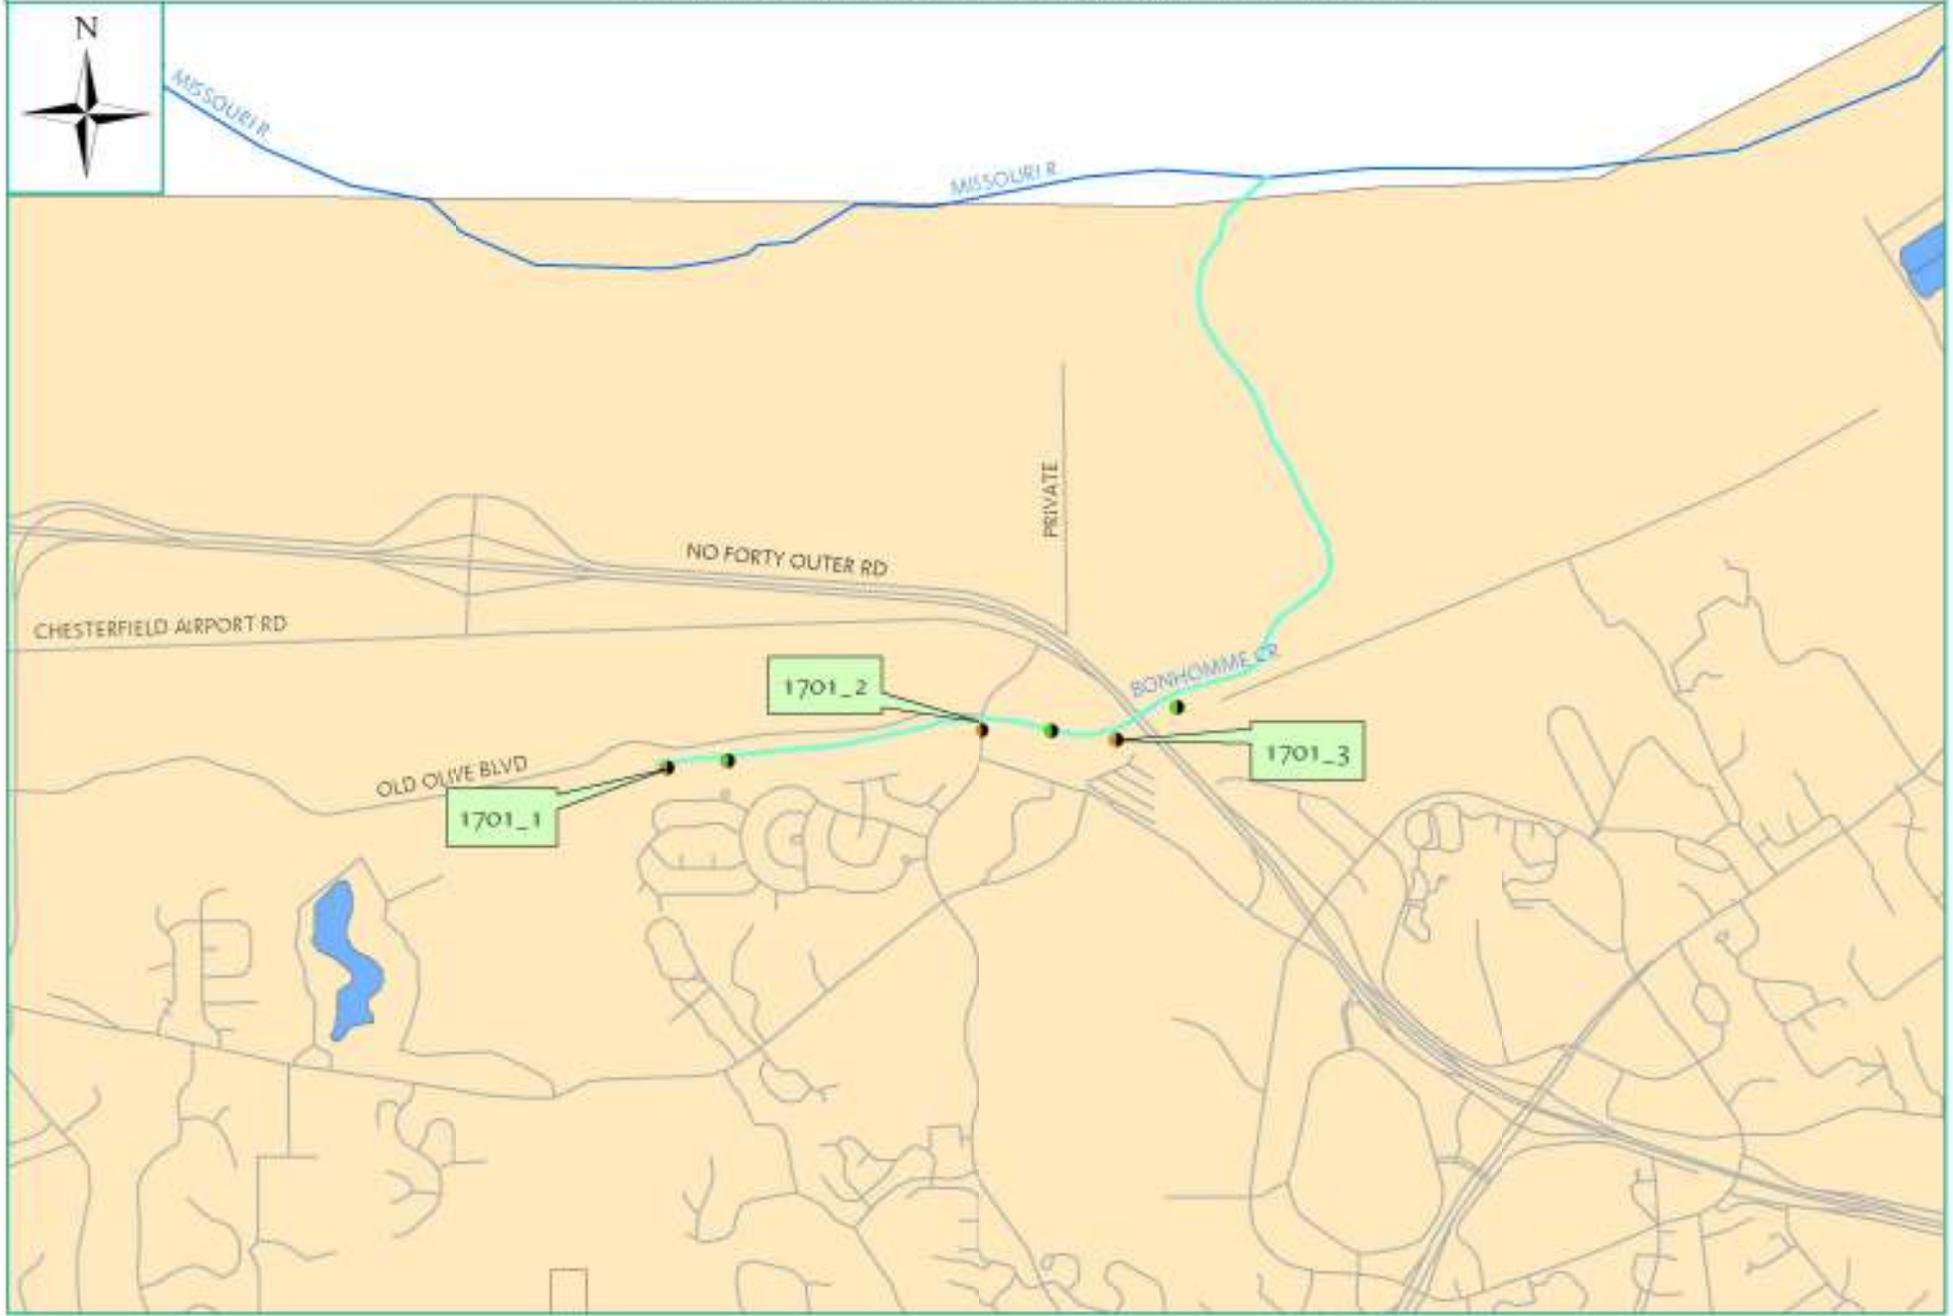
# Bonhomme Creek (WBID 1701)

- Upstream Boundary
- Downstream Boundary

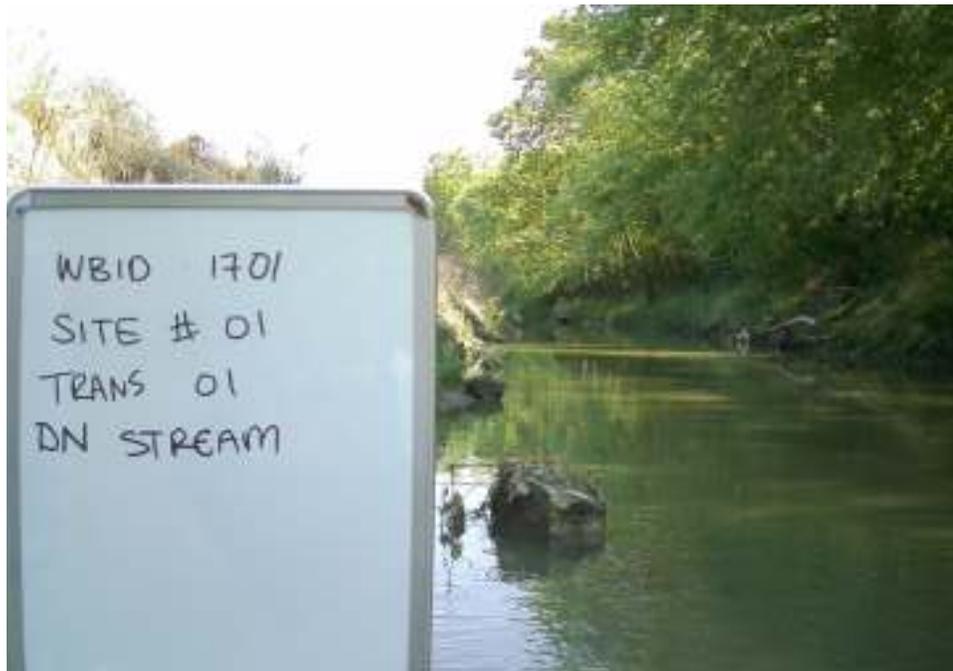
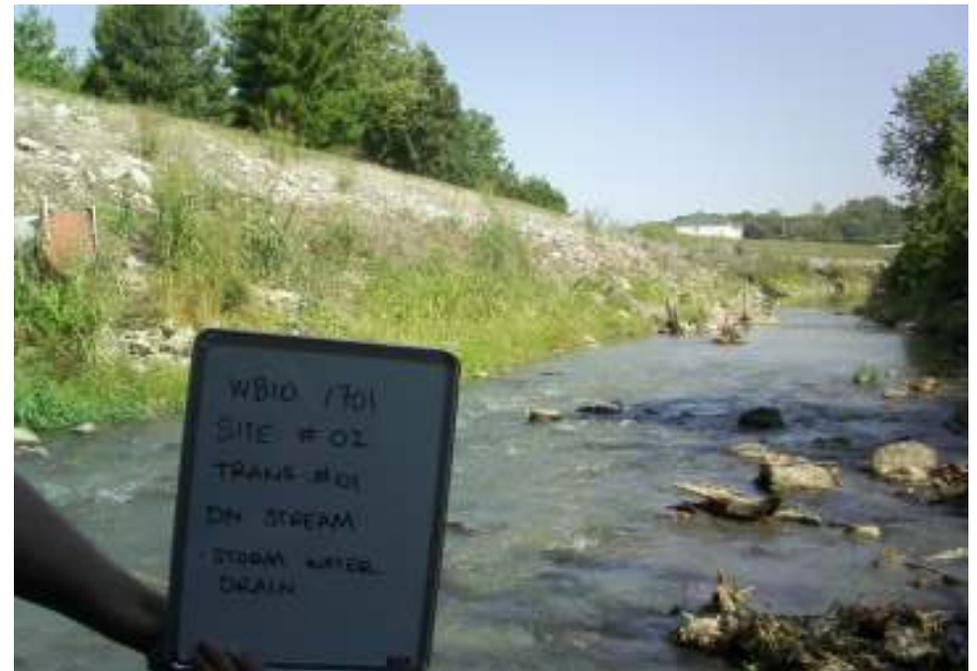
Photo ID#	Photo Purpose	Photo ID#	Photo Purpose	Photo ID#	Photo Purpose
<u>1701-1-98</u>	<u>Upstream site 1</u>	<u>1701-1-99</u>	<u>DN Stream site 1</u>

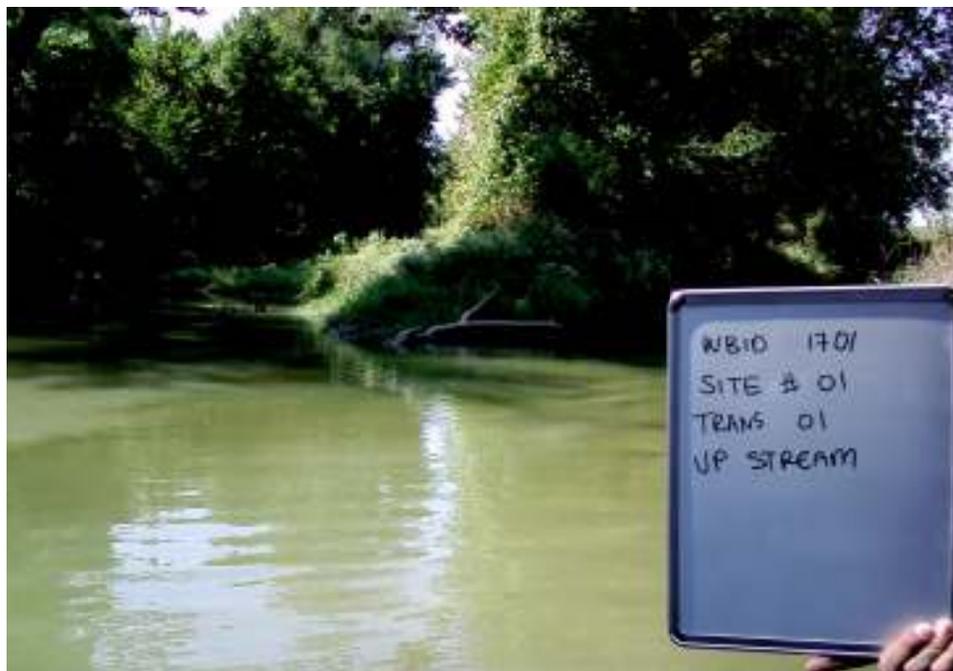
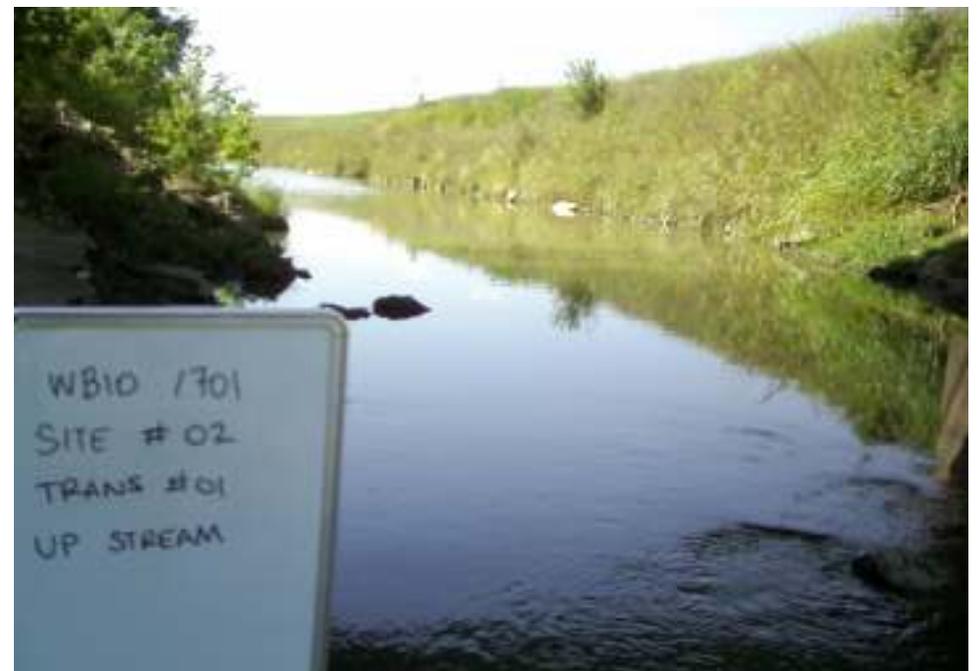
Photo ID#	Photo Purpose	Photo ID#	Photo Purpose	Photo ID#	Photo Purpose
<u>1701-2-101</u>	<u>upstream site 2</u>	<u>1701-2-102</u>	<u>Storm water pipe site 2 dn stream</u>

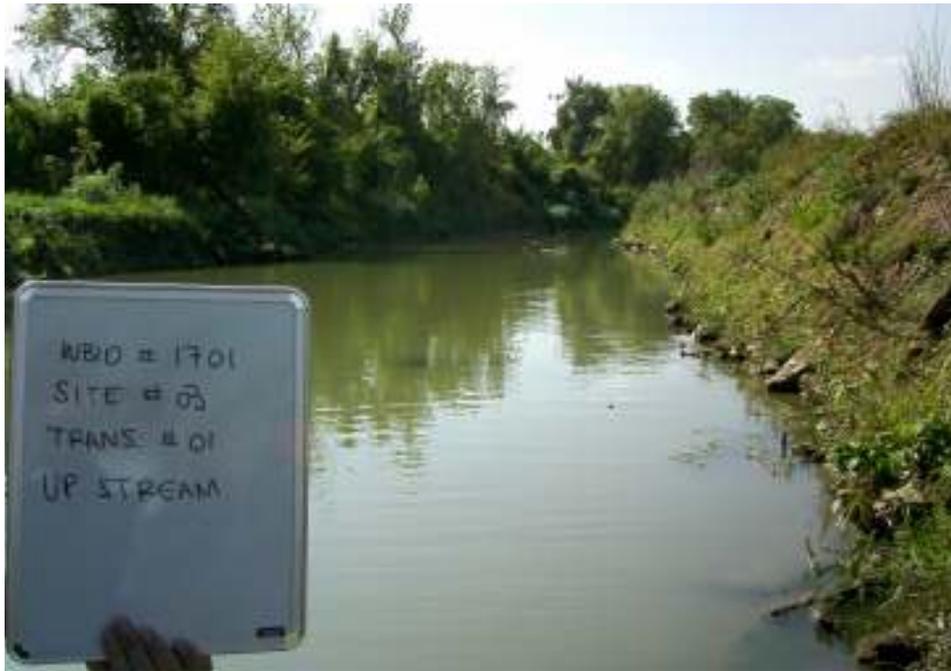
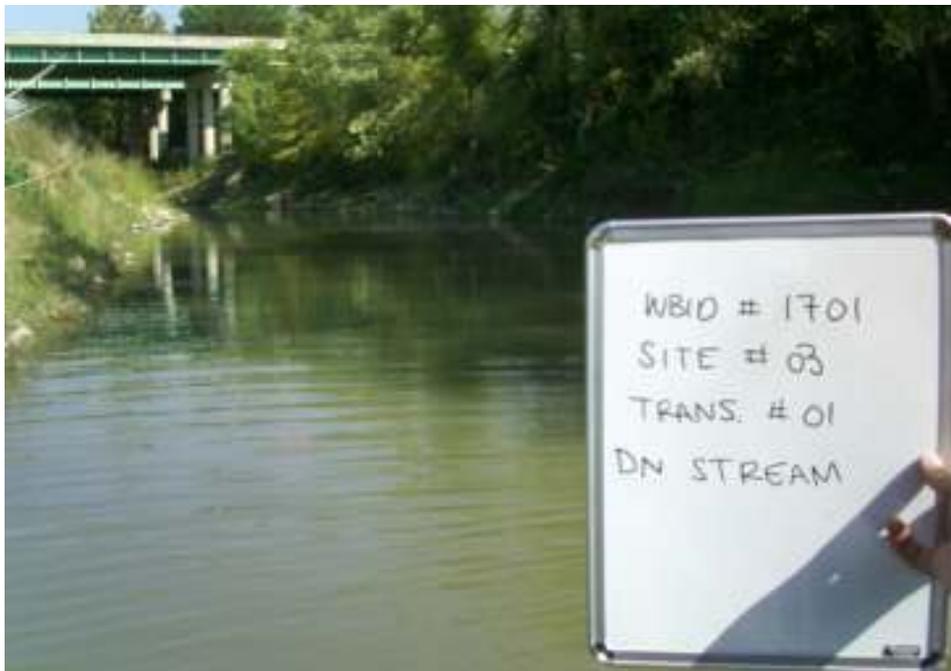
Photo ID#	Photo Purpose	Photo ID#	Photo Purpose	Photo ID#	Photo Purpose
<u>1701-3-103</u>	<u>Site 3 T-1 UP Stream</u>	<u>1701-3-104</u>	<u>Site 3 T-1 DN Stream</u>
