Use Attainability Analysis

WBID 2027 Little Meramec River (renamed in 2009)

Submitted by
SES, Inc.

To
Missouri Department of Natural Resources
Water Protection Program

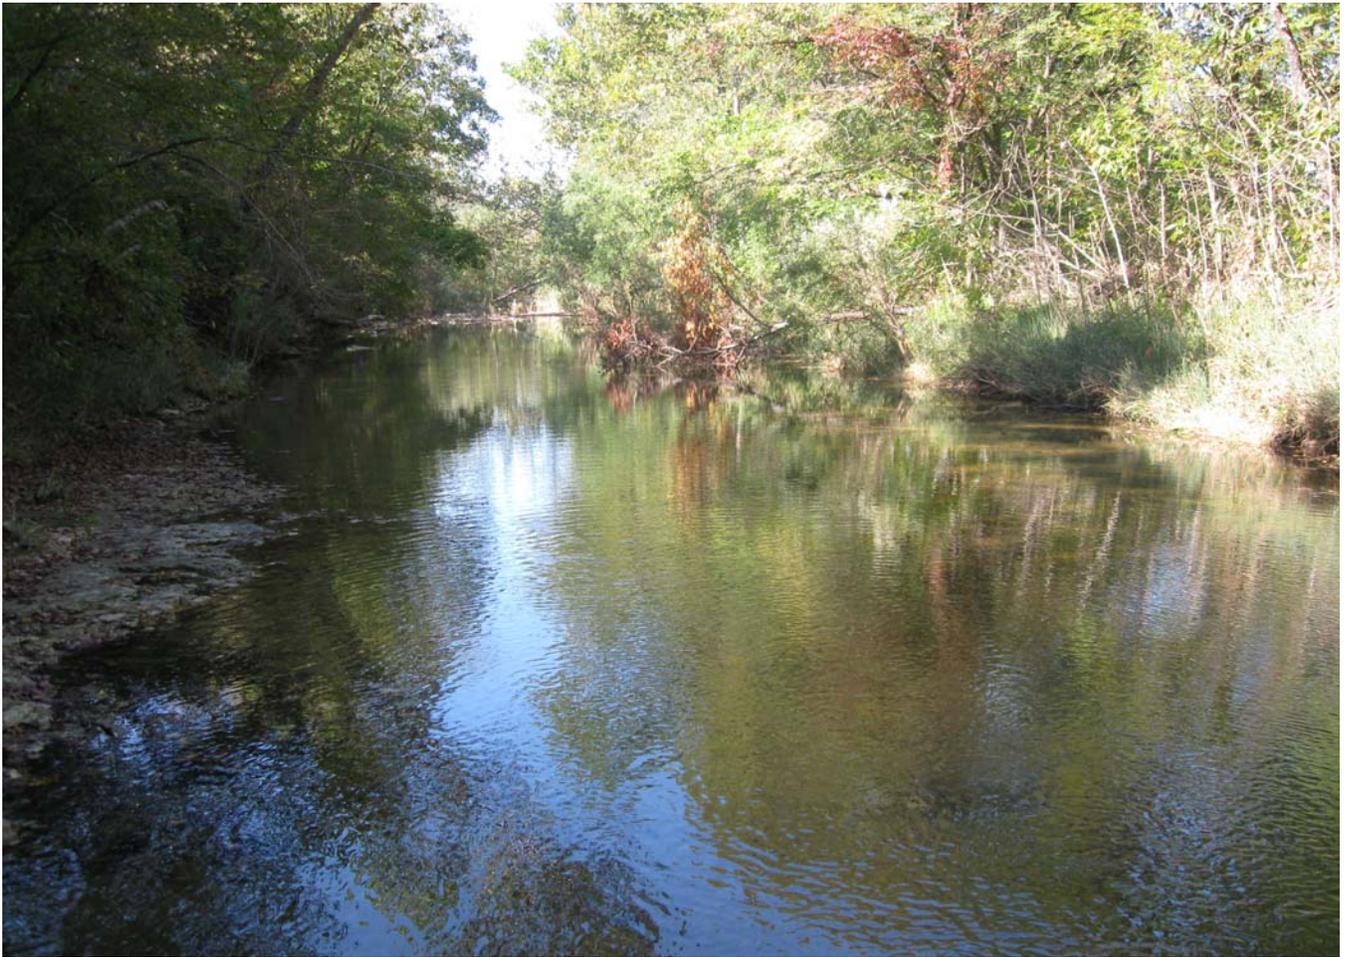
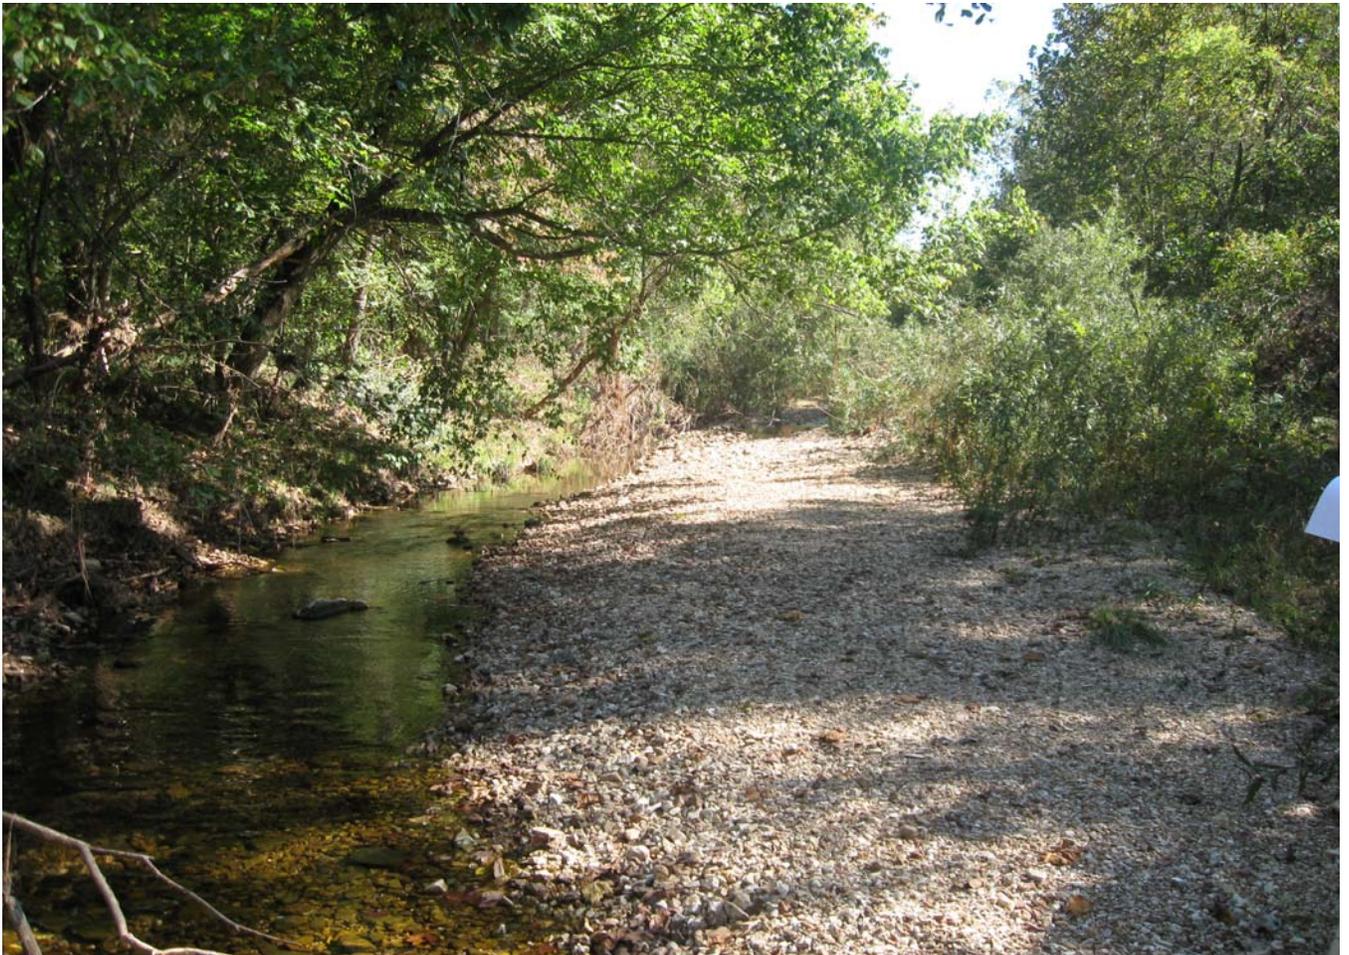
| Photo ID# | Photo Purpose | Photo ID# | Photo Purpose | Photo ID# | Photo Purpose |
|---|---|---|---|---|---|
| 52 | Downstream | 53 | upstream | | |

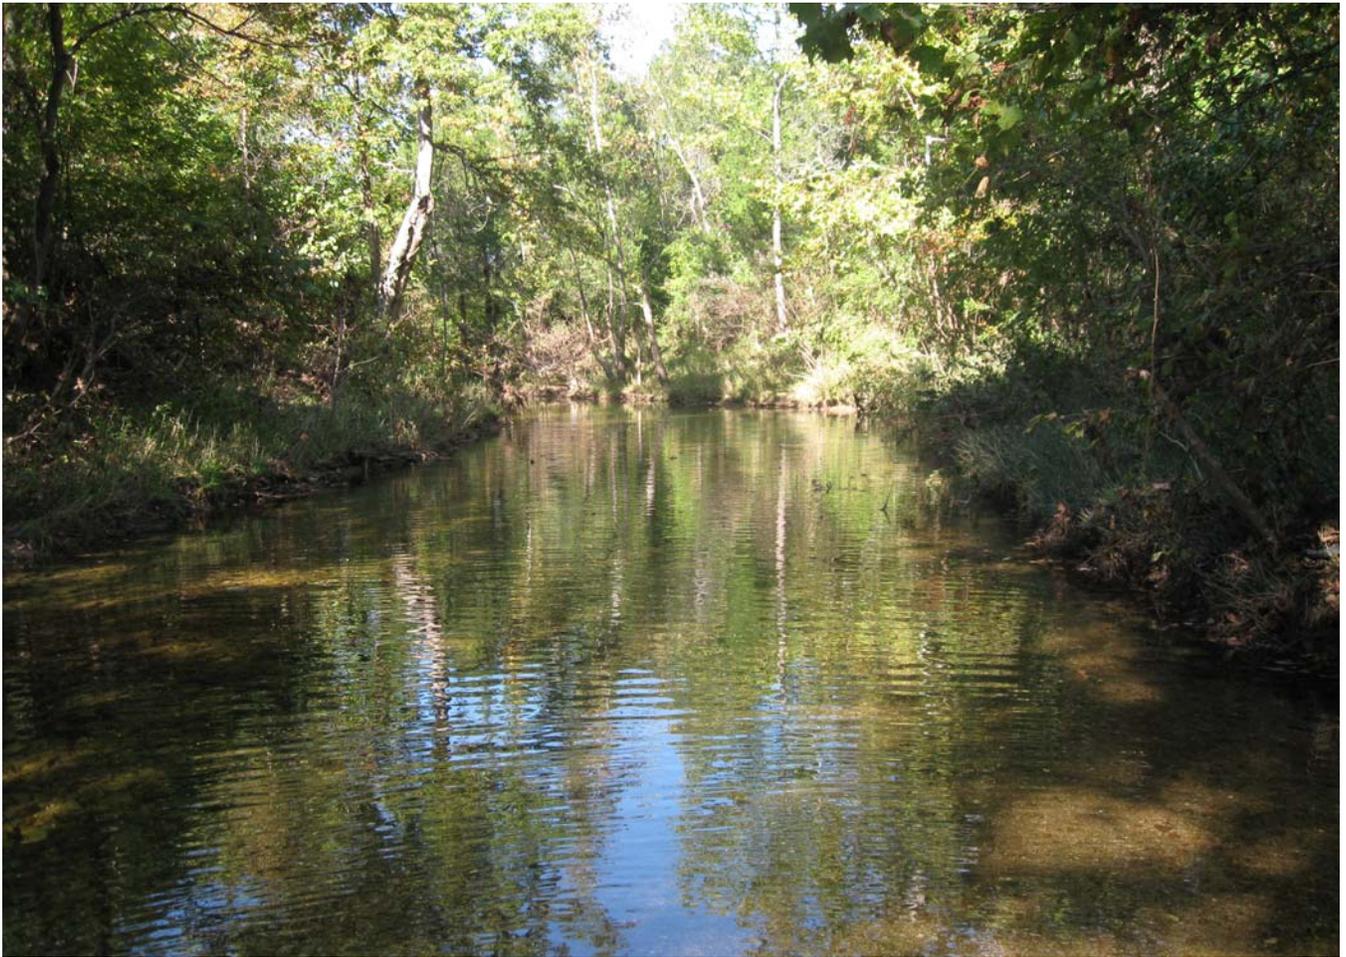
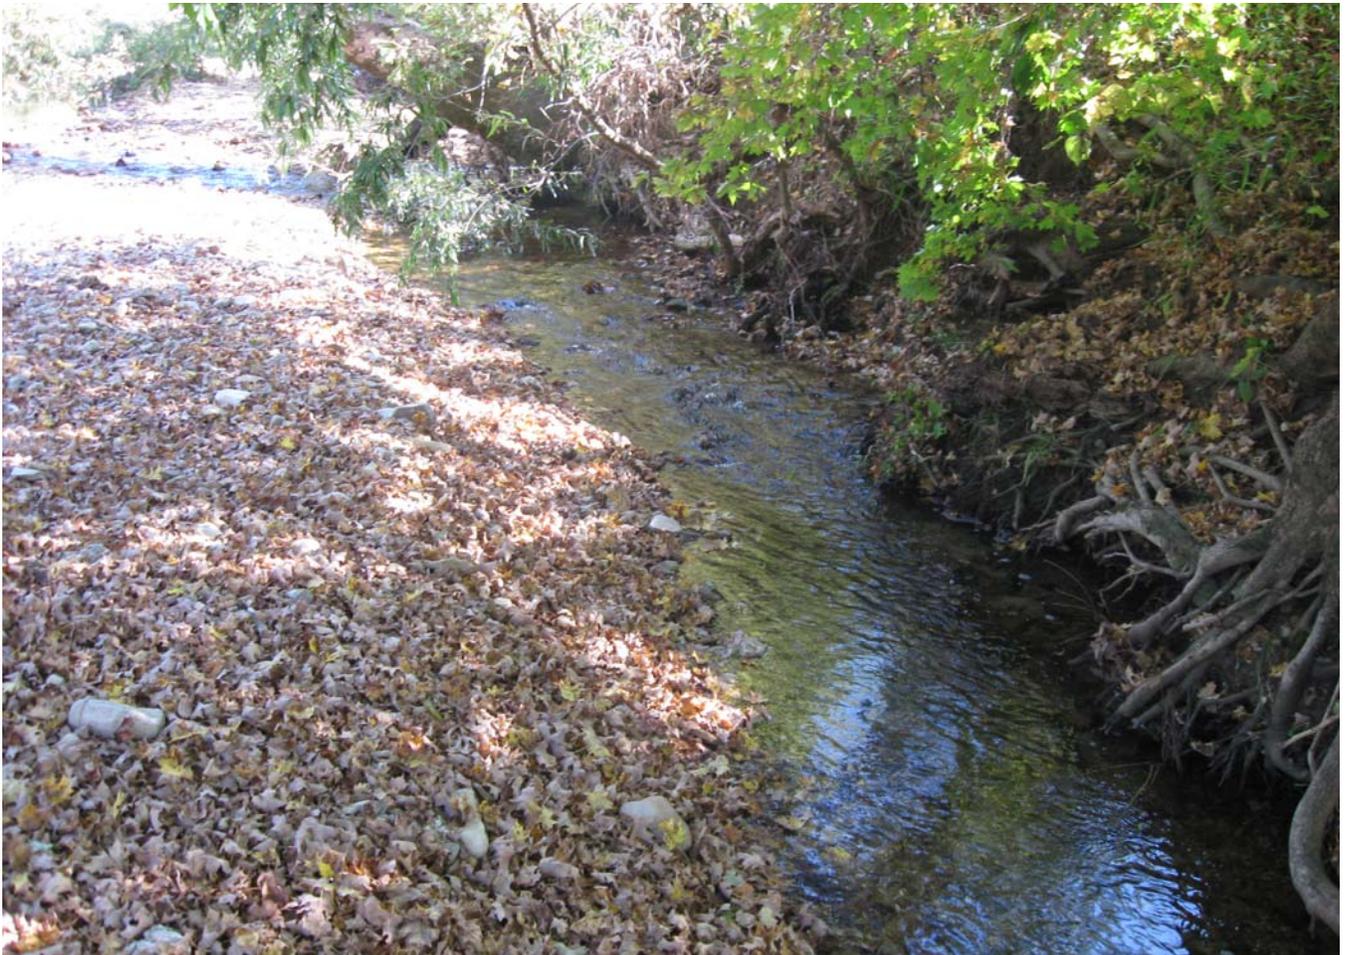
| Photo ID# | Photo Purpose | Photo ID# | Photo Purpose | Photo ID# | Photo Purpose |
|---|---|---|---|---|---|
| 54 | Downstream | 55 | upstream | | |

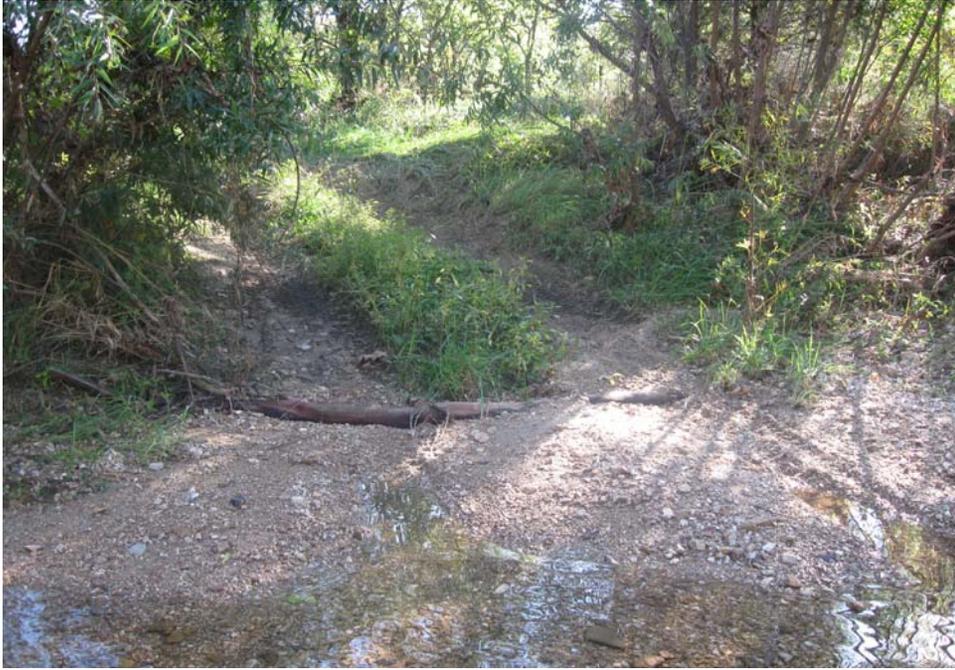
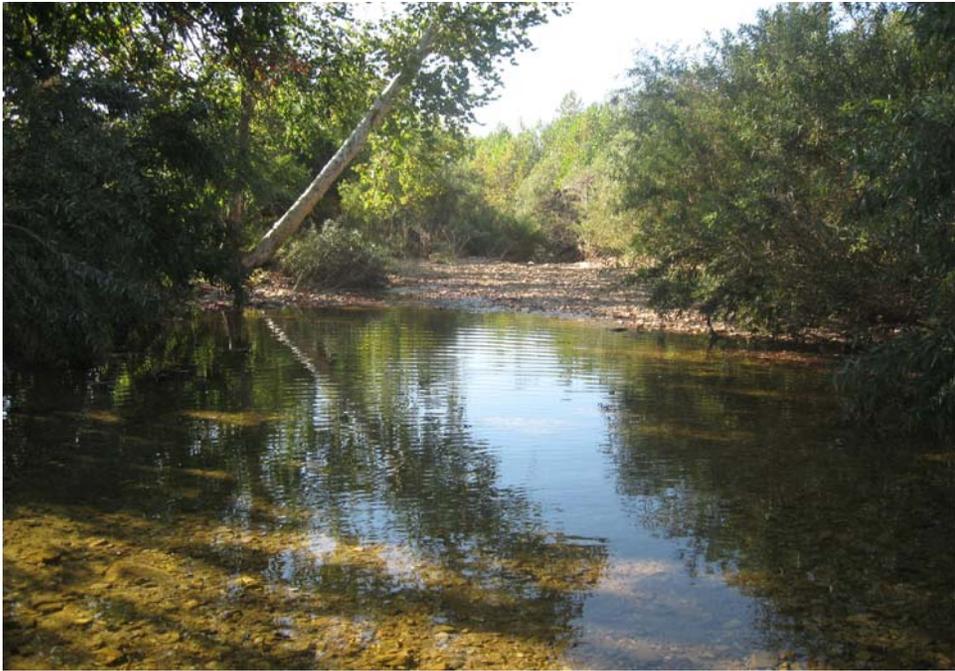
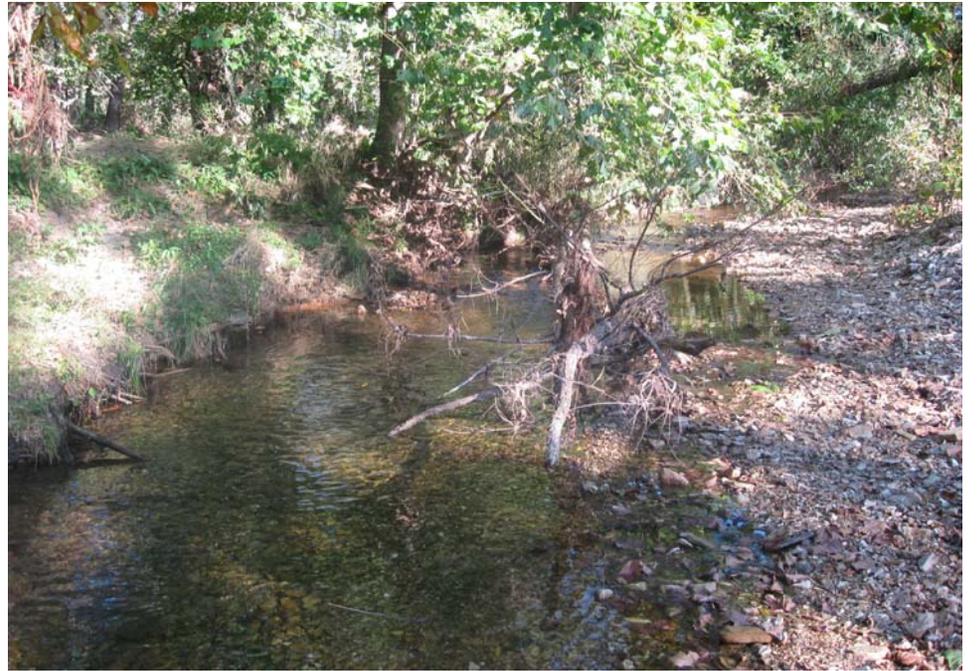
| Photo ID# | Photo Purpose | Photo ID# | Photo Purpose | Photo ID# | Photo Purpose |
|---|---|---|---|---|---|
| 56 | Downstream | 57 | Road | 58 | upstream |
