Use Attainability Analysis

WBID N/A (unclassified) Tributary to St. Johns Creek

To
Missouri Department of Natural Resources
Water Protection Program

Field Data Sheets for Recreational Use Stream Surveys

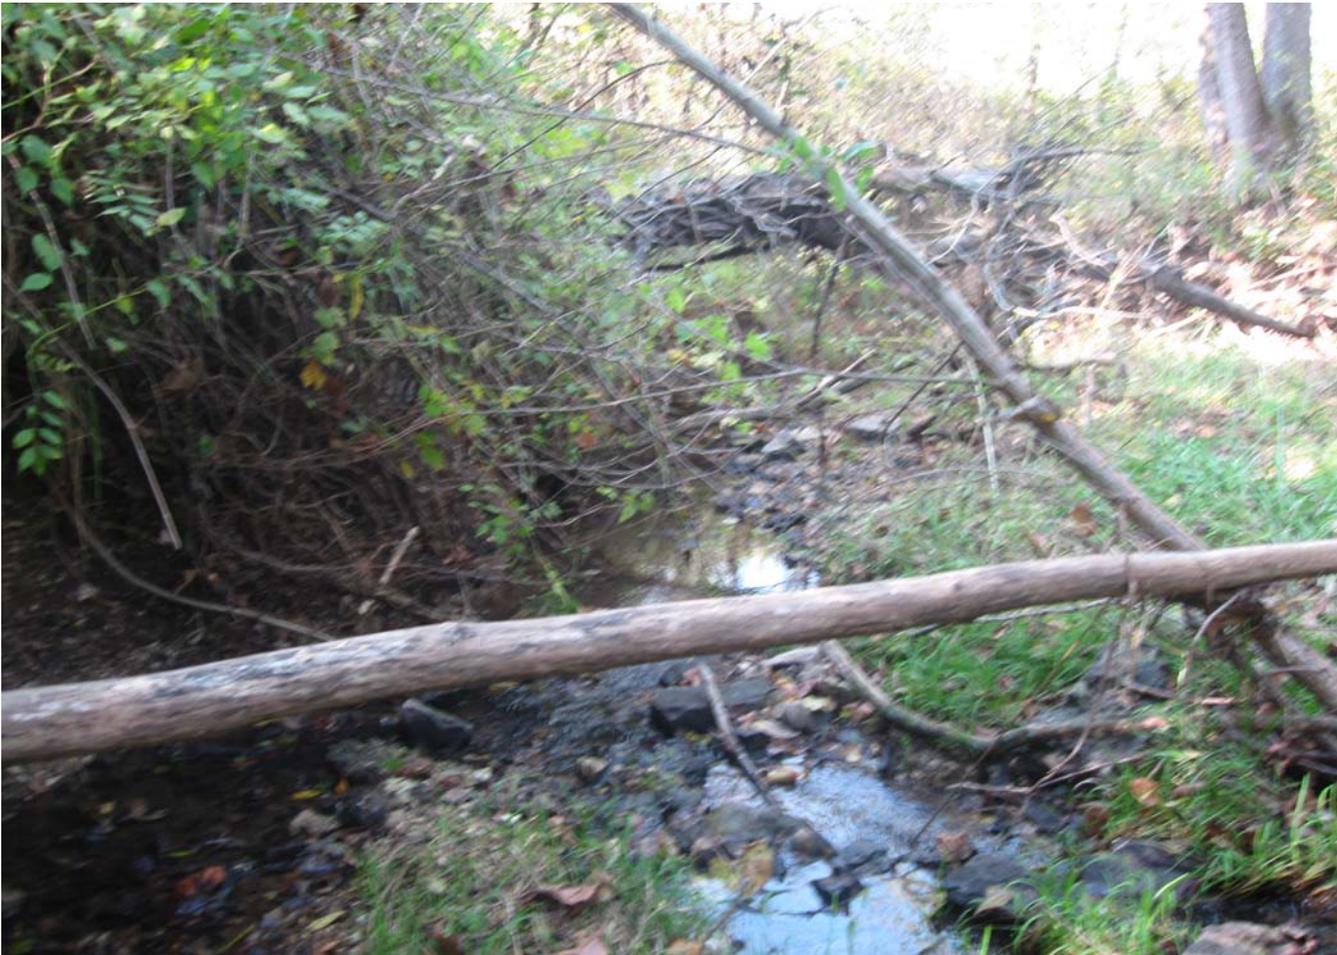
Photo ID#	Photo Purpose	Photo ID#	Photo Purpose	Photo ID#	Photo Purpose
104	downstream	105	upstream		
Photo ID#	Photo Purpose	Photo ID#	Photo Purpose	Photo ID#	Photo Purpose
Photo ID#	Photo Purpose	Photo ID#	Photo Purpose	Photo ID#	Photo Purpose

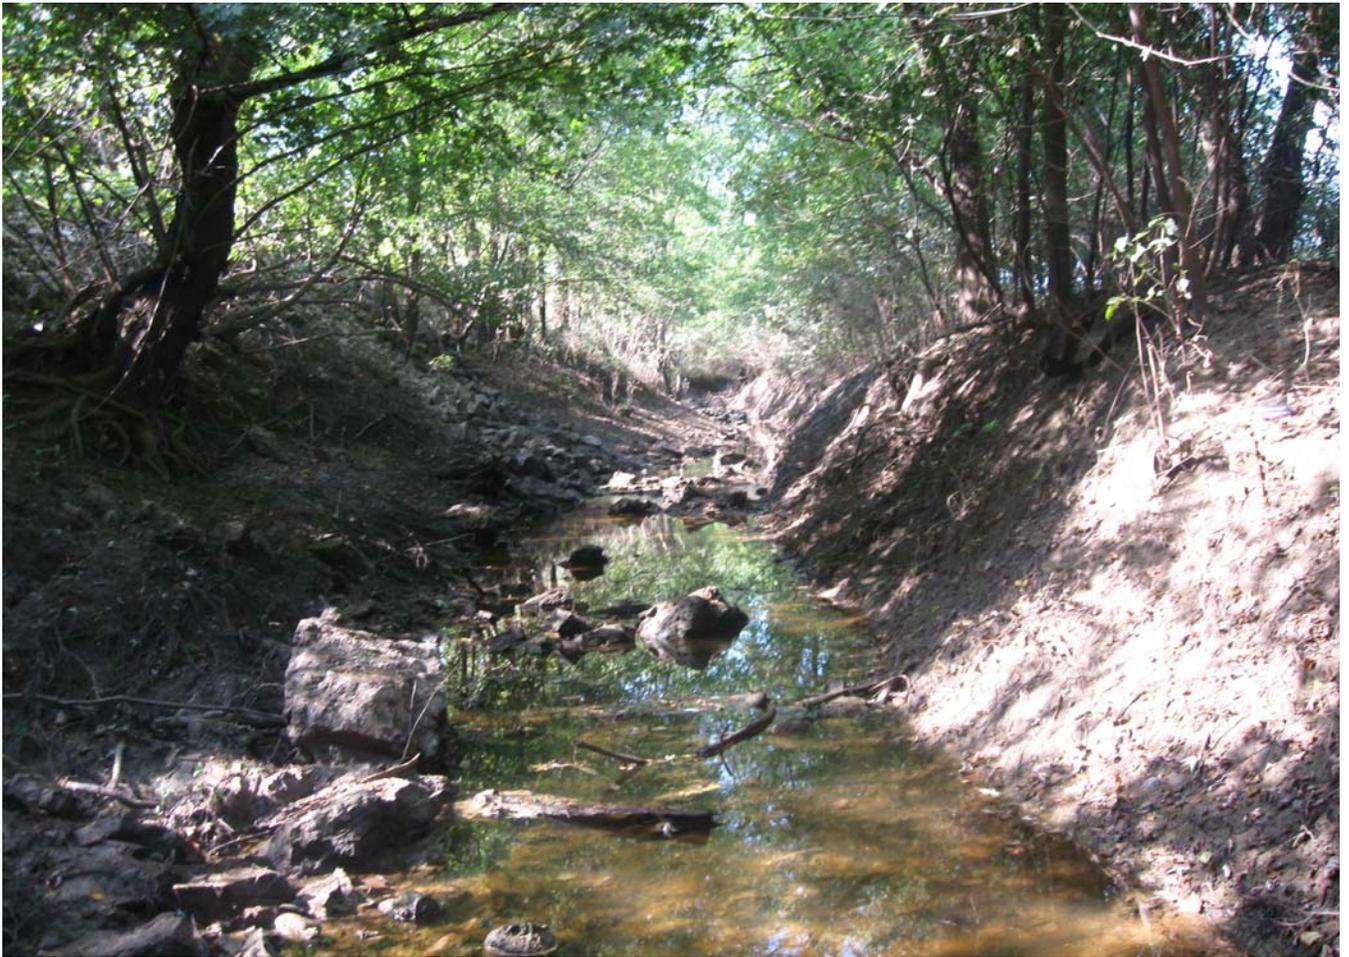
Photo ID#	Photo Purpose	Photo ID#	Photo Purpose	Photo ID#	Photo Purpose
102	downstream	103	upstream		
Photo ID#	Photo Purpose	Photo ID#	Photo Purpose	Photo ID#	Photo Purpose
Photo ID#	Photo Purpose	Photo ID#	Photo Purpose	Photo ID#	Photo Purpose
