Use Attainability Analysis

WBID 3826 Deer Creek

Submitted by
SES, Inc.

November 4, 2008

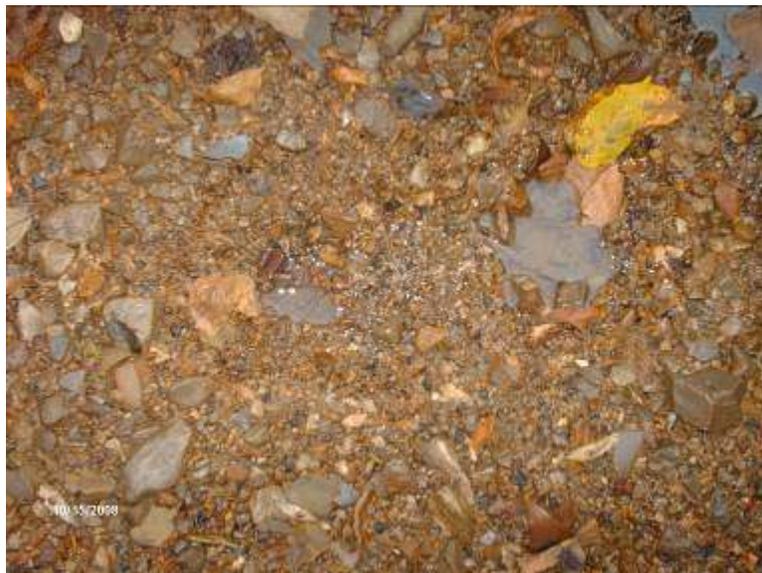
Site#1 Photo ID#51

Photo ID#	Photo Purpose	Photo ID#	Photo Purpose	Photo ID#	Photo Purpose
51	Footprints	52	Upstream	53	Downstream
Photo ID#	Photo Purpose	Photo ID#	Photo Purpose	Photo ID#	Photo Purpose
Photo ID#	Photo Purpose	Photo ID#	Photo Purpose	Photo ID#	Photo Purpose

<input type="checkbox"/> Roads	<input checked="" type="checkbox"/> Foot paths/prints	<input type="checkbox"/> Dock/platform	<input type="checkbox"/> Camping Sites	<input type="checkbox"/> Rope swings
<input type="checkbox"/> RV / ATV Tracks	<input type="checkbox"/> Fire pit/ring	<input type="checkbox"/> NPDES Discharge	<input type="checkbox"/> Fishing Tackle	<input type="checkbox"/> Livestock Watering
<input type="checkbox"/> None of the above	Comments / Other:

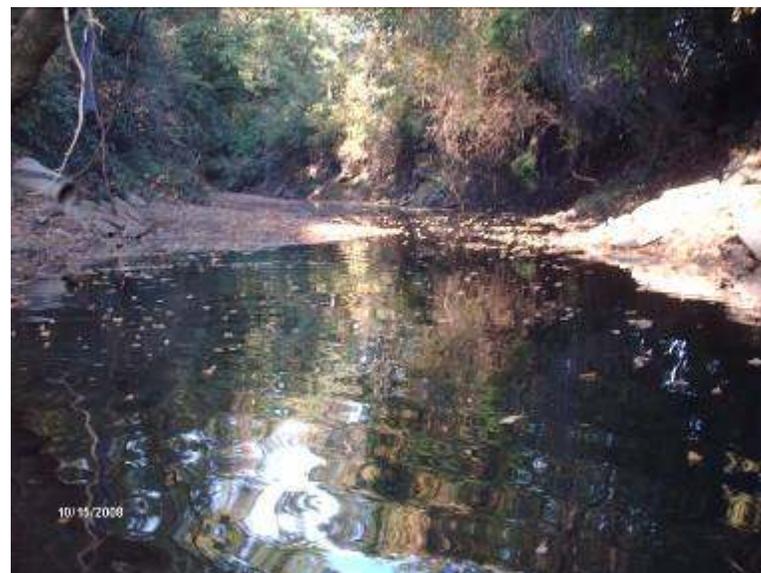
Site#1 Photo ID#52

20% Cobble	50 % Gravel	% Sand	% Silt	% Mud/Clay	30% Bedrock
------------	-------------	--------	--------	------------	-------------

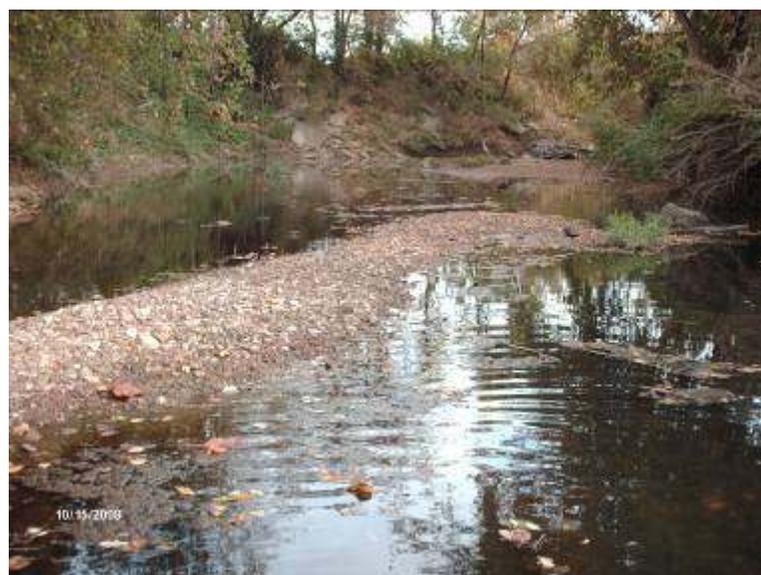
Site#2 Photo ID#54

Photo ID#	Photo Purpose	Photo ID#	Photo Purpose	Photo ID#	Photo Purpose
54	Downstream	55	upstream		
Photo ID#	Photo Purpose	Photo ID#	Photo Purpose	Photo ID#	Photo Purpose
Photo ID#	Photo Purpose	Photo ID#	Photo Purpose	Photo ID#	Photo Purpose

10% Cobble	70% Gravel	20% Sand	% Silt	% Mud/Clay	% Bedrock
------------	------------	----------	--------	------------	-----------

Algae on 10% of substrate.

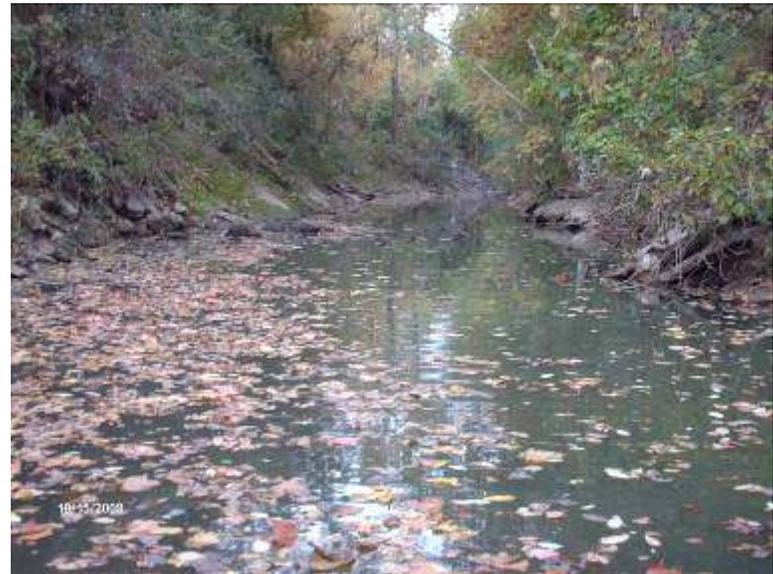
Site#3 Photo ID#56

Photo ID#	Photo Purpose	Photo ID#	Photo Purpose	Photo ID#	Photo Purpose
56	Upstream	57	Downstream		
Photo ID#	Photo Purpose	Photo ID#	Photo Purpose	Photo ID#	Photo Purpose
Photo ID#	Photo Purpose	Photo ID#	Photo Purpose	Photo ID#	Photo Purpose

Algae on 5% of substrate.

70% of substrate is man-made waste asphalt and cement.
