**THE EFFECTS OF THE NOVEMBER 1981  
LIQUID-FERTILIZER PIPELINE BREAK ON GROUNDWATER  
IN PHELPS COUNTY, MISSOURI**

By  
James E. Vandike, Geologist  
March 1982

Water Resources Report No. 75

Water Resources Data and Research  
Missouri Department of Natural Resources  
Division of Geology and Land Survey  
Rolla, Missouri 65401

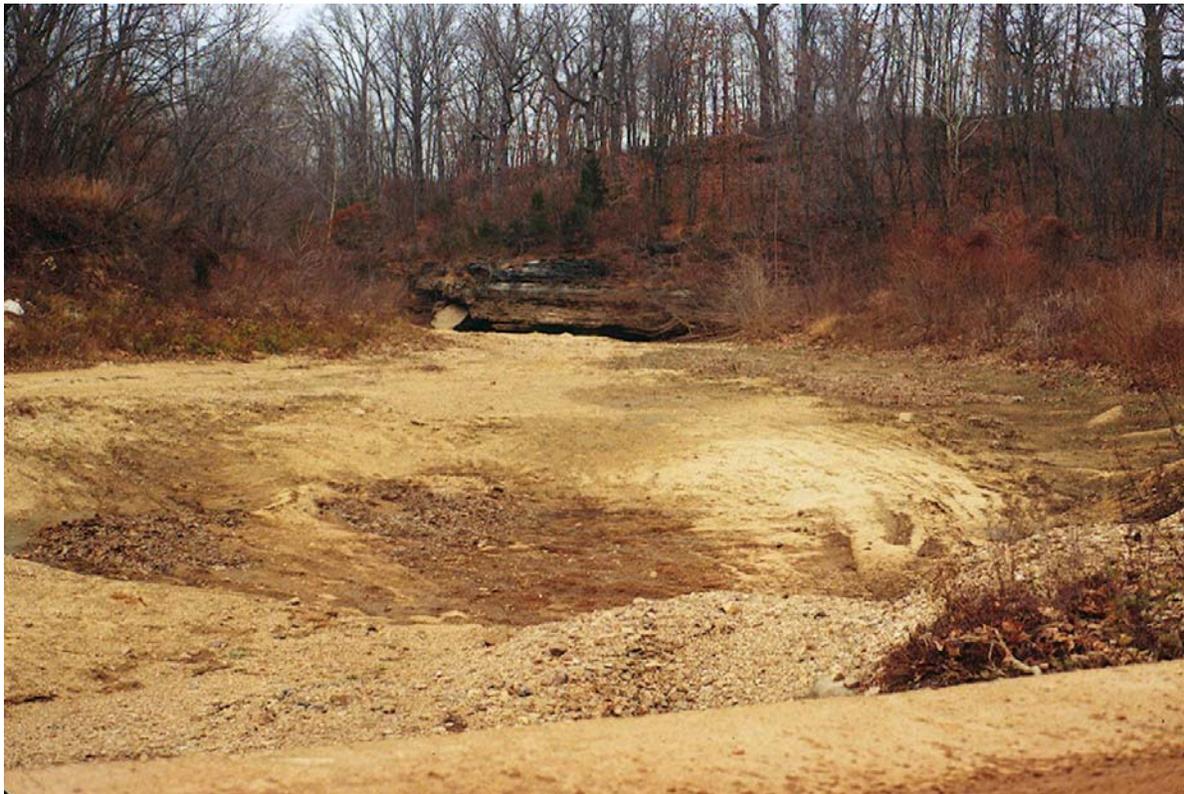
Photo 1. Dry Fork below Spring Hill Road (Sec. 11, T. 36 N., R. 7 W.)

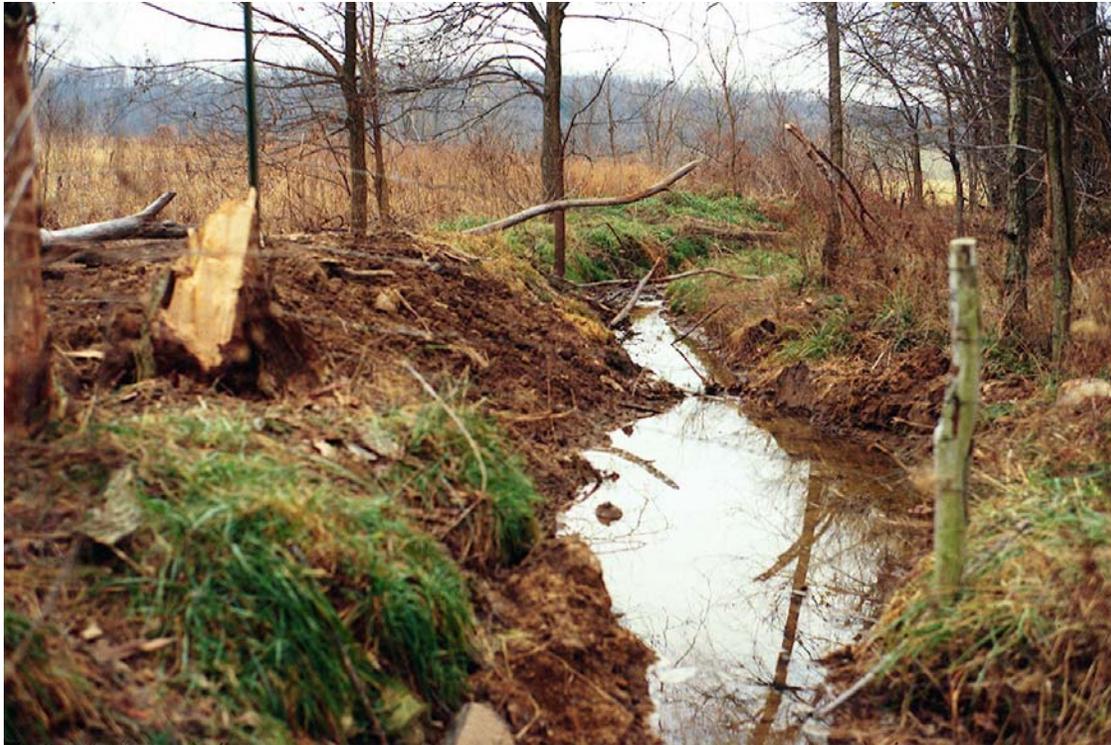
Photo 2. Spill site after pipeline had been repaired.

When notified, Environmental Emergency Response personnel from the Missouri Division of Environmental Quality visited the spill site. The break was being repaired at the time, and the spill volume initially estimated by Williams Pipeline Company indicated the leak to be minor; only about 32 barrels, or 1,344 gallons (5,087 L), had been lost. For clarity, a time sequence accompanies calendar dates in this report, Day 0 being November 15, 1981, the date the spill was reported.

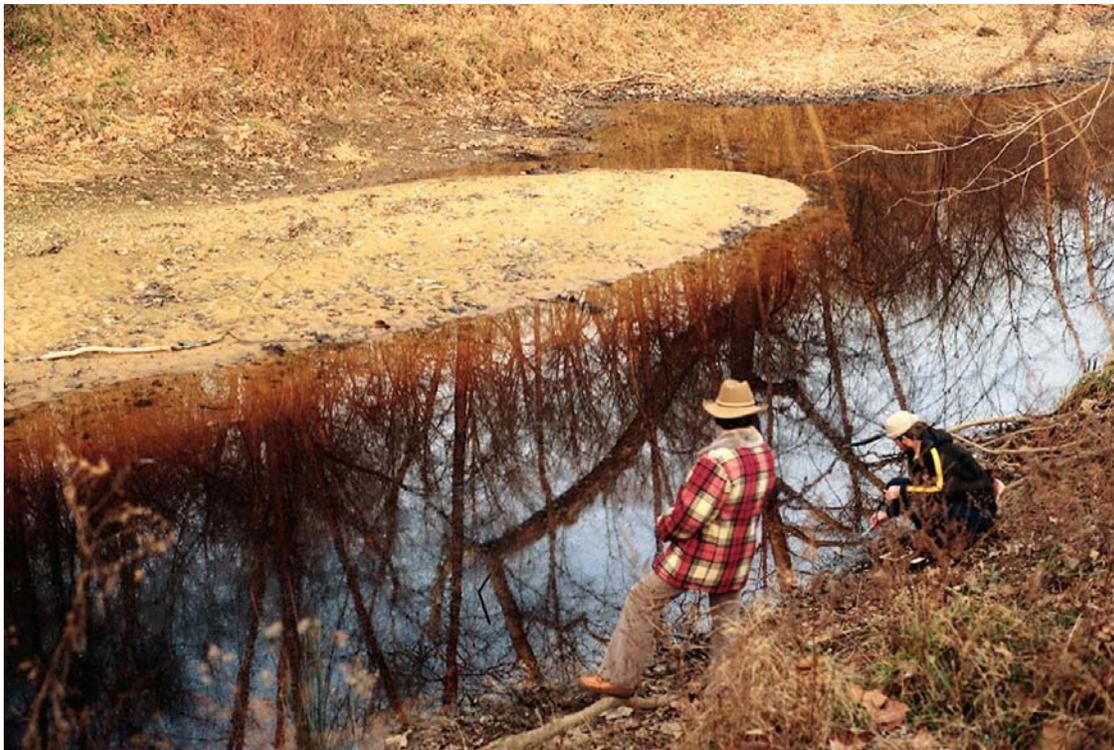
Photo 3. Pools of high-nitrogen water in Dry Fork downstream of the spill site.

On November 15, 1981, a buried section of pipeline owned by Williams Pipeline Company was reported to be leaking where the line crosses an unnamed spring-fed tributary of Dry Fork in Sec. 35, T. 36 N., R. 7 W. (photo 2, figure 3). The pipeline was carrying liquid nitrogen fertilizer (45.1 percent ammonium nitrate, 34.8 percent urea, 20.1 percent water). Spilled material that surfaced followed the unnamed tributary approximately 1,100 ft (335 m) to Dry Fork, which was not flowing at this time upstream from the spill. Downstream for about 1 mile (1.6 km), the creek contained a series of large pools, with flow occurring between them (photo 3). At the terminus of the pools, the creek bed again became dry. Downstream there were scattered pools, but no flow, for approximately 9.5 miles (15.3 km).

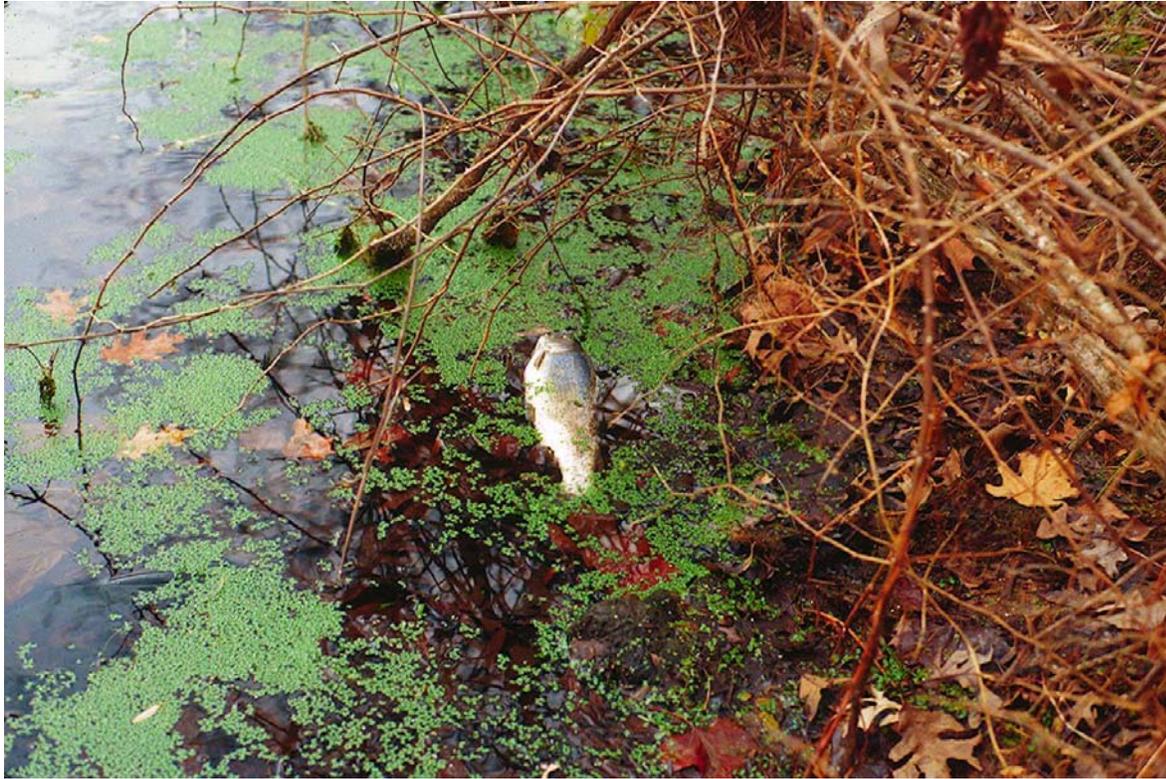
Photo 4. Dead trout at Maramec Spring.

On Day 5 (November 20) dissolved oxygen content at Maramec Spring measured essentially normal at 7.0 mg/L. On Day 7 (November 22), Rainbow trout in concrete impoundments fed by Maramec Spring began showing signs of stress associated with low levels of dissolved oxygen. On Day 8 (November 23), however, it measured 3.0 mg/L; on Day 9 (November 24), 1.0 mg/L. Dissolved oxygen content decreased to a minimum of less than 0.2 mg/L and remained below 1.0 mg/L for 8 days. An enormous effort was needed to keep the fish alive. Numerous large pumps aerated the spring water, increasing the oxygen content in the concrete impoundments to survival levels. About 37,000 sculpins and large spring-basin trout that could not be caught and released downstream were killed (photo 4). Three species of cave fauna living in the cave system were severely affected: *Cambarus hubrichti* (cave crayfish), *Typhlichthys subterraneus* (southern cavefish), and *Typhlotriton speleaus* (Ozark blind cave salamander). The Department of Conservation estimates that over a thousand cavefish were lost downstream. By the time oxygen levels increased to a point where aquatic life could survive, spring-basin animals that had not been removed were dead. Dissolved oxygen began to increase on Day 17 (December 2) and generally increased daily for the next 10 days. On Day 27 (December 12) levels began decreasing again, from 6.7 mg/L to 4.7 mg/L on Day 30 (December 15). On Day 31 oxygen content began increasing again, and after Day 44 (December 29) it was essentially normal (figure 4).

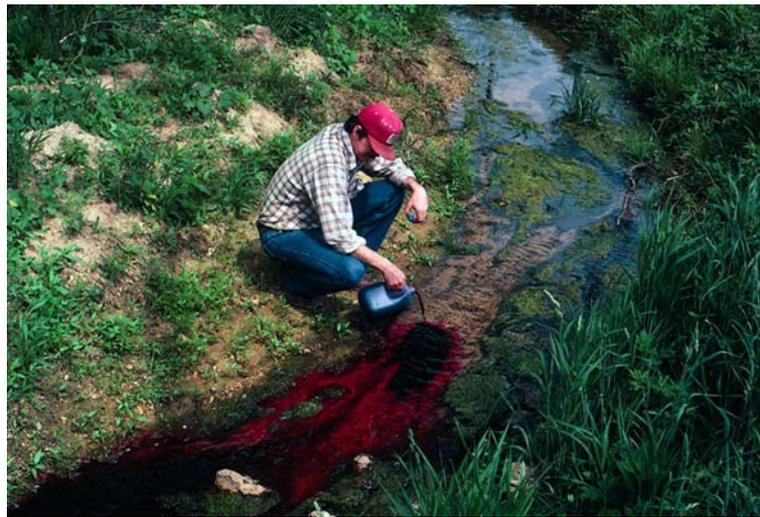
Photo 5. Rhodamine WT fluorescent dye being injected at the spill site.

On May 13, 1982, three gallons of Rhodamine WT (20%) fluorescent dye was introduced into the unnamed spring-fed tributary of Dry Fork where the pipeline leak occurred in the NE ¼ Sec. 35, T. 36 N., R. 7 W. (photo 5). The dye was carried downstream into Dry Fork, a few hundred feet to the east. For the next mile downstream, Dry Fork consisted of several pools connected by flow. Downstream from the pools there was no flow for the next several miles. The dye reappeared at Maramec Spring, 12.8 miles to the northeast, between 11 and 12 days after it was injected. The dye was detected in both activated charcoal packets and in water samples collected from the spring (figure 9). The straight-line velocity of the dye through the groundwater system was between 1.07 and 1.16 miles per day.
