# National Register of Historic Places Registration Form

historic name Blake, John P. and Dora, House  
other names/site number N/A

street & number 549 North Taylor [N/A] not for publication  
city or town Kirkwood [N/A] vicinity  
state Missouri code MO county St. Louis code 189 zip code 63122

**Blake, John P. and Dora, House  
St. Louis County, Missouri  
Historic Resources of Kirkwood, Missouri**

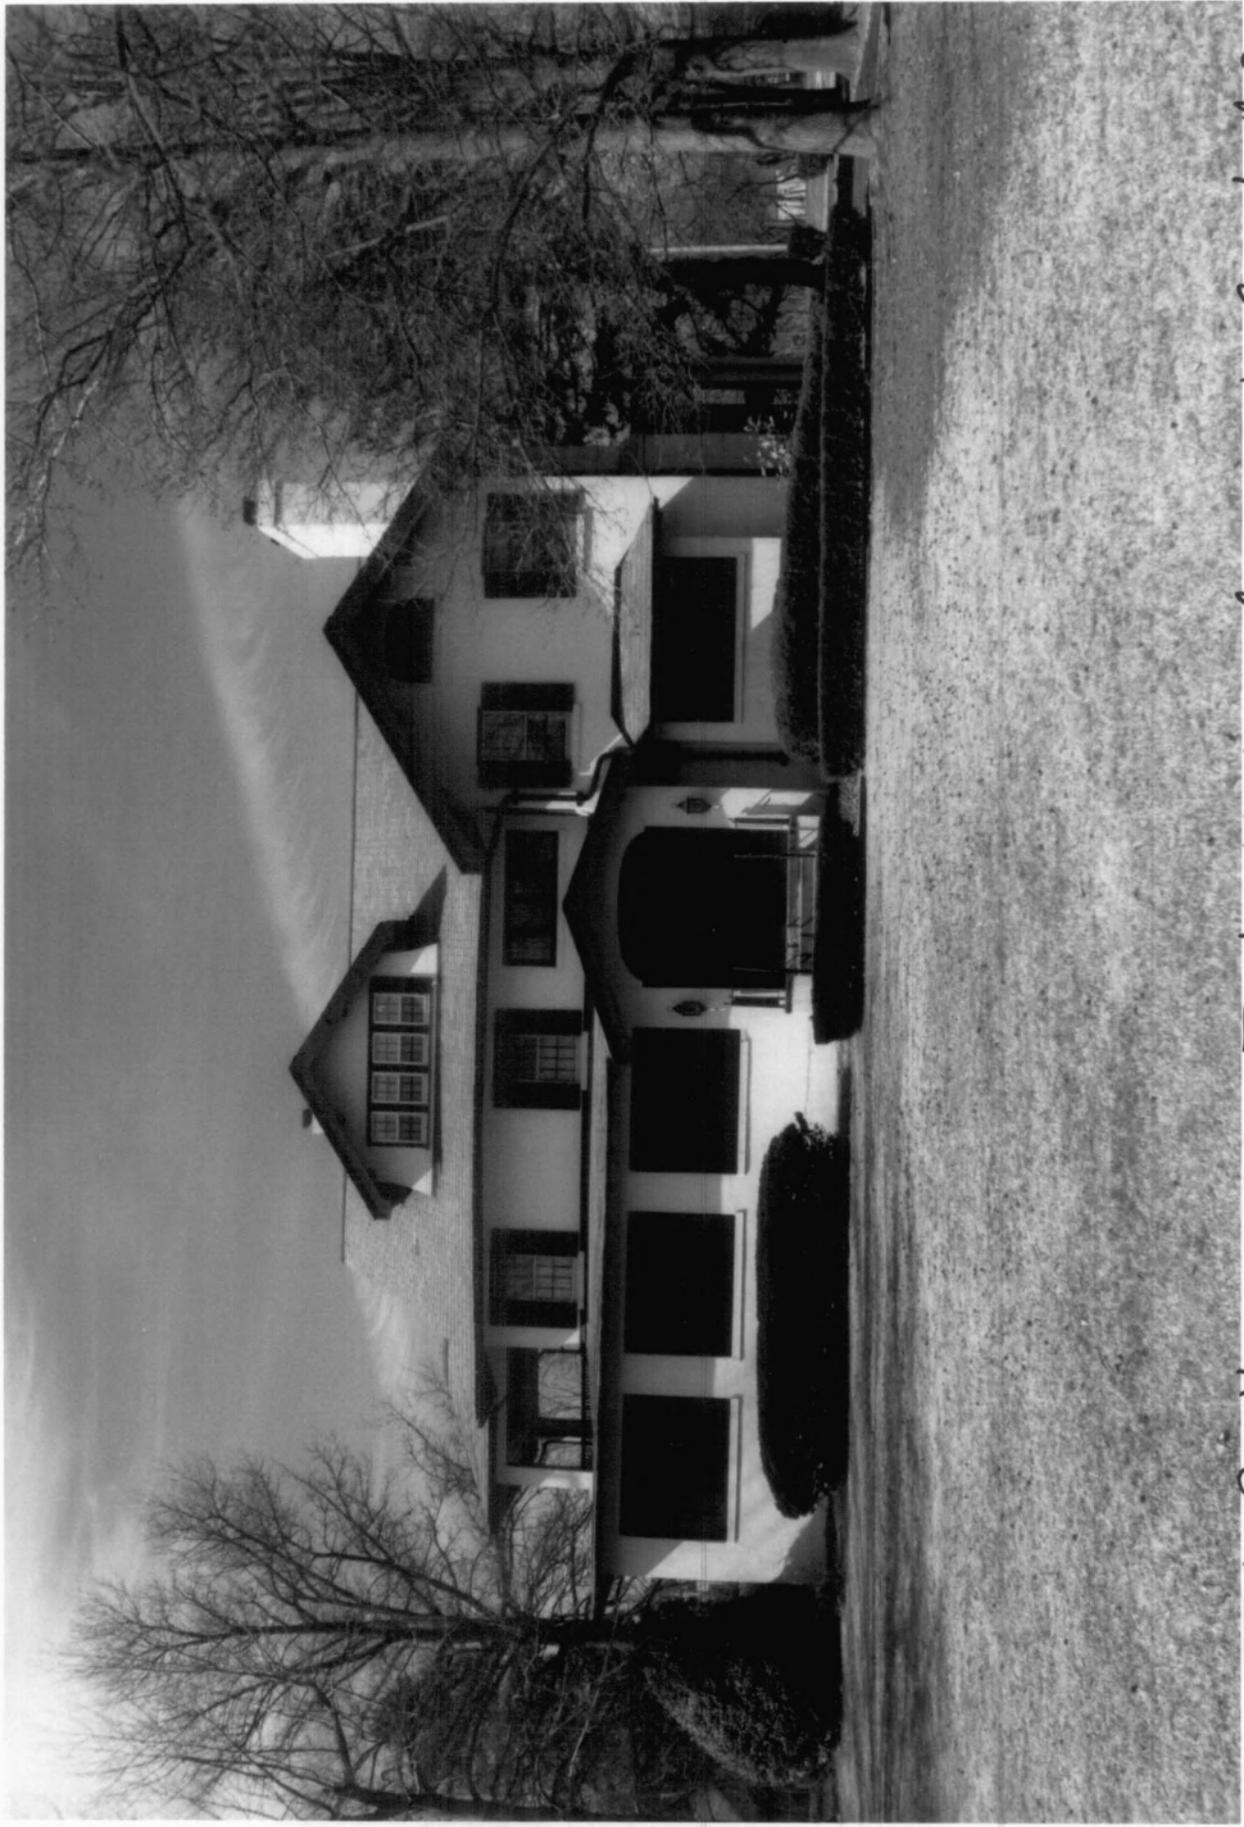
Blake, John P., House, 549 N. Taylor, Kirkwood, St. Louis County, Mo. 4.

1. Facade, east elevation.
2. Southeast corner.
3. Northwest corner.
4. Southwest corner.
5. Interior, front hall.
6. Dining Room.
7. Stair Hall.

The facade also features a bay window on its north end. This window contains single-leaf wood casement windows with leaded glass. Each leaf contains several small squares of glass. In addition, the facade features a projecting bay with a gabled roof which intersects with the main-house roof. The central front doorway is set beneath a cross gable on the front porch. It features a single-leaf wood door with a large pane of glass. It is topped by a beveled glass transom and flanked by sidelights. It is accented by an elliptical arch opening of the entry to the porch at that location. The porch is accessed by a concrete stoop and stairs, with a wrought iron railing. To the south of the front door are two double-leaf wood, French-style doors with multiple lights.

The majority of the windows are double-hung wood sash with multi-lights in both sash. They have plain wood surrounds and wide wood lugsills. Many of the windows are flanked by working wood shutters. The windows in the gable of the projecting facade bay are single-leaf casement windows. The center window has six lights; the side windows each contain two lights. Above the entrance is a band of single-leaf wood casement windows containing leaded glass.
