United States Department of the Interior
National Park Service
**National Register of Historic Places
Registration Form**

historic name Ballenger Building

street & number 27-29 South Ninth Street. [N/A] not for publication

**Ballenger Building
Boone County, Missouri**

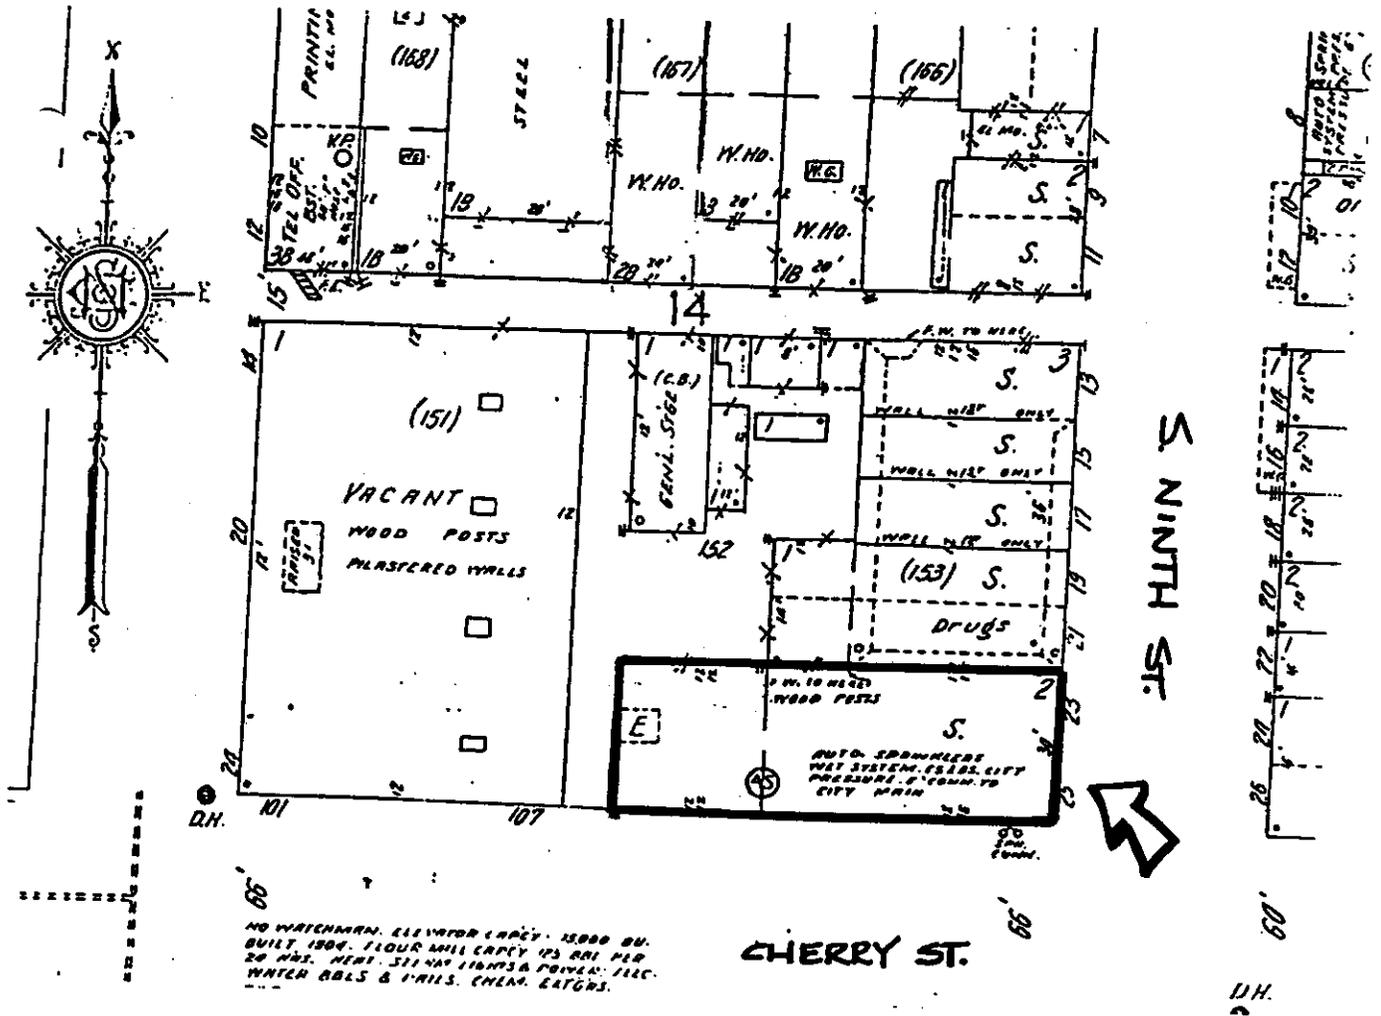
Figure One. 1931 Sanborn Map of the property.

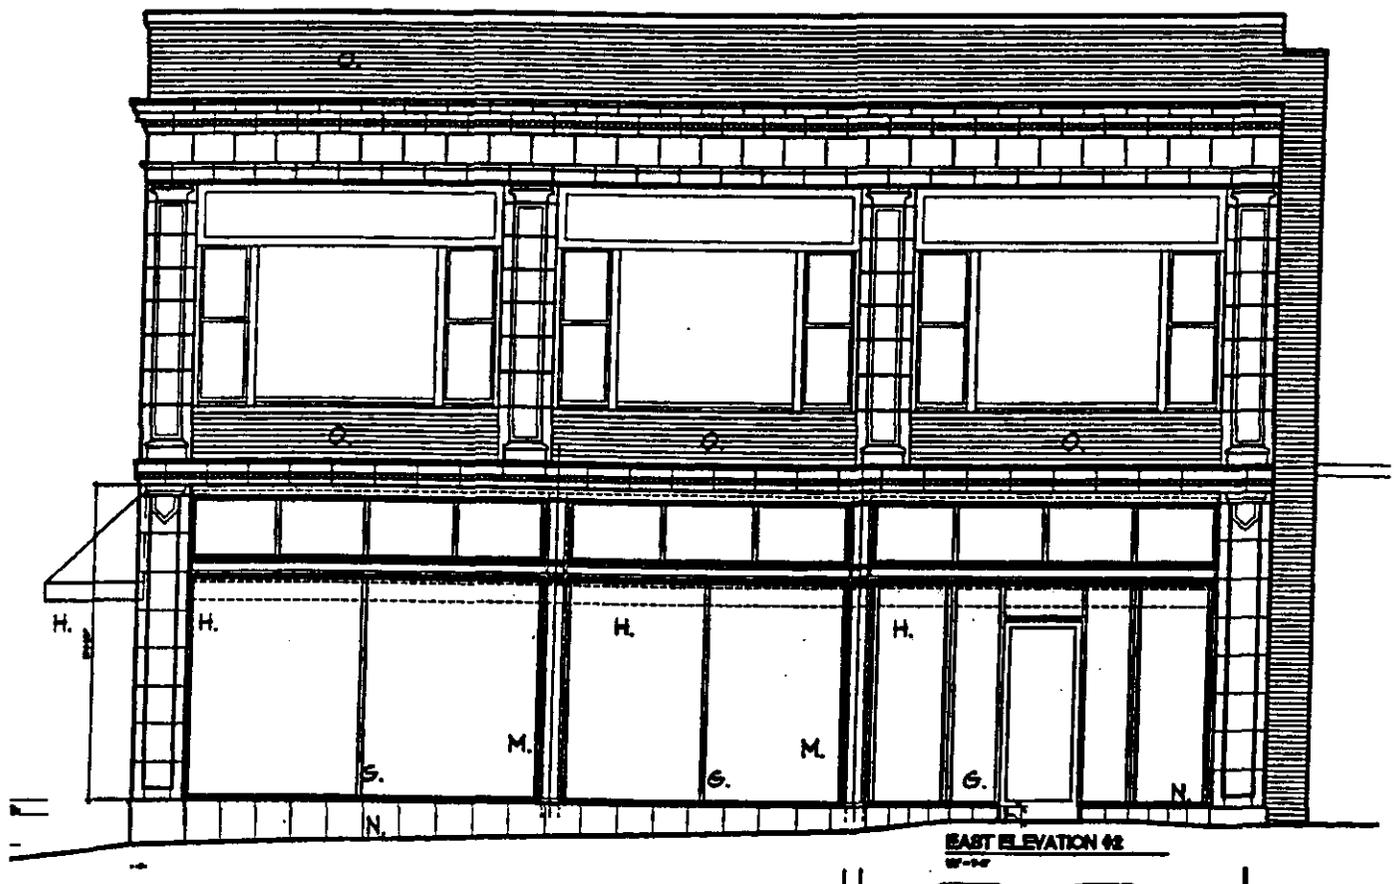
Figure Two. Facade, with proposed new storefront. Drawn by William Howell, Renner-Howell Architects, Columbia, MO.

The current storefront dates to the 1980s, when the building was remodeled to house a restaurant. It consists of stuccoed wall with large groups of casement windows. That storefront is slated for demolition, and will be replaced with a new unit which has a more historically appropriate configuration. (See Figure Two.) Selected demolition to date has uncovered large steel pipe columns which support the wide opening of the storefront. The columns, which appear to have been installed when the terra cotta front was added, will be retained. Interestingly enough, the pipe columns do not line up with the pilasters of the second floor, a condition which seems to indicate that the 1930s storefront did not have such wide trim pieces between its bays. If so, then the only historic terra cotta which appears to have been lost over the years would be

bulkhead tiles which probably matched those still in place on the side wall.² The replacement storefront will include new bulkheads, modeled after the existing side pieces.

building does meet the registration requirements in its present state, the current rehab project will include the installation of a replacement storefront which will bring it more fully into compliance.³ The replacement storefront will include a traditional combination of large display windows with bulkheads and transoms. (See Figure Two.) The design of the restored storefront is based upon existing materials and conditions, including the iron support poles in the front, and the configuration of the ground floor unit of the south bay.

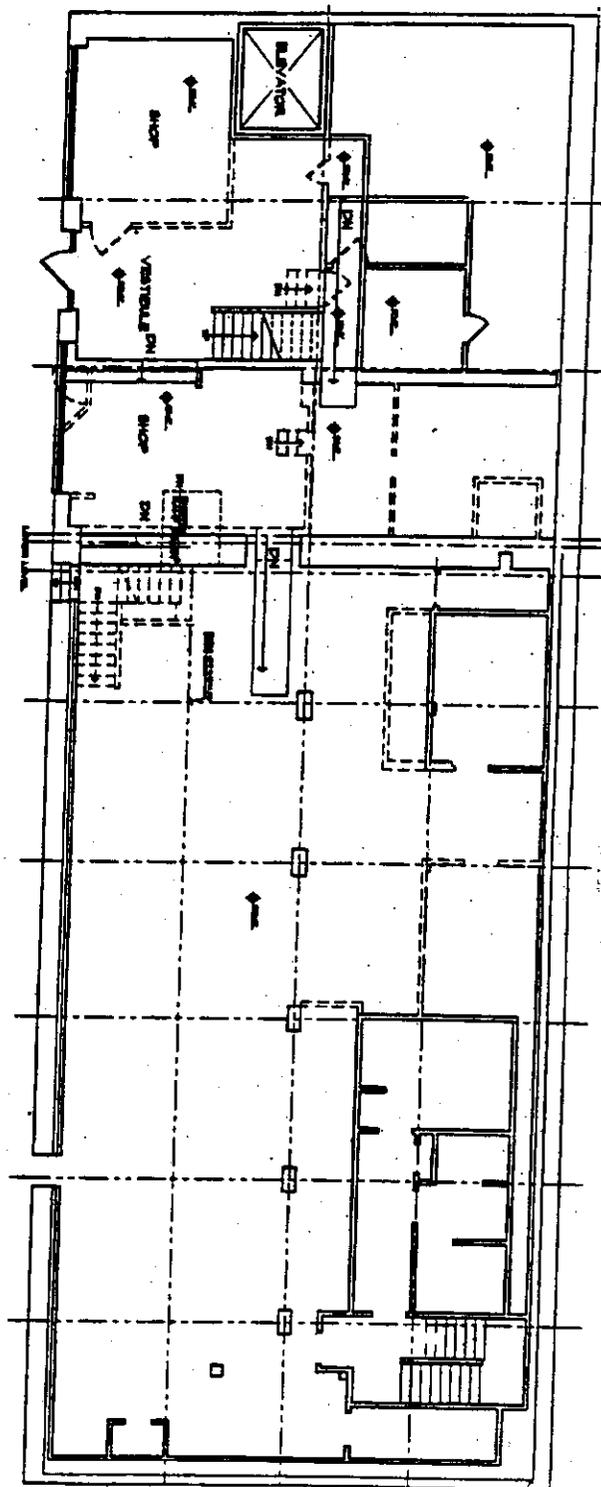
Figure Four. Basement Floor Plan. Drawn by Bill Howell, Renner-Howell Architects, Columbia, MO.

The ground floor and basement of the original building are accessed by the entranceway on Ninth Street. A large stairway just inside the front door leads down to the basement. The basement is mostly open, with a concrete floor and exposed limestone foundation walls. (See photo 12.) A second set of stairs near the west end of the basement leads to a door on Cherry Street. The basement is currently vacant, and undergoing rehabilitation.

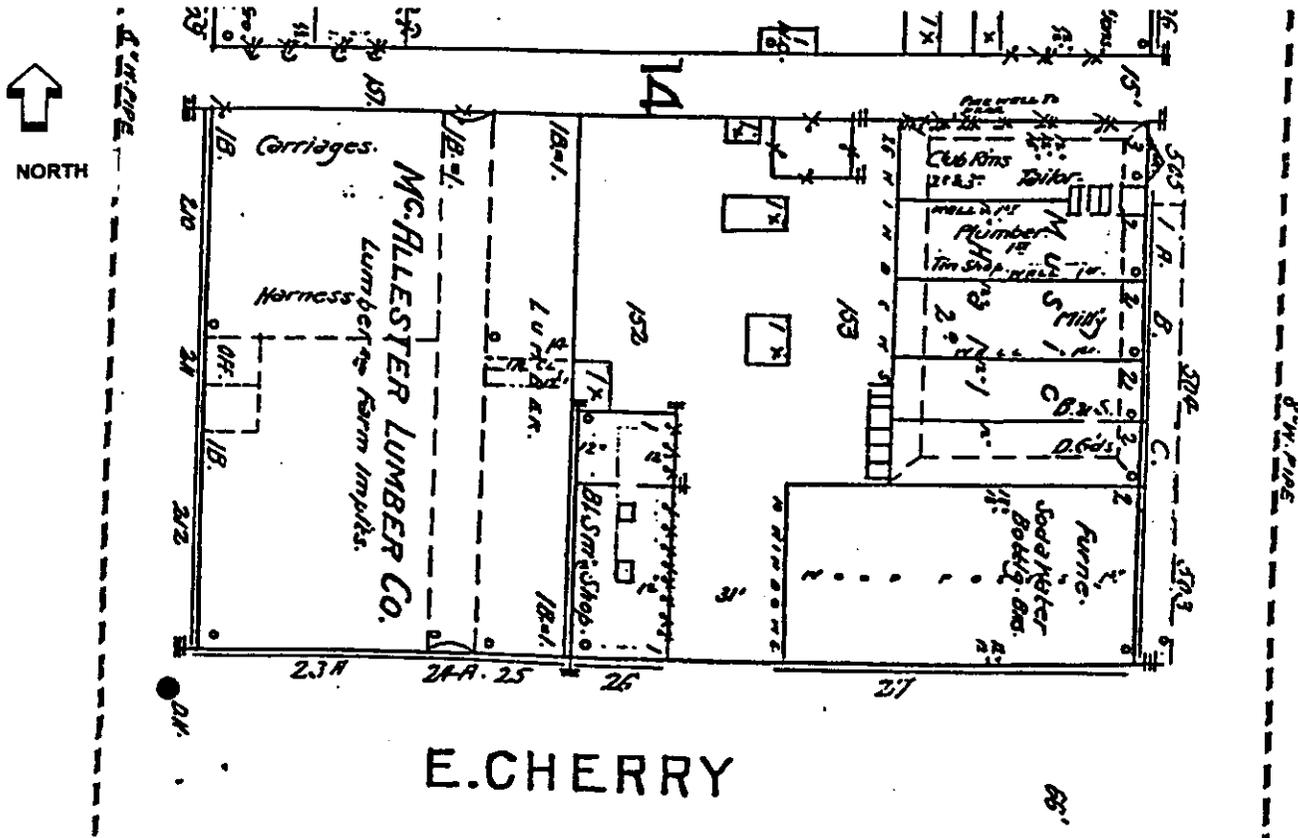
Figure Five. 1895 Sanborn Map. The Ballenger Building is in the lower right corner, north of Cherry Street.

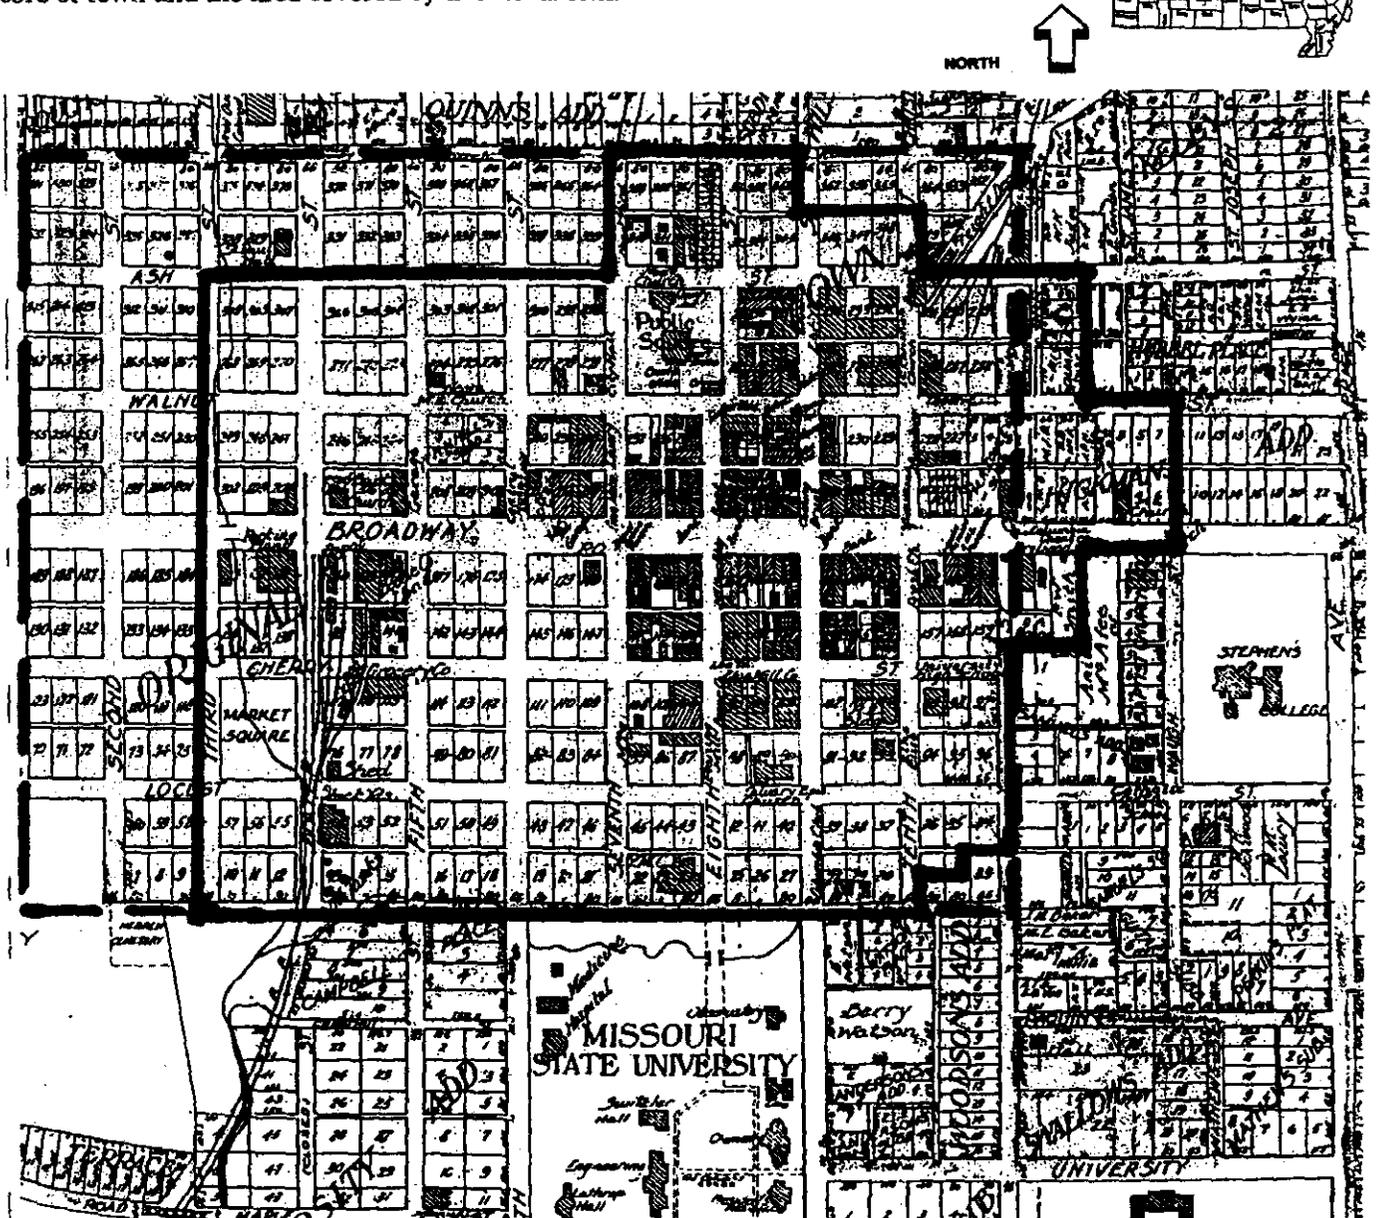
Below. Base Map: 1917 Atlas map of Columbia. Dashed line represents the boundary of the town lots created by the 1821 plat of Columbia. The solid line represents the boundaries of the Columbia Special Business District, which is the current commercial core of town and the area covered by this document.

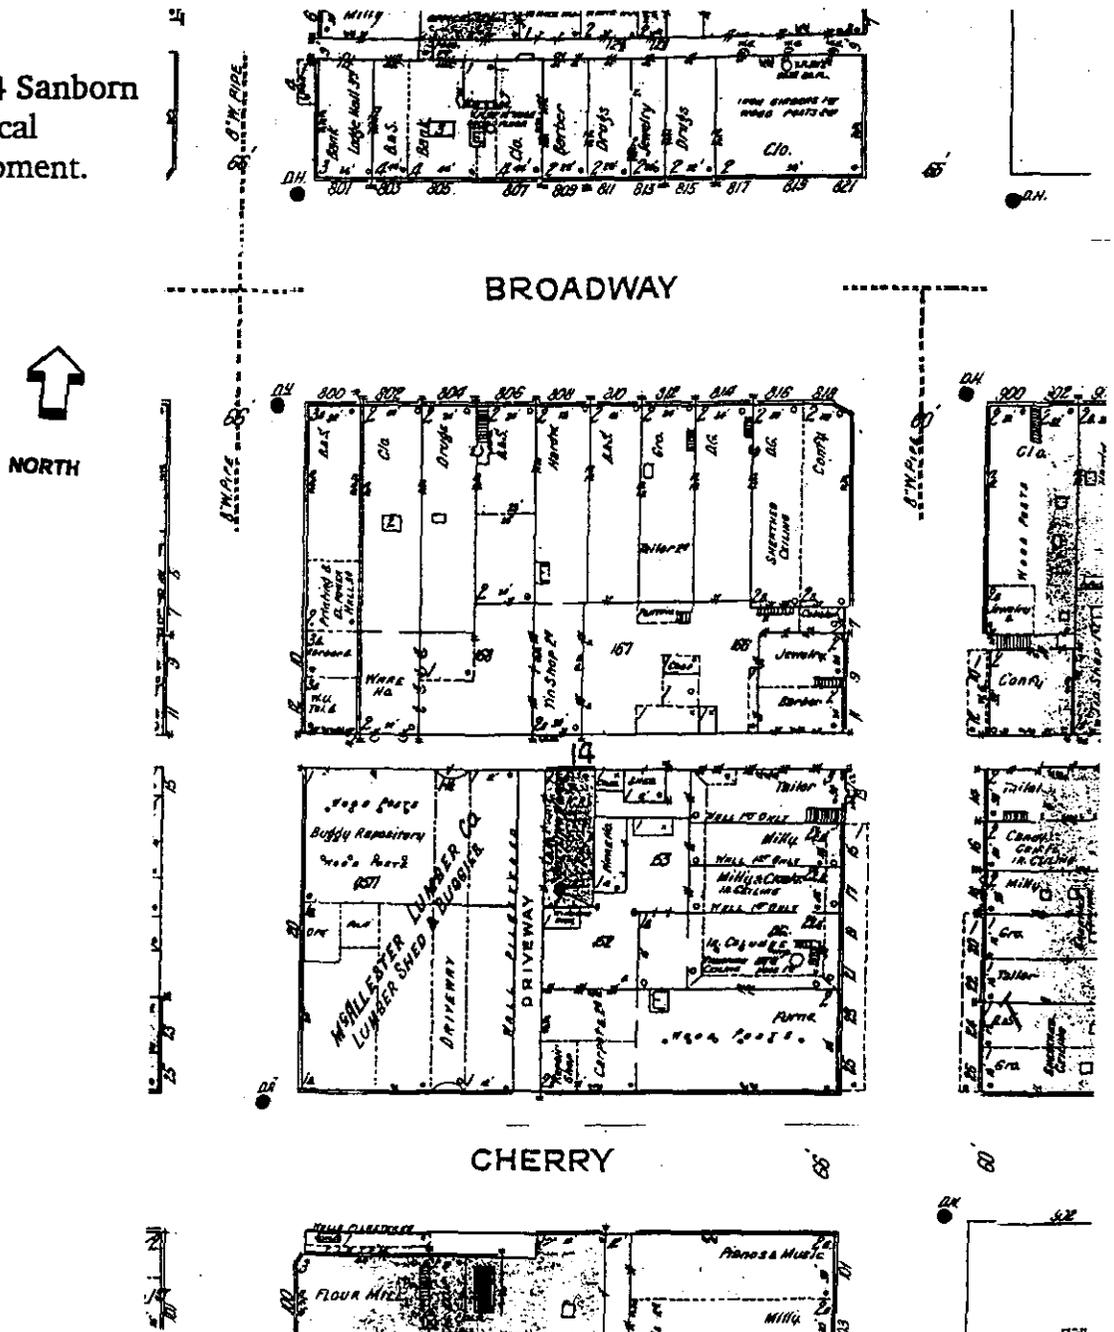
Figure Four. 1914 Sanborn Map, showing typical patterns of development.

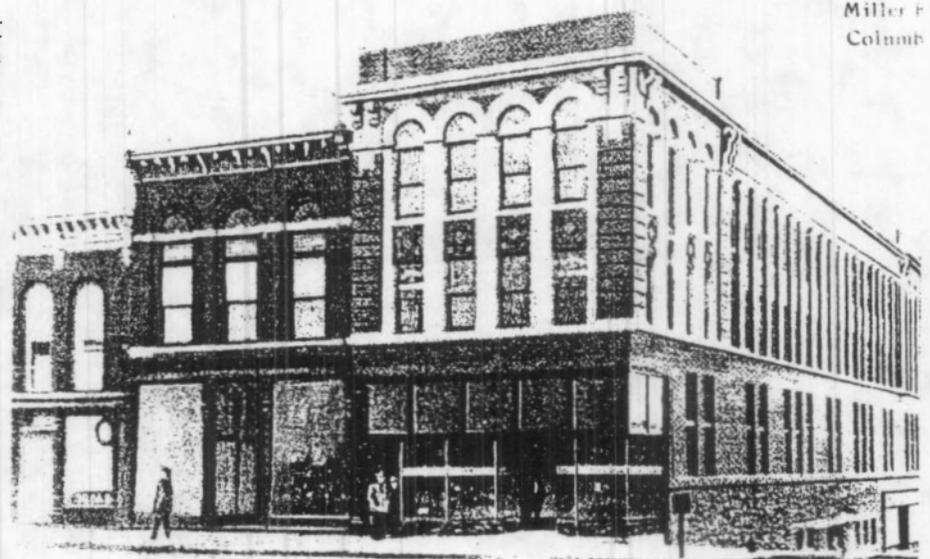
Figure Six. Historic Photo of the Intersection of Eighth Street and Broadway, with typical 19th century storefronts, taken ca. 1915.

Many North American commercial buildings of the late 1800s and early 1900s, including several in downtown Columbia, reflect the widespread availability of prefabricated building parts, which varied from individual elements such as cornices or widow hoods to entire storefront "kits." Mass-produced architectural elements were available from a number of manufacturers, all easily shipped by rail to any interested building owner. One account noted that "factory-produced architectural elements, sold by catalogue, offered small-town merchants....an opportunity to order complete 'store fronts' for their buildings. Even without a local architect, the latest in eclectic and lavish ornament could be added to any kind of building, of any age, or any material."⁶⁰ Columbia's connection to the North Missouri Railroad in the 1860s provided local merchants and builders with easy access to such components.

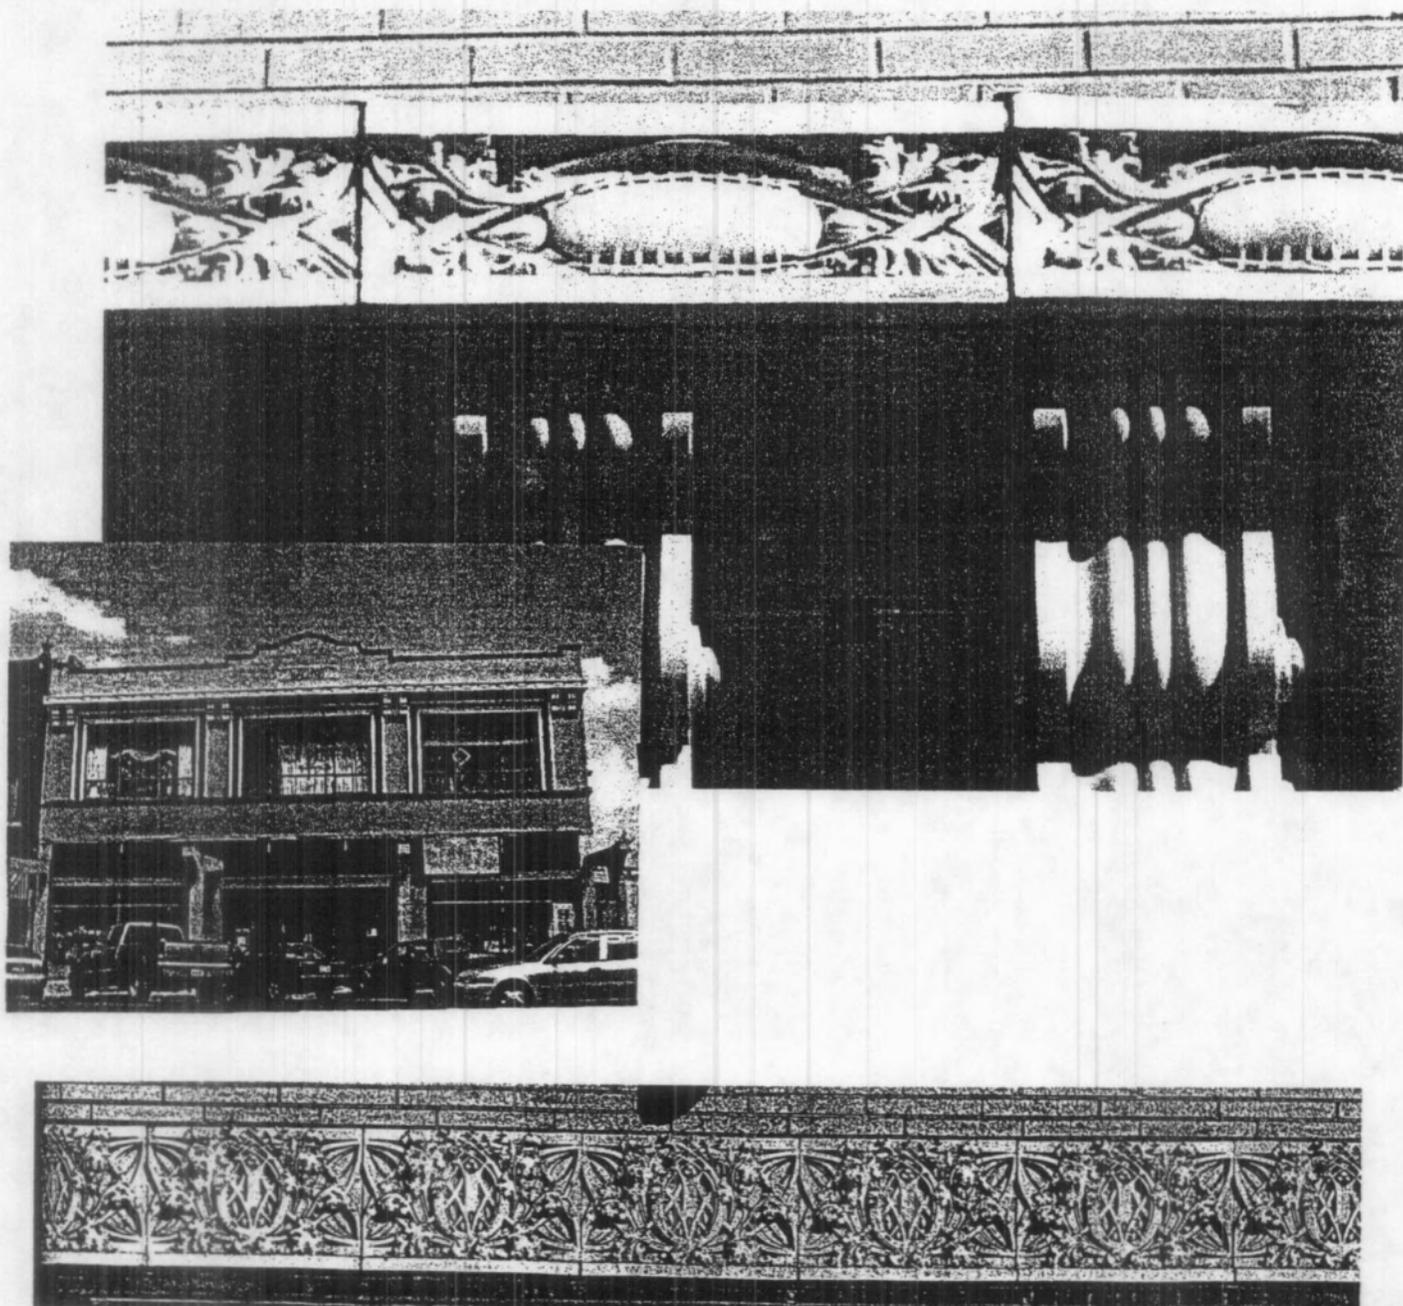
Top: The Victor Barth Building, with a detail of the cornice ornament.

Bottom: Detail of terra Cotta ornament designed by Louis Sullivan ca. 1913. (From William de Witt, ed. Louis Sullivan: The Function of Ornament. New York and London: W. W. Norton and Co., 1986, p. 137.)

The new century also saw new building materials. As noted above, specialty bricks of varying colors and textures became popular, as did a new architectural product—terra cotta. The survey report noted that, “around 1910 terra cotta came into use and from that point on was to dominate architectural detailing in Columbia well into the 1930s.”⁶³ Recent study has shown that more than one fourth of the surviving historic 20th century commercial buildings downtown today have some type of terra cotta detailing. Historic terra cotta components range from ornamental rooftop coping to full wall sheathing; the earliest known example was built in 1909, and the latest application was ca. 1940.
