NATIONAL REGISTER OF HISTORIC PLACES REGISTRATION FORM

historic name Patterson, Elisha and Lucy, Farmstead Historic District

street & number 15505 New Halls Ferry Road N/A not for publication

city or town Florissant vicinity

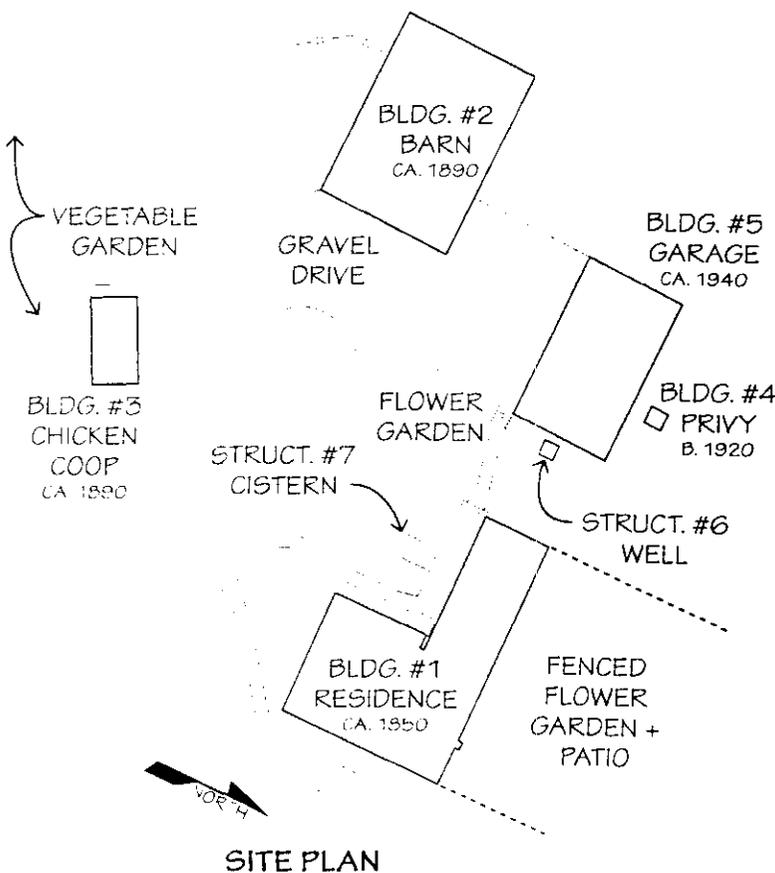
SITE PLAN

The house fronts east onto New Halls Ferry Road with the farm buildings set behind. The house dominates the site. It was placed on top of the tallest hill on the property, with a commanding presence over New Halls Ferry Road. The barn and other agricultural structures were placed in

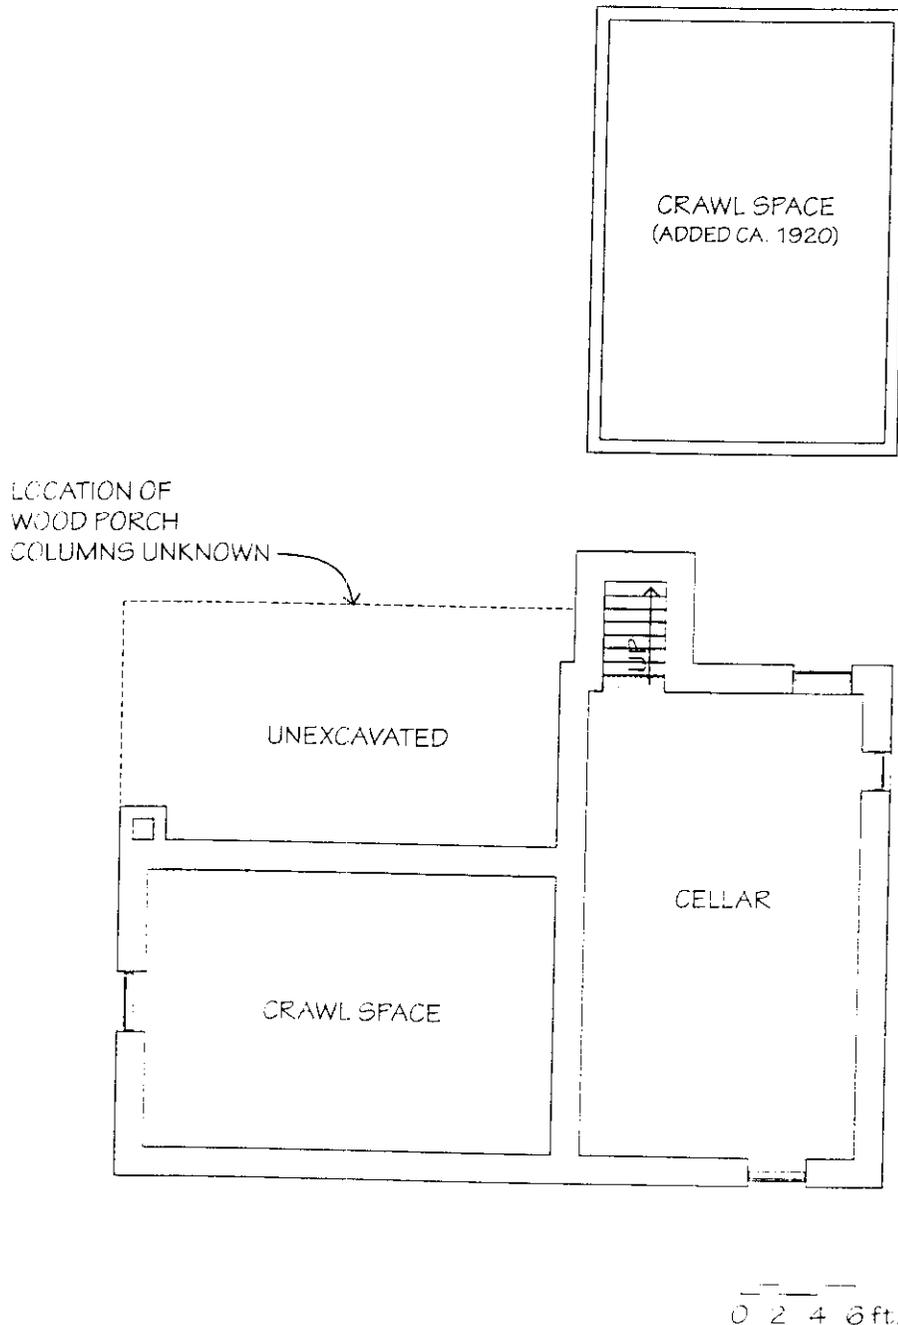
RESIDENCE BASEMENT PLAN - ORIGINAL

The foundation of the original structure is coursed rubble limestone. The foundation walls are more than one foot thick. The Entrance Hall and Bedroom were built over a crawl space, supported by limestone frost walls. The walls below the Parlor and Dining Room extended to form a cellar. The dirt-floored original cellar would have had slightly less than six feet of headroom. Where intended to be visible, the stonework is extremely well crafted — smoothly dressed with tight joints and flush struck mortar.

During the 1930's, the cellars were dug out and all of the foundations were underpinned with concrete.⁶ Approximately 10" of concrete is now visible below the cellar walls, providing roughly 6'-9" of clearance below the bottoms of the floor joists. The crawl space walls have 48" of concrete exposed below the stone. The frost wall underpinning flares with an angled buttress below the stone to retain soil loads.

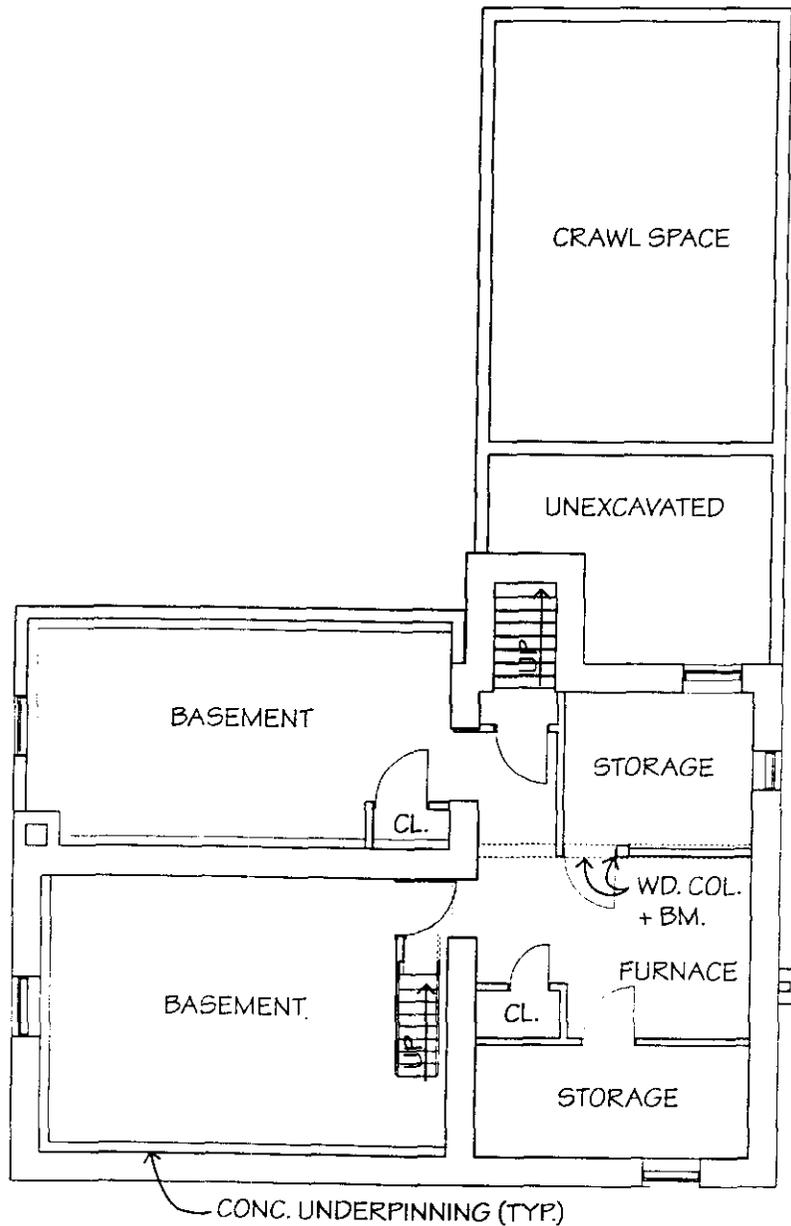
RESIDENCE BASEMENT PLAN - CURRENT

The post and beam support below the west wall of the Parlor is a later addition. The beam pockets were obviously cut into pre-laid stonework. The column and beam match the dimensions, circular saw marks, and joinery of timbers found in the barn's structure.

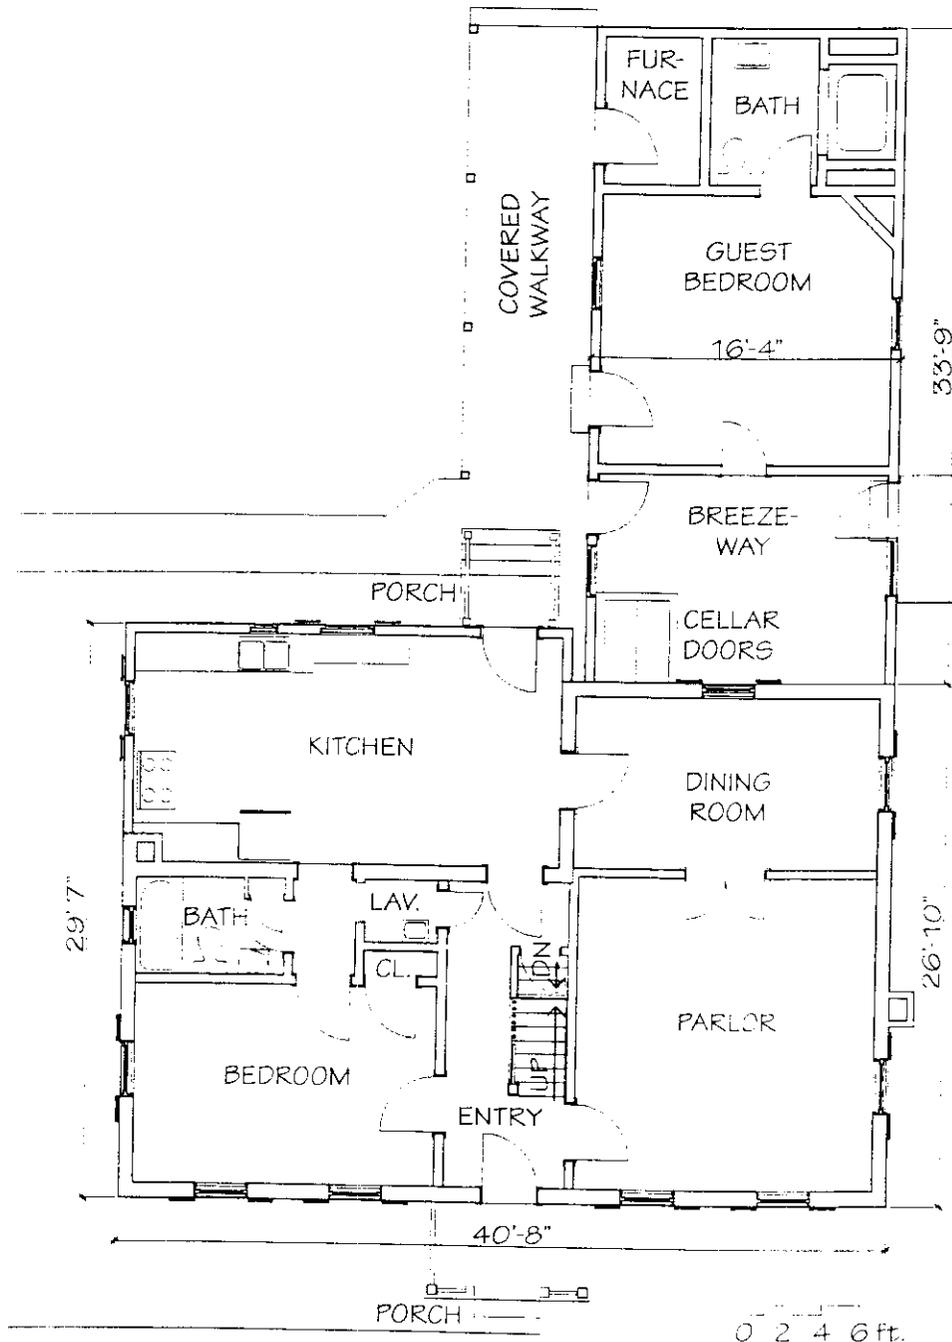
RESIDENCE GROUND LEVEL PLAN - CURRENT

The Kitchen replaced an earlier porch. This addition was built over a crawl space with concrete frost walls. Wood posts from the earlier construction are visible embedded in the concrete. These foundations were later underpinned and buttressed with concrete, similar to the procedure used below the bedroom. The Kitchen floor is supported by 1½" x 7¼" joists at 17" on center.

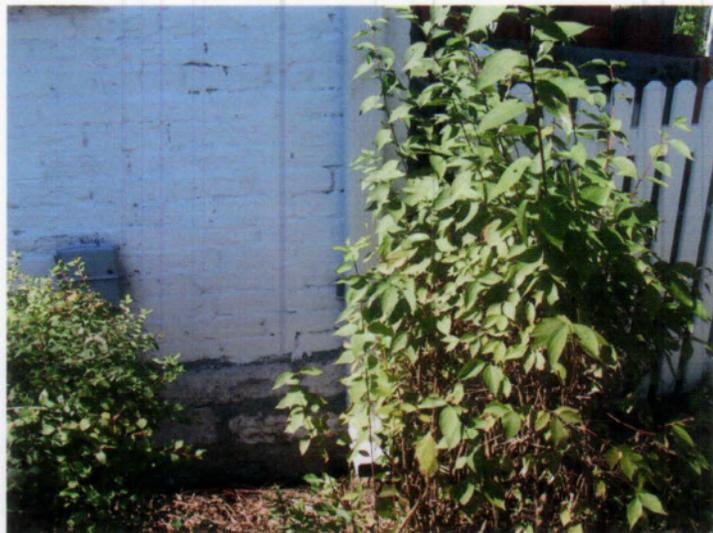
Detail of limestone foundation & patched brickwork

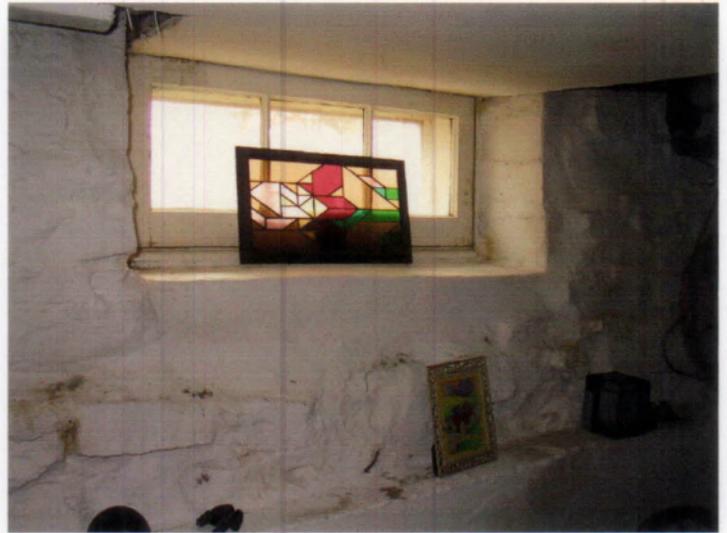
Detail of frost wall with underpinning

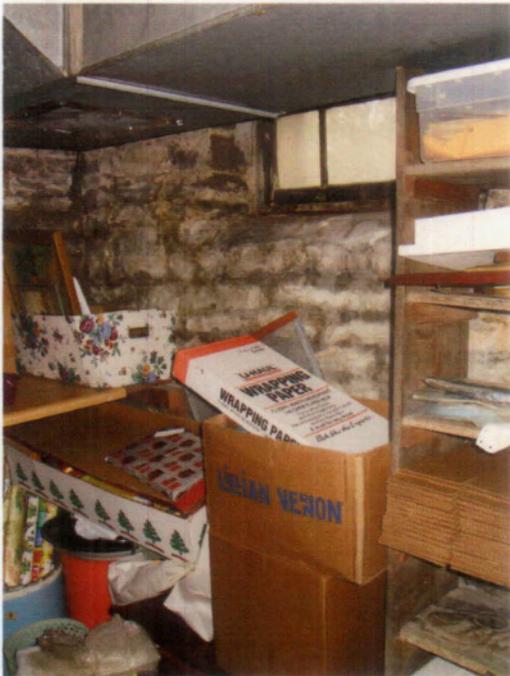
Underpinning at original cellar wall

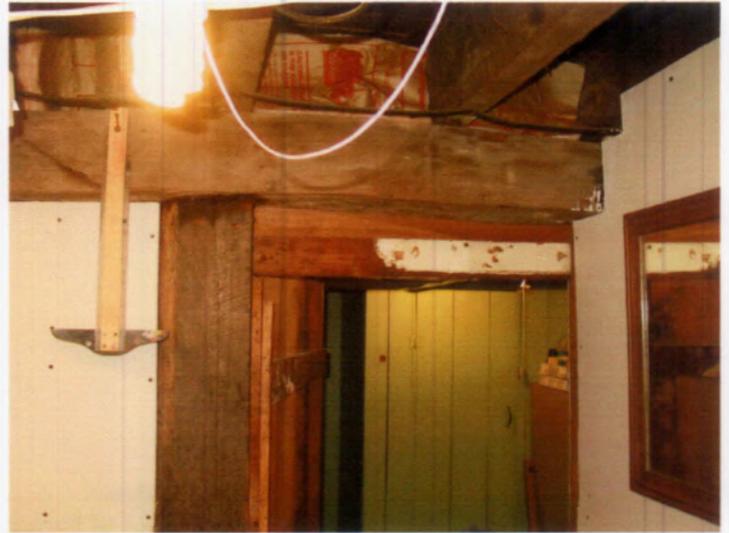
Post and beam support in Basement

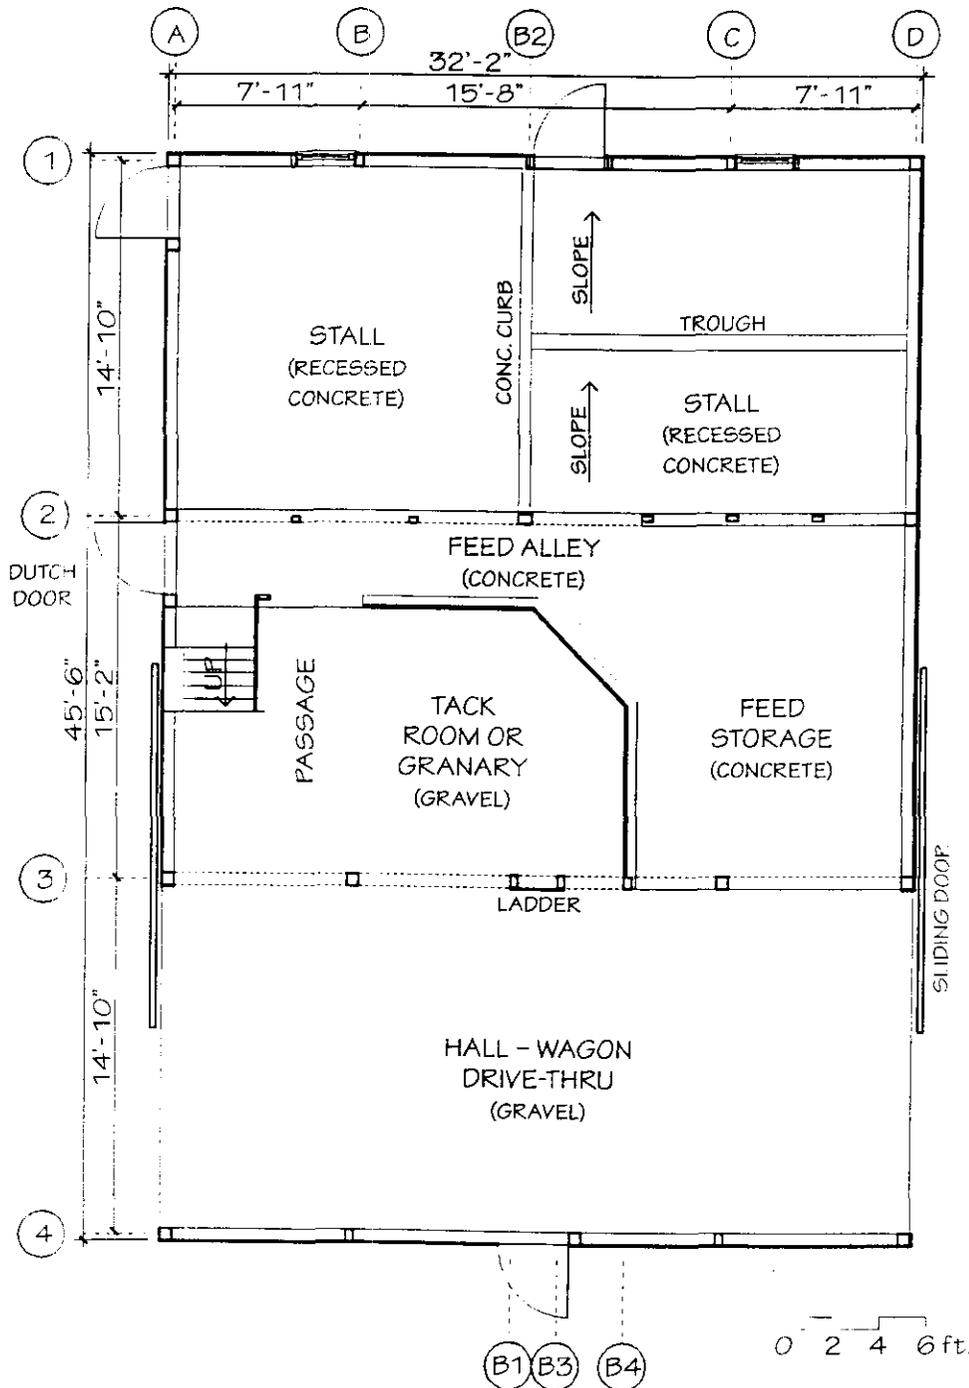
BARN GROUND LEVEL PLAN - CURRENT

The entire structure sits on concrete foundations with integral raised cheek walls. The curbs have a rough, board-formed finish.

The two interior columns along column line #2 were also removed. A series of intermediate columns, installed to replace the two main columns, were also used to support the breast boards and feed bins, tool racks, and other wall-mounted equipment.

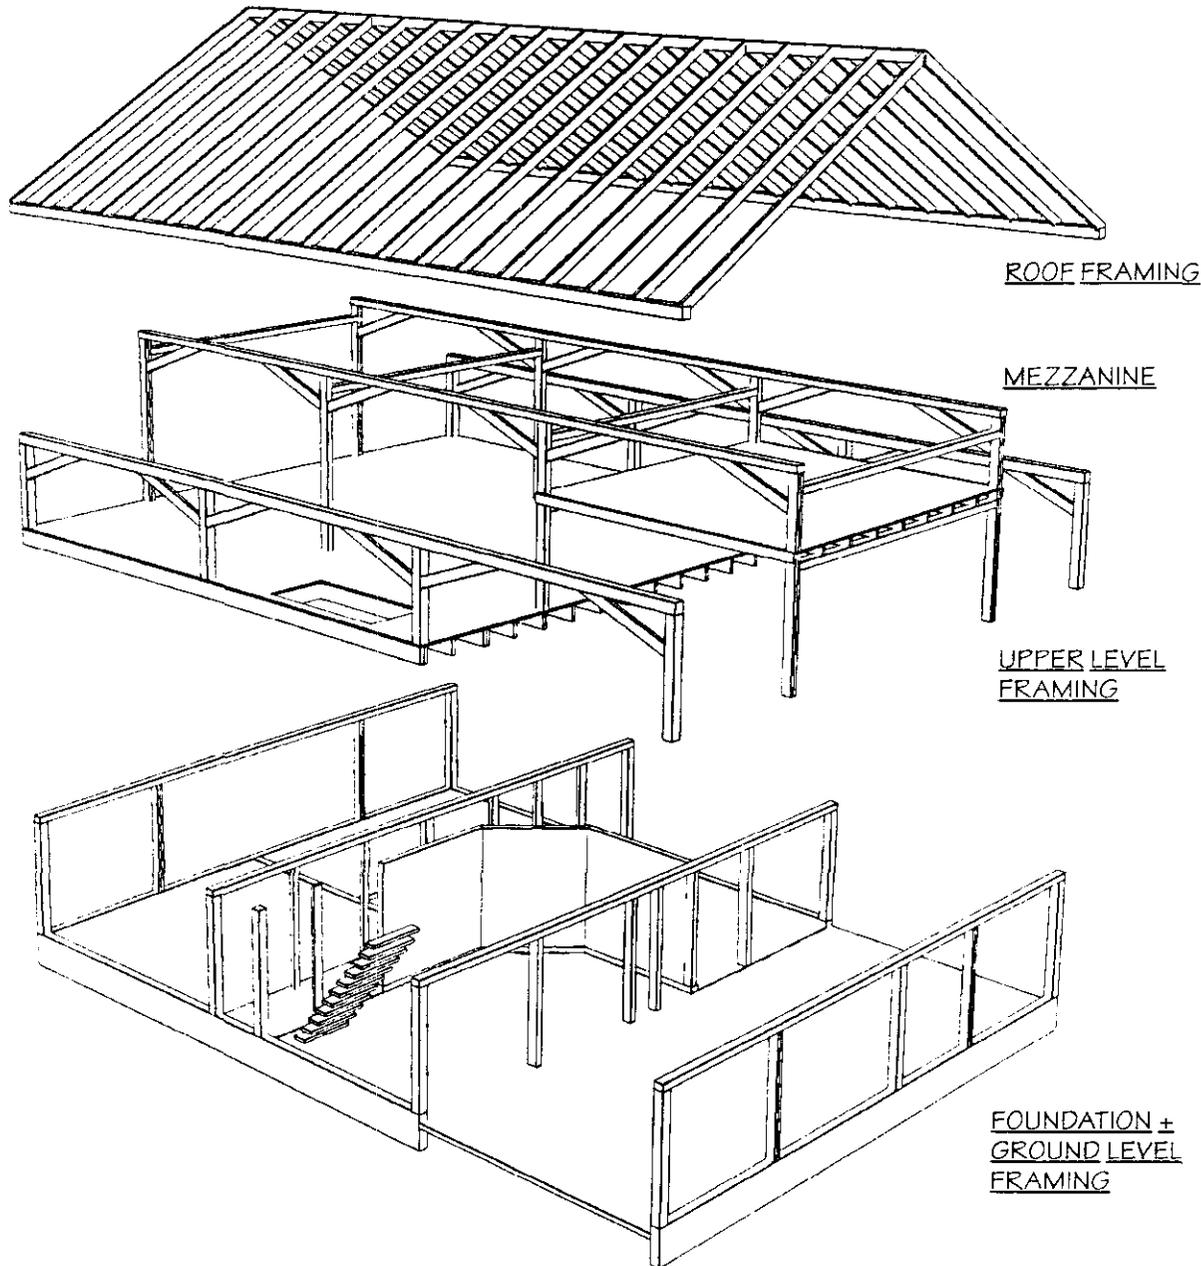
BARN EXPLODED ISOMETRIC

NOTE: INTERMEDIATE HEAVY TIMBER
WALL FRAMING AND WIND BRACING
NOT SHOWN FOR CLARITY.

The building was originally roofed with wood shingles. The barn still retains the spaced wood plank sheathing for the shingles. The sheathing is especially noteworthy because the rafters are obviously not the originals. Even after failure of the original roof structure and installation of new rafters, the early barn was again reroofed with wood shingles.

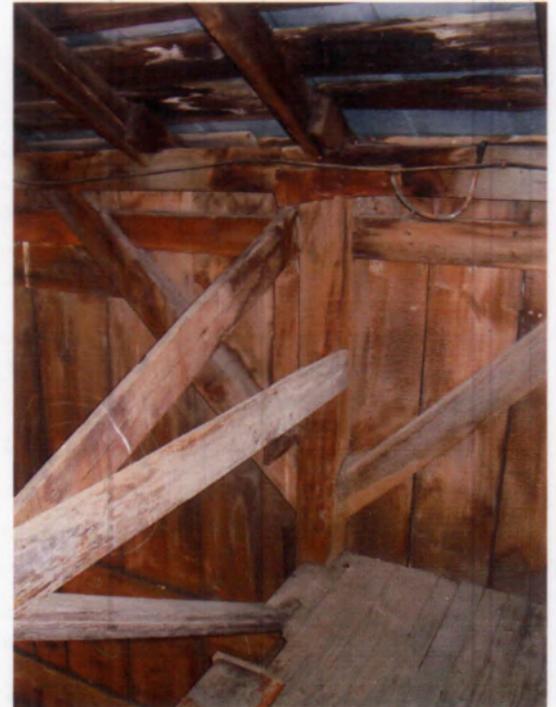
Rafter notch over mid-span beam showing
dove-tail beam splice

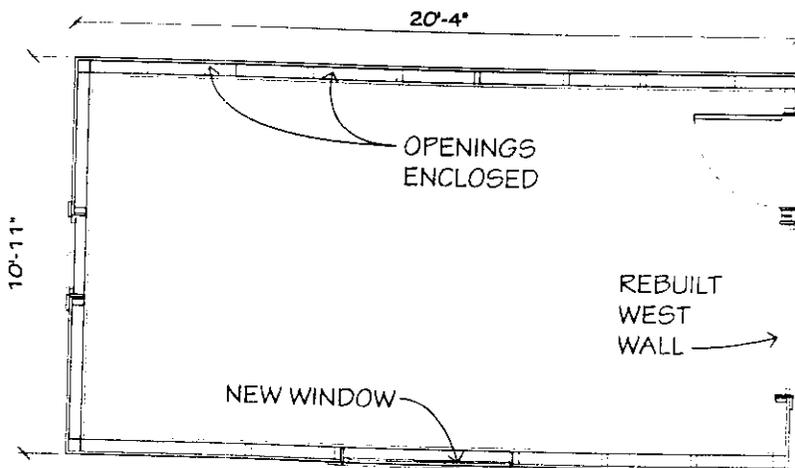
CHICKEN COOP PLAN (CURRENT CONDITION)

The original condition of the west wall is unknown. The original wall had been removed by previous owners; the entire side of the building was covered by a large corrugated metal door. The current owners have reframed the wall to bring it into character with their concept of the original design. The Marty's provided an historically appropriate door and screen door to serve their current uses for the building. They also installed a large window into this wall. The original window was probably much smaller, matching the unit at the east elevation.

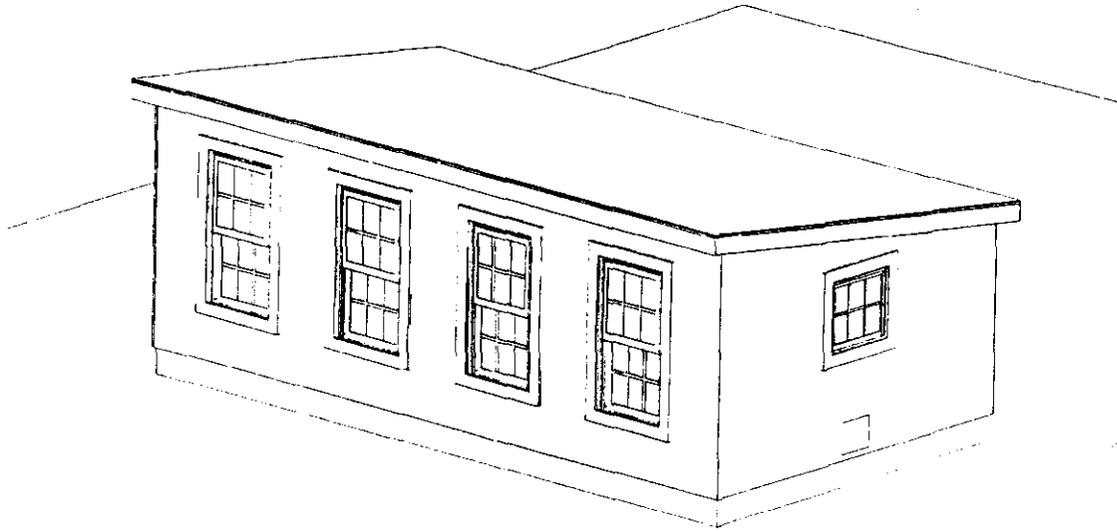
ISOMETRIC OF CHICKEN COOP FROM SOUTHEAST
(CONJECTURED ORIGINAL CONDITION)

The date of construction for the chicken coop is unknown. The configuration of the concrete foundation and curbs, the use of antique wood framing, and the method of assembly for the exterior walls are all very similar to the barn. These elements suggest that the chicken coop and the barn could have been built at about the same time, circa 1890.

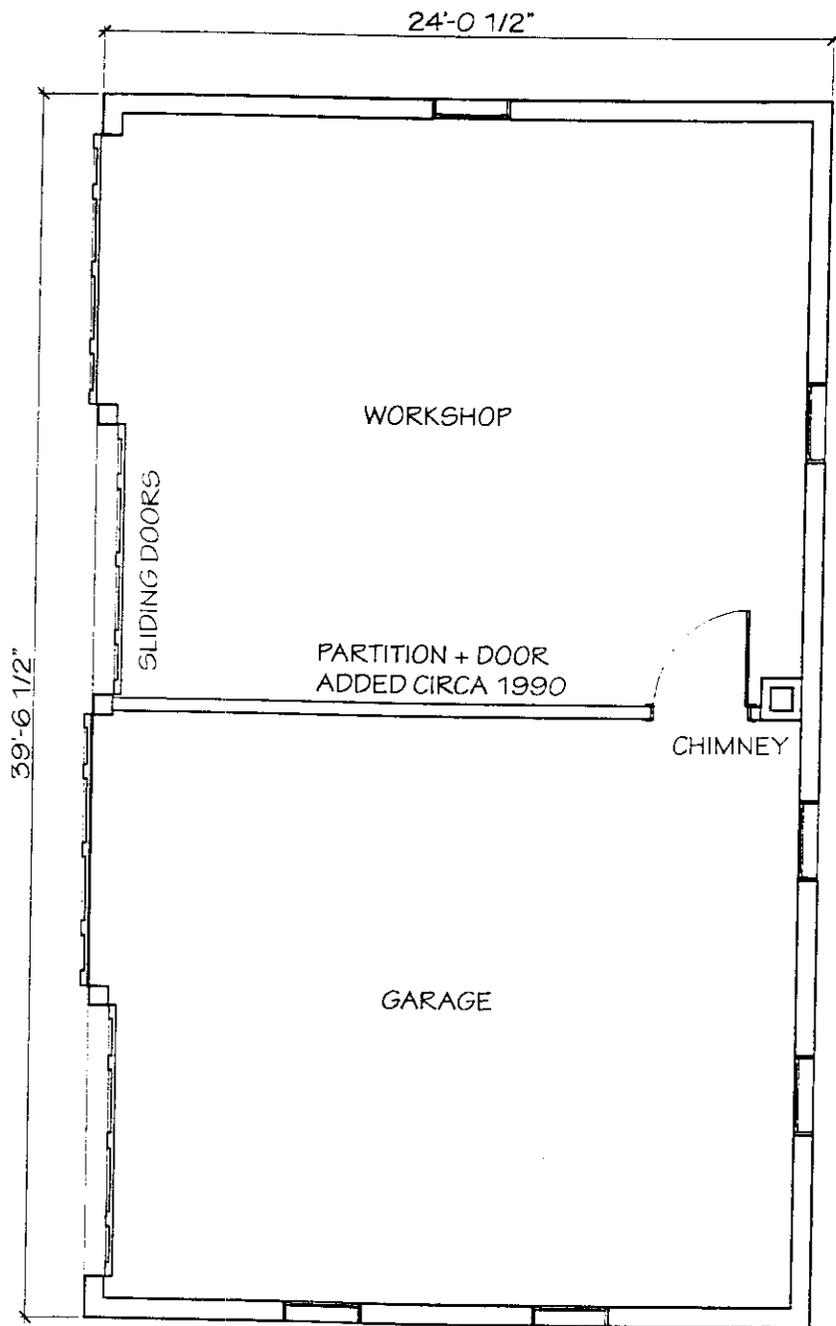
GARAGE PLAN

The garage has a concrete floor and foundation. All exterior walls are single-whythe concrete masonry to a height of eight feet. The masonry has been painted white on the exterior. The gables are wood framed and covered with asbestos composite siding.
