National Register of Historic Places Registration Form

historic name Kress Building

street & number 1025 E. Broadway [N/A] not for publication

Kress Building
Boone County, Missouri
Historic Resources of Downtown Columbia, Missouri

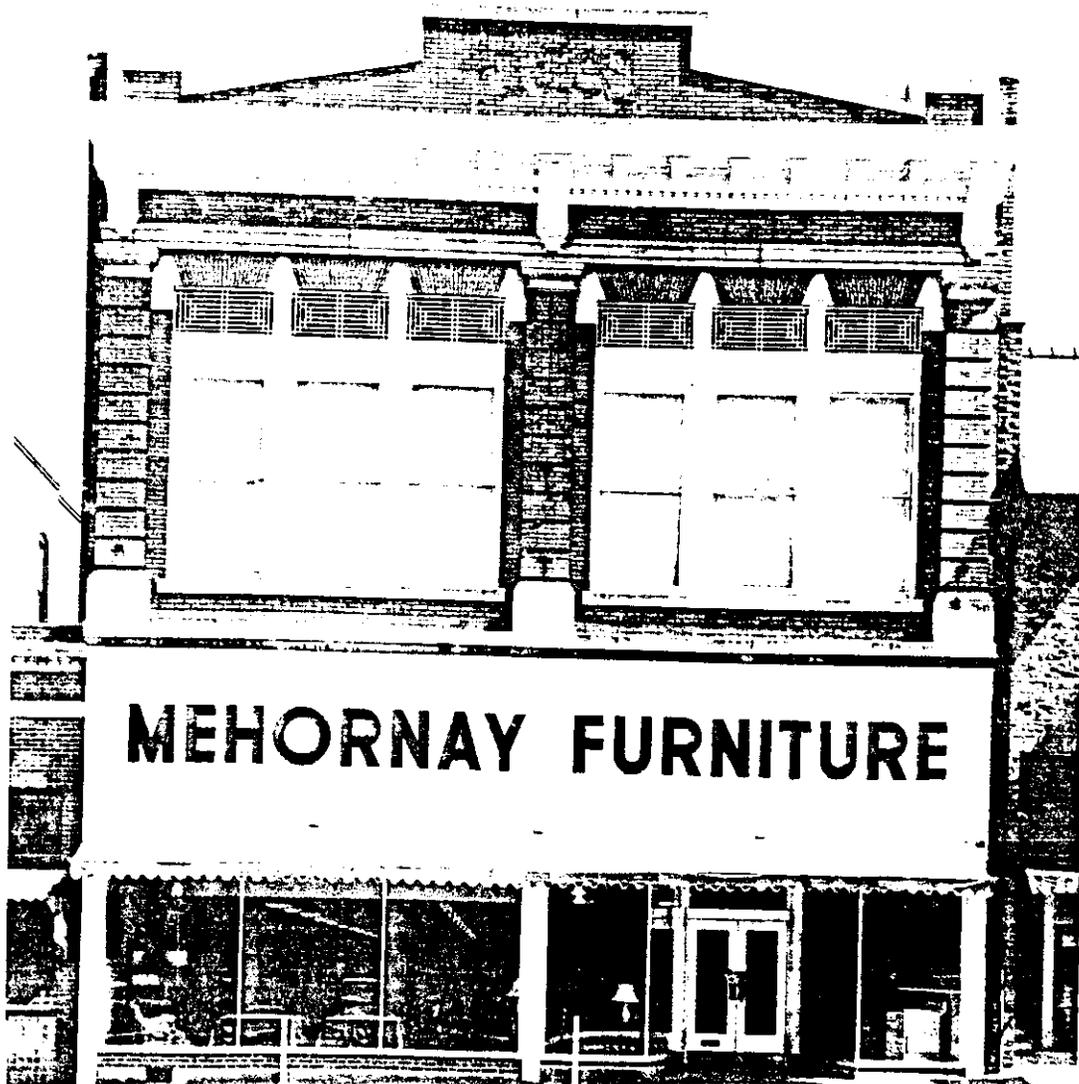
Figure One. This photo appeared in the *Columbia Missourian*, probably in 1946, the year occupants changed from the Kress Co. to Mehornay Furniture. (Used by permission, State Historical Society of Missouri, Columbia.)

The façade of the building is typical of two-part commercial blocks, in that the ground floor is relatively open, and the upper floor is more enclosed. The lower section of the façade contains an open storefront topped by horizontal metal banding, all of which appear to date to ca. 1946. The storefront consists of large plate glass windows, set over very low bulkhead walls. More than half of the storefront components appear to have been in place since the 1940s or before. The main entrance is recessed along the east side wall, and a door to the second floor is recessed along the west wall. The main doors are of wood and glass, and appear to be several decades old. (See Figure One, ca. 1946 photo.) The west doorway is modern.

Information about other Kress stores in the country show that the Columbia store also had much in common with early Kress stores in other locations. A note in the introduction to the Kress Collection catalogue noted that there was a "stylistic consistency of most early stores (1905-1930)." ¹² That account noted that a "typical early building was brick, two-story, located on a corner, and had a façade with restrained Classical Revival trim, including a cornice at the level of the second story ceiling." That description also noted the nearly uniform placement of signs--there was usually a red signboard along the lower façade, a hanging sign, and finally, one "on a raised central portion of the parapet."¹³ Historic photos show that the Columbia store had all three types of signs, and the raised portion of the parapet still bears a very faint outline of the Kress sign, which is clearly visible in the photo taken shortly after Mehornay Furniture moved in. (See Figure One.)

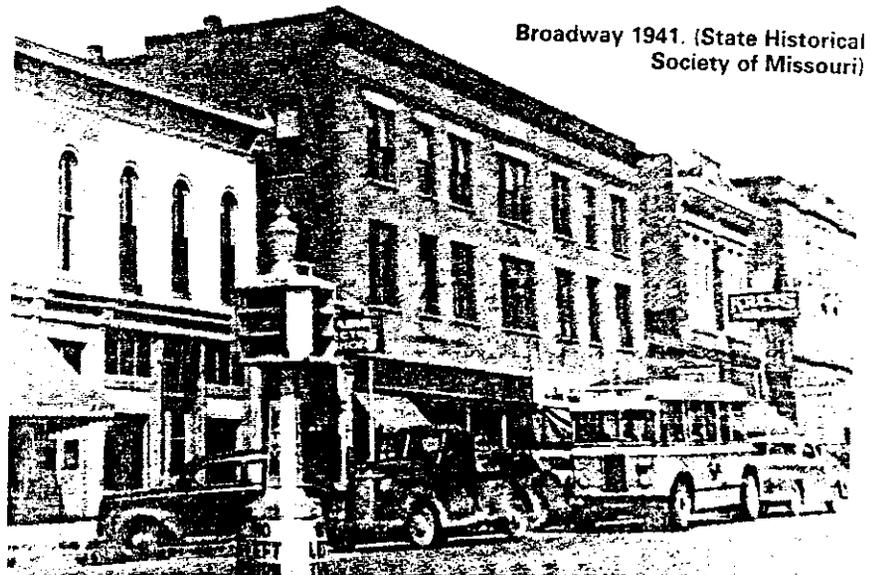
Figure Four. Photo of Broadway taken in 1941. The Kress store is on the right side of the photo. (Photo from the State Historical Society of Missouri was reprinted in Russell, Vicki, et. al. Images of Our Lives Since 1901. Columbia, MO: Columbia Daily Tribune, 2001.)
