# MISSOURI OFFICE OF HISTORIC PRESERVATION

## ARCHITECTURAL/HISTORIC INVENTORY SURVEY FORM

BN-AS 004-001

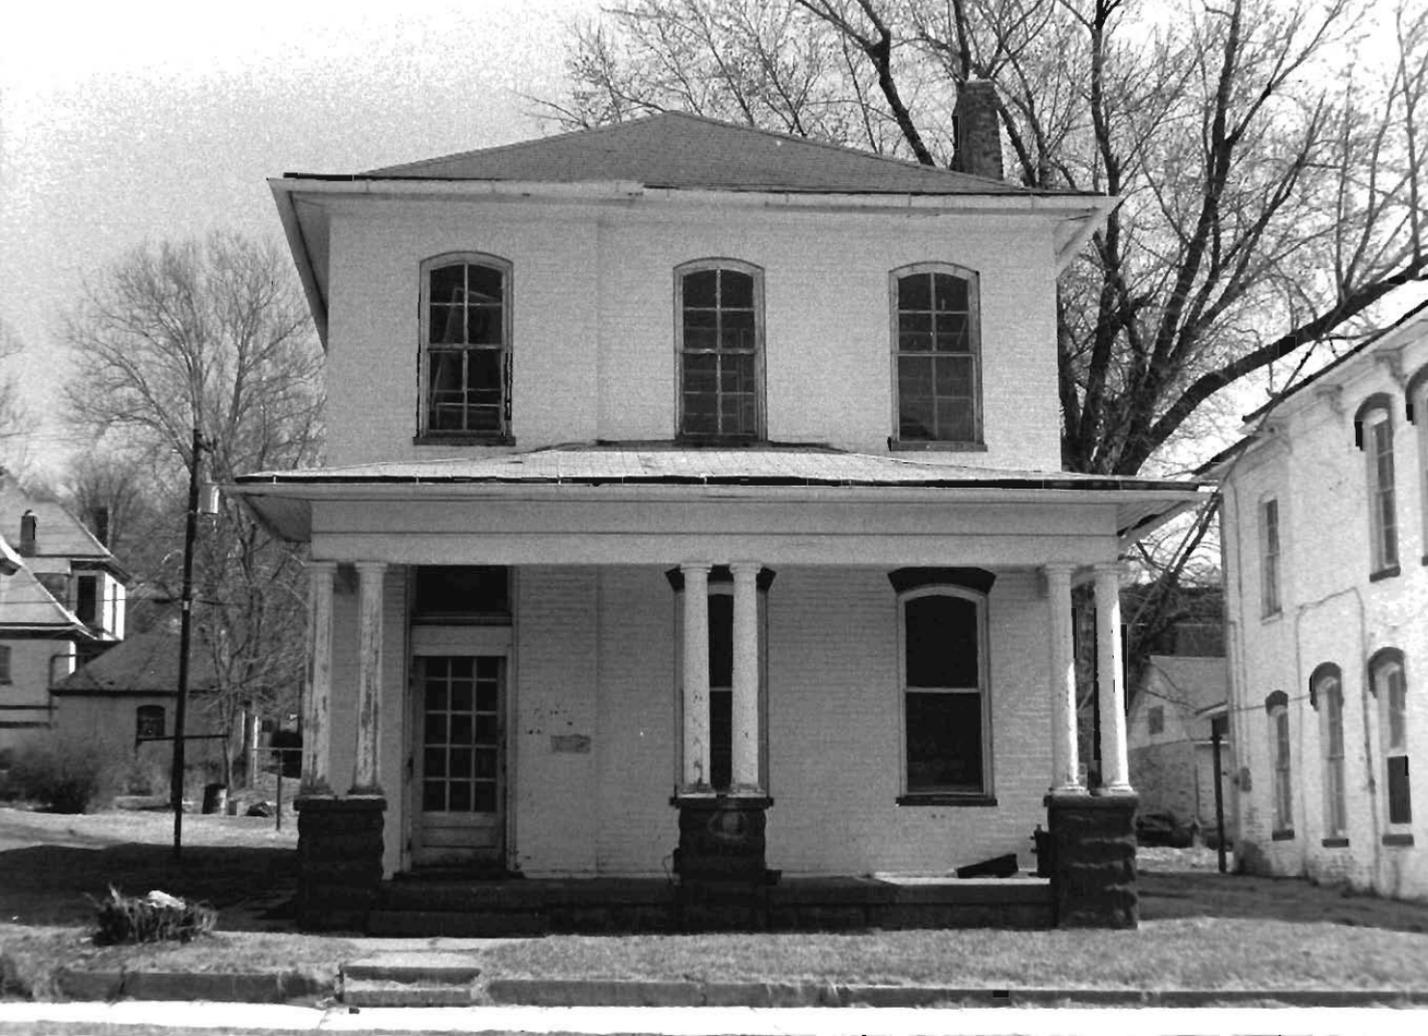
42. FURTHER DESCRIPTION OF IMPORTANT FEATURES 2 story, 3 bay, brick, 2/3 Georgian floor plan with hip roof and internal, side brick chimney. Two-bay porch attached to front elevation (west) is an 1900 Colonial Revival design with stone piers with paired Tuscan columns that support a molded entablature and hip roof. Slightly projecting left bay contains a single door with transom; center and right bays contain 1/1 double hung windows. Symmetrical upper facade has original 4/4 window sashes. All fenestration has arched brick lintels.		34. WALL TREATMENT Painted

35. PLAN SHAPE Rectangular			
43. BUILDING PERMIT RECORDS INDICATE REPAIR OF THE DWELLING IN 1898 FOR APPLICANT, A.L. FEUGUAY; HOWEVER, THE CHARACTERISTICS OF THE BUILDING ARE CAL860. IT HAS A HIGH DEGREE OF ARCHITECTURAL INTEGRITY AND IS SIGNIFICANT AS A REPRESENTATION OF ITALIANATE RESIDENTIAL PROPERTY TYPE.		36. CHANGES (EXPLAIN IN NO. 42) ADDITION ( ) ALTERED ( <input checked="" type="checkbox"/> ) MOVED ( )

37. CONDITION INTERIOR _____ EXTERIOR <i>Good</i>			
44. DESCRIPTION OF ENVIRONMENT AND OUTBUILDINGS In residential neighborhood; commercial zone to west and south of property.		38. PRESERVATION UNDERWAY? YES ( ) NO ( <input checked="" type="checkbox"/> )

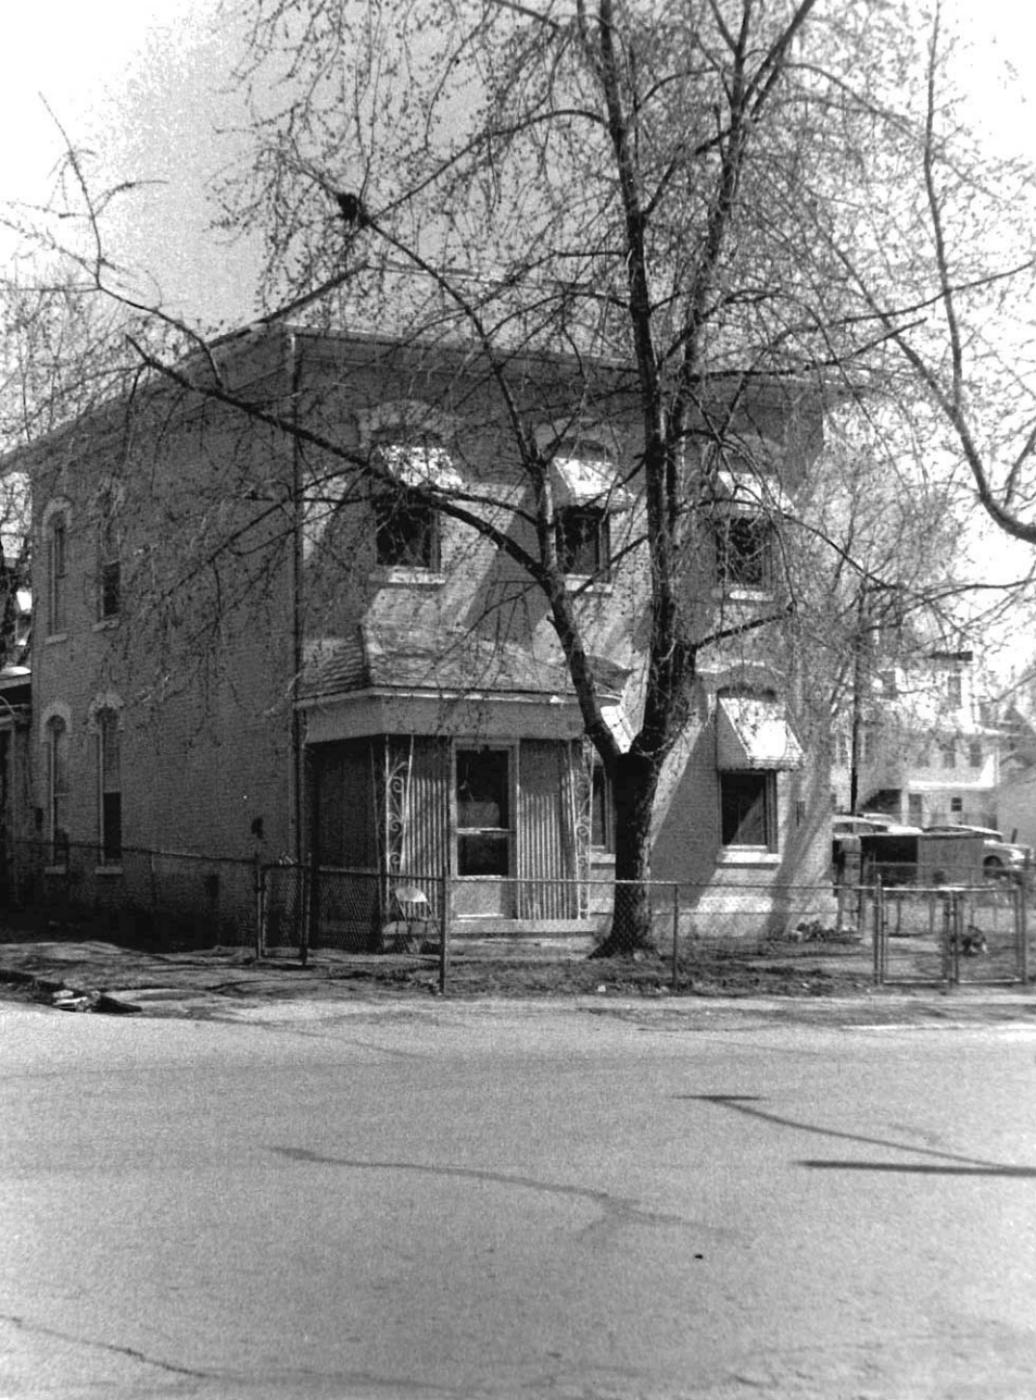
BN-15-004-003

<b>11. ON NATIONAL REGISTER?</b> YES ( ) NO ( X )	<b>21. ORIGINAL USE, IF APPARENT</b> Single Family Residence OIA	<b>34. WALL TREATMENT</b> Painted		
<b>12. IS IT ELIGIBLE?</b> YES ( X ) NO ( )	<b>22. PRESENT USE</b> Same OB	<b>35. PLAN SHAPE</b> Rectangular		
<b>13. PART OF ESTAB. HIST. DISTRICT?</b> YES ( ) NO ( X )	<b>23. OWNERSHIP</b> PUBLIC ( ) PRIVATE ( X )	<b>36. CHANGES (EXPLAIN IN NO. 42)</b> ADDITION ( ) ALTERED ( X X ) MOVED ( )	SECTION	
<b>14. DISTRICT POTENTIAL?</b> YES ( X ) NO ( )	<b>24. OWNER'S NAME AND ADDRESS IF KNOWN</b>	<b>37. CONDITION</b> INTERIOR _____ EXTERIOR Good		
<b>15. NAME OF ESTABLISHED DISTRICT</b>	<b>25. OPEN TO PUBLIC?</b> YES ( ) NO ( X )	<b>38. PRESERVATION UNDERWAY?</b> YES ( ) NO ( X X )		
<b>42. FURTHER DESCRIPTION OF IMPORTANT FEATURES</b> 2 story, 3 bay, asymmetrical, brick dwelling with truncated hip roof and molded frieze. 2/3 Georgian plan with left bay entry, enclosed first story. First bay porch is recent alteration. Other bays contain 1/1 windows with stone sills and ornamental hoodmolds (probably cast iron).		<b>39. ENDANGERED? BY WHAT?</b> YES ( X X ) NO ( ) Poor Maintenance

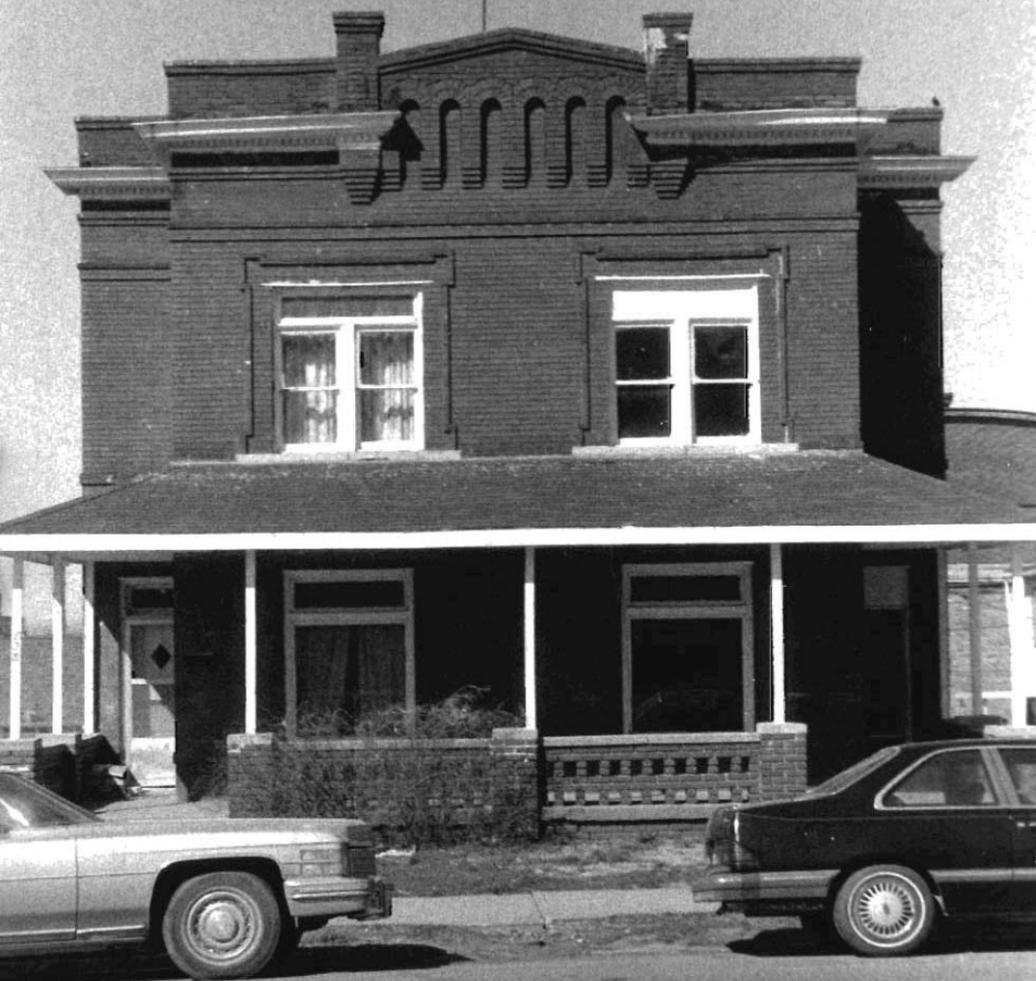
BNAS 004-004

<p>9. COORDINATES UTM LAT _____ LONG _____</p> <p>10. SITE ( ) STRUCTURE ( ) BUILDING (X) OBJECT ( )</p> <p>11. ON NATIONAL REGISTER? YES ( ) NO (X)</p> <p>12. IS IT ELIGIBLE? YES (X) NO ( )</p> <p>13. PART OF ESTAB. HIST. DISTRICT? YES ( ) NO (X)</p> <p>14. DISTRICT POTENTIAL? YES (X) NO ( )</p> <p>15. NAME OF ESTABLISHED DISTRICT</p>	<p>25. OPEN TO PUBLIC? YES ( ) NO (X)</p> <p>26. LOCAL CONTACT PERSON OR ORGANIZATION</p> <p>27. OTHER SURVEYS IN WHICH INCLUDED</p>	4. PRESENT LOCAL NAME(S) OR DESIGNATION(S)	
<p>42. FURTHER DESCRIPTION OF IMPORTANT FEATURES <u>2 story, 4 bay, symmetrical, brick duplex dwelling with flat roof, brick, string courses, and molded, brick parapet. "U" shaped porch attached to front elevation (east) has received major alteration; it has an open brick railing and pedestals with wood planks supporting a hip roof. Recessed end bays contain single doors with transoms. Center bays contain picture windows with transoms; second story contains</u></p> <p>43. HISTORY AND SIGNIFICANCE <u>paired l/l windows with transom; openings are defined with raised brick frame. Dentiled cornice at back of parapet except a center where parapet has a cable effect which contains Romanesque ornamentation of brick.</u></p> <p>43. Building permit records indicate construction in 1896 for applicant, E. E. Lomack. It has a high degree of architectural integrity and is significant as a representation of Classic Revival duplex property type (with Romanesque and Colonial Revival elements).</p>	<p>PHOTO MUST BE PROVIDED</p>	5. OTHER NAME(S)

<p>44. DESCRIPTION OF ENVIRONMENT AND OUTBUILDINGS In residential neighborhood primarily of ca 1860-90 buildings; vacant lots to south; in close proximity to commercial zone on south and west.</p>	<p>45. SOURCES OF INFORMATION BP #4474, 3/21/96; site</p>	6. TOWNSHIP	
<p>46. PREPARED BY Mary Jo Winder</p> <p>47. ORGANIZATION City of St. Joseph</p> <p>48. DATE 7/88</p> <p>49. REVISION DATE(S)</p>	<p>46. PREPARED BY Mary Jo Winder</p> <p>47. ORGANIZATION City of St. Joseph</p> <p>48. DATE 7/88</p> <p>49. REVISION DATE(S)</p>	RANGE	
<p>RETURN THIS FORM WHEN COMPLETED TO: OFFICE OF HISTORIC PRESERVATION P.O. BOX 176 JEFFERSON CITY, MISSOURI 65102 PH. 314-751-4096</p> <p>IF ADDITIONAL SPACE IS NEEDED, ATTACH SEPARATE SHEET(S) TO THIS FORM</p>	<p>46. PREPARED BY Mary Jo Winder</p> <p>47. ORGANIZATION City of St. Joseph</p> <p>48. DATE 7/88</p> <p>49. REVISION DATE(S)</p>	SECTION

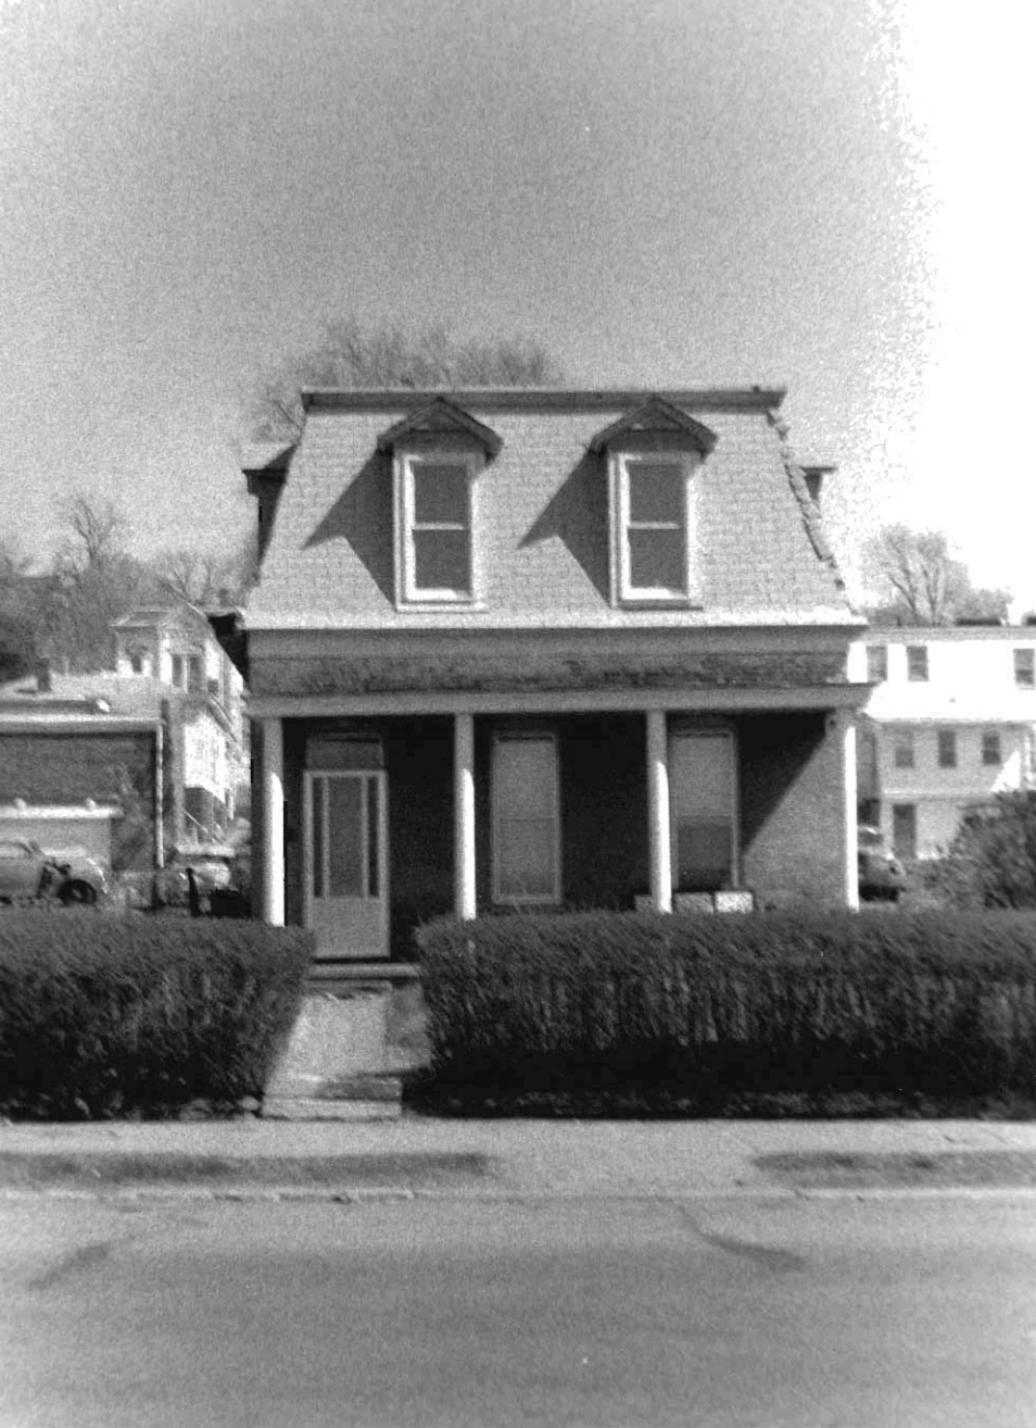
<b>1. NO. 38</b>	<b>4. PRESENT LOCAL NAME(S) OR DESIGNATION(S)</b>		1. NO.	
<b>2. COUNTY</b> Buchanan	<b>5. OTHER NAME(S)</b>			2. COUNTY
<b>3. LOCATION OF</b> Dept. of P & Z NEGATIVES Roll #10-3				
<b>6. SPECIFIC LEGAL LOCATION</b> TOWNSHIP _____ RANGE _____ SECTION _____ IF CITY OR TOWN, STREET ADDRESS 801 South 10th Street	<b>16. THEMATIC CATEGORY</b> Architecture	<b>28. NO. OF STORIES</b> 2 <b>29. BASEMENT?</b> YES ( ) NO ( )	5. OTHER NAME(S)	
<b>7. CITY OR TOWN</b> IF RURAL, VICINITY St. Joseph	<b>17. DATE(S) OR PERIOD</b> ca. 1870	<b>30. FOUNDATION MATERIAL</b> Brick		
<b>8. DESCRIPTION OF LOCATION</b> Legal: Lot 8, Block 10, Patee's Addition	<b>18. STYLE OR DESIGN</b> Italianate 42 19	<b>31. WALL CONSTRUCTION</b> Brick		
<b>9. COORDINATES</b> UTM LAT _____ LONG _____	<b>19. ARCHITECT OR ENGINEER</b>	<b>32. ROOF TYPE AND MATERIAL</b> Trunc. Hip/Comp Shingle	6. TOWNSHIP	
<b>10.</b> SITE ( ) STRUCTURE ( ) BUILDING ( X ) OBJECT ( )	<b>20. CONTRACTOR OR BUILDER</b> 40 99	<b>33. NO. OF BAYS</b> FRONT 3 SIDE _____		RANGE

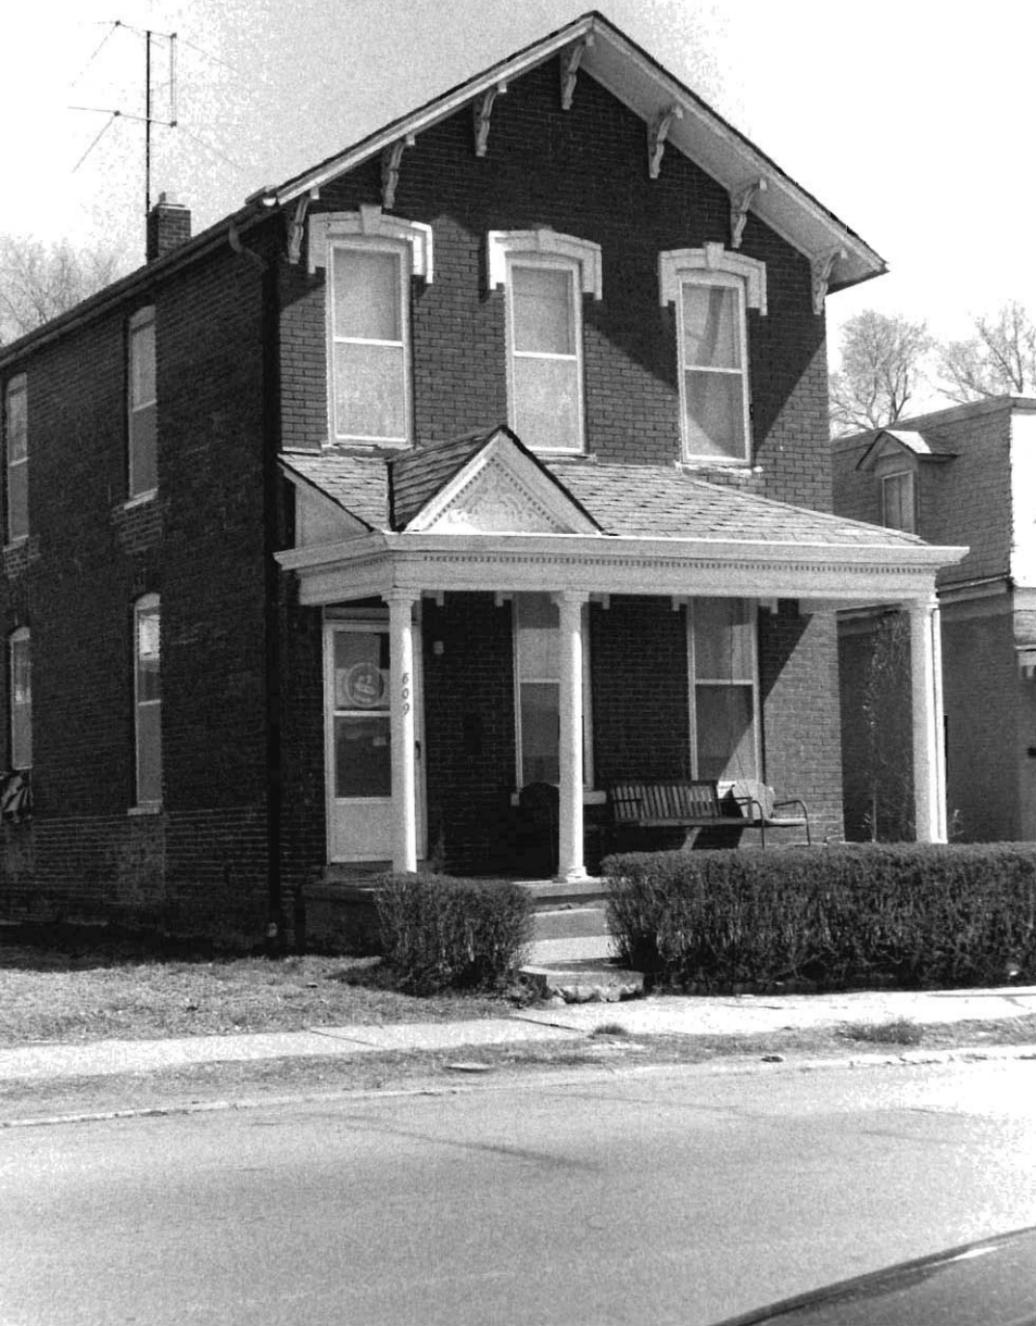
7. CITY OR TOWN IF RURAL, VICINITY <b>St. Joseph</b>	17. DATE(S) OR PERIOD <b>ca. 1880/1905</b>	29. BASEMENT? YES ( ) NO ( )
8. DESCRIPTION OF LOCATION <b>Legal: Lot 6, Block 9, Patee's Addition</b>	18. STYLE OR DESIGN <b>50 18</b> <b>Italianate/Colonial Revival</b>	30. FOUNDATION MATERIAL <b>Brick</b>

12. IS IT ELIGIBLE? YES ( <input checked="" type="checkbox"/> ) NO ( )	25. OPEN TO PUBLIC? YES ( ) NO ( <input checked="" type="checkbox"/> )	37. CONDITION INTERIOR _____ EXTERIOR <b>Good</b>

Building permit files indicate repairs in 1905 for applicant, G. A. Sprengle; however, stylistic features are ca1880 Italianate and ca1890 Colonial Revival (porch). It has a high degree of integrity and is significant both for its vernacular Italianate residential property type characteristics and its Colonial Revival porch. (On 1883 Sanborn map)

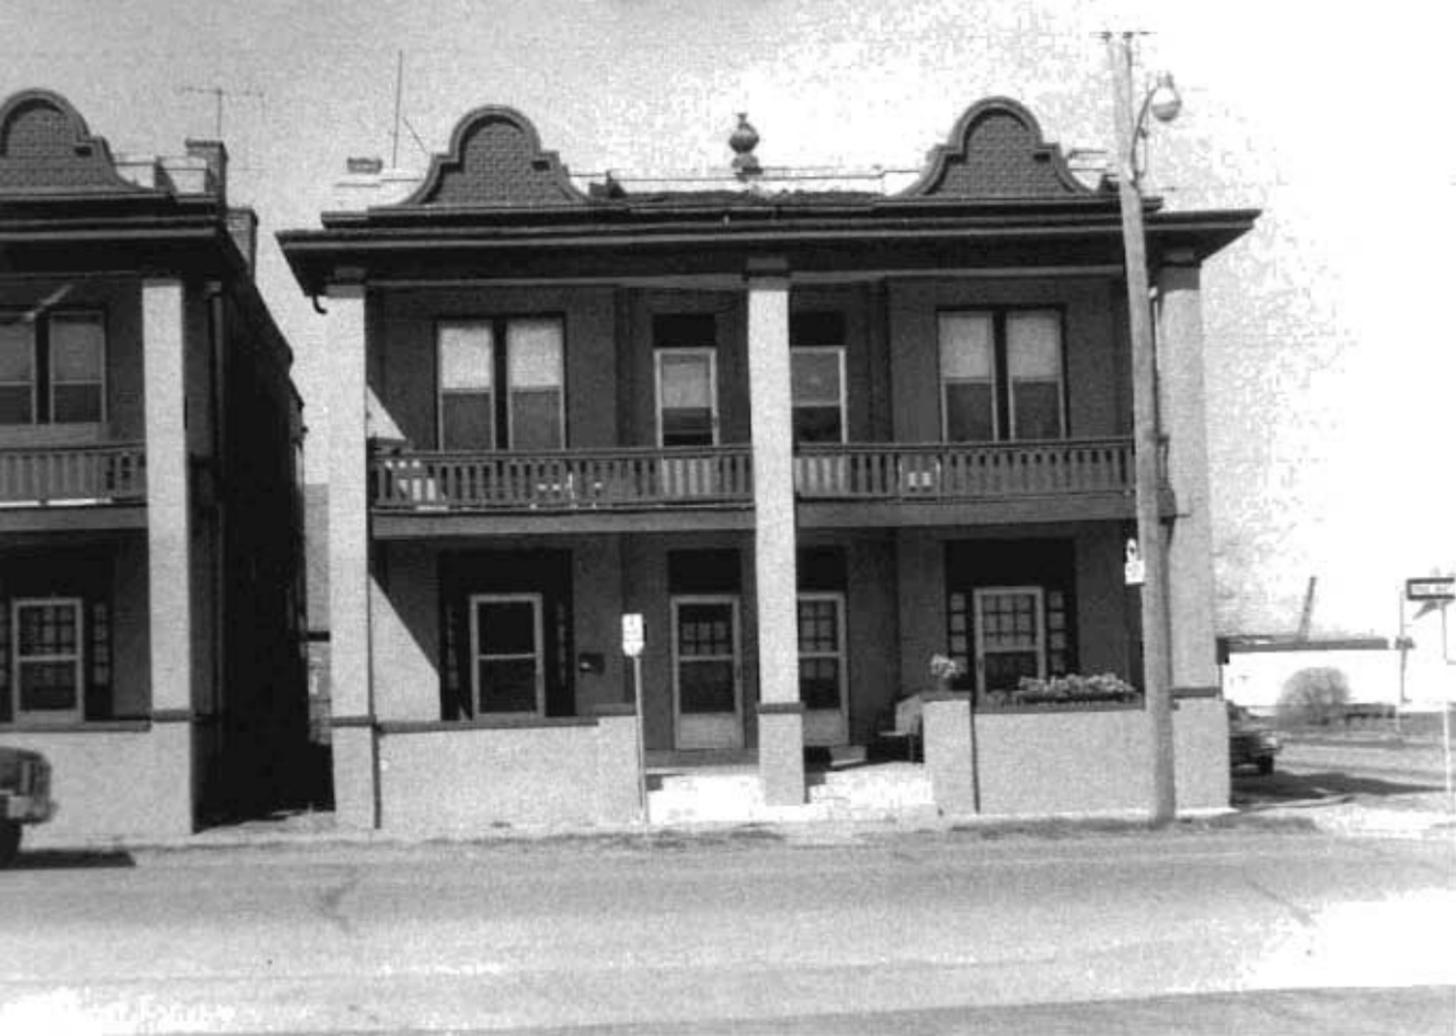
<p>43. HISTORY AND SIGNIFICANCE <b>story contains paired 1/1 windows. Center bays contain single door with transoms both stories. Parapet wall ornamented with exaggerated arched-top pediments with molded edge and geometric relief pattern on end bays; center of wall has large urn ornament.</b></p> <p>43. Building permit records indicate construction of 3 residences in 1888 for applicant, James Horigan (\$10,500). The buildings maintain a high degree of integrity and are significant as representations of Neoclassical multi-family residential property type.</p>	<p>28. NO. OF STORIES <b>2</b></p> <p>29. BASEMENT? YES ( ) NO (X)</p> <p>30. FOUNDATION MATERIAL <b>Flat PR</b></p> <p>31. WALL CONSTRUCTION <b>Brick w/ Stucco</b></p> <p>32. ROOF TYPE AND MATERIAL <b>Flat PR</b></p> <p>33. NO. OF BAYS FRONT 4 SIDE</p> <p>34. WALL TREATMENT <b>Stucco</b></p> <p>35. PLAN SHAPE <b>Rectangular</b></p> <p>36. CHANGES (EXPLAIN IN NO. 42) ADDITION ( ) ALTERED ( ) MOVED ( )</p> <p>37. CONDITION INTERIOR _____ EXTERIOR <b>Good</b></p> <p>38. PRESERVATION UNDERWAY? YES ( ) NO (X)</p> <p>39. ENDANGERED? BY WHAT? YES (X) NO ( ) <b>Deteriorated Environment</b></p> <p>40. VISIBLE FROM PUBLIC ROAD? YES (X) NO ( )</p> <p>41. DISTANCE FROM AND FRONTAGE ON ROAD</p>	6. TOWNSHIP

<p>44. DESCRIPTION OF ENVIRONMENT AND OUTBUILDINGS <b>At edge of residential neighborhood; Patee park to north; commercial zone on all boundaries.</b></p>	<p>45. SOURCES OF INFORMATION <b>BP #BB362, 5/21/88; site</b></p>	RANGE
<p>46. PREPARED BY <b>Mary Jo Winder</b></p> <p>47. ORGANIZATION <b>City of St. Joseph</b></p> <p>48. DATE <b>7/88</b></p>	<p>49. REVISION DATE(S)</p>	SECTION
<p>RETURN THIS FORM WHEN COMPLETED TO: OFFICE OF HISTORIC PRESERVATION P.O. BOX 176 JEFFERSON CITY, MISSOURI 65102 PH. 314-751-4096</p> <p>IF ADDITIONAL SPACE IS NEEDED, ATTACH SEPARATE SHEET(S) TO THIS FORM</p>

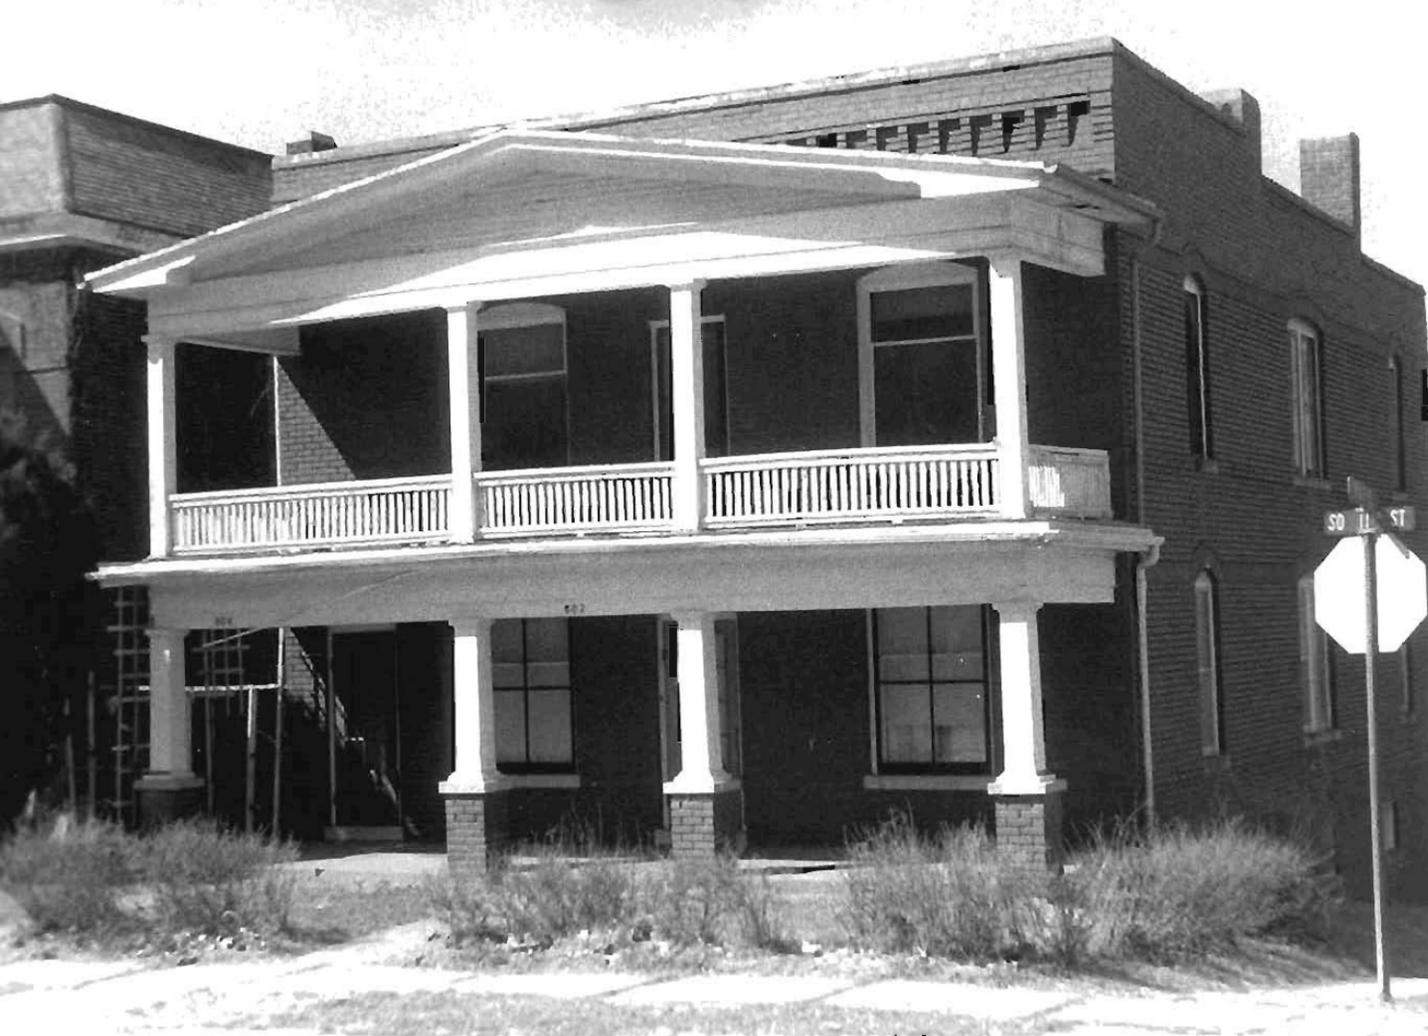
<p>9. COORDINATES UTM LAT _____ LONG _____</p> <p>10. SITE ( ) STRUCTURE ( ) BUILDING (X) OBJECT ( )</p> <p>11. ON NATIONAL REGISTER? YES ( ) NO (X)</p> <p>12. IS IT ELIGIBLE? YES (X) NO ( )</p> <p>13. PART OF ESTAB. HIST. DISTRICT? YES ( ) NO (X)</p> <p>14. DISTRICT POTENTIAL? YES (X) NO ( )</p> <p>15. NAME OF ESTABLISHED DISTRICT</p>	<p>25. OPEN TO PUBLIC? YES ( ) NO (X)</p> <p>26. LOCAL CONTACT PERSON OR ORGANIZATION</p> <p>27. OTHER SURVEYS IN WHICH INCLUDED</p>	4. PRESENT LOCAL NAME(S) OR DESIGNATION(S)	
<p>42. FURTHER DESCRIPTION OF IMPORTANT FEATURES</p> <p><b>2 story, 4 bay, symmetrical-ly massed, brick duplex dwelling with flat roof and side, brick chimneys. Two story, three bay porch attached to front elevation (east) has brick pedestals with square columns that support a wide entablature and upper porch which has smaller columns, open slat railing, entablature and front gable roof with boxed returns. First bay contains entry, second and fourth bays contain wide 1/1 double</b></p> <p>43. HISTORY AND SIGNIFICANCE</p> <p><b>hung windows (with rails at upper 1/3 point) within openings with stone sills and arched, brick lintels, both stories; third bay contains single door, both stories. Parapet wall has ornamental, brick bracketing.</b></p> <p>43. Building permit records indicate construction in 1912 for applicant, A. Hoppe. It has a high degree of architectural integrity and is significant as a representation of early 20th century Classic Revival duplex property type.</p>	<p style="font-size: 2em; font-weight: bold;">X</p> <p style="text-align: center;">PHOTO MUST BE PROVIDED</p>	5. OTHER NAME(S)

<p>44. DESCRIPTION OF ENVIRONMENT AND OUTBUILDINGS</p> <p><b>In residential neighborhood; on corner lot; on block of closely spaced dwellings with shallow setbacks.</b></p>	<p>45. SOURCES OF INFORMATION</p> <p><b>BP #7279, 7/16/12; site</b></p>	6. TOWNSHIP	
<p>46. PREPARED BY <b>Mary Jo Winder</b></p> <p>47. ORGANIZATION <b>City of St. Joseph</b></p> <p>48. DATE <b>7/88</b></p> <p>49. REVISION DATE(S)</p>	<p>44. DESCRIPTION OF ENVIRONMENT AND OUTBUILDINGS</p>	RANGE	
<p>RETURN THIS FORM WHEN COMPLETED TO: OFFICE OF HISTORIC PRESERVATION P.O. BOX 176 JEFFERSON CITY, MISSOURI 65102 PH. 314-751-4096</p> <p>IF ADDITIONAL SPACE IS NEEDED, ATTACH SEPARATE SHEET(S) TO THIS FORM</p>	<p>44. DESCRIPTION OF ENVIRONMENT AND OUTBUILDINGS</p>	SECTION

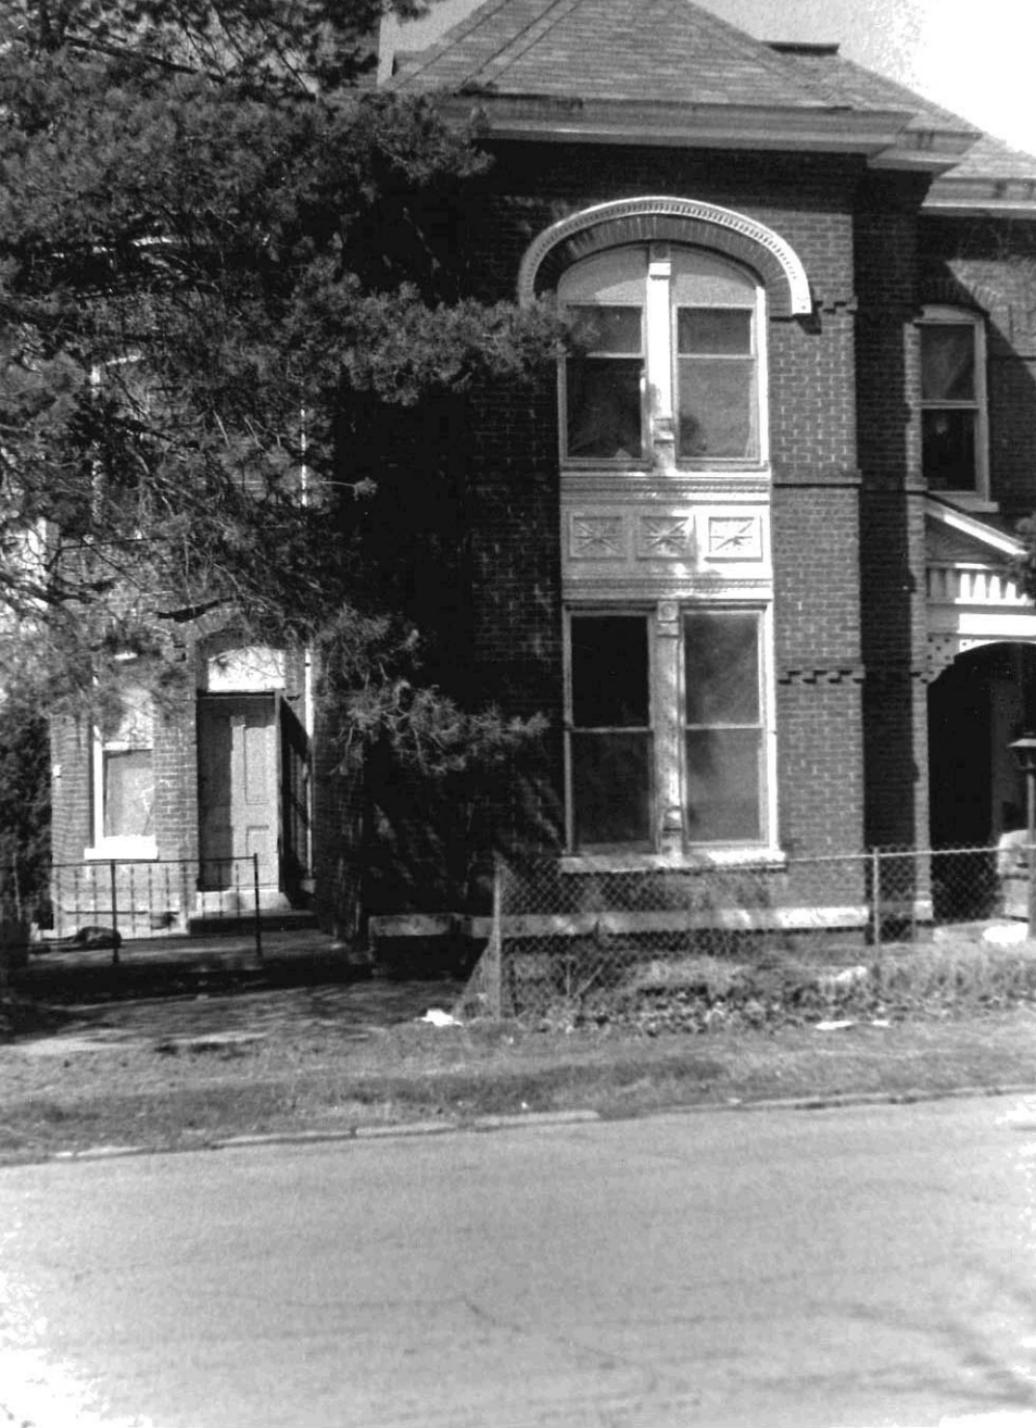
<p>42. FURTHER DESCRIPTION OF IMPORTANT FEATURES <b>2 story, 4 bay, asymmetrical, brick dwelling with truncated hip roof with molded, boxed cornice and dentiled string course of brick. Left two bays are part of octagonal south side elevation two-story wing with octagonal, hip roof; first bay has l/l window, both stories; second has single door with transom on first story, openings have stone sills and brick hoodmolds. Projecting third bay is front wing</b></p>	<p style="font-size: 2em; font-weight: bold;">X</p> <p style="text-align: center;">PHOTO MUST  BE PROVIDED</p>	4. PRESENT LOCAL NAME(S) OR DESIGNATION(S)	
<p>43. HISTORY AND SIGNIFICANCE <b>with slightly projecting unit that contains paired l/l windows, both stories; ornamentation includes fluted engaged columns between window units, decorated panel between stories and arched opening with brick hoodmold with dentiled cornice (stone or cast iron). Right bay is recessed and contains single door with transom on first story, l/l window on second; small porch attached to bay has Eastlake ornamentation. Porch on left two bays has been demolished.</b></p> <p>43. <b>There are no building permits of record for this dwelling and it does not appear on the 1883 Sanborn map; therefore it can be established that construction occurred between 1883 and 1887. It has a high degree of integrity and is significant as a repre-</b></p>	<p>44. DESCRIPTION OF ENVIRONMENT AND OUTBUILDINGS <b>sensation of Queen Anne duplex property type.</b> <b>In residential neighborhood of ca1860-1900 dwellings.</b></p>	5. OTHER NAME(S)

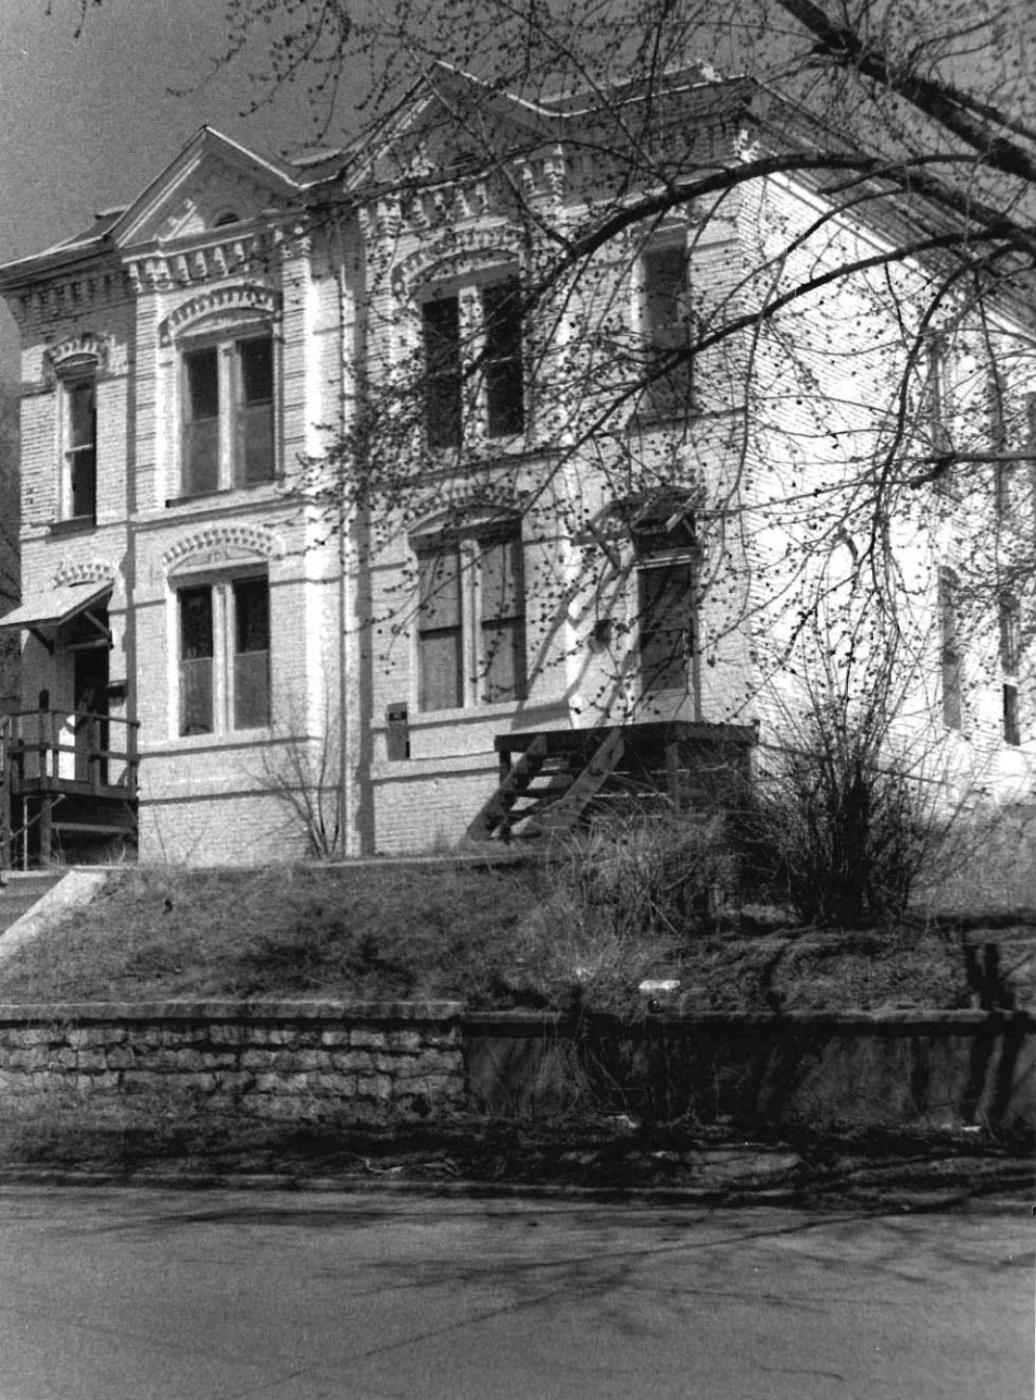
<b>43. HISTORY AND SIGNIFICANCE</b> with enframed gable with molded cornice, dentils and small semi-circular vent opening. Porch has been removed; replacement of individual small wood decks  43. There are no building permits of record for this dwelling and it does not appear on the 1883 Sanborn map; therefore, it can be established that construction occurred between 1883 and 1887. It has a moderate to high degree of integrity due to demolition and alterations and is significant as a representation of Queen Anne duplex property type.	<b>25. OPEN TO PUBLIC?</b> YES ( ) NO (X)	<b>37. CONDITION</b> INTERIOR _____ EXTERIOR Fair-Good		
<b>44. DESCRIPTION OF ENVIRONMENT AND OUTBUILDINGS</b> In residential neighborhood primarily of ca1860-1900 dwellings.	<b>26. LOCAL CONTACT PERSON OR ORGANIZATION</b>	<b>38. PRESERVATION UNDERWAY?</b> YES ( ) NO (XX)		
<b>45. SOURCES OF INFORMATION</b> No relevent building permit; site	<b>27. OTHER SURVEYS IN WHICH INCLUDED</b>	<b>39. ENDANGERED? BY WHAT?</b> YES (XX) NO ( ) Poor Maintenance

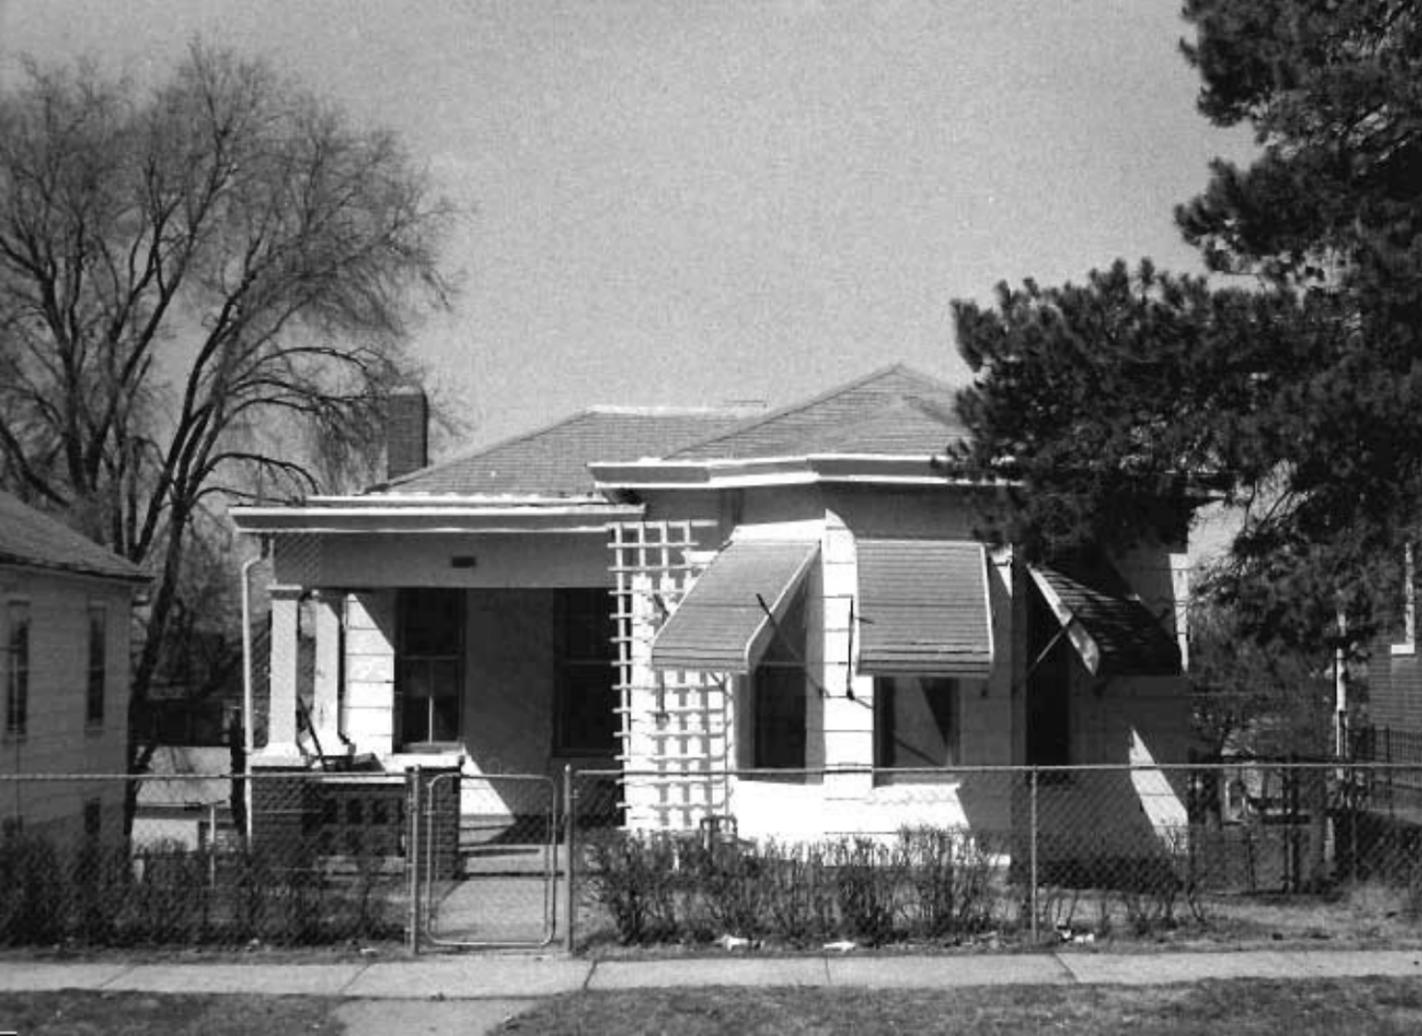
<b>17. DESCRIPTION OF ENVIRONMENT AND OUTBUILDINGS</b> In residential neighborhood primarily of late 19th century dwellings.	<b>26. LOCAL CONTACT PERSON OR ORGANIZATION</b>	<b>38. PRESERVATION UNDERWAY?</b> YES ( ) NO ( XX )	
<b>18. SOURCES OF INFORMATION</b> BP # D1561, 3/23/91; BP #5-81, 9/14/21; site; 1888 Sanborn map	<b>27. OTHER SURVEYS IN WHICH INCLUDED</b>	<b>39. ENDANGERED? BY WHAT?</b> YES ( XX ) NO ( ) Incompatible Alterat on	
<b>19. RETURN THIS FORM WHEN COMPLETED TO:</b> OFFICE OF HISTORIC PRESERVATION P.O. BOX 176 JEFFERSON CITY, MISSOURI 65102 PH. 314-751-4096	<b>28. DISTANCE FROM AND FRONTAGE ON ROAD</b>	<b>40. VISIBLE FROM PUBLIC ROAD?</b> YES ( X ) NO ( )	
<b>20. IF ADDITIONAL SPACE IS NEEDED, ATTACH SEPARATE SHEET(S) TO THIS FORM</b>	<b>41. PHOTO MUST BE PROVIDED</b>	<b>46. PREPARED BY</b> Mary Jo Winder	
<b>21. IF ADDITIONAL SPACE IS NEEDED, ATTACH SEPARATE SHEET(S) TO THIS FORM</b>	<b>42. PREPARED BY</b> Mary Jo Winder	<b>47. ORGANIZATION</b> City of St. Joseph

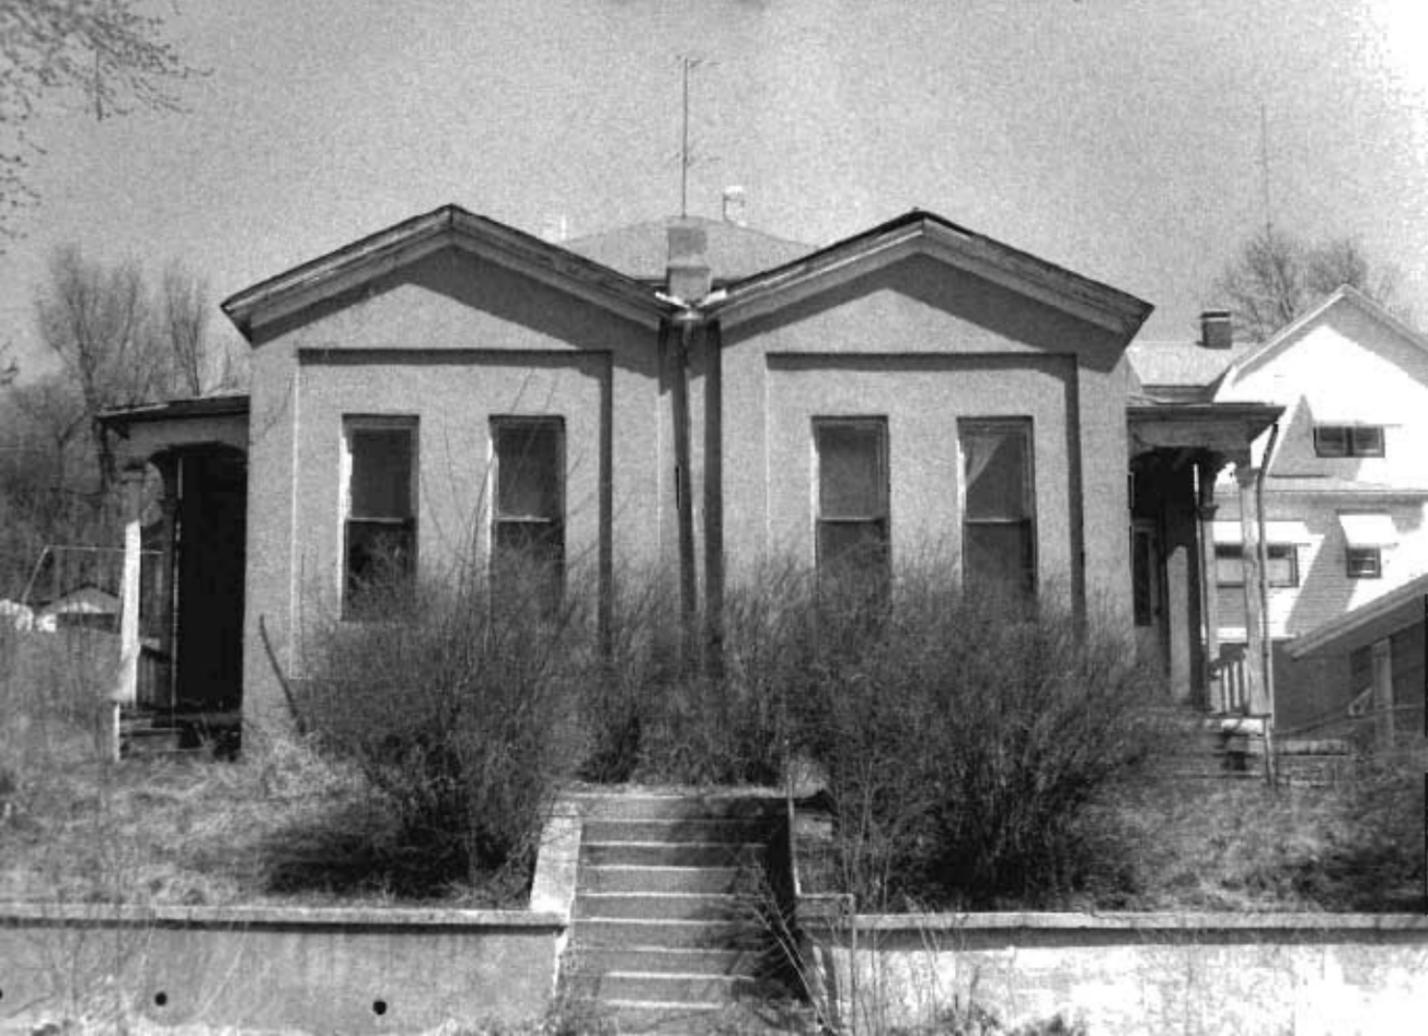
<p>43. HISTORY AND SIGNIFICANCE <b>window. A building permit issued to Miss Leona F. Schall in 1909 indicates major alterations to this dwelling; however, stylistic features and the building's presence on the 1883 Sanborn map indicate a ca1870 original construction. It has a moderate to high degree of integrity and is significant as a representation of vernacular Italianate duplex property type.</b></p>	<p>26. LOCAL CONTACT PERSON OR ORGANIZATION</p>	<p><b>PHOTO MUST BE PROVIDED</b></p>	
<p>44. DESCRIPTION OF ENVIRONMENT AND OUTBUILDINGS <b>In residential neighborhood primarily of ca1860-1900 dwellings; modern house on lot to the south.</b></p>	<p>27. OTHER SURVEYS IN WHICH INCLUDED</p>	<p>38. PRESERVATION UNDERWAY? YES ( ) NO (X)</p>	SECTION
<p>45. SOURCES OF INFORMATION <b>BP #6029, 8/16/09; site</b></p>	<p>46. PREPARED BY <b>Mary Jo Winder</b></p>	<p>39. ENDANGERED? BY WHAT? YES (X) NO ( ) <b>Neglect/Vacancy</b></p>

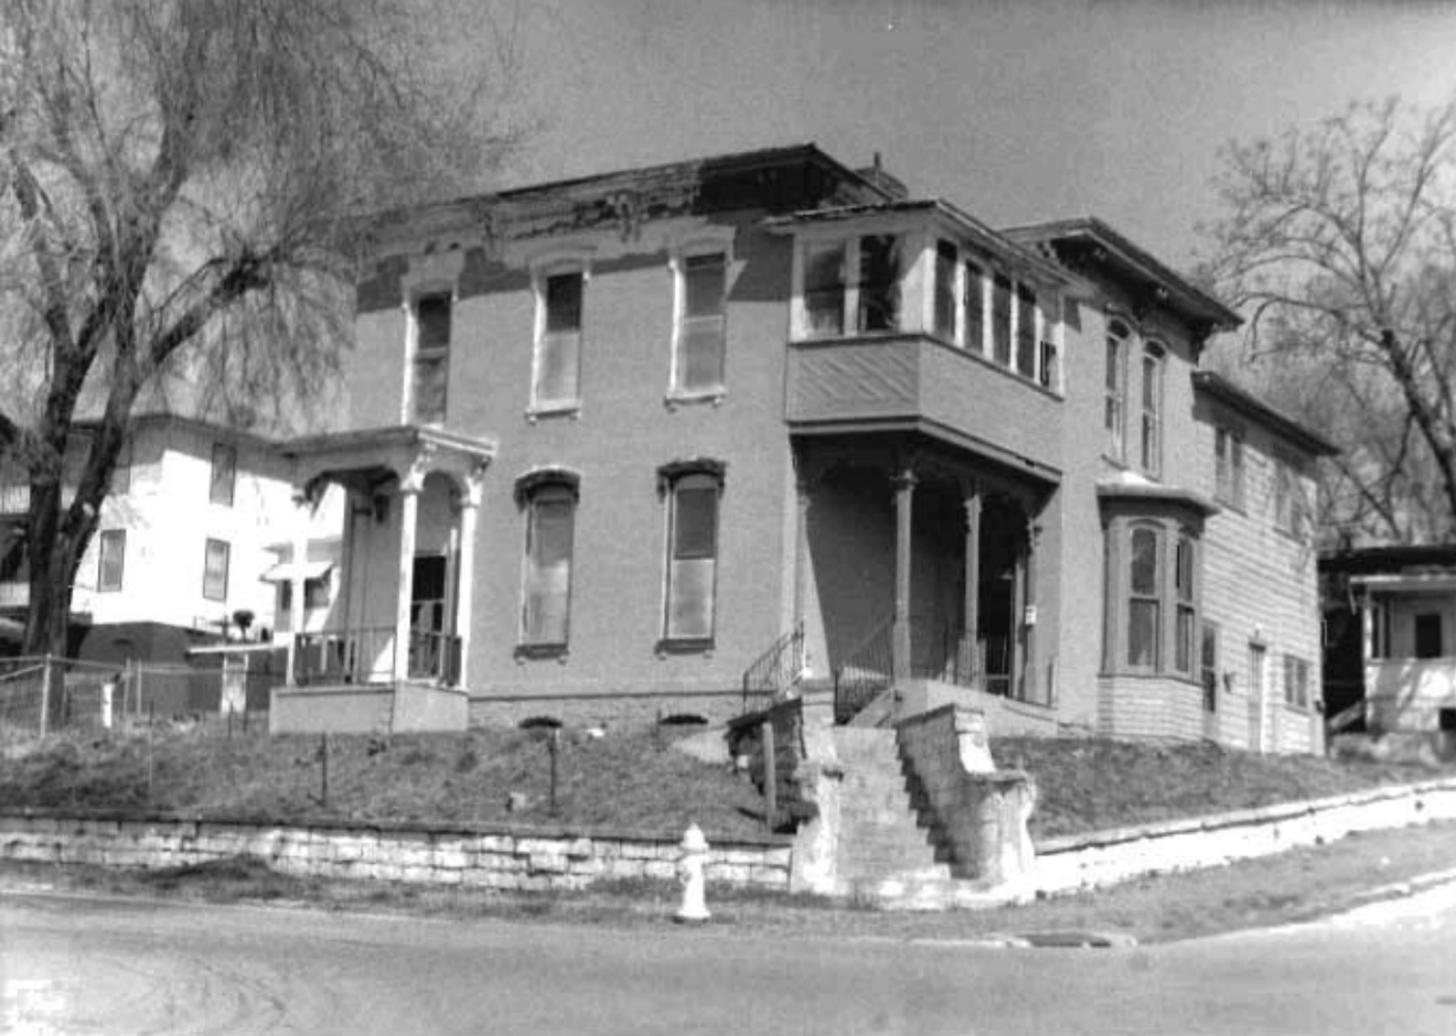
<p>43. HISTORY AND SIGNIFICANCE <b>under small Italianate corner porch in fourth bay has original hoodmold and transom; porch on second story has been enclosed (1926). Addition was constructed in 1926.</b></p>	<p>24. OWNER'S NAME AND ADDRESS IF KNOWN</p>	<p>36. CHANGES (EXPLAIN IN NO. 42) ADDITION (XX) ALTERED (XX) MOVED ( )</p>	
<p>44. DESCRIPTION OF ENVIRONMENT AND OUTBUILDINGS <b>In residential neighborhood; on corner lot; surrounding buildings ca1860-1900.</b></p>	<p>25. OPEN TO PUBLIC? YES ( ) NO (X)</p>	<p>37. CONDITION INTERIOR _____ EXTERIOR <b>Fair</b></p>	SECTION
<p>45. SOURCES OF INFORMATION <b>BP #31926; BP #4059, 1/5/26; site ; 1883 Sanborn map</b></p>	<p>26. LOCAL CONTACT PERSON OR ORGANIZATION</p>	<p>38. PRESERVATION UNDERWAY? YES ( ) NO (XX)</p>	
<p>RETURN THIS FORM WHEN COMPLETED TO: <b>OFFICE OF HISTORIC PRESERVATION P.O. BOX 176 JEFFERSON CITY, MISSOURI 65102 PH. 314-751-4096</b></p>	<p>27. OTHER SURVEYS IN WHICH INCLUDED</p>	<p>39. ENDANGERED? BY WHAT? YES (XX) NO ( ) <b>Poor Maintenance</b></p>
