# MISSOURI OFFICE OF HISTORIC PRESERVATION

## ARCHITECTURAL/HISTORIC INVENTORY SURVEY FORM

BN-AS 004-001

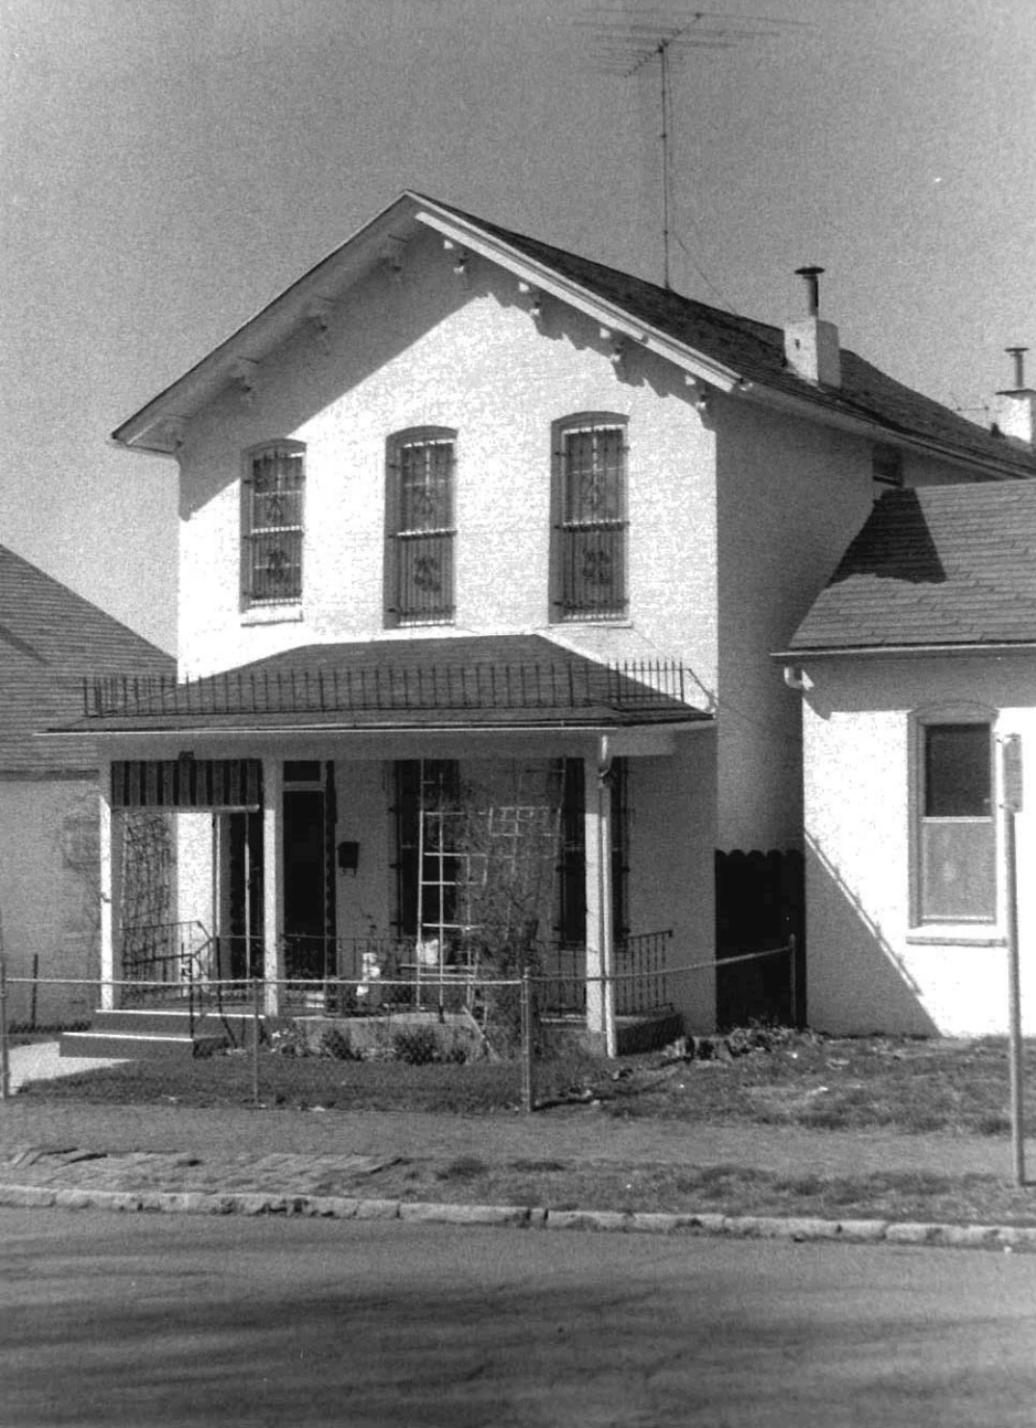
<p>42. FURTHER DESCRIPTION OF IMPORTANT FEATURES Two story, three bay, asymmetrical, brick dwelling with front gable roof with console brackets and molded cornice and internal, side, brick chimneys. Porch attached to front elevation (east) is ca 1900 or later with simple wood post supports and hip roof. Left bay contains entry with transom; center and right bay contain 4/4 double windows. Second story bays each contain 4/4 windows. All fenestration</p> <p>43. HISTORY AND SIGNIFICANCE has stone sills and arched, brick lintels. Wrought iron crest on porch roof. Also, wrought iron railing added later includes porch railing and ornamental window grates.</p> <p>43. There are no building permits of record for this dwelling; however, stylistic features indicate original construction to be ca 1860 with a later porch alteration. It has a moderate to high degree of architectural integrity and is significant as a representation of mid 19th century vernacular residential property type. (On 1883 Sanborn map)</p>	<p style="font-size: 2em; font-weight: bold;">X</p> <p style="text-align: center;">PHOTO MUST BE PROVIDED</p>	4. PRESENT LOCAL NAME(S) OR DESIGNATION(S)

<p>44. DESCRIPTION OF ENVIRONMENT AND OUTBUILDINGS In residential neighborhood; closely spaced dwellings with shallow setbacks.</p>	<p>45. SOURCES OF INFORMATION No relevant building permit. 1883 Sanborn map</p>	<p>46. PREPARED BY Mary Jo Winder</p> <p>47. ORGANIZATION City of St. Joseph</p> <p>48. DATE 7/88</p> <p>49. REVISION DATE(S)</p>	5. OTHER NAME(S)
<p>RETURN THIS FORM WHEN COMPLETED TO: OFFICE OF HISTORIC PRESERVATION P.O. BOX 176 JEFFERSON CITY, MISSOURI 65102 PH. 314-751-4096</p> <p>IF ADDITIONAL SPACE IS NEEDED, ATTACH SEPARATE SHEET(S) TO THIS FORM</p>	<p>6. TOWNSHIP</p> <p>RANGE</p> <p>SECTION</p>	6. TOWNSHIP

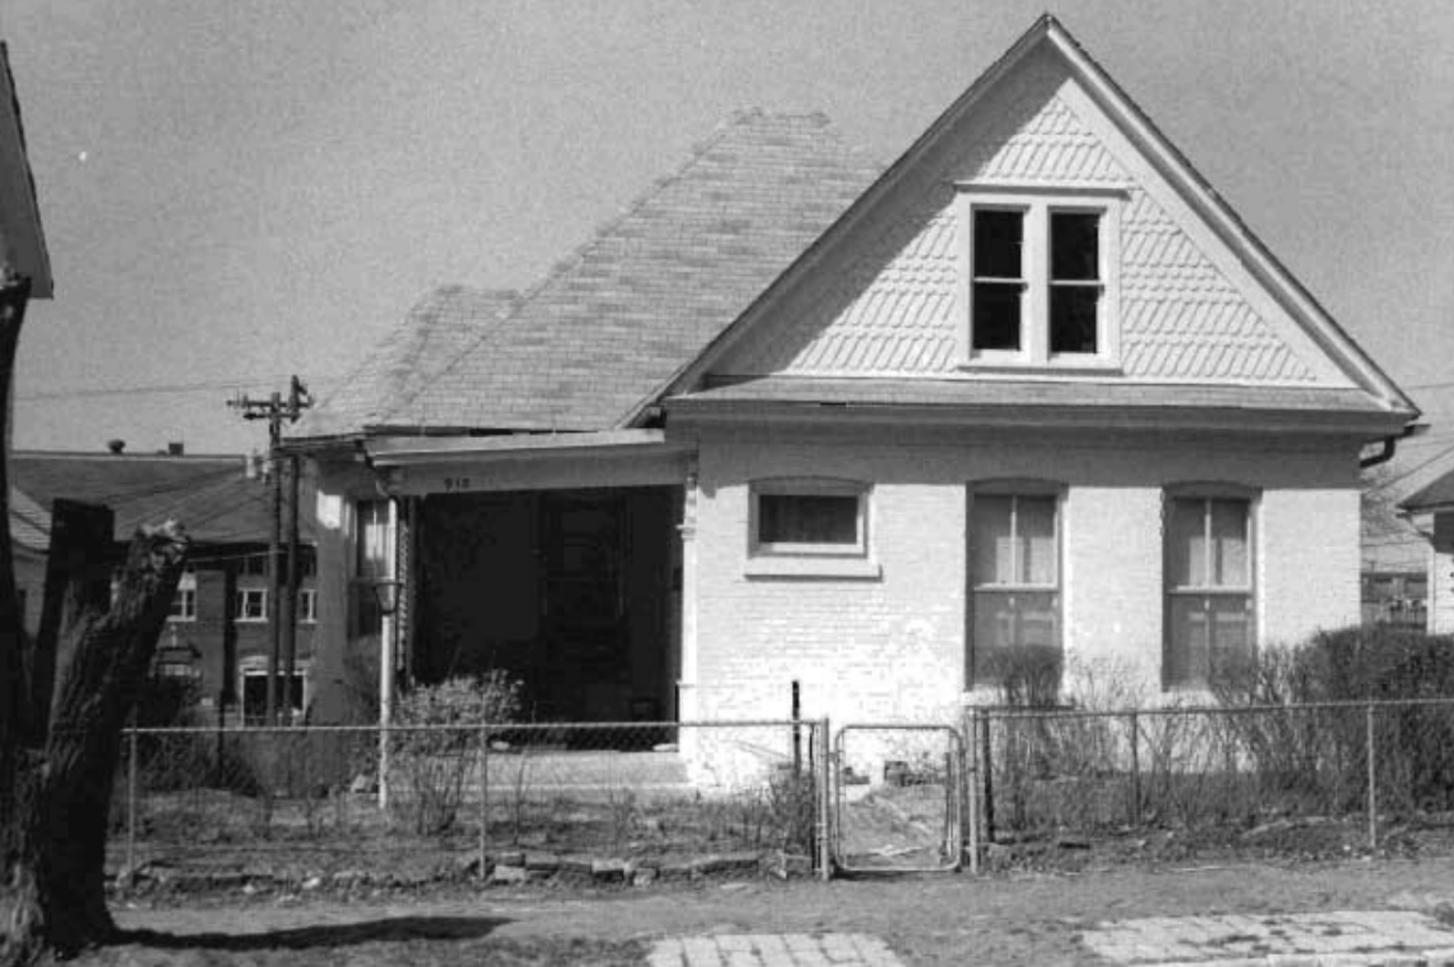
<p>42. FURTHER DESCRIPTION OF IMPORTANT FEATURES <b>1 1/2 story, 5 bay, asymmetrical, brick dwelling with hip and front gable roof forms. Left bay is part of polyzonal three-bay unit on south elevation, with polyzonal, hip roof; it contains a 2/2 double hung window within opening with stone sill and arched brick lintel (typical opening treatment). Recessed second bay contains 1/1 window; porch attached has been altered but retains some decorative</b></p> <p>43. HISTORY AND SIGNIFICANCE <b>Italianate elements. Right three bays in projecting front gable wing with small single-light window and 2/2 double hung windows; enframed gable has patterned wood shingle wall and plain frieze and contains paired 1/1 windows with plain frame with narrow cornice.</b></p> <p>43. <b>There are no building permits of record for this dwelling; however stylistic features indicate original construction of ca 1870 with later, early 20th century alterations. It has a moderate to high degree of architectural integrity and is significant as a representation of vernacular early Queen Anne residential property type. Alterations also significant characteristics. (On 1883 Sanborn map).</b></p> <p>44. DESCRIPTION OF ENVIRONMENT AND OUTBUILDINGS <b>In residential neighborhood</b></p>	4. PRESENT LOCAL NAME(S) OR DESIGNATION(S)	5. OTHER NAME(S)

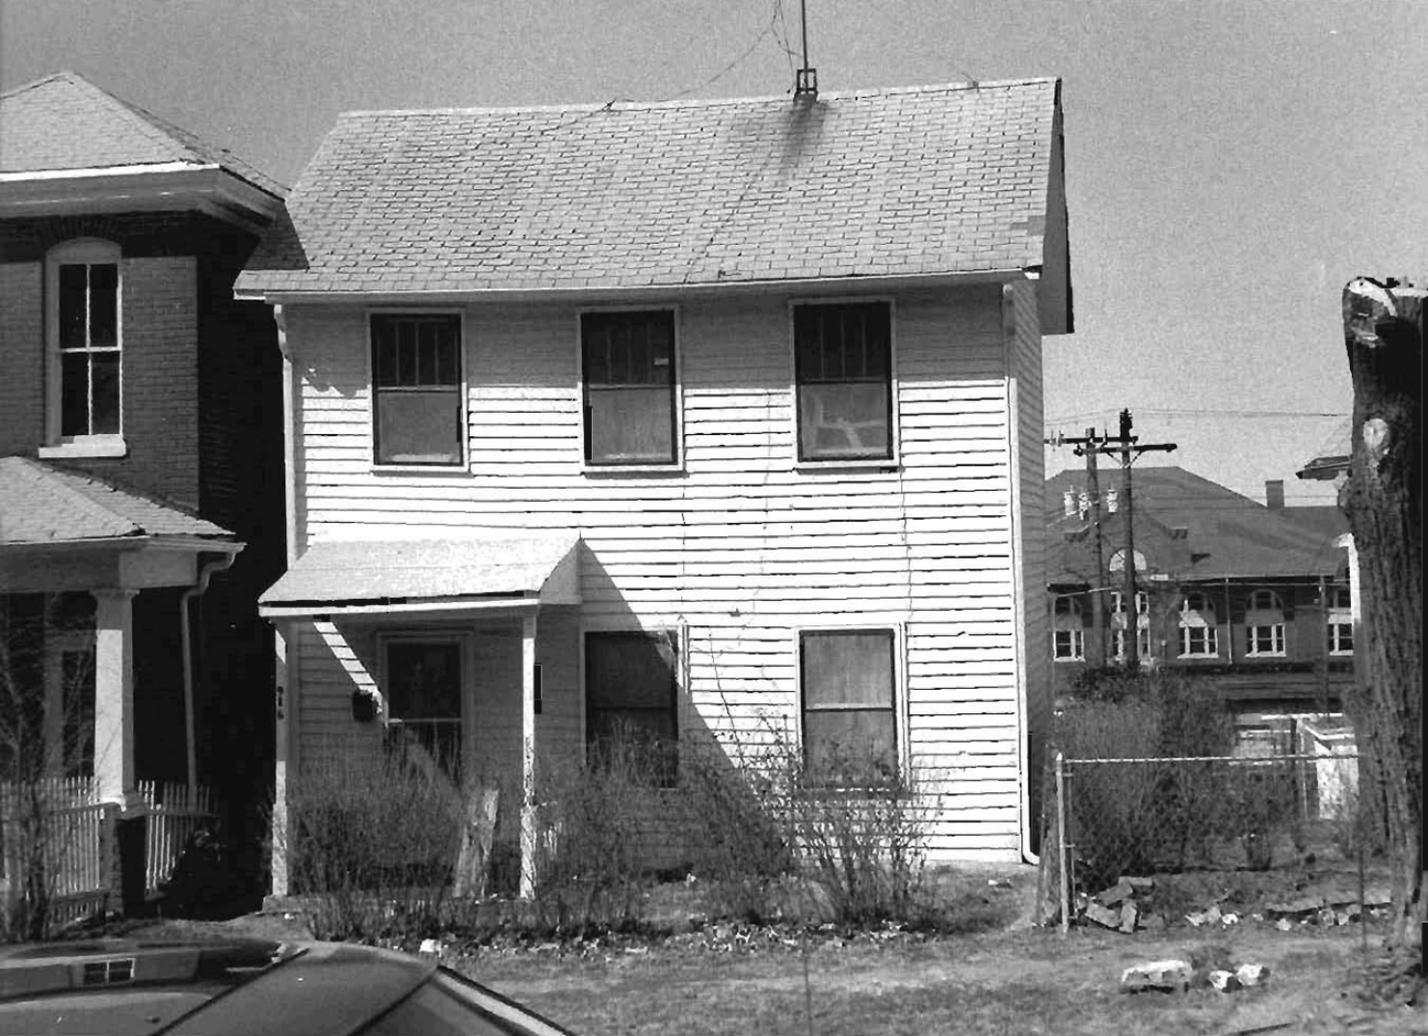
<b>42. FURTHER DESCRIPTION OF IMPORTANT FEATURES</b> 2 story, 3 bay, asymmetrical, frame dwelling with side gable roof and plain corner boards. Left bay contains single door; sheltered by small porch with wood post supports, open slat railing and shed roof. Center and right bay have 1/1 windows. Three bays of upper facade each contain a 4/1 window (vertical mullions).	<div style="border: 2px solid black; width: 100%; height: 100%; display: flex; align-items: center; justify-content: center;"> <p style="font-size: 2em; margin: 0;">PHOTO MUST BE PROVIDED</p> </div>	5. OTHER NAME(S)
<b>43. HISTORY AND SIGNIFICANCE</b> A building permit was issued to G. Wiermann for a residence and wood house on this property in 1888. Since 918 S. 11th has the same legal description, it can be assumed that the permit was for both buildings. This building could have been moved to this site from another at the time; features of it indicate an earlier construction period than 1888 (ca1850). It has a moderate degree of integrity and is significant as a representation of mid-late 19th century vernacular residential property type. (Not on 1883 Sanborn map).	<b>28. NO. OF STORIES</b> 2 <b>29. BASEMENT?</b> YES ( ) NO ( ) <b>30. FOUNDATION MATERIAL</b>  <b>31. WALL CONSTRUCTION</b> Frame <b>32. ROOF TYPE AND MATERIAL</b> Gable/Comp. Shingle <b>33. NO. OF BAYS</b> FRONT 3 SIDE <b>34. WALL TREATMENT</b> Weatherboard <b>35. PLAN SHAPE</b> "L" <b>36. CHANGES (EXPLAIN IN NO. 42)</b> ADDITION ( ) ALTERED (XX) MOVED ( ) <b>37. CONDITION</b> INTERIOR _____ EXTERIOR Fair-Good <b>38. PRESERVATION UNDERWAY?</b> YES ( ) NO (XX) <b>39. ENDANGERED? BY WHAT?</b> YES (XX) NO ( ) Poor Maintenance <b>40. VISIBLE FROM PUBLIC ROAD?</b> YES (X) NO ( ) <b>41. DISTANCE FROM AND FRONTAGE ON ROAD</b>	6. TOWNSHIP

<b>44. DESCRIPTION OF ENVIRONMENT AND OUTBUILDINGS</b> In residential neighborhood; in block of closely spaced buildings with shallow setbacks.	<b>45. SOURCES OF INFORMATION</b> BP #BB164, 3/31/88; site; 1888 Sanborn map	RANGE
<b>RETURN THIS FORM WHEN COMPLETED TO:</b> OFFICE OF HISTORIC PRESERVATION P.O. BOX 176 JEFFERSON CITY, MISSOURI 65102 PH. 314-751-4096  IF ADDITIONAL SPACE IS NEEDED, ATTACH SEPARATE SHEET(S) TO THIS FORM	<b>46. PREPARED BY</b> Mary Jo Winder <b>47. ORGANIZATION</b> City of St. Joseph <b>48. DATE</b> 7/88 <b>49. REVISION DATE(S)</b>	SECTION

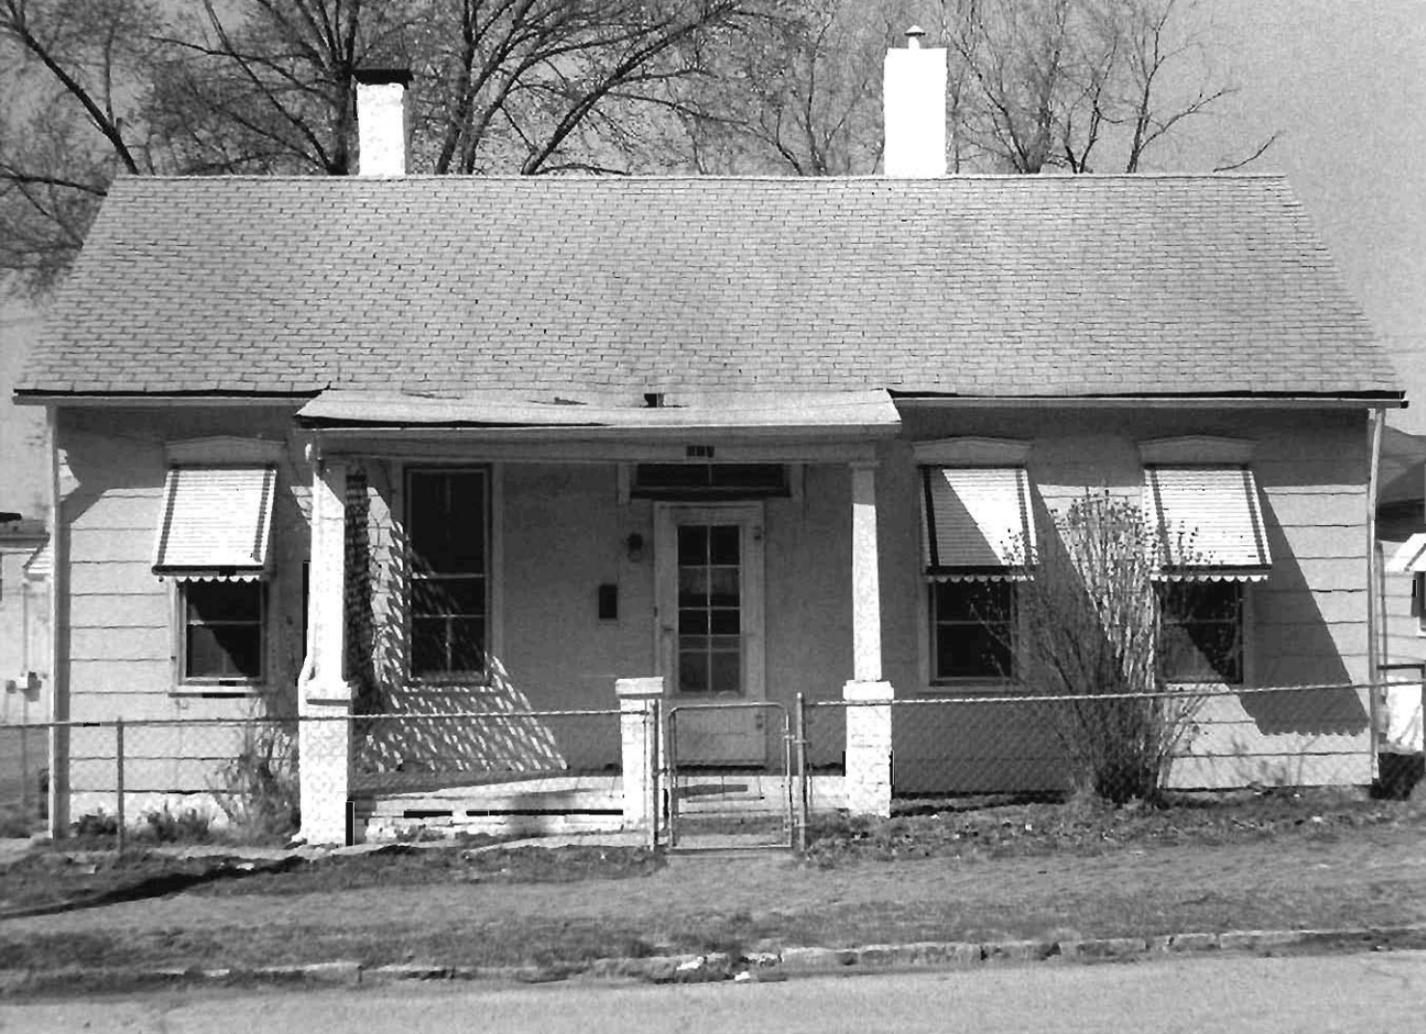
42. FURTHER DESCRIPTION OF IMPORTANT FEATURES <u>1 story, 5 bay, symmetrical, frame dwelling with side gable roof and internal stucco covered brick chimneys. Center bays contain single door with divided transom (sidelights have been covered). End bays contain 4/4 windows; frames have pedimented lintels with narrow cornices. Porch attached over second and entry bays is a later (ca. 1900) alteration (kitchen repair noted on</u>	<div style="border: 2px solid black; width: 100%; height: 100%; display: flex; align-items: center; justify-content: center;"> <div style="text-align: center;"> <p>PHOTO MUST BE PROVIDED</p> </div> </div>	5. OTHER NAME(S)

43. HISTORY AND SIGNIFICANCE <u>building permit in 1896, so porch may be same date); it has brick pedestals with square tapered columns and shed roof.</u>  43. Building permit records indicate the repair of the kitchen of this dwelling in 1896 for applicant S. W. Wolf and Son; however, stylistic features indicate a ca1850 original construction date. It has a moderate degree of architectural integrity due to alterations and porch addition and is significant as a representation of mid 19th century Greek Revival residential property type.	6. TOWNSHIP

44. DESCRIPTION OF ENVIRONMENT AND OUTBUILDINGS <u>In residential neighborhood; shallow setback</u>	RANGE		
45. SOURCES OF INFORMATION <u>BP #4819, 11/24/96; site ; 1883 Sanborn map</u>	46. PREPARED BY <u>Mary Jo Winder</u> 47. ORGANIZATION <u>City of St. Joseph</u> 48. DATE <u>7/88</u> 49. REVISION DATE(S)	SECTION	
RETURN THIS FORM WHEN COMPLETED TO: OFFICE OF HISTORIC PRESERVATION P.O. BOX 176 JEFFERSON CITY, MISSOURI 65102 PH. 314-751-4096			
IF ADDITIONAL SPACE IS NEEDED, ATTACH SEPARATE SHEET(S) TO THIS FORM

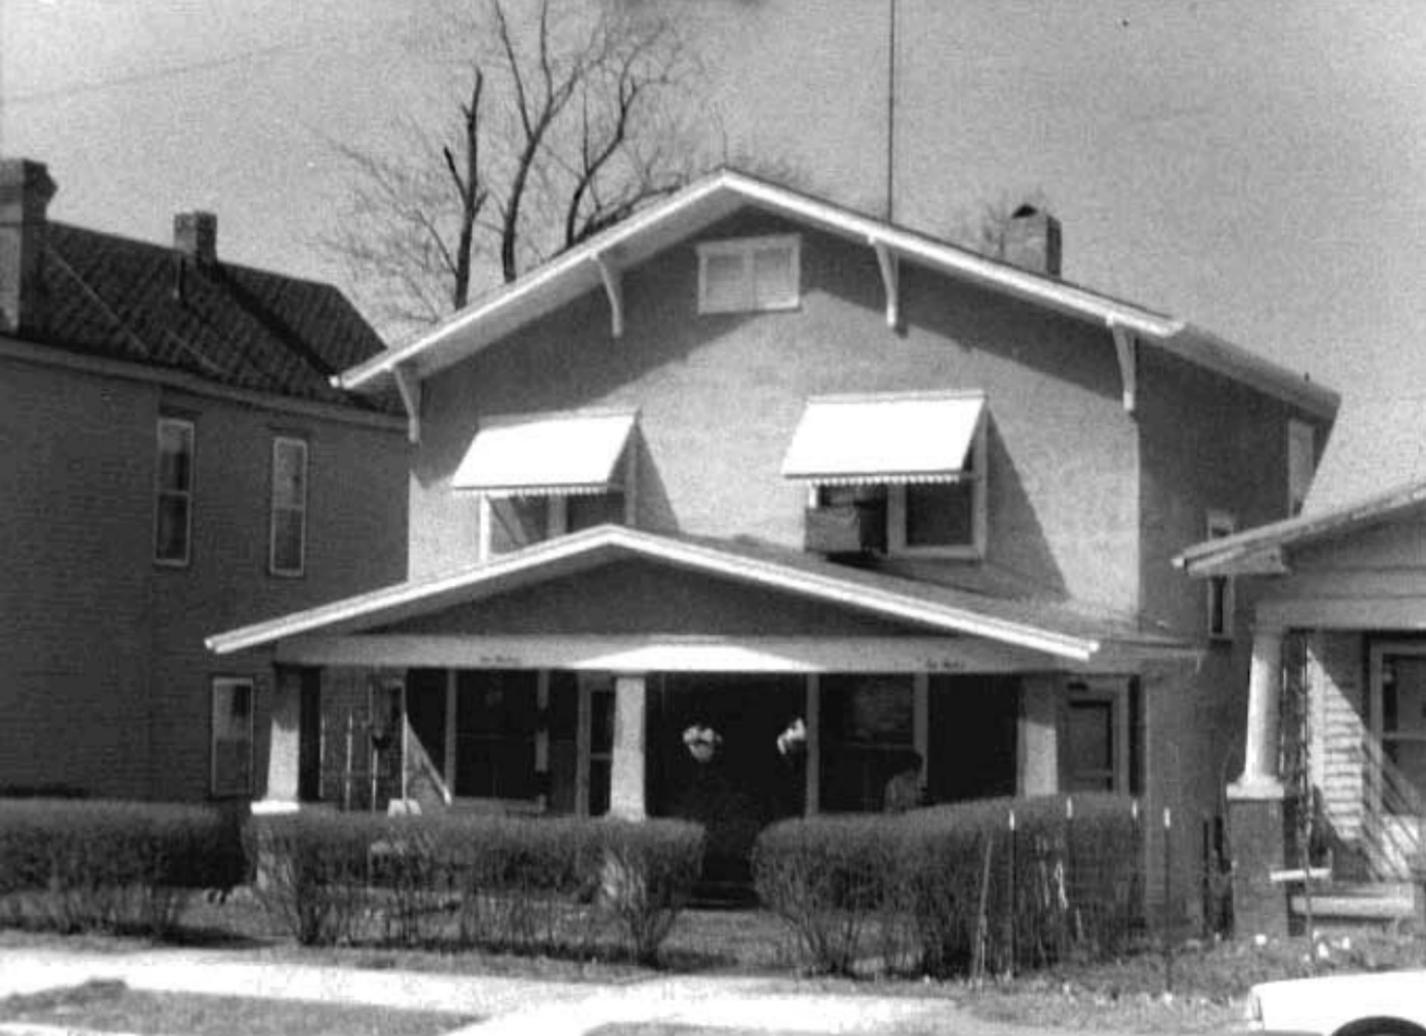
<p>42. FURTHER DESCRIPTION OF IMPORTANT FEATURES 2 story, 4 bay, symmetrically massed, stucco/frame dwelling with front gable roof with "bungalow-type" wood braces. Porch attached to front elevation (east) is 1921 alteration with pedestals (brick/stucco) with wide square columns that support entablature and front gable roof. First and third bays contain picture windows; second and fourth bay have single doors. Two-bay second</p> <p>43. HISTORY AND SIGNIFICANCE story has paired 1/1 windows in each; paired vented openings in gable wall. All fenestration has plain wood frames with narrow cornices. Building permits for a wash house in 1890 for applicant John Broder and a porch in 1921 indicate the original construction of this dwelling to be pre1887; however, features of such a not apparent. It is an obviously remodeled dwelling but any identifiable exterior features of the pre1921 construction phase are no longer evident. It has a moderate degree of integrity and is significant as a representation of early 20th century vernacular residential property type. (On 1883 Sanborn map.)</p> <p>44. DESCRIPTION OF ENVIRONMENT AND OUTBUILDINGS In residential neighborhood of ca1860-1900 dwellings.</p>	<div style="border: 2px solid black; padding: 20px; width: 100px; margin: auto;"> <p style="text-align: center; font-weight: bold;">PHOTO MUST BE PROVIDED</p> </div>	4. PRESENT LOCAL NAME(S) OR DESIGNATION(S)

<p>45. SOURCES OF INFORMATION BP #5-260, 11/9/21; BP #D1124, 7/1/90; site ; 1883 Sanborn ma</p> <p>46. PREPARED BY Mary Jo Winder</p> <p>47. ORGANIZATION City of St. Joseph</p> <p>48. DATE 7/88</p> <p>49. REVISION DATE(S)</p>	<p>5. OTHER NAME(S)</p> <p>6. TOWNSHIP</p> <p>RANGE</p> <p>SECTION</p>	5. OTHER NAME(S)	
<p>RETURN THIS FORM WHEN COMPLETED TO: OFFICE OF HISTORIC PRESERVATION P.O. BOX 176 JEFFERSON CITY, MISSOURI 65102 PH. 314-751-4096</p> <p>IF ADDITIONAL SPACE IS NEEDED, ATTACH SEPARATE SHEET(S) TO THIS FORM</p>		SECTION

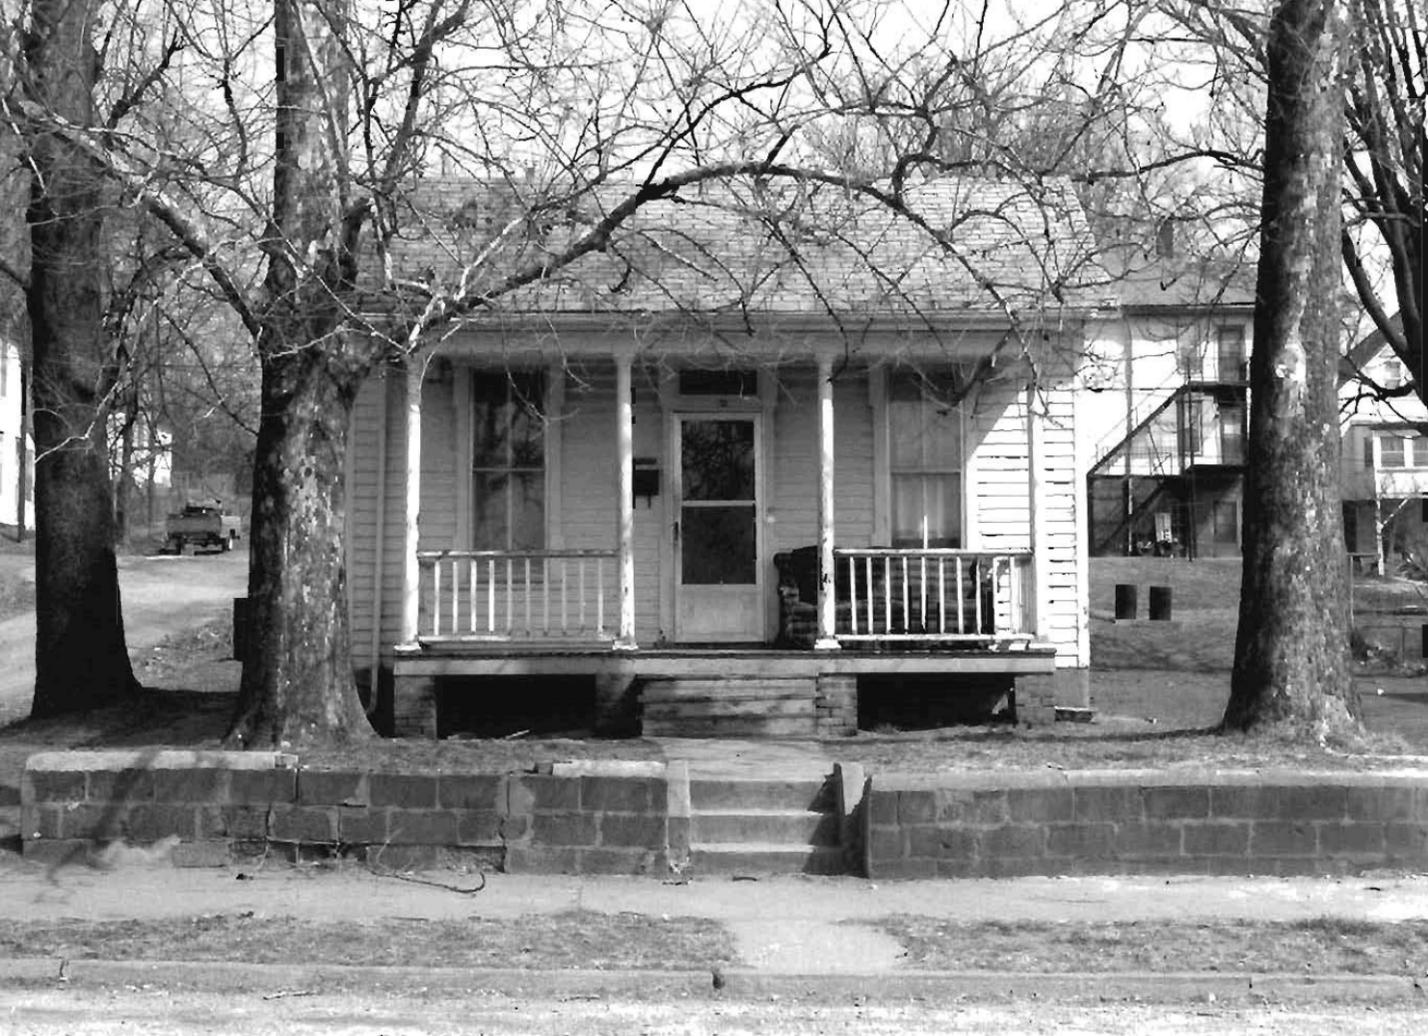
7. CITY OR TOWN IF RURAL, VICINITY St. Joseph	17. DATE(S) OR PERIOD ca. 1850	29. BASEMENT? YES ( ) NO ( )			
8. DESCRIPTION OF LOCATION Legal: Lot 6, Block 27, Patee's Addition	18. STYLE OR DESIGN Vernacular/Greek Revival <b>31 08</b>	30. FOUNDATION MATERIAL

23. OWNERSHIP PUBLIC ( ) PRIVATE (X)	24. OWNER'S NAME AND ADDRESS IF KNOWN	37. CONDITION INTERIOR _____ EXTERIOR <u>Good</u>			
25. OPEN TO PUBLIC? YES ( ) NO (X)	26. LOCAL CONTACT PERSON OR ORGANIZATION	38. PRESERVATION UNDERWAY? YES ( ) NO (XX)

27. OTHER SURVEYS IN WHICH INCLUDED	39. ENDANGERED? BY WHAT? YES (XX) NO ( ) Poor Maintenance	40. VISIBLE FROM PUBLIC ROAD? YES (X) NO ( )			
42. FURTHER DESCRIPTION OF IMPORTANT FEATURES 1 story, 3 bay, symmetrical, frame dwelling with side gable roof and plain corner boards. Three-bay porch attached to front elevation (west) has brick foundation piers, narrow Tuscan columns, open slat railing and flat roof. Center bay contains single door with transom. End bays contain 2/2 windows. All openings have shaped surrounds with narrow molded cornice.	PHOTO MUST BE PROVIDED

44. DESCRIPTION OF ENVIRONMENT AND OUTBUILDINGS In residential neighborhood; corner lot; vacant lot to south.					
45. SOURCES OF INFORMATION No relevant building permit; site; 1883 Sanborn map	46. PREPARED BY Mary Jo Winder	47. ORGANIZATION City of St. Joseph	6. TOWNSHIP		
RETURN THIS FORM WHEN COMPLETED TO: OFFICE OF HISTORIC PRESERVATION P.O. BOX 176 JEFFERSON CITY, MISSOURI 65102 PH. 314-751-4096	48. DATE 7/88	49. REVISION DATE(S)			
IF ADDITIONAL SPACE IS NEEDED, ATTACH SEPARATE SHEET(S) TO THIS FORM			RANGE		
			SECTION

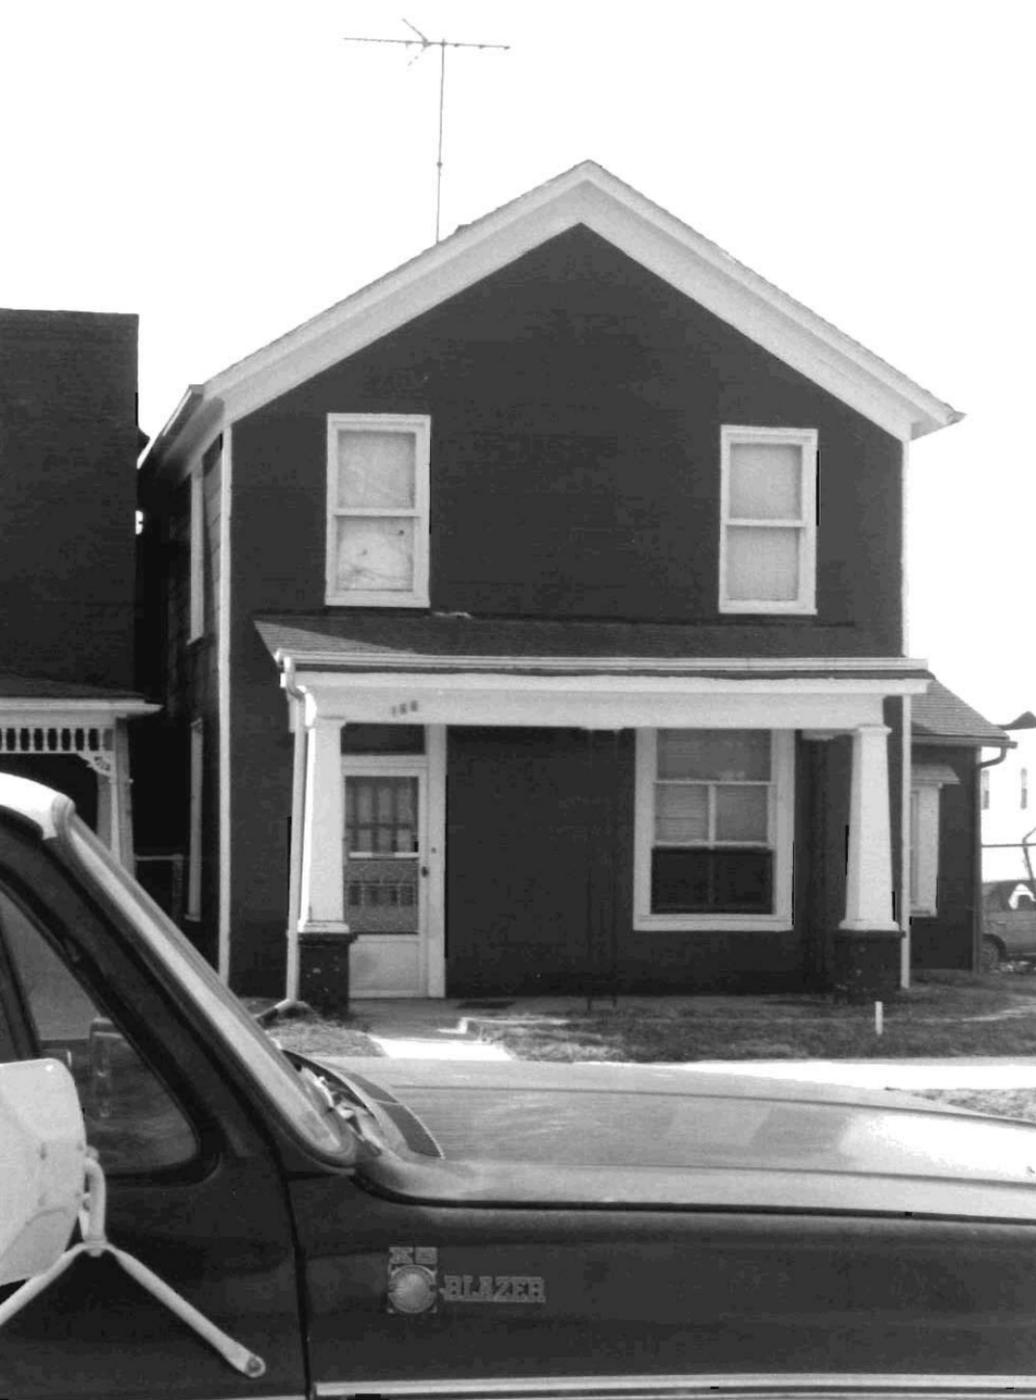
<p>16. FURTHER DESCRIPTION OF IMPORTANT FEATURES <b>2 story, 3 bay, asymmetrical, frame dwelling with front gable roof, wide fascia and narrow corner boards. Right bay is recessed one story addition that contains a 1/1 window within slightly projecting wide, frame with small shed roof. Left and center bays sheltered by one-story porch with brick pedestals and tapered square wood corner columns that support entablature and shed roof. Right bay con-</b></p>	<p>25. OPEN TO PUBLIC? YES ( ) NO ( <input checked="" type="checkbox"/> )</p>	<p>37. CONDITION INTERIOR _____ EXTERIOR <b>Good</b></p>	5. OTHER NAME(S)
<p>17. HISTORY AND SIGNIFICANCE <b>tains door with transom; center bay has wide window with 1/4 sash. Symmetrical two-bay upper facade has 1/1 window in each.</b></p>	<p>26. LOCAL CONTACT PERSON OR ORGANIZATION</p>	<p>38. PRESERVATION UNDERWAY? YES ( ) NO ( <input checked="" type="checkbox"/> )</p>

<p>18. DESCRIPTION OF ENVIRONMENT AND OUTBUILDINGS <b>In residential neighborhood; in close proximity to commercial zone to south and west.</b></p>	<p>27. OTHER SURVEYS IN WHICH INCLUDED</p>	<p>39. ENDANGERED? BY WHAT? YES ( <input checked="" type="checkbox"/> ) NO ( ) <b>Poor Maintenance</b></p>	SECTION
<p>19. SOURCES OF INFORMATION <b>BP #3804, 11/2/94; site; 1883 Sanborn map</b></p>	<p>40. VISIBLE FROM PUBLIC ROAD? YES ( <input checked="" type="checkbox"/> ) NO ( )</p>	<p>41. DISTANCE FROM AND FRONTAGE ON ROAD</p>	
<p>20. RETURN THIS FORM WHEN COMPLETED TO: OFFICE OF HISTORIC PRESERVATION P.O. BOX 176 JEFFERSON CITY, MISSOURI 65102 PH. 314-751-4096</p>	<p>42. PREPARED BY <b>Mary Jo Winder</b></p>	<p>43. ORGANIZATION <b>City of St. Joseph</b></p>	SECTION
<p>IF ADDITIONAL SPACE IS NEEDED, ATTACH SEPARATE SHEET(S) TO THIS FORM</p>	<p>44. DATE <b>7/88</b></p>	<p>45. REVISION DATE(S)</p>

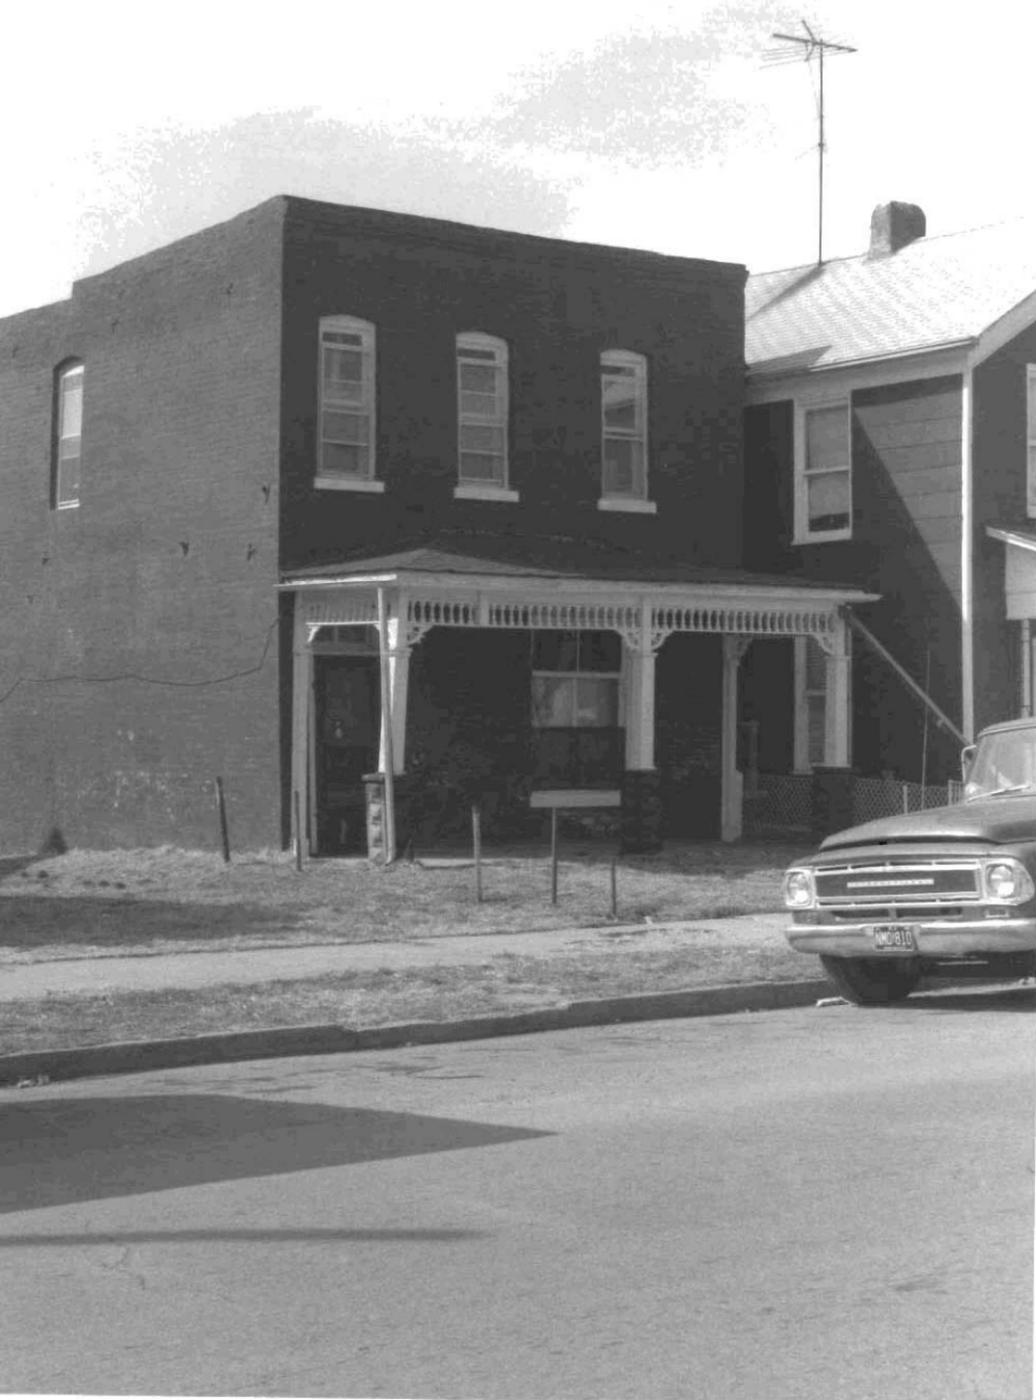
<p>42. FURTHER DESCRIPTION OF IMPORTANT FEATURES <b>2 story, 2 bay, asymmetrical brick dwelling with flat roof and parapet with narrow, brick cornice. Two-bay porch attached to front elevation (east) has stone pedestals with square post supports, spindled frieze, wagon wheel corner brackets and hip roof. Left bay contains single door with arched two light transom. Right bay has wide 1/2 window. Three-bay second story has 1/1 window in each; stone sills and</b></p>	<p>26. LOCAL CONTACT PERSON OR ORGANIZATION</p>	<p>37. CONDITION INTERIOR _____ EXTERIOR <b>Good</b></p>		
<p>43. HISTORY AND SIGNIFICANCE <b>arched brick lintels. Building permits issued to John M. Tetherow for an addition in 1891 and to E.L. Serven for construction of a porch in 1895 indicate an original construction date of pre1887. It has a moderate degree of integrity and has moderate significance as a representation of mid to late 19th century vernacular commercial/residential(?) property type. (On 1883 Sanborn map)</b></p>	<p>27. OTHER SURVEYS IN WHICH INCLUDED</p>	<p><b>PHOTO MUST BE PROVIDED</b></p>

<p>44. DESCRIPTION OF ENVIRONMENT AND OUTBUILDINGS <b>At edge of residential neighborhood; commercial zone and Patee House hotel (1858) located south of building.</b></p>	<p>45. SOURCES OF INFORMATION <b>BP #1852, 9/28/91; BP #3951, 3/20/95; site; 1883 Sanborn map</b></p>	<p>46. PREPARED BY <b>Mary Jo Winder</b></p>		
<p>47. ORGANIZATION <b>City of St. Joseph</b></p>	<p>48. DATE <b>7/88</b></p>	<p>49. REVISION DATE(S)</p>		
<p>RETURN THIS FORM WHEN COMPLETED TO: OFFICE OF HISTORIC PRESERVATION P.O. BOX 176 JEFFERSON CITY, MISSOURI 65102 PH. 314-751-4096</p>

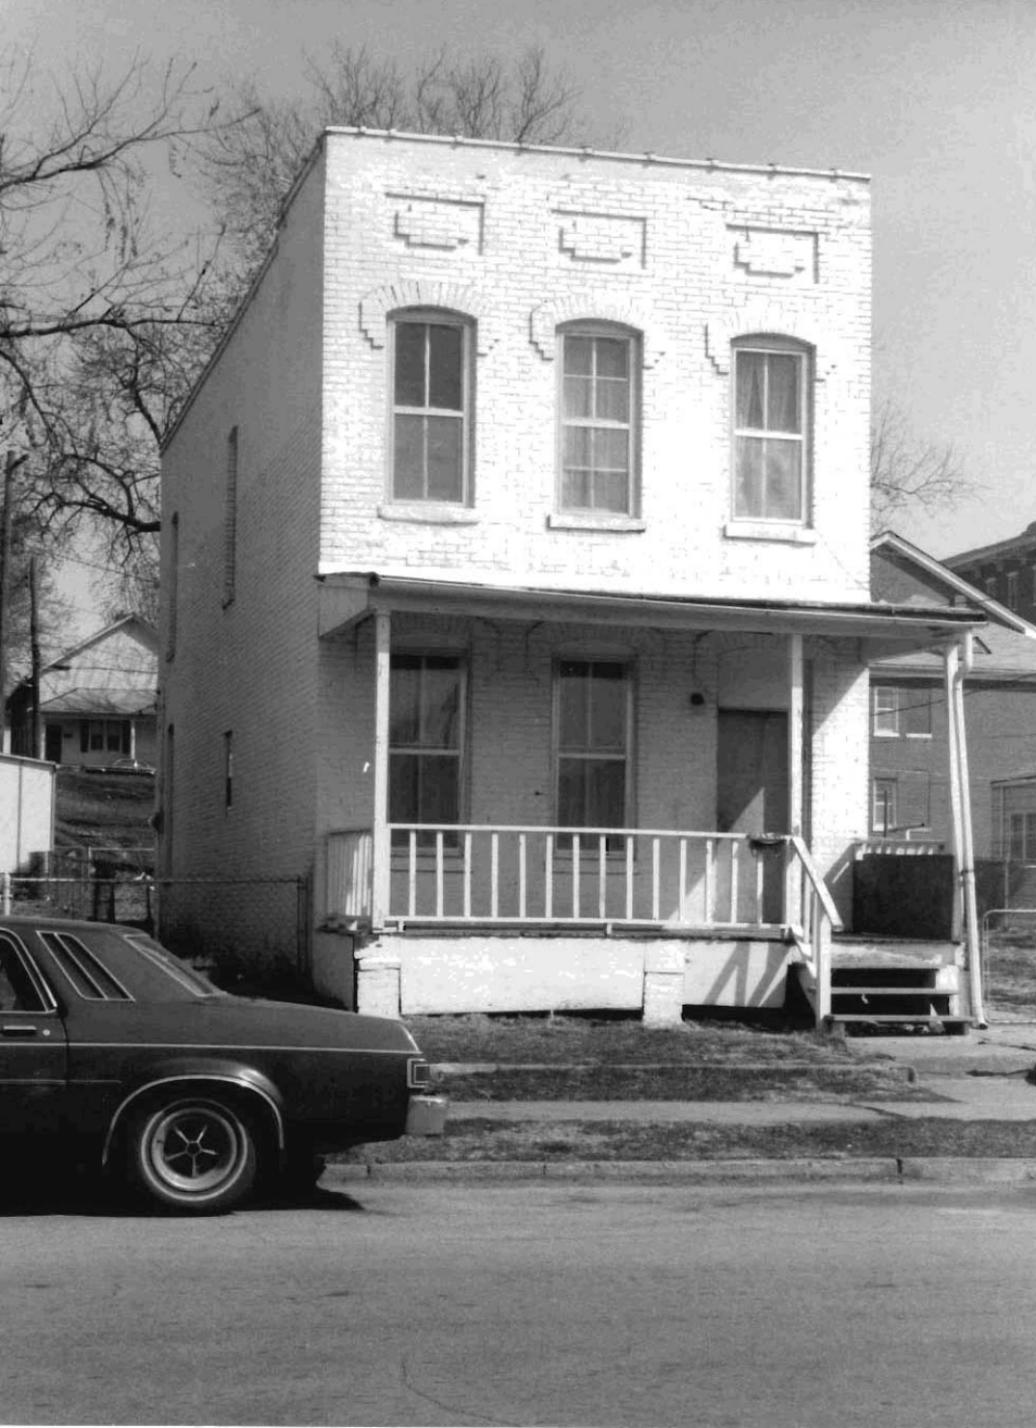
<b>9. COORDINATES</b> UTM LAT _____ LONG _____ <b>10. SITE ( ) STRUCTURE ( )</b> BUILDING (X) OBJECT ( ) <b>11. ON NATIONAL REGISTER?</b> YES ( ) NO (X) <b>12. IS IT ELIGIBLE?</b> YES (X) NO ( ) <b>13. PART OF ESTAB. HIST. DISTRICT?</b> YES ( ) NO (X) <b>14. DISTRICT POTENTIAL?</b> YES (X) NO ( ) <b>15. NAME OF ESTABLISHED DISTRICT</b>	<b>26. LOCAL CONTACT PERSON OR ORGANIZATION</b>  <b>27. OTHER SURVEYS IN WHICH INCLUDED</b>	4. PRESENT LOCAL NAME(S) OR DESIGNATION(S)	
<b>42. FURTHER DESCRIPTION OF IMPORTANT FEATURES</b> 2 story, 3 bay, asymmetrical, brick dwelling with flat roof. Porch attached to front elevation (west) is later alteration with simple wood post supports, open slat railing and shed roof. Right bay contains single door entry with arched transom (covered); left and center bays contain 2/2 windows; all openings have stone sills and simple brick hoodmolds. Symmetrical three-bay second story has same window configuration; brick panel above each window with brick ornament. <b>43. HISTORY AND SIGNIFICANCE</b> There are building permits of record for this building; however, stylistic features indicate a ca 1860 or earlier original construction. It has a moderate to high degree of architectural integrity and is significant as a representation of mid 19th century vernacular Italianate commercial/residential property (may be one of few remaining in city). (On 1883 Sanborn map)	PHOTO MUST BE PROVIDED	5. OTHER NAME(S)

<b>44. DESCRIPTION OF ENVIRONMENT AND OUTBUILDINGS</b> At edge of residential neighborhood; commercial zone to south, also in close proximity to 1858 Patee House hotel. <b>45. SOURCES OF INFORMATION</b> No relevant building permit; site; 1883 Sanborn map	<b>46. PREPARED BY</b> Mary Jo Winder <b>47. ORGANIZATION</b> City of St. Joseph <b>48. DATE</b> 7/88 <b>49. REVISION DATE(S)</b>	6. TOWNSHIP	
<b>RETURN THIS FORM WHEN COMPLETED TO:</b> OFFICE OF HISTORIC PRESERVATION P.O. BOX 176 JEFFERSON CITY, MISSOURI 65102 PH. 314-751-4096 IF ADDITIONAL SPACE IS NEEDED, ATTACH SEPARATE SHEET(S) TO THIS FORM	RANGE	SECTION

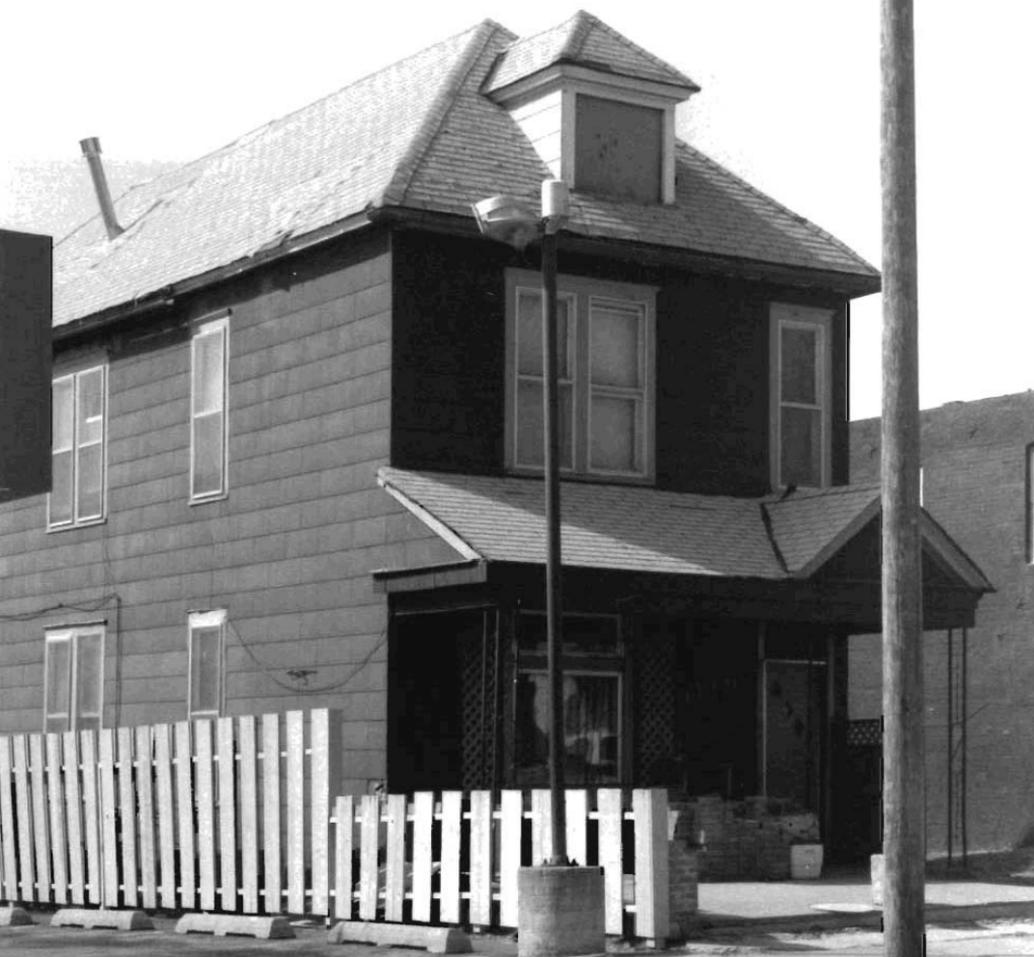
<p>42. FURTHER DESCRIPTION OF IMPORTANT FEATURES <b>2 story, 2 bay, asymmetrical, frame dwelling with hip roof with centered hip roof dormer. Porch attached to front elevation (east) has new support elements of wrought iron that support original shed roof with gable above entry bay. Left bay contains wide window with transom; second story has paired 1/1 windows; right bay has single door with transom; single 1/1 window on second story. Opening in dormer</b></p> <p>43. HISTORY AND SIGNIFICANCE <b>has been boarded up. Asbestos siding is a later alteration. Building permit records indicate construction in 1899 for applicant, John Schlecher. It has a moderate degree of architectural integrity due to excessive alterations and is moderately significant as a representation of turn of the century vernacular residential property type.</b></p>	<p style="font-size: 2em; font-weight: bold;">X</p> <p style="text-align: center;">PHOTO MUST BE PROVIDED</p>	4. PRESENT LOCAL NAME(S) OR DESIGNATION(S)

<p>44. DESCRIPTION OF ENVIRONMENT AND OUTBUILDINGS <b>At edge of residential neighborhood; commercial zone to south and west.</b></p>	<p>45. SOURCES OF INFORMATION <b>BP #7192, 9/26/99; site</b></p>	<p>46. PREPARED BY <b>Mary Jo Winder</b></p> <p>47. ORGANIZATION <b>City of St. Joseph</b></p> <p>48. DATE <b>7/88</b></p> <p>49. REVISION DATE(S)</p>	5. OTHER NAME(S)
<p>RETURN THIS FORM WHEN COMPLETED TO: OFFICE OF HISTORIC PRESERVATION P.O. BOX 176 JEFFERSON CITY, MISSOURI 65102 PH. 314-751-4096</p> <p>IF ADDITIONAL SPACE IS NEEDED, ATTACH SEPARATE SHEET(S) TO THIS FORM</p>	<p>6. TOWNSHIP</p> <p>RANGE</p> <p>SECTION</p>	6. TOWNSHIP

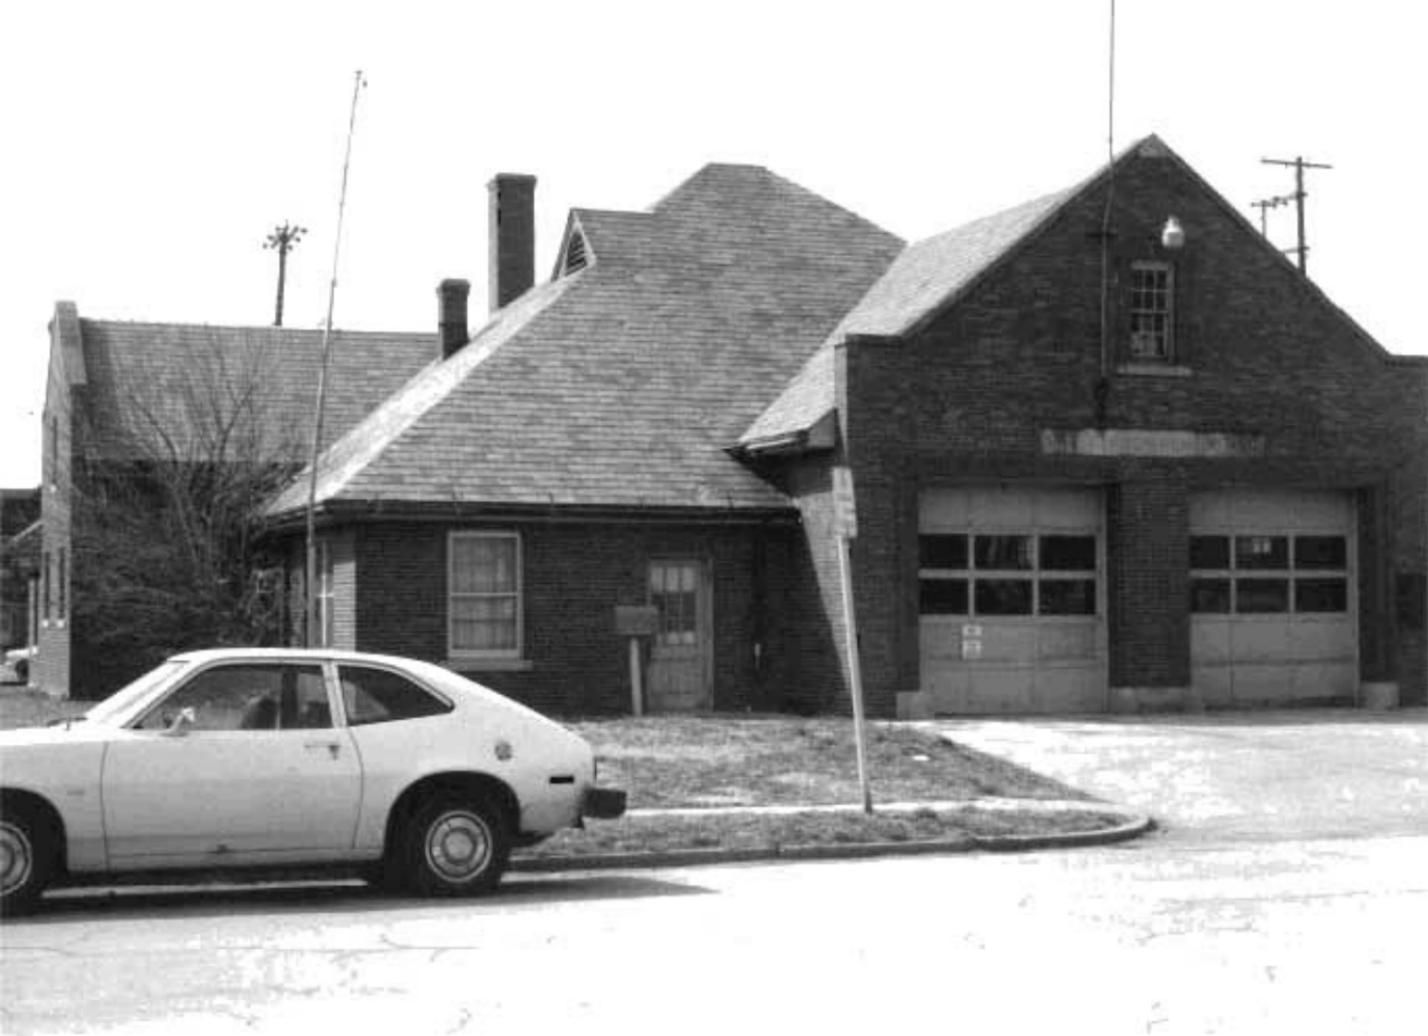
<p>42. FURTHER DESCRIPTION OF IMPORTANT FEATURES <b>1½ story, 5 bay, asymmetrical, brick fire station building with hip and gable roof forms with stone capped gabled parapets; off-set left, brick chimneys. First bay is east wall of rear/south side wing; second and third bays in central portion have 6/6 windows and single door. Projecting front gable wing contains two garage door openings (paneled) framed with soldier course and header brick work;</b></p>	<div style="border: 2px solid black; padding: 20px; width: 100px; margin: 0 auto;"> <p style="text-align: center; font-weight: bold;">PHOTO MUST BE PROVIDED</p> </div>	4. PRESENT LOCAL NAME(S) OR DESIGNATION(S)	
<p>43. HISTORY AND SIGNIFICANCE <b>sign panel above doors; small 6/6 window in gable wall.</b>  <b>Building permit records indicate construction of the fire station in 1939 for \$27,102. It has a high degree of architectural integrity and is significant as a representation of suburban fire station property type.</b></p>	5. OTHER NAME(S)

<p>44. DESCRIPTION OF ENVIRONMENT AND OUTBUILDINGS <b>At edge of residential neighborhood; commercial zone on east, south and west.</b></p>	6. TOWNSHIP		
<p>45. SOURCES OF INFORMATION <b>BP #9508, 5/22/39; site</b></p>	<p>46. PREPARED BY <b>Mary Jo Winder</b></p> <hr/> <p>47. ORGANIZATION <b>City of St. Joseph</b></p> <hr/> <p>48. DATE <b>7/88</b> 49. REVISION DATE(S)</p>	RANGE	
<p>RETURN THIS FORM WHEN COMPLETED TO: <b>OFFICE OF HISTORIC PRESERVATION P.O. BOX 176 JEFFERSON CITY, MISSOURI 65102 PH. 314-751-4096</b></p> <p>IF ADDITIONAL SPACE IS NEEDED, ATTACH SEPARATE SHEET(S) TO THIS FORM</p>	SECTION
