# MISSOURI OFFICE OF HISTORIC PRESERVATION

## ARCHITECTURAL/HISTORIC INVENTORY SURVEY FORM

BN-AS 004-001

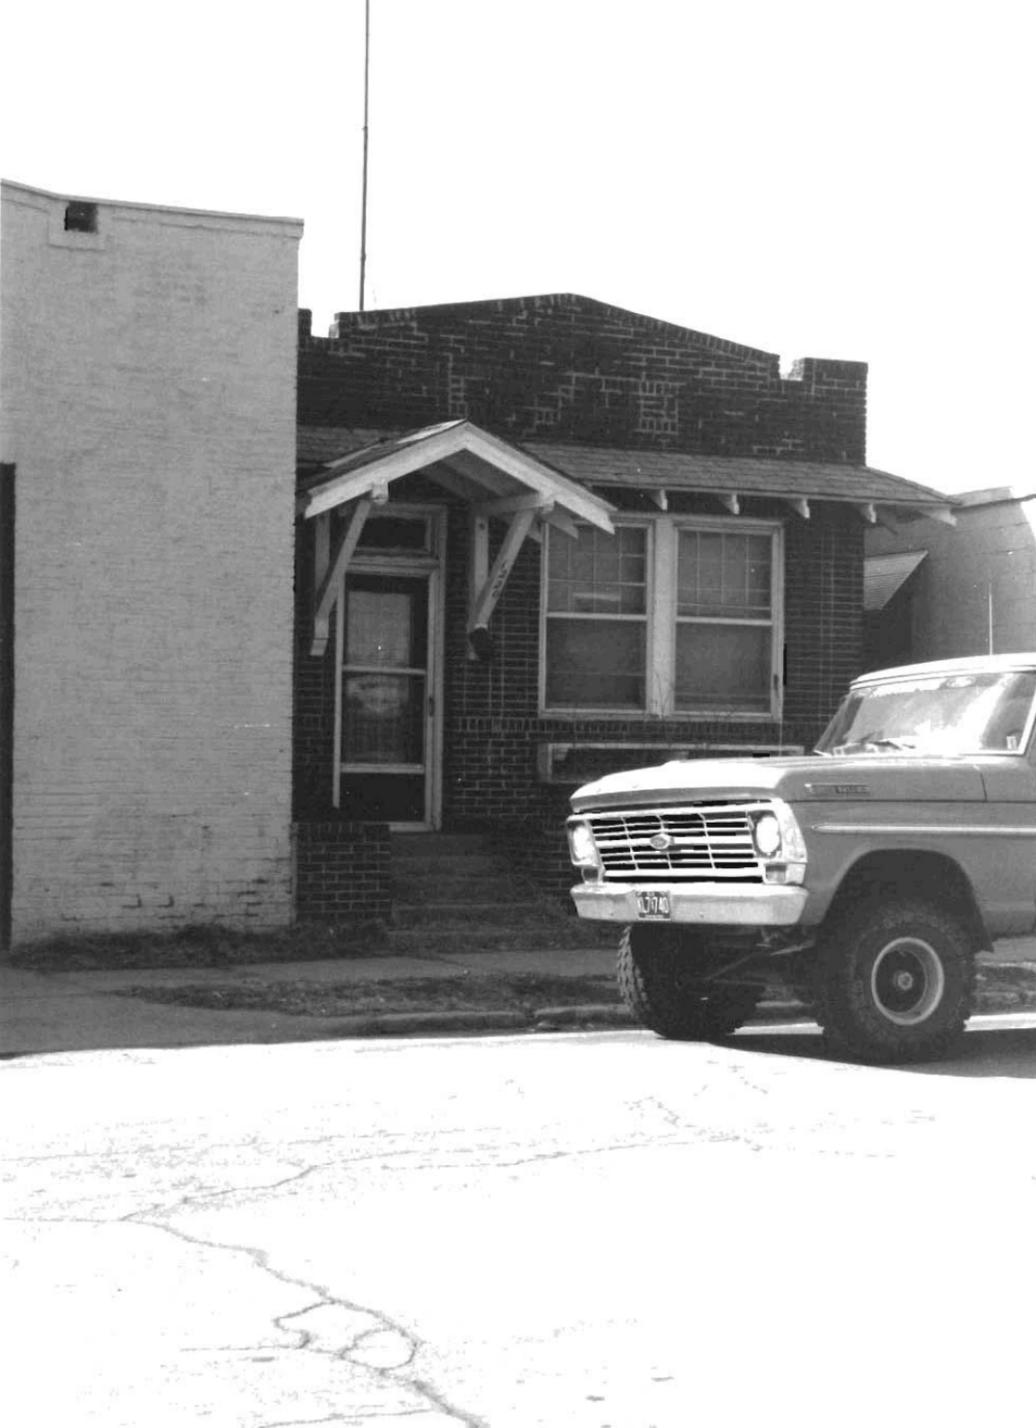
<p>43. HISTORY AND SIGNIFICANCE <b>wall gable-shaped and stepped at corners. Building permit records indicate construction in 1924 for applicant C. D. Morris. It has a high degree of architectural integrity and is significant as a representation of Classic Revival (vernacular) commercial/office property type.</b></p>		6. TOWNSHIP	
<p>44. DESCRIPTION OF ENVIRONMENT AND OUTBUILDINGS <b>In warehouse/commercial zone; common walls w/other commercial buildings.</b></p>		RANGE	
<p>45. SOURCES OF INFORMATION <b>BP #2757, 6/18/24; site</b></p>	<p>46. PREPARED BY <b>Mary Jo Winder</b></p> <hr/> <p>47. ORGANIZATION <b>City of St. Joseph</b></p>	SECTION	
<p>RETURN THIS FORM WHEN COMPLETED TO: OFFICE OF HISTORIC PRESERVATION P.O. BOX 176 JEFFERSON CITY, MISSOURI 65102 PH. 314-751-4096</p>		<p>48. DATE <b>7/88</b></p> <hr/> <p>49. REVISION DATE(S)</p>

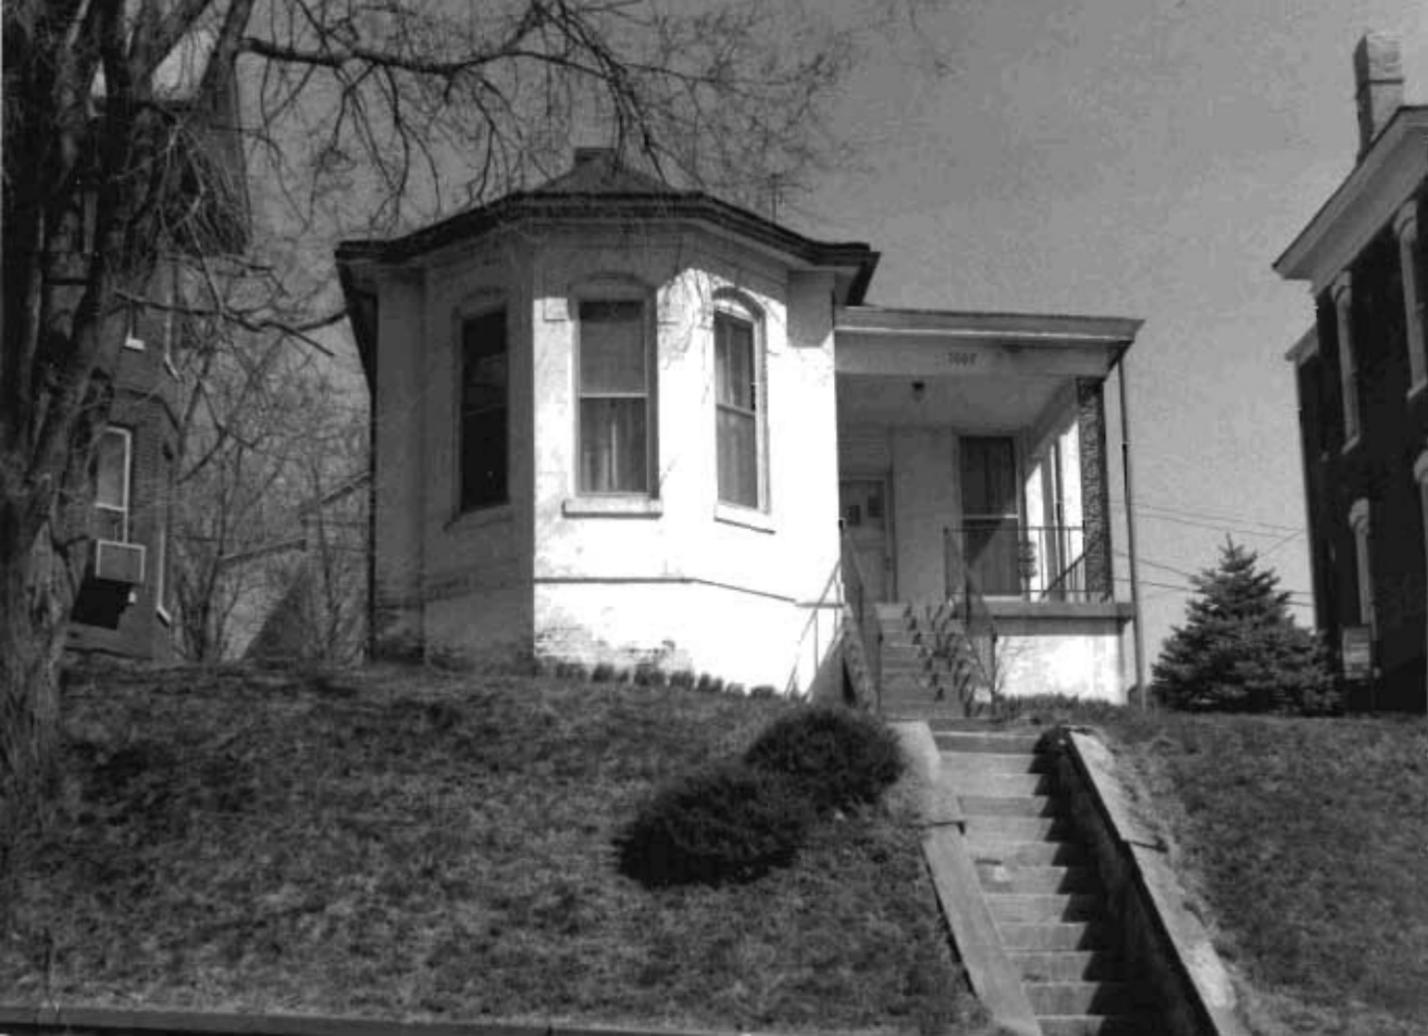
9. COORDINATES UTM LAT _____ LONG _____ 10. SITE ( ) STRUCTURE ( ) BUILDING (X) OBJECT ( ) 11. ON NATIONAL REGISTER? YES ( ) NO (X) 12. IS IT ELIGIBLE? YES (X) NO ( ) 13. PART OF ESTAB. HIST. DISTRICT? YES ( ) NO (X) 14. DISTRICT POTENTIAL? YES (X) NO ( ) 15. NAME OF ESTABLISHED DISTRICT	42. FURTHER DESCRIPTION OF IMPORTANT FEATURES 1 story, 5 bay, asymmetrical, brick dwelling with hip roof, plain frieze and brick water table. Left three bays form polyzonal bay unit in projecting front wing; each contains a 1/1 double hung window with arched lintel, brick hoodmolds and incised panel in arch. Right two bays recessed under porch which is an alteration containing a single door (opening has been altered with modern door and brick infill in transom area) 43. HISTORY AND SIGNIFICANCE and a 1/1 window. Porch has same configuration as original with all new materials (except roof) of concrete block foundation and wrought iron rails and support. 43. There are no building permits of record for this dwelling, however, stylistic features indicate a ca 1870 construction date. It has a high degree of architectural integrity and is significant as a representation of mid 19th century vernacular Italianate residential property type (porch is a non-contributing alteration.) 44. DESCRIPTION OF ENVIRONMENT AND OUTBUILDINGS In residential neighborhood primarily of ca1860-1900 dwellings. 45. SOURCES OF INFORMATION No relevant building permit. 1888 Sanborn map; site	<div style="border: 2px solid black; width: 100px; height: 100px; margin: 0 auto;"> <div style="text-align: center; padding: 5px;"> <p>PHOTO MUST BE PROVIDED</p> </div> </div>

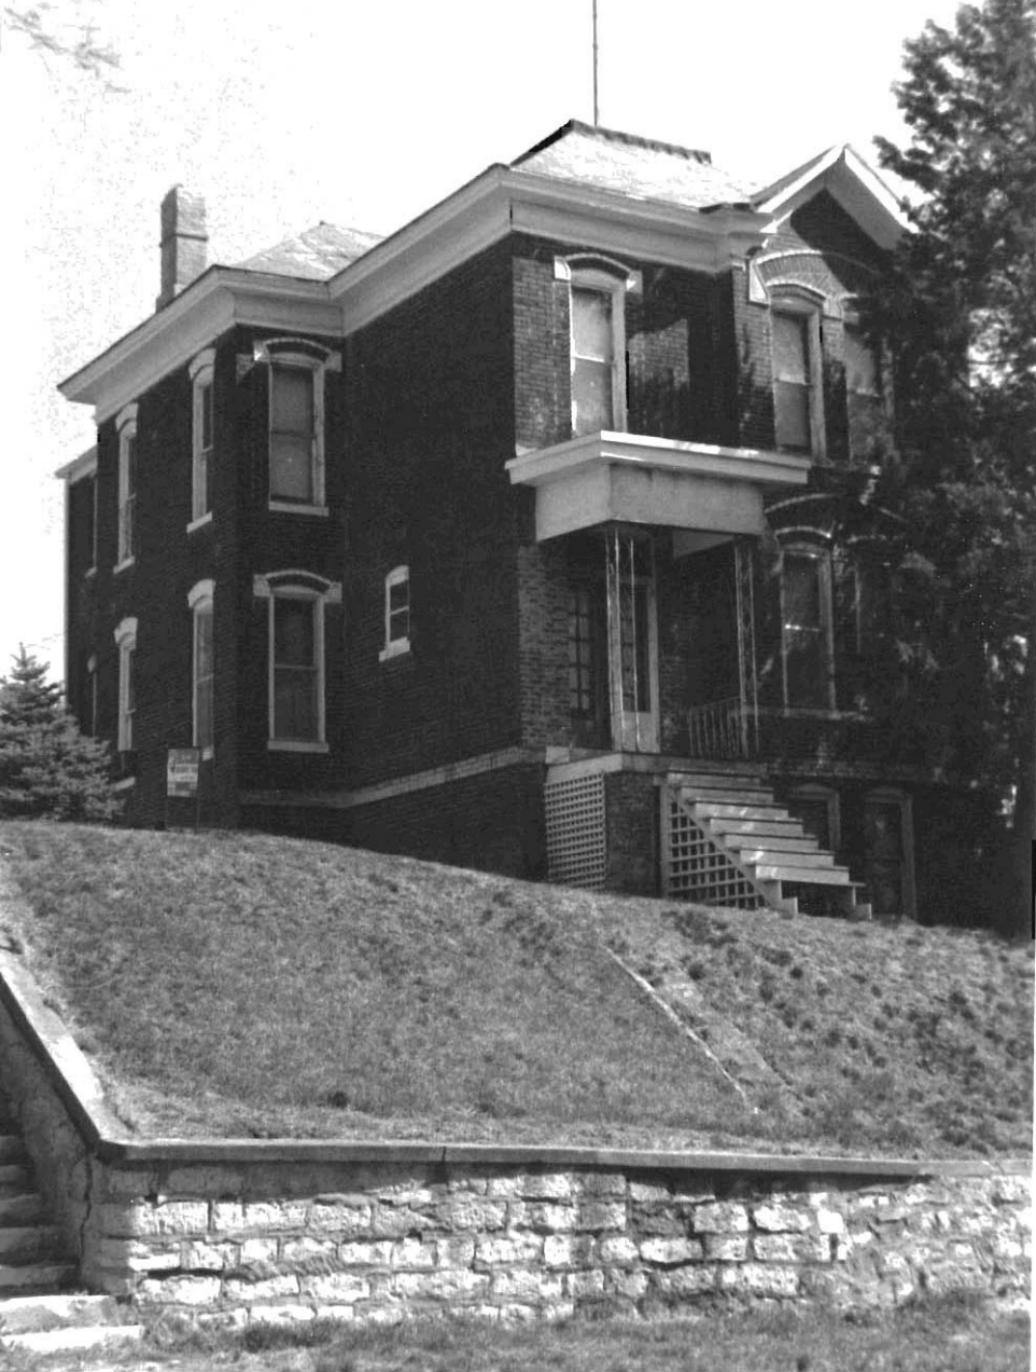
<p>42. FURTHER DESCRIPTION OF IMPORTANT FEATURES 2 story, 3 bay, asymmetrical, brick dwelling with hip roof with molded frieze, molded boxed cornice, an internal side brick chimney, and brick water table. Recessed left bay contains l/l double hung window; both stories with stone sill and arched molded brick lintel with ornamented stone cornerblocks. Center bay contains double door entry with transom; french doors; l/l window above small porch attached over entry is an alteration with brick pedestal, lattices in fill, wrought iron supports and rail, wide entablature and flat roof. Slightly projecting right bay with gable roof contains paired l/l double hung windows with brick voussiors on first and second stories; paired window is exposed sub-story.</p> <p>43. HISTORY AND SIGNIFICANCE 43. There are no building permits of record for this dwelling, however, stylistic features indicate original construction of ca1880. It has a high degree of architectural integrity and is significant as a representation of transitional Italianate/Queen Anne residential property type.</p>	<p>PHOTO MUST BE PROVIDED</p>	4. PRESENT LOCAL NAME(S) OR DESIGNATION(S)

<p>44. DESCRIPTION OF ENVIRONMENT AND OUTBUILDINGS In residential neighborhood primarily of ca1860-1900 dwellings.</p>	<p>45. SOURCES OF INFORMATION No relevant building permit. 1888 Sanborn map; site</p>	5. OTHER NAME(S)	
<p>46. PREPARED BY Mary Jo Winder</p> <p>47. ORGANIZATION City of St. Joseph</p> <p>48. DATE 7/88</p>	<p>49. REVISION DATE(S)</p>	6. TOWNSHIP	
<p>RETURN THIS FORM WHEN COMPLETED TO: OFFICE OF HISTORIC PRESERVATION P.O. BOX 176 JEFFERSON CITY, MISSOURI 65102 PH. 314-751-4096</p> <p>IF ADDITIONAL SPACE IS NEEDED, ATTACH SEPARATE SHEET(S) TO THIS FORM</p>	<p>6. TOWNSHIP RANGE</p> <p>SECTION</p>	RANGE

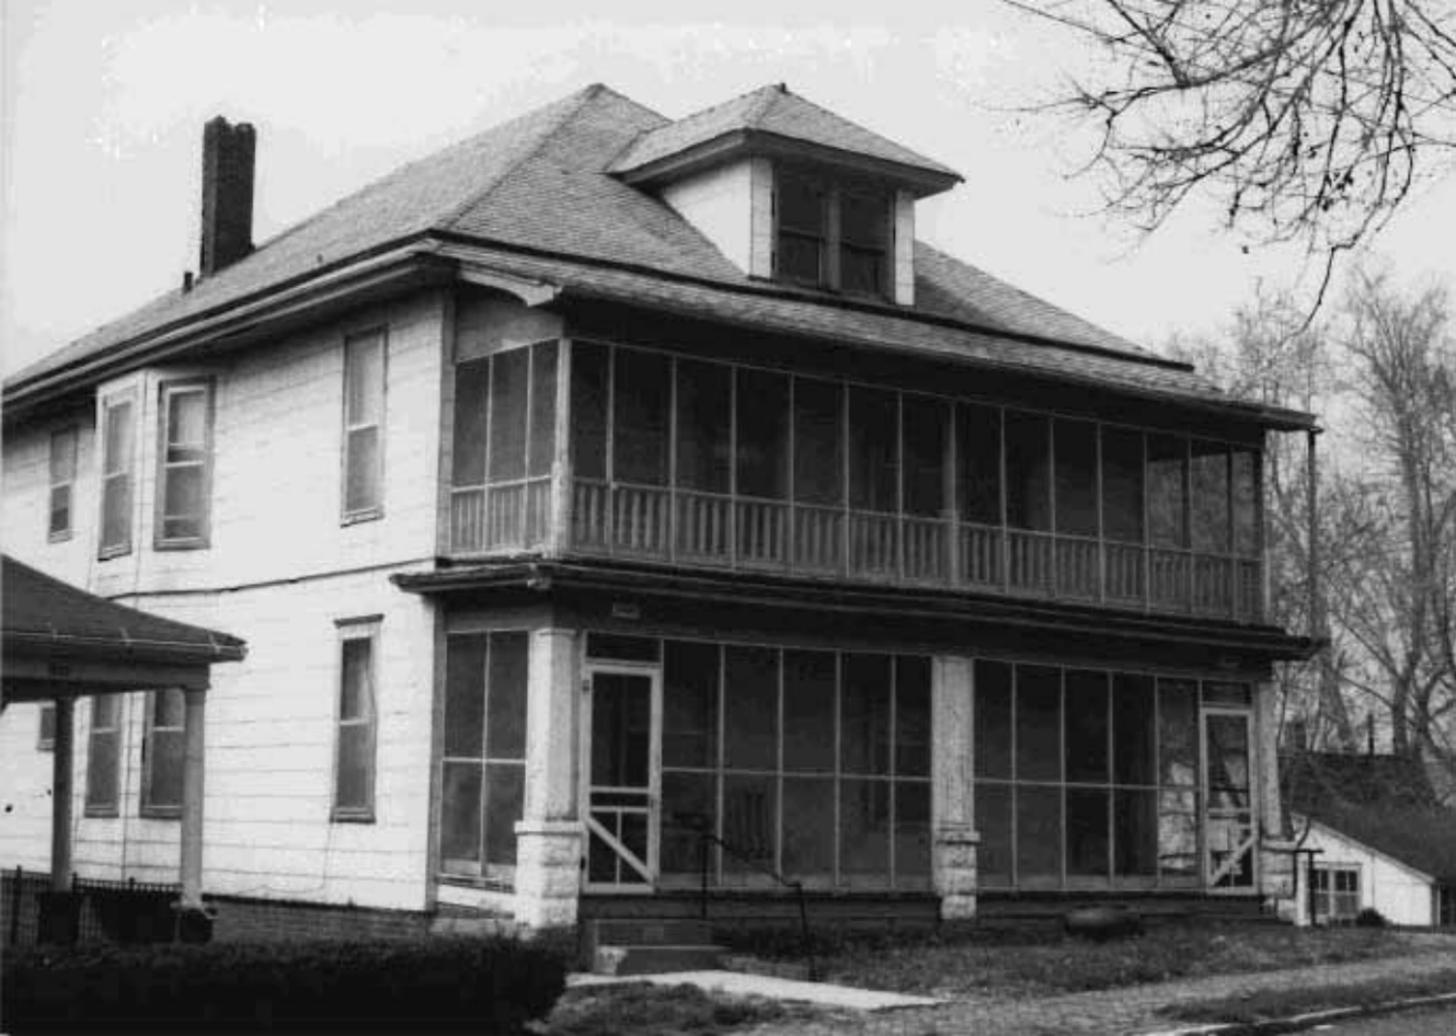
<p>42. FURTHER DESCRIPTION OF IMPORTANT FEATURES <b>2 story, 4 bay, symmetrical, frame duplex dwelling with hip roof with hip roof dormes and boxed cornice. Second story porch attached to front elevation (east) has stone foundation and pedestals with square columns supporting upper portion which has open slat railing and shed roof with shaped fascia; both levels have screened panels (an addition). Dormer contains paired l/l windows. First and fourth bay contain</b></p> <p>43. HISTORY AND SIGNIFICANCE <b>entries; second and third have windows.</b></p> <p><b>Building permit records indicate construction in 1909 for applicant, J. H. Patterson. It has a high degree of architectural integrity and is significant as a representation pf early 20th century Classic Revival duplex property type.</b></p>	<p style="font-size: 2em; font-weight: bold;">X</p> <p style="text-align: center;">PHOTO MUST BE PROVIDED</p>	4. PRESENT LOCAL NAME(S) OR DESIGNATION(S)

<p>44. DESCRIPTION OF ENVIRONMENT AND OUTBUILDINGS <b>In residential neighborhood primarily of ca1860-1900 dwellings; vacant lot adjacent on north.</b></p> <p>45. SOURCES OF INFORMATION <b>BP #6333, 11/26/09; site</b></p>	<p>46. PREPARED BY <b>Mary Jo Winder</b></p> <p>47. ORGANIZATION <b>City of St. Joseph</b></p> <p>48. DATE <b>7/88</b></p> <p>49. REVISION DATE(S)</p>	5. OTHER NAME(S)	
<p>RETURN THIS FORM WHEN COMPLETED TO: <b>OFFICE OF HISTORIC PRESERVATION P.O. BOX 176 JEFFERSON CITY, MISSOURI 65102 PH. 314-751-4096</b></p> <p>IF ADDITIONAL SPACE IS NEEDED, ATTACH SEPARATE SHEET(S) TO THIS FORM</p>	<p>6. TOWNSHIP</p> <p>RANGE</p> <p>SECTION</p>	6. TOWNSHIP

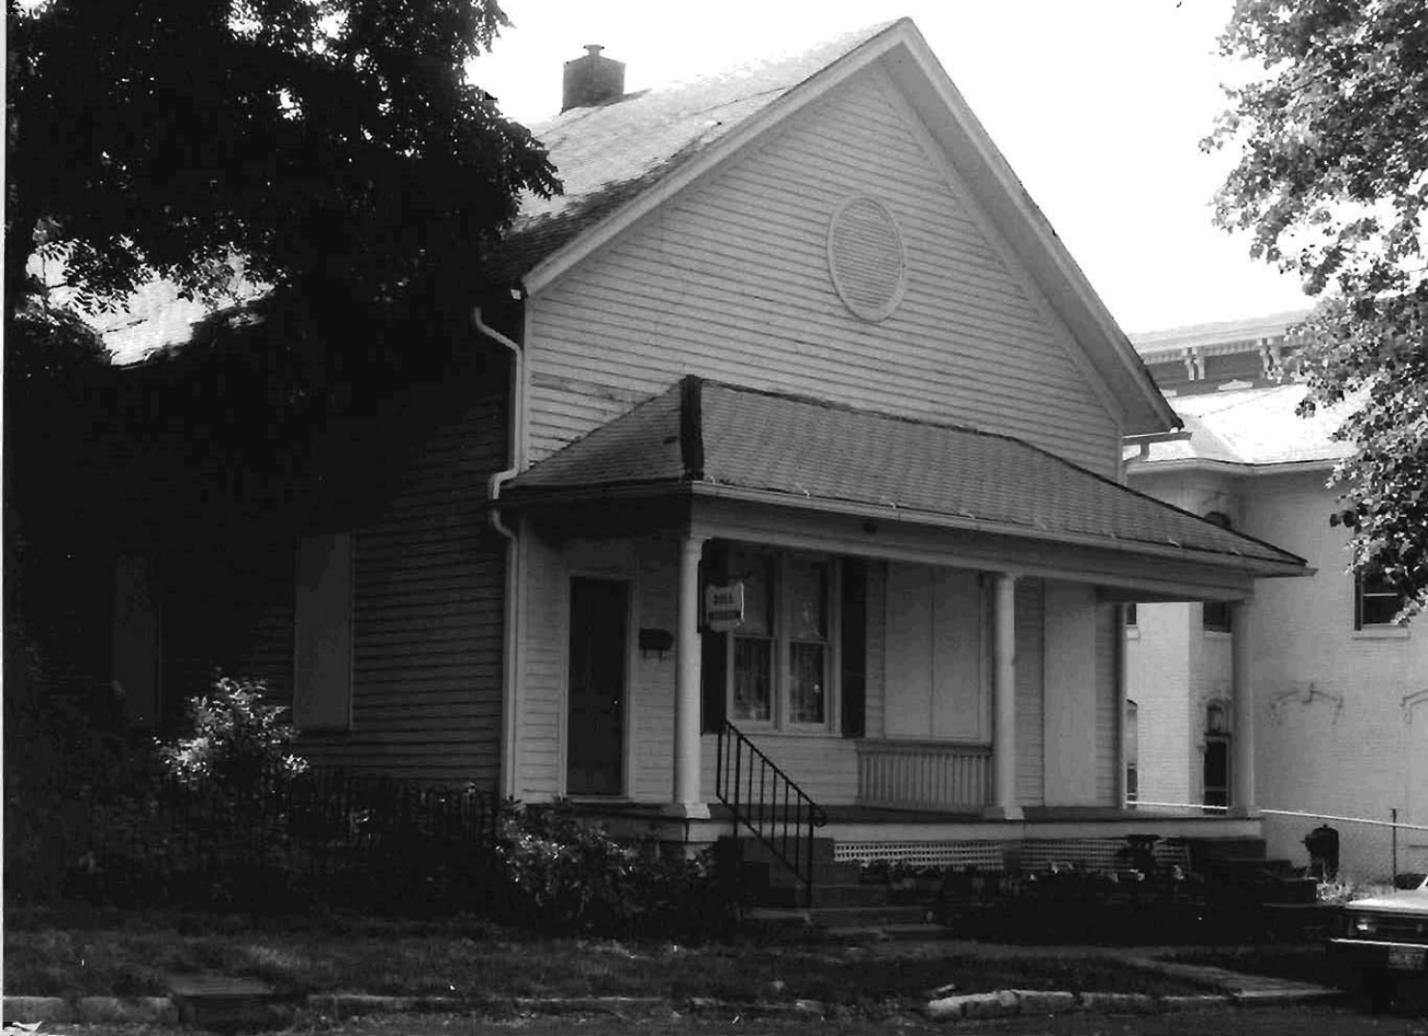
<p>42. FURTHER DESCRIPTION OF IMPORTANT FEATURES <u>1 1/2 story, 4 bay, symmetrical, frame building with front gable roof, molded frieze and plain corner boards. Ca 1900 porch attached to front elevation (west) has Tuscan columns, molded entablature, hip roof and lattice foundation infill; balustrade divides porch in half. Right half has openings boarded. Left bay has single door with transom; second bay has</u></p>		5. OTHER NAME(S)		
<p>43. HISTORY AND SIGNIFICANCE <u>paired 1/1 windows. Gable wall has a large circular vented opening.</u></p> <p>43. The building was originally constructed to house a Baptist Church. Side elevation walls contain evidence of tall windows that have been drastically reduced. By 1911 it was used as a duplex dwelling. It has a moderate to high degree of integrity and is significant as a representation of mid to late 19th Century church property type.</p>	6. TOWNSHIP

<p>44. DESCRIPTION OF ENVIRONMENT AND OUTBUILDINGS <u>In residential neighborhood in block with ca 1870-1900 dwellins.</u></p>	RANGE			
<p>45. SOURCES OF INFORMATION <u>Sanborn maps of 1883, 1888, 1911; site</u></p>	<p>46. PREPARED BY <u>Mary Jo Winder</u></p> <p>47. ORGANIZATION <u>City of St. Joseph</u></p> <p>48. DATE <u>7/88</u></p> <p>49. REVISION DATE(S)</p>	SECTION		
<p>RETURN THIS FORM WHEN COMPLETED TO: OFFICE OF HISTORIC PRESERVATION P.O. BOX 176 JEFFERSON CITY, MISSOURI 65102 PH. 314-751-4096</p> <p>IF ADDITIONAL SPACE IS NEEDED, ATTACH SEPARATE SHEET(S) TO THIS FORM</p>

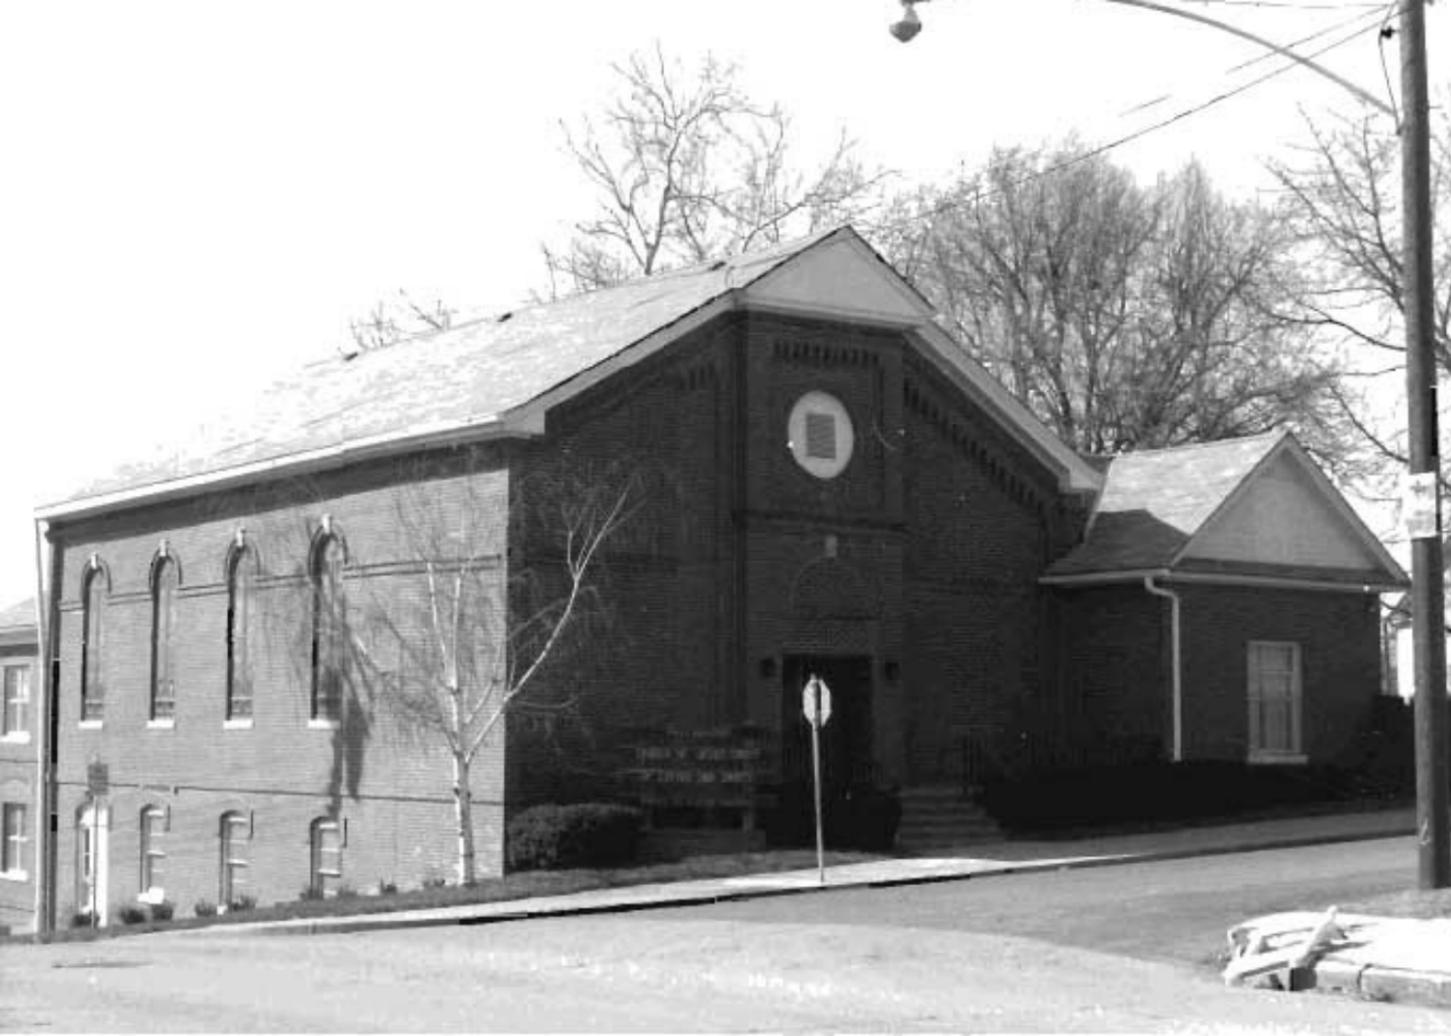
<p>43. HISTORY AND SIGNIFICANCE <b>the entry indicates an alteration; an original semi-circular arch with keystone is intact. Other alterations on the facade are a window opening that has been bricked in (right of entry) and on the southeast corner where a change in the wall indicates that the church once had a square corner tower. South side elevation contains stained glass windows with molded, arched, brick lintels with keystones; basement exposed on this elevation. Side/front addition projects beyond front facade; it contains a wide window opening and has an enframed gable with patterned wood shingle siding and a large opening that is now boarded over.</b></p>	<p>44. DESCRIPTION OF ENVIRONMENT AND OUTBUILDINGS <b>Issuance of a permit in 1894 for a wood shed indicates the church to be in existence before 1887. It has a moderate to high degree of integrity and is significant as a representation of mid to late 19th century church property type. Appears on 1883 Sanborn map. At edge of residential neighborhood; Patee House hotel (1858) in block to southeast.</b></p>	6. TOWNSHIP

<p>45. SOURCES OF INFORMATION <b>BP #3564, 6/15/94; site; 1883 Sanborn map</b></p>	<p>46. PREPARED BY <b>Mary Jo Winder</b></p> <hr/> <p>47. ORGANIZATION <b>City of St. Joseph</b></p> <hr/> <p>48. DATE <b>7/88</b> 49. REVISION DATE(S)</p>	RANGE	
<p>RETURN THIS FORM WHEN COMPLETED TO: <b>OFFICE OF HISTORIC PRESERVATION P.O. BOX 176 JEFFERSON CITY, MISSOURI 65102 PH. 314-751-4096</b></p>	<p>IF ADDITIONAL SPACE IS NEEDED, ATTACH SEPARATE SHEET(S) TO THIS FORM</p>	SECTION

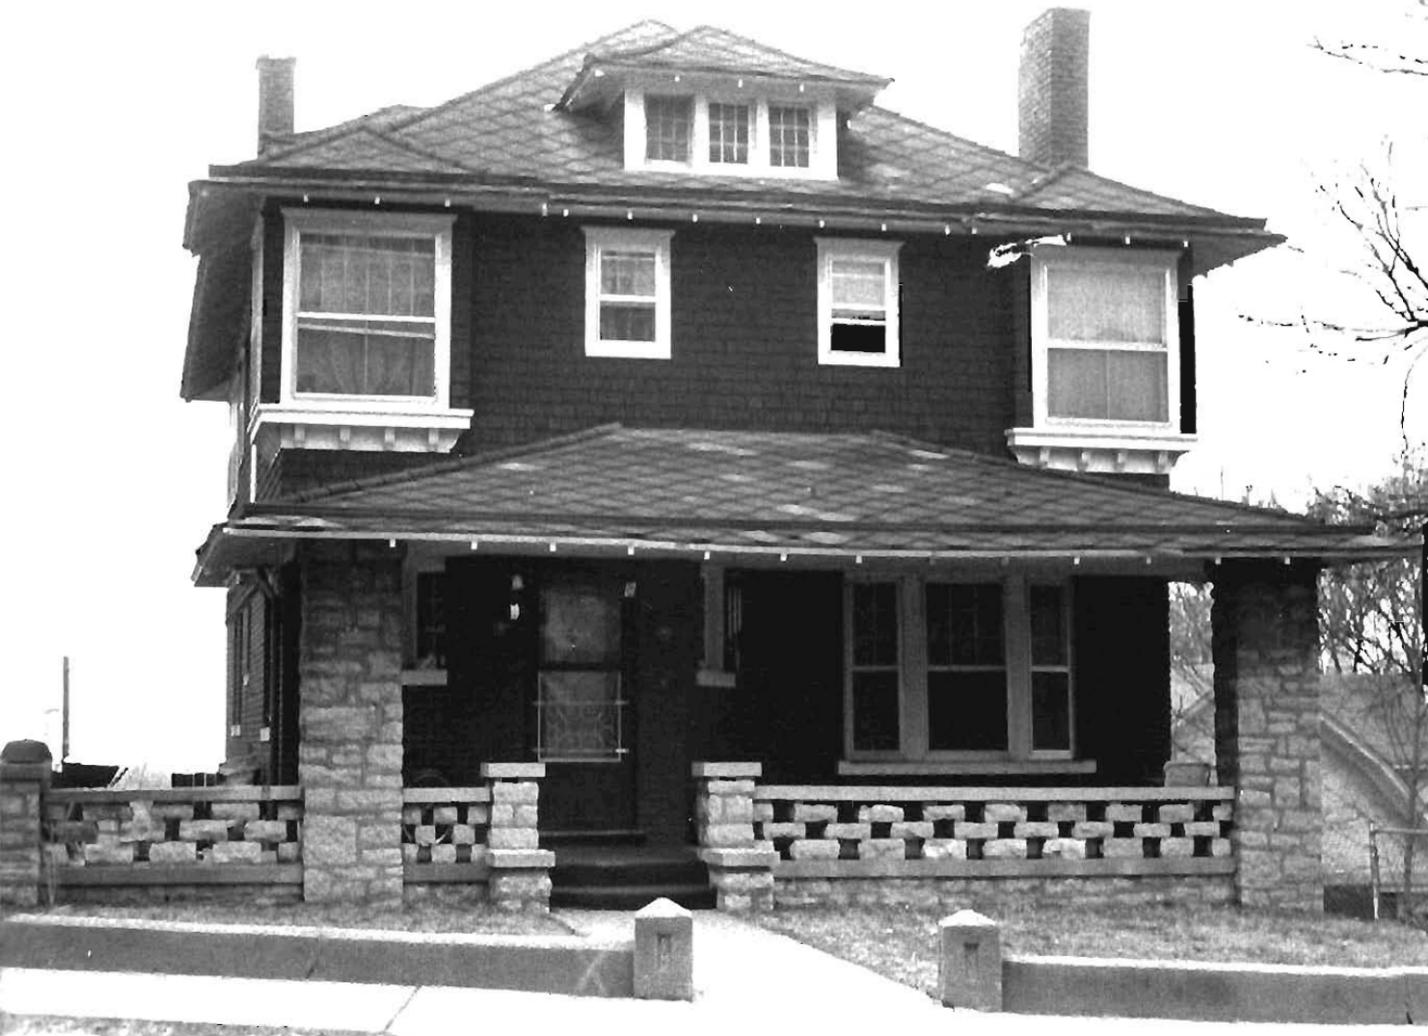
<p>42. FURTHER DESCRIPTION OF IMPORTANT FEATURES <b>2½ story, 2 bay, asymmetrical brick/frame dwelling with hip roof with exposed rafters, hip roof dormers, and offset left and side brick chimneys. Porch attached to front elevation (east) has open stone railing, stone foundation and stone piers that support hip roof with exposed rafters. Left bay contains single door in slightly projecting polyzonal unit with small six-</b></p> <p>43. HISTORY AND SIGNIFICANCE <b>light casement windows in sides. Right bay has window grouping of 9/1 window with 6/1 sidelights. First story windows have stone sills. Symmetrical upper facade has boxed corner units that are supported by small brackets and contain wide 18/1 windows; unit terminates with hip roofs; small 6/1 windows in center. Dormer contains a grouping of three 9-light casement windows.</b></p> <p>43. <b>Building permit records indicate construction in 1909 for applicant, E.G. Meek. It has a high degree of integrity and is significant as a representation of Arts and Crafts residential property type.</b></p> <p>44. DESCRIPTION OF ENVIRONMENT AND OUTBUILDINGS <b>In residential neighborhood primarily of turn of the century dwellings.</b></p> <p>45. SOURCES OF INFORMATION <b>B.P. #5950, 7/12/09; site</b></p>	<p>46. PREPARED BY <b>Mary Jo Winder</b></p> <p>47. ORGANIZATION <b>City of St. Joseph</b></p> <p>48. DATE <b>7/88</b></p> <p>49. REVISION DATE(S)</p>	4. PRESENT LOCAL NAME(S) OR DESIGNATION(S)

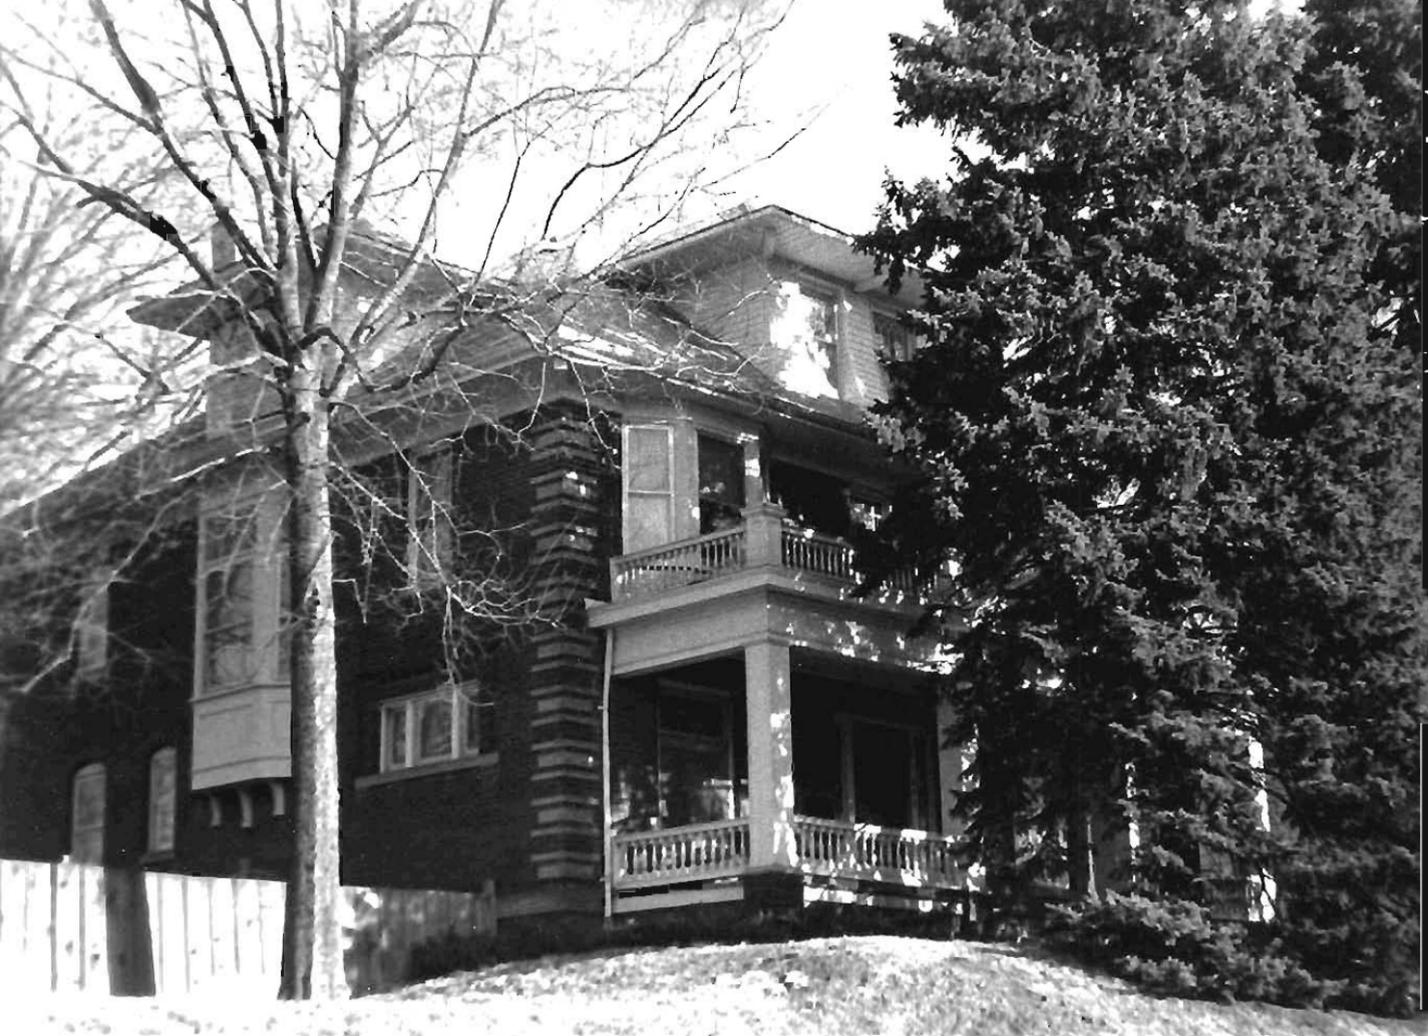
<p>42. FURTHER DESCRIPTION OF IMPORTANT FEATURES <b>2½ story, 3 bay, symmetrical, brick dwelling with hip roof with boxed cornice and hip roof dormers, molded frieze and contrasting brick quoining and water table. Three-bay porch attached to front elevation (west) has brick foundation pedestals, square columns that support a wide molded entablature and upper porch; both porches with balustrades with turned balusters; upper porch</b></p> <p>43. HISTORY AND SIGNIFICANCE <b>with paneled support posts. Center bay contains single door with sidelights, second story with single door; end bays contain wide window with transom, second story with polygonal bay unit with 1/1 window in each side. Dormer is flared at base, has wood shingle siding and contains two 1/1 windows with prism upper sashes. 43. There are no building permits of record for this dwelling; however, stylistic features indicate construction of ca1910. The 1911 Sanborn map is the first record of its existence. It has a high degree of integrity and is significant as a representation of Neoclassical residential property type.</b></p> <p>44. DESCRIPTION OF ENVIRONMENT AND OUTBUILDINGS <b>In residential neighborhood; low density area</b></p>	<p>45. SOURCES OF INFORMATION <b>No B.P., site; 1911 Sanborn map</b></p>	<p>46. PREPARED BY <b>Mary Jo Winder</b></p> <p>47. ORGANIZATION <b>City of St. Joseph</b></p> <p>48. DATE <b>7/88</b></p> <p>49. REVISION DATE(S)</p>	4. PRESENT LOCAL NAME(S) OR DESIGNATION(S)

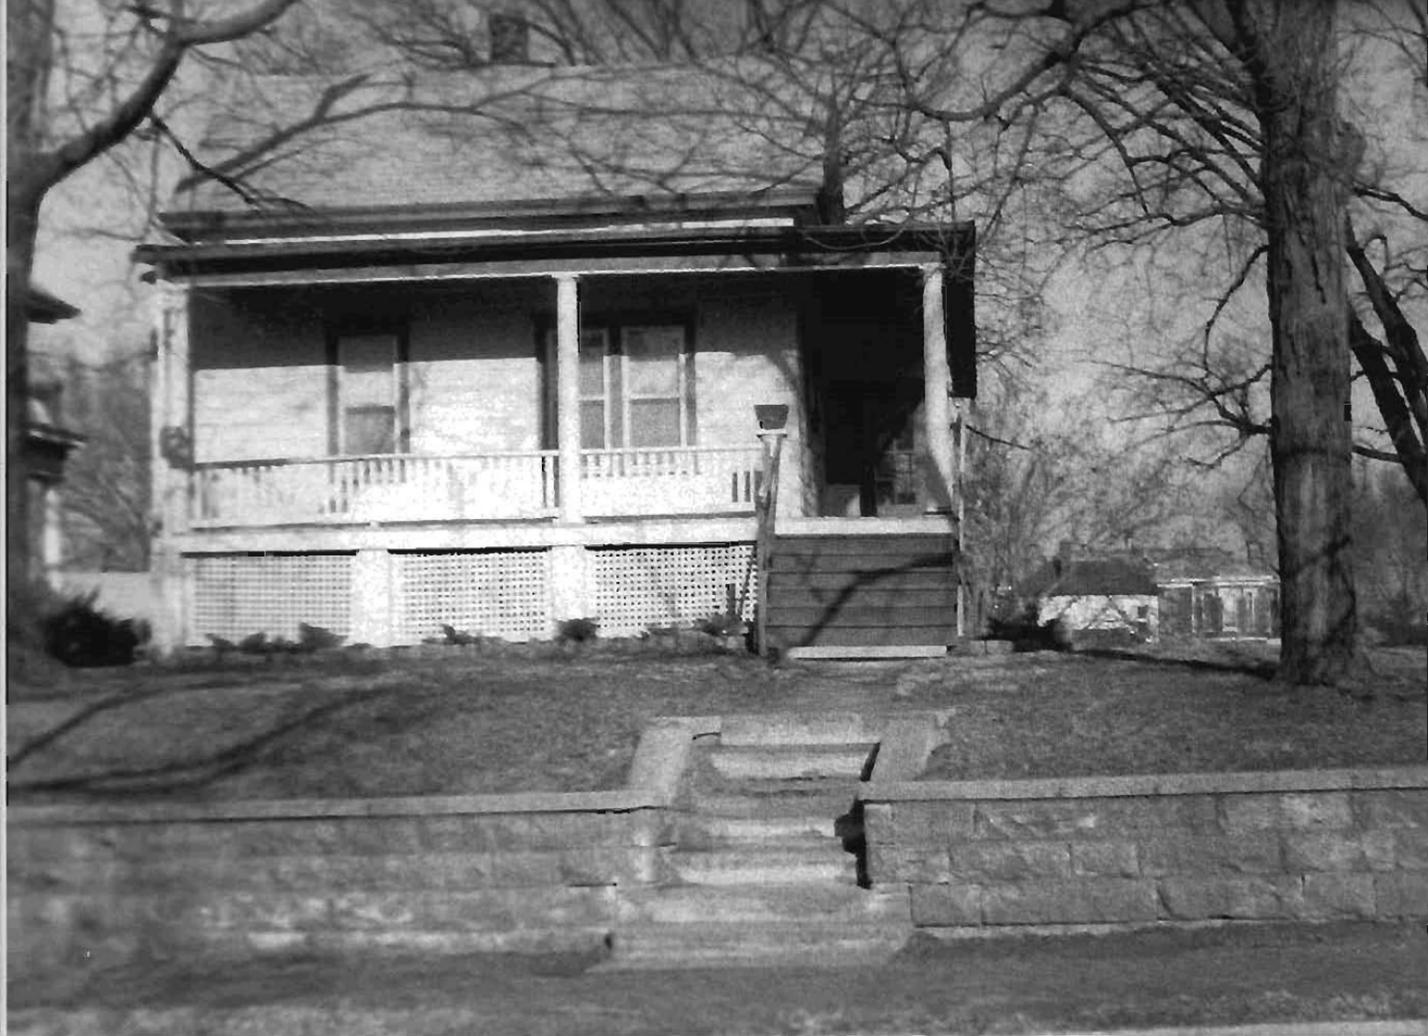
<p>42. FURTHER DESCRIPTION OF IMPORTANT FEATURES <b>1 story, 3 bay, asymmetrical frame dwelling with side gable roof and centralized brick chimney. Porch attached to front (west) and south elevations has Tuscan columns, open slat railing, wood lattice foundation infill and flat roof. Left bay contains 1/1 double hung window; second bay has paired 1/1 windows; recessed right bay is enclosed porch with entry door with side light. Modern siding is a later alteration.</b></p>	<p>PHOTO MUST BE PROVIDED</p>	4. PRESENT LOCAL NAME(S) OR DESIGNATION(S)	
<p>43. HISTORY AND SIGNIFICANCE <b>The only building permit of record for the property is one for a barn in 1909 for applicant, N.S. Hillyard. It has characteristics that place original construction of pre1887; the porch was probably altered ca1910. It has a moderate degree of integrity and is significant as a representation of late 19th/early 20th century vernacular residential property type.</b></p>	5. OTHER NAME(S)

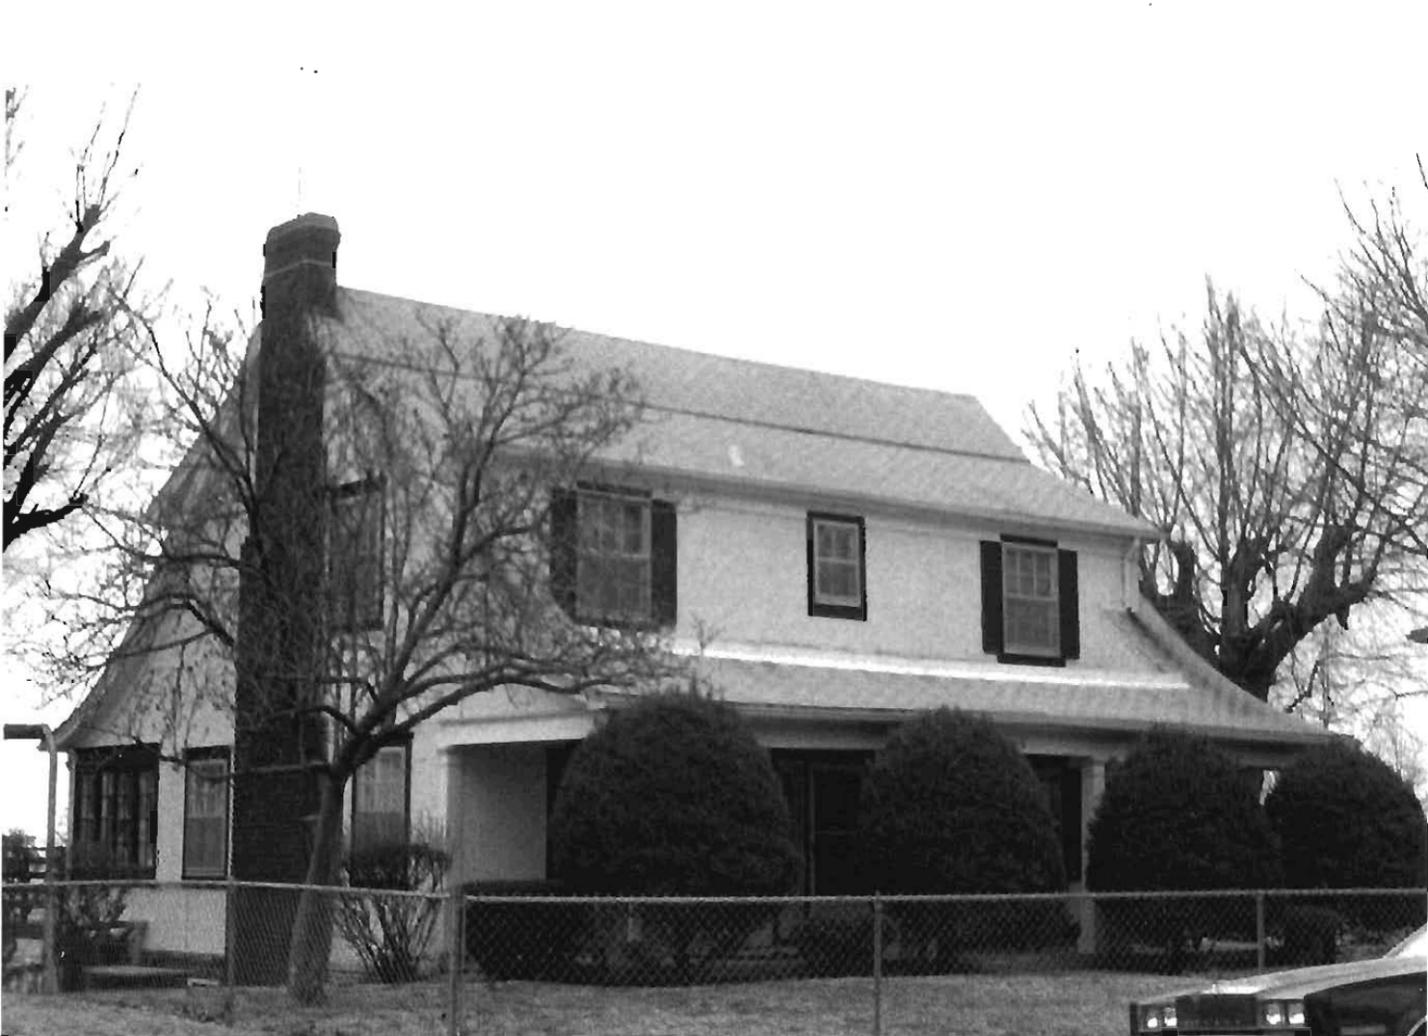
<p>9. COORDINATES UTM LAT _____ LONG _____</p> <p>10. SITE ( ) STRUCTURE ( ) BUILDING (X) OBJECT ( )</p> <p>11. ON NATIONAL REGISTER? YES ( ) NO (X)</p> <p>12. IS IT ELIGIBLE? YES (X) NO ( )</p> <p>13. PART OF ESTAB. HIST. DISTRICT? YES ( ) NO (X)</p> <p>14. DISTRICT POTENTIAL? YES (X) NO ( )</p> <p>15. NAME OF ESTABLISHED DISTRICT</p>	<p>25. OPEN TO PUBLIC? YES ( ) NO (X)</p> <p>26. LOCAL CONTACT PERSON OR ORGANIZATION</p> <p>27. OTHER SURVEYS IN WHICH INCLUDED</p>	4. PRESENT LOCAL NAME(S) OR DESIGNATION(S)	
<p>42. FURTHER DESCRIPTION OF IMPORTANT FEATURES <u>2 story, 3 bay, symmetrical, stucco/frame dwelling with side gambrel roof (variation of), molded frieze and external brick chimney. Open veranda across front elevation (east) shelters single door with sidelights and 6/6 double hung windows in flanking side bays; supports are square columns. Continuous dormer projects from roof with 6/6 windows in end bays and smaller 2/2 window in center. End bay</u></p> <p>43. HISTORY AND SIGNIFICANCE <u>windows have shutters. Brick bands on chimney pot top.</u></p> <p><u>Building permit records indicate construction in 1904 for applicant, A. Thompson. It has a high degree of architectural integrity and is significant as a representation of Dutch Colonial Revival residential property type.</u></p>	<div style="border: 2px solid black; width: 100%; height: 100%; display: flex; align-items: center; justify-content: center;"> <p style="font-size: 2em; margin: 0;">X</p> </div> <p style="text-align: center; font-weight: bold; margin: 0;">PHOTO MUST BE PROVIDED</p>	5. OTHER NAME(S)

<p>44. DESCRIPTION OF ENVIRONMENT AND OUTBUILDINGS</p> <p><u>In residential neighborhood; dwellings on large lots; most ca 1900-10 dwellings.</u></p>	6. TOWNSHIP		
<p>45. SOURCES OF INFORMATION</p> <p><u>BP #2266, 12/21/04; site</u></p>	<p>46. PREPARED BY <u>Mary Jo Winder</u></p> <p>47. ORGANIZATION <u>City of St. Joseph</u></p> <p>48. DATE <u>7/88</u></p> <p>49. REVISION DATE(S)</p>	RANGE	
<p>RETURN THIS FORM WHEN COMPLETED TO: OFFICE OF HISTORIC PRESERVATION P.O. BOX 176 JEFFERSON CITY, MISSOURI 65102 PH. 314-751-4096</p> <p>IF ADDITIONAL SPACE IS NEEDED, ATTACH SEPARATE SHEET(S) TO THIS FORM</p>	SECTION

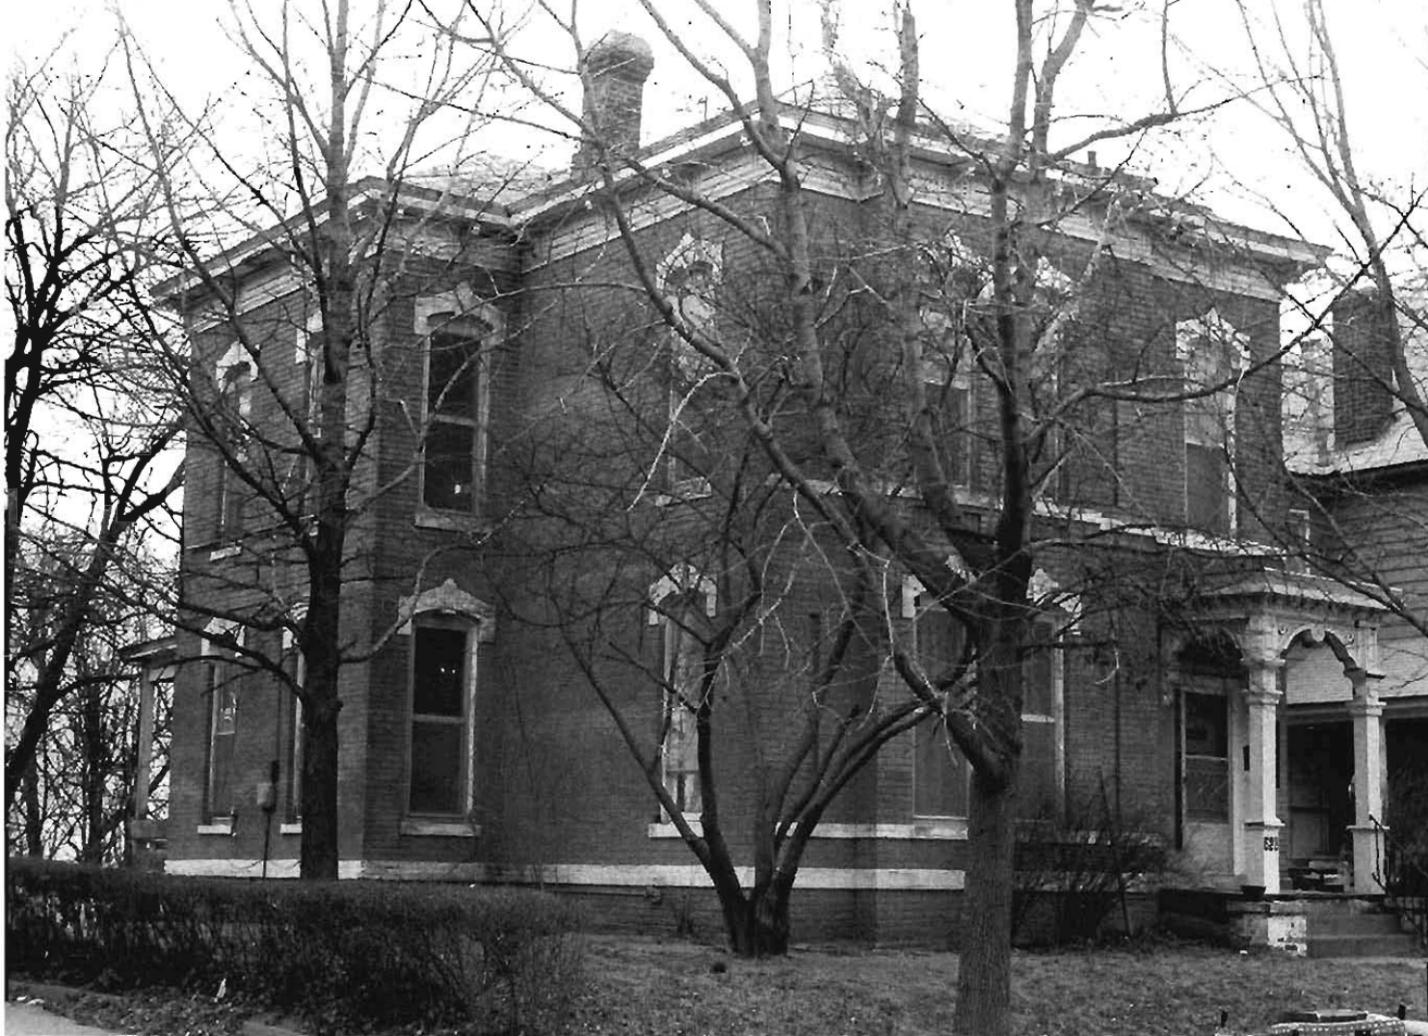
<p>42. FURTHER DESCRIPTION OF IMPORTANT FEATURES 2 story, 4 bay, asymmetrical, brick dwelling with hip roof with molded boxed cornice, paneled frieze with ornamental brackets, brick water table and off-set left brick chimney with shaped pot. Left bay is west wall of rear portion of building and it contains 1/1 window with stone sill and decorative hoodmold, both stories (typical window treatment). Second and third bays have slight projection; each bay contains</p> <p>43. HISTORY AND SIGNIFICANCE typical window, both stories; brick panels on either side of projection and decorative brickwork between stories. Right bay contains entry with transom on first and typical window on second. Small flat roof porch attached over entry has heavy square corner columns and a profusion of Italianate ornamentation.</p> <p>43. There are no building permits of record for this dwelling; however, stylistic features indicate a ca1865 original construction date. It has a high degree of integrity and is an outstanding representation of mid 19th century Italianate residential property type.</p>		4. PRESENT LOCAL NAME(S) OR DESIGNATION(S)

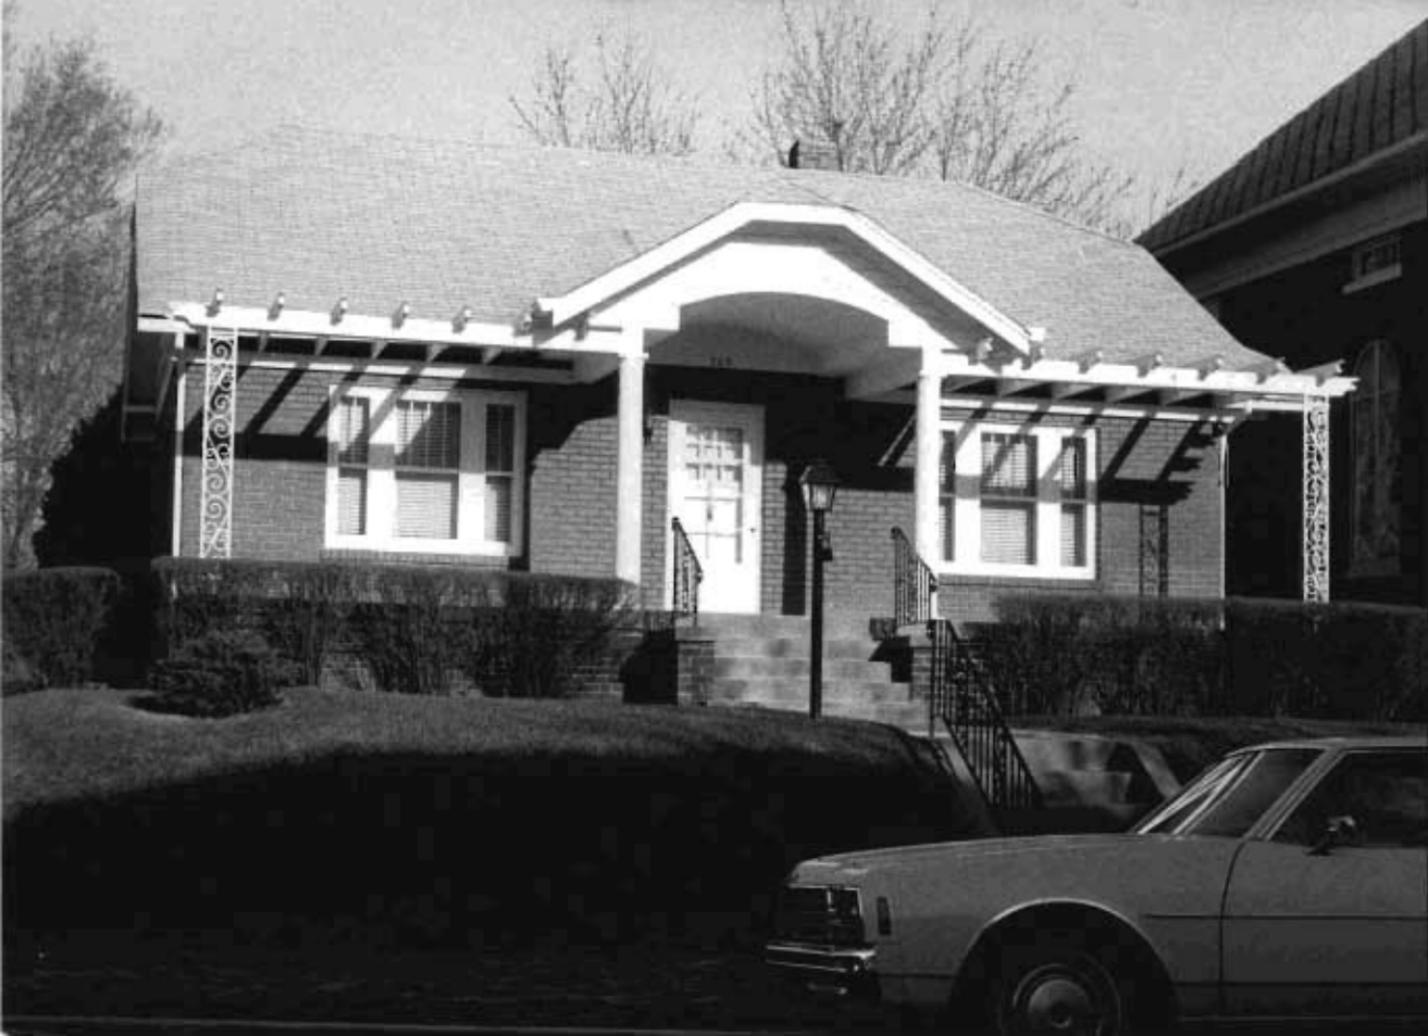
<p>42. FURTHER DESCRIPTION OF IMPORTANT FEATURES <u>1 1/2 story, 3 bay, symmetrical, brick dwelling with side hipped gable roof with porch roof projection (also hipped gable form) over center bay. End bays contain grouping of 4/1 windows with 2/1 sidelights (vertical mullions). Single door entry in center bay; porch roof supported by Tuscan corner columns. Open rafter and beams with notched edges attached over end bays with decorative wrought iron corner supports.</u></p> <p>43. HISTORY AND SIGNIFICANCE</p>	<div style="border: 2px solid black; width: 100%; height: 100%; display: flex; align-items: center; justify-content: center;"> <p style="font-size: 2em; margin: 0;">X</p> </div> <p style="text-align: center; font-weight: bold; margin: 5px 0;">PHOTO MUST BE PROVIDED</p>	4. PRESENT LOCAL NAME(S) OR DESIGNATION(S)	
<p>44. DESCRIPTION OF ENVIRONMENT AND OUTBUILDINGS <u>In residential neighborhood primarily of turn of the century dwellings.</u></p>	<p>45. SOURCES OF INFORMATION <u>BP #3946, 3/19/95; BP #4840, 3/24/08; site</u></p>	<p>46. PREPARED BY <u>Mary Jo Winder</u></p> <p>47. ORGANIZATION <u>City of St. Joseph</u></p> <p>48. DATE <u>7/88</u></p> <p>49. REVISION DATE(S)</p>	5. OTHER NAME(S)
