# MISSOURI OFFICE OF HISTORIC PRESERVATION

## ARCHITECTURAL/HISTORIC INVENTORY SURVEY FORM

BN-AS 004-001

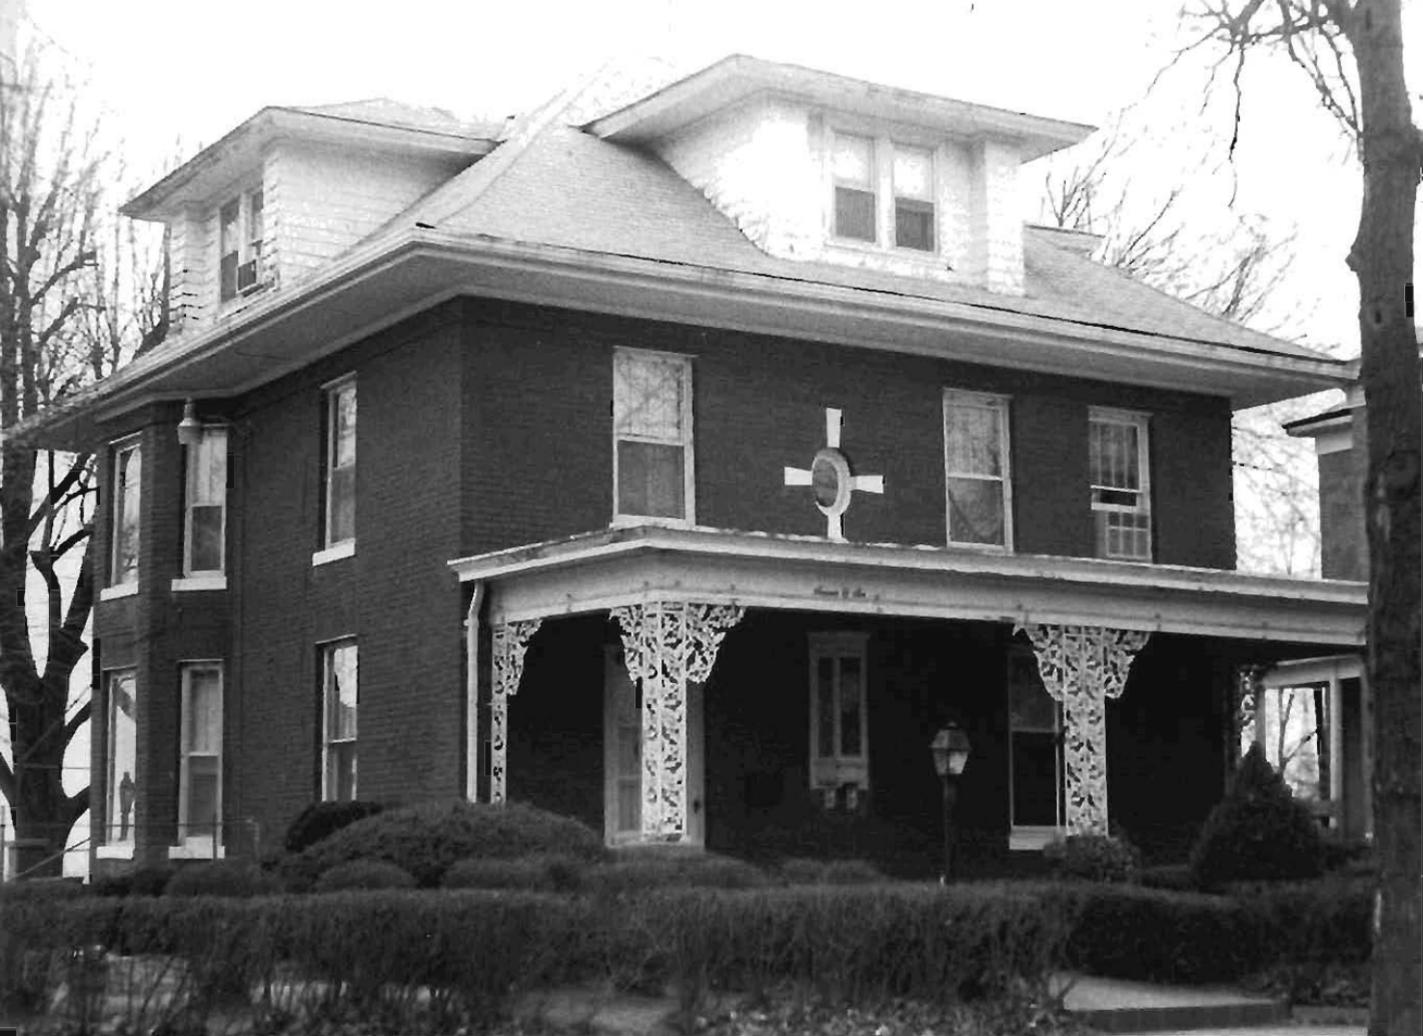
<b>9. COORDINATES</b> UTM LAT _____ LONG _____ <b>10.</b> SITE ( ) STRUCTURE ( ) BUILDING (X) OBJECT ( ) <b>11. ON NATIONAL REGISTER?</b> YES ( ) NO (X) <b>12. IS IT ELIGIBLE?</b> YES (X) NO ( ) <b>13. PART OF ESTAB. HIST. DISTRICT?</b> YES ( ) NO (X) <b>14. DISTRICT POTENTIAL?</b> YES (X) NO ( ) <b>15. NAME OF ESTABLISHED DISTRICT</b>	<b>42. FURTHER DESCRIPTION OF IMPORTANT FEATURES</b> 2½ story, 3 bay, asymmetrical brick dwelling with hip roof with boxed cornice and hip roof dormers. Porch attached to front elevation (east) has ornamental wrought iron supports (an alteration) entablature and flat roof. Left bay contains single door, 4/1 window (vertical mullions) on second story. Polyzoal "lantern" window unit in second bay; oval window on second story. Wide double hung window in right bay with two 4/1 windows in second story. Dormers have recessed walls that contain paired 1/1 windows and have wood shingle siding. <b>43. HISTORY AND SIGNIFICANCE</b> Building permit records indicate construction in 1901 for applicant. T.E. Rawlings. It has a moderate to high degree of integrity due to porch alterations and is significant as a representation of Neoclassical residential property type.	PHOTO MUST BE PROVIDED

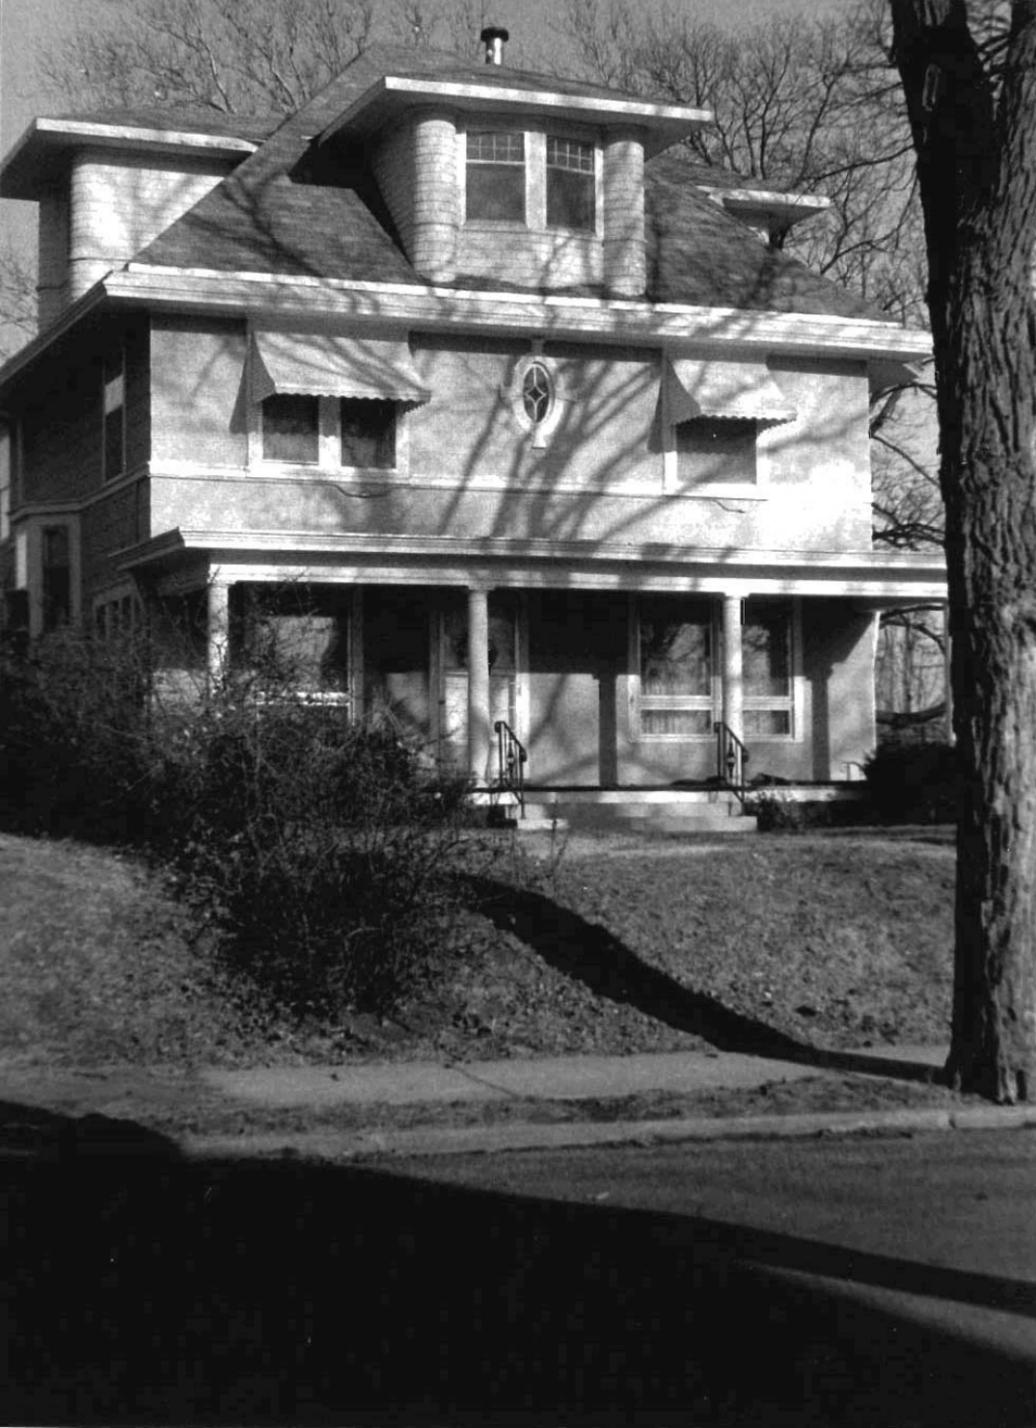
<p>10. SITE ( ) STRUCTURE ( ) BUILDING (X) OBJECT ( )</p>	<p>11. ON NATIONAL REGISTER? YES ( ) NO (X)</p>	<p>12. IS IT ELIGIBLE? YES (X) NO ( )</p>	RANGE
<p>13. PART OF ESTAB. HIST. DISTRICT? YES ( ) NO (X)</p>	<p>14. DISTRICT POTENTIAL? YES (X) NO ( )</p>	<p>42. FURTHER DESCRIPTION OF IMPORTANT FEATURES <b>2½ story, 3 bay, asymmetrical, frame dwelling with hip roof with molded boxed cornices (may have been altered), hip roof dormers and continuous sills on second story. Three bay porch attached to front elevation has Tuscan columns that support molded entablature and flat roof with molded cornice. Left bay contains wide window with pivoted bottom unit- center contains a single door and right</b></p>	SECTION
<p>15. NAME OF ESTABLISHED DISTRICT</p>	<p>43. HISTORY AND SIGNIFICANCE <b>bay has paired windows with pivoted unit. Second story has paired 1/1 windows and a wide 1/1 window in end bays and ornamented oval window in center. Dormers have "shingle style" influence with organic walls and contain paired windows with 8/1 sash; mullioned sash in upper 1/3.</b></p> <p>43. Building permit records indicate construction in 1902 for applicant, R.W. Douglas. It has a high degree of integrity and is significant as a representation of Neoclassical residential property type.</p>	<div style="border: 2px solid black; padding: 10px; text-align: center;"> <p><b>PHOTO MUST BE PROVIDED</b></p> </div>

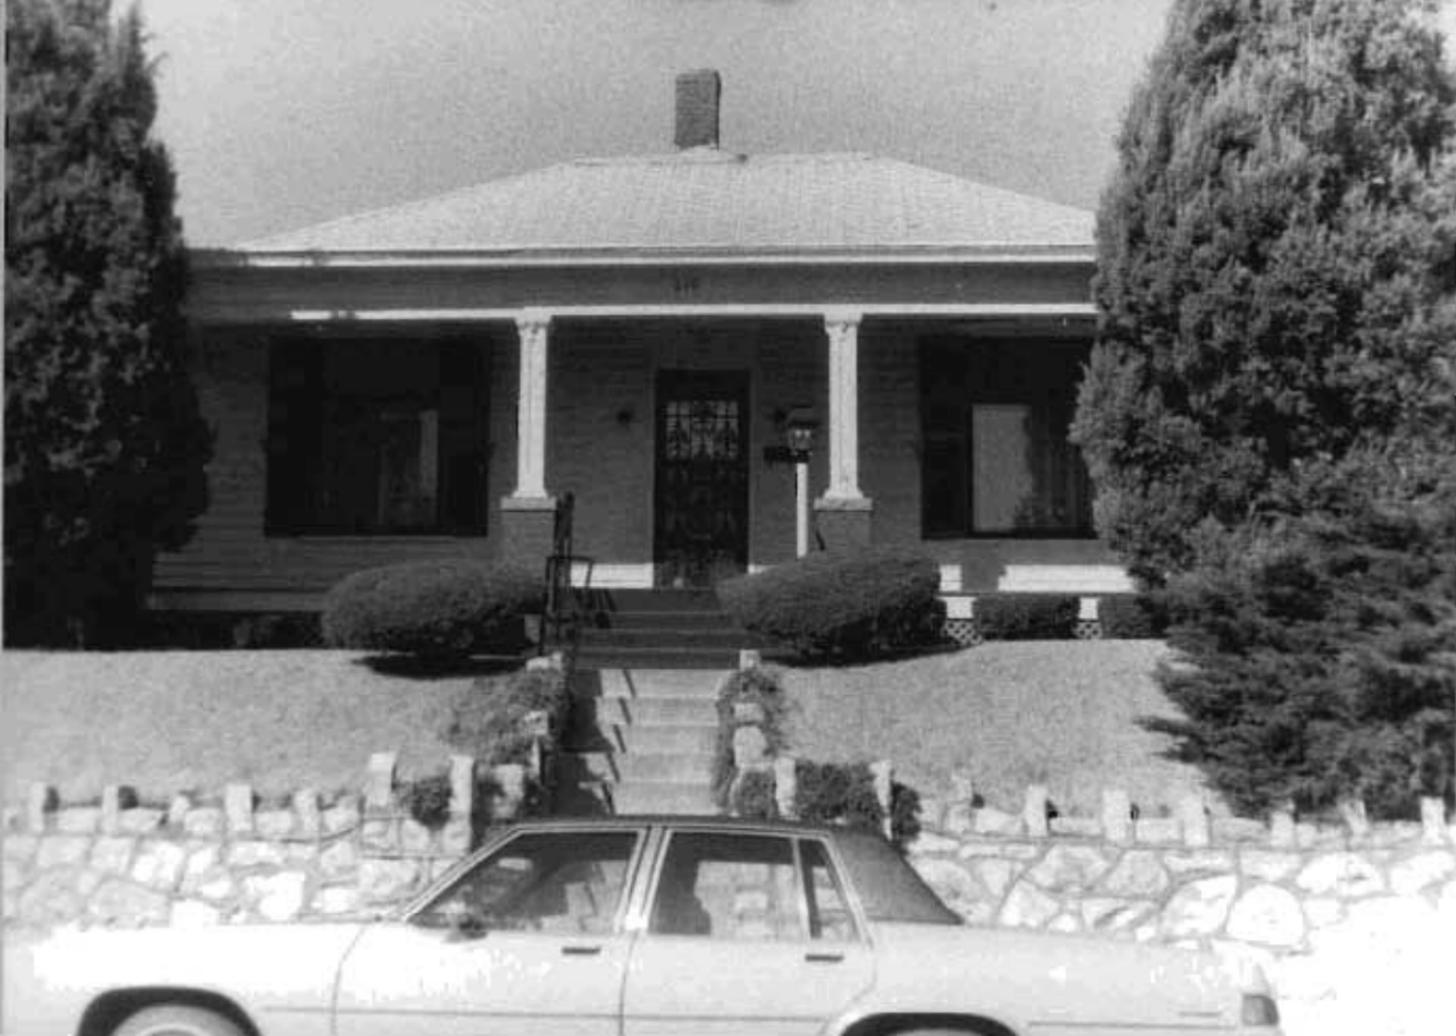
<p>42. FURTHER DESCRIPTION OF IMPORTANT FEATURES <b>1 story, 3 bay, symmetrical, frame dwelling with truncated hip roof and centralized brick chimney. Open veranda on front elevation (east) has brick pedestals with paneled wood columns that support wide entablature and molded cornice's lattice foundation infill. End bays contain picture windows with leaded transoms; decorative shutters. Single door entry in center bay with transom; modern wrought iron door.</b></p>	<div style="border: 2px solid black; padding: 20px; width: 100px; margin: auto;"> <p style="text-align: center;">PHOTO MUST BE PROVIDED</p> </div>	4. PRESENT LOCAL NAME(S) OR DESIGNATION(S)	
<p>43. HISTORY AND SIGNIFICANCE <b>Building's original construction before 1887; some Greek Revival characteristics that would place it ca. 1860. Building permit records indicate an alteration to an existing in 1912; original construction could predate 1887; however, there are no apparent features of an earlier period. It has a moderate degree of integrity and is significant as a representation of vernacular Classic Revival residential property type.</b></p>	5. OTHER NAME(S)

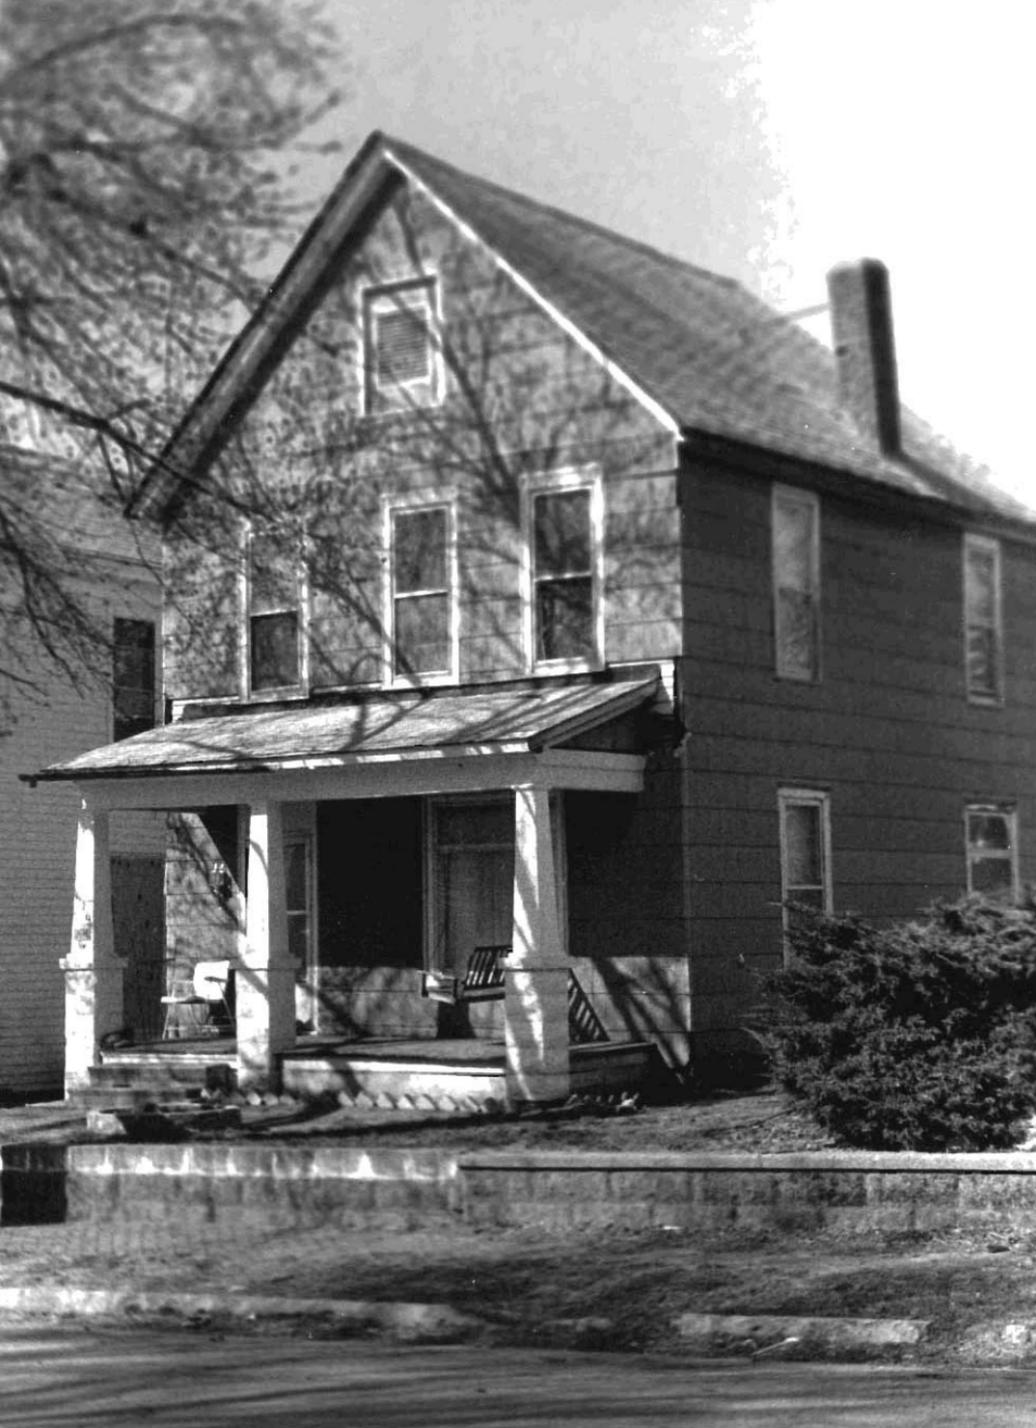
<b>9. COORDINATES</b> UTM LAT _____ LONG _____  <b>10.</b> SITE ( ) BUILDING (X) STRUCTURE ( ) OBJECT ( )  <b>11. ON NATIONAL REGISTER?</b> YES ( ) NO (X)  <b>12. IS IT ELIGIBLE?</b> YES (X) NO ( )  <b>13. PART OF ESTAB. HIST. DISTRICT?</b> YES ( ) NO (X)  <b>14. DISTRICT POTENTIAL?</b> YES (X) NO ( )  <b>15. NAME OF ESTABLISHED DISTRICT</b>	<b>26. LOCAL CONTACT PERSON OR ORGANIZATION</b>  <b>27. OTHER SURVEYS IN WHICH INCLUDED</b>	<b>39. ENDANGERED? BY WHAT?</b> YES (XX) NO ( ) Poor Maintenance  <b>40. VISIBLE FROM PUBLIC ROAD?</b> YES (X) NO ( )  <b>41. DISTANCE FROM AND FRONTAGE ON ROAD</b>	4. PRESENT LOCAL NAME(S) OR DESIGNATION(S)
<b>42. FURTHER DESCRIPTION OF IMPORTANT FEATURES</b> 2 story, 2 bay, asymmetrical, frame dwelling with front gable roof. Porch attached to front elevation (east) has stone pedestals with tapered, square columns, entablature and shed roof. Left bay contains single door with transom; right bay has picture window with transom. Three-bay, upper facade has three 1/1 double hung windows. Vented opening in gable. Asbestos siding is a later alteration	PHOTO MUST BE PROVIDED		5. OTHER NAME(S)

<b>43. HISTORY AND SIGNIFICANCE</b>  Building permit records indicate a construction phase in 1895 for applicant, Therisa Howe; however original construction possibly predates 1887. It has a moderate degree of integrity and is significant as a representation of late 19th century vernacular residential property type.			6. TOWNSHIP
<b>44. DESCRIPTION OF ENVIRONMENT AND OUTBUILDINGS</b>  In residential neighborhood; on block of closely spaced dwellings w/shallow setbacks			RANGE
<b>45. SOURCES OF INFORMATION</b>  BP #4221, 7/9/95; site; 1897 Sanborn map	<b>46. PREPARED BY</b> Mary Jo Winder  <b>47. ORGANIZATION</b> City of St. Joseph  <b>48. DATE</b> 7/88	<b>49. REVISION DATE(S)</b>	SECTION
RETURN THIS FORM WHEN COMPLETED TO: OFFICE OF HISTORIC PRESERVATION P.O. BOX 176 JEFFERSON CITY, MISSOURI 65102 PH. 314-751-4096			
IF ADDITIONAL SPACE IS NEEDED, ATTACH SEPARATE SHEET(S) TO THIS FORM

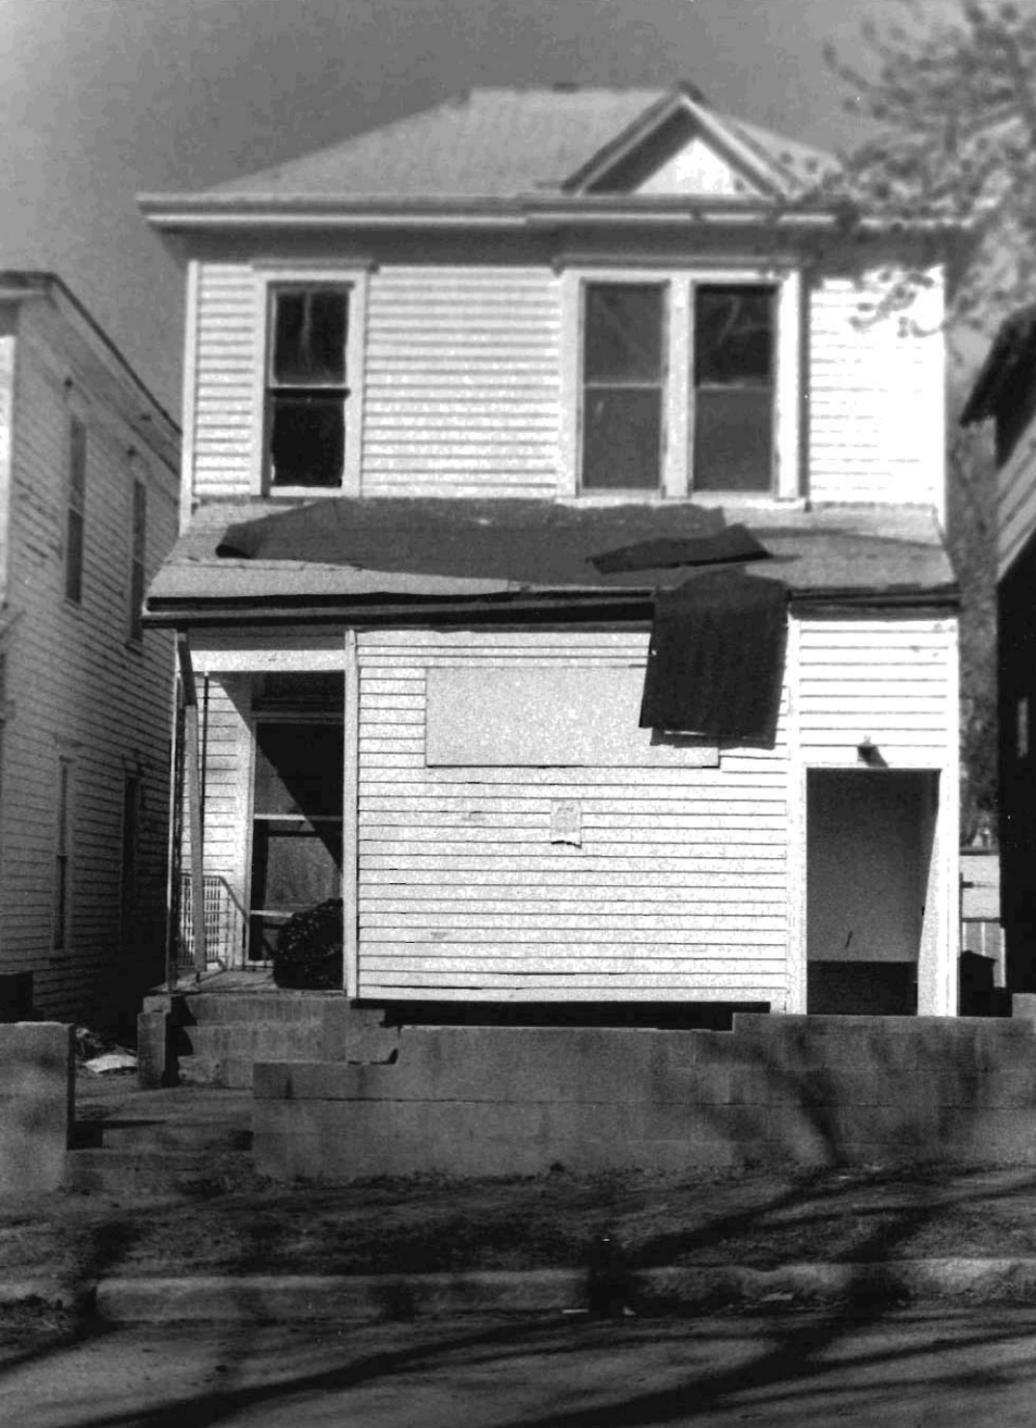
<p>17. HISTORY AND SIGNIFICANCE Building permit records indicate a construction phase in 1890 for applicant, Mrs. Honora Conner, however, stylistic features indicate a ca 1860 original construction date. It has a moderate degree of integrity due to the incompatible front addition and is significant as a representation of vernacular Italianate residential property type.</p>	<p>26. LOCAL CONTACT PERSON OR ORGANIZATION</p>	<p>38. PRESERVATION UNDERWAY? YES ( ) NO (X)</p>	
<p>18. DESCRIPTION OF ENVIRONMENT AND OUTBUILDINGS In residential neighborhood; closely spaced buildings w/shallow setbacks.</p>	<p>27. OTHER SURVEYS IN WHICH INCLUDED</p>	<p>39. ENDANGERED? BY WHAT? YES (X) NO ( ) Neglect/Incompatible addition</p>	
<p>19. SOURCES OF INFORMATION BP #D892, 4/26/90; site; 1897 Sanborn map</p>	<p>40. VISIBLE FROM PUBLIC ROAD? YES (X) NO ( )</p>	<p>41. DISTANCE FROM AND FRONTAGE ON ROAD</p>	
<p>RETURN THIS FORM WHEN COMPLETED TO: OFFICE OF HISTORIC PRESERVATION P.O. BOX 176 JEFFERSON CITY, MISSOURI 65102 PH. 314-751-4096</p>		<p>46. PREPARED BY Mary Jo Winder</p>	5. OTHER NAME(S)

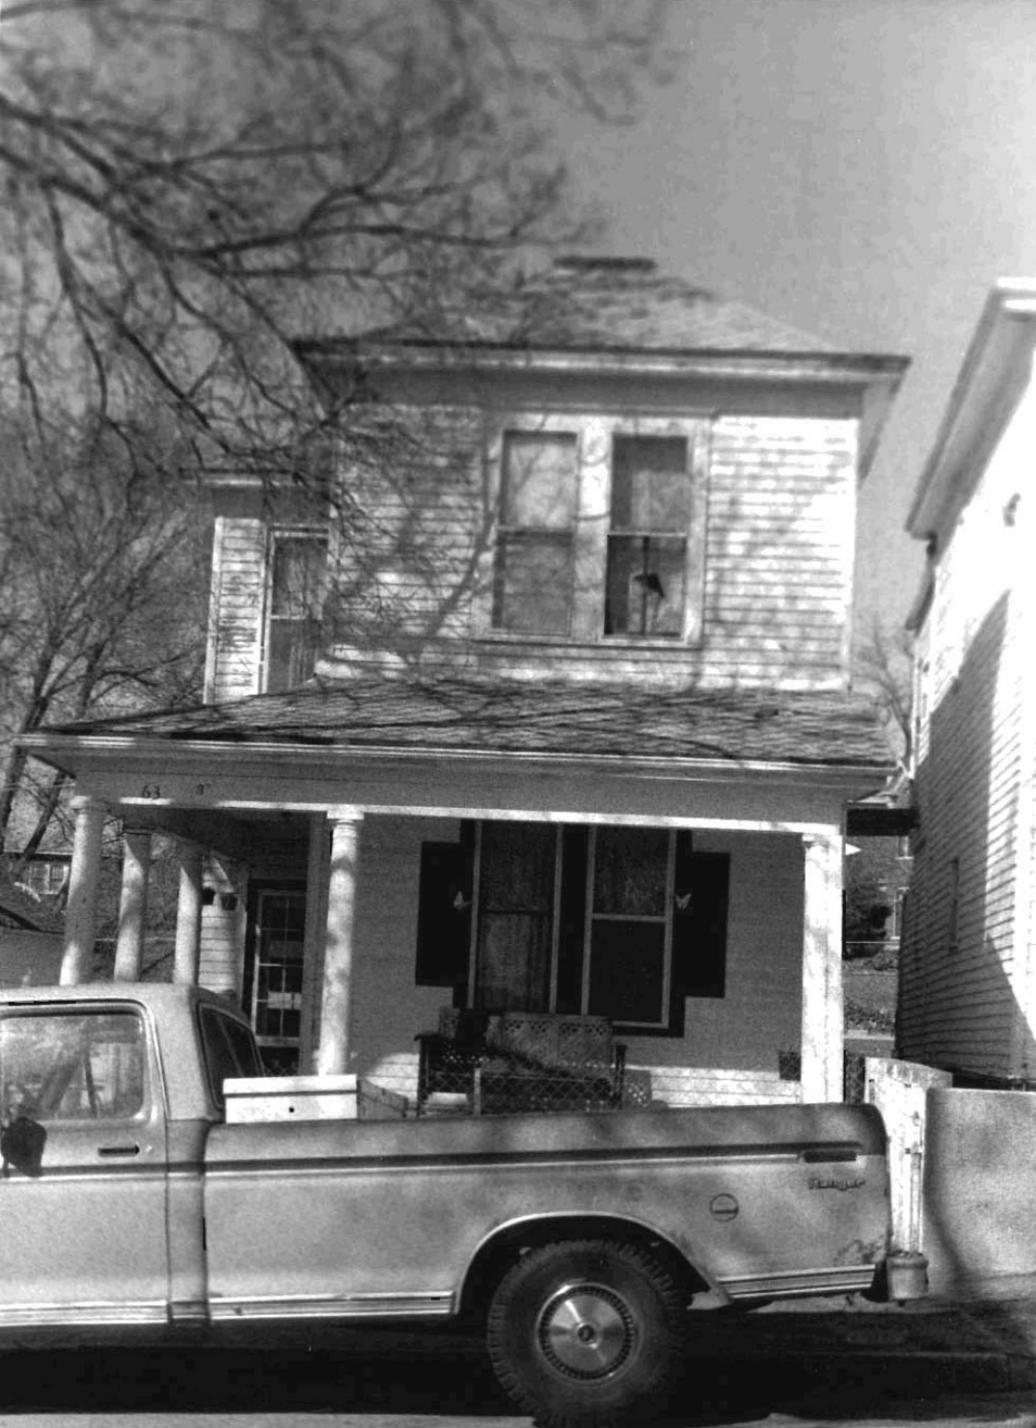
<p>42. FURTHER DESCRIPTION OF IMPORTANT FEATURES <b>2 story, 2 bay, asymmetrical, frame dwelling with truncated hip roof with molded, boxed cornice. Recessed left bay contains single door with transom (covered); 1/1 window on second story. Right bay contains paired 1/1 windows (both stories). Porch attached to front elevation is 1890 alteration with Colonial Revival features of Tuscan columns and molded entablature. Fenestration is within</b></p> <p>43. HISTORY AND SIGNIFICANCE <b>plain frames with narrow cornices.</b></p> <p>A building permit issued to Mrs. Honora Connor for this property in 1890 may have been for alterations to this and the dwelling to the north (same legal description). Both buildings have characteristics that indicate a ca1860-70 original construction. This dwelling has a moderate to high degree of integrity and is significant as a representation of vernacular Italianate residential property type. The porch alteration also has some historic significance.</p>		4. PRESENT LOCAL NAME(S) OR DESIGNATION(S)

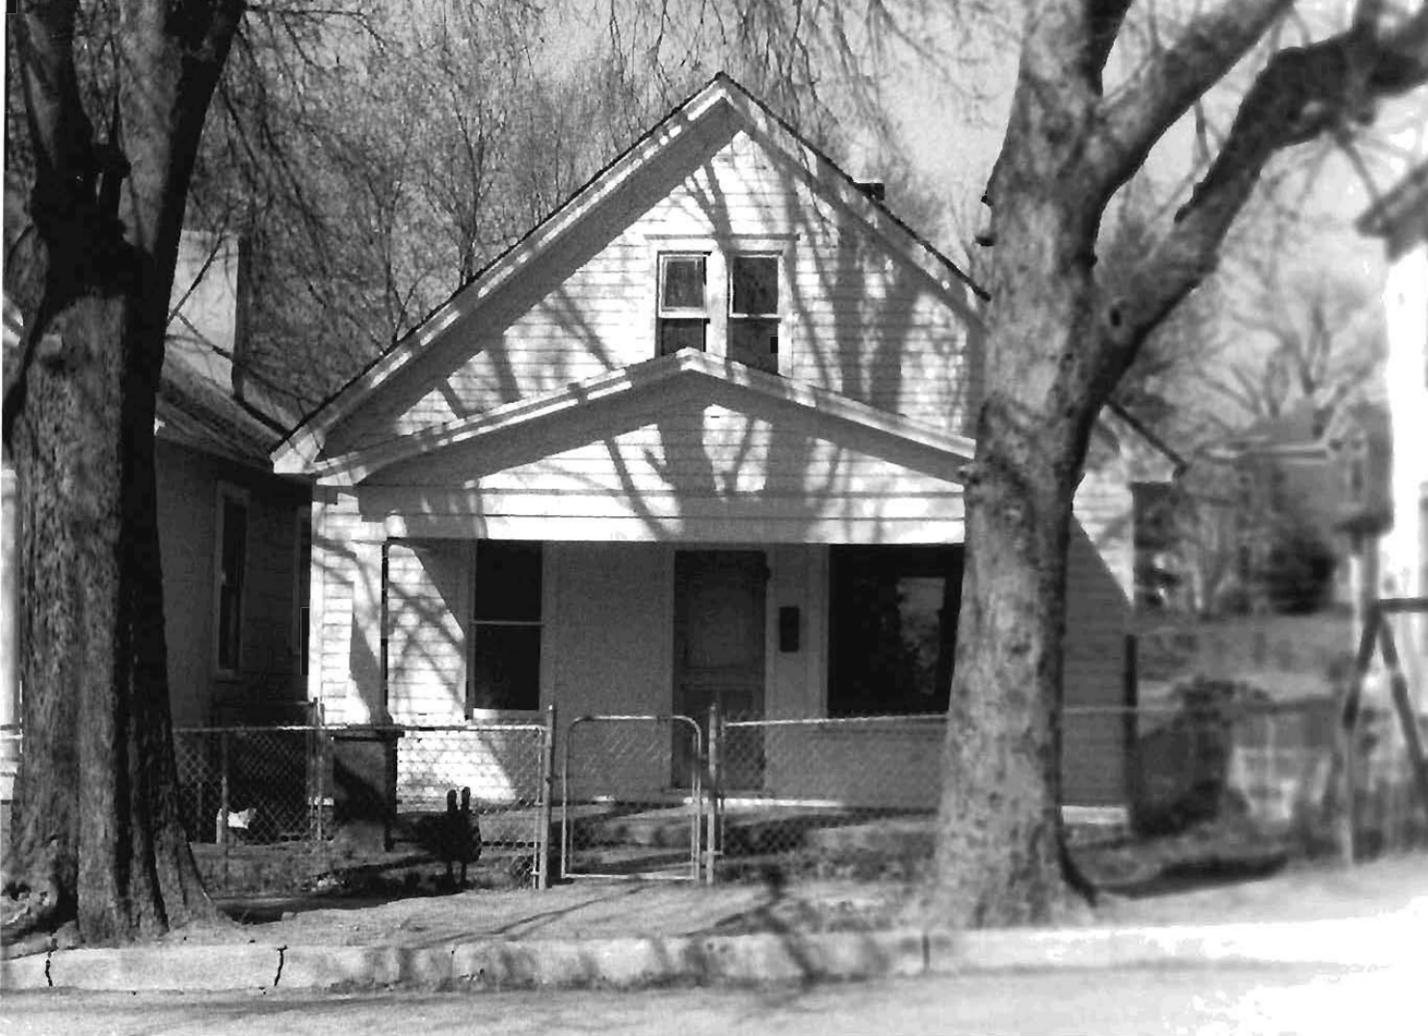
<p>42. FURTHER DESCRIPTION OF IMPORTANT FEATURES <b>1 1/2 story, 3 bay, symmetrical-ly massed, frame dwelling with front gable roof, molded cornice, plain frieze and corner boards. One-bay porch attached to front elevation (east) has masonry pedestals with tapered, square columns that support entablature and front gable roof. Left bay contains 1/1 window, center bay has single door; right bay has single light picture window (glazing is an alter-</b></p>	PHOTO MUST BE PROVIDED		4. PRESENT LOCAL NAME(S) OR DESIGNATION(S)
<p>43. HISTORY AND SIGNIFICANCE <b>half story.</b></p> <p><b>Building permit records indicate construction in 1888 for applicant, Honora Connors, who also applied for a permit in 1890 for two dwellings sited north of this property. It has a moderate degree of integrity and is significant as a representation of late 19th century vernacular residential property type.</b></p>	<p>44. DESCRIPTION OF ENVIRONMENT AND OUTBUILDINGS <b>In residential neighborhood; closely spaced dwellings w/shallow setbacks.</b></p>		5. OTHER NAME(S)

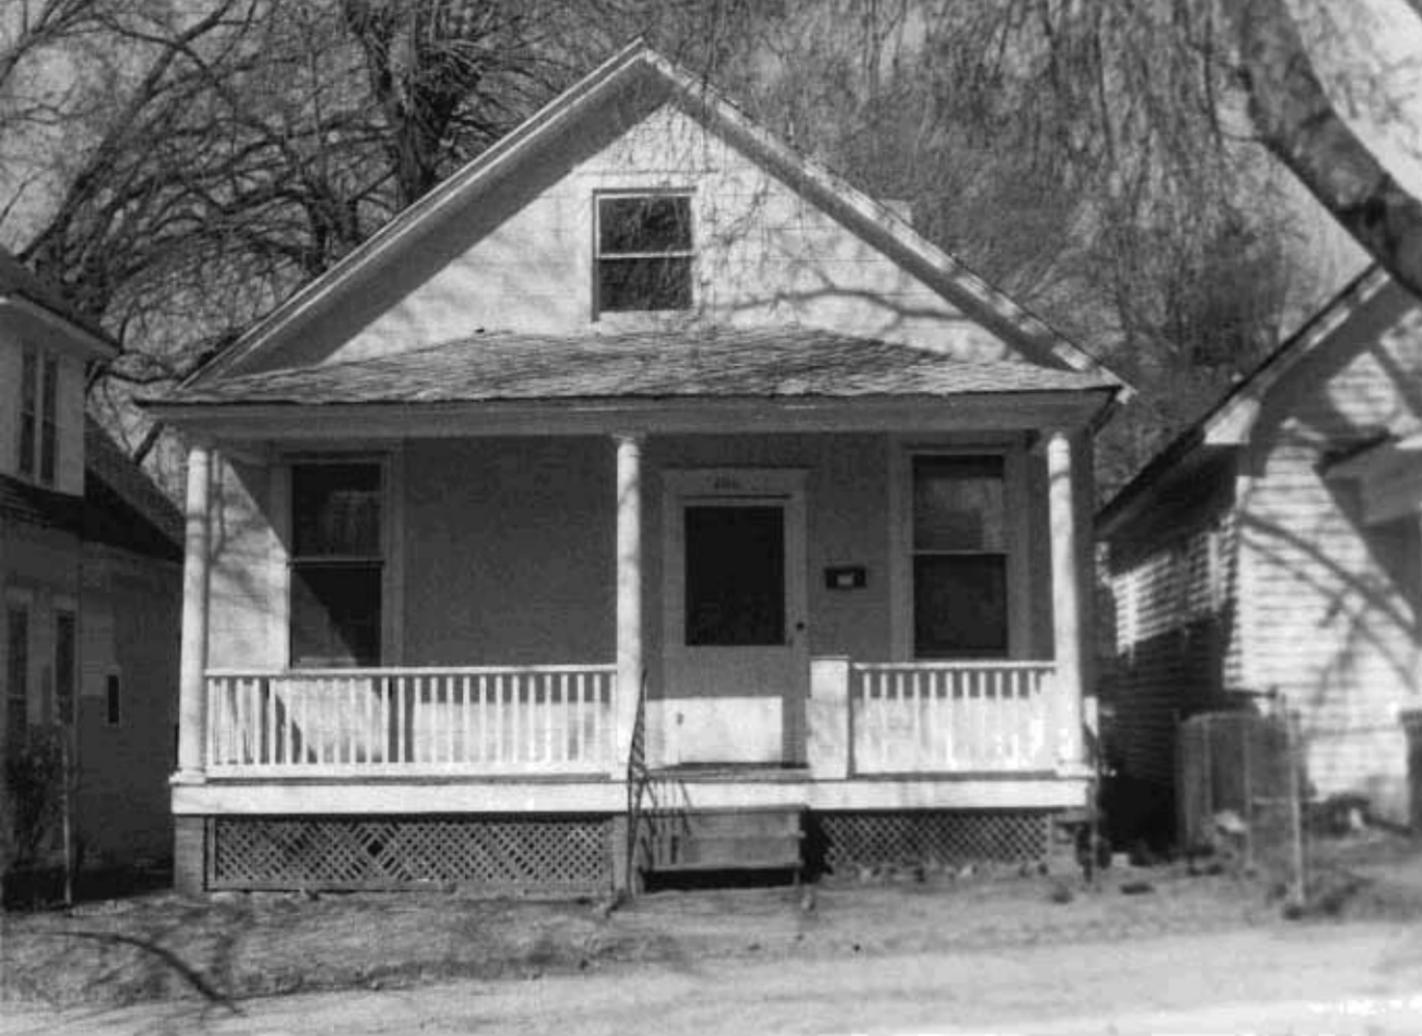
42. FURTHER DESCRIPTION OF IMPORTANT FEATURES <b>1½ story, 3 bay, asymmetrical, fram dwelling with front gable roof with molded cornice. Two-bay porch attached to front elevation has Tuscan columns that support a hip roof, open slat railing and wood lattice foundation infill. End bays contain 1/1 windows; center bay contains offset right single door entry. Smaller 1/1 window centered in gable half story. Asbestos siding is later alteration.</b>	<b>PHOTO MUST BE PROVIDED</b>
--	-------------------------------

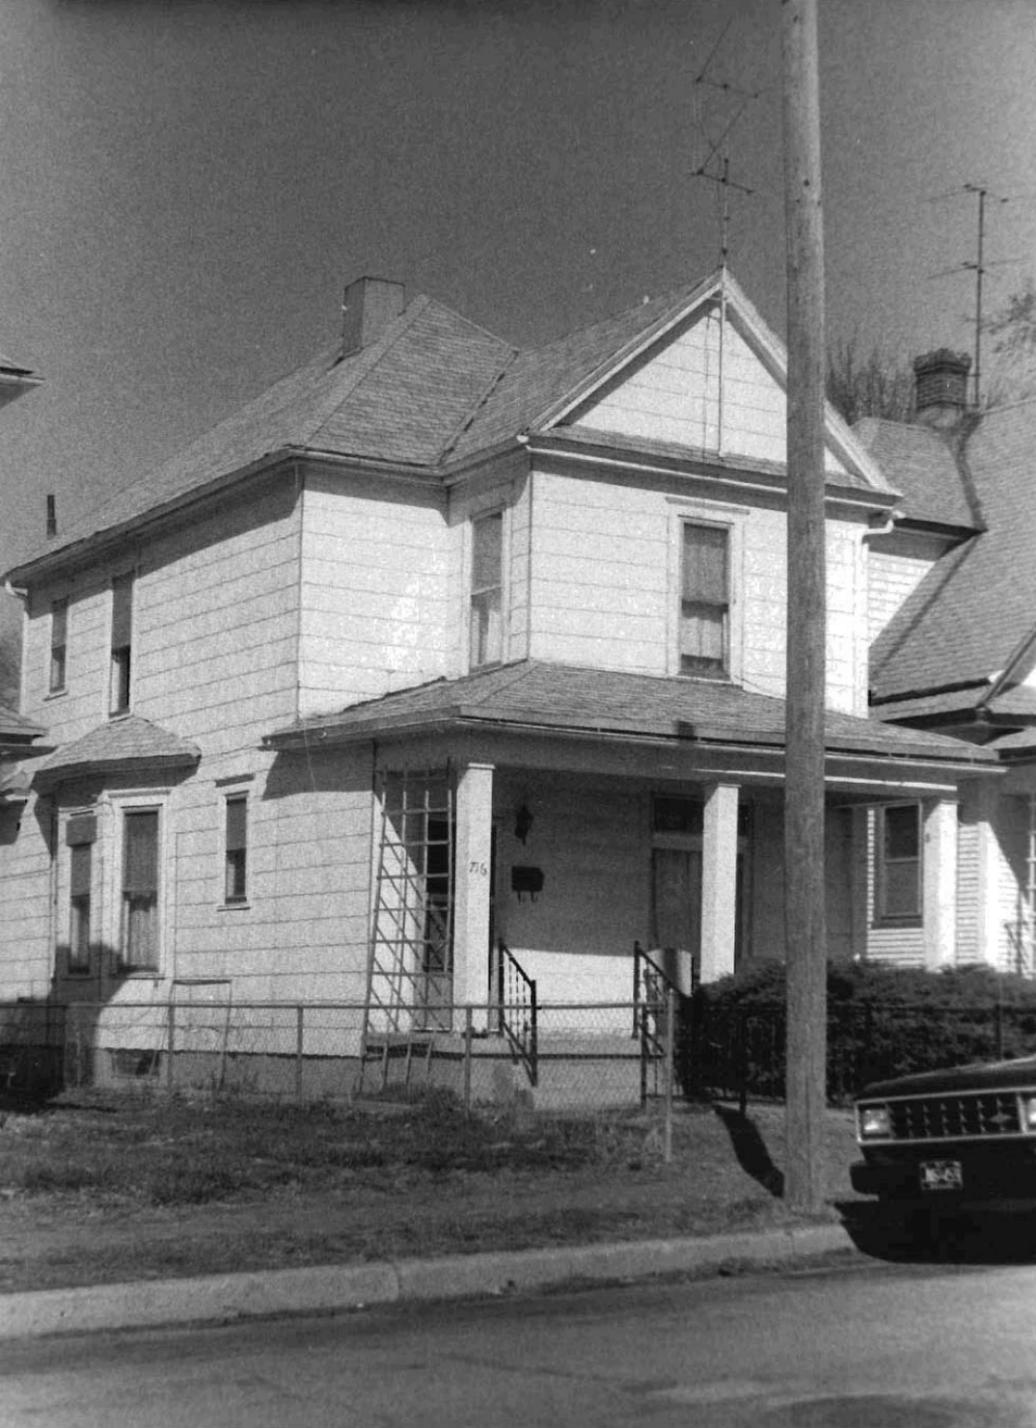
<p>47. ORGANIZATION <b>City of St. Joseph</b></p>	<p>44. DESCRIPTION OF ENVIRONMENT AND OUTBUILDINGS <b>In residential neighborhood; closely spaced dwellings w/narrow setbacks.</b></p>	<p>40. VISIBLE FROM PUBLIC ROAD? YES (X) NO ( )</p>	
<p>48. DATE <b>7/88</b></p>	<p>45. SOURCES OF INFORMATION <b>BP #A112-, 6/27/03; site</b></p>	<p>41. DISTANCE FROM AND FRONTAGE ON ROAD</p>	OFFICE OF HISTORIC PRESERVATION P.O. BOX 176 JEFFERSON CITY, MISSOURI 65102 PH. 314-751-4096
<p>49. REVISION DATE(S)</p>	<p>46. PREPARED BY <b>Mary Jo Winder</b></p>	<p>42. FURTHER DESCRIPTION OF IMPORTANT FEATURES <b>2 story, 2 bay, asymmetrical, frame dwelling with hip roof with front gable projection. Porch attached to front elevation (east) has square columns that support a plain entablature and hip roof. Left bay contains single door (originally was recessed). Right bay has picture window with transom on first story, 1/1 window in second. Fenestration has plain frames with narrow cornices.</b></p>

<p>RETURN THIS FORM WHEN COMPLETED TO:</p>	<p>47. ORGANIZATION <b>City of St. Joseph</b></p>	<p>43. HISTORY AND SIGNIFICANCE <b>Building permit records indicate construction in 1903 for applicant, E.V. Veath. It has a moderate degree of integrity and has moderate significance as a representation of early 20th century vernacular residential property type.</b></p>	48. DATE <b>7/88</b>
<p>IF ADDITIONAL SPACE IS NEEDED, ATTACH SEPARATE SHEET(S) TO THIS FORM</p>	<p>48. DATE <b>7/88</b></p>	<p>44. DESCRIPTION OF ENVIRONMENT AND OUTBUILDINGS <b>In residential neighborhood; closely spaced dwellings w/narrow setbacks.</b></p>	
<p>OFFICE OF HISTORIC PRESERVATION P.O. BOX 176 JEFFERSON CITY, MISSOURI 65102 PH. 314-751-4096</p>	<p>49. REVISION DATE(S)</p>	<p>45. SOURCES OF INFORMATION <b>BP #A112-, 6/27/03; site</b></p>	PHOTO MUST BE PROVIDED

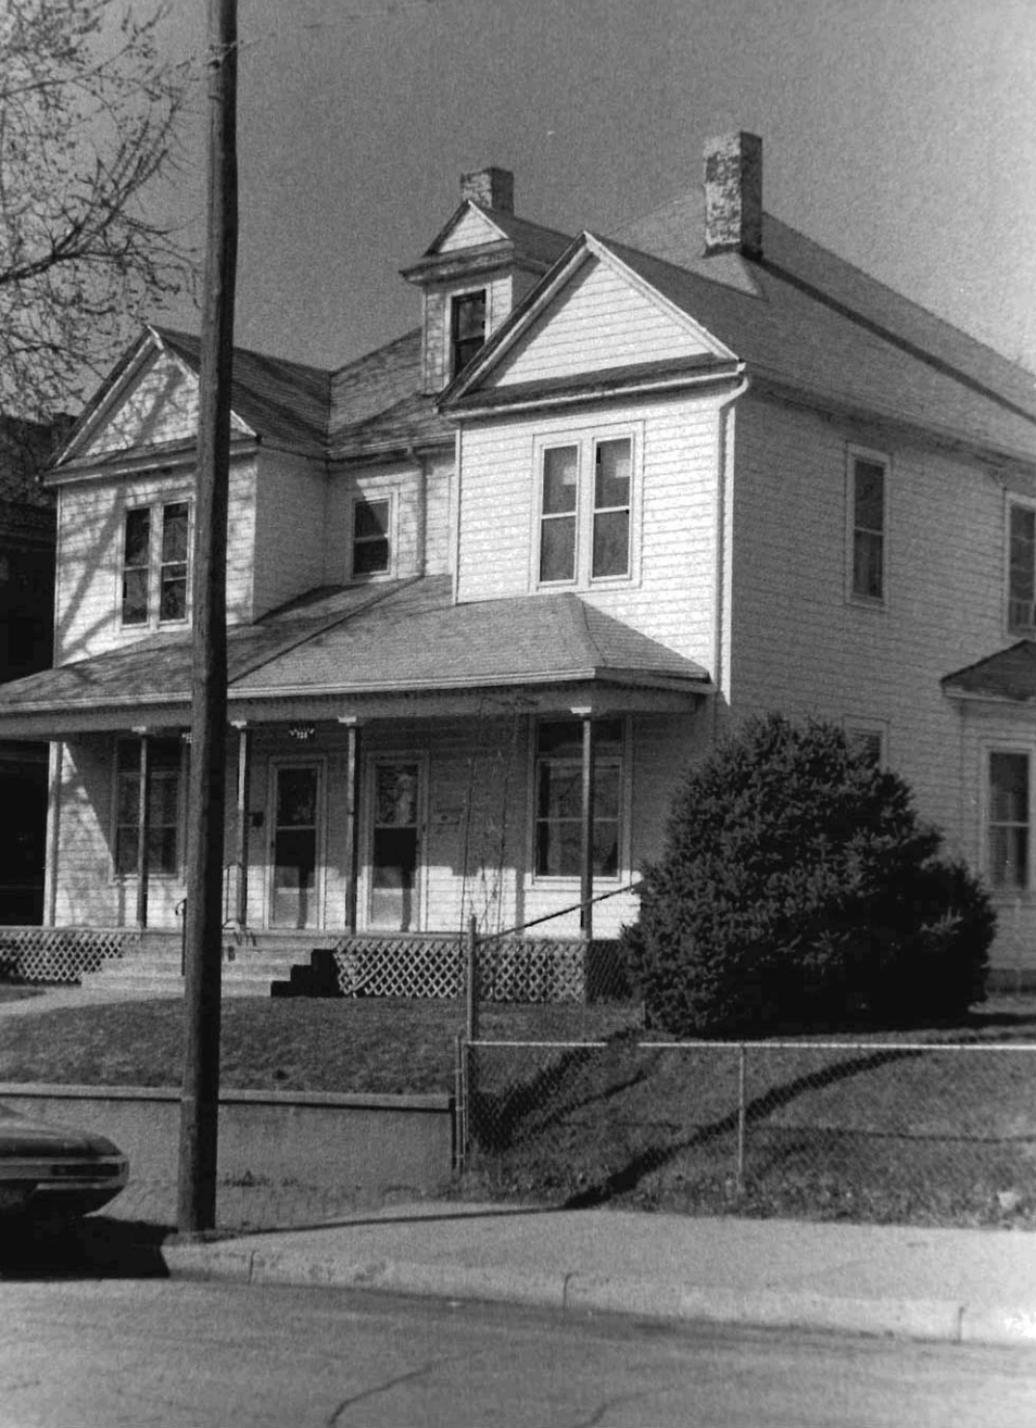
<p>42. FURTHER DESCRIPTION OF IMPORTANT FEATURES <b>2 story, 4 bay, symmetrical, frame, duplex dwelling with hip roof with projecting front gable roofs and centered gable roof dormer; centralized brick chimneys. Porch attached to front elevation (east) has been altered; original elements are an entablature with dentils and hip roof. End bays contain wide 1/1 windows with transoms; second story contains paired 1/1 windows; gabled hip roof</b></p>	<p><b>PHOTO MUST BE PROVIDED</b></p>	
<p>43. HISTORY AND SIGNIFICANCE <b>above. Center bays contain single doors; bays are recessed on second story; each has a small 1/1 window. Dormer has a small 1/1 window and gabled hip roof.</b></p> <p><b>43. Building permit records indicate original construction in 1902 for applicant, A.B. Demuth. It has a moderate to high degree of integrity due to alterations and is significant as a representation of early 20th century vernacular Classic Revival duplex property type.</b></p>

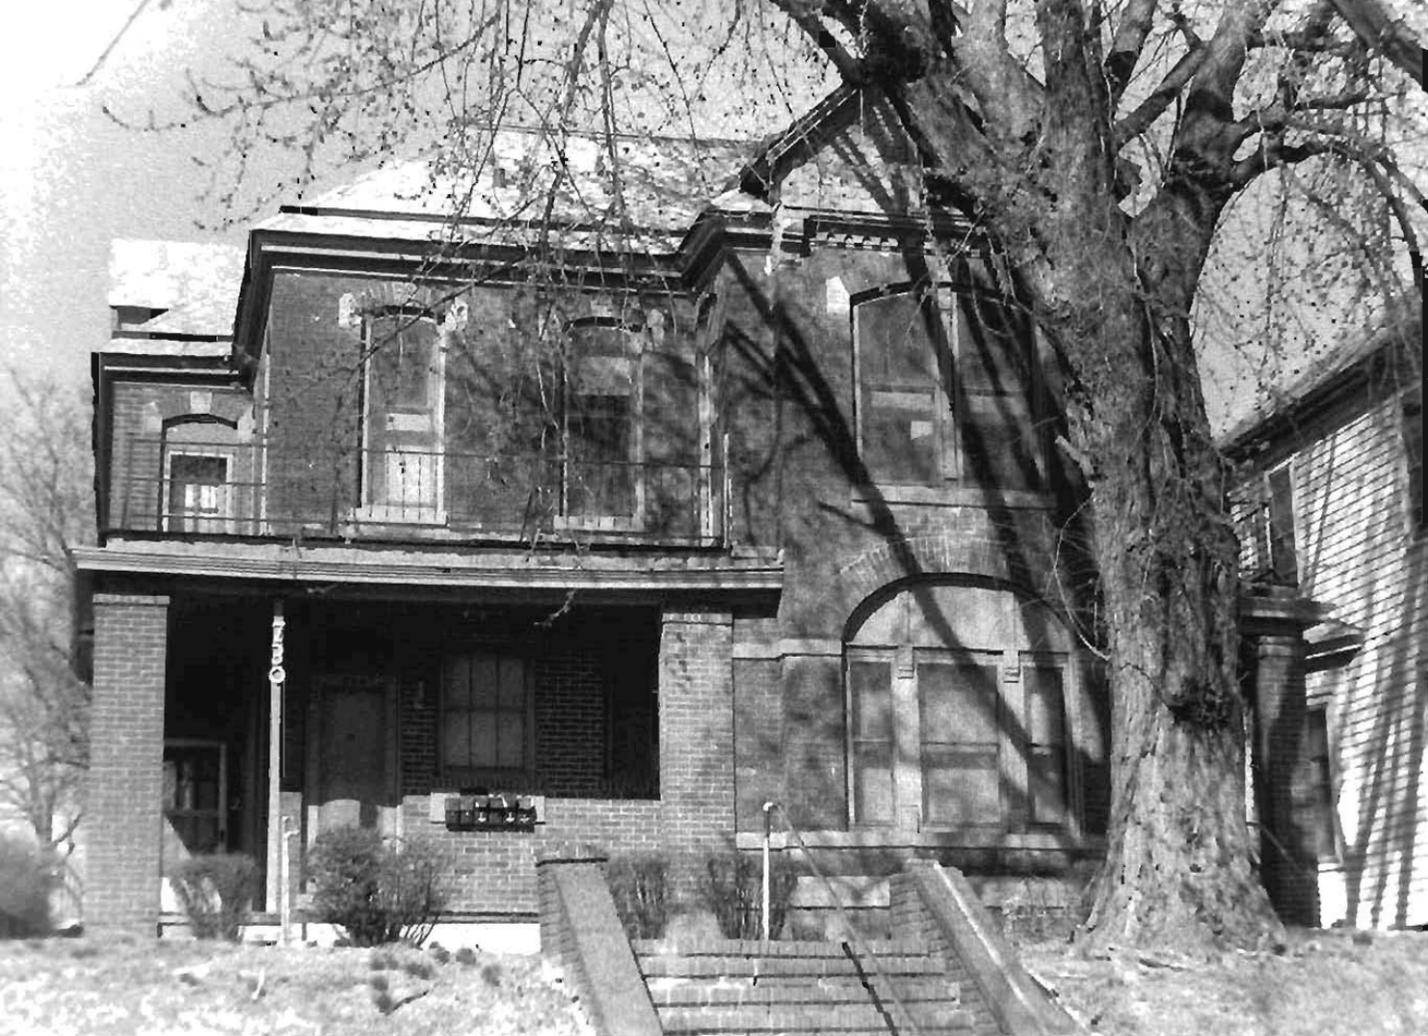
43. The only building permit for the dwelling is one issued to E.L. Spratt in 1925 when major alterations were performed on the existing ca1880 original structure. The existing porch may be an original configuration but elements are more recent. It has a high degree of integrity (excepting porch alteration) and is significant as a representation of transition Italianate/Queen Anne residential property type.

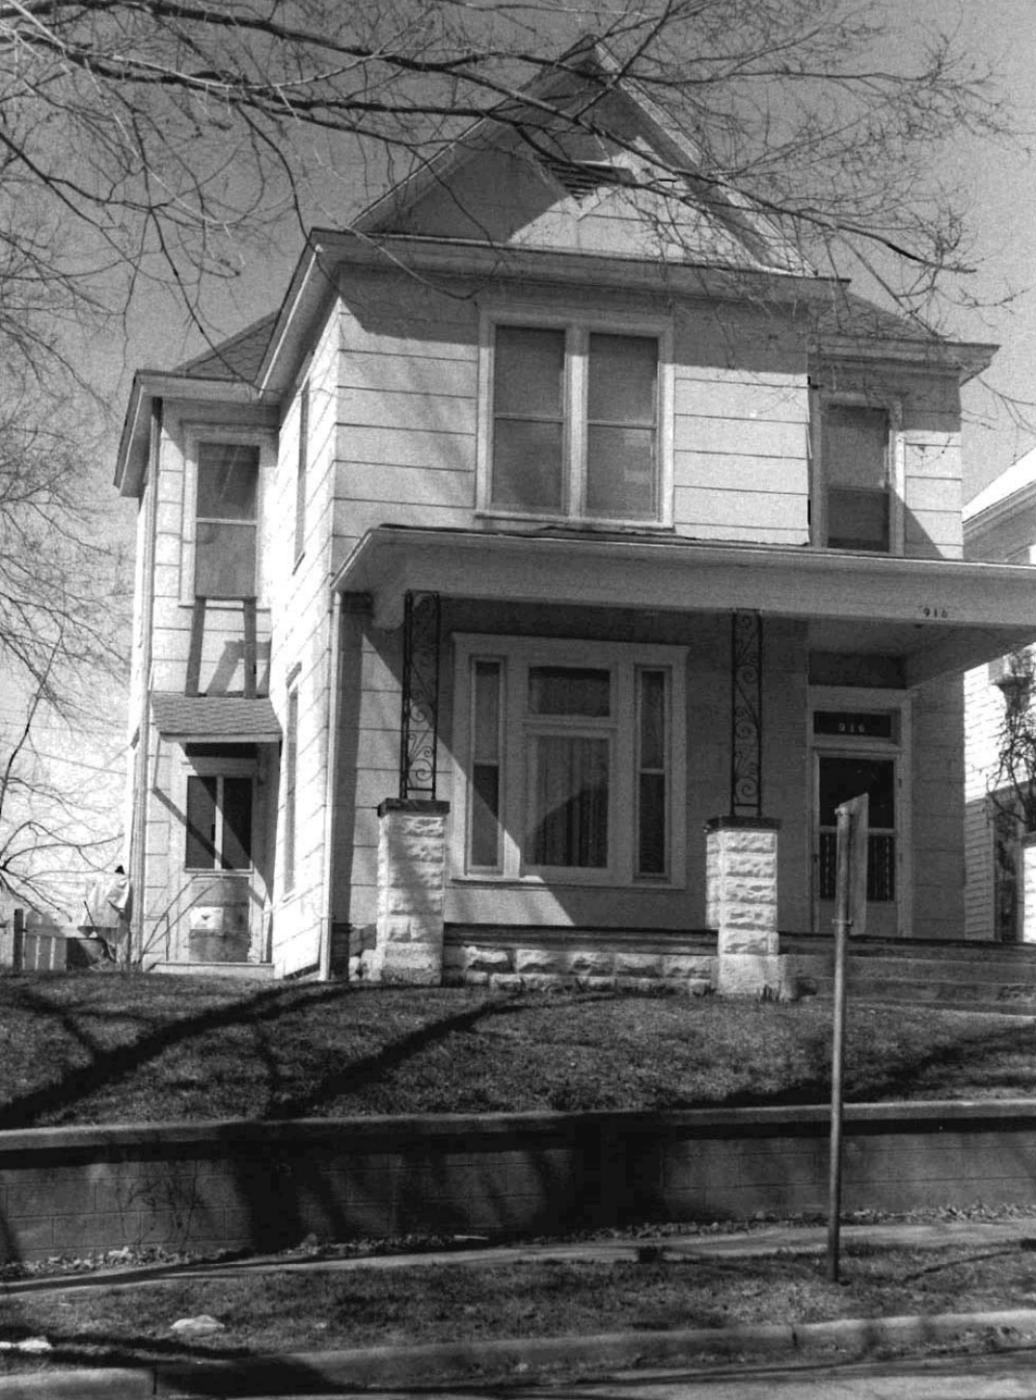
<b>43. HISTORY AND SIGNIFICANCE</b> enframed gable contains diamond shape vented opening. Slightly recessed right bay contains single door with transom and 1/1 window on second. All fenestration has plain frames with narrow cornices. Porch attached to second and third bays has newer wrought iron supports; original elements include stone pedestals, molded entablature and flat roof. 43. Building permit records indicate construction in 1896 for applicant, James T. Jackson. It has a moderate to high degree of architectural integrity due to alterations and is significant as a representation of late 19th century vernacular residential property type (probably originally exhibited Colonial Revival characteristics.) <b>44. DESCRIPTION OF ENVIRONMENT AND OUTBUILDINGS</b> In residential neighborhood primarily of ca1880-1900 dwellings.	6. TOWNSHIP		
<b>45. SOURCES OF INFORMATION</b> BP #4551, 5/9/96; site	<b>46. PREPARED BY</b> Mary Jo Winder <b>47. ORGANIZATION</b> City of St. Joseph <b>48. DATE</b> 7/88 <b>49. REVISION DATE(S)</b>	RANGE
