# MISSOURI OFFICE OF HISTORIC PRESERVATION

## ARCHITECTURAL/HISTORIC INVENTORY SURVEY FORM

BN-AS 004-001

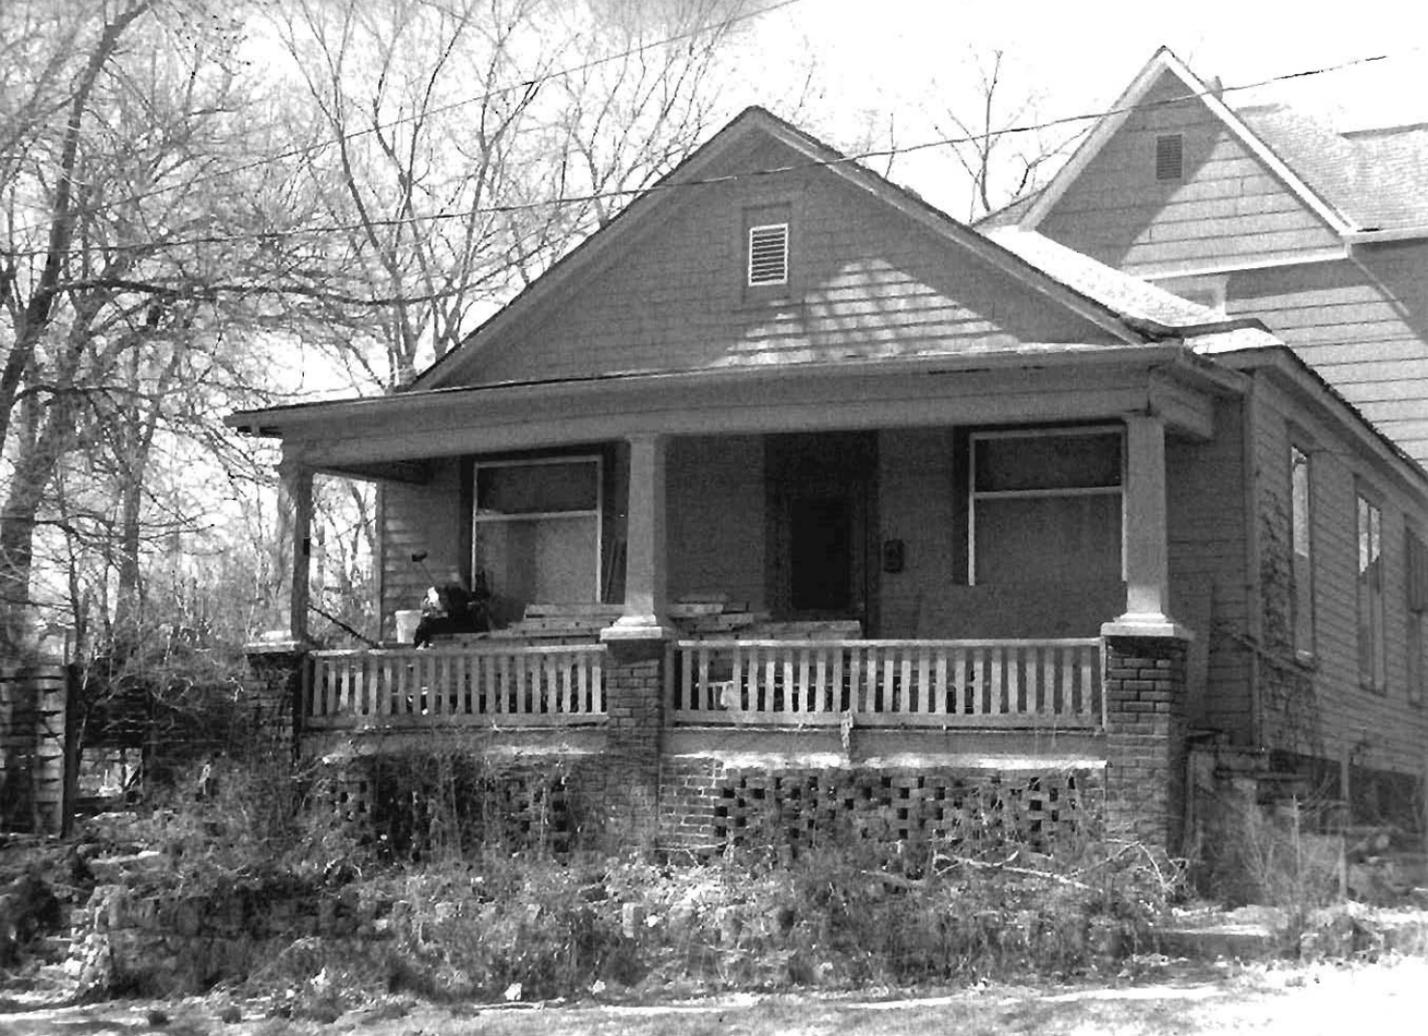
<p>42. FURTHER DESCRIPTION OF IMPORTANT FEATURES <b>1 story, 3 bay, asymmetrical, frame dwelling with hip roof, front gable projection, plain frieze and corner boards. Porch attached to front elevation (east) has open brick foundation infill, brick piers with tapered, square columns, molded entablature and flat roof. End bays contain picture windows; center bay has single door with transom. Gable wall has wood shingle siding and a small</b></p> <p>43. HISTORY AND SIGNIFICANCE <b>opening with vent insert. All fenestration has plain wood frames with narrow cornices.</b></p>		4. PRESENT LOCAL NAME(S) OR DESIGNATION(S)	
<p>44. DESCRIPTION OF ENVIRONMENT AND OUTBUILDINGS <b>In residential neighborhood; on corner lot; faces church on opposite side of street.</b></p>	<p>45. SOURCES OF INFORMATION <b>BP #D705, 3/13/90; BP #5-972, 8/11/22; site; 1897 Sanborn map</b></p>	5. OTHER NAME(S)	
<p>46. PREPARED BY <b>Mary Jo Winder</b></p> <p>47. ORGANIZATION <b>City of St. Joseph</b></p> <p>48. DATE <b>7/88</b></p> <p>49. REVISION DATE(S)</p>	<p>RETURN THIS FORM WHEN COMPLETED TO: <b>OFFICE OF HISTORIC PRESERVATION P.O. BOX 176 JEFFERSON CITY, MISSOURI 65102 PH. 314-751-4096</b></p> <p>IF ADDITIONAL SPACE IS NEEDED, ATTACH SEPARATE SHEET(S) TO THIS FORM</p>	6. TOWNSHIP

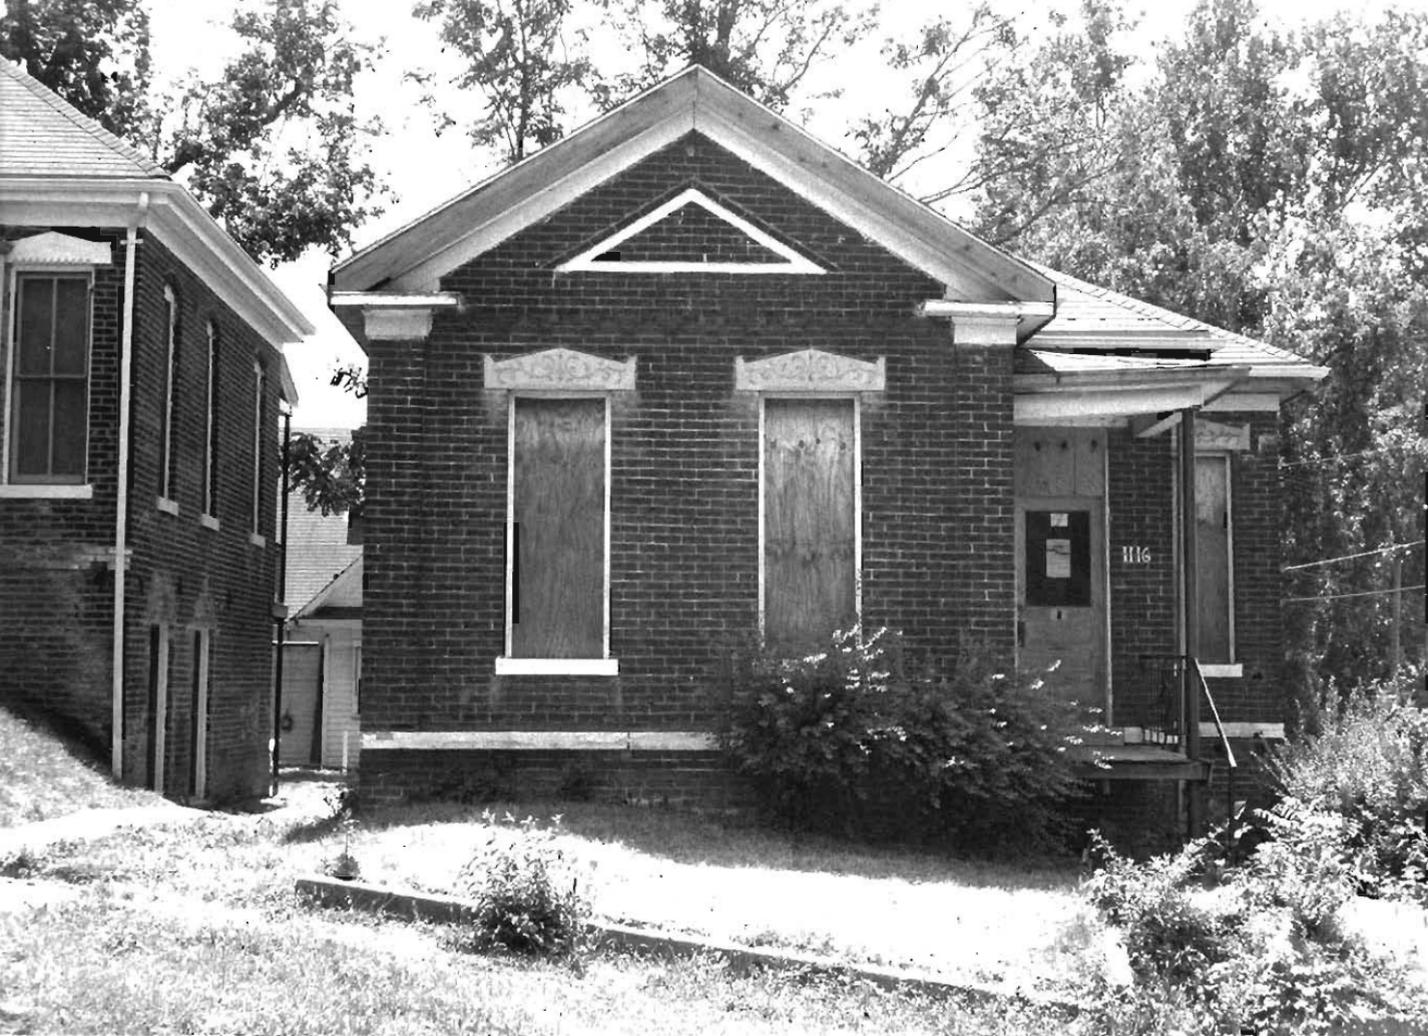
<p>42. FURTHER DESCRIPTION OF IMPORTANT FEATURES <b>1 story, 4 bay, asymmetrical, brick dwelling with hip and gable roof forms, molded frieze and stone water table. Two-bay front gable portion on left with window (boarded) in each; lug sills and pedimented stone lintel with incised ornamentation. Gable ornamented with triangular panel and molded returns. Recessed third bay has single door with boarded transom; small porch</b></p>	<p><b>PHOTO MUST BE PROVIDED</b></p>	6. TOWNSHIP RANGE SECTION
<p>43. HISTORY AND SIGNIFICANCE <b>attached is of new elements. Fourth bay is further recessed and has a window as in first and second bays.</b></p> <p><b>There are no building permits of record for this dwelling; however, Sanborn maps indicate construction between 1883 and 1888 (it does not appear on the map of 83). It was constructed at the same time as three similar dwellings on the block. It has a high degree of integrity and is significant as a representation of vernacular Queen Anne residential property type.</b></p>	<p>44. DESCRIPTION OF ENVIRONMENT AND OUTBUILDINGS <b>In residential neighborhood primarily of ca1870-1890 dwellings.</b></p>

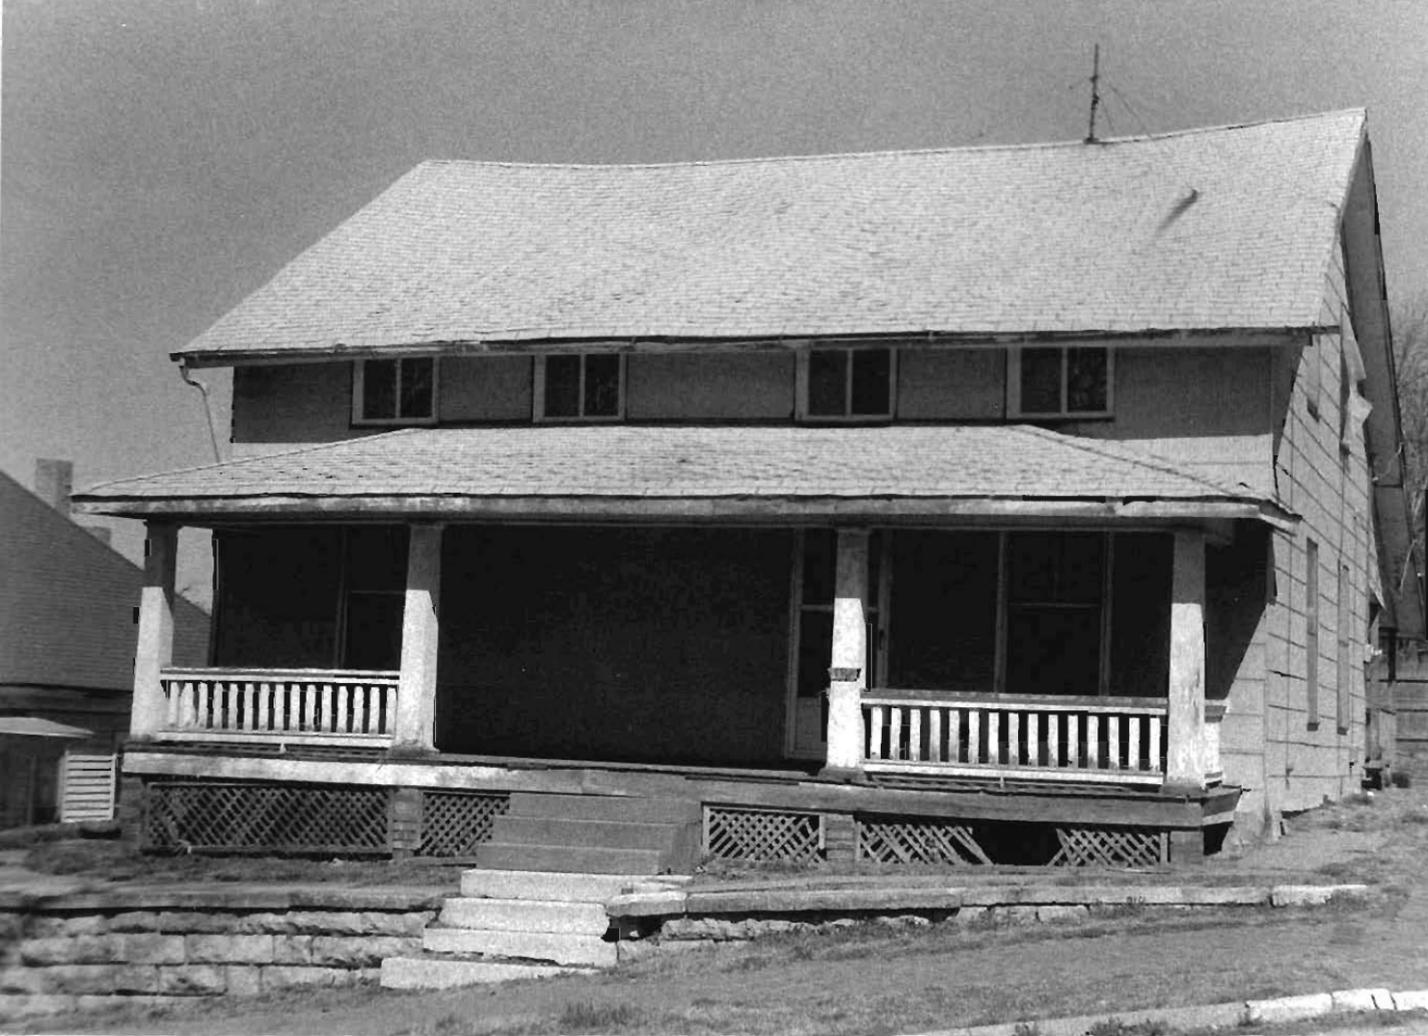
<p>42. FURTHER DESCRIPTION OF IMPORTANT FEATURES <b>1 3/4 story, 3 bay, symmetrically massed, frame dwelling with side gable roof. Porch attached to front elevation (south) is later (ca. 1900) alteration; it has three bays and square wood columns, open slat railing, hip roof and lattice foundation infill. End bays contain 2/1 windows; off-set right single door entry was probably balanced by another that has been closed over on the</b></p> <hr/> <p>43. HISTORY AND SIGNIFICANCE <b>left (1911 Sanborn maps indicates the building as a duplex). Upper story windows are symmetrically spaced two light units with vertical mullions.</b></p> <p><b>43. The earliest building permit of record for this dwelling is one for a wood shed in 1894 for applicant, J.F. Lehey; however characteristics indicate an original ca1860 construction date. It has a moderate degree of integrity and is significant as a representation of mid 19th century vernacular residential property type.</b></p>	<div style="border: 2px solid black; padding: 20px; width: 100px; margin: 0 auto;"> <p style="text-align: center; font-weight: bold;">PHOTO MUST BE PROVIDED</p> </div>	4. PRESENT LOCAL NAME(S) OR DESIGNATION(S)

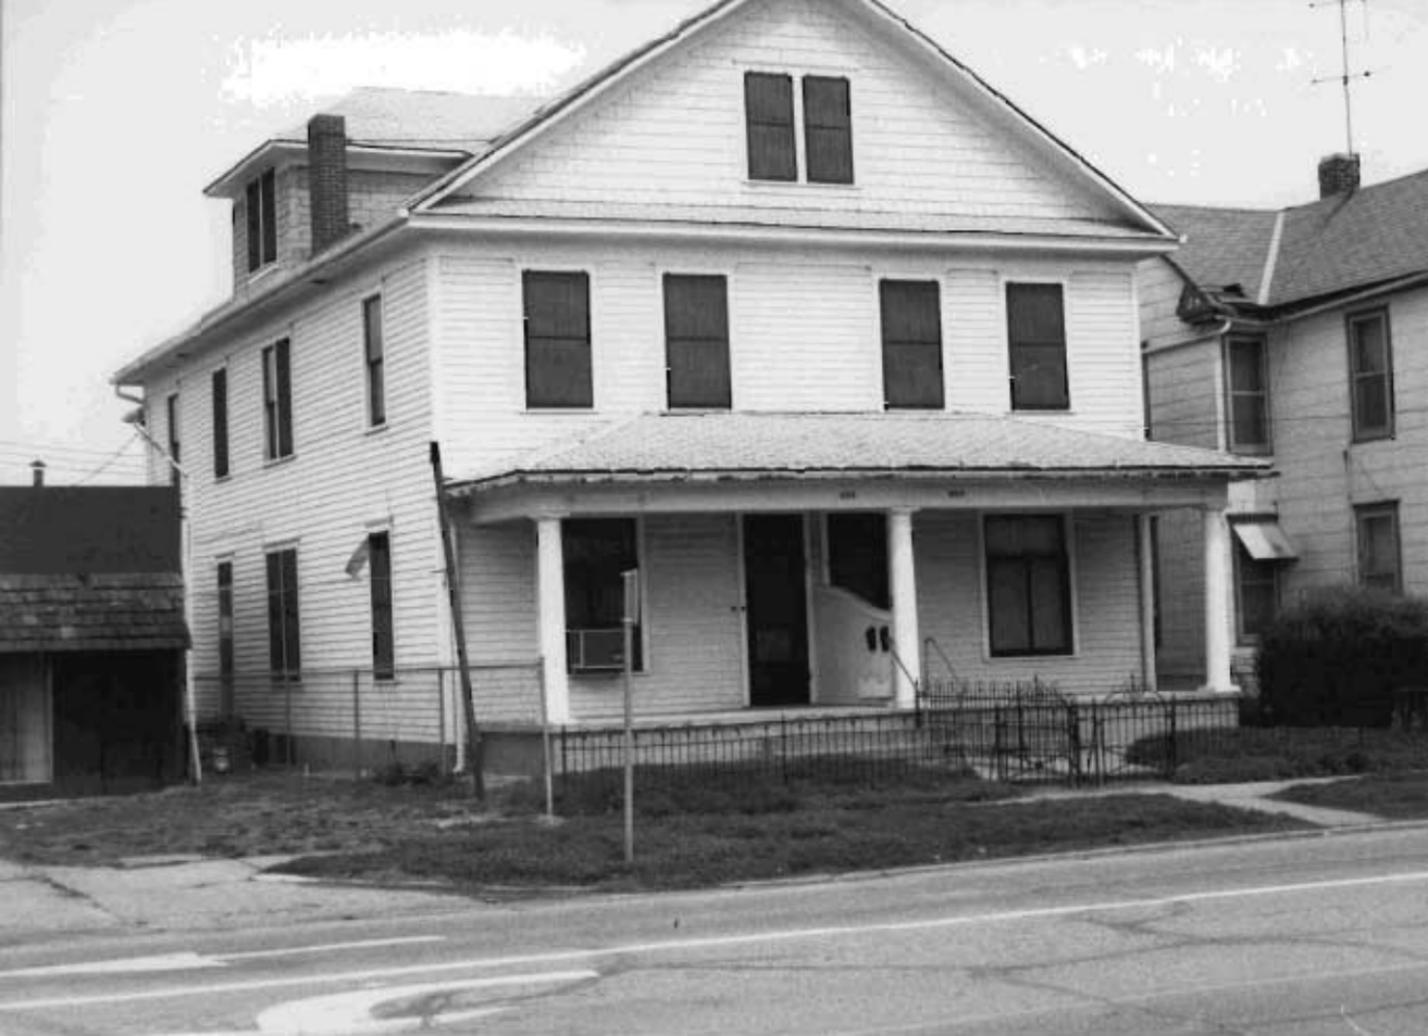
<p>42. FURTHER DESCRIPTION OF IMPORTANT FEATURES <b>1 1/2 story, 4 bay, asymmetrical frame dwelling with varying hip, hipped gable and gable roof forms. Left bay is a first story hip roof projecting wing that contains 1/1 windows. Second bay has a wide window with transom; two 1/1 double hung windows in upper cropped-gable half story. Third bay is recessed and contains a 1/1 window; gable roof dormer with 1/1 window offset to the right. Fourth bay is the side veranda, which wraps around corner of building to include the third bay and all of east side elevation; supports are turned posts on brick pedestals. First story windows have pedimented lintels.</b></p> <p>43. HISTORY AND SIGNIFICANCE <b>Building permit records indicate a construction phase in 1897 for applicant, E.G. Bjurstrom; however, the original construction probably is pre1887. It has a moderate degree of integrity due to excessive alterations and has moderate significance as a representation of late 19th century vernacular residential property type.</b></p>	<div style="border: 2px solid black; padding: 20px; text-align: center;"> <p>PHOTO MUST BE PROVIDED</p> </div>	4. PRESENT LOCAL NAME(S) OR DESIGNATION(S)

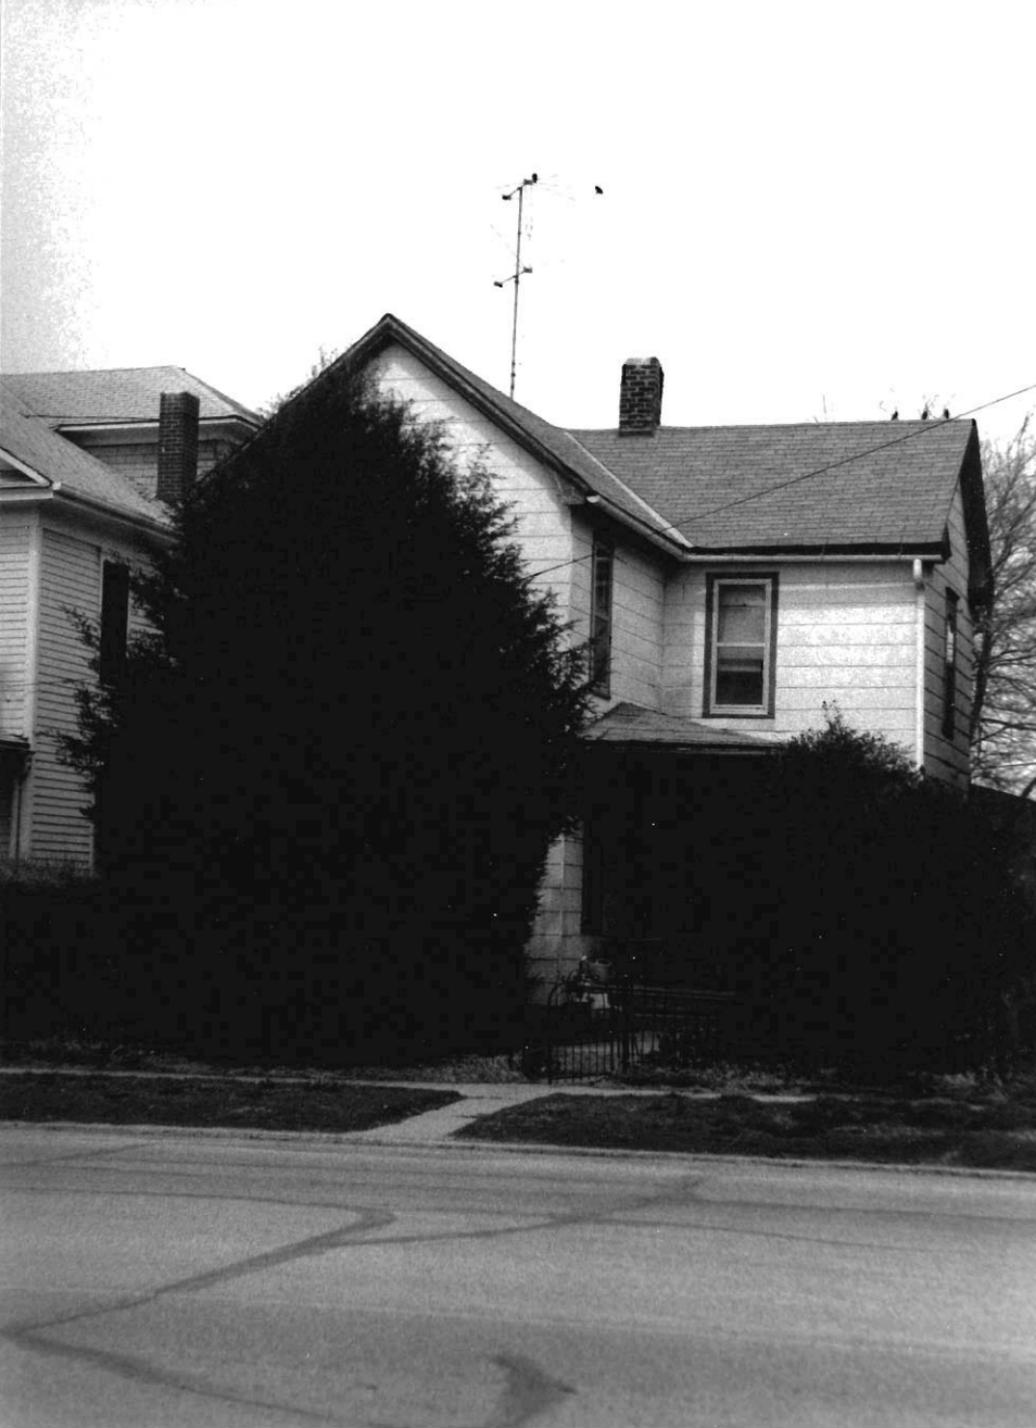
<p>42. FURTHER DESCRIPTION OF IMPORTANT FEATURES <u>2 story, 3 bay, asymmetrical, frame dwelling with cross gable roof and centralized brick chimney. Recessed left bay contains 1/1 window, both stories, projecting front gable wing has picture window with transom, both stories; recessed right bay has picture window with transom on first story and 1/1 window on second. Porch attached to right bay and hip roof. Asbestos siding is a</u></p> <p>43. HISTORY AND SIGNIFICANCE <u>later alteration.</u></p> <p>Building permit records indicate a construction phase in 1901 for applicant, Mrs. N.F. Murray; however, stylistic features indicate a ca1860 original construction. The first record of its existence is on the 1883 Sanborn map. It has a moderate degree of integrity and is significant as a representation of vernacular "I" house property type (mid 19th century).</p>	<p style="font-size: 2em; margin: 0;">X</p> <p style="text-align: center; margin: 0;">PHOTO MUST BE PROVIDED</p>	4. PRESENT LOCAL NAME(S) OR DESIGNATION(S)

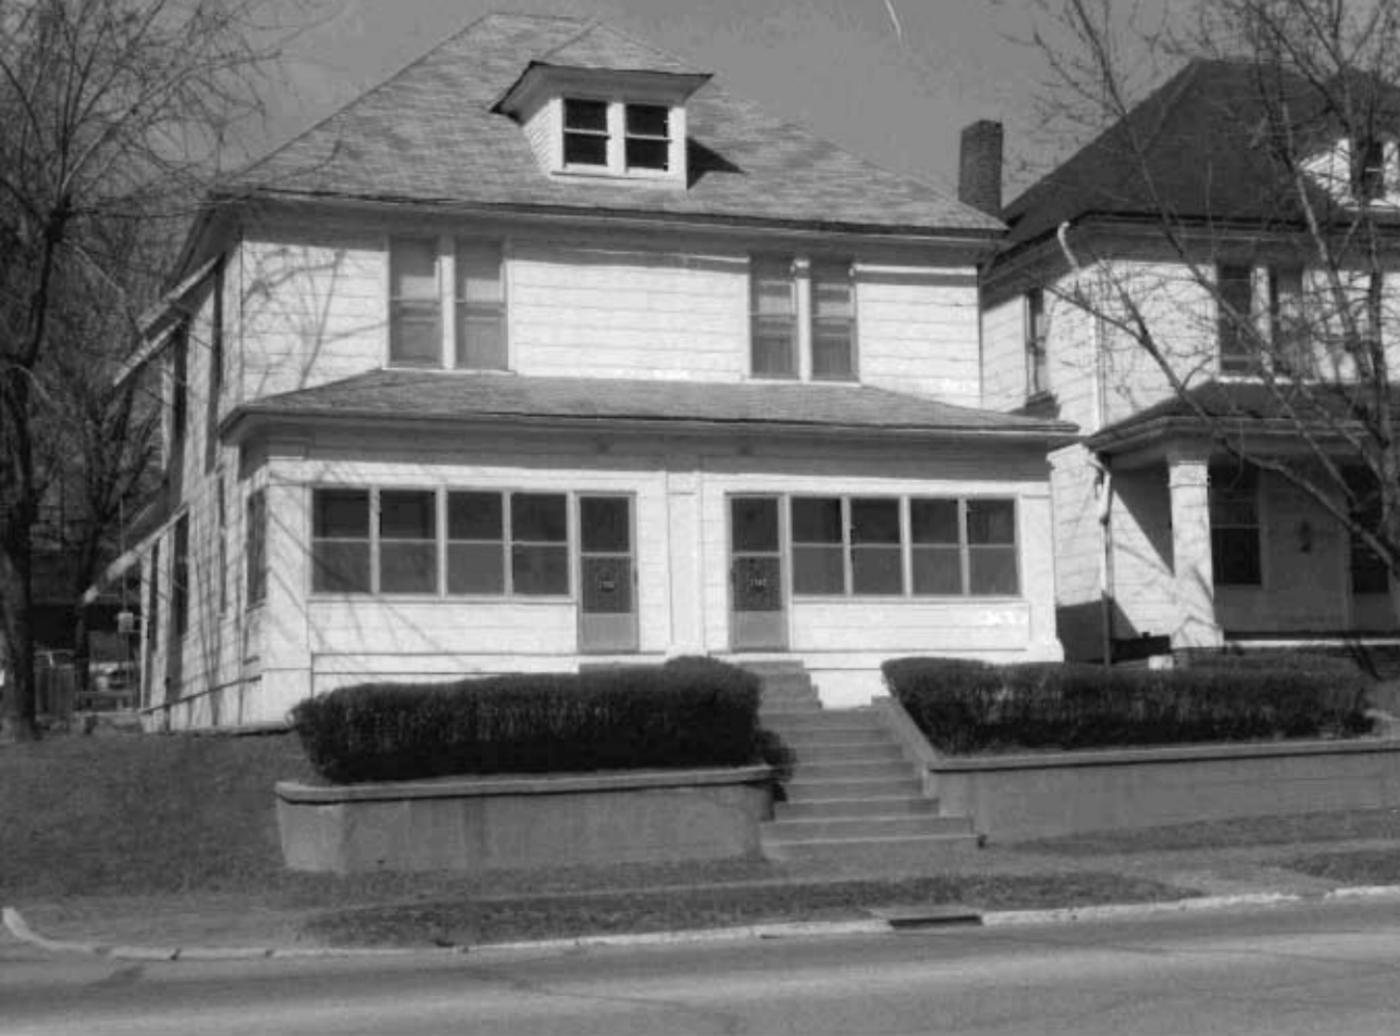
<b>42. FURTHER DESCRIPTION OF IMPORTANT FEATURES</b> 2½ story, 2 bay, symmetrical frame duplex dwelling with hip roof with boxed cornice, plain fascia and hip roof dormer. Porch has been enclosed, otherwise is same dwelling as 1305-07 Mitchell. Wood panel separates unit doors and bands of windows on either side. Two-bay second story has paired 1/1 windows. Dormer contains smaller paired 1/1 windows.  <b>43. HISTORY AND SIGNIFICANCE</b>  Building permit records indicate construction in 1903 for applicant, N.B. Taynor, who is listed as applicant on similar building on adjoining lot to east. It has a moderate degree of integrity due to alterations and is significant as a representation of early 20th century Classic Revival duplex property type.	PHOTO MUST BE PROVIDED	4. PRESENT LOCAL NAME(S) OR DESIGNATION(S)	
<b>44. DESCRIPTION OF ENVIRONMENT AND OUTBUILDINGS</b>  At edge of residential neighborhood; faces block of industrial/warehouse buildings.	<b>45. SOURCES OF INFORMATION</b> Site; BP# 1258, 8/28/03	5. OTHER NAME(S)

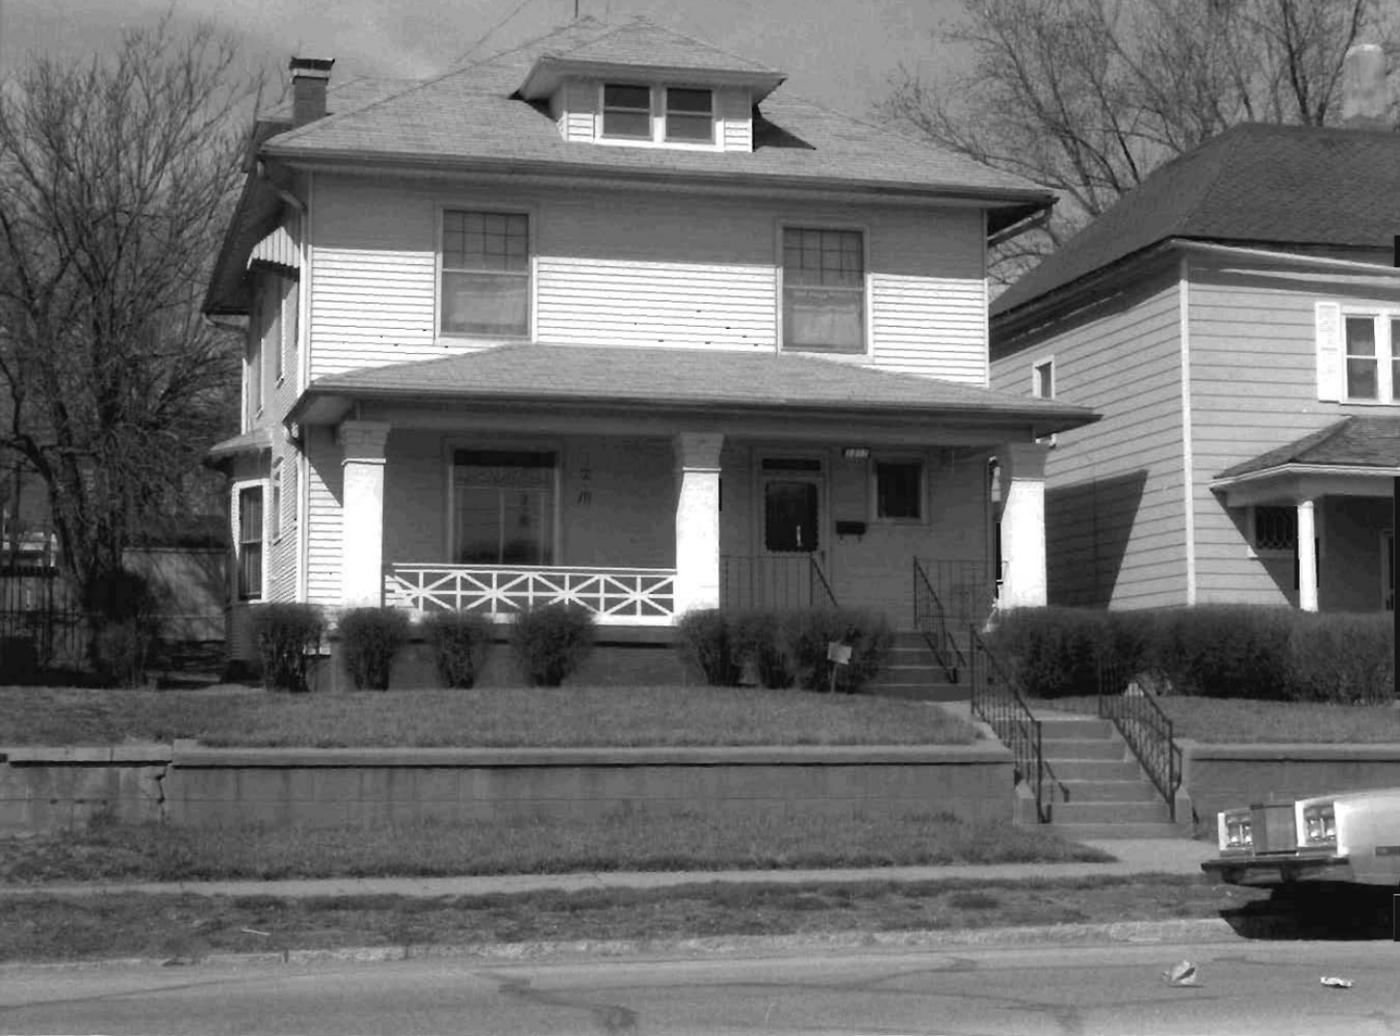
BN-AS 004-098

<p>42. FURTHER DESCRIPTION OF IMPORTANT FEATURES <b>2½ story, 2 bay, asymmetrical, frame dwelling with hip roof with boxed cornice and hip roof dormers. Porch attached to front elevation (south) has brick foundation, wide, square columns with geometric capitals, open railing and hip roof. Left bay contains wide window with leaded transom; right bay has single door with narrow transom and small square window. Symmetrical upper facade has wide 12/1</b></p> <p>43. HISTORY AND SIGNIFICANCE <b>windows. Dormer contains small paired 8/1 windows. Building permit records indicate construction in 1909 for applicant, Miss H.E. Mecum. It has a high degree of integrity and is significant as a representation of vernacular Neoclassical residential property type.</b></p>		<p><b>PHOTO MUST BE PROVIDED</b></p>
<p>44. DESCRIPTION OF ENVIRONMENT AND OUTBUILDINGS <b>In residential neighborhood; faces industrial/warehouse zone.</b></p>

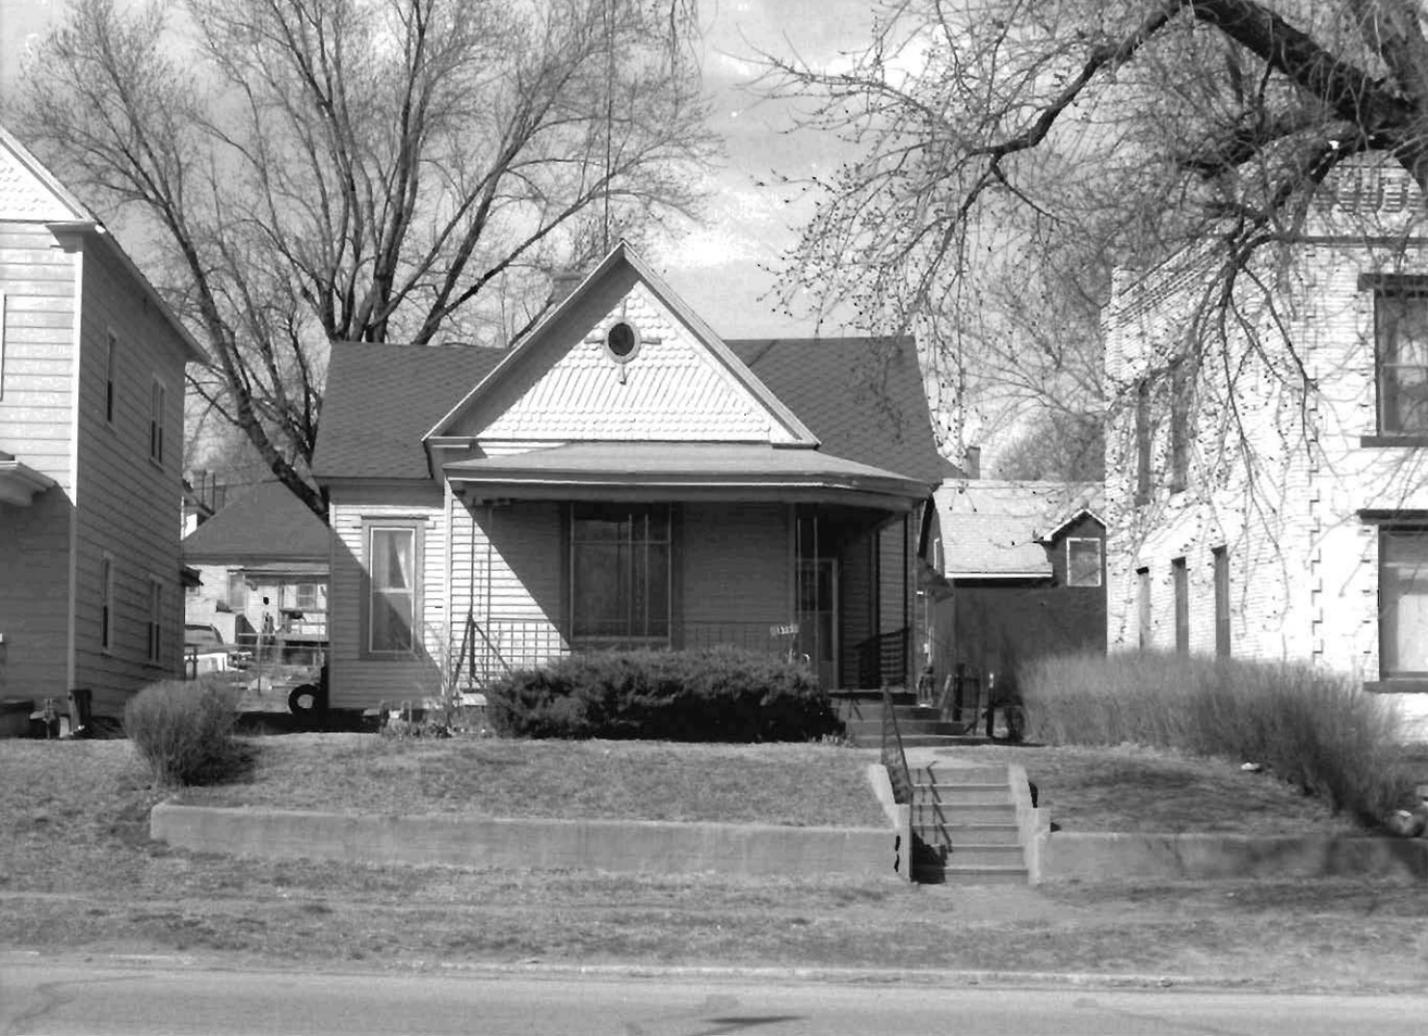
BU-PS-004-100

<b>11. ON NATIONAL REGISTER?</b> YES ( ) NO (X)	<b>12. IS IT ELIGIBLE?</b> YES (X) NO ( )		5. OTHER NAME(S)
<b>13. PART OF ESTAB. HIST. DISTRICT?</b> YES ( ) NO (X)	<b>14. DISTRICT POTENTIAL?</b> YES (X) NO ( )			
<b>15. NAME OF ESTABLISHED DISTRICT</b>	<b>42. FURTHER DESCRIPTION OF IMPORTANT FEATURES</b> 1 story, 3 bay, asymmetrical, frame dwelling with cross gable roof, plain frieze and corner boards. Recessed left bay contains a 1/1 window. Projecting front gable wing contains wide 1/1 window (upper sash in top 1/3); gable wall has patterned wood shingles and oval opening (now closed). Recessed right bay contains a single door with transom. Wrap-around porch attached to center and right bay		6. TOWNSHIP	
<b>43. HISTORY AND SIGNIFICANCE</b> Roof is original.  Building permit records indicate construction in 1903 for applicant Charles E. Herycele. It has a moderate to high degree of integrity and is significant as a representation of transitional Queen Anne/Colonial Revival residential property type.	<div style="border: 2px solid black; padding: 10px; text-align: center;">                     PHOTO MUST BE PROVIDED                 </div>

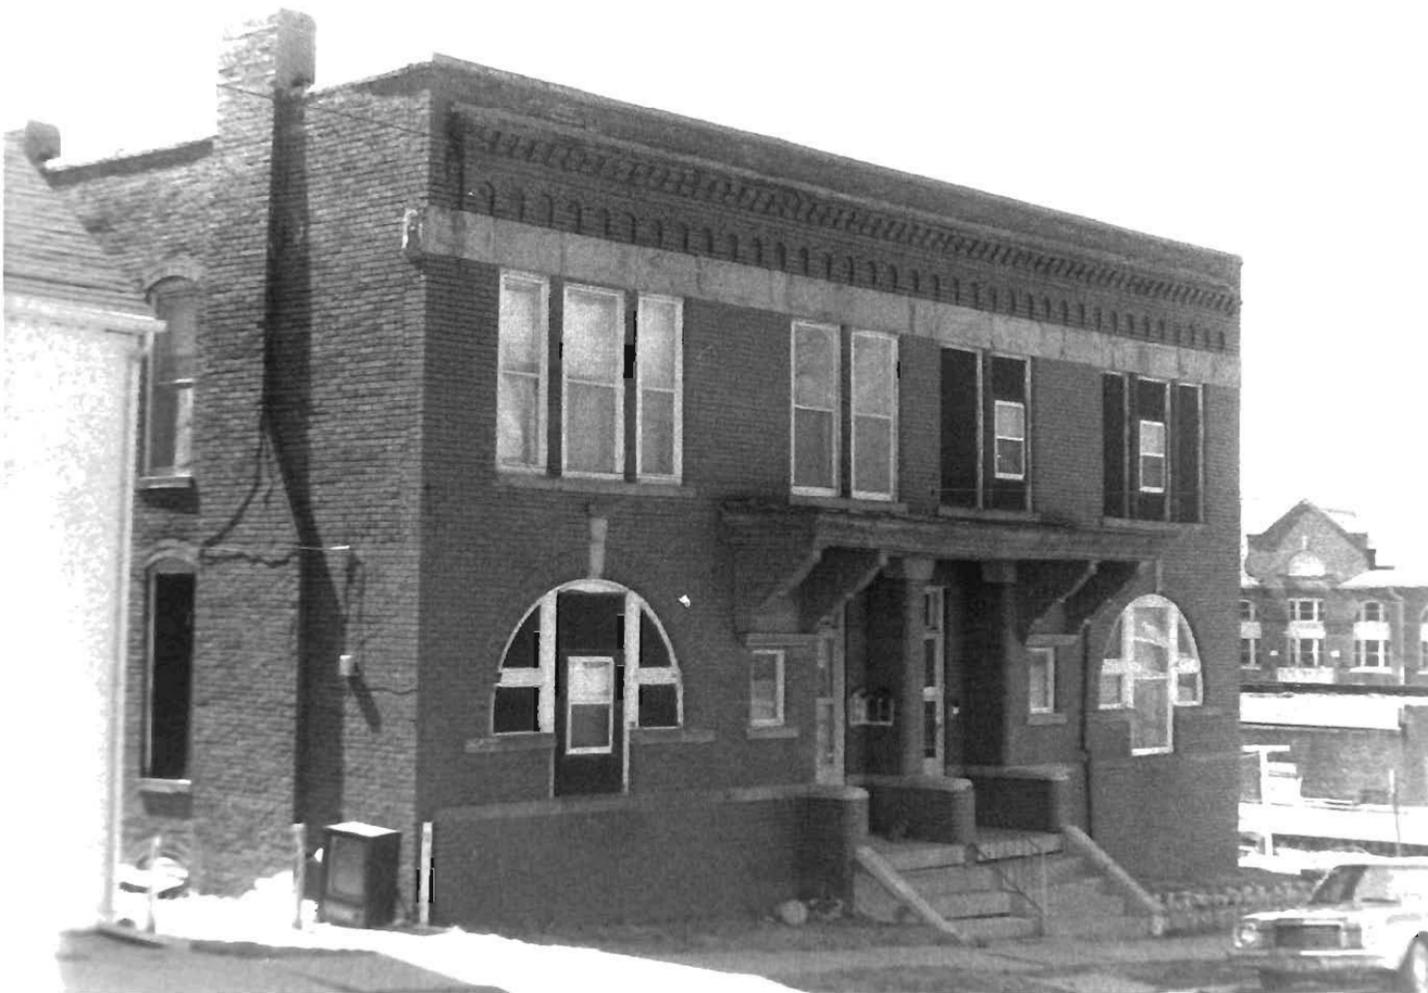
<p>42. FURTHER DESCRIPTION OF IMPORTANT FEATURES <b>2 story, 4 bay, symmetrical, brick multi-family dwelling with flat roof; side, brick chimneys, stone belt course above second story windows with brickwork pattern of arcade and bracketed cornice on parapet wall. Center bays contain recessed single door entries with transoms; smooth cornered brick on edges around entries; small single light windows on either side of entries; flat roof over</b></p> <hr/> <p>43. HISTORY AND SIGNIFICANCE <b>bays supported by heavy brackets; second story center bays contain paired l/l windows (openings altered on right side). End bays have Romanesque semi-circular arched openings on first story; stone sills and keystone; original configuration is right bay with l/l window with shortened sidelights; second story has grouping of rectangular opening, center and narrower sidelights.</b></p> <hr/> <p>43. <b>Building permit records indicate construction in 1889 for applicant, W.O. McReynolds. It has a moderate to high degree of integrity and is significant as a representation of Romanesque/Classic Revival multi-family property type.</b></p> <hr/> <p>44. DESCRIPTION OF ENVIRONMENT AND OUTBUILDINGS <b>At edge of residential neighborhood; commercial zone to west.</b></p>	<div style="border: 2px solid black; padding: 20px; text-align: center;"> <p>PHOTO MUST BE PROVIDED</p> </div>	5. OTHER NAME(S)

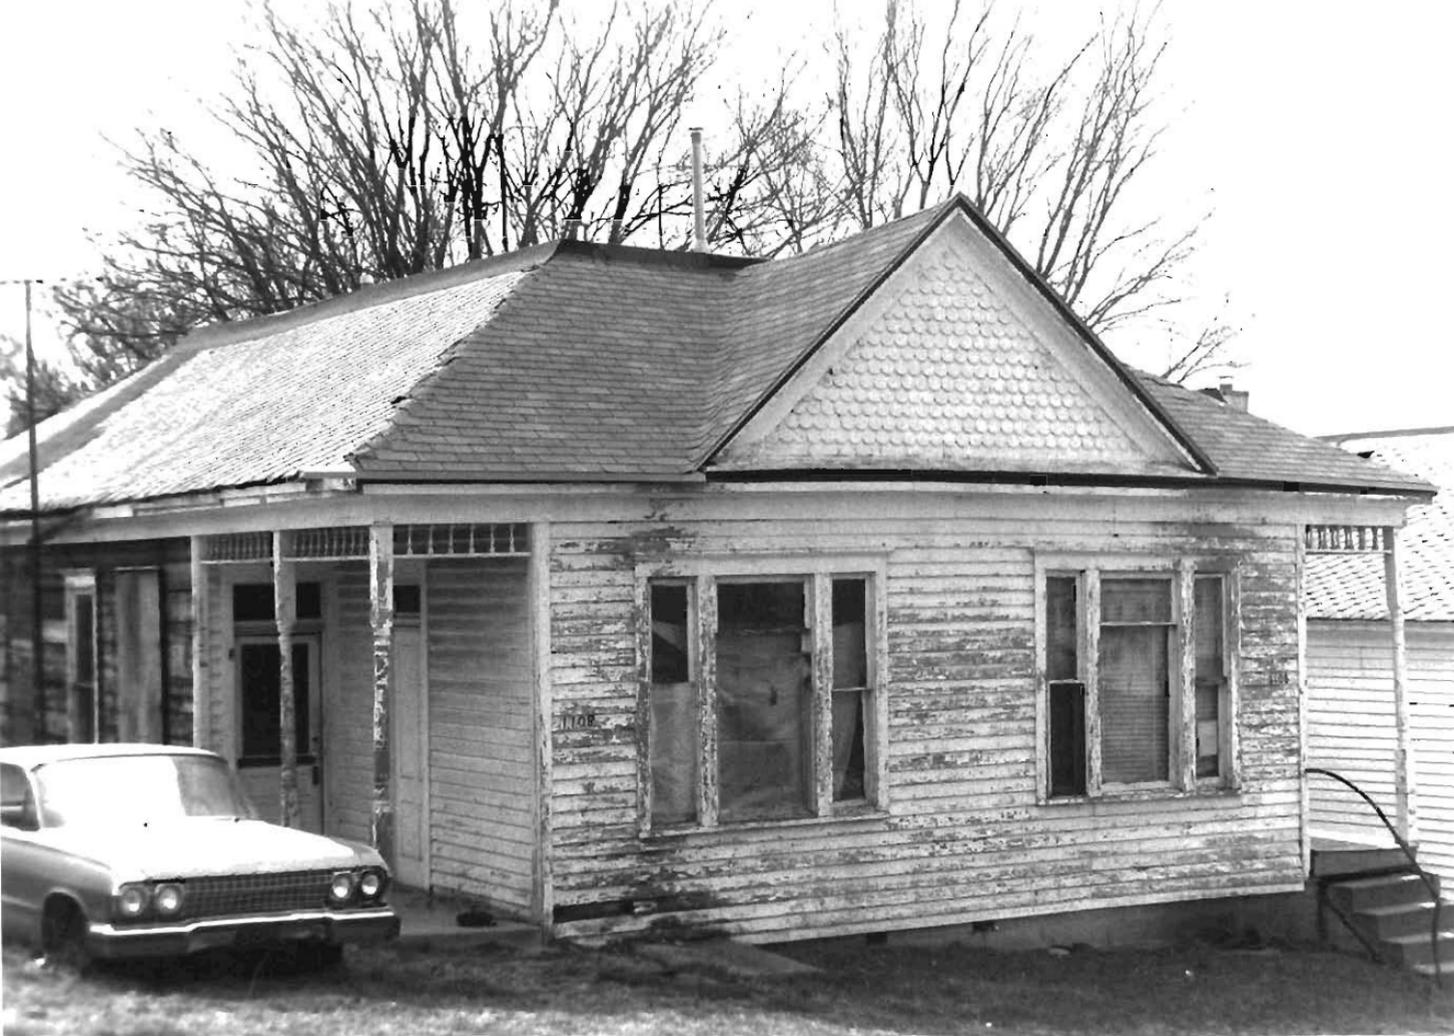
<p>42. FURTHER DESCRIPTION OF IMPORTANT FEATURES <b>1 story, 4 bay, symmetrical, frame duplex dwelling with truncated hip roof with centered front gable, plain frieze and corner boards. Recessed end bays with single door with transom under corner veranda with turned post and spindled frieze. Center bays contain wide window with transom with narrow l/l side lights. All fenestration has plain frames with narrow cornice moldings. Enframed gable has fish-</b></p> <p>43. HISTORY AND SIGNIFICANCE <b>scale wood shingle wall with plain frieze.</b></p> <p><b>Building permit records indicate construction in 1899 for applicant, Pike Peyely. It has a moderate degree of architectural integrity and is significant as a representation of vernacular Queen Anne duplex property type. Its construction coincides with the 1891-1915 period in the city's historical development.</b></p>		4. PRESENT LOCAL NAME(S) OR DESIGNATION(S)

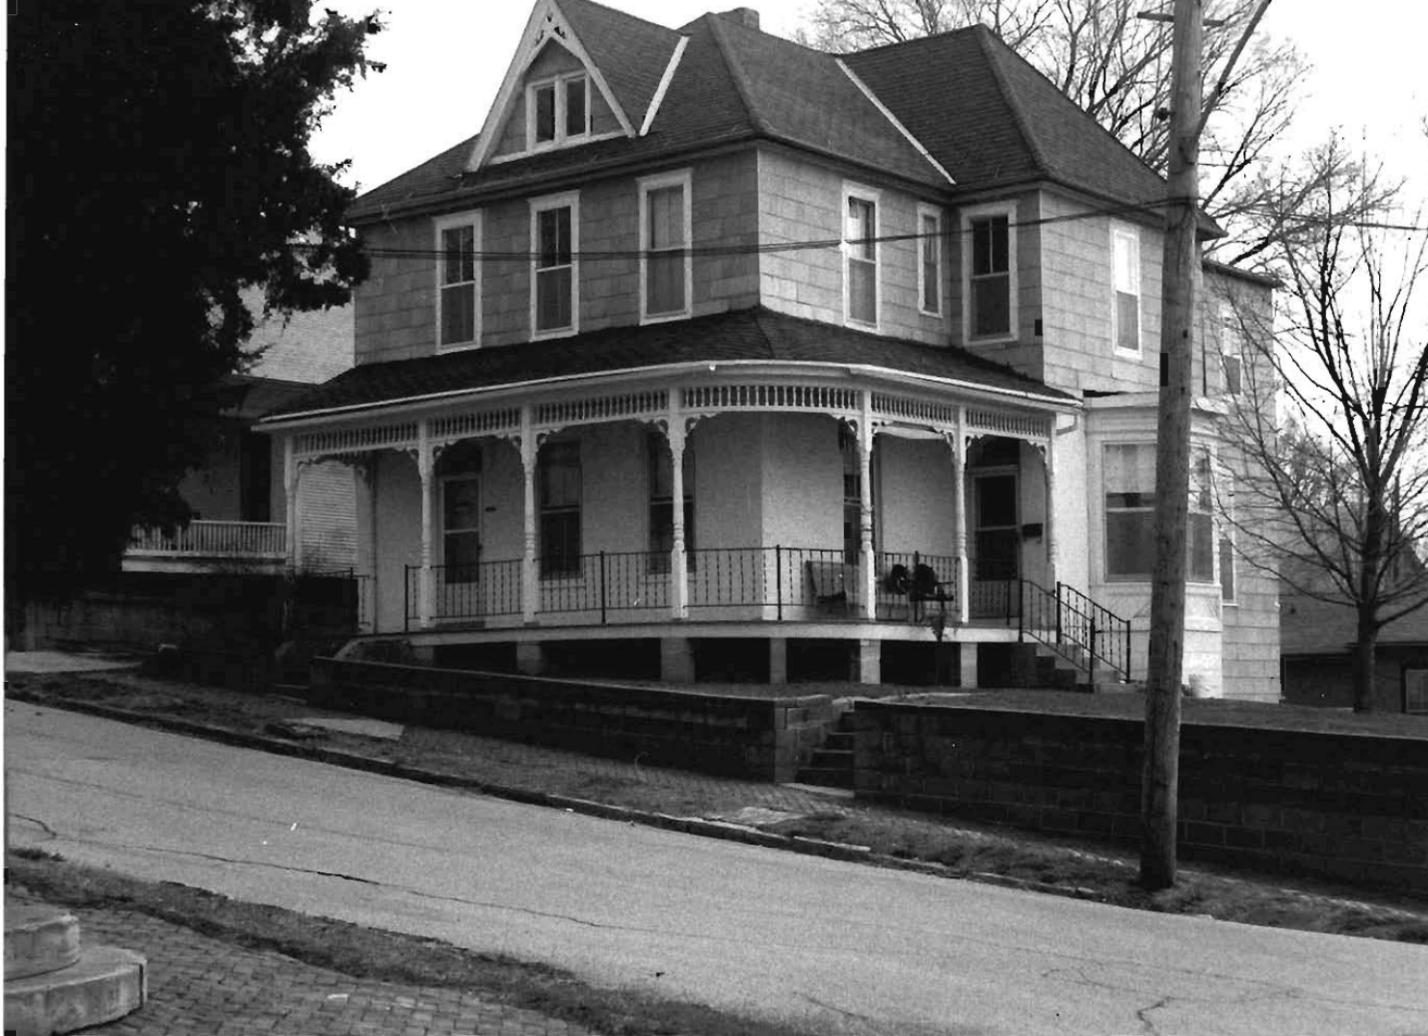
BN-16001-104

<p>42. FURTHER DESCRIPTION OF IMPORTANT FEATURES <b>2 story, 5 bay, asymmetrical, brick/frame dwelling with hip roof. Brick first story is ca. 1860 and has four bays; single door entries with transom in first and recessed fourth bays; second and third bays have 2/2 windows, openings have arched, simple, brick hoodmolds. Wrap around porch attached to these bays has turned posts, spindled frieze and ornamental corner brackets (wrought iron railing is a later alteration).</b></p> <p>43. HISTORY AND SIGNIFICANCE <b>Frame, upper story bays each contain 2/2 windows within plain frames with narrow cornices. Gable centered above 1-3rd bays contains paired single light rectangular windows and has ornamented gable millwork. Fifth bay is one story polygonal bay unit on west elevation that contains 1/1 windows and has a flat roof. 43. Building permit records indicate a major alteration or addition in 1902 for applicant, F. L. Enderbrock (also took out a permit in 1887 for a wood shed on same property). It has a high degree of architectural integrity and is significant as a representation of early 20th century Queen Anne residential property type (original Italianate dwelling still apparent and significant). Appears on 1883 Sanborn map.</b></p> <p>44. DESCRIPTION OF ENVIRONMENT AND OUTBUILDINGS <b>map. In residential neighborhood; vacant lot to corner on west side.</b></p>	4. PRESENT LOCAL NAME(S) OR DESIGNATION(S)

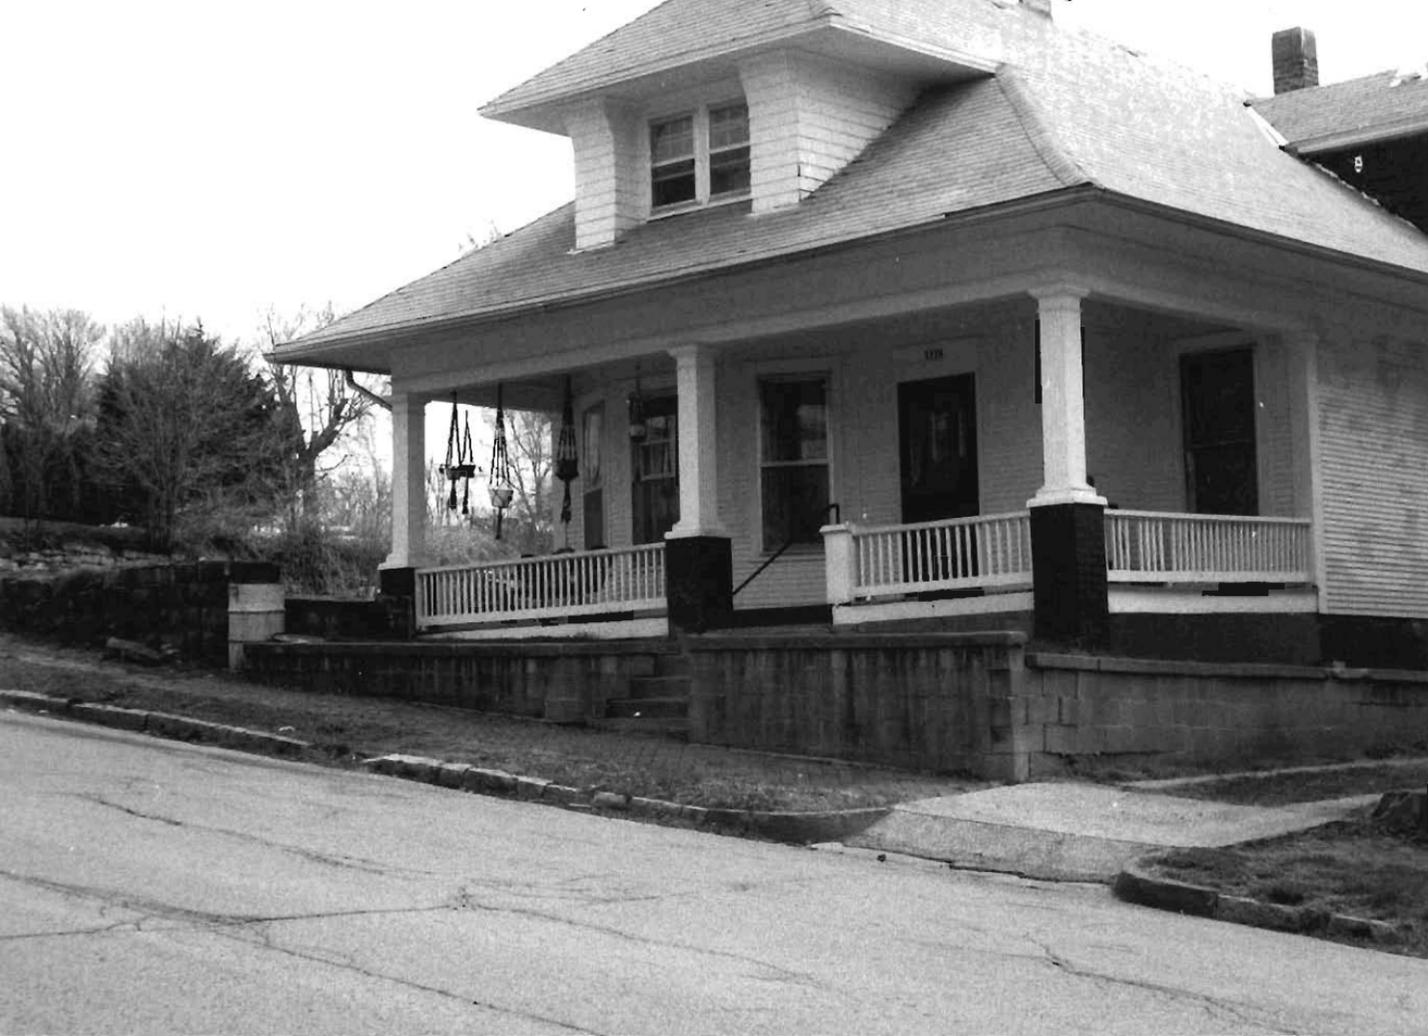
BU-A5-004-105

<p>42. FURTHER DESCRIPTION OF IMPORTANT FEATURES <b>1½ story, 5 bay, asymmetrical, frame dwelling with hip roof with hip roof dormers, boxed eaves. Veranda with brick pedestals, square, fluted wood columns, wide entablature and open slat railing shelters left three bays which form polyzonal bay unit, each with 1/1 window. Fenestration has plain frames with narrow cornice moldings. Large dormer with shingled, walls with recessed paired 6/1 windows.</b></p> <p>43. HISTORY AND SIGNIFICANCE  <b>Building permit records indicate construction in 1902 for applicant, F. Enderbrock (also owned property adjacent on west). The dwelling has a high degree of architectural integrity and is significant as a representation of Neoclassical residential property type.</b></p>		4. PRESENT LOCAL NAME(S) OR DESIGNATION(S)	
<p>44. DESCRIPTION OF ENVIRONMENT AND OUTBUILDINGS  <b>In residential neighborhood; vacant lot to corner on east side.</b></p>	<p>45. SOURCES OF INFORMATION <b>BP #A547, 9/19/02; site</b></p>	<p>46. PREPARED BY <b>Mary Jo Winder</b></p> <p>47. ORGANIZATION <b>City of St. Joseph</b></p> <p>48. DATE <b>7/88</b> 49. REVISION DATE(S)</p>	5. OTHER NAME(S)
