# MISSOURI OFFICE OF HISTORIC PRESERVATION

## ARCHITECTURAL/HISTORIC INVENTORY SURVEY FORM

BN-AS 004-001

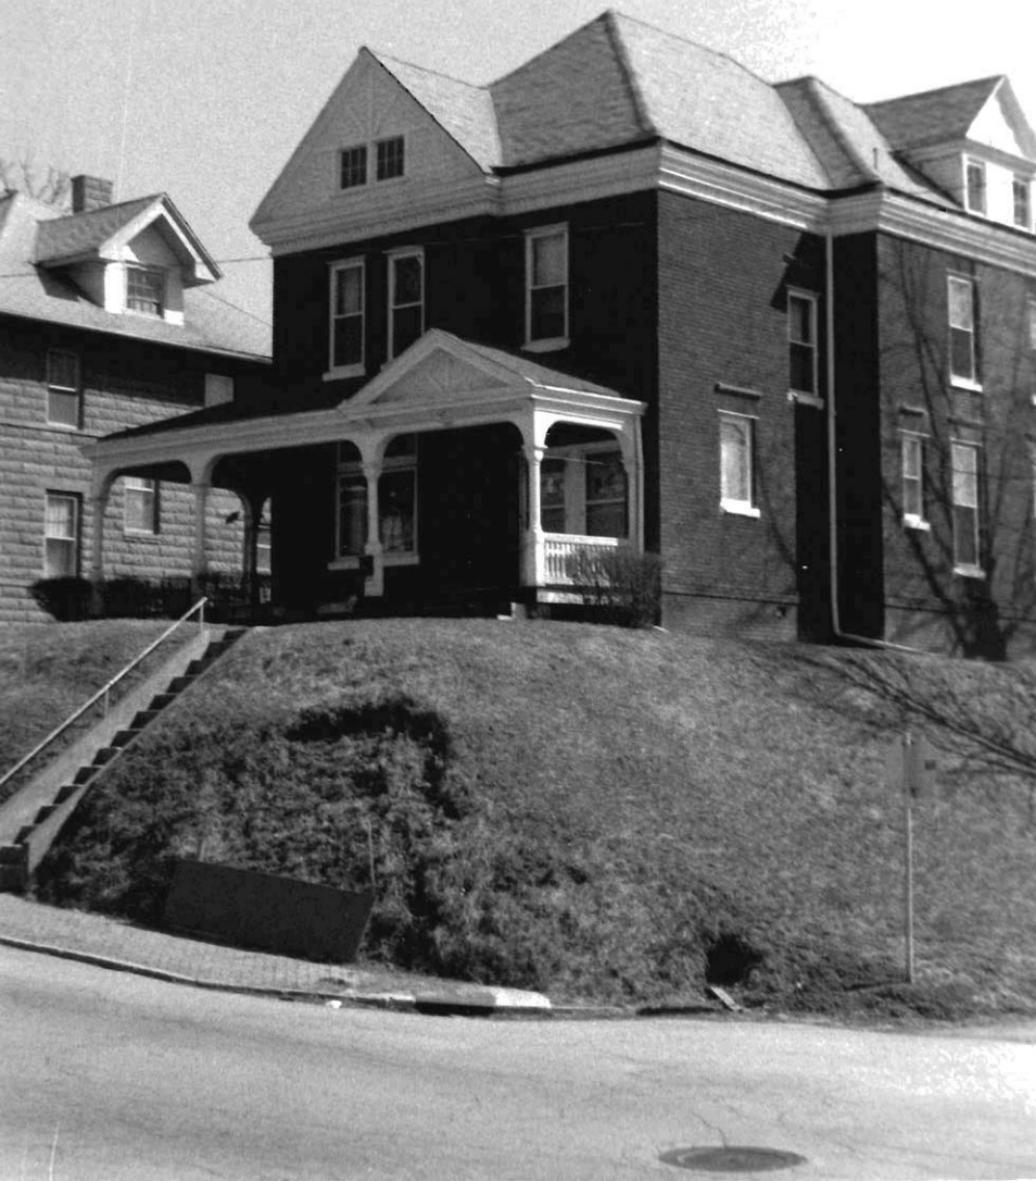
<p>42. FURTHER DESCRIPTION OF IMPORTANT FEATURES <b>2½ story, 4-bay, asymmetrical, brick dwelling with hip roof with gable roof projection and gable roof side elevation dormer; heavily molded and ornamented frieze and cornice; brick water table. Porch attached to front elevation wraps around east side elevation; it has wood columns with Beysantine shape capitals and springing arches, and molded, boxed cornice; gable roof over</b></p> <p>43. HISTORY AND SIGNIFICANCE <b>entry bay (3rd) with ornamented pediment; one section of turned ballustrade remains intact. Recessed left bay contains single door with transom with 1/1 window on second story; second bay has picture window with transom, two 1/1 windows on second, and paired, square, six-light windows in shingled and half-timbered gable half story; third bay has double door entry with transom and 1/1 window on second story; fourth bay is recessed wall of back portion of building.</b></p> <p>43. <b>There are no building permits of record; however, 1888 and 1897 Sanborn maps indicate construction between these years (it appears on the map of 97). It has a high degree of integrity and is significant as a representation of Queen Anne residential property</b></p> <p>44. DESCRIPTION OF ENVIRONMENT AND OUTBUILDINGS <b>type.</b> <b>In residential neighborhood; in block of other late 19th/early 20th century dwellings; faces block w/public school.</b></p>	<div style="border: 2px solid black; padding: 20px; text-align: center;"> <p>PHOTO MUST BE PROVIDED</p> </div>	4. PRESENT LOCAL NAME(S) OR DESIGNATION(S)

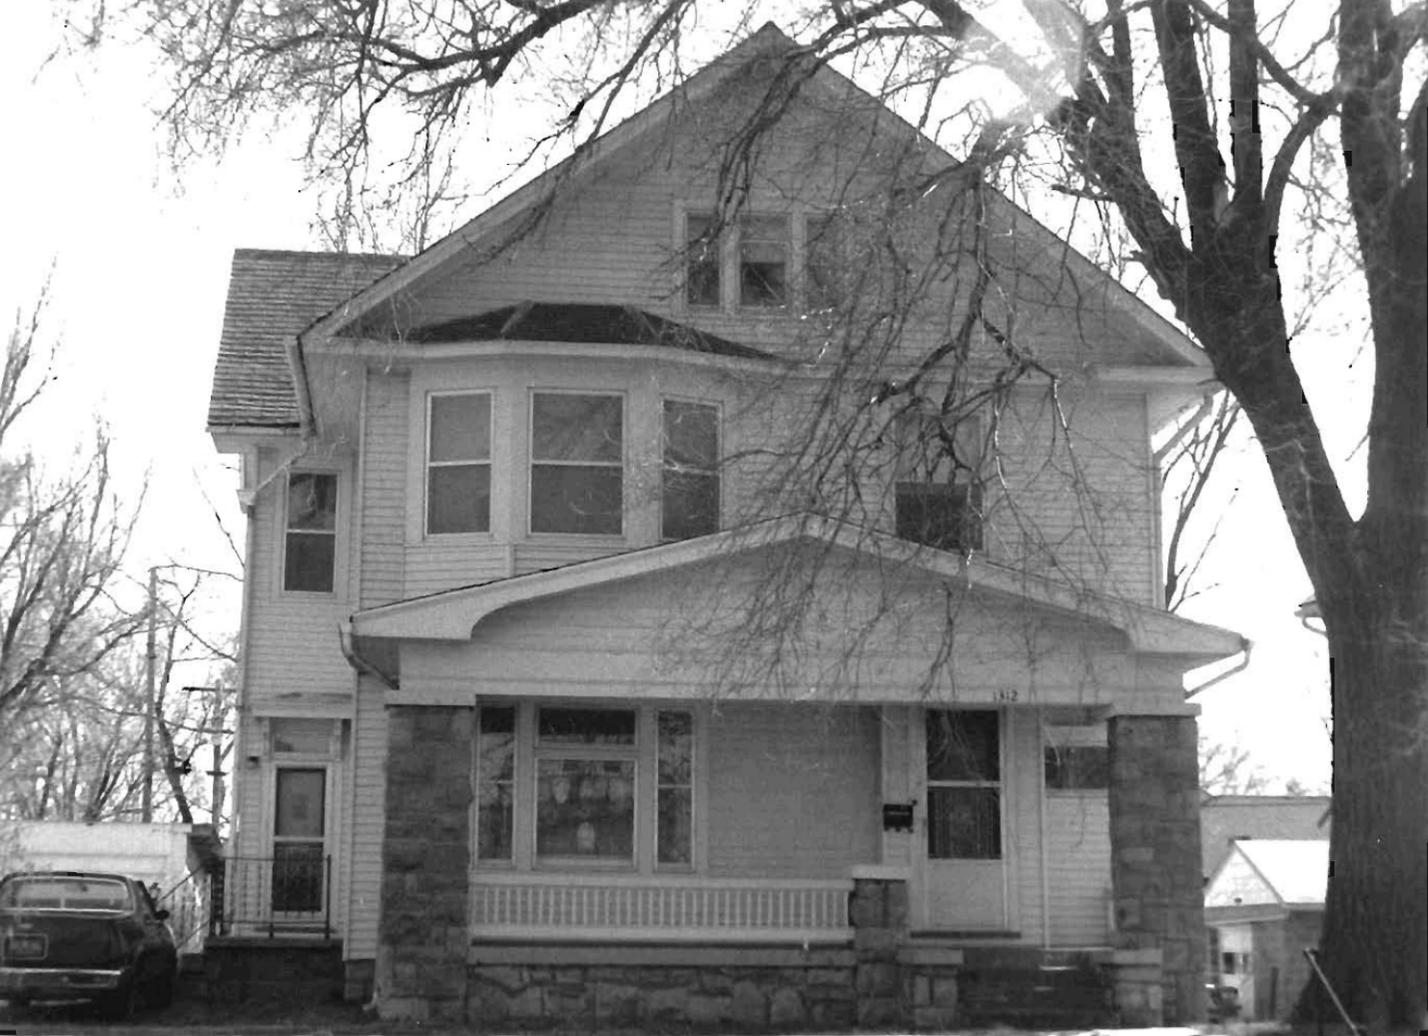
<p>42. FURTHER DESCRIPTION OF IMPORTANT FEATURES <b>2 1/2 story, 3 bay, asymmetrical, frame dwelling with cross gable roof; narrow corner boards. Recessed left bay contains door with transoms with bracketed shed roof; 1/1 window on second story. Front gable porch attached to second and third bays of front elevation (north) has random ashlar foundation and corner piers, open slat railing, molded entablature and boxed gable returns.</b></p> <p>43. HISTORY AND SIGNIFICANCE <b>Second bay contains picture window with transom with narrow 1/1 sidelights; second story has polyzonal bay unit with polyzonal hip roof; 1/1 window in each side. Right bay has slight projection which contains a single door; small single light window on right; 1/1 window on second story. Gable has grouping of three small windows.</b></p> <p>43. Building permit records indicate construction in 1909 for applicant, John W. Koch. It has a high degree of integrity and is significant as a representation of early 20th century Classic Revival residential property type.</p> <p>44. DESCRIPTION OF ENVIRONMENT AND OUTBUILDINGS <b>In residential neighborhood in area of other turn of the century dwellings; faces public school across Olive.</b></p>	<p>45. SOURCES OF INFORMATION <b>BP #6256, 10/21/09; site</b></p>	<p>46. PREPARED BY <b>Mary Jo Winder</b></p> <p>47. ORGANIZATION <b>City of St. Joseph</b></p> <p>48. DATE <b>7/88</b></p> <p>49. REVISION DATE(S)</p>	4. PRESENT LOCAL NAME(S) OR DESIGNATION(S)

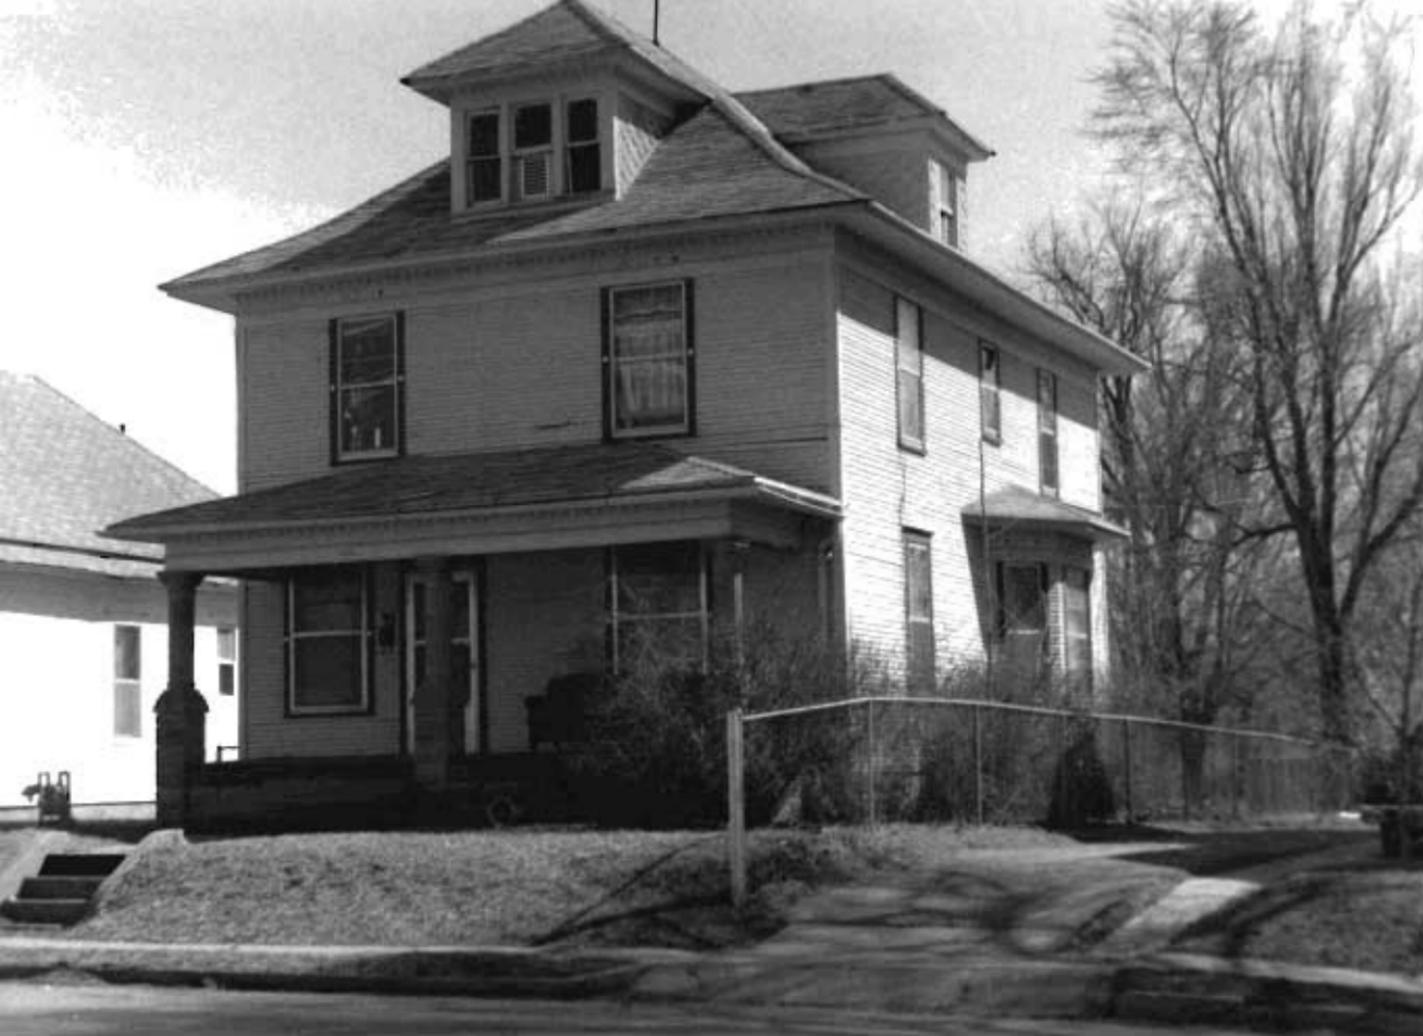
BN-10009-109

42. FURTHER DESCRIPTION OF IMPORTANT FEATURES 2 1/2 story, 2 bay, asymmetrical, frame dwelling with hip roof with flared eaves and hip roof dormers, molded frieze with dentils and plain corner boards. Porch attached to front elevation (north) has stone foundation and pedestals with fluted masonry Doric columns, molded entablature with dentils and hip roof. Left bay contains 1/1 window and single door on first story, 1/1 window on second. Right bay contains		5. OTHER NAME(S)
---	--	------------------

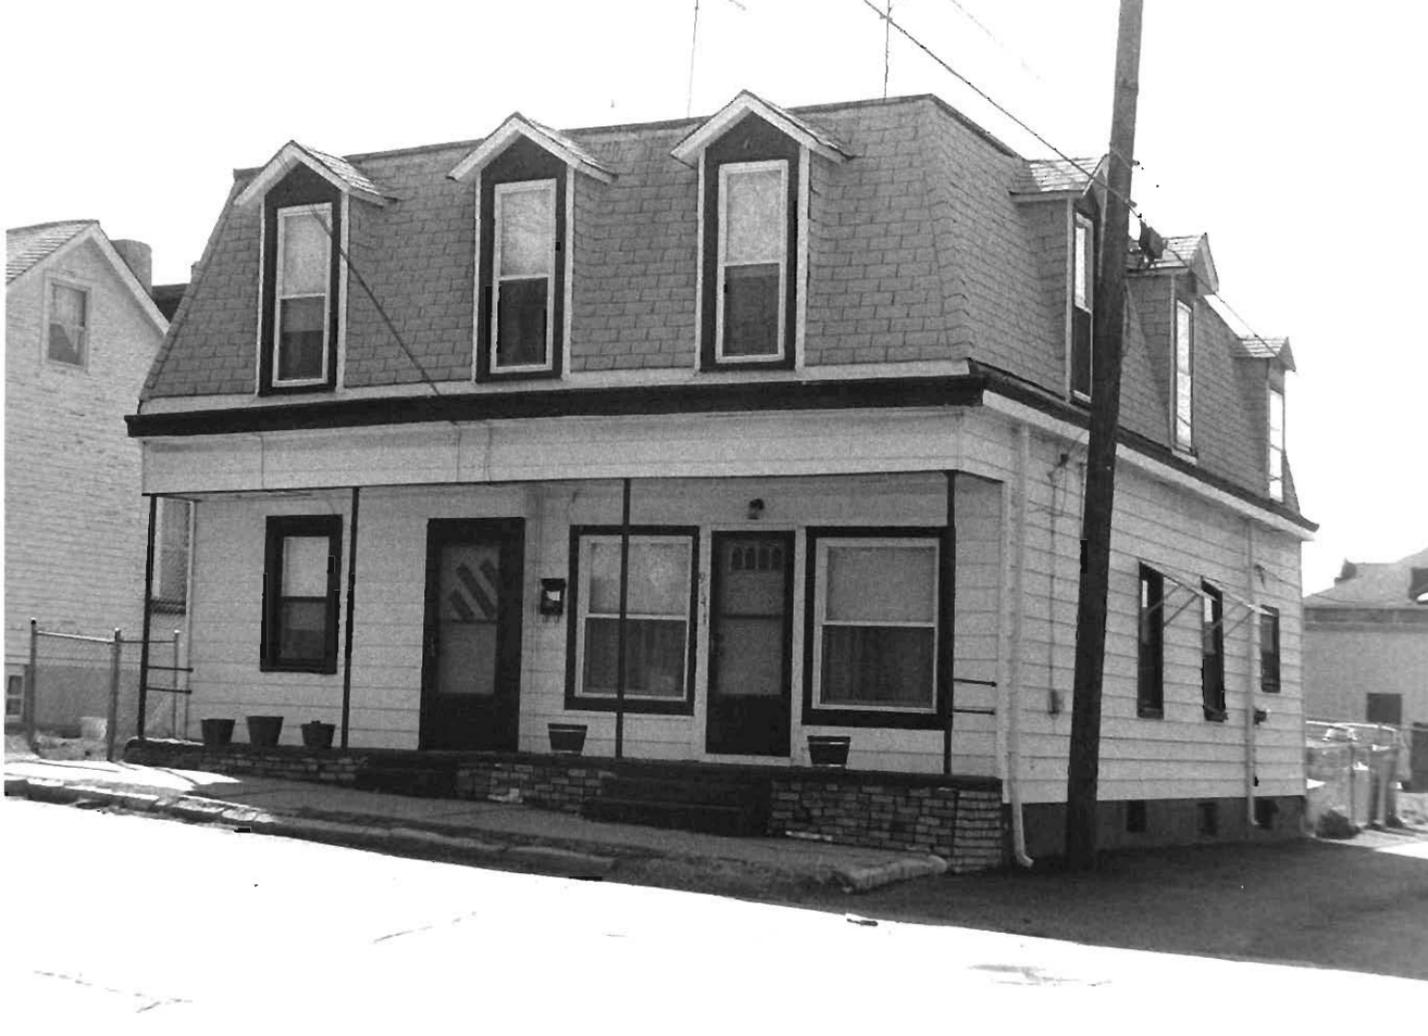
BA-15004-113

<p>42. FURTHER DESCRIPTION OF IMPORTANT FEATURES <b>1½ story, 5 bay, asymmetrical frame dwelling with mansard roof with gable roof dormer. Narrow veranda across facade has been completely altered with new foundation, supports and siding. Fenestration also has been altered with first bay containing 1/1 windows; second and fourth bays containing single doors and third and fifth bay containing wide 1/1 windows. Dormers contain 1/1 windows.</b></p> <p>43. HISTORY AND SIGNIFICANCE <b>Building permit records indicate construction of an addition in 1891 for applicant, Mrs. Fannie McCormick; however stylistic features indicate a ca 1870 original construction. It has a moderate degree of architectural integrity and is moderately significant as a representation of 2nd Empire vernacular residential property type.</b></p>	4. PRESENT LOCAL NAME(S) OR DESIGNATION(S)	5. OTHER NAME(S)	
<p>44. DESCRIPTION OF ENVIRONMENT AND OUTBUILDINGS <b>At edge of residential neighborhood; commercial zone in close proximity to south and west.</b></p>	6. TOWNSHIP	RANGE

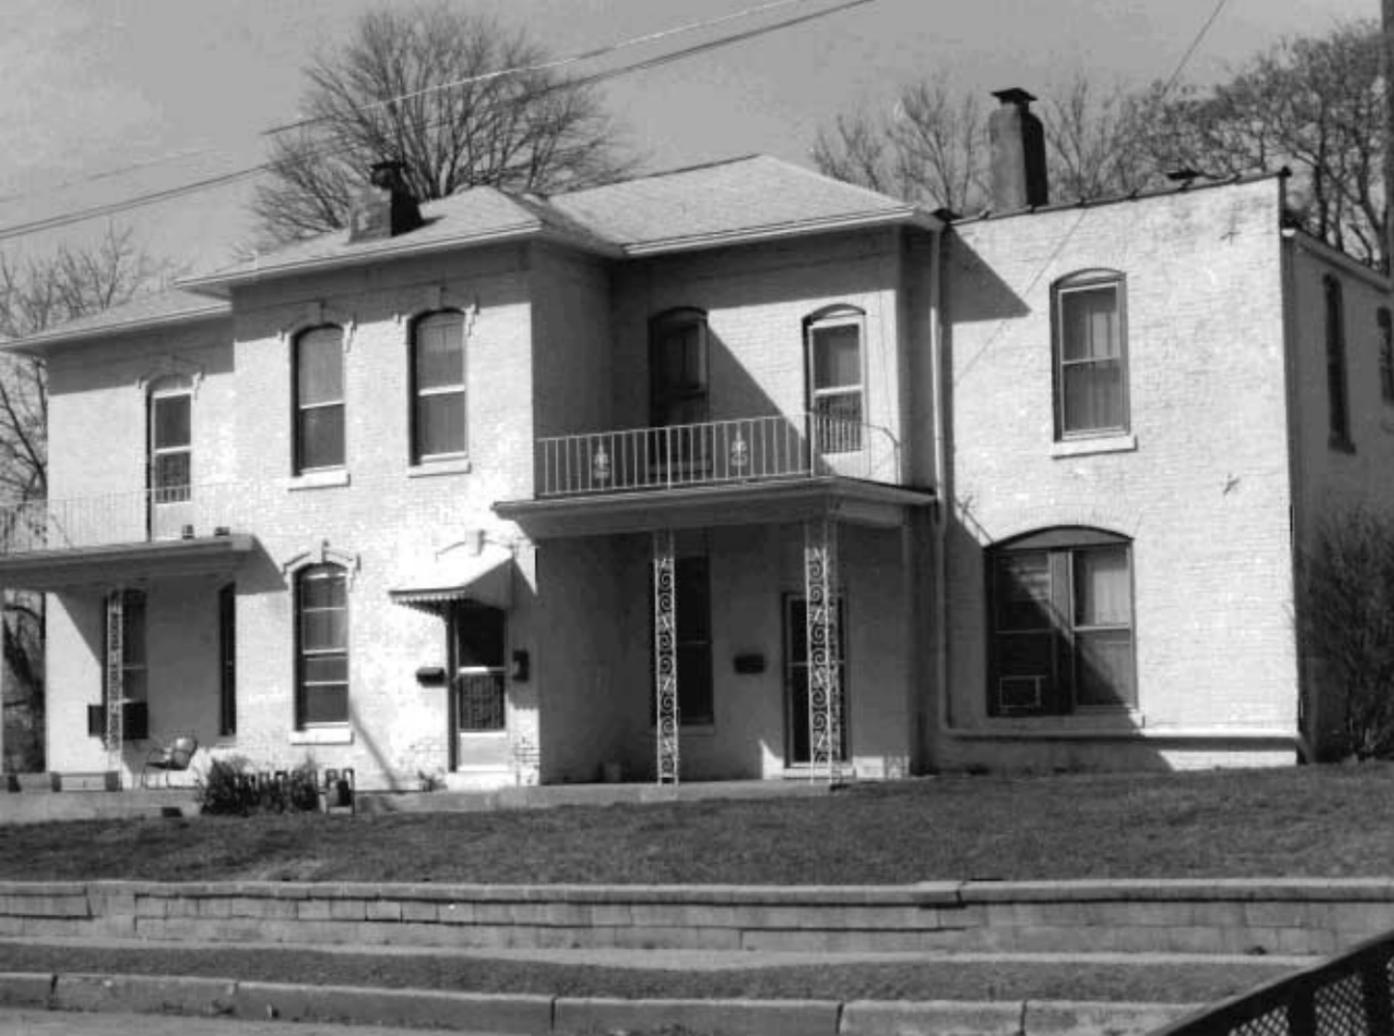
<p>42. FURTHER DESCRIPTION OF IMPORTANT FEATURES 2 story, 7 bay, asymmetrical, brick dwelling with hip roof (flat roof on side addition) and molded frieze. Recessed first and second bays each contain 2/2 window with stone lug sill and brick hoodmold with flat keystone (typical treatment of left four bays); porch attached to bays has decorative wrought iron supports and railing on upper deck (new materials); second story has single door opening. Third and fourth bays in projecting wings have typical windows both stories, fourth has single door on first story. Recessed fifth and sixth bays have 2/2 windows in arched openings with stone sill and brick lintel (typical of right 3 bays) and door openings, both stories; similar porch on these bays. First bay flat roof side addition has paired 1/1 windows on first story, a single 2/2 window on second.</p> <p>43. HISTORY AND SIGNIFICANCE There are no building permits of record for this dwelling; however, stylistic features indicate a ca1860 original construction. It has a moderate degree of integrity and is significant as a representation of Italianate residential property type. (On 1883 Sanborn map)</p>	<div style="border: 2px solid black; padding: 20px; text-align: center;"> <p>PHOTO MUST BE PROVIDED</p> </div>	4. PRESENT LOCAL NAME(S) OR DESIGNATION(S)

<p>44. DESCRIPTION OF ENVIRONMENT AND OUTBUILDINGS At edge of residential neighborhood; in close proximity to Patee House hotel (1858); on corner lot.</p> <p>45. SOURCES OF INFORMATION Site; 1883 Sanborn map</p>	<p>46. PREPARED BY Mary Jo Winder</p> <p>47. ORGANIZATION City of St. Joseph</p> <p>48. DATE 7/88</p> <p>49. REVISION DATE(S)</p>	5. OTHER NAME(S)	
<p>RETURN THIS FORM WHEN COMPLETED TO: OFFICE OF HISTORIC PRESERVATION P.O. BOX 176 JEFFERSON CITY, MISSOURI 65102 PH. 314-751-4096</p> <p>IF ADDITIONAL SPACE IS NEEDED, ATTACH SEPARATE SHEET(S) TO THIS FORM</p>	6. TOWNSHIP RANGE SECTION

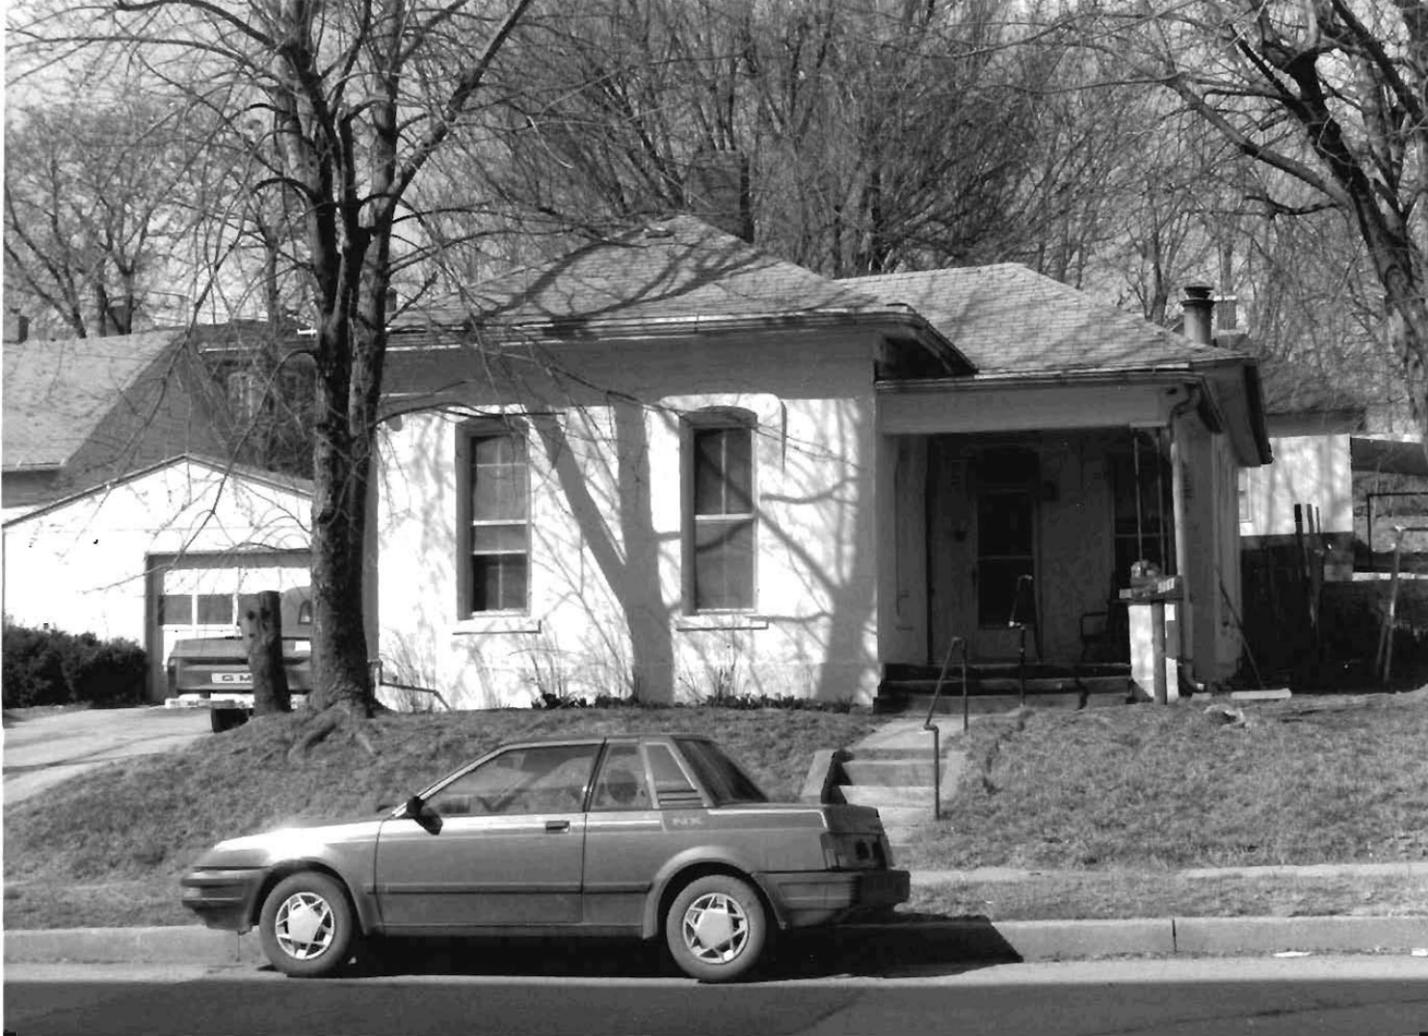
<p>42. FURTHER DESCRIPTION OF IMPORTANT FEATURES 1 story, 4 bay, asymmetrical, brick/stucco dwelling with hip roof, plain frieze and centralized brick chimney. Left two bays in front wing; each has 2/2 window within arched opening with stone sill and hoodmold (typical). Recessed right bays contain single door with transom and 2/2 window; porch attached to bays has been altered with wrought iron corner support on brick</p>	<p style="font-size: 2em; font-weight: bold;">X</p> <p style="text-align: center;">PHOTO MUST BE PROVIDED</p>	4. PRESENT LOCAL NAME(S) OR DESIGNATION(S)	
<p>43. HISTORY AND SIGNIFICANCE pedestal. Stucco is a later alteration that covers all wall surfaces (including hoodmolds).</p> <p>43. There are no building permits of record for this dwelling; however, stylistic features indicate a ca 1860 original construction date. It has a moderate-high degree of integrity and is significant as a representation of vernacular Italianate residential property type. (On 1883 Sanborn map)</p>	5. OTHER NAME(S)	6. TOWNSHIP

<p>44. DESCRIPTION OF ENVIRONMENT AND OUTBUILDINGS In residential neighborhood; in close proximity to 1858 Patee hotel.</p>	RANGE	SECTION	
<p>45. SOURCES OF INFORMATION Site; 1883 Sanborn map</p>	<p>46. PREPARED BY Mary Jo Winder</p> <p>47. ORGANIZATION City of St. Joseph</p> <p>48. DATE 7/88</p> <p>49. REVISION DATE(S)</p>	SECTION	
<p>RETURN THIS FORM WHEN COMPLETED TO: OFFICE OF HISTORIC PRESERVATION P.O. BOX 176 JEFFERSON CITY, MISSOURI 65102 PH. 314-751-4096</p> <p>IF ADDITIONAL SPACE IS NEEDED, ATTACH SEPARATE SHEET(S) TO THIS FORM</p>		SECTION

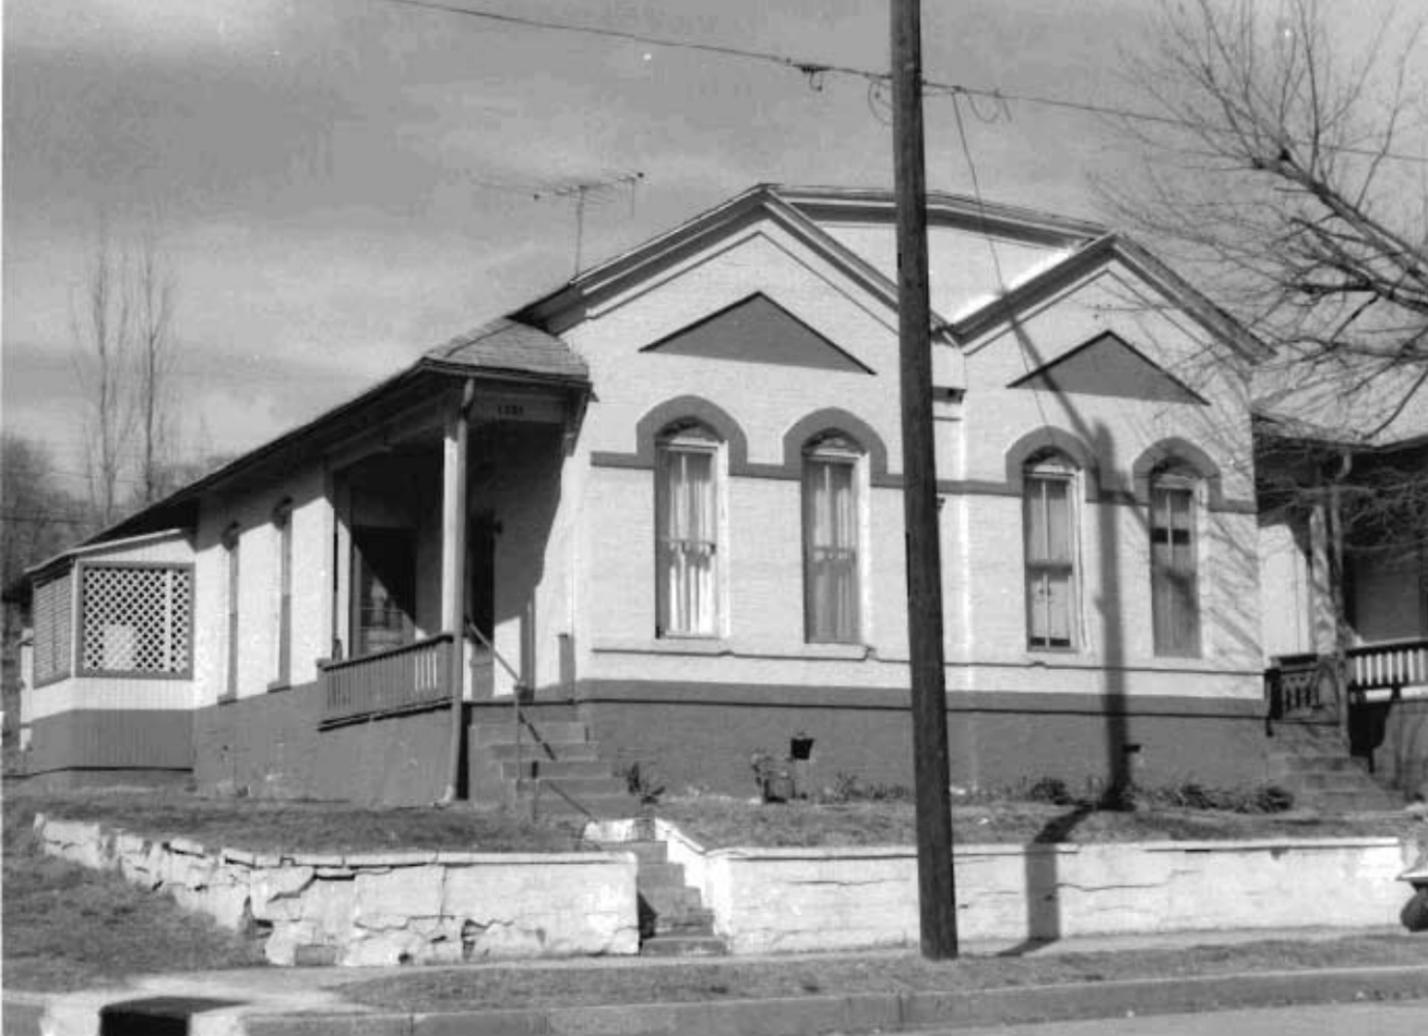
<p>42. FURTHER DESCRIPTION OF IMPORTANT FEATURES 1 story, 6 bay, symmetrical, brick, duplex dwelling with hip roof variation with twin front gables. Recessed end bays contain single doors with transoms in arched openings under corner verandas with post corner supports and open slat railings (not original elements). Center four bays separated in half by recessed vertical panel each half with two bays each with 2/2 window in slightly</p> <p>43. HISTORY AND SIGNIFICANCE pointed arch opening; each half terminates with gable with plain frieze and molded cornice; gable wall has recessed pediment-shape panels; windows have continuous stone sills and brick lintels; ornamented panels in arch above windows. Roof has been altered with infill between gables.</p> <p>43. There are no building permits of record for this dwelling; however, stylistic features indicate a ca1860 original construction date. It has a moderate degree of integrity and is significant as a representation of vernacular Italianate duplex property type.</p>		4. PRESENT LOCAL NAME(S) OR DESIGNATION(S)

<p>44. DESCRIPTION OF ENVIRONMENT AND OUTBUILDINGS  In residential neighborhood; on corner lot; same type building on lot to east; in close proximity to 1858 Patee House hotel.</p>	<p>45. SOURCES OF INFORMATION Site ; 1883 Sanborn map</p>	<p>46. PREPARED BY Mary Jo Winder</p> <p>47. ORGANIZATION City of St. Joseph</p> <p>48. DATE 7/88</p> <p>49. REVISION DATE(S)</p>	5. OTHER NAME(S)
<p>RETURN THIS FORM WHEN COMPLETED TO: OFFICE OF HISTORIC PRESERVATION P.O. BOX 176 JEFFERSON CITY, MISSOURI 65102 PH. 314-751-4096</p> <p>IF ADDITIONAL SPACE IS NEEDED, ATTACH SEPARATE SHEET(S) TO THIS FORM</p>	<p>6. TOWNSHIP</p> <p>RANGE</p> <p>SECTION</p>

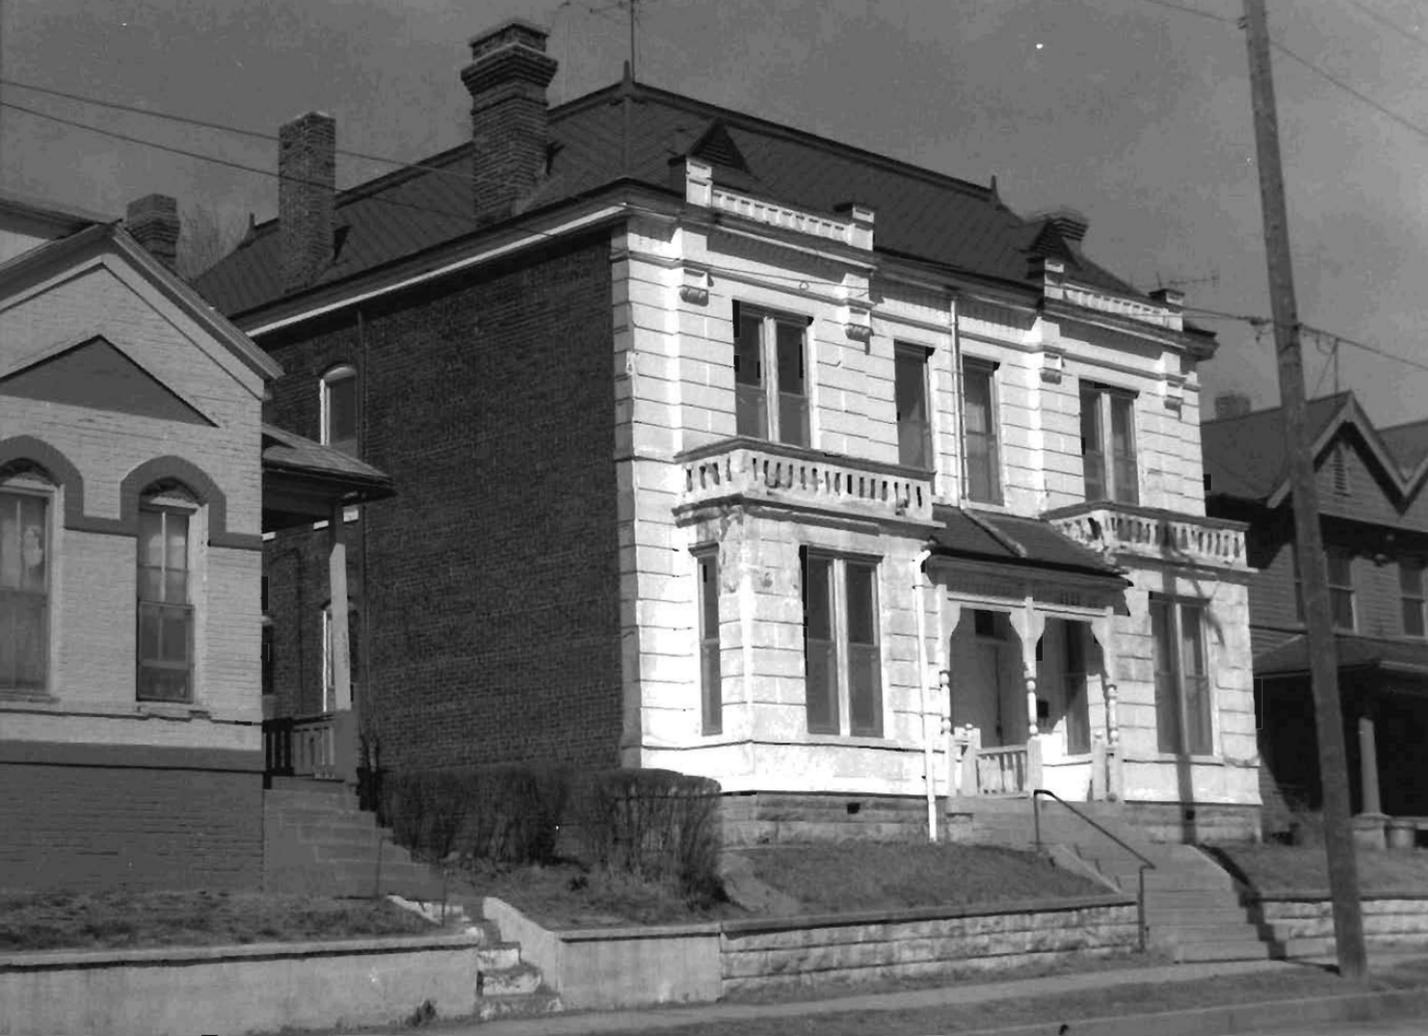
BN-AS-004-122

<p>42. FURTHER DESCRIPTION OF IMPORTANT FEATURES <b>2-story, 4 bay, symmetrical, brick/stone, duplex dwelling with truncated hip roof with top cornice and corner ornament and molded lower cornice, wide ornamented frieze, and internal, side brick chimneys. Front elevation (south) faced with smooth limestone on coarsed ashlar foundation. End bays have projecting first story rectangular bay units with paired narrow 1/1 windows with</b></p> <p>43. HISTORY AND SIGNIFICANCE <b>continuous sills, stone cornices and ballustrades; second story has slightly projecting walls and contains paired 1/1 windows between ornamented, engaged pilasters that begin at the top of windows and terminate above lower roof cornice as part of segmented parapet; vented gable centered in roof above. Recessed Eastlake frame porch with turned posts and ballusters, spindled frieze and shed roof; second story contains 1/1 windows. Front chimneys have been maintained with shaped pots; center and back chimneys have been altered.</b></p> <p>43. Building permit records indicate construction in 1889 for applicant Joseph Pfiesser. It has a high degree of integrity and is significant as a representation</p> <p>44. DESCRIPTION OF ENVIRONMENT AND OUTBUILDINGS <b>of Renaissance Revival (Classic) duplex property type. In residential neighborhood; other duplex dwellings on either side; closely spaced buildings w/shallow setbacks.</b></p> <p>45. SOURCES OF INFORMATION <b>BP #A370, 5/13/89; site</b></p>	<p>46. PREPARED BY <b>Mary Jo Winder</b></p> <p>47. ORGANIZATION <b>City of St. Joseph</b></p> <p>48. DATE <b>7/88</b></p> <p>49. REVISION DATE(S)</p>	4. PRESENT LOCAL NAME(S) OR DESIGNATION(S)

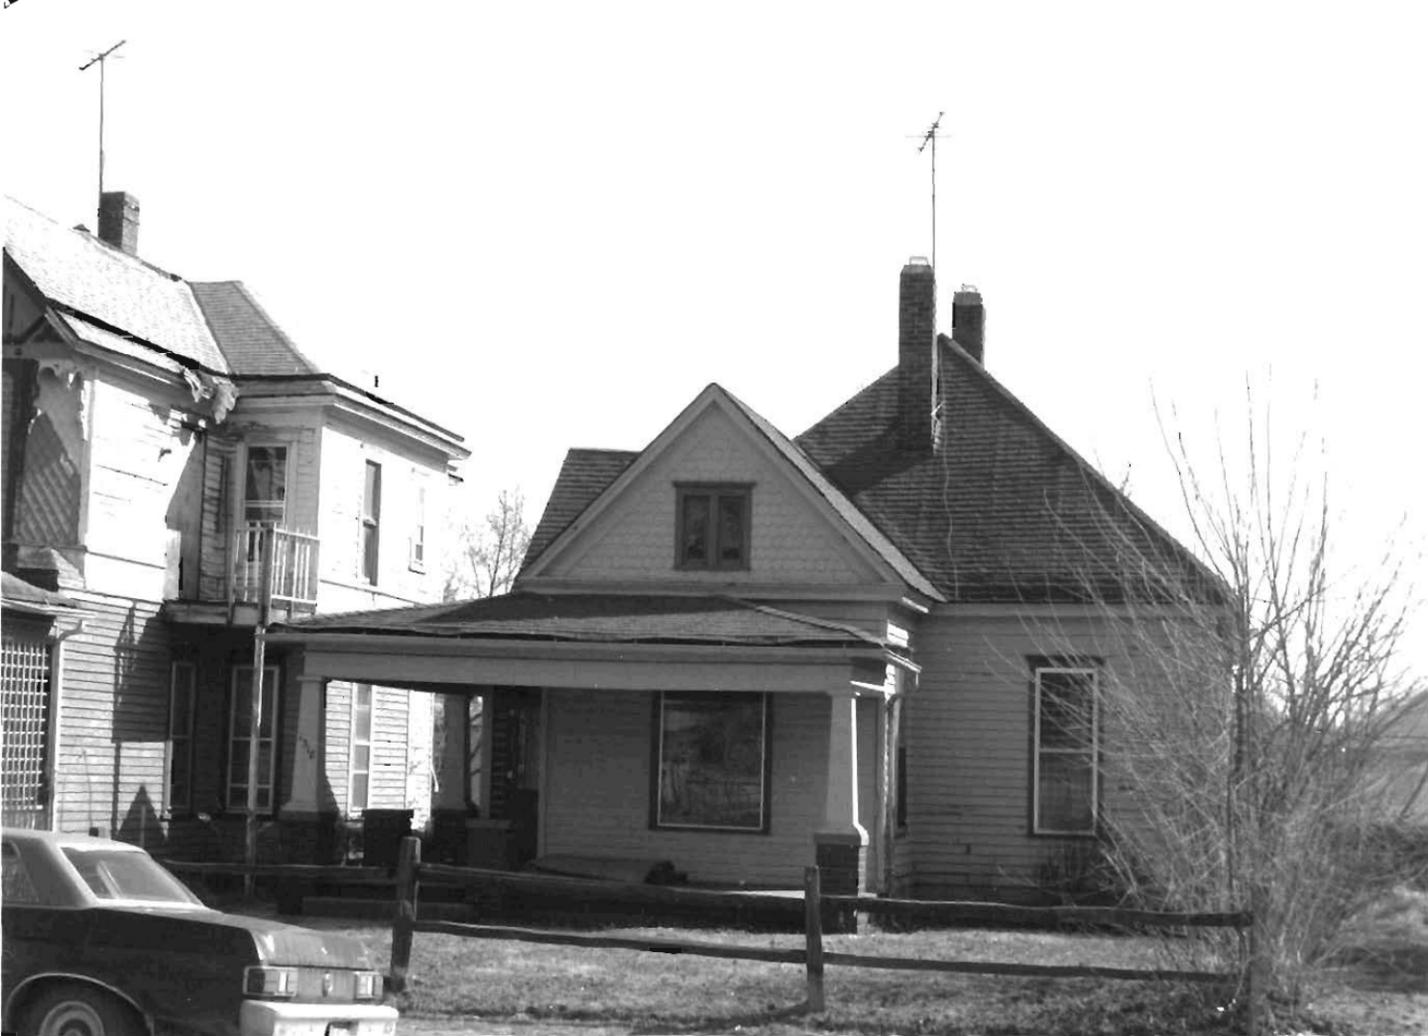
<p>42. FURTHER DESCRIPTION OF IMPORTANT FEATURES <b>2 story, 4 bay, asymmetrical frame dwelling with hip roof with p-ojecting front gable and "stick" detailing. Left bay is part of rear portion of house with 1/1 windows, both stories. Second bay contains entry with transom on first story, 1/1 window on second. Third bay is projecting front gable wing with camfered corners with bracketed gable corner supports on second</b></p>	<p style="font-size: 2em; font-weight: bold;">PHOTO MUST BE PROVIDED</p>		4. PRESENT LOCAL NAME(S) OR DESIGNATION(S)
<p>43. HISTORY AND SIGNIFICANCE <b>story; first story has wide window with transom with shaped surround; second story has paired 1/1 windows with ornamented pediment; gable has ornamented "stick style" detailing and contain a small, arched 1/1 window. Later (ca 1900) attached to second and third bays has stone pedestals with square tapered columns, molded entablature, hip roof and open slot railing. Recessed right bay has 1/1 windows both stories; small porch attached to bay.</b></p> <p>43. Building permit records indicate construction in 1899 for applicant, Lizzie Kueker. It has a high degree of integrity and is significant as a representation of Queen Anne residential property type.</p>	<p>44. DESCRIPTION OF ENVIRONMENT AND OUTBUILDINGS <b>In residential neighborhood primarily of cal870-1900 dwellings.</b></p>		5. OTHER NAME(S)

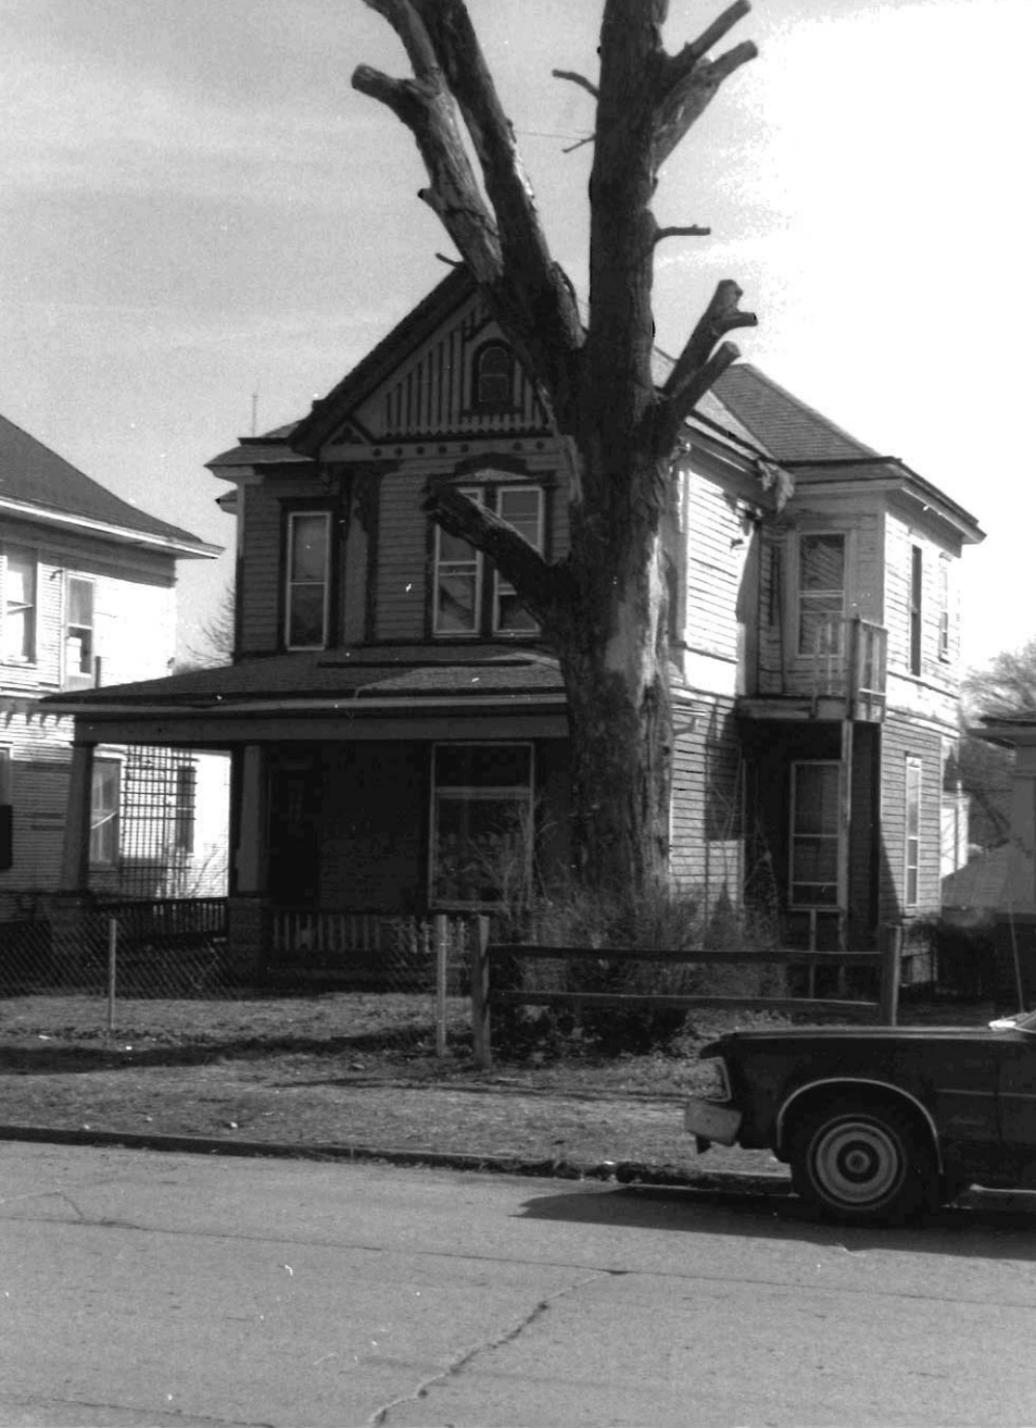
<b>9. COORDINATES</b> UTM LAT _____ LONG _____ <b>10. SITE ( )</b> STRUCTURE ( ) BUILDING (X) OBJECT ( ) <b>11. ON NATIONAL REGISTER?</b> YES ( ) NO (X) <b>12. IS IT ELIGIBLE?</b> YES (X) NO ( ) <b>13. PART OF ESTAB. HIST. DISTRICT?</b> YES ( ) NO (X) <b>14. DISTRICT POTENTIAL?</b> YES (X) NO ( ) <b>15. NAME OF ESTABLISHED DISTRICT</b>	<b>25. OPEN TO PUBLIC?</b> YES ( ) NO (X) <b>26. LOCAL CONTACT PERSON OR ORGANIZATION</b> <b>27. OTHER SURVEYS IN WHICH INCLUDED</b>	4. PRESENT LOCAL NAME(S) OR DESIGNATION(S)	
<b>42. FURTHER DESCRIPTION OF IMPORTANT FEATURES</b> 2 1/2 story, 3 bay, symmetrical, frame dwelling with hip roof with boxed cornice and hip roof dormer. Molded and dentiled frieze and plan corner boards. Three-bay porch attached to front elevation (north) has fluted Doric columns, open rail with turned balusters and shaped, fluted rails, molded and dentiled entablature and hip roof. End bays contain picture windows with transoms (leaded); center bay contains entry. <b>43. HISTORY AND SIGNIFICANCE</b> Two-bay second story with each containing a polyzonal bay unit with window with transom in center and narrow l/l windows in sides. Polyzonal shape dormer has small l/l window in center and narrow single lights on sides; dentils at roof line. 43. Building permit records indicate construction in 1903 for applicant, Dr. E.A. Mendell. It has a high degree of architectural integrity and is significant as a representation of turn of the century Classic/Neoclassical residential property type.	PHOTO MUST BE PROVIDED	5. OTHER NAME(S)

<b>44. DESCRIPTION OF ENVIRONMENT AND OUTBUILDINGS</b> In residential neighborhood; on corner lot.	6. TOWNSHIP	RANGE	
<b>45. SOURCES OF INFORMATION</b> BP #A984, 5/1/03; site	<b>46. PREPARED BY</b> Mary Jo Winder <b>47. ORGANIZATION</b> City of St. Joseph <b>48. DATE</b> 7/88 <b>49. REVISION DATE(S)</b>	SECTION	
<b>RETURN THIS FORM WHEN COMPLETED TO:</b> OFFICE OF HISTORIC PRESERVATION P.O. BOX 176 JEFFERSON CITY, MISSOURI 65102 PH. 314-751-4096 IF ADDITIONAL SPACE IS NEEDED, ATTACH SEPARATE SHEET(S) TO THIS FORM

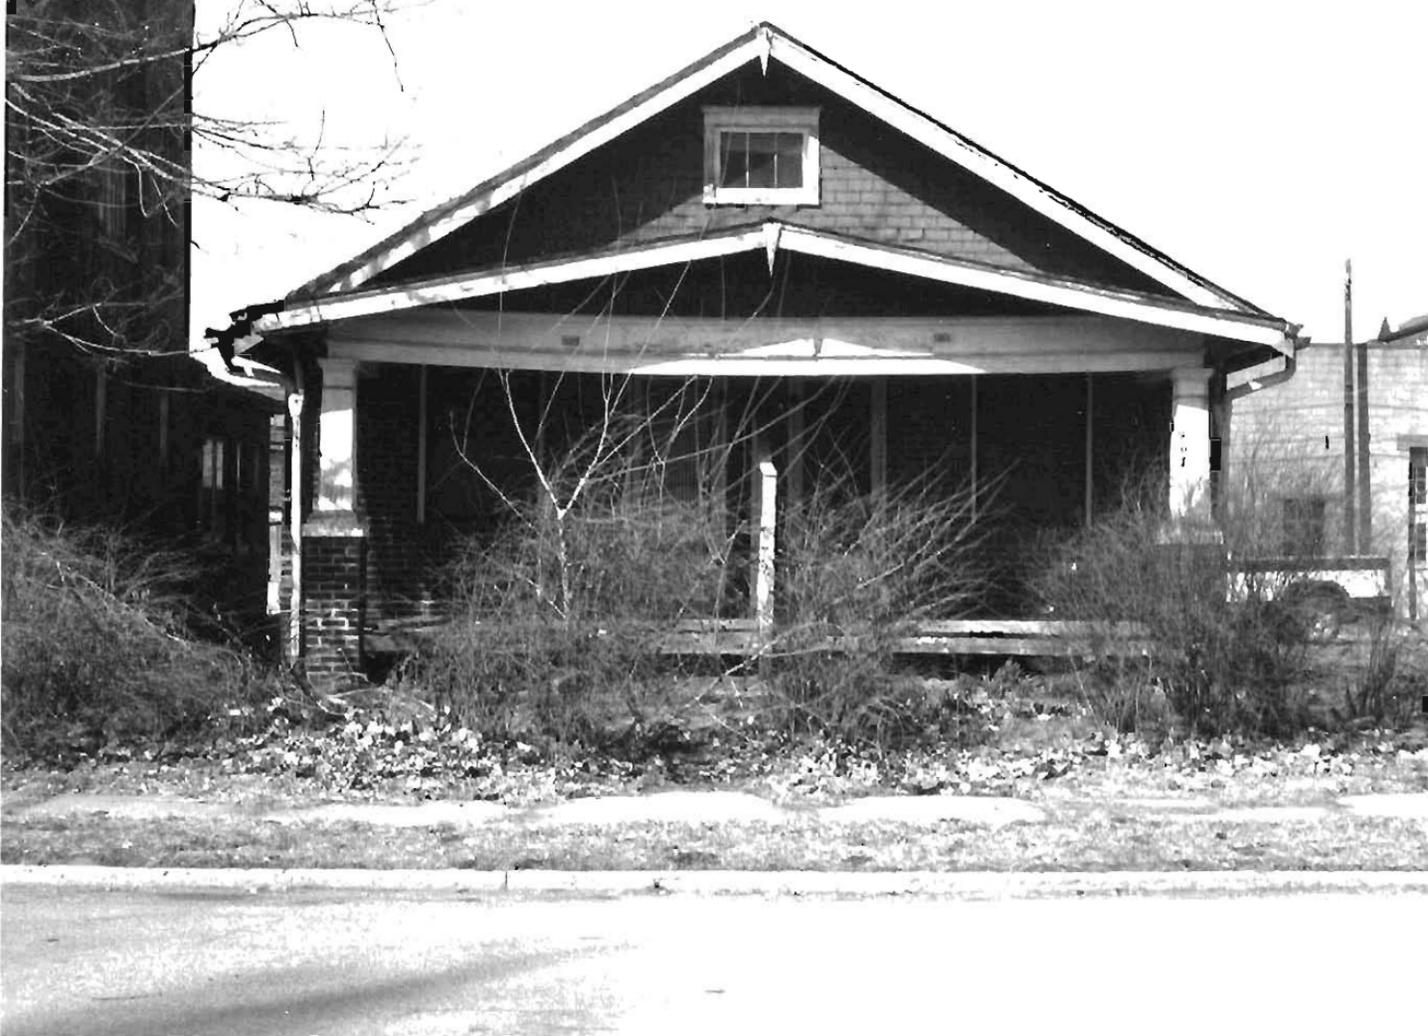
<p>42. FURTHER DESCRIPTION OF IMPORTANT FEATURES <b>1 story, 5 bay, asymmetrical, brick dwelling with gable roof and internally placed stucco covered brick chimneys. Left bay in projecting front gable wing has been altered; window opening has been reduced to an opening that contains a single light fixed window with small 1/1 side-lights; small brick-framed diamond opening in gable wall. Second bay contains 1/1 window; porch attached to bay has wood post</b></p>		4. PRESENT LOCAL NAME(S) OR DESIGNATION(S)	
<p>43. HISTORY AND SIGNIFICANCE <b>supports and open slat railing. Thrid bay contains 1/1 window opening has simple brick hoodmold. Fourth and Fifth bays are in room addition to side wing; they contain a single door and a 2/2 window; simple porch with shed roof attached to addition.</b></p> <p><b>43. There are no building permits of record for this dwelling; however, stylistic features indicate a ca 1860 construction date. It has a moderate to high degree of integrity and is significant as a representation of mid 19th century vernacular property type.</b></p>	5. OTHER NAME(S)

<p>44. DESCRIPTION OF ENVIRONMENT AND OUTBUILDINGS <b>In residential neighborhood; commercial zone in close proximity to west.</b></p>	6. TOWNSHIP		
<p>45. SOURCES OF INFORMATION <b>No relevant building permit.</b></p>	RANGE		
<p>RETURN THIS FORM WHEN COMPLETED TO: <b>OFFICE OF HISTORIC PRESERVATION P.O. BOX 176 JEFFERSON CITY, MISSOURI 65102 PH. 314-751-4096</b></p> <p>IF ADDITIONAL SPACE IS NEEDED, ATTACH SEPARATE SHEET(S) TO THIS FORM</p>	<p>46. PREPARED BY <b>Mary Jo Winder</b></p> <hr/> <p>47. ORGANIZATION <b>City of St. Joseph</b></p> <hr/> <p>48. DATE <b>7/88</b></p> <hr/> <p>49. REVISION DATE(S)</p>	SECTION

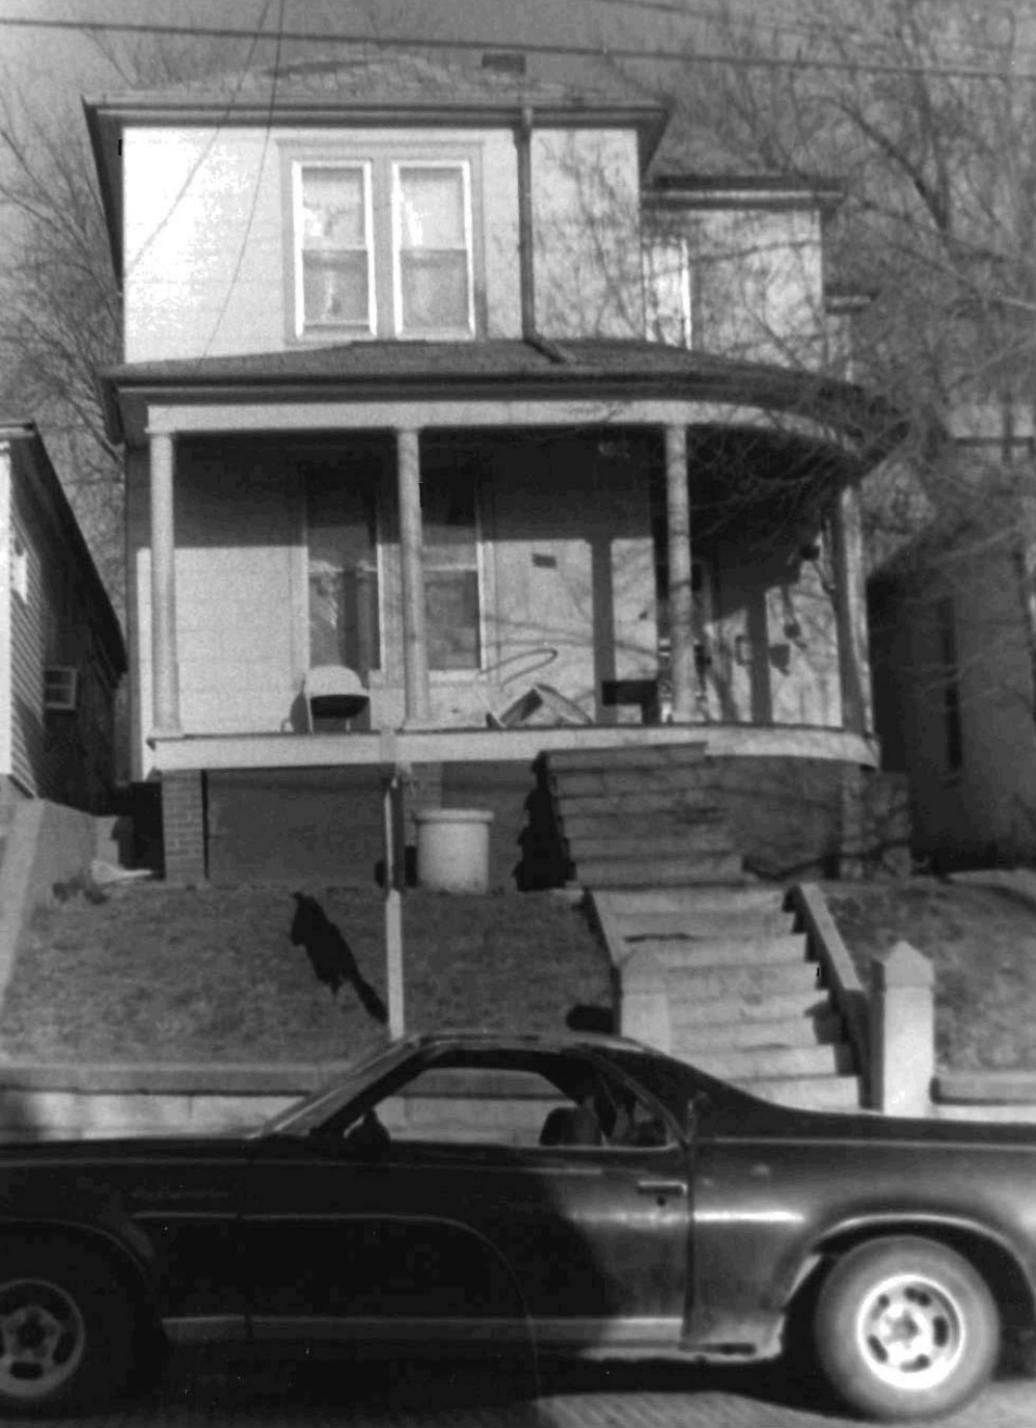
BN AS 004-128

43. HISTORY AND SIGNIFICANCE  Building permit records indicate construction in 1910 for applicant, C. D. Hicks. It has a moderate degree of integrity and is significant as a representation of Dutch Colonial Revival residential property type.
