# MISSOURI OFFICE OF HISTORIC PRESERVATION

## ARCHITECTURAL/HISTORIC INVENTORY SURVEY FORM

BN-AS 004-001

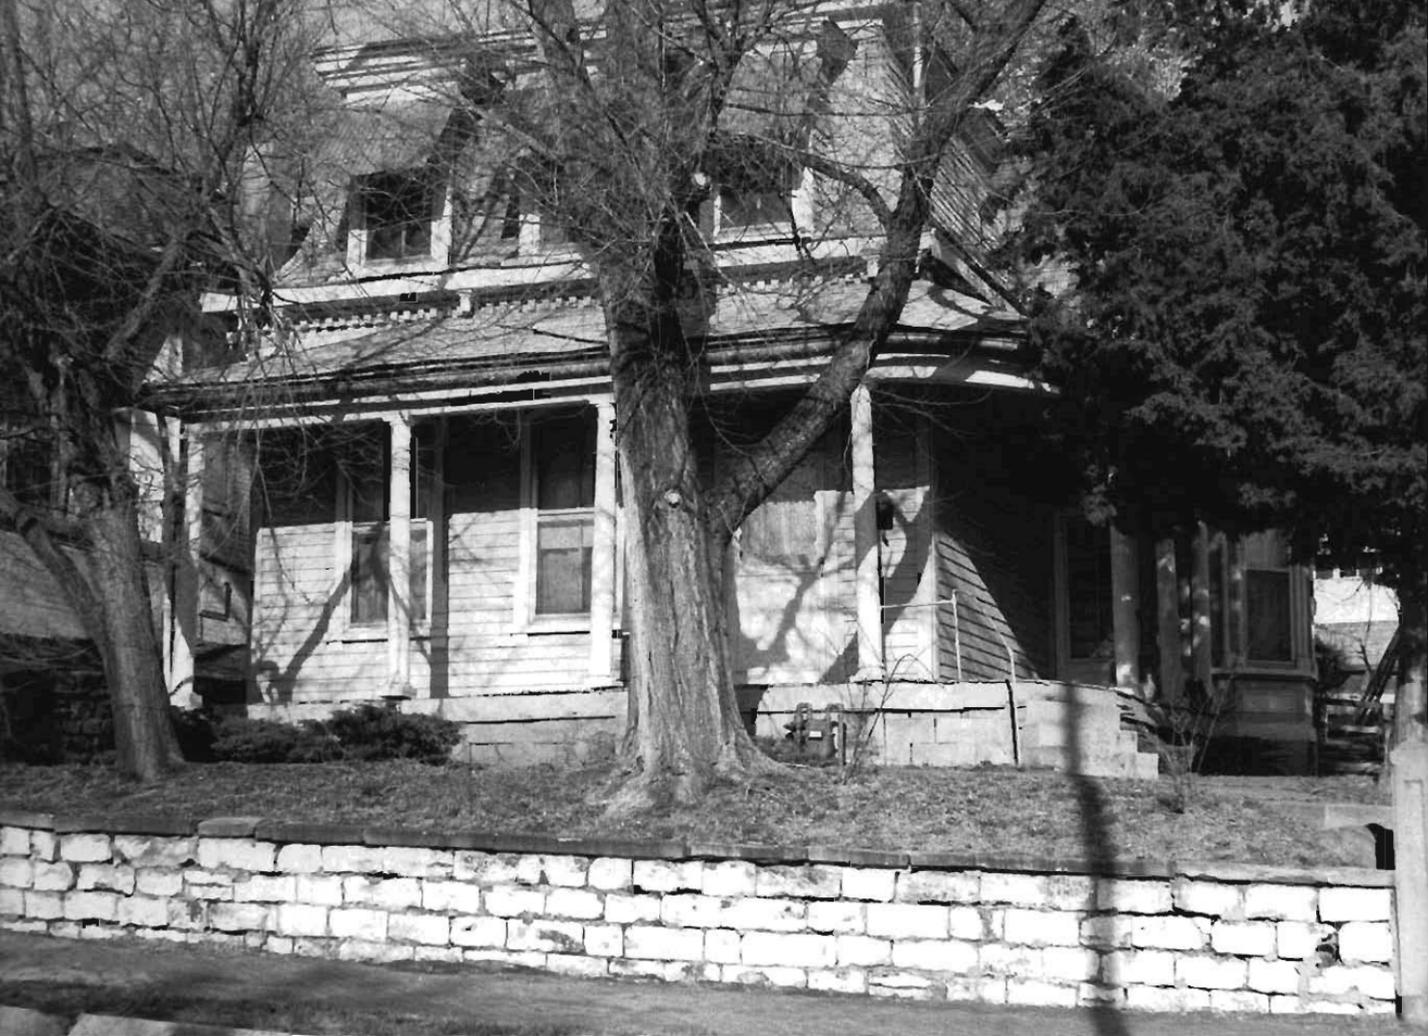
BN-45-009-140

<b>9. COORDINATES</b> UTM LAT _____ LONG _____ <b>10.</b> SITE ( ) STRUCTURE ( ) BUILDING (X) OBJECT ( ) <b>11. ON NATIONAL REGISTER?</b> YES ( ) NO (X) <b>12. IS IT ELIGIBLE?</b> YES (X) NO ( ) <b>13. PART OF ESTAB. HIST. DISTRICT?</b> YES ( ) NO (X) <b>14. DISTRICT POTENTIAL?</b> YES (X) NO ( ) <b>15. NAME OF ESTABLISHED DISTRICT</b>	<b>42. FURTHER DESCRIPTION OF IMPORTANT FEATURES</b> 2 story, 5 bay, asymmetrical, frame dwelling with mansard roof with boxed, bracketed lower cornice with dentils below and heavy, molded top cornices. Left two bays contain 2/2 windows within arched openings. Third bay has door with transom; wood frames are shapeted, top and bottom of sides. Recessed fourth bay contains single door with transom. Fifth bay is one side of first story, polyzonal  <b>43. HISTORY AND SIGNIFICANCE</b> bay unit with 1/1 window; narrow paired engaged columns flank windows; paneling below. Colonial Revival porch, probably constructed wither in 1901 or 1910, attached to front and wraps onto south elevation to shelter fourth bay; Tuscan columns. Flat roof dormers (3) have molded cornices and contain 2/2 windows. 43. Building permit records indicate construction phases in 1901 for Edgar Sleppy and in 1910 for Judge C. Sleppy; however, stylistic features are of a ca1870 original construction period. It has a high degree of integrity and is significant as a representation of 2nd Empire residential property type.	PHOTO MUST BE PROVIDED

<b>44. DESCRIPTION OF ENVIRONMENT AND OUTBUILDINGS</b> In residential neighborhood; on corner lot; neighborhood commercial building on corner to west.	<b>45. SOURCES OF INFORMATION</b> BP #A5858, 7/19/10; BP #8447, 5/25/01; site; 1883 Sanborn map	5. OTHER NAME(S)  6. TOWNSHIP  RANGE  SECTION
<b>46. PREPARED BY</b> Mary Jo Winder <b>47. ORGANIZATION</b> City of St. Joseph <b>48. DATE</b> 7/88 <b>49. REVISION DATE(S)</b>		RETURN THIS FORM WHEN COMPLETED TO: OFFICE OF HISTORIC PRESERVATION P.O. BOX 176 JEFFERSON CITY, MISSOURI 65102 PH. 314-751-4096  IF ADDITIONAL SPACE IS NEEDED, ATTACH SEPARATE SHEET(S) TO THIS FORM

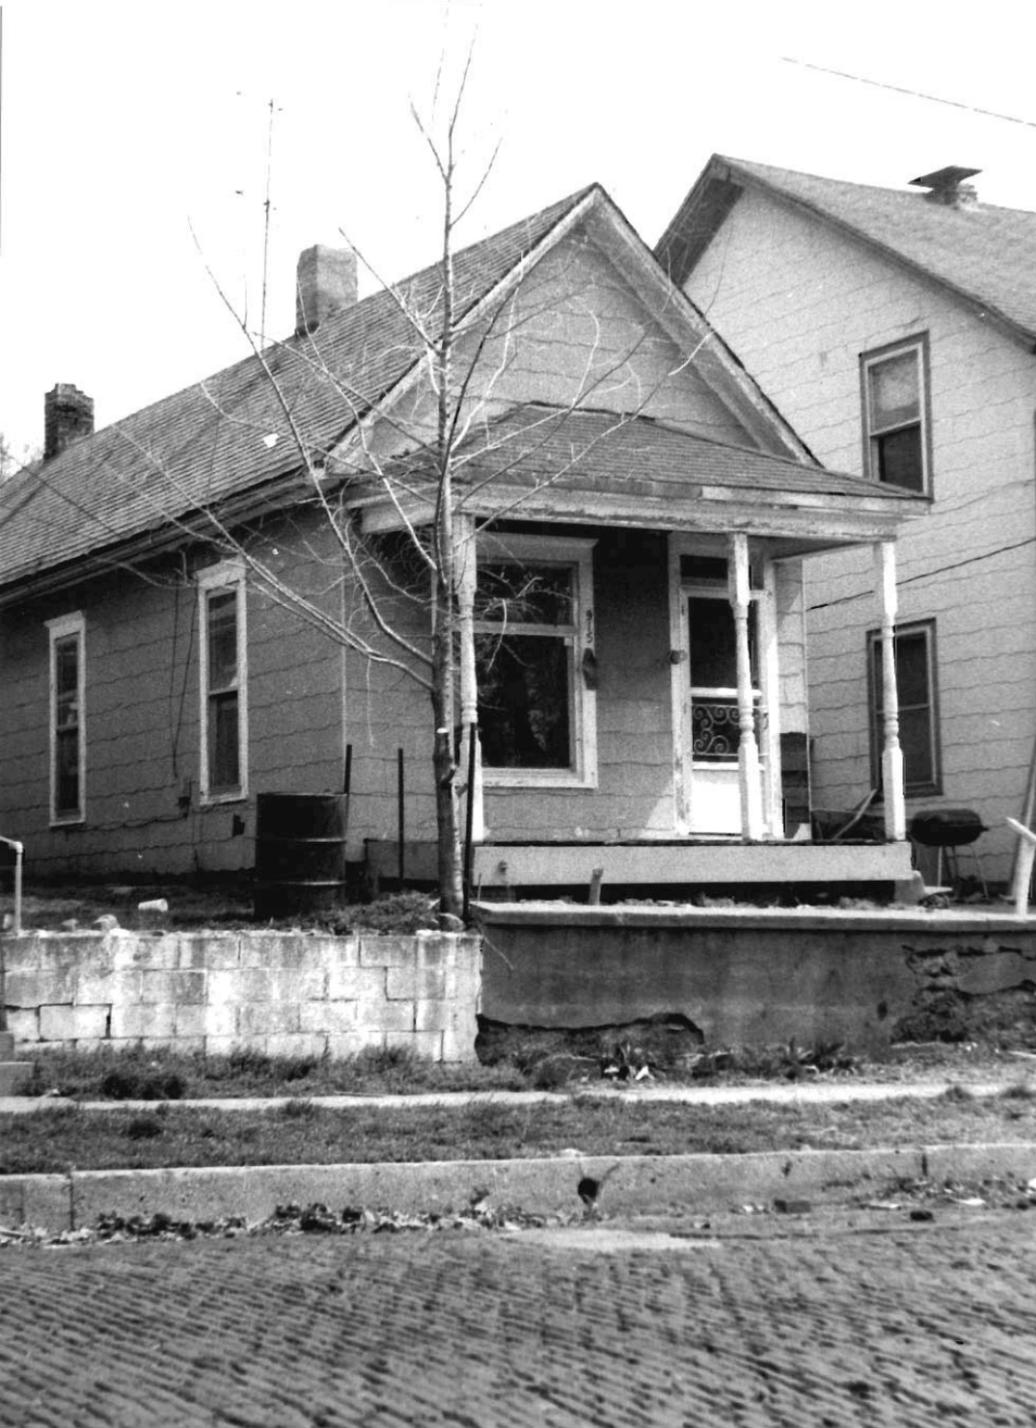
BN-15009-142

<p>9. COORDINATES UTM LAT _____ LONG _____</p> <p>10. SITE ( ) BUILDING (X) STRUCTURE ( ) OBJECT ( )</p> <p>11. ON NATIONAL REGISTER? YES ( ) NO (X)</p> <p>12. IS IT ELIGIBLE? YES (X) NO ( )</p> <p>13. PART OF ESTAB. HIST. DISTRICT? YES ( ) NO (X)</p> <p>14. DISTRICT POTENTIAL? YES (X) NO ( )</p> <p>15. NAME OF ESTABLISHED DISTRICT</p>	<p>25. OPEN TO PUBLIC? YES ( ) NO (X)</p> <p>26. LOCAL CONTACT PERSON OR ORGANIZATION</p> <p>27. OTHER SURVEYS IN WHICH INCLUDED</p>	4. PRESENT LOCAL NAME(S) OR DESIGNATION(S)	
<p>42. FURTHER DESCRIPTION OF IMPORTANT FEATURES <b>1 story, 2 bay, asymmetrical, frame shotgun dwelling with front gable roof and centralized chimneys. Porch attached to front elevation (west) is later (ca.1900) alteration with turned posts, entablature and hip roof. Left bay contains wide windows; right bay has single door with transom; fenestration has plain frames with narrow cornice moldings.</b></p>	<div style="border: 2px solid black; padding: 20px; width: 100%;"> <p style="text-align: center; font-weight: bold;">PHOTO MUST BE PROVIDED</p> </div>		5. OTHER NAME(S)

<p>43. HISTORY AND SIGNIFICANCE <b>First building permit of record is one for repairs in 1938 for applicant, S.M. Mund; however, stylistic features indicate a ca 1900 construction date. It has a moderate to high degree of architectural integrity and is significant as a representation of vernacular shotgun residential property type.</b></p>			6. TOWNSHIP
<p>44. DESCRIPTION OF ENVIRONMENT AND OUTBUILDINGS <b>In residential neighborhood.</b></p>			RANGE
<p>45. SOURCES OF INFORMATION <b>BP #9209, 2/7/38; site; 1911 Sanborn map</b></p>	<p>46. PREPARED BY <b>Mary Jo Winder</b></p> <p>47. ORGANIZATION <b>City of St. Joseph</b></p> <p>48. DATE <b>7/88</b> 49. REVISION DATE(S)</p>		SECTION
<p>RETURN THIS FORM WHEN COMPLETED TO: OFFICE OF HISTORIC PRESERVATION P.O. BOX 176 JEFFERSON CITY, MISSOURI 65102 PH. 314-751-4096</p> <p>IF ADDITIONAL SPACE IS NEEDED, ATTACH SEPARATE SHEET(S) TO THIS FORM</p>

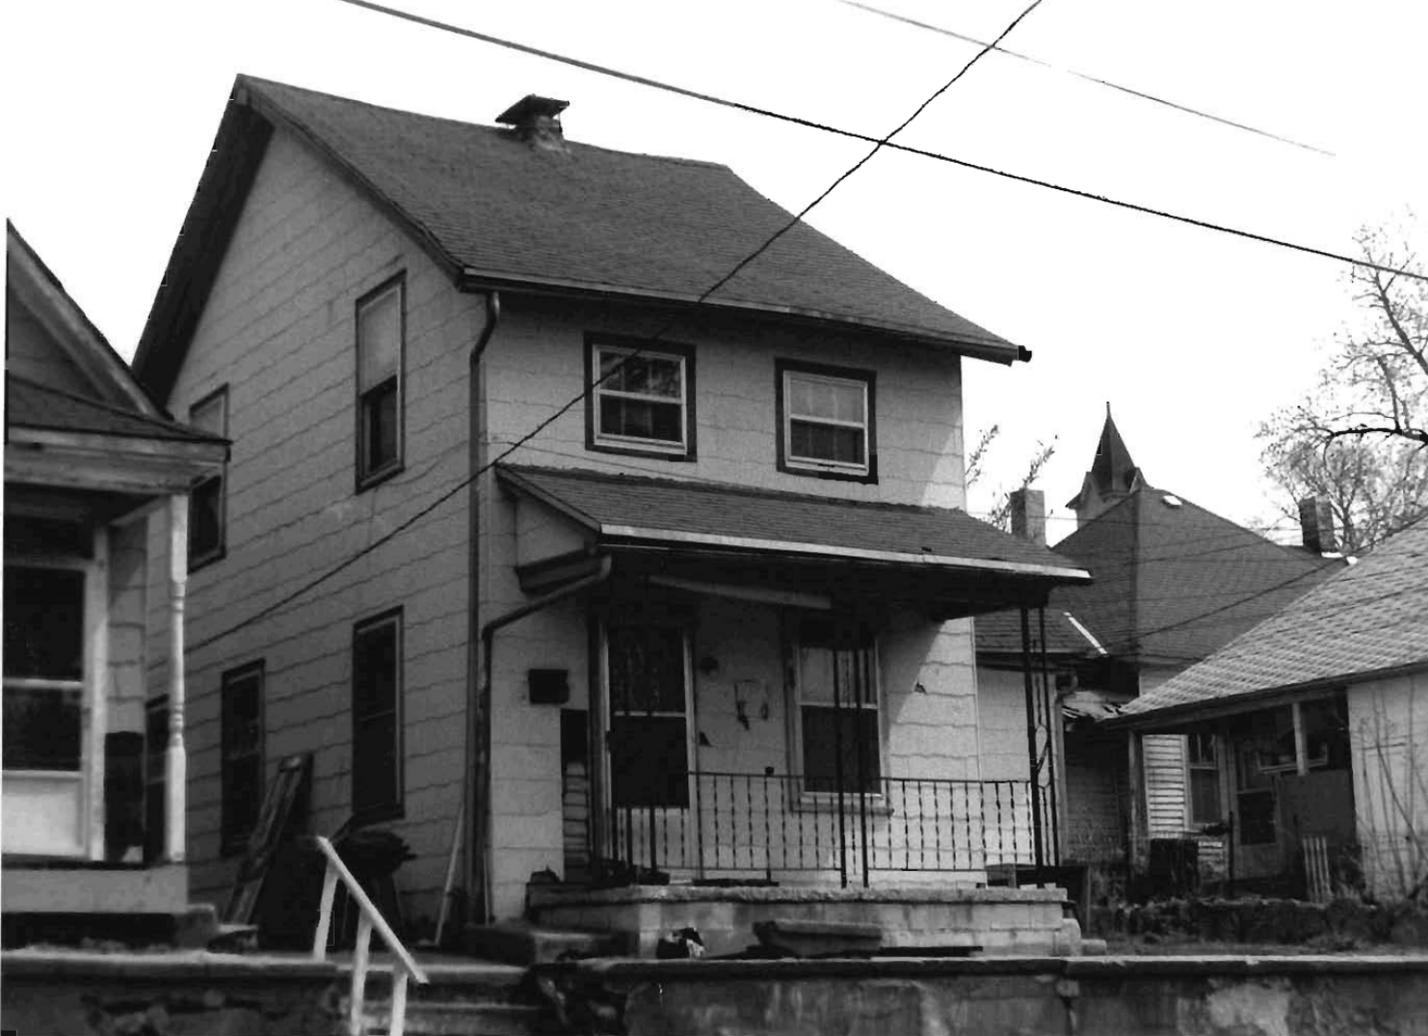
BN-AS-004.143

<p>9. COORDINATES UTM LAT LONG</p> <p>10. SITE ( ) STRUCTURE ( ) BUILDING (X) OBJECT ( )</p> <p>11. ON NATIONAL REGISTER? YES ( ) NO (X)</p> <p>12. IS IT ELIGIBLE? YES (X) NO ( )</p> <p>13. PART OF ESTAB. HIST. DISTRICT? YES ( ) NO (X)</p> <p>14. DISTRICT POTENTIAL? YES (X) NO ( )</p> <p>15. NAME OF ESTABLISHED DISTRICT</p>	<p>25. OPEN TO PUBLIC? YES ( ) NO (X)</p> <p>26. LOCAL CONTACT PERSON OR ORGANIZATION</p> <p>27. OTHER SURVEYS IN WHICH INCLUDED</p>	4. PRESENT LOCAL NAME(S) OR DESIGNATION(S)	
<p>42. FURTHER DESCRIPTION OF IMPORTANT FEATURES <b>1 3/4 story, 2 bay, symmetrically massed frame dwelling with side gable roof. Porch attached to front elevation (west) is an alteration with concrete block foundation, wrought iron railing and supports and shed roof. Left bay contains single door; right bay has 1/1 window. Upper 3/4 story contains mullioned 6 light 1/2 window (easement?). Asbestos siding is a later alteration.</b></p>	<p style="font-size: 2em; font-weight: bold;">PHOTO MUST BE PROVIDED</p>		5. OTHER NAME(S)

<p>43. HISTORY AND SIGNIFICANCE <b>Stylistic features indicate construction of this dwelling to be ca1860. It has a moderate to high degree of integrity and is significant as a representation of mid 19th century vernacular residential property type. This may be 1/2 of a duplex; the south 1/2 of which may have been demolished (1888 Sanborn map shows this dwelling to be a duplex).</b></p>			6. TOWNSHIP
<p>44. DESCRIPTION OF ENVIRONMENT AND OUTBUILDINGS <b>In residential neighborhood.</b></p>			RANGE
<p>45. SOURCES OF INFORMATION <b>BP #9209, 2/7/38; site; 1888 and 1911 Sanborn map</b></p>	<p>46. PREPARED BY <b>Mary Jo Winder</b></p> <p>47. ORGANIZATION <b>City of St. Joseph</b></p> <p>48. DATE <b>7/88</b> 49. REVISION DATE(S)</p>		SECTION
<p>RETURN THIS FORM WHEN COMPLETED TO: <b>OFFICE OF HISTORIC PRESERVATION P.O. BOX 176 JEFFERSON CITY, MISSOURI 65102 PH. 314-751-4096</b></p> <p>IF ADDITIONAL SPACE IS NEEDED, ATTACH SEPARATE SHEET(S) TO THIS FORM</p>

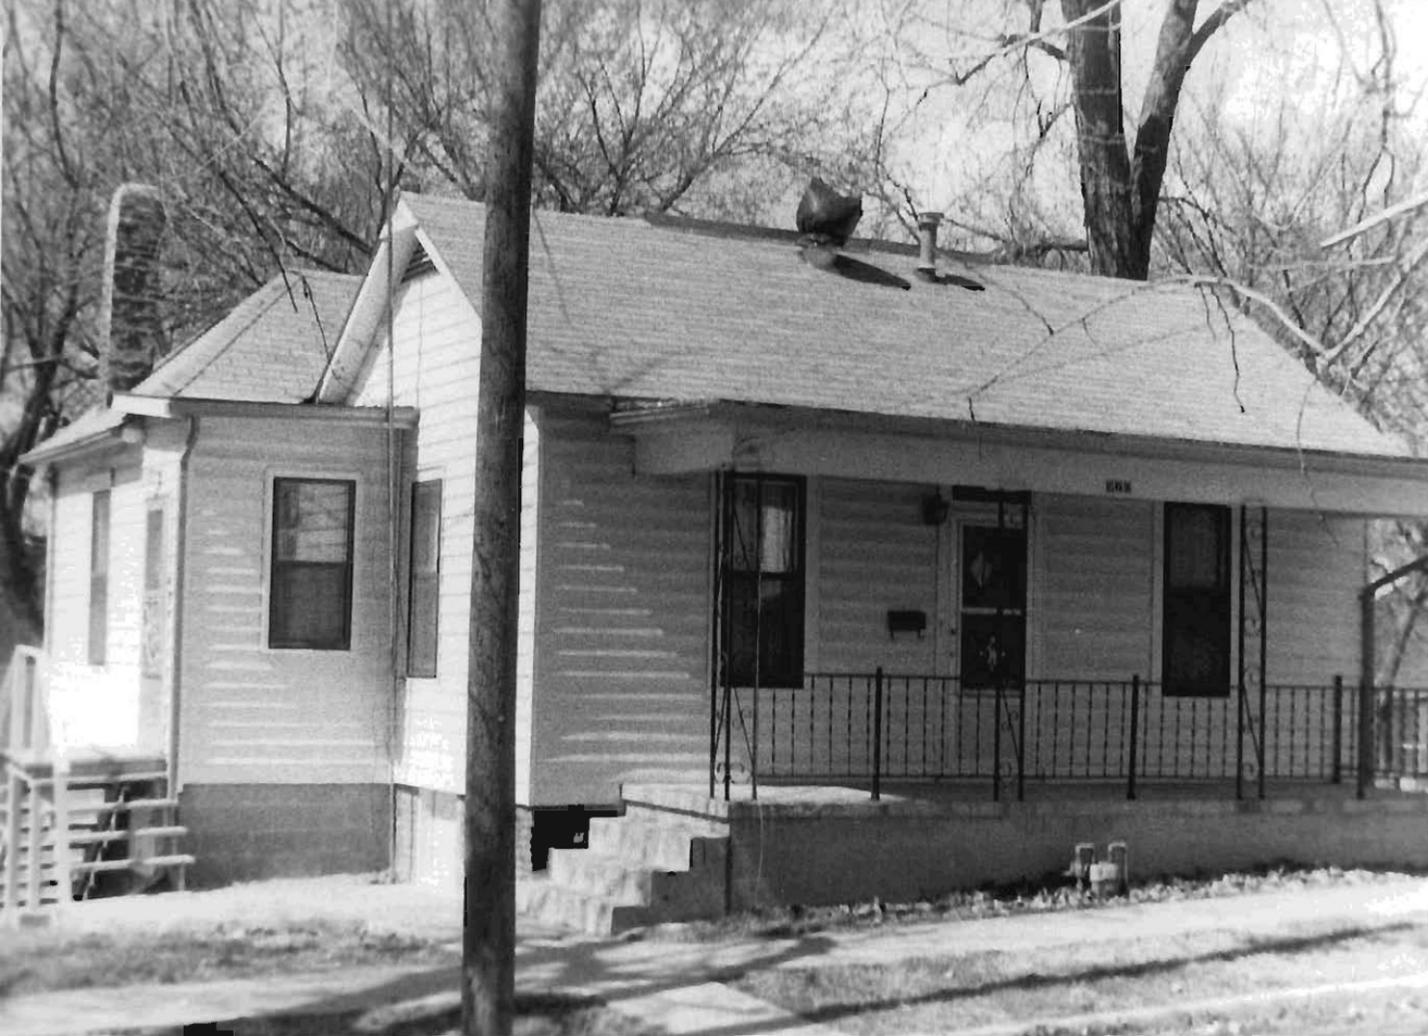
BN-AC 004-144

10. SITE ( ) STRUCTURE ( ) BUILDING (X) OBJECT ( ) 11. ON NATIONAL REGISTER? YES ( ) NO (X) 12. IS IT ELIGIBLE? YES (X) NO ( ) 13. PART OF ESTAB. HIST. DISTRICT? YES ( ) NO (X) 14. DISTRICT POTENTIAL? YES (X) NO ( ) 15. NAME OF ESTABLISHED DISTRICT	28. NO. OF STORIES 29. BASEMENT? YES ( ) NO ( ) 30. FOUNDATION MATERIAL  31. WALL CONSTRUCTION <u>WU</u> 32. ROOF TYPE AND MATERIAL <u>HP GB 63</u> 33. NO. OF BAYS FRONT SIDE 34. WALL TREATMENT <u>IR</u> 35. PLAN SHAPE <u>99</u> 36. CHANGES (EXPLAIN IN NO. 42) ADDITION ( ) ALTERED ( ) MOVED ( ) 37. CONDITION INTERIOR _____ EXTERIOR _____ 38. PRESERVATION UNDERWAY? YES ( ) NO ( ) 39. ENDANGERED? BY WHAT? YES ( ) NO ( ) 40. VISIBLE FROM PUBLIC ROAD? YES (X) NO ( ) 41. DISTANCE FROM AND FRONTAGE ON ROAD	5. OTHER NAME(S)

44. DESCRIPTION OF ENVIRONMENT AND OUTBUILDINGS <u>BP #7751, 3/18/13; site</u>	45. SOURCES OF INFORMATION  46. PREPARED BY <u>Mary Jo Winder</u> 47. ORGANIZATION <u>City of St. Joseph</u> 48. DATE 49. REVISION DATE(S)	RANGE

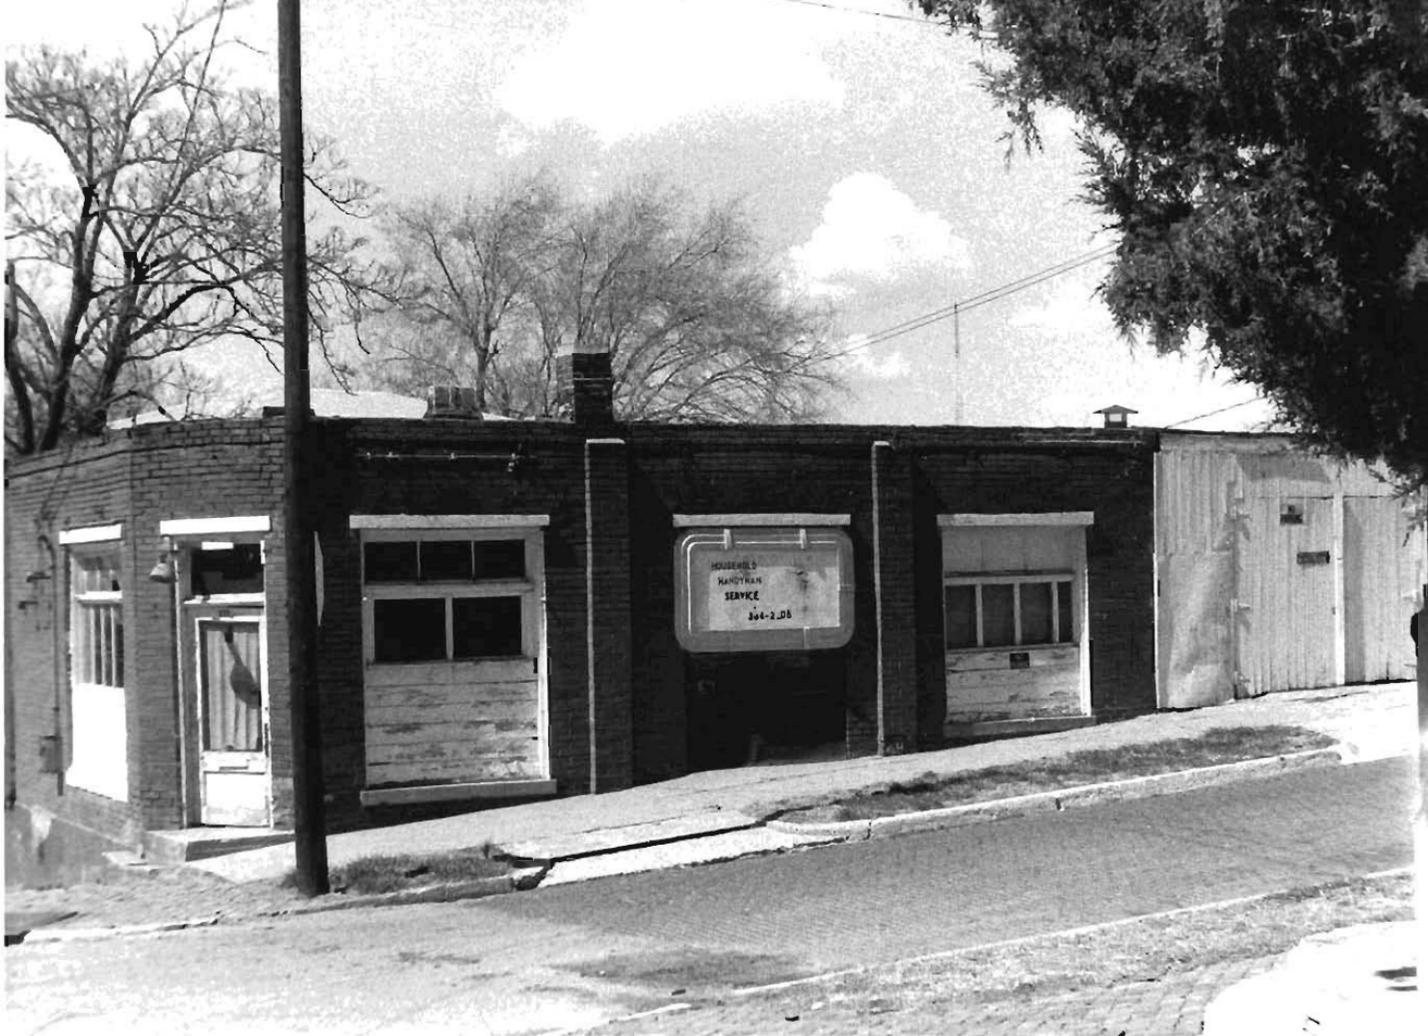
44. DESCRIPTION OF ENVIRONMENT AND OUTBUILDINGS In residential neighborhood of cal880-1910 dwellings					
45. SOURCES OF INFORMATION BP# 5818, 5/24/09; site		46. PREPARED BY Mary Jo Winder			
RETURN THIS FORM WHEN COMPLETED TO: OFFICE OF HISTORIC PRESERVATION P.O. BOX 176 JEFFERSON CITY, MISSOURI 65102 PH. 314-751-4096		47. ORGANIZATION City of St. Joseph			
IF ADDITIONAL SPACE IS NEEDED, ATTACH SEPARATE SHEET(S) TO THIS FORM.		48. DATE 7/88
