# **Bridgeton Landfill, LLC**

## **Weekly Data Submittals**

**Week of December 28, 2014 – January 3, 2015**

**Required by Section 52.F of Agreed Order, Case No. 13SL-CC01088  
Effective May 13, 2013**

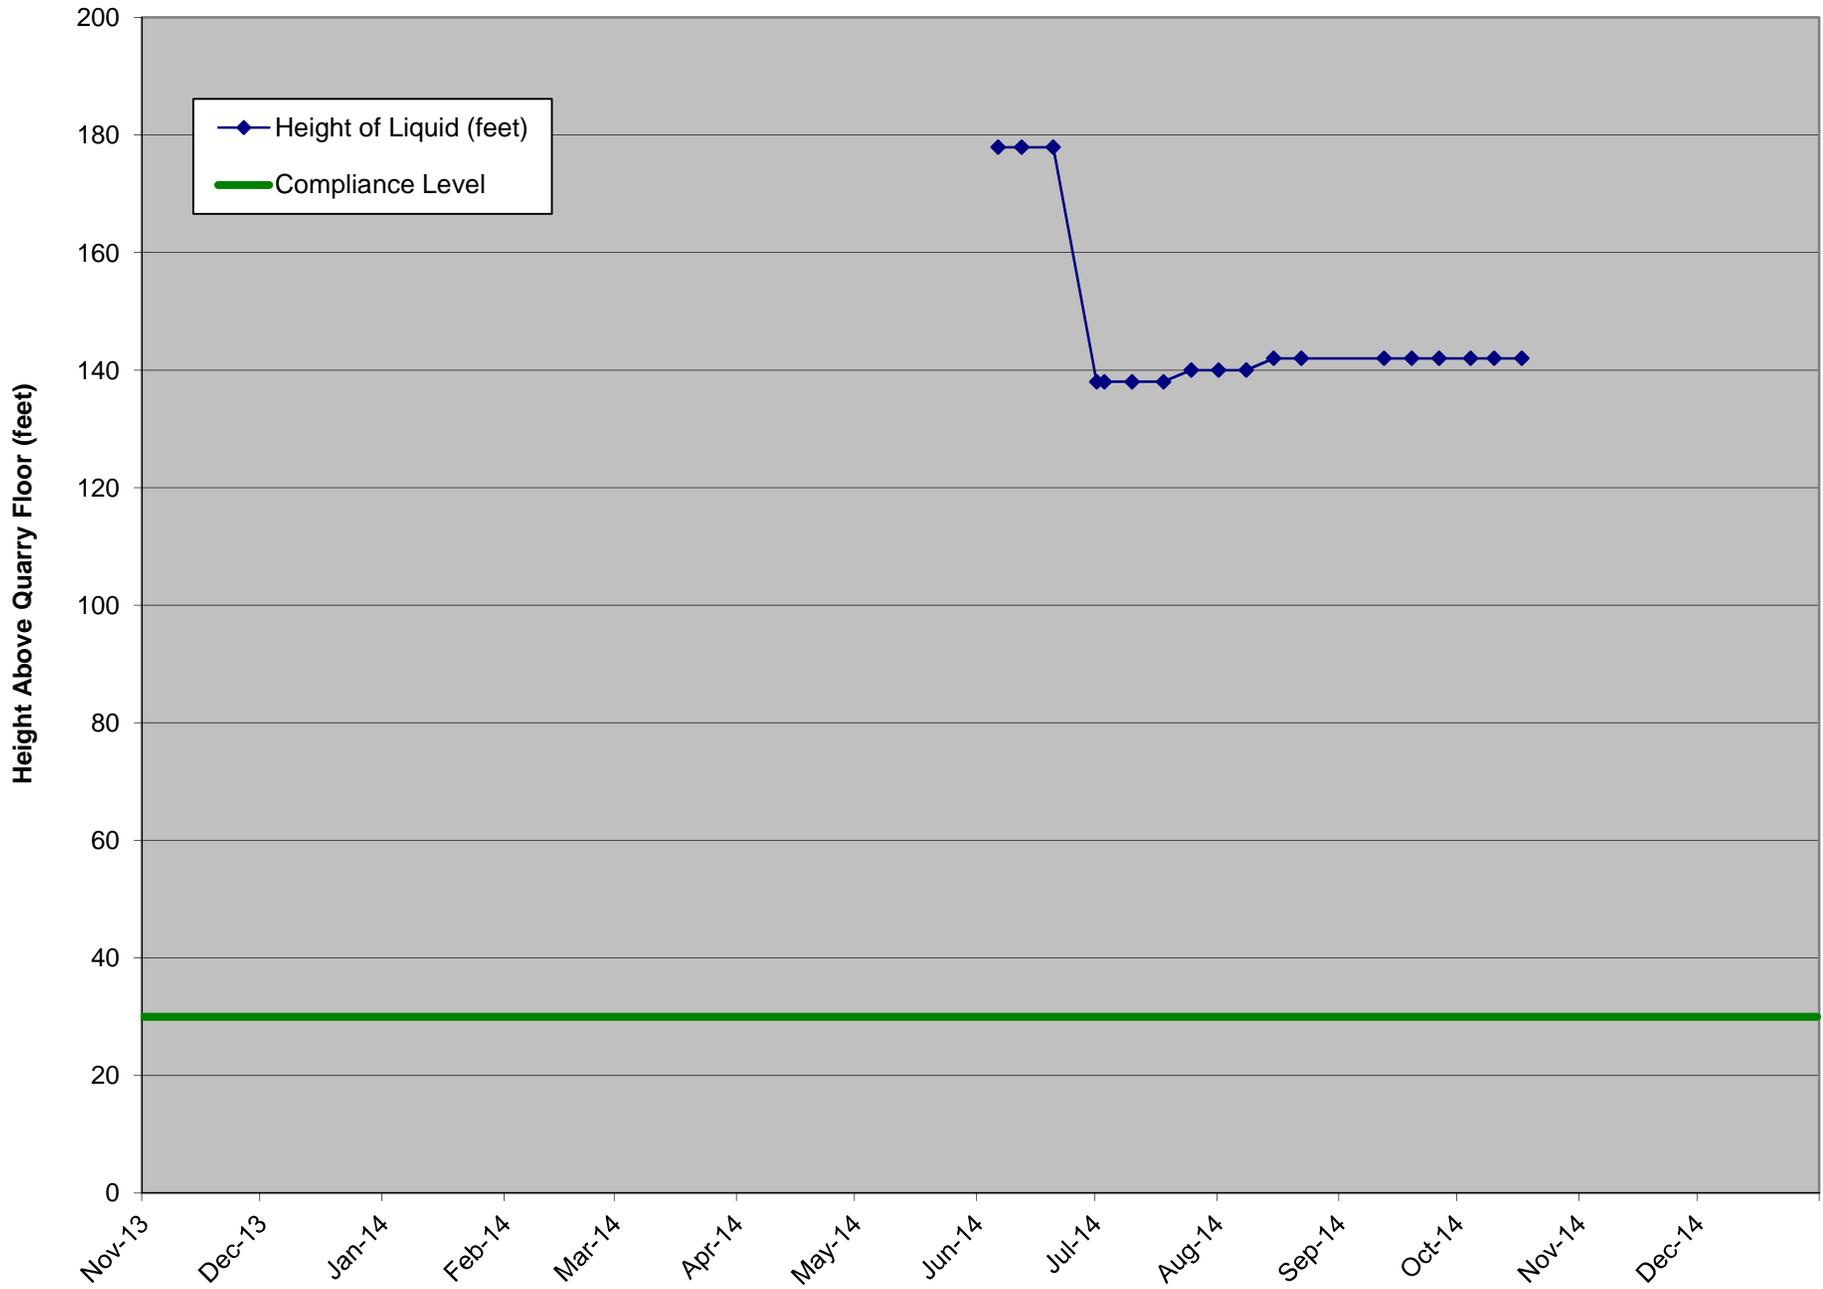
# LCS-1D Liquid Level Above Quarry Floor

Leachate Collection Sump (LCS)-1D, -5A, and -6B were partially or fully operational during the weekly reporting period. LCS-1D, while operational at the time of inspection, has a broken transducer.

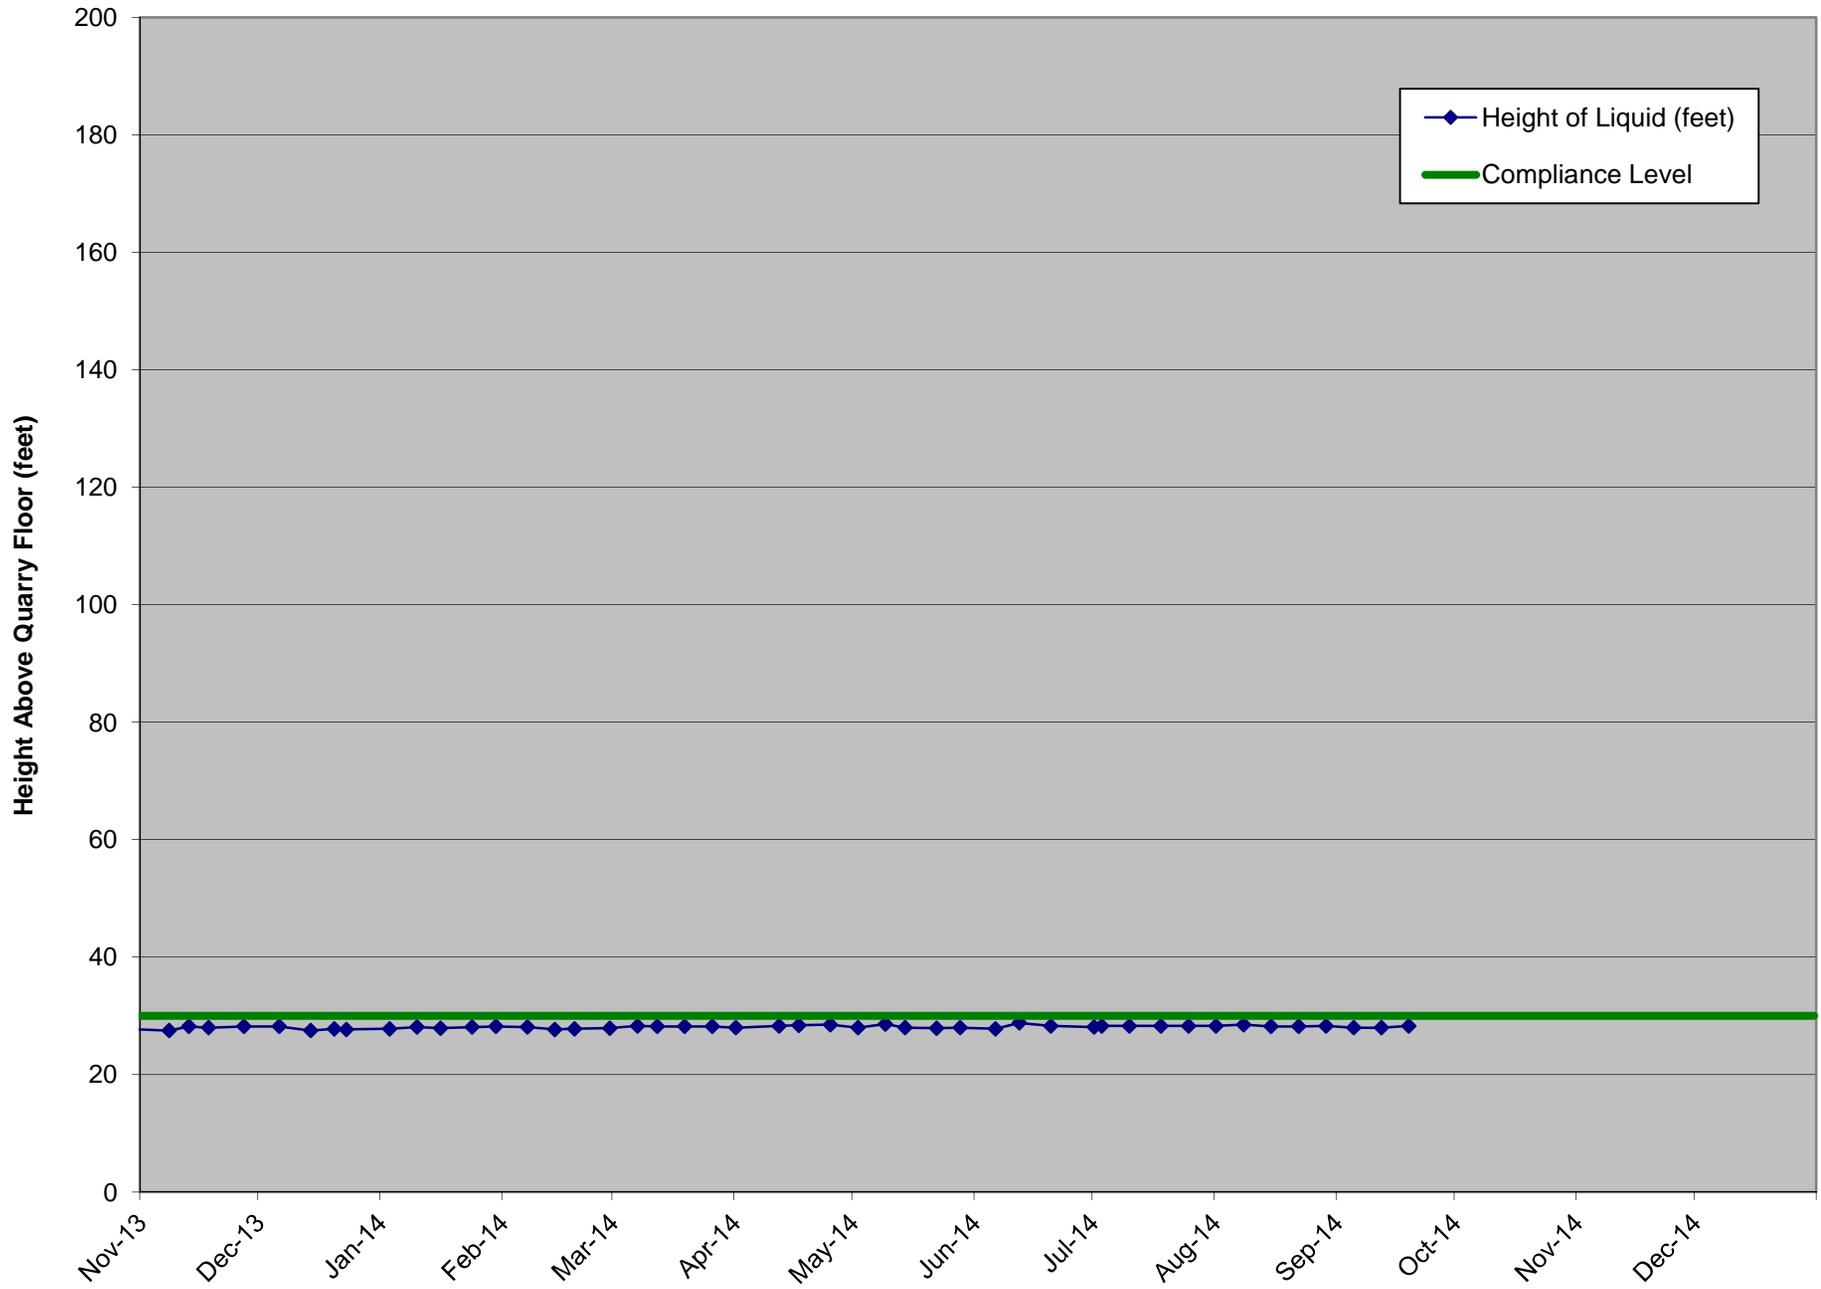
### LCS-2D Liquid Level Above Quarry Floor

The pump in LCS-2D was off during the weekly monitoring event due to an “over current” error.

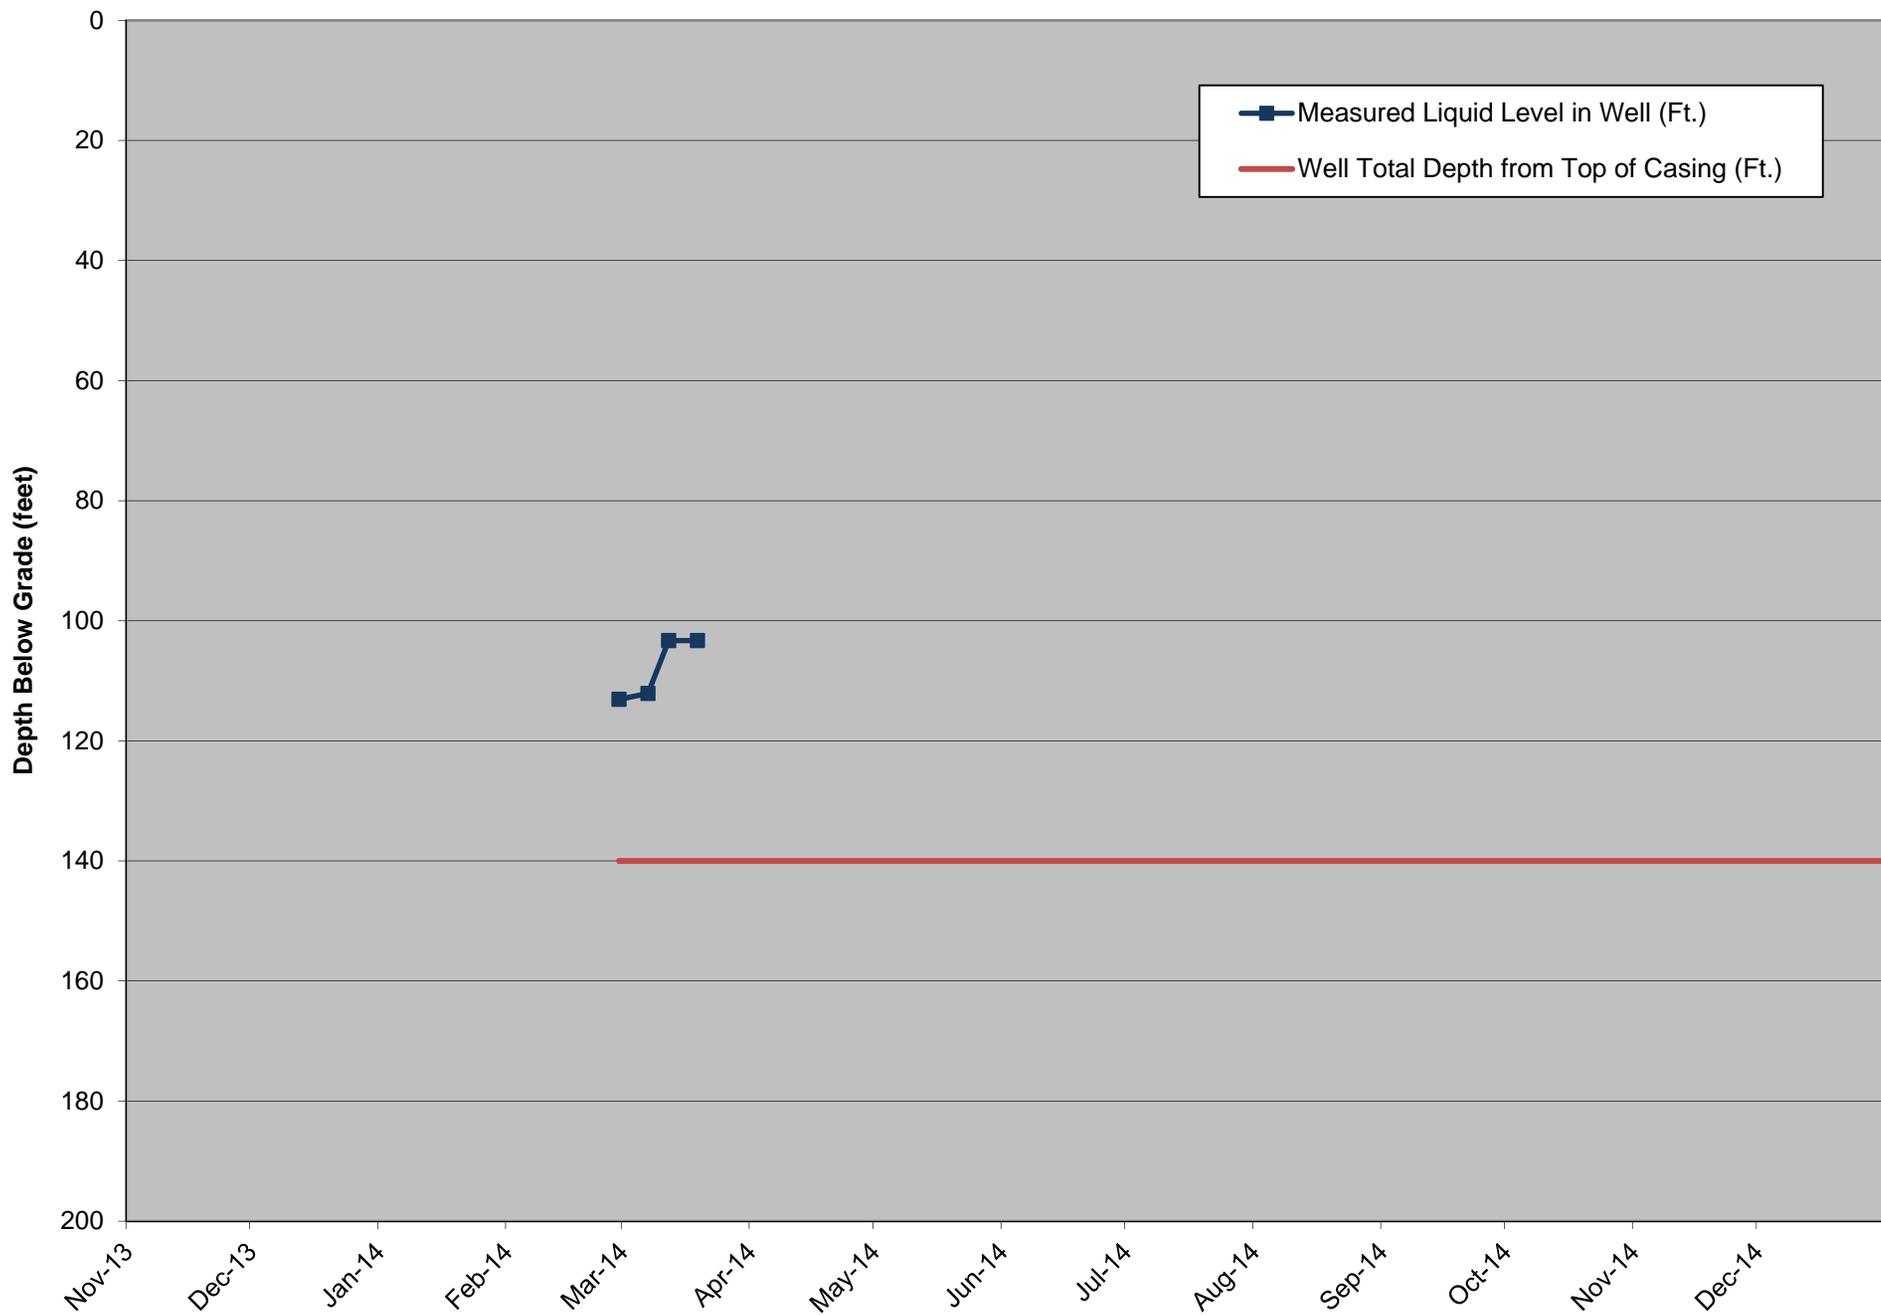
### LCS-3D Liquid Level Below Ground Surface

The transducer melted in LCS-3D in March 2014 and is currently non-operational.
