# **Bridgeton Landfill, LLC**

## **Weekly Data Submittals**

**Week of December 28, 2014 – January 3, 2015**

**Required by Section 52.F of Agreed Order, Case No. 13SL-CC01088  
Effective May 13, 2013**

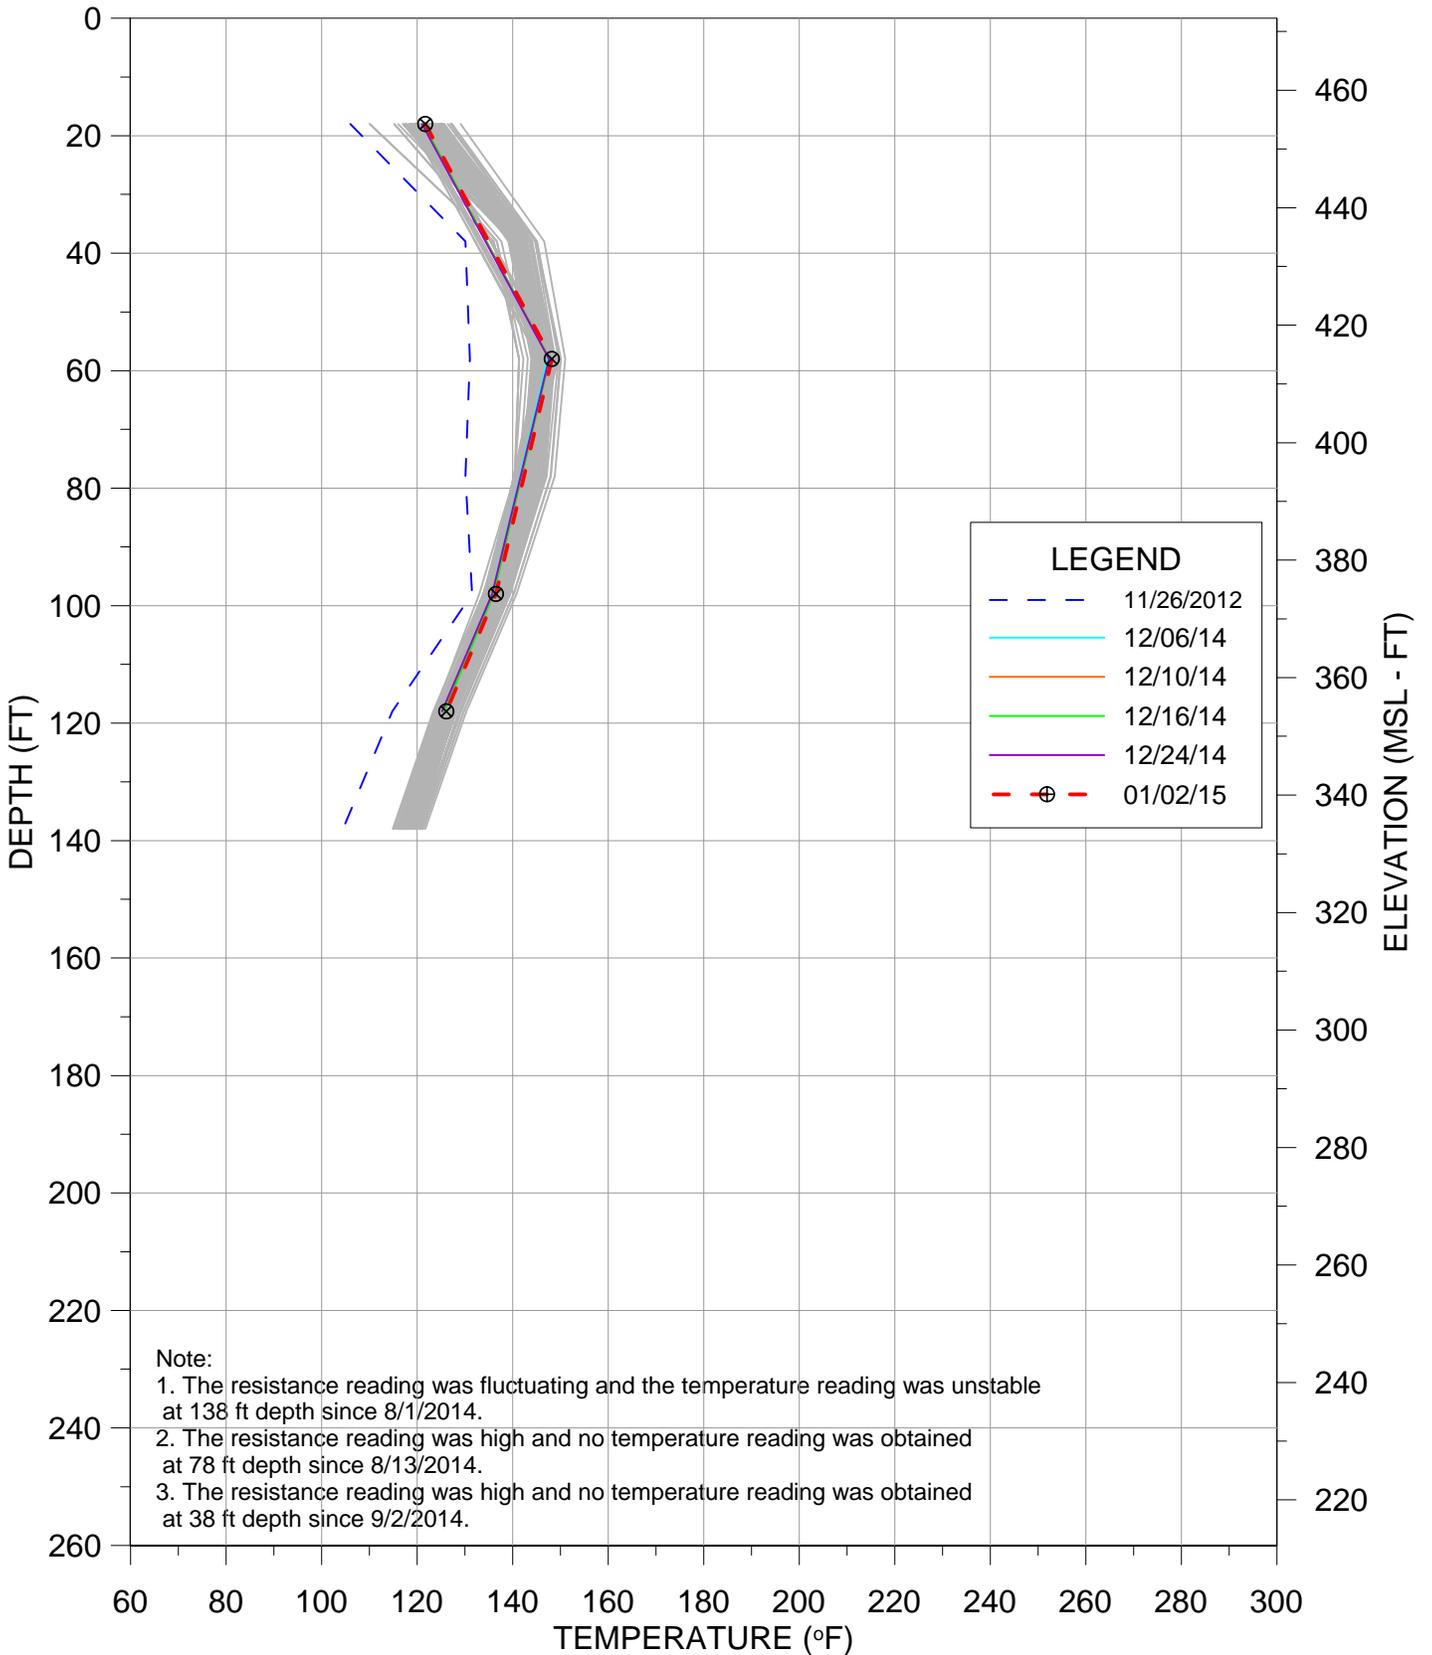
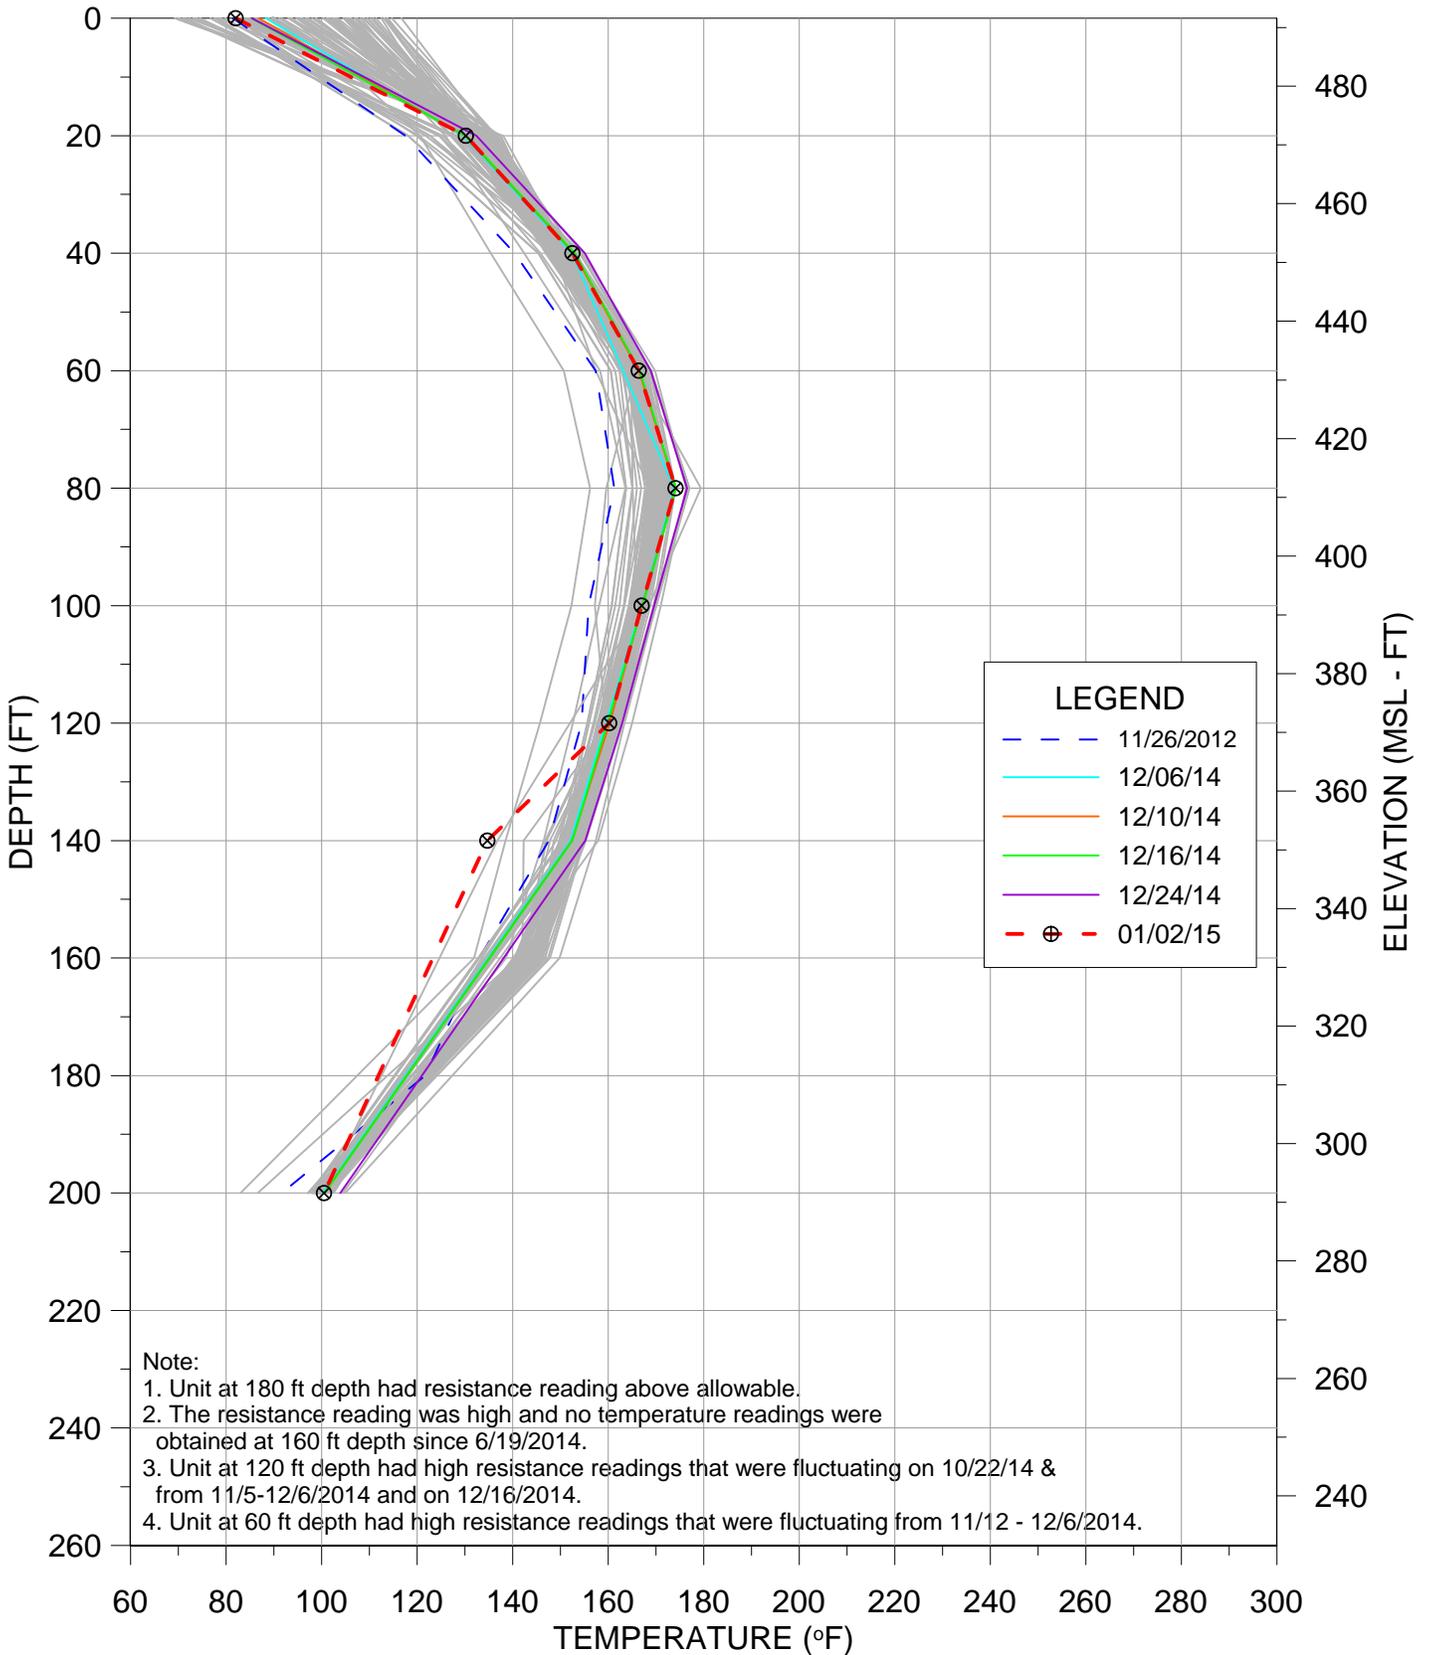
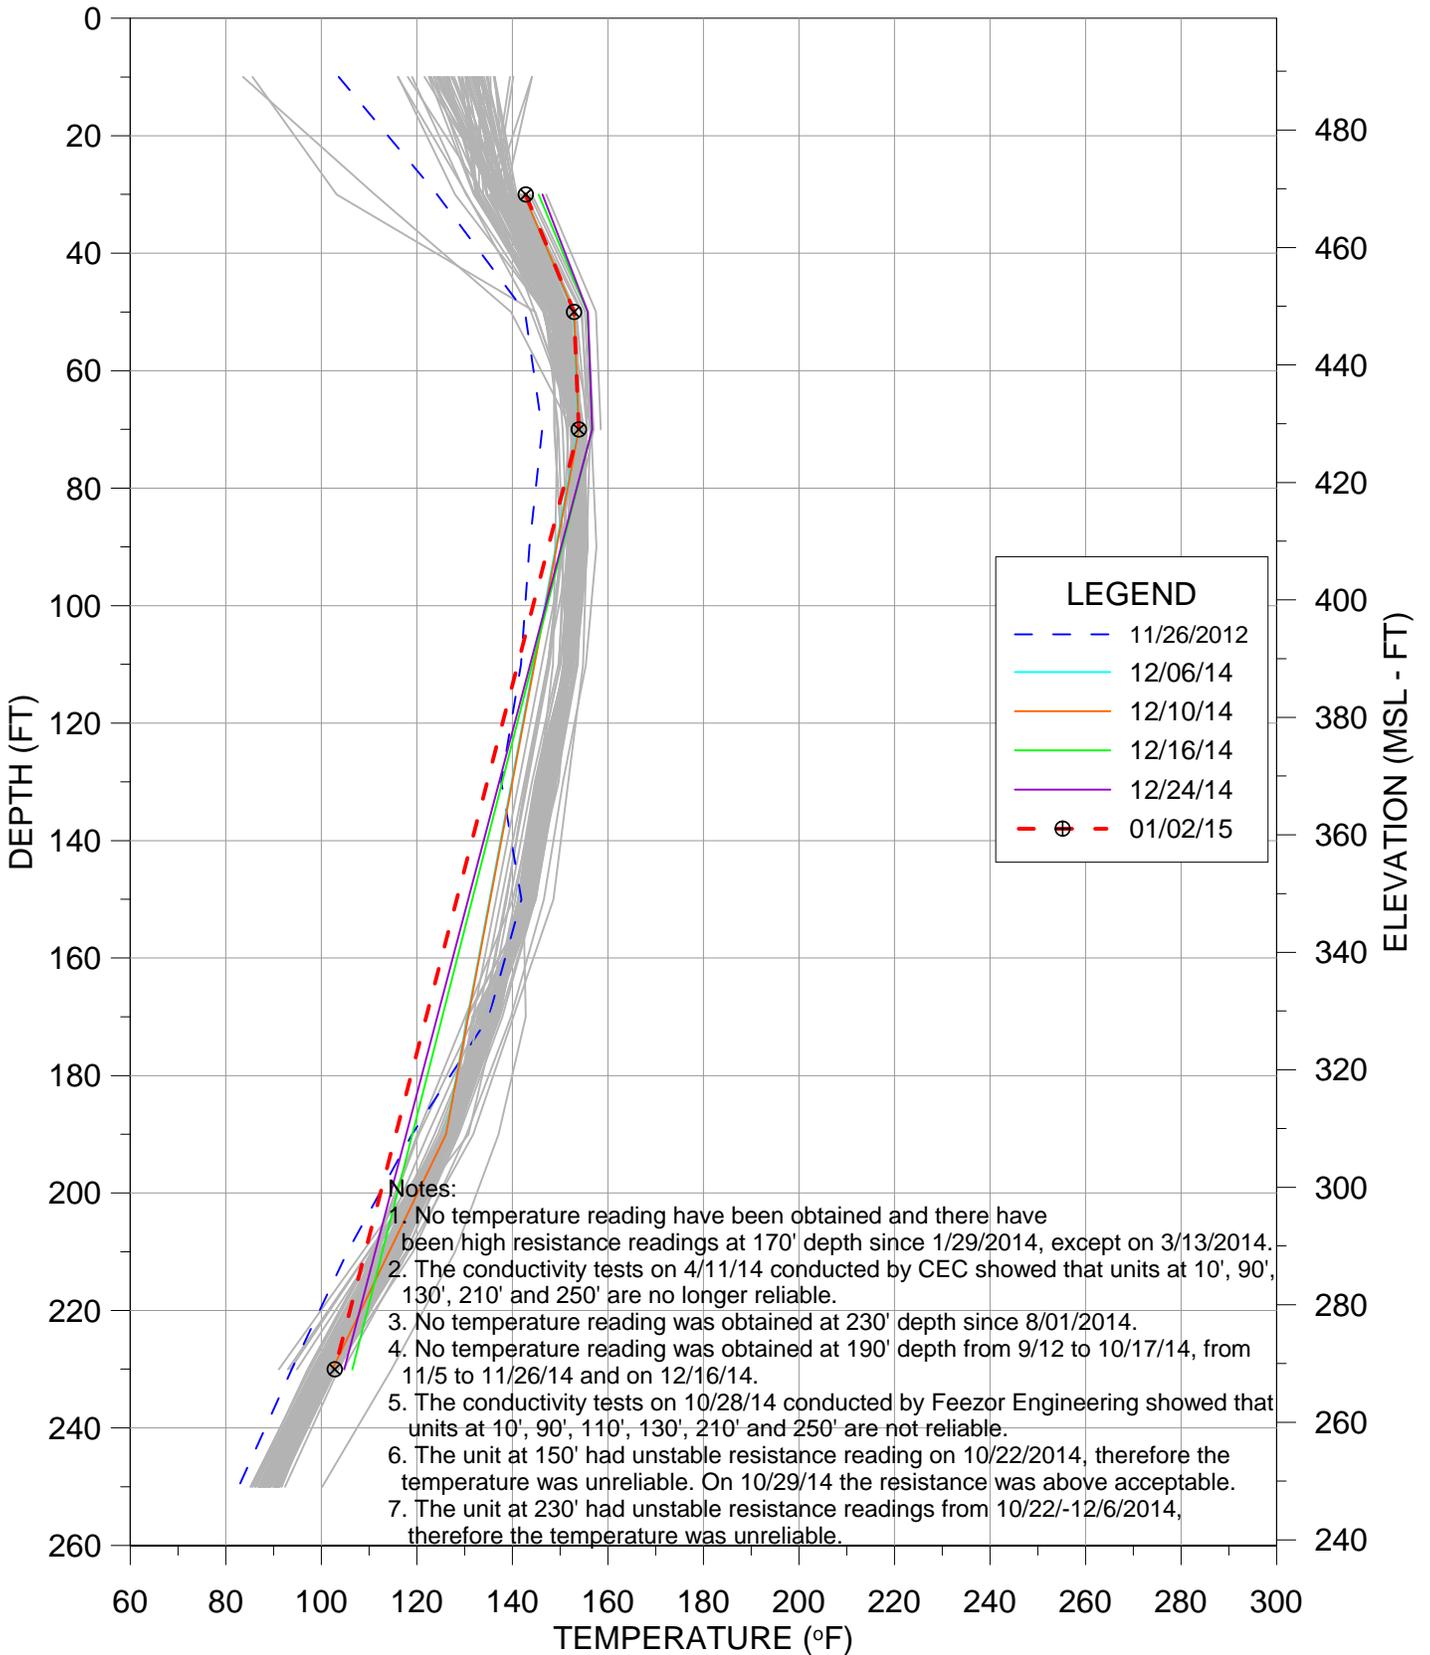
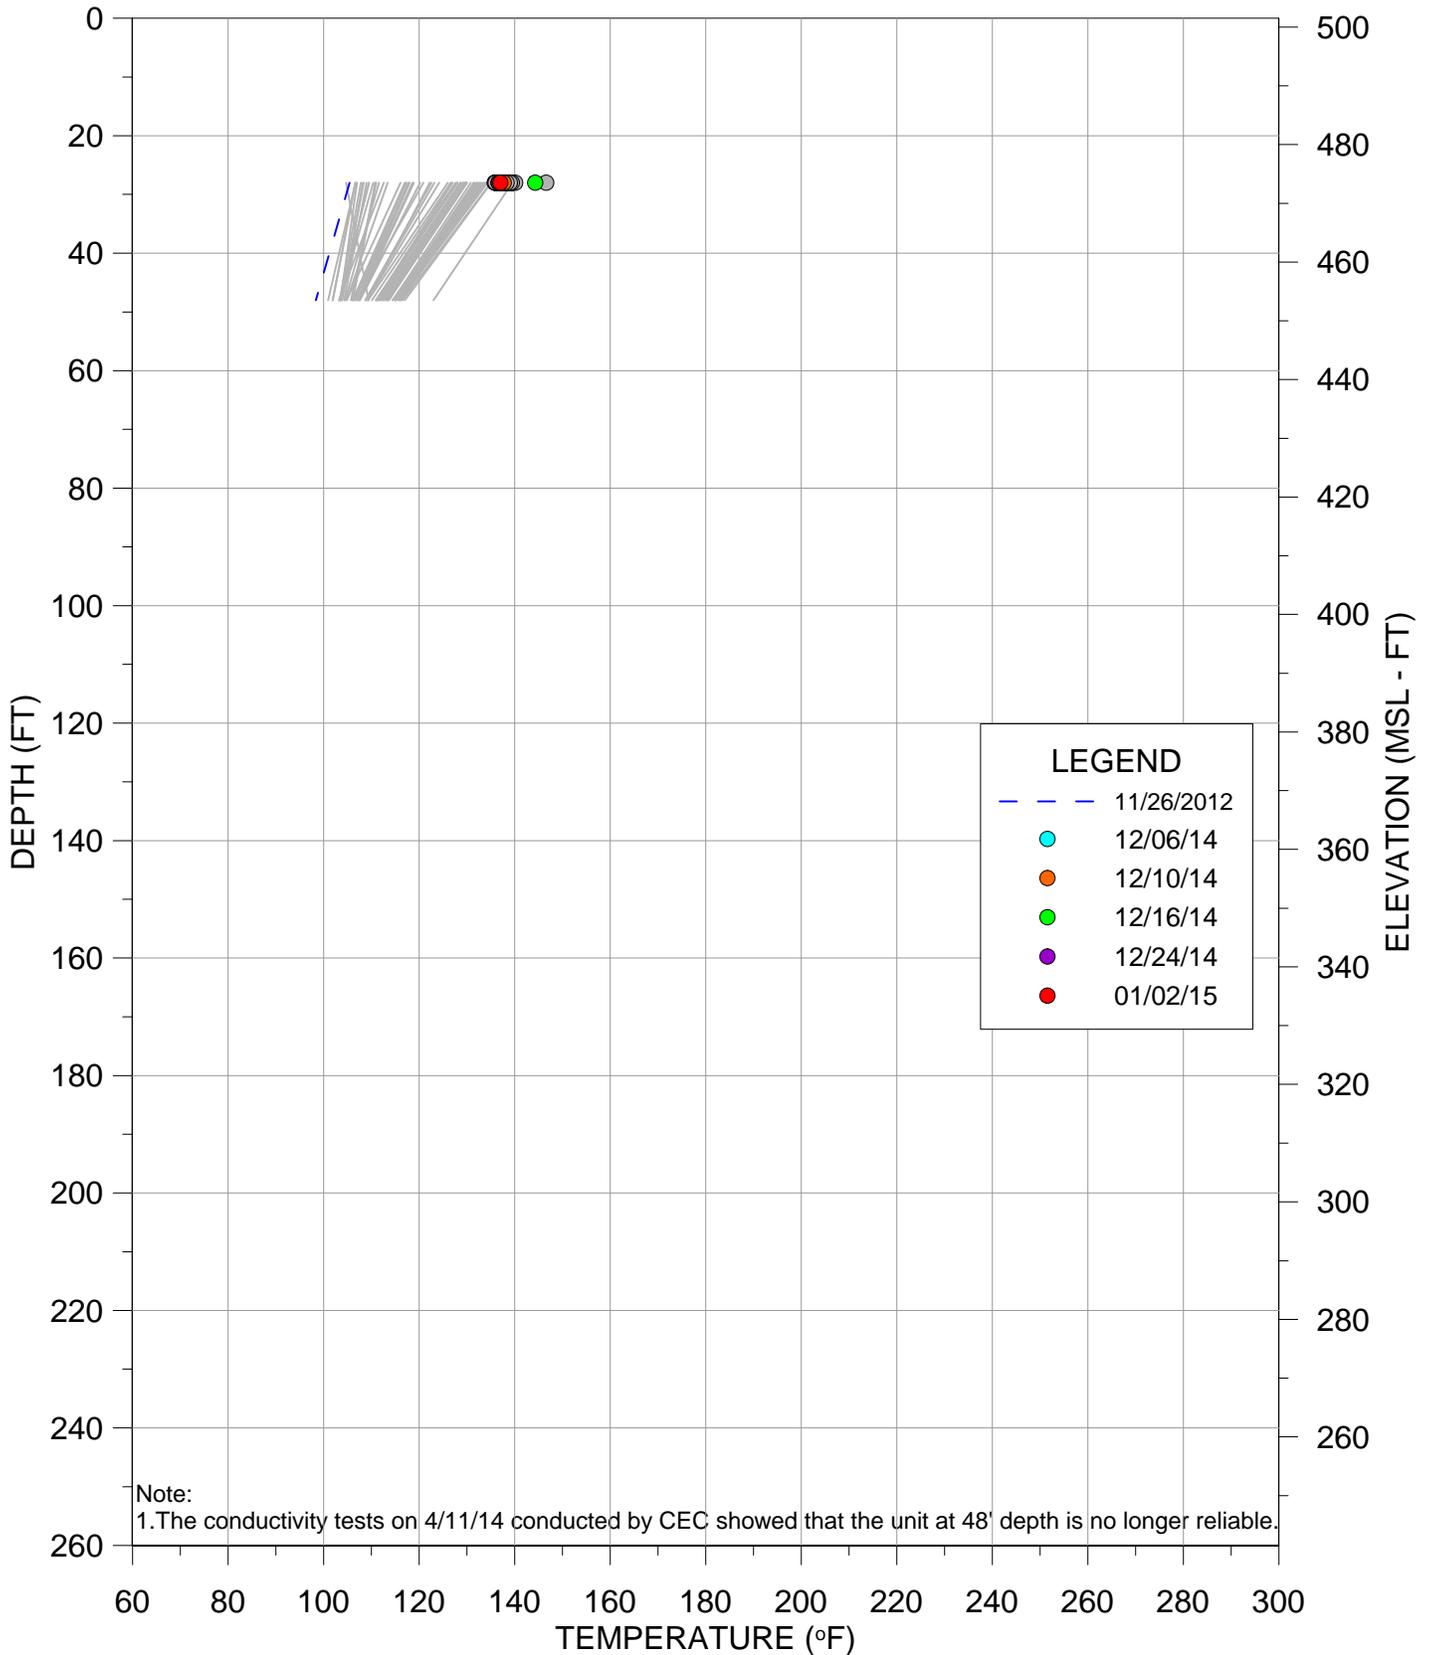
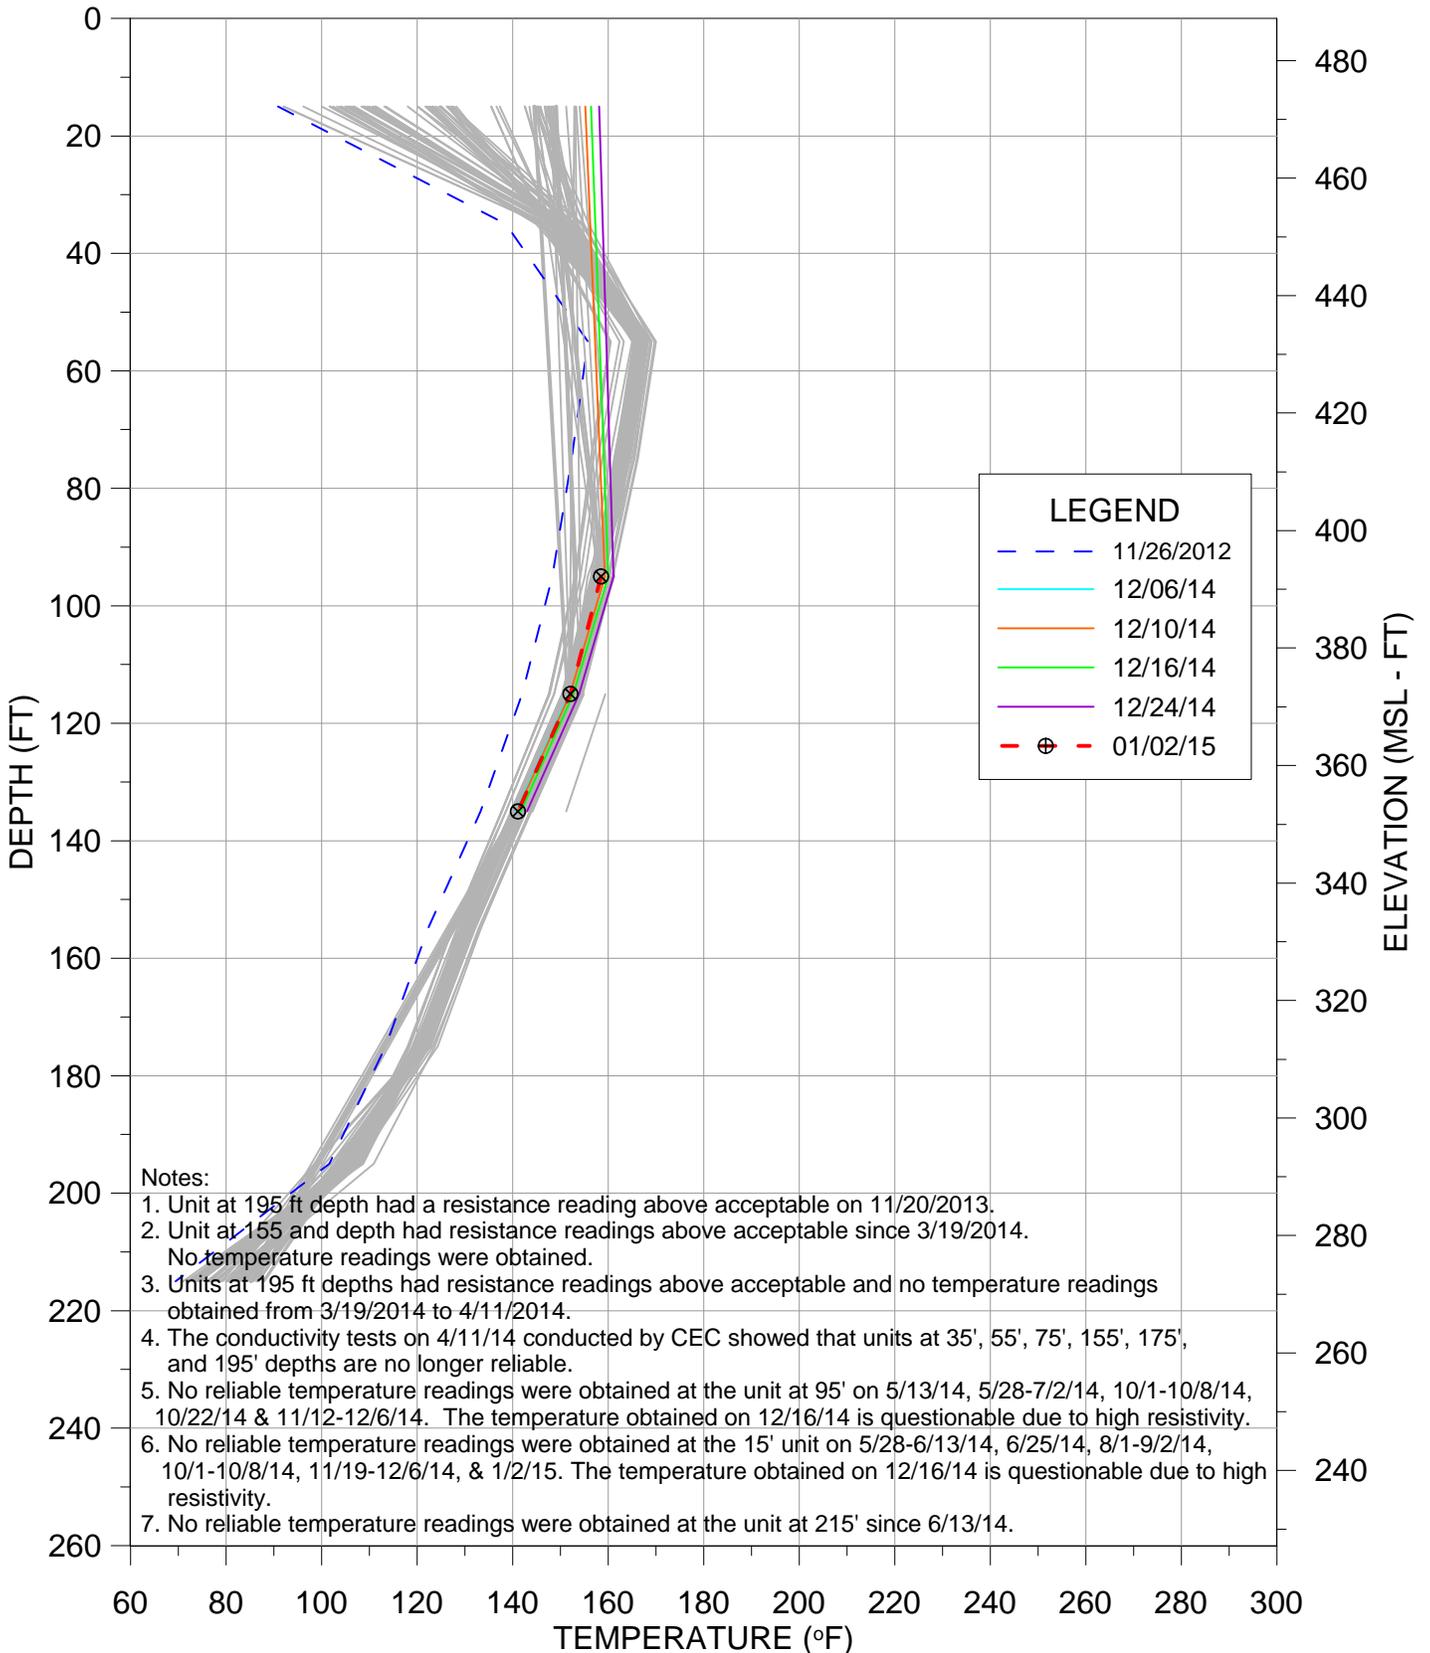
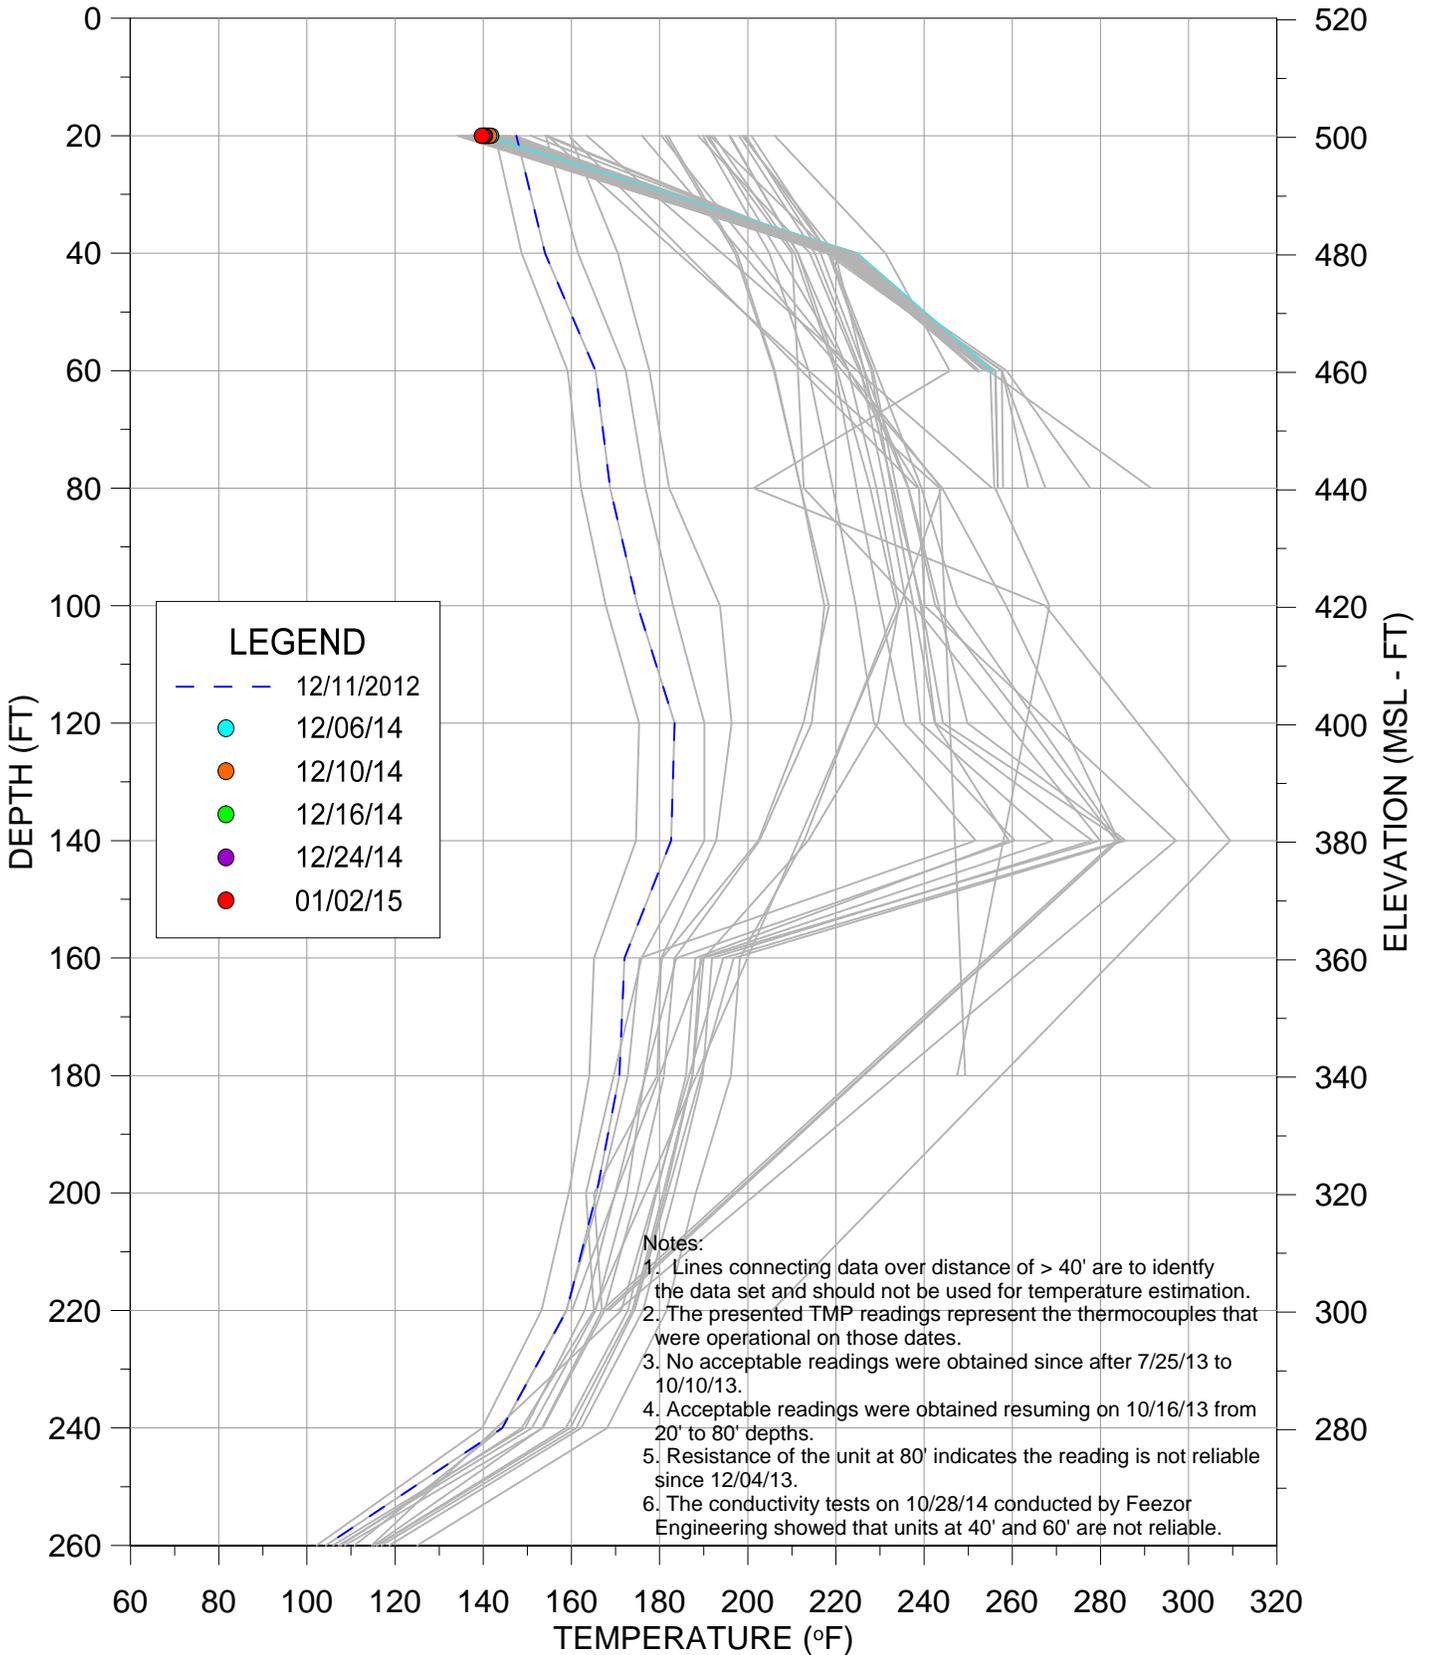
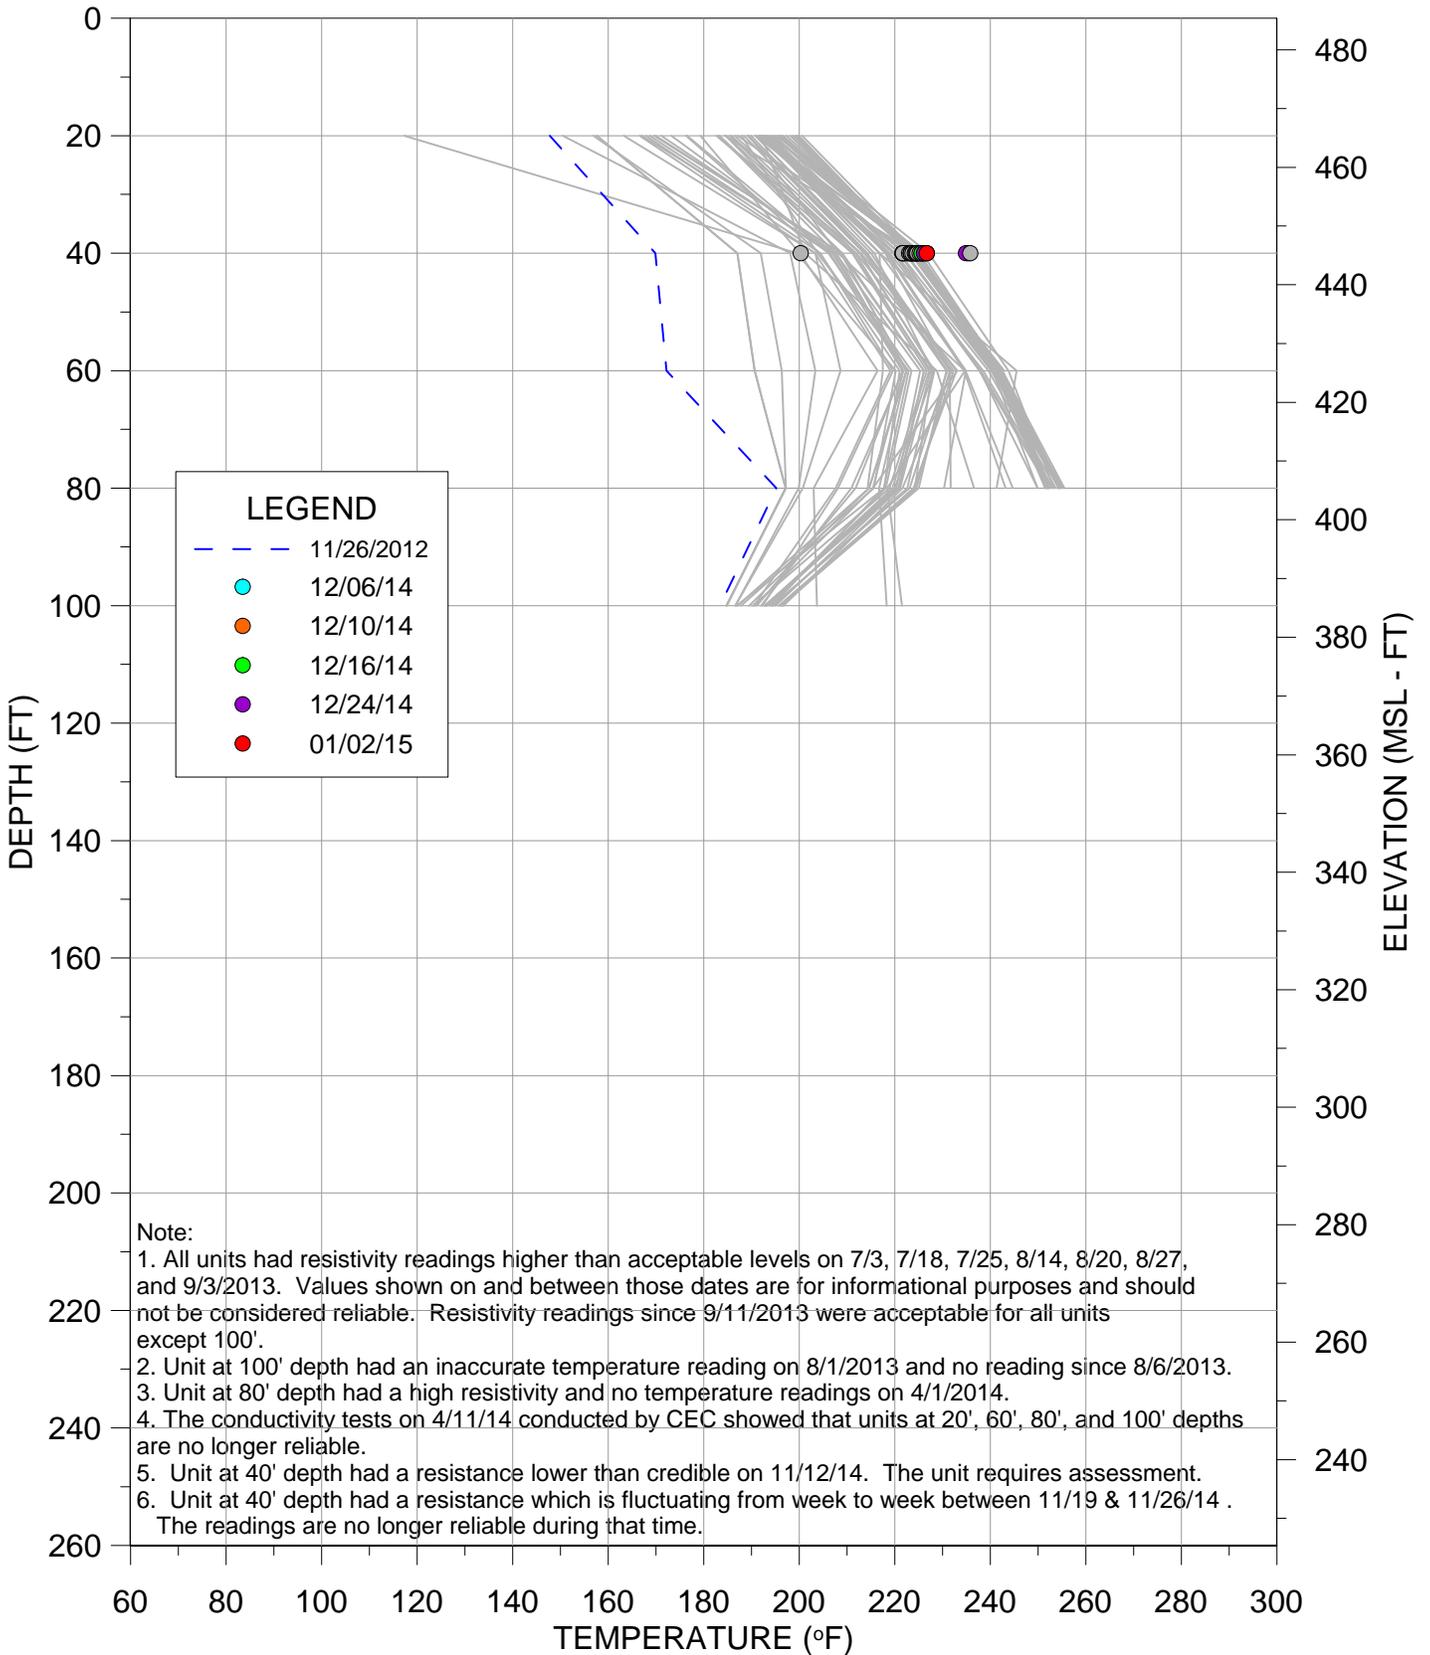
The following TMPs indicated generally consistent profiles to previous observations: TMP-1, -2, -3, -4, -6, -8, -9, -10, -11, -14, -16, -17, and -18.

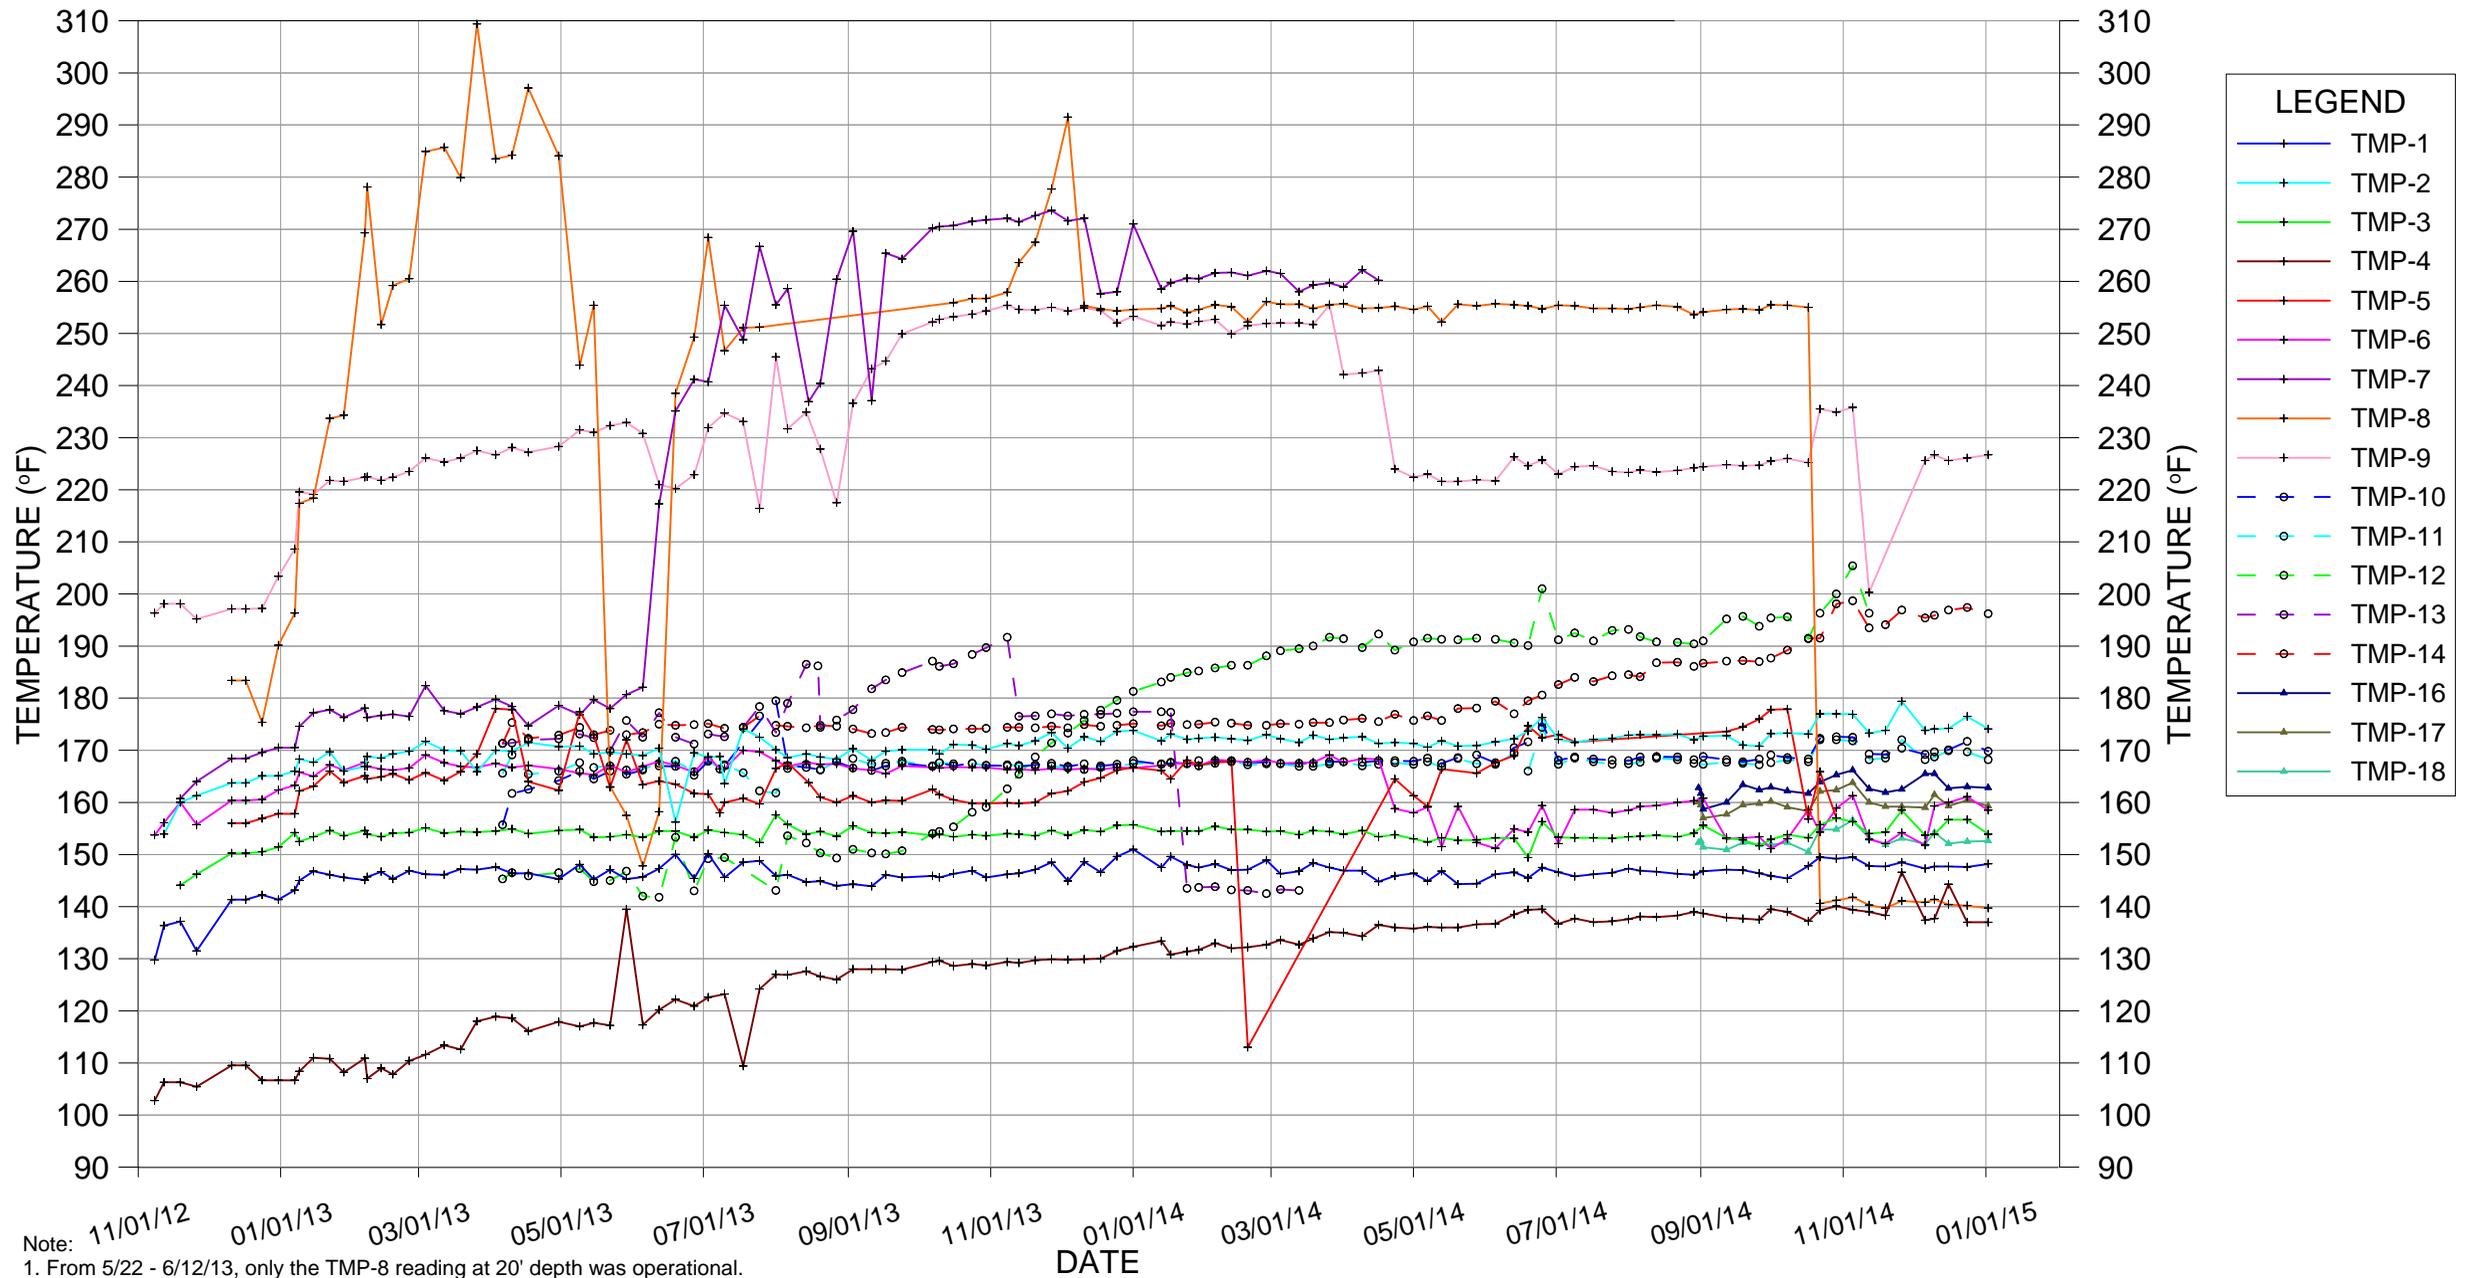
# MAXIMUM TEMPERATURES

1. From 5/22 - 6/12/13, only the TMP-8 reading at 20' depth was operational. No valid readings were obtained for TMP-8 from 8/1 to 10/10/2013. Valid readings from 20' to 40' resumed on 10/16/2013.
2. A new OMEGA dial was installed at TMP-7R on 6/12/2013 enabling more valid readings.
3. No valid readings were obtained for TMP-10 and TMP-12 on 7/18/2013 or 7/25/2013.
4. End terminals were replaced just prior to the 8/6/2013 readings with type T Omega connectors (part # SMPW-CC-T-M) on all TMPs except for TMP-8.

TEMPERATURE VS TIME  
BRIDGETON LANDFILL

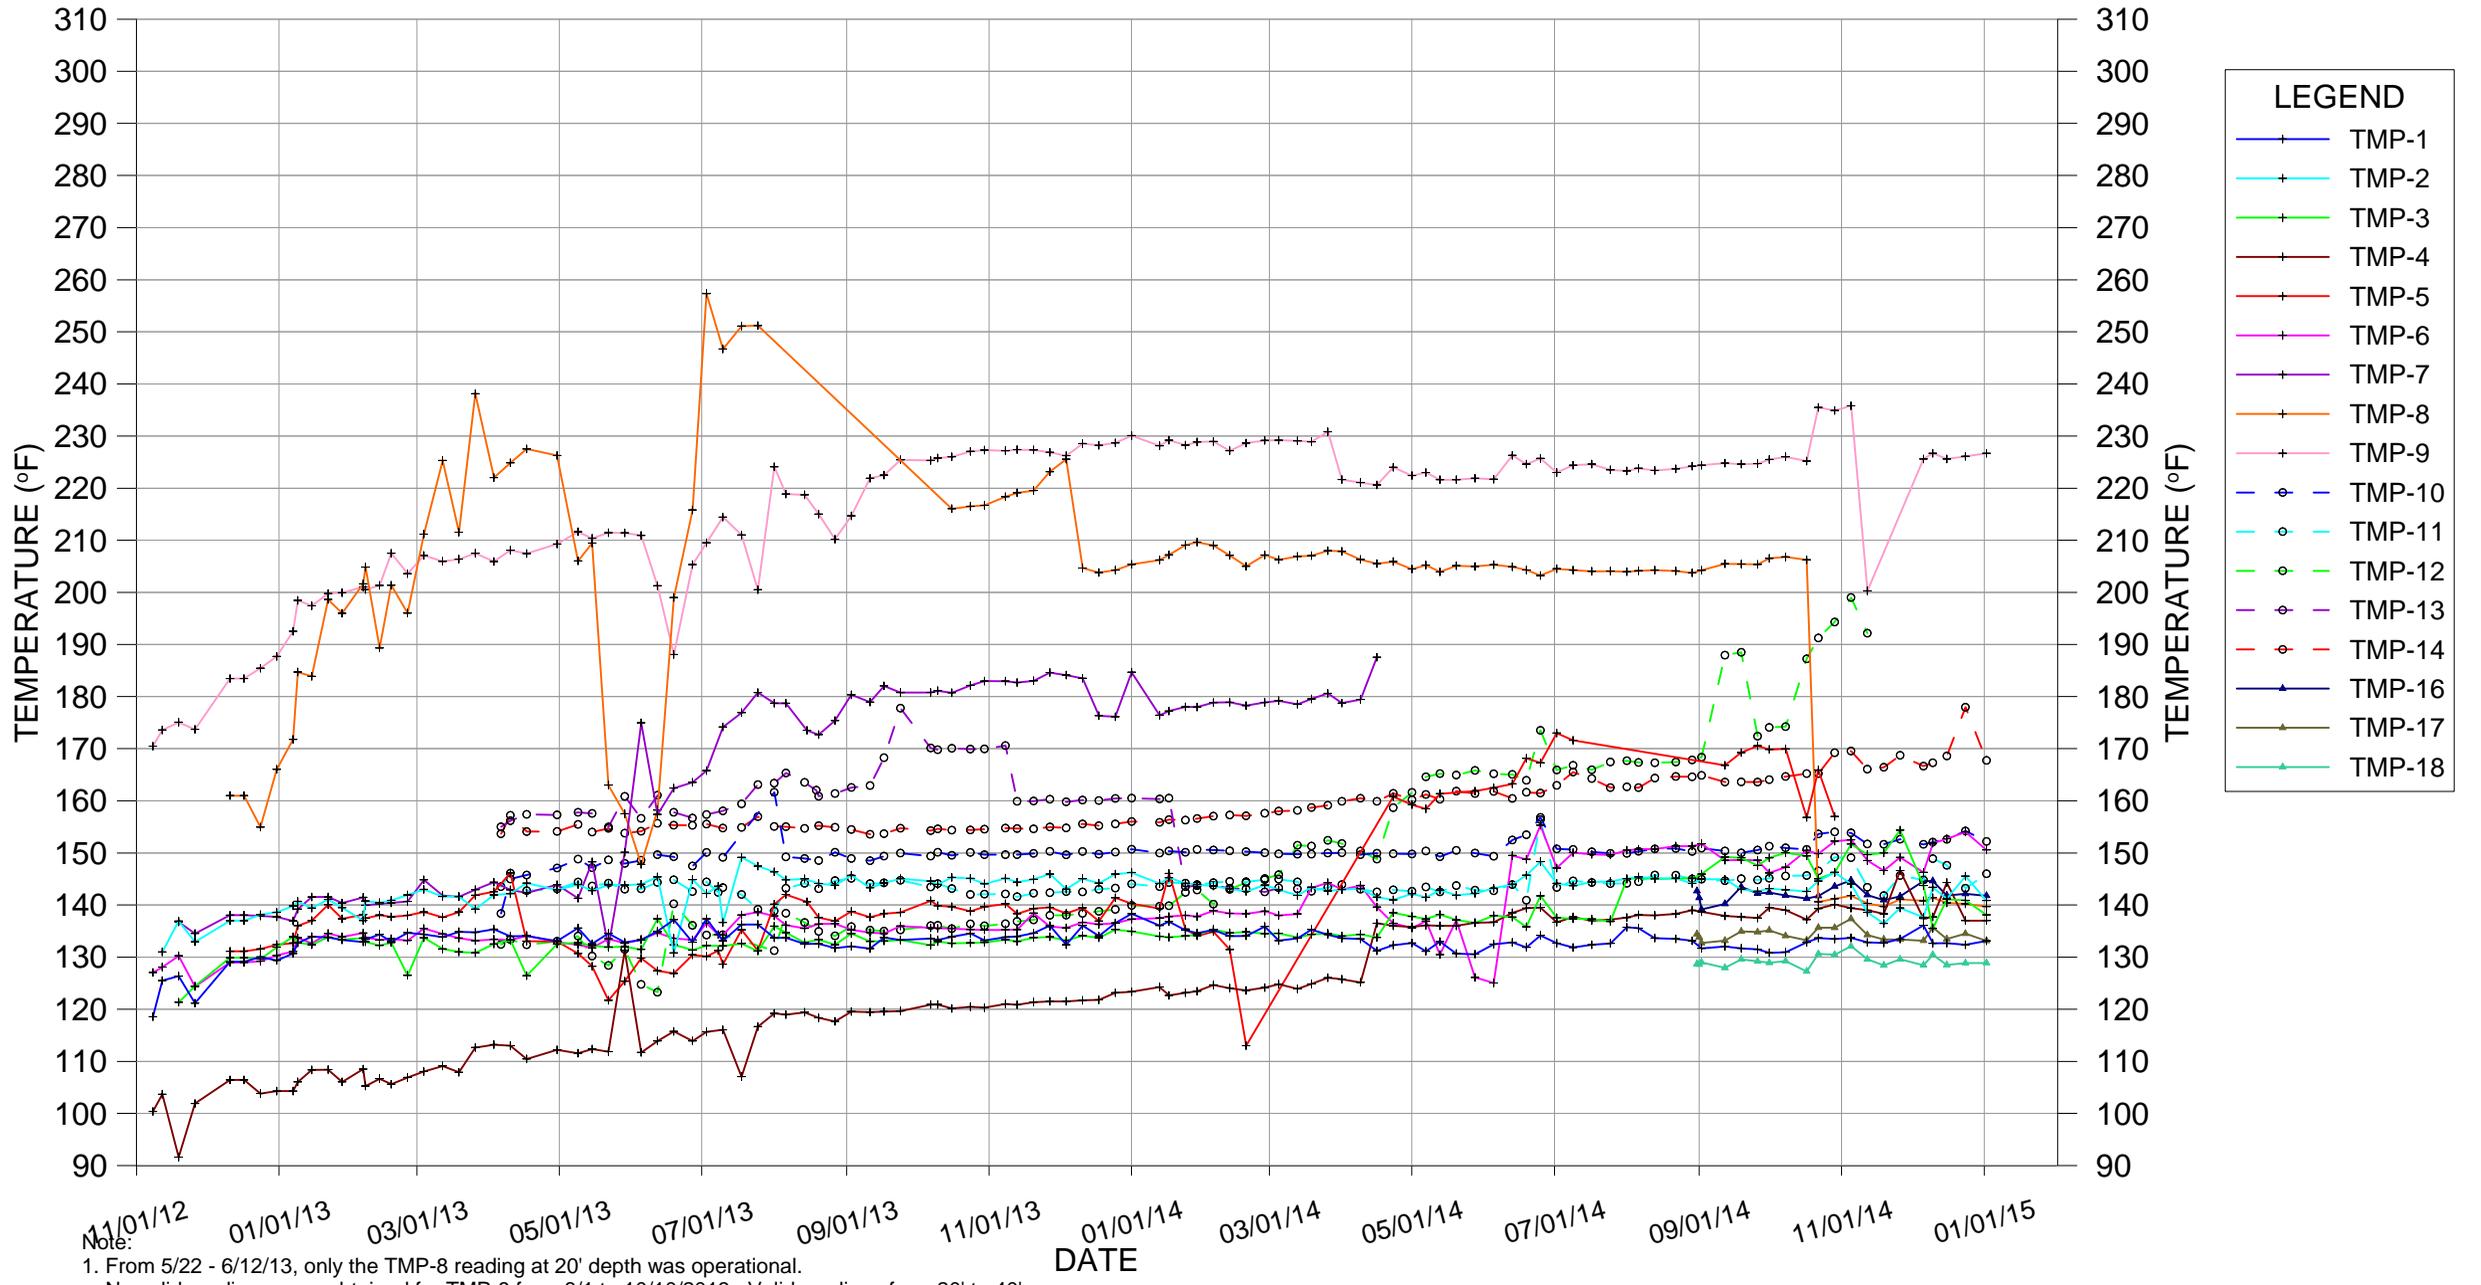
# AVERAGE TEMPERATURES

1. From 5/22 - 6/12/13, only the TMP-8 reading at 20' depth was operational. No valid readings were obtained for TMP-8 from 8/1 to 10/10/2013. Valid readings from 20' to 40' resumed on 10/16/2013.
2. A new OMEGA dial was installed at TMP-7R on 6/12/2013 enabling more valid readings.
3. No valid readings were obtained for TMP-10 and TMP-12 on 7/18/2013 or 7/25/2013.
4. End terminals were replaced just prior to the 8/6/2013 readings with type T Omega connectors (part # SMPW-CC-T-M) on all TMPs except for TMP-8.

TEMPERATURE VS TIME  
BRIDGETON LANDFILL
