# **Bridgeton Landfill, LLC**

## **Weekly Data Submittals**

**Week of December 28, 2014 – January 3, 2015**

**Required by Section 52.F of Agreed Order, Case No. 13SL-CC01088  
Effective May 13, 2013**

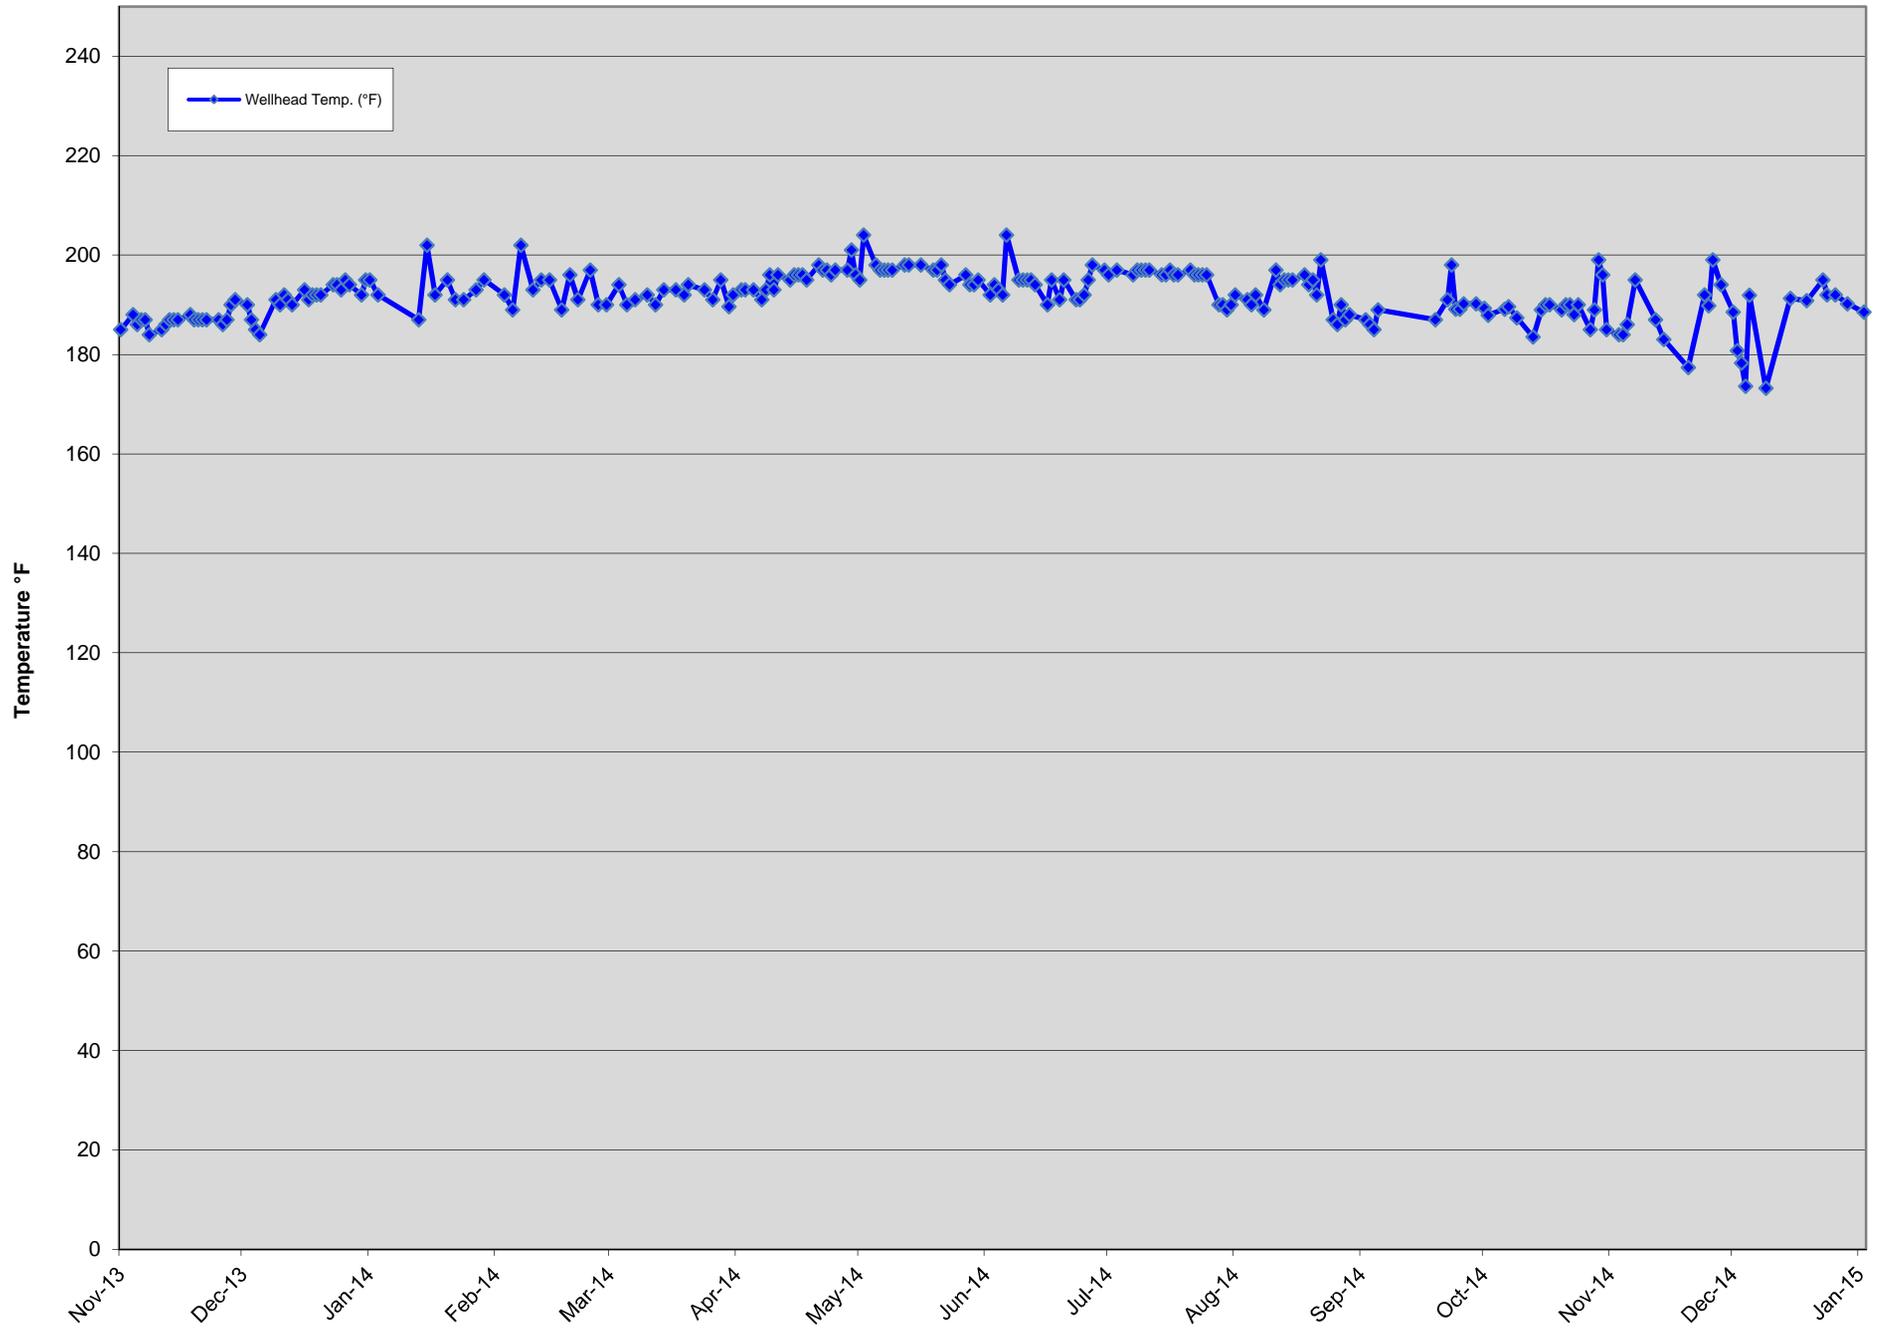
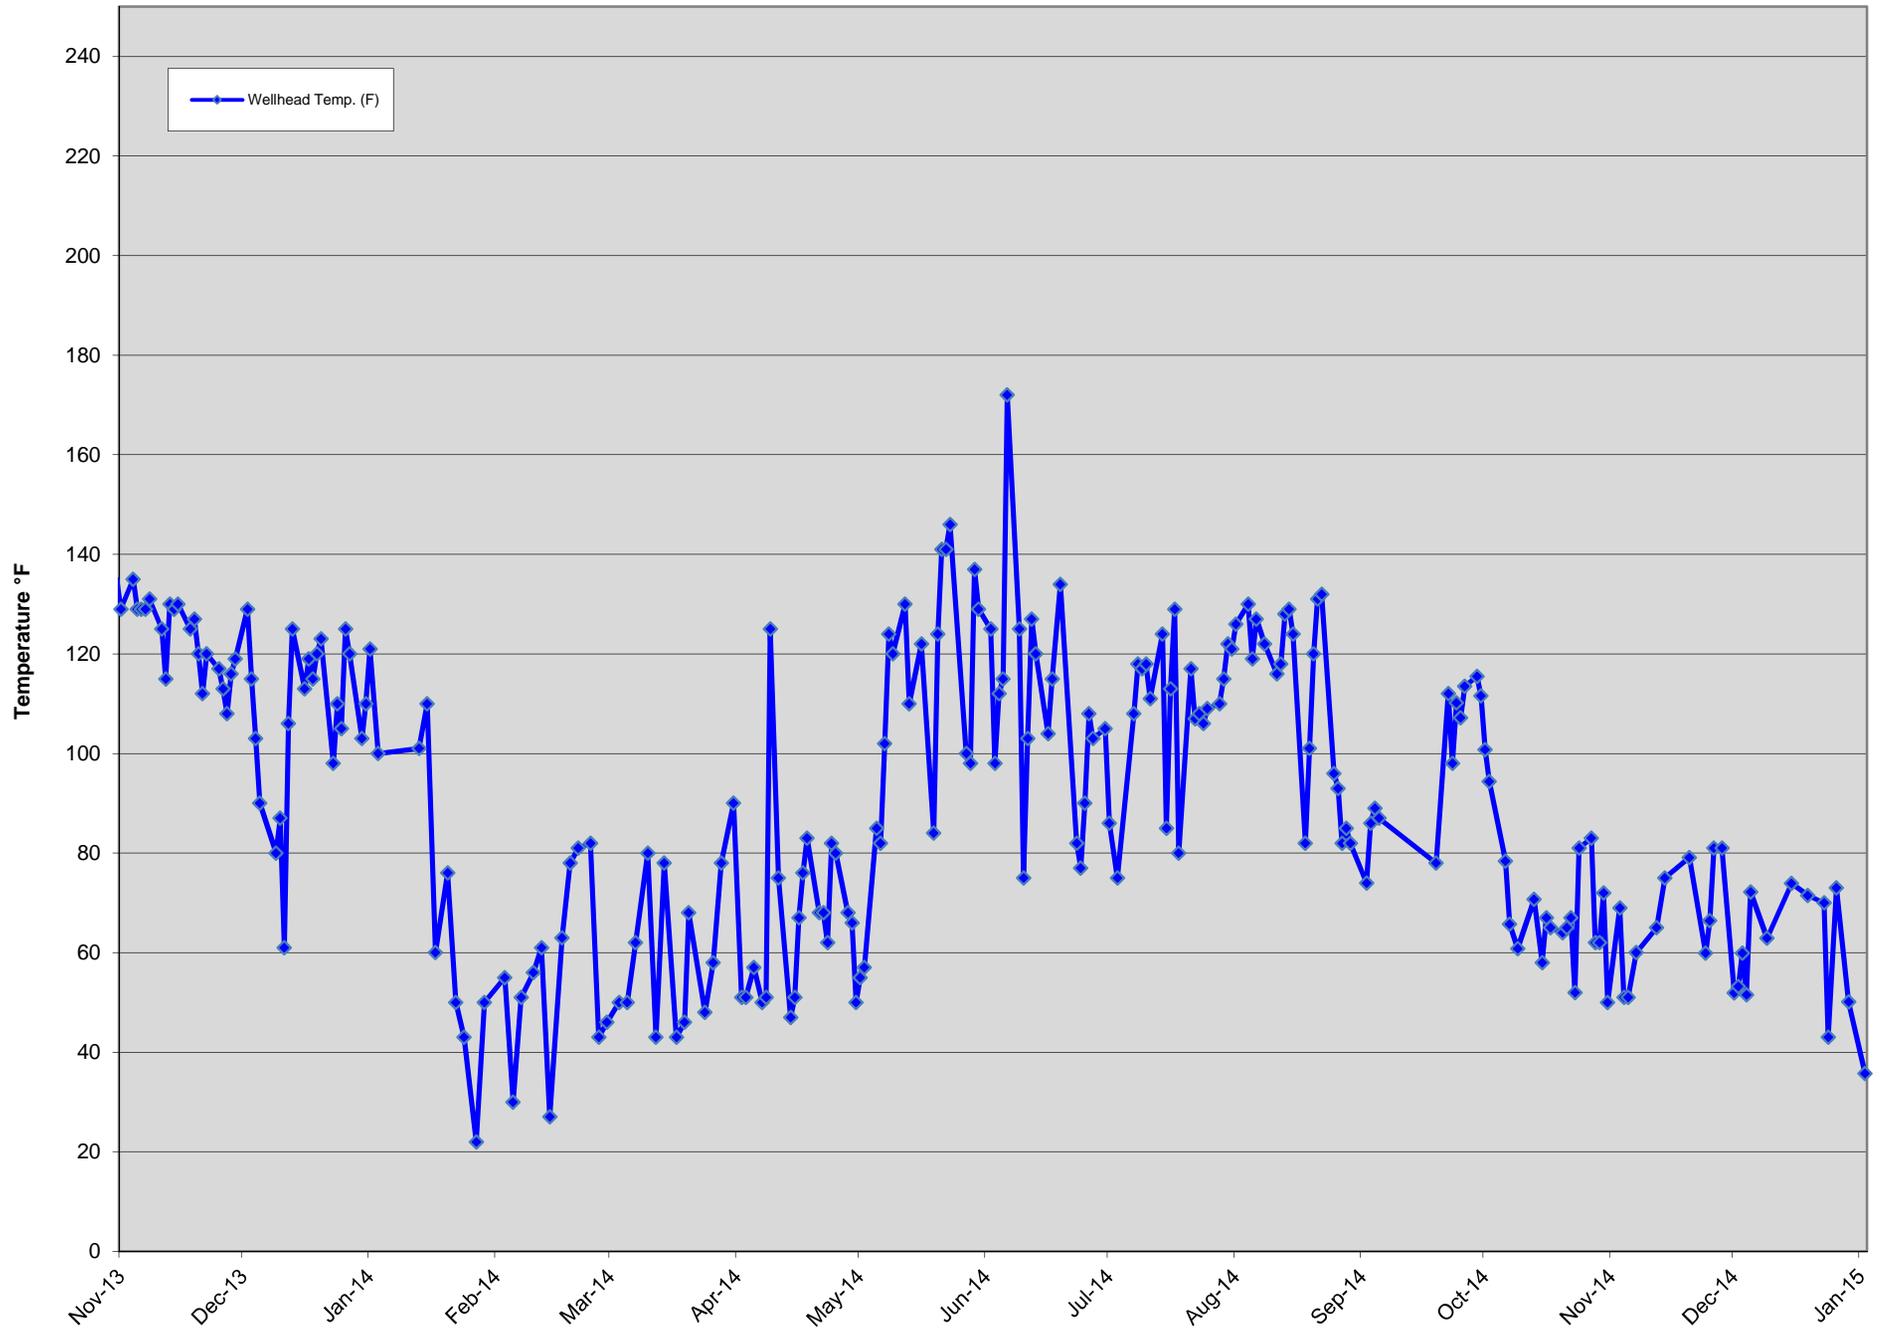
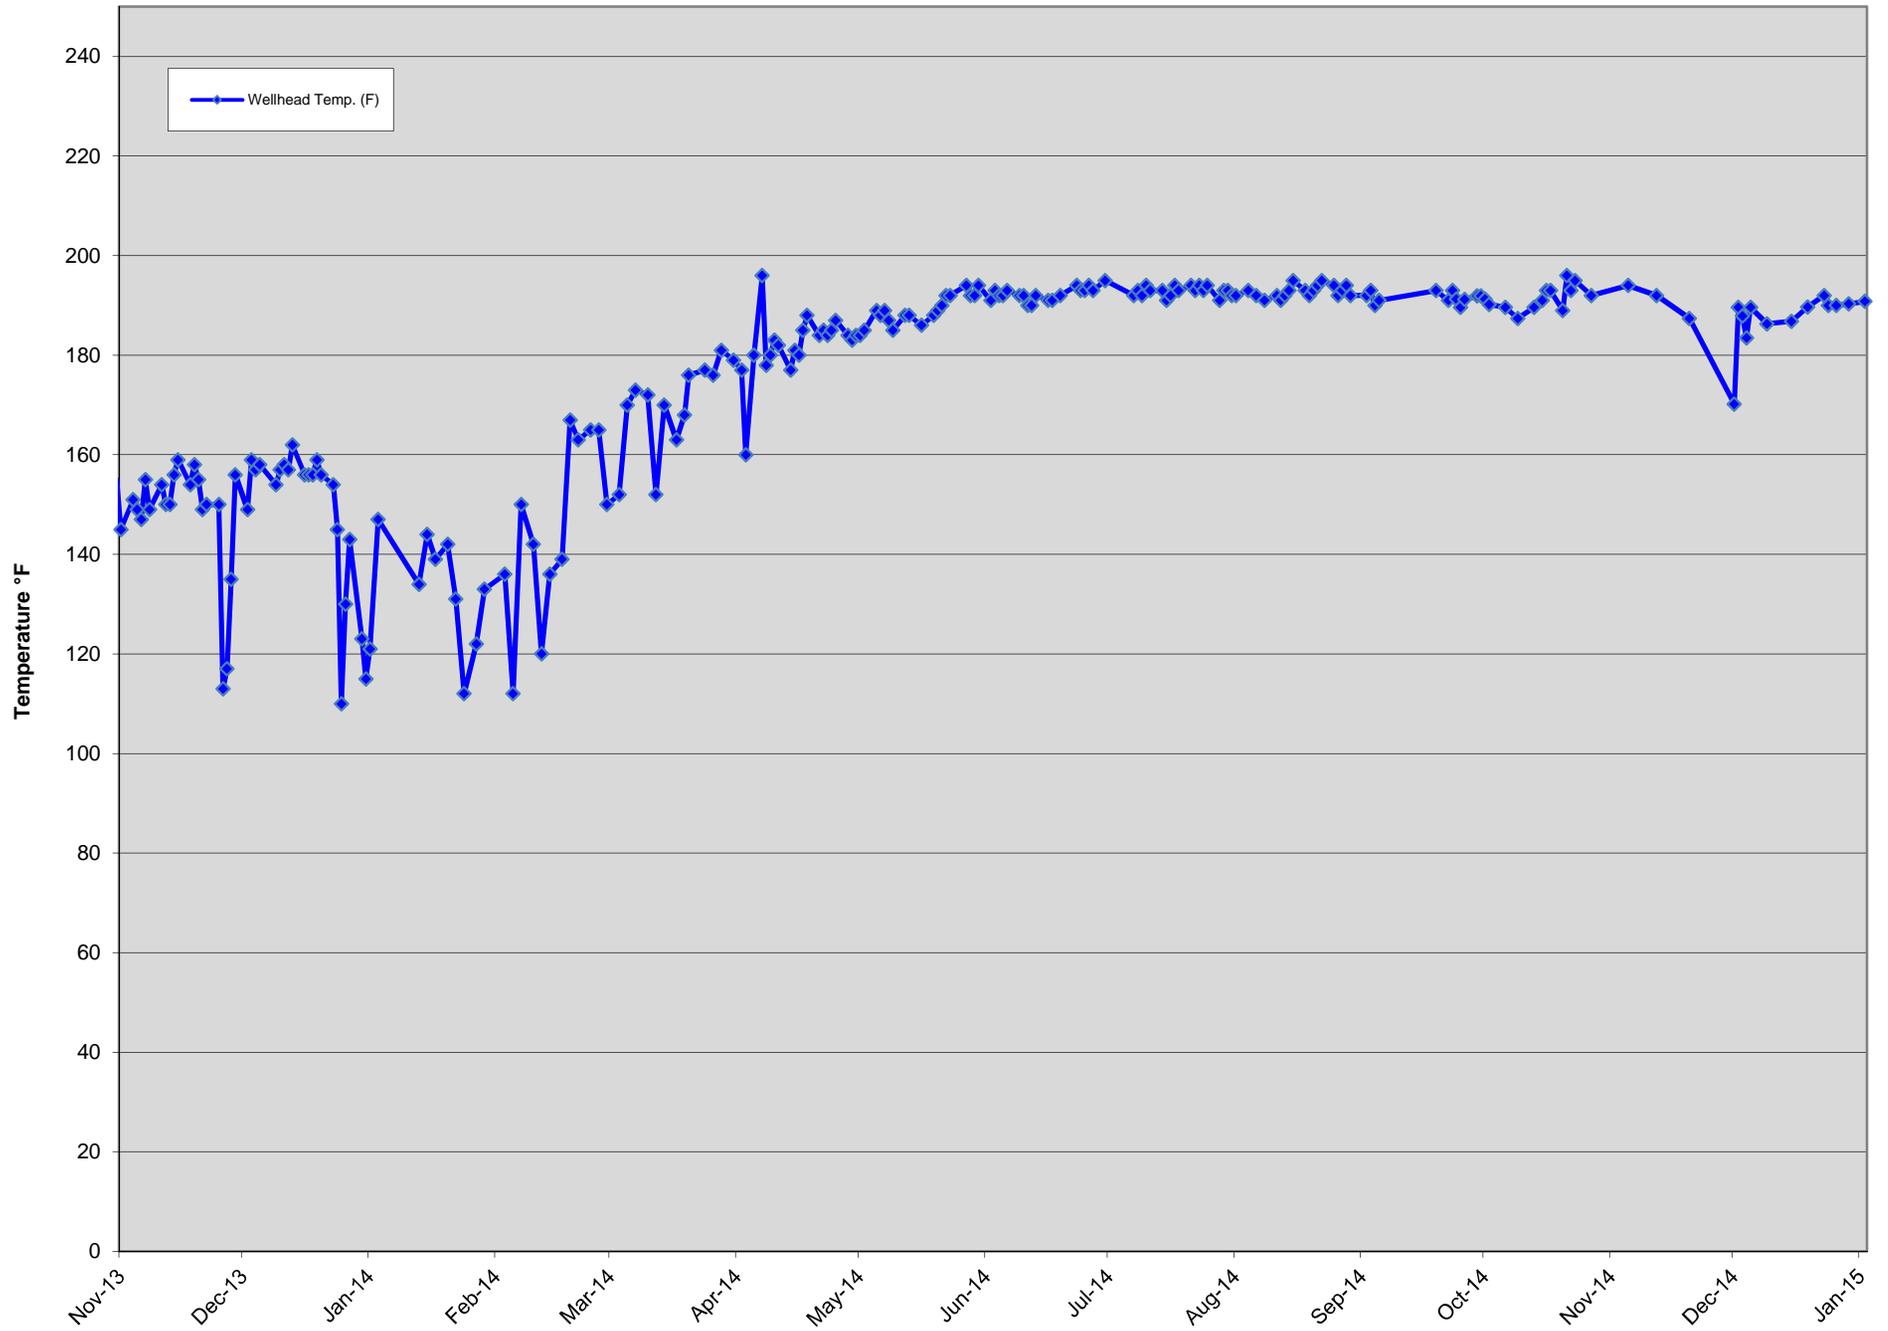
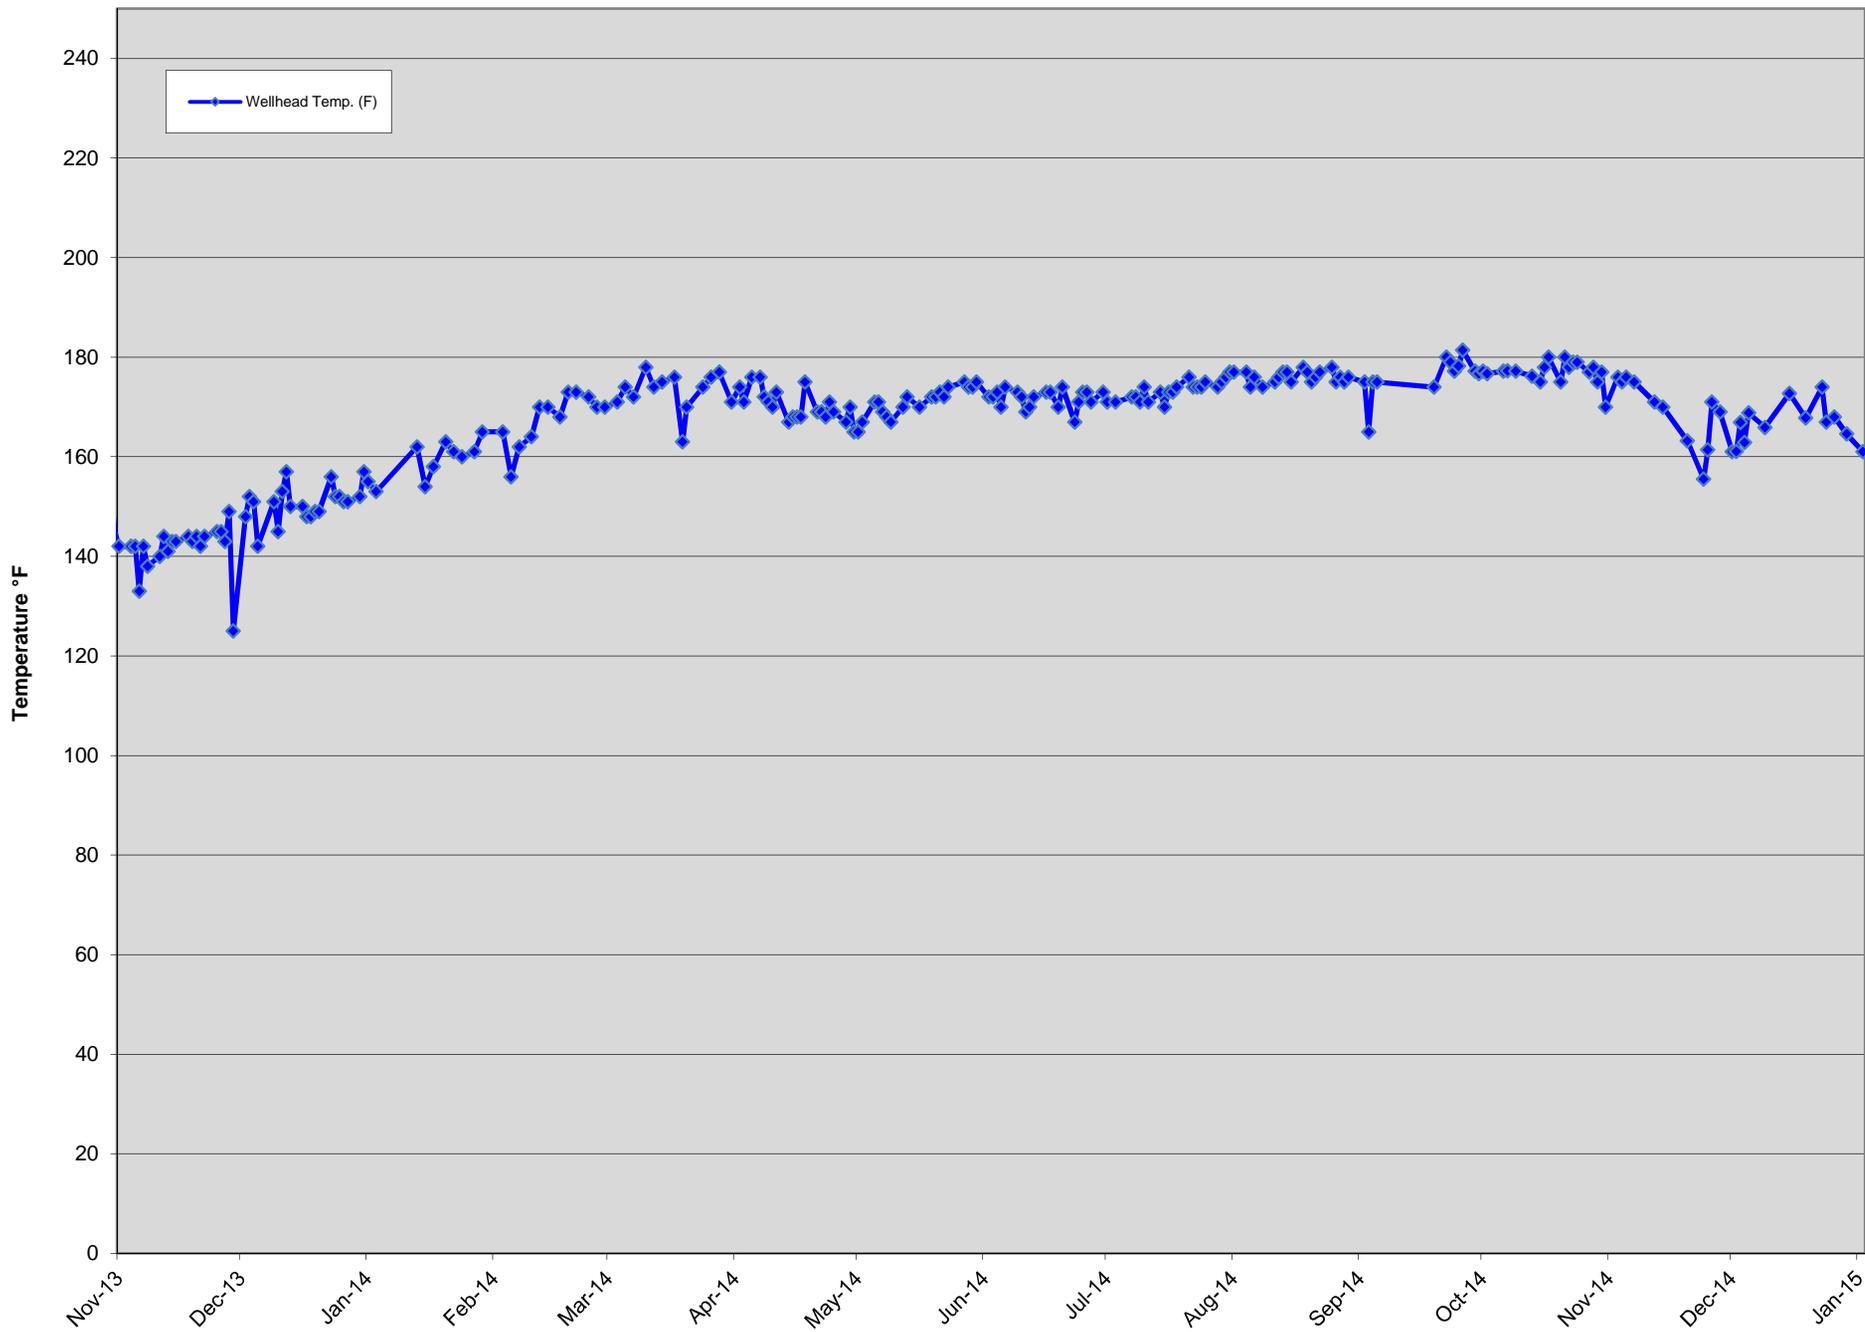
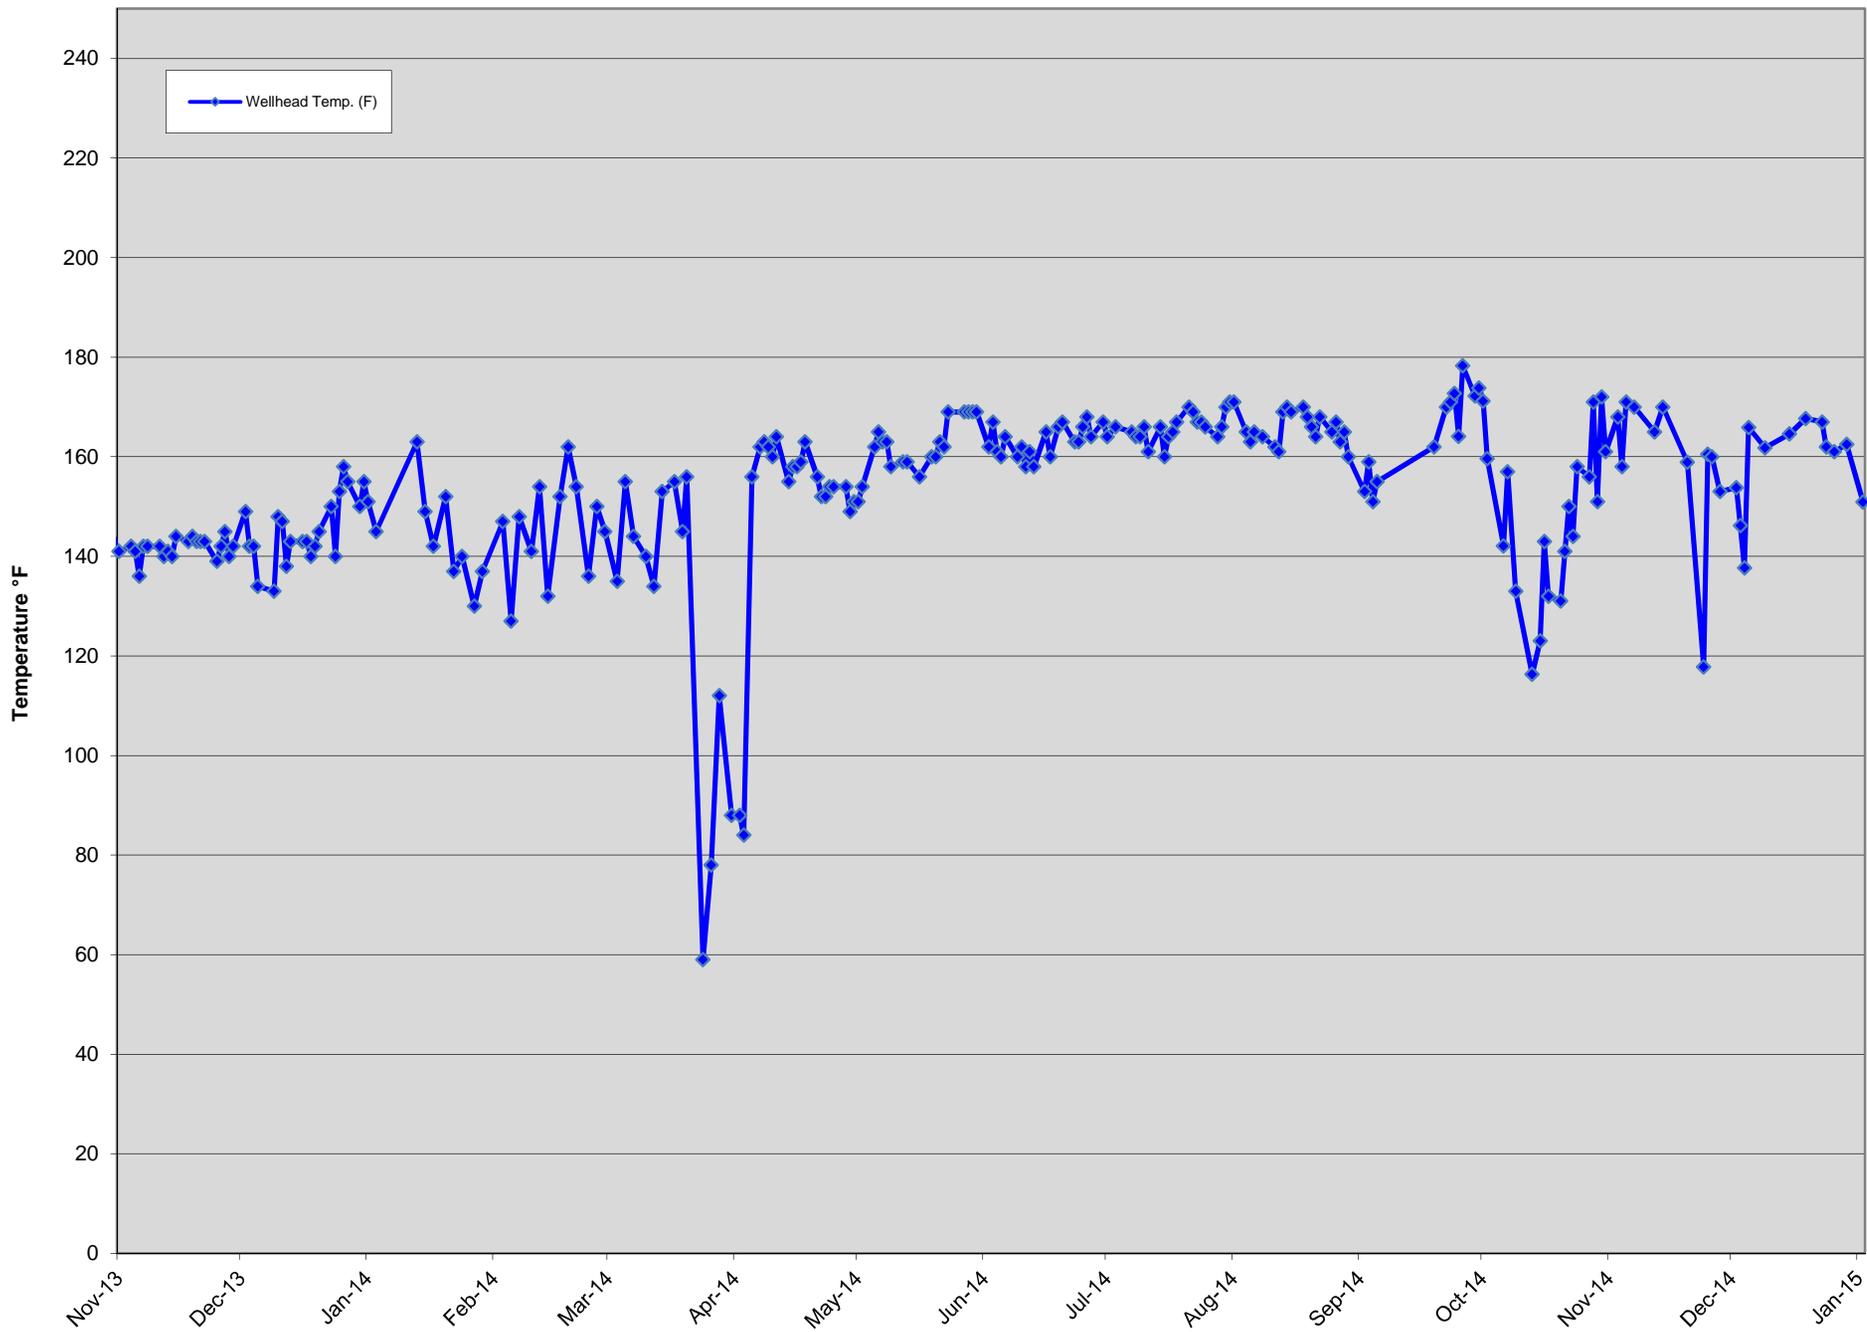
For the remaining six wells without a cooling system installed (GIW-1, -8, -9, -11, -12, and -13), with the exception of GIW-11, gas temperatures were generally consistent over the past week as well as compared to prior weeks. GIW-11 has been experiencing 20-30 degree fluctuations in gas temperature, which is likely due to its proximity to GIW series wells with cooling loops installed.
