# **Bridgeton Landfill, LLC**

## **Weekly Data Submittals**

**Week of December 28, 2014 – January 3, 2015**

**Required by Section 52.F of Agreed Order, Case No. 13SL-CC01088  
Effective May 13, 2013**

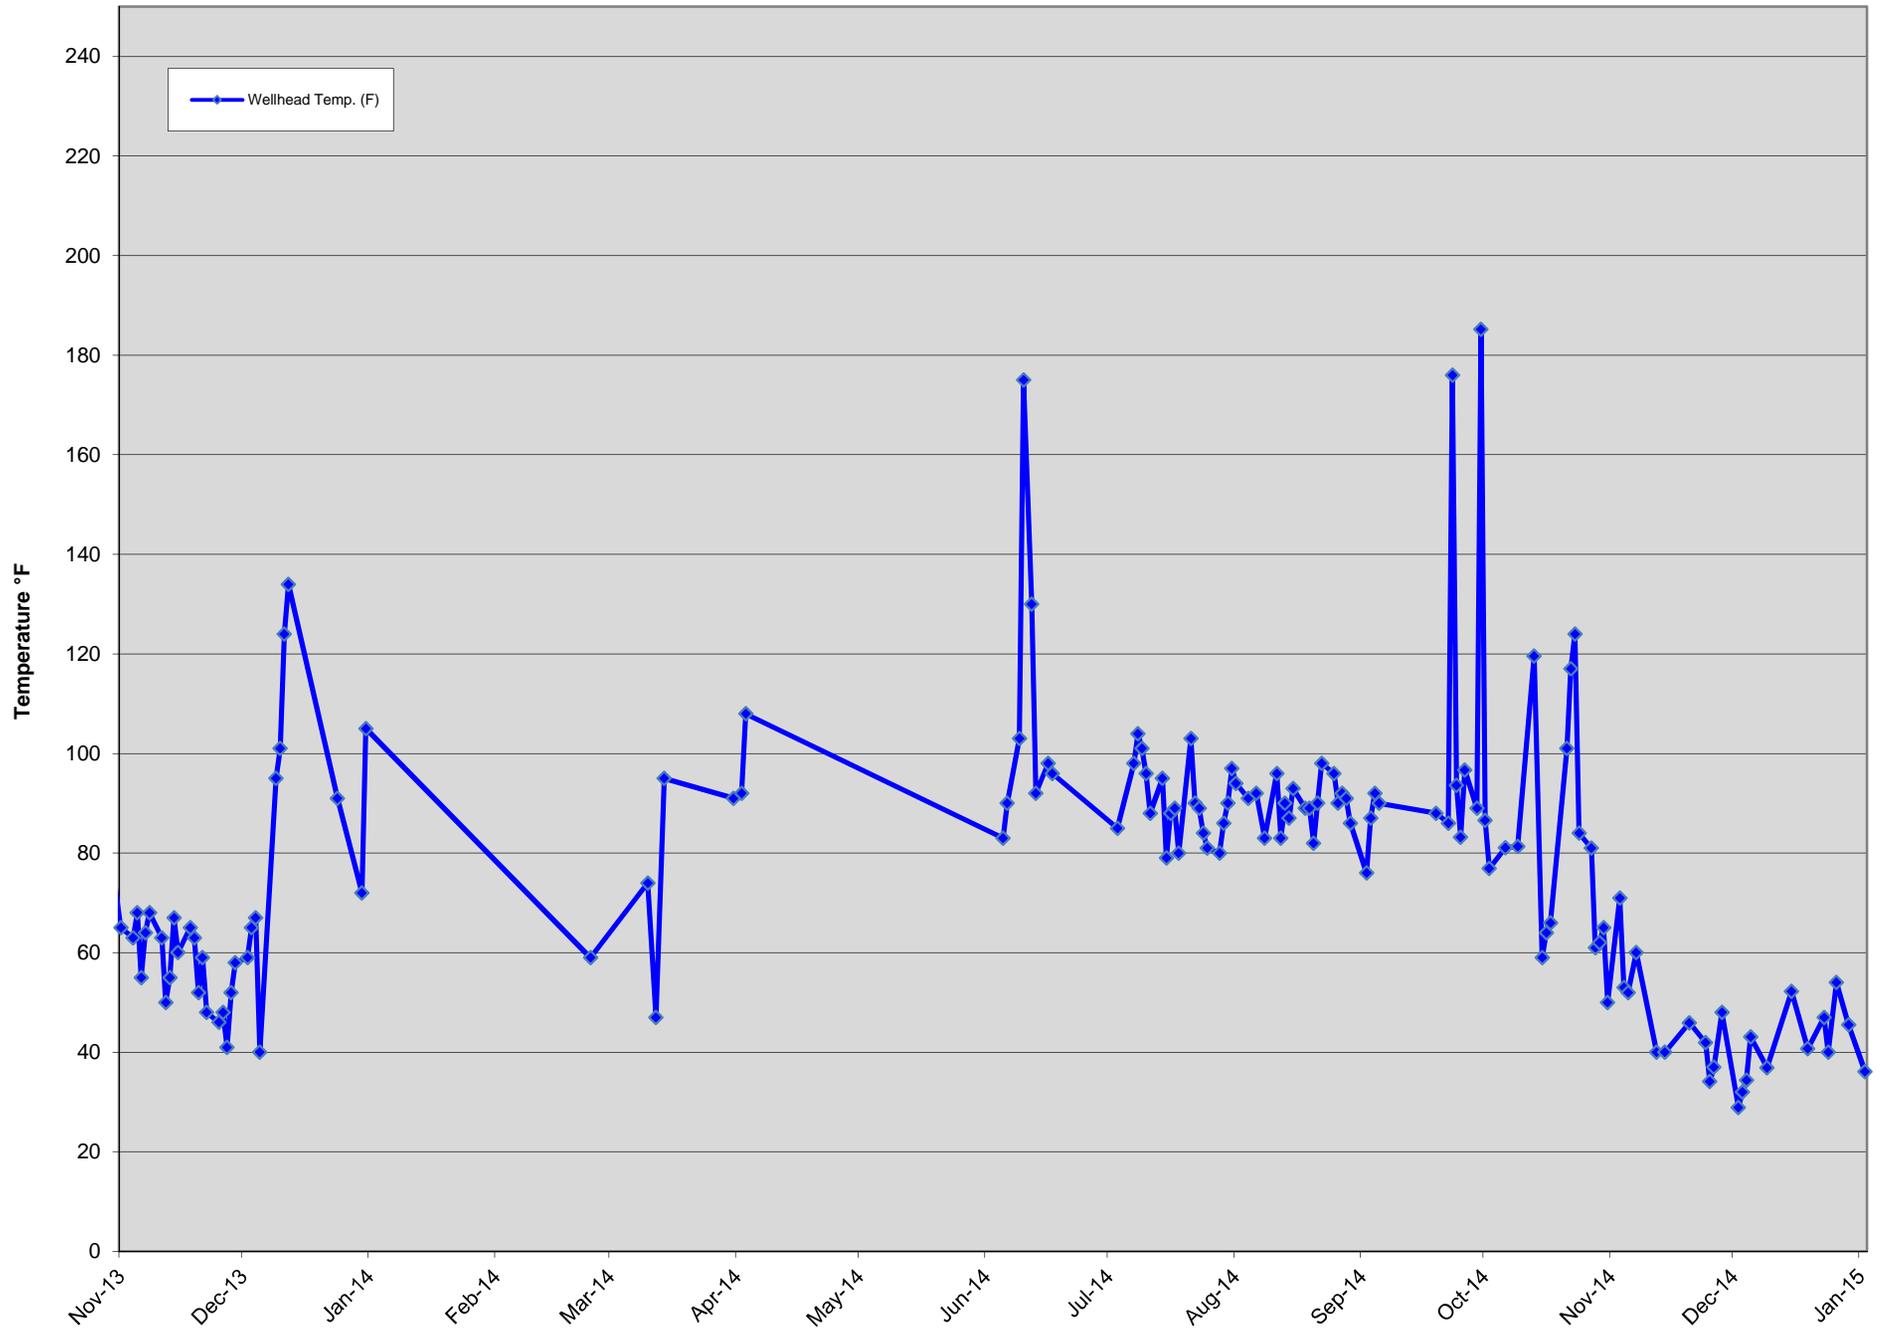
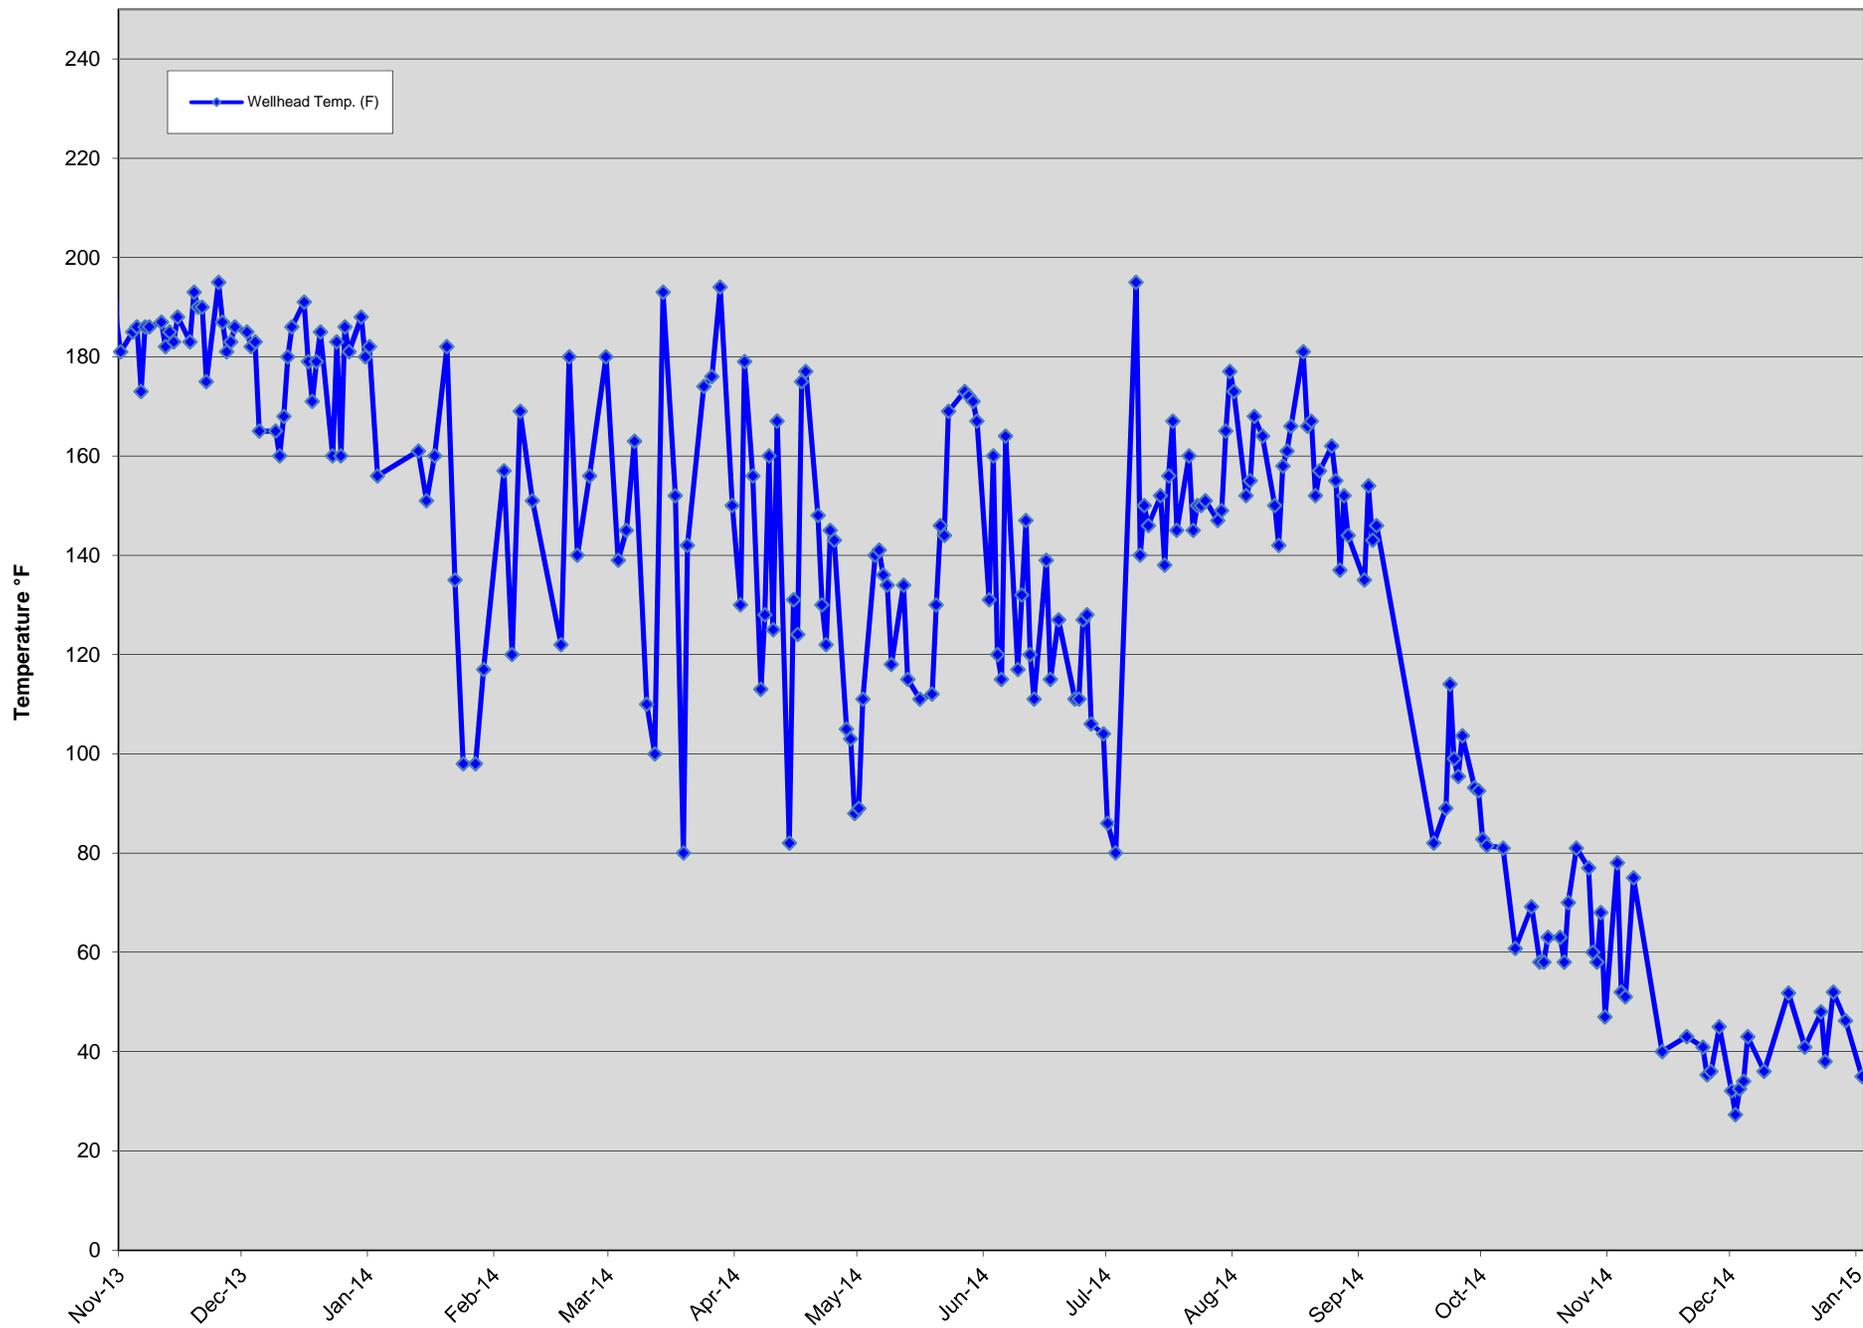
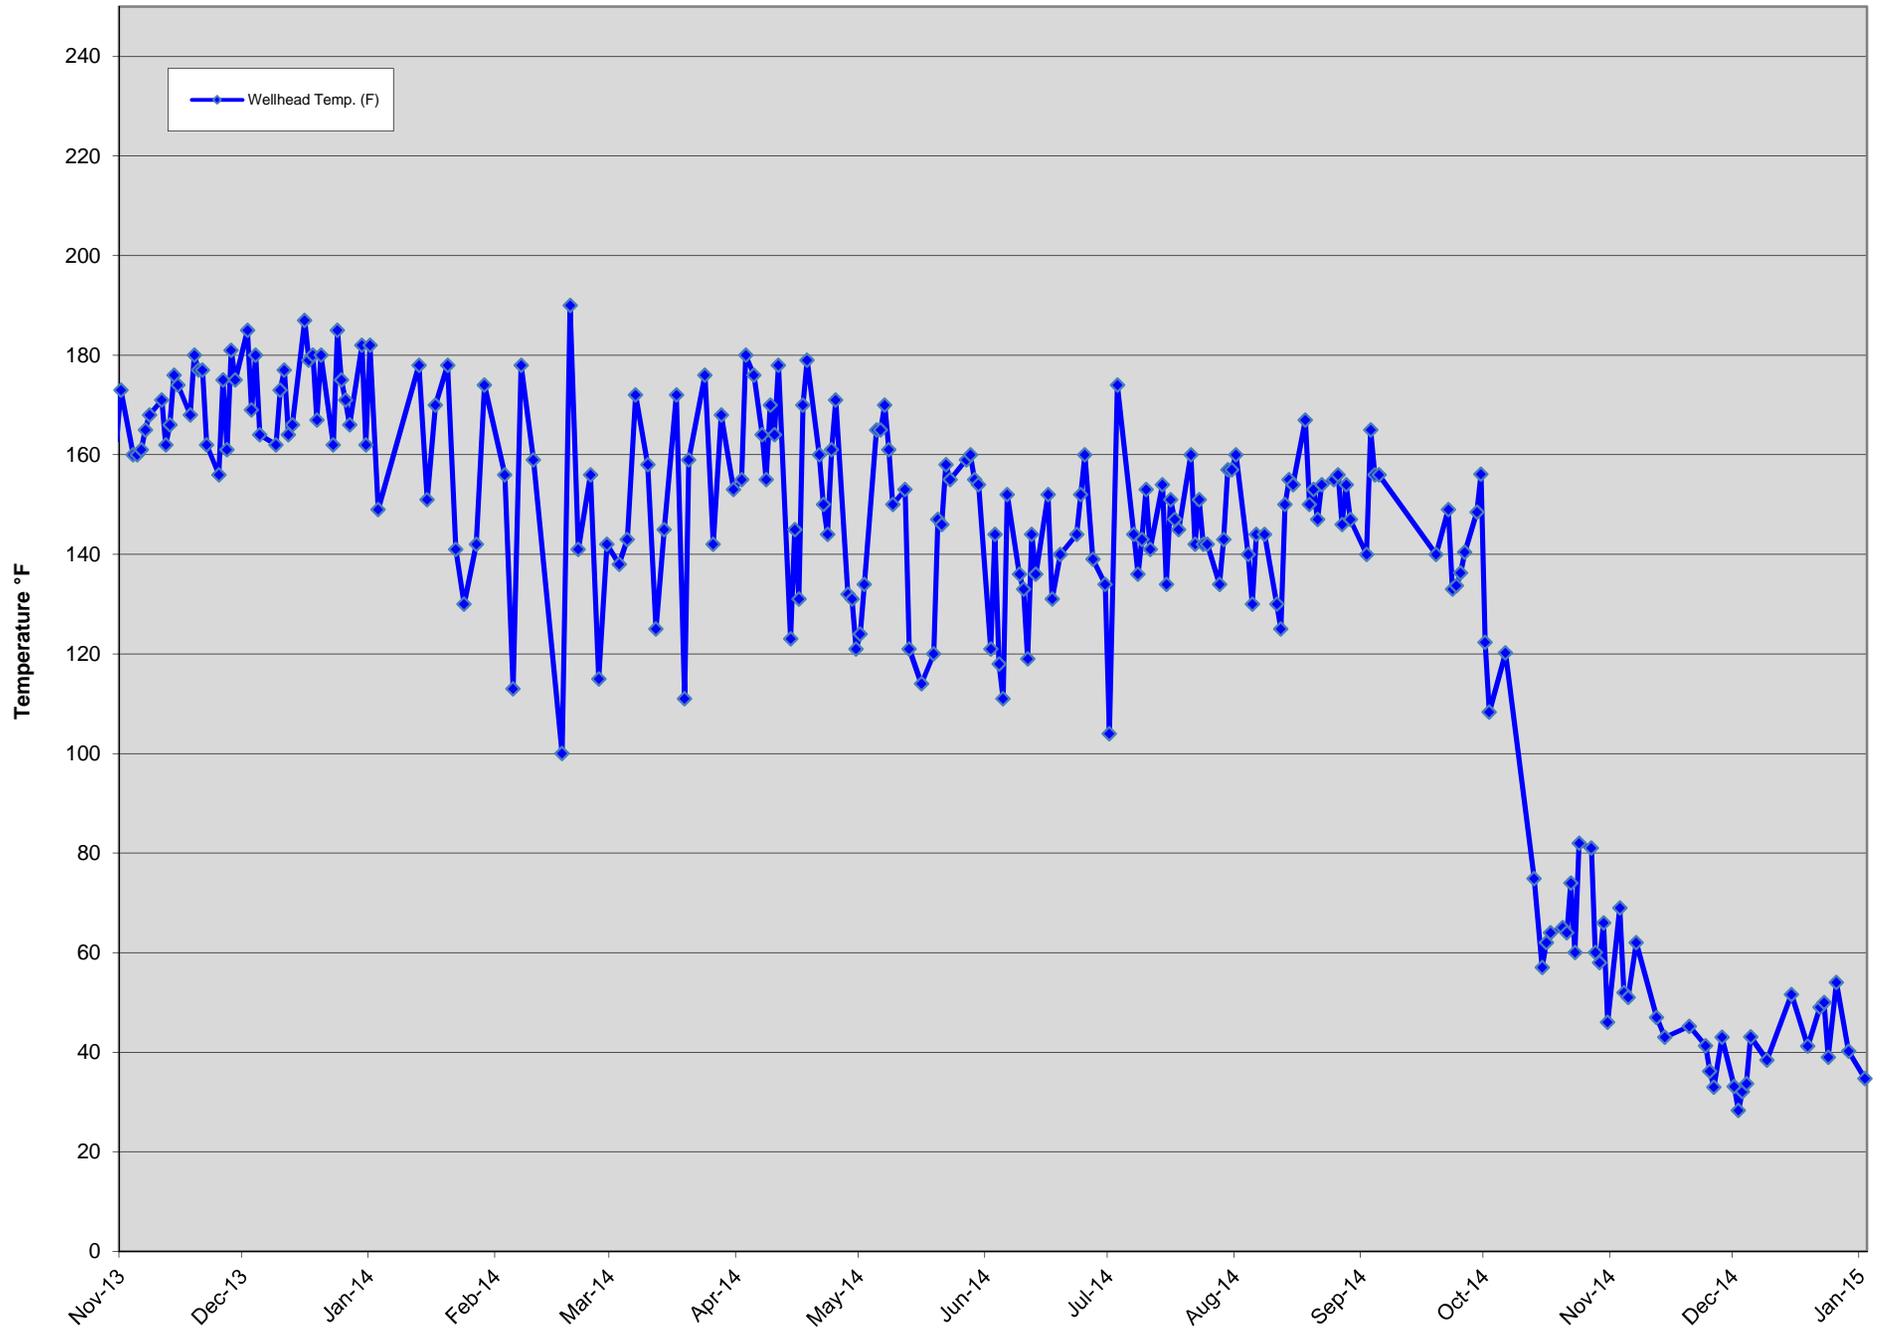
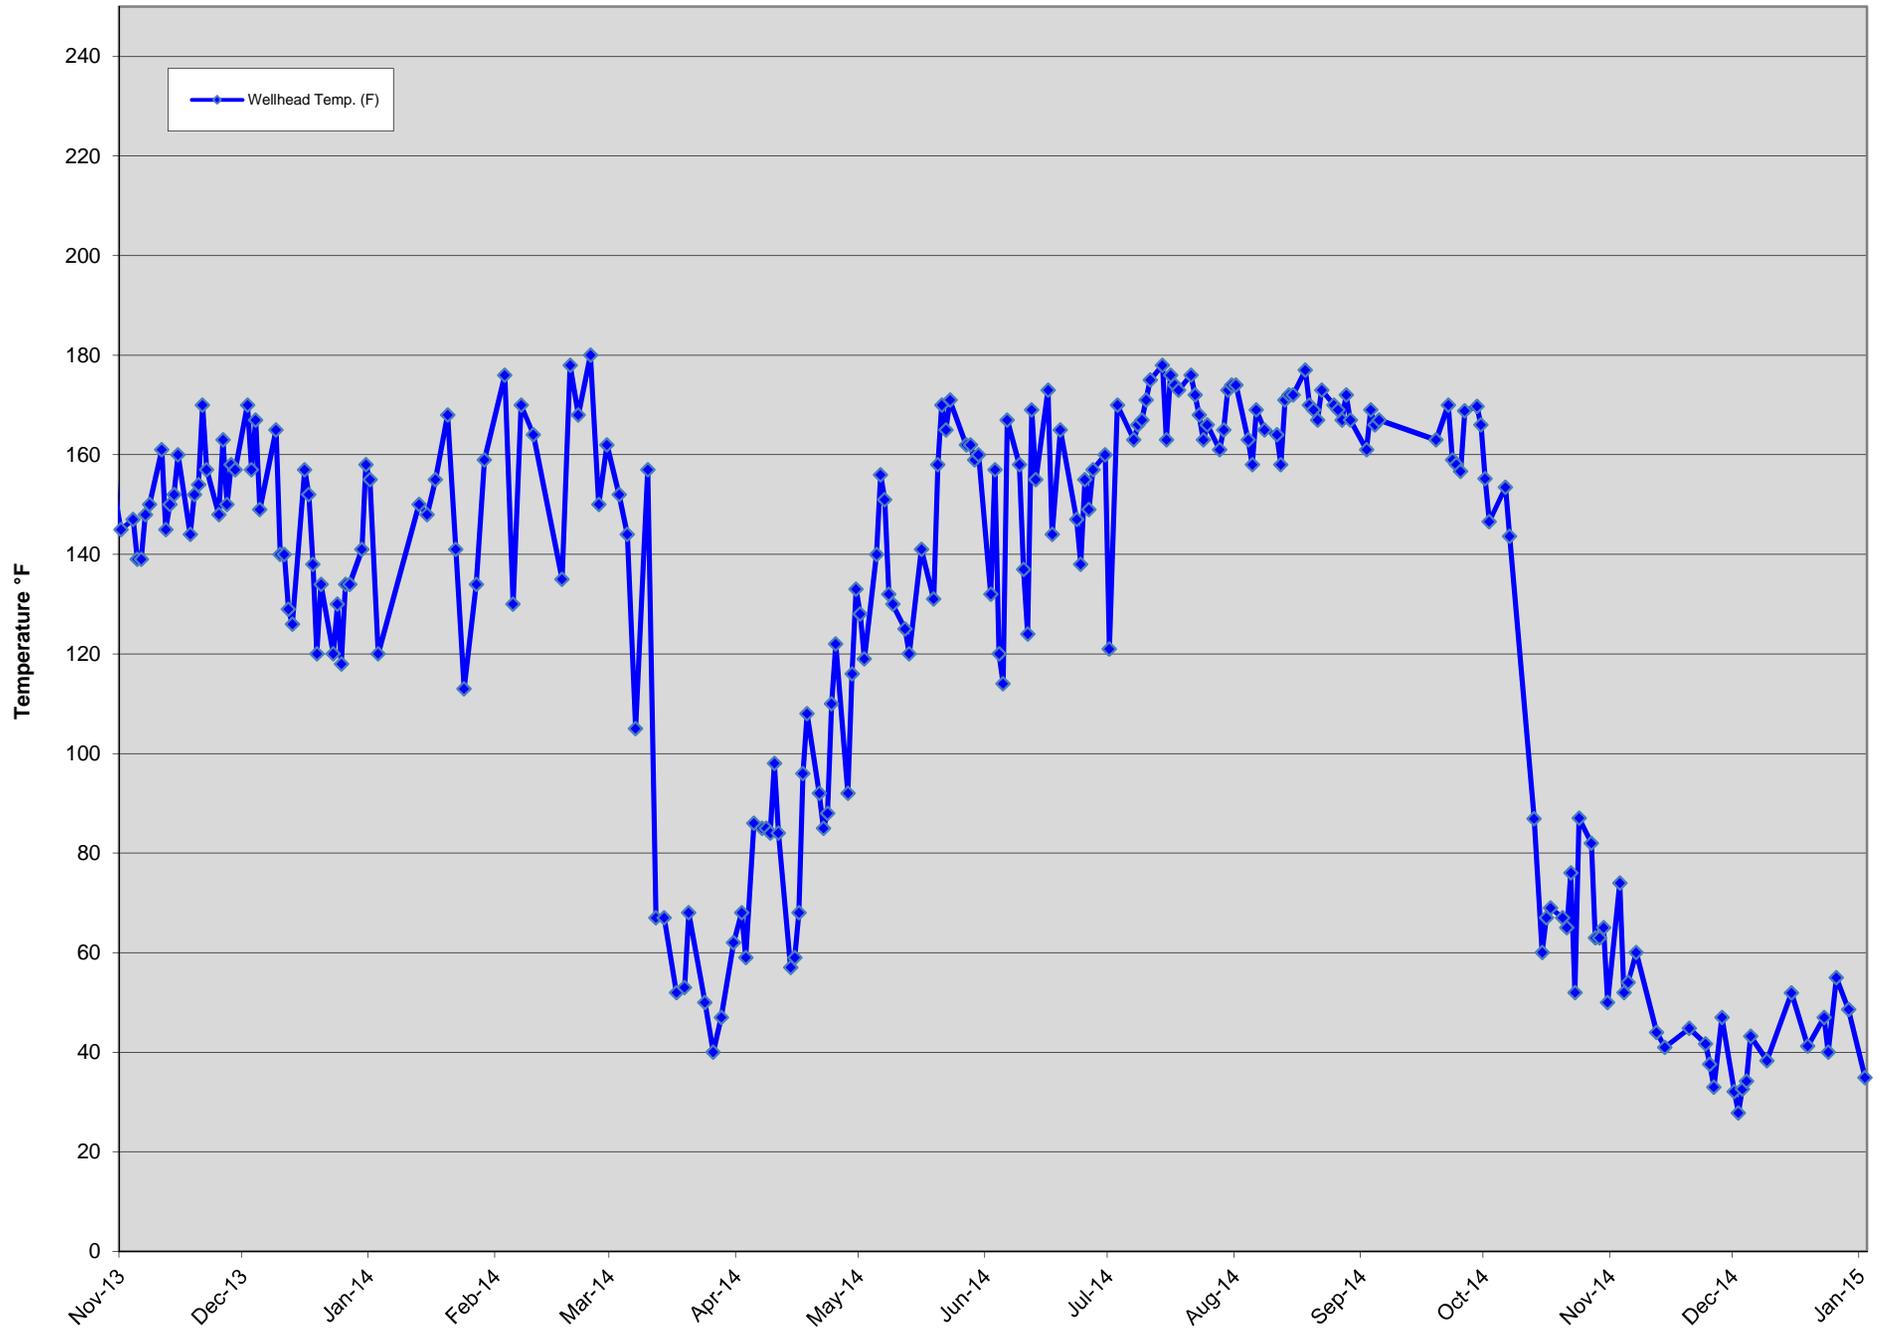
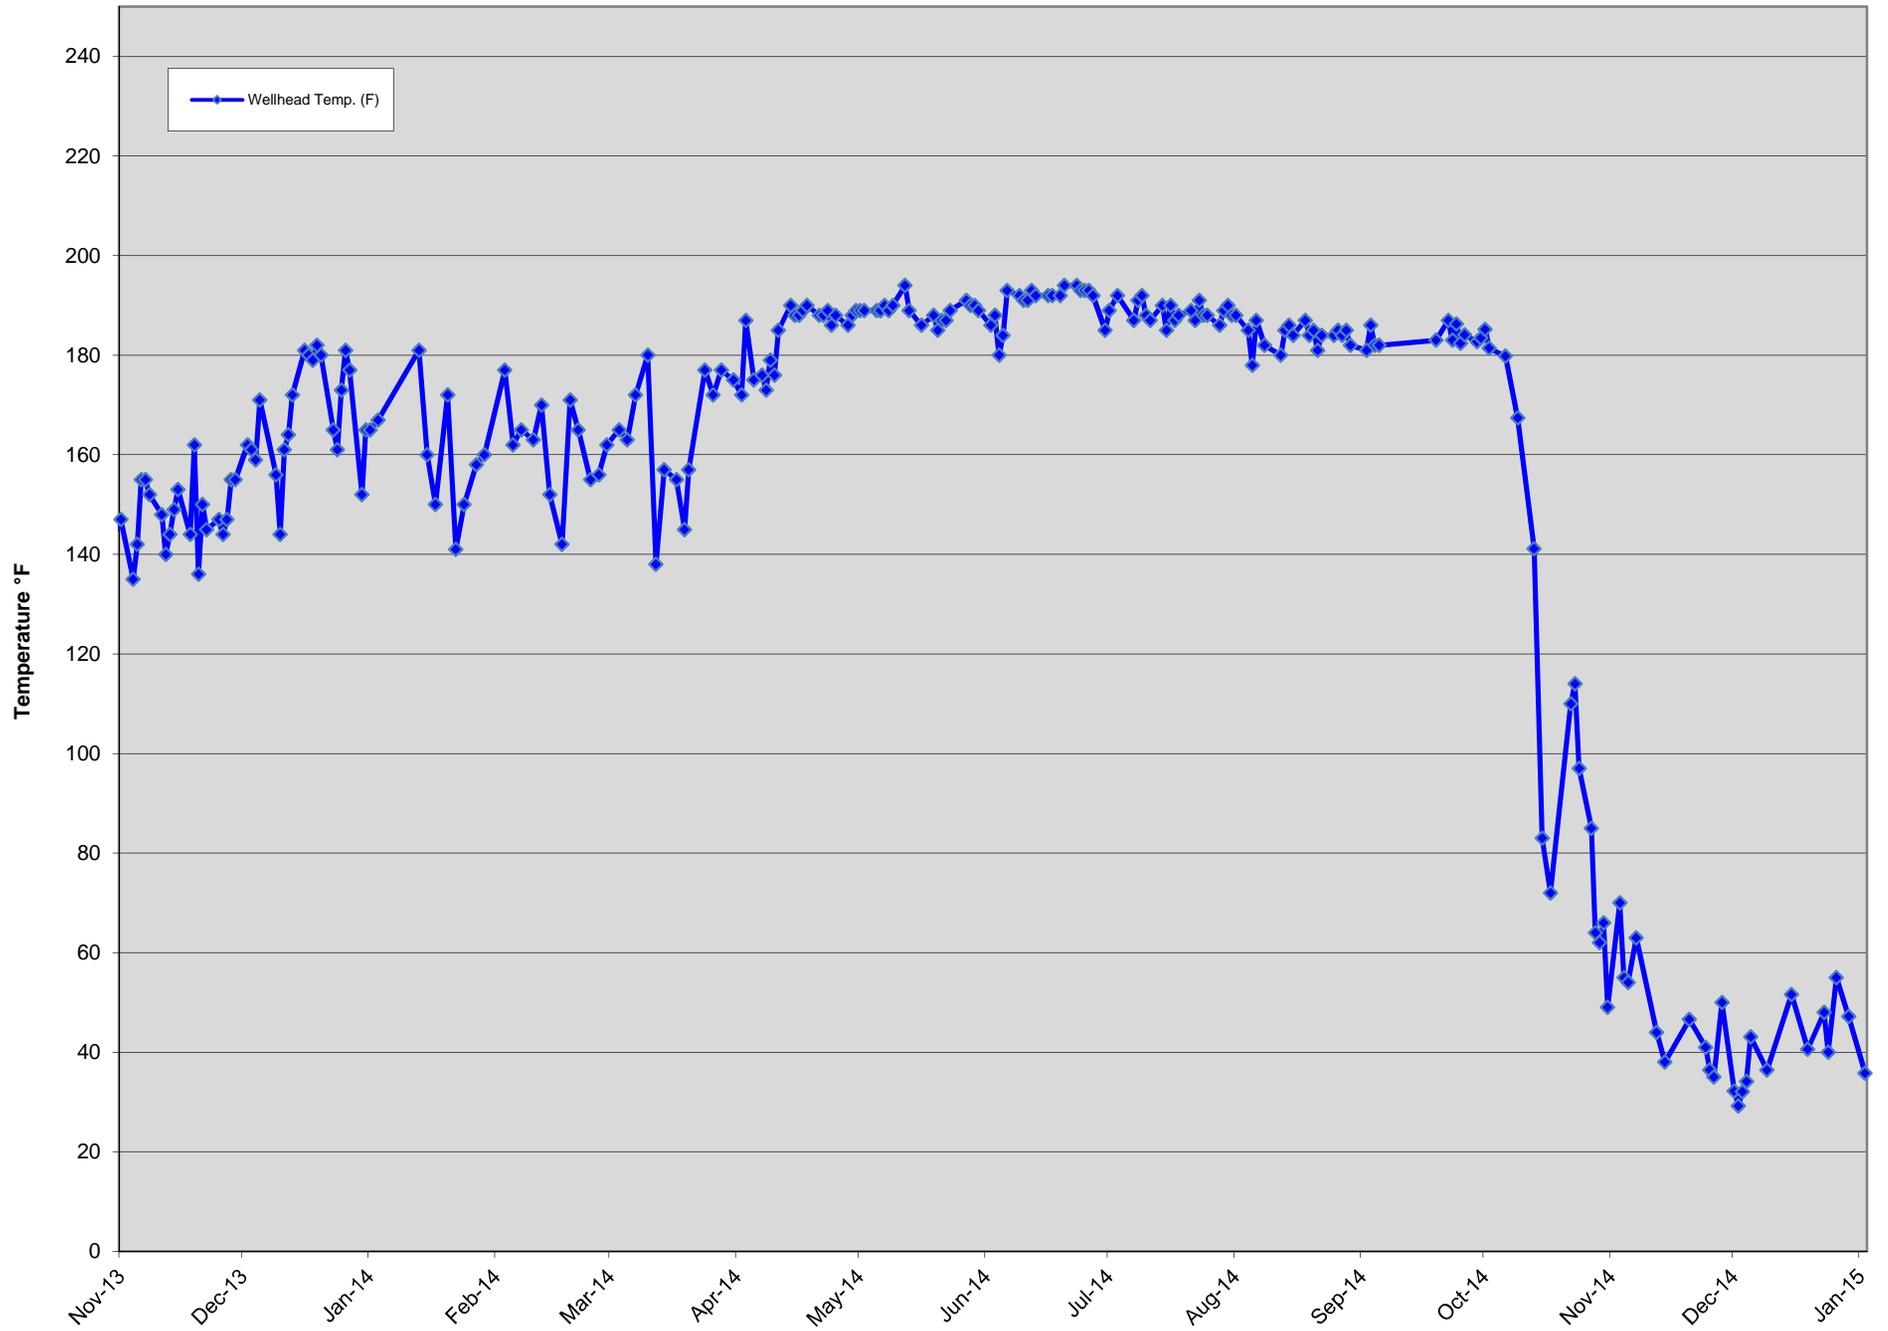
There are currently water circulation cooling loops installed in seven Gas Interceptor Wells (GIWs) (GIW-2 through GIW-7, as well as GIW-10). Wellhead gas temperatures in these wells are all in the low to mid 40-50°F range.

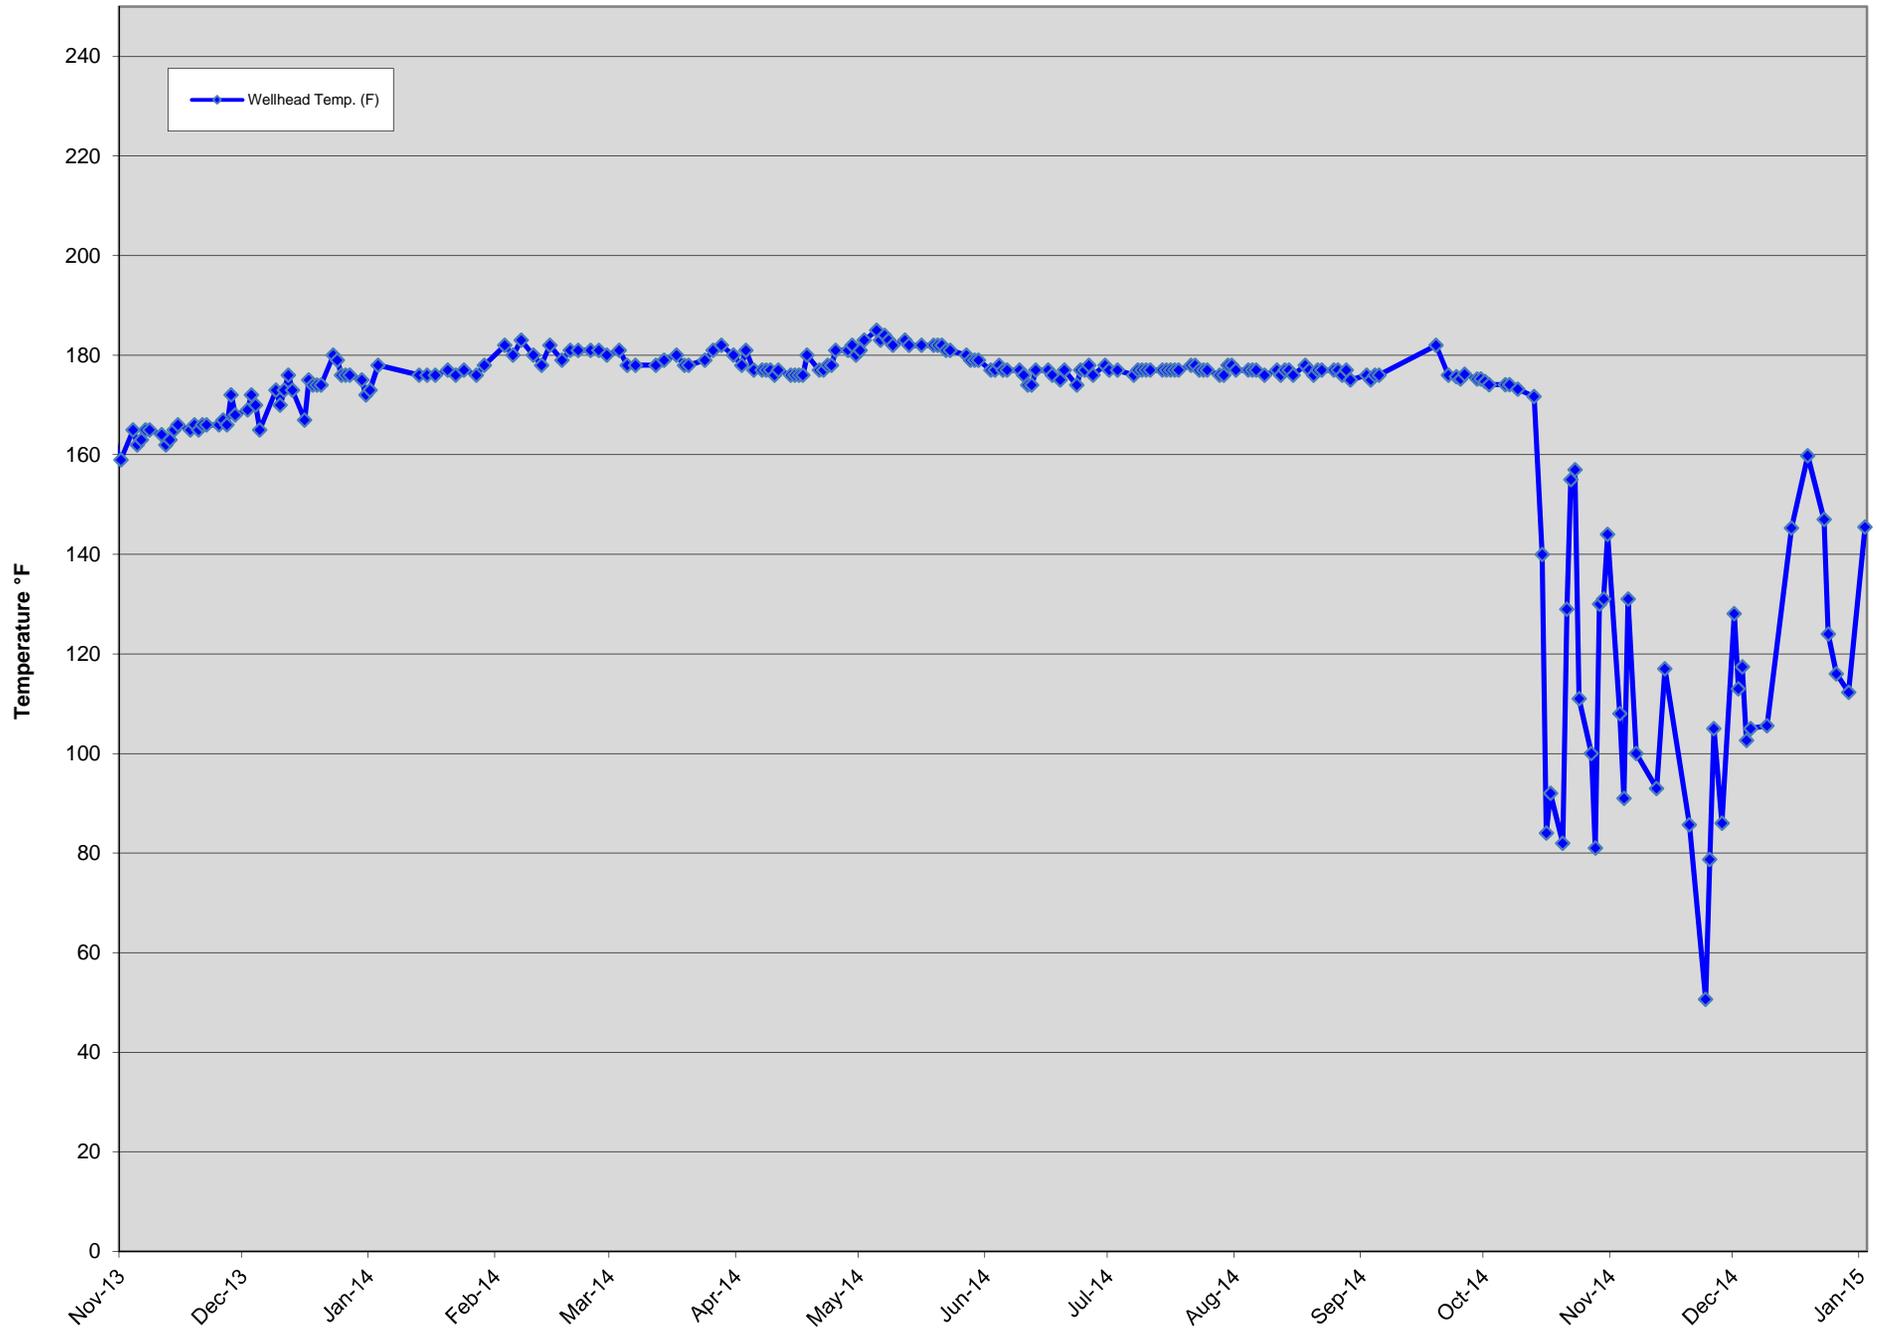
# GIW-11 Wellhead Temperatures

For the remaining six wells without a cooling system installed (GIW-1, -8, -9, -11, -12, and -13), with the exception of GIW-11, gas temperatures were generally consistent over the past week as well as compared to prior weeks. GIW-11 has been experiencing 20-30 degree fluctuations in gas temperature, which is likely due to its proximity to GIW series wells with cooling loops installed.
