# **Bridgeton Landfill, LLC**

## **Weekly Data Submittals**

**Week of December 28, 2014 – January 3, 2015**

**Required by Section 52.F of Agreed Order, Case No. 13SL-CC01088  
Effective May 13, 2013**

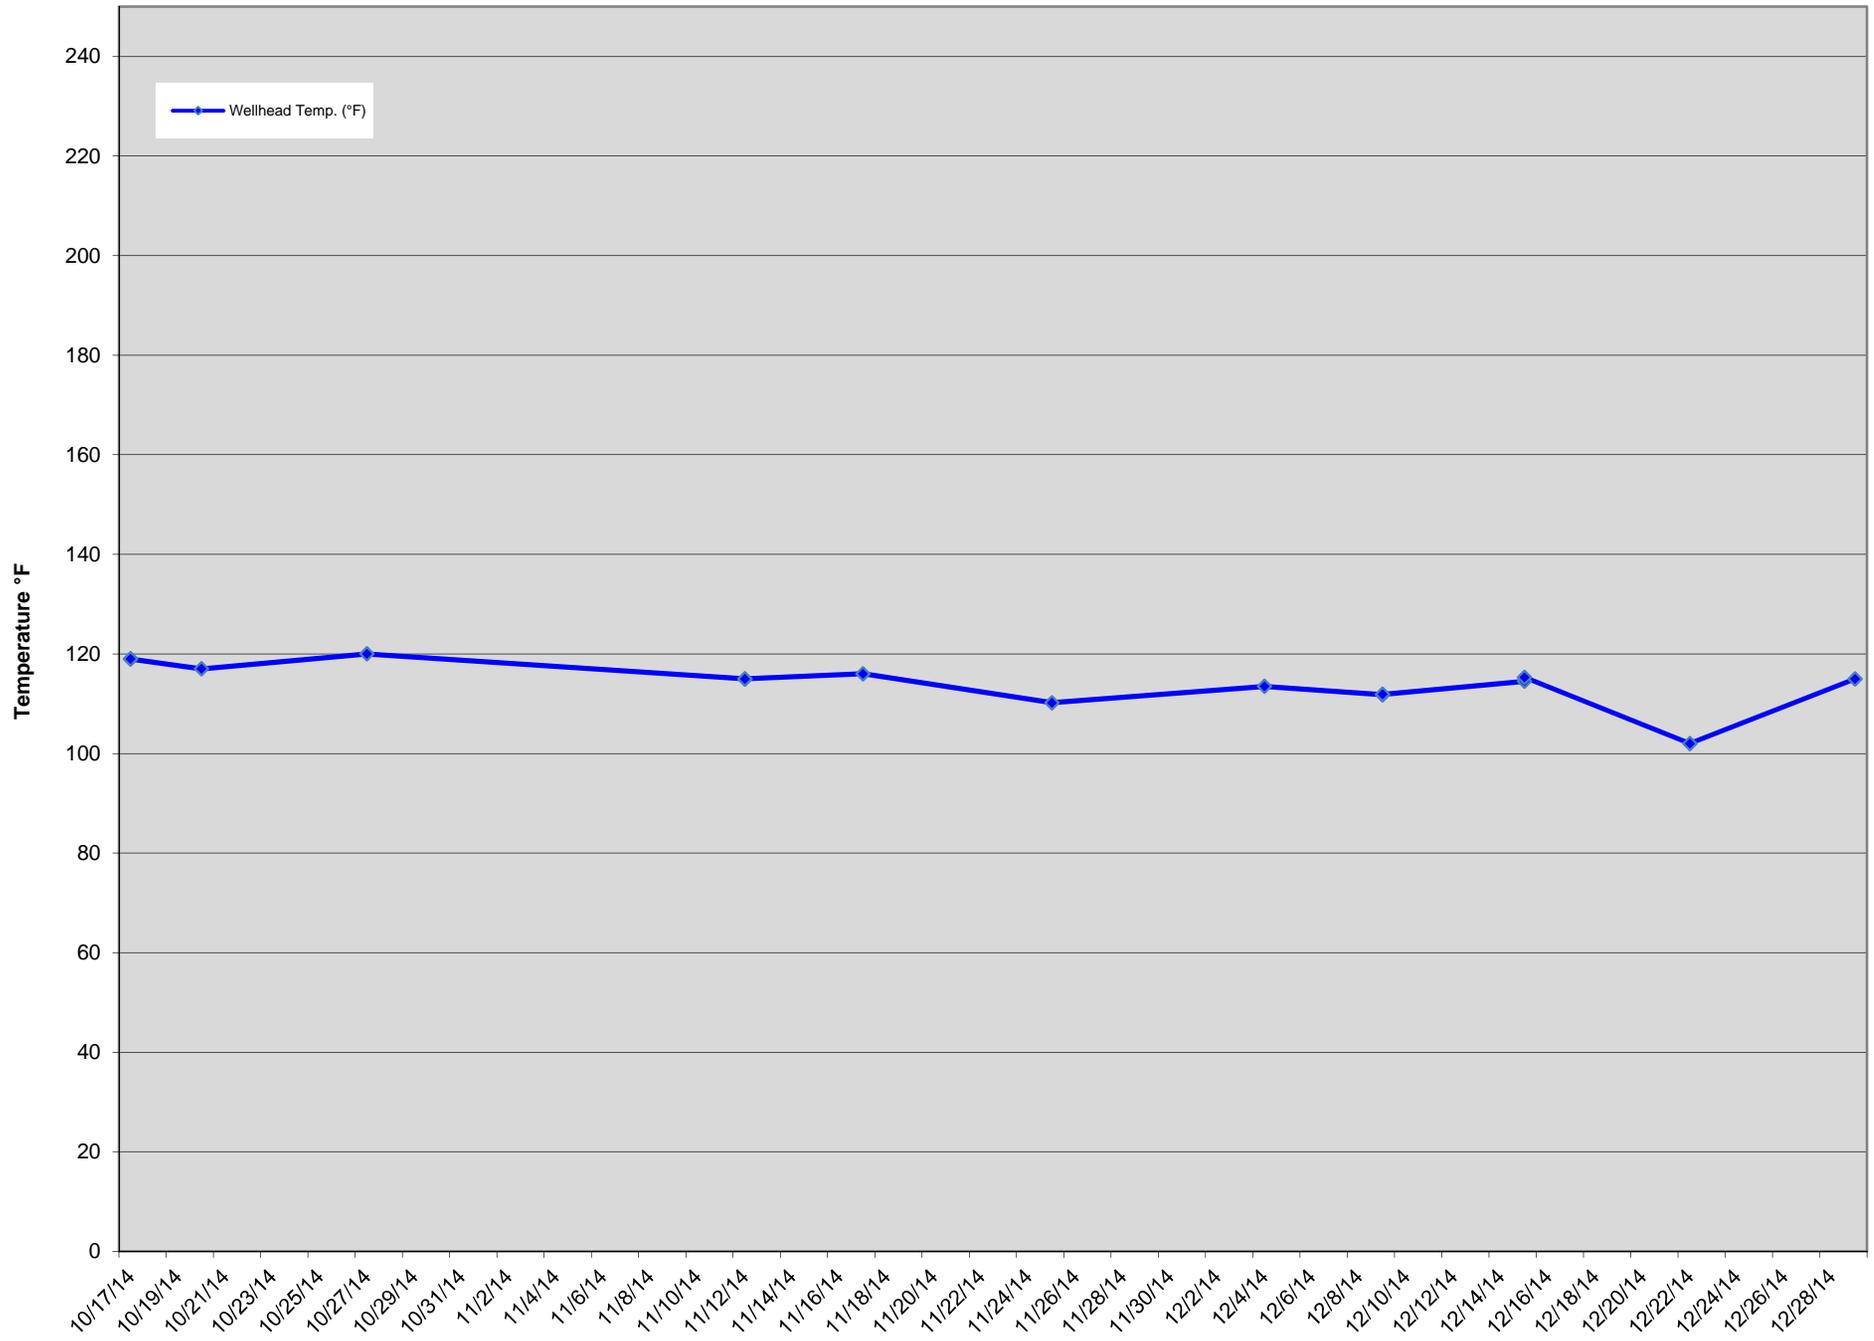
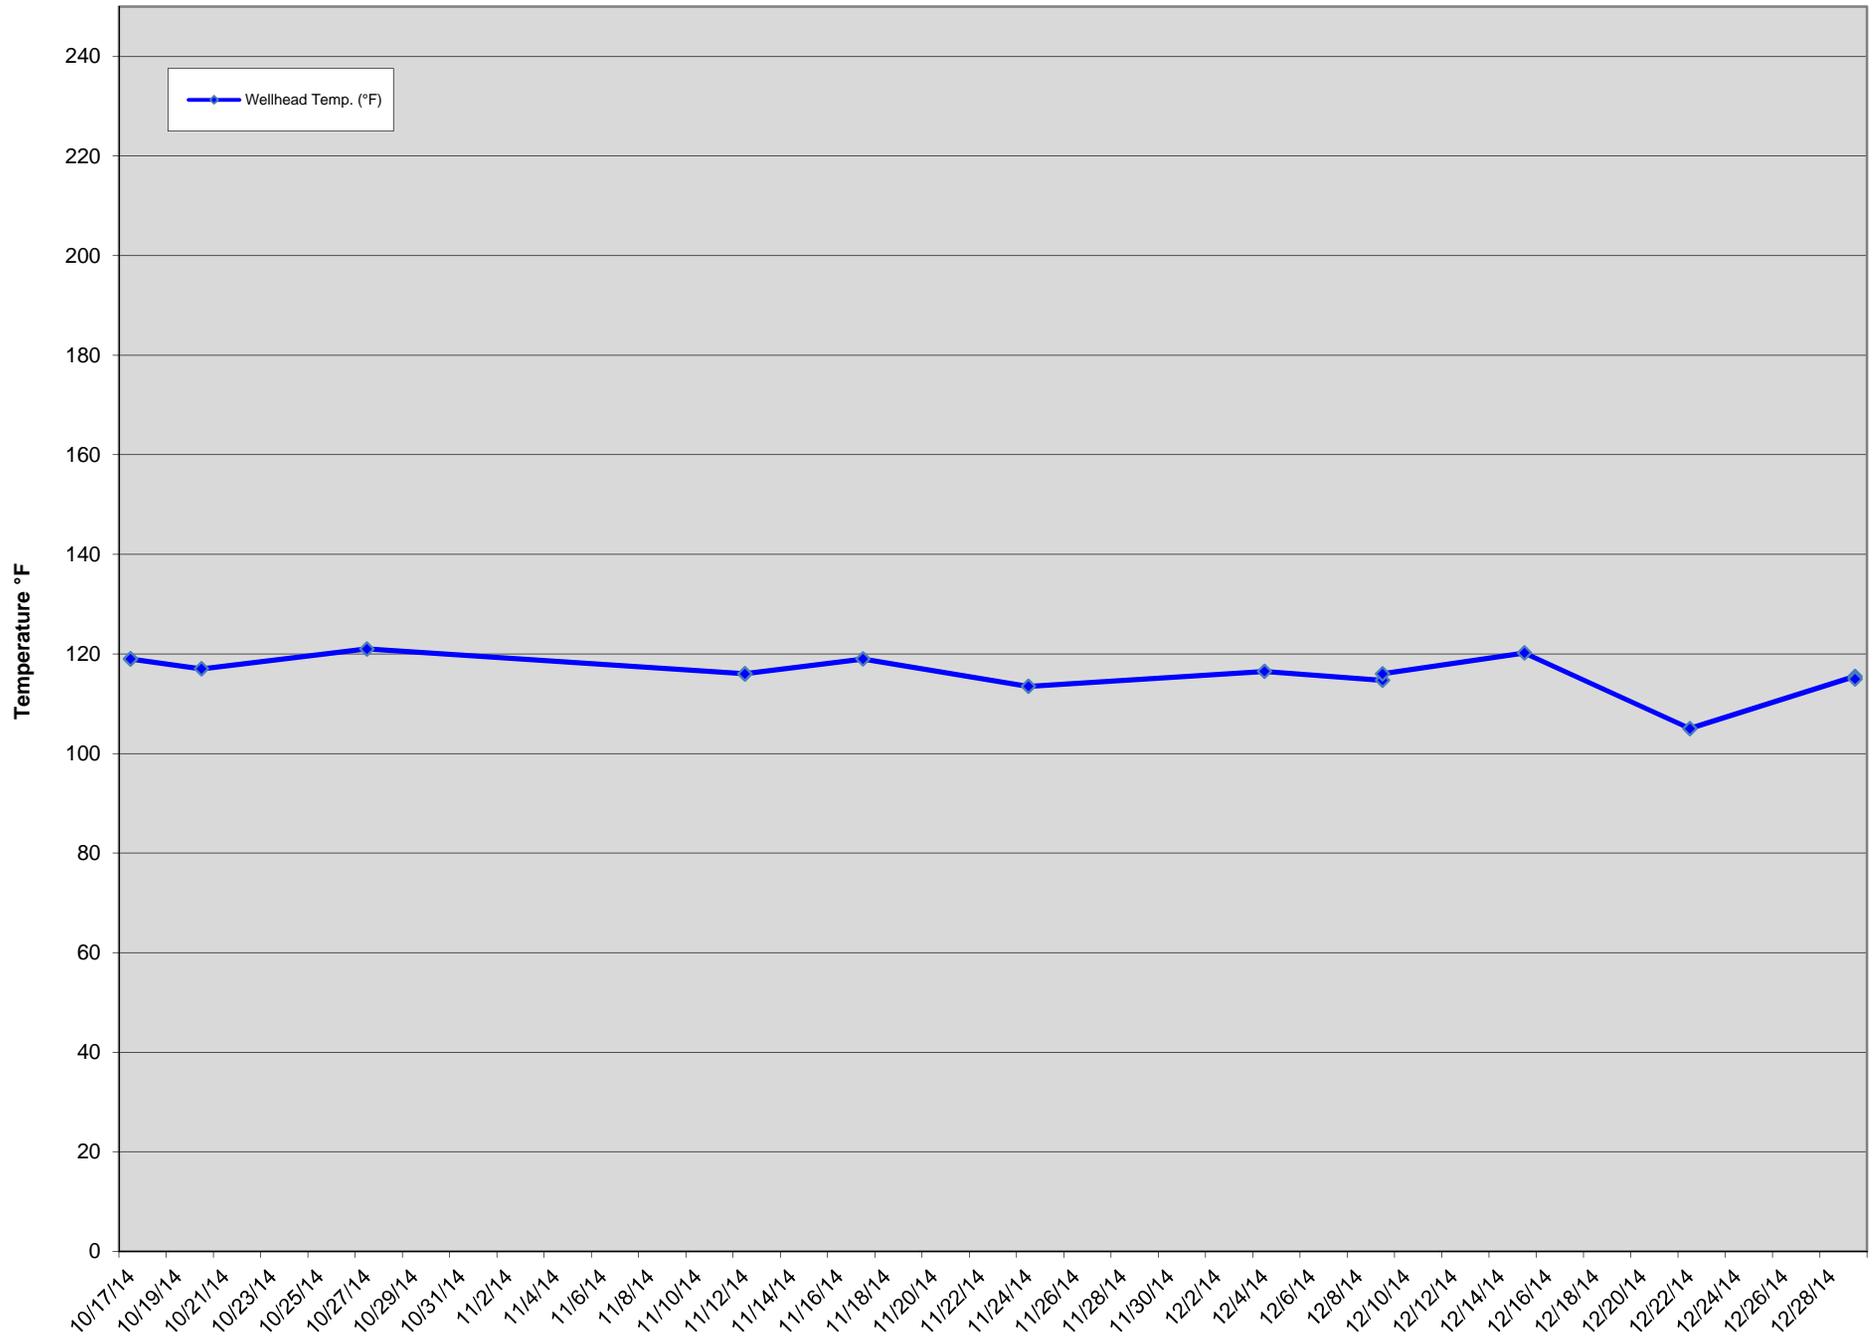
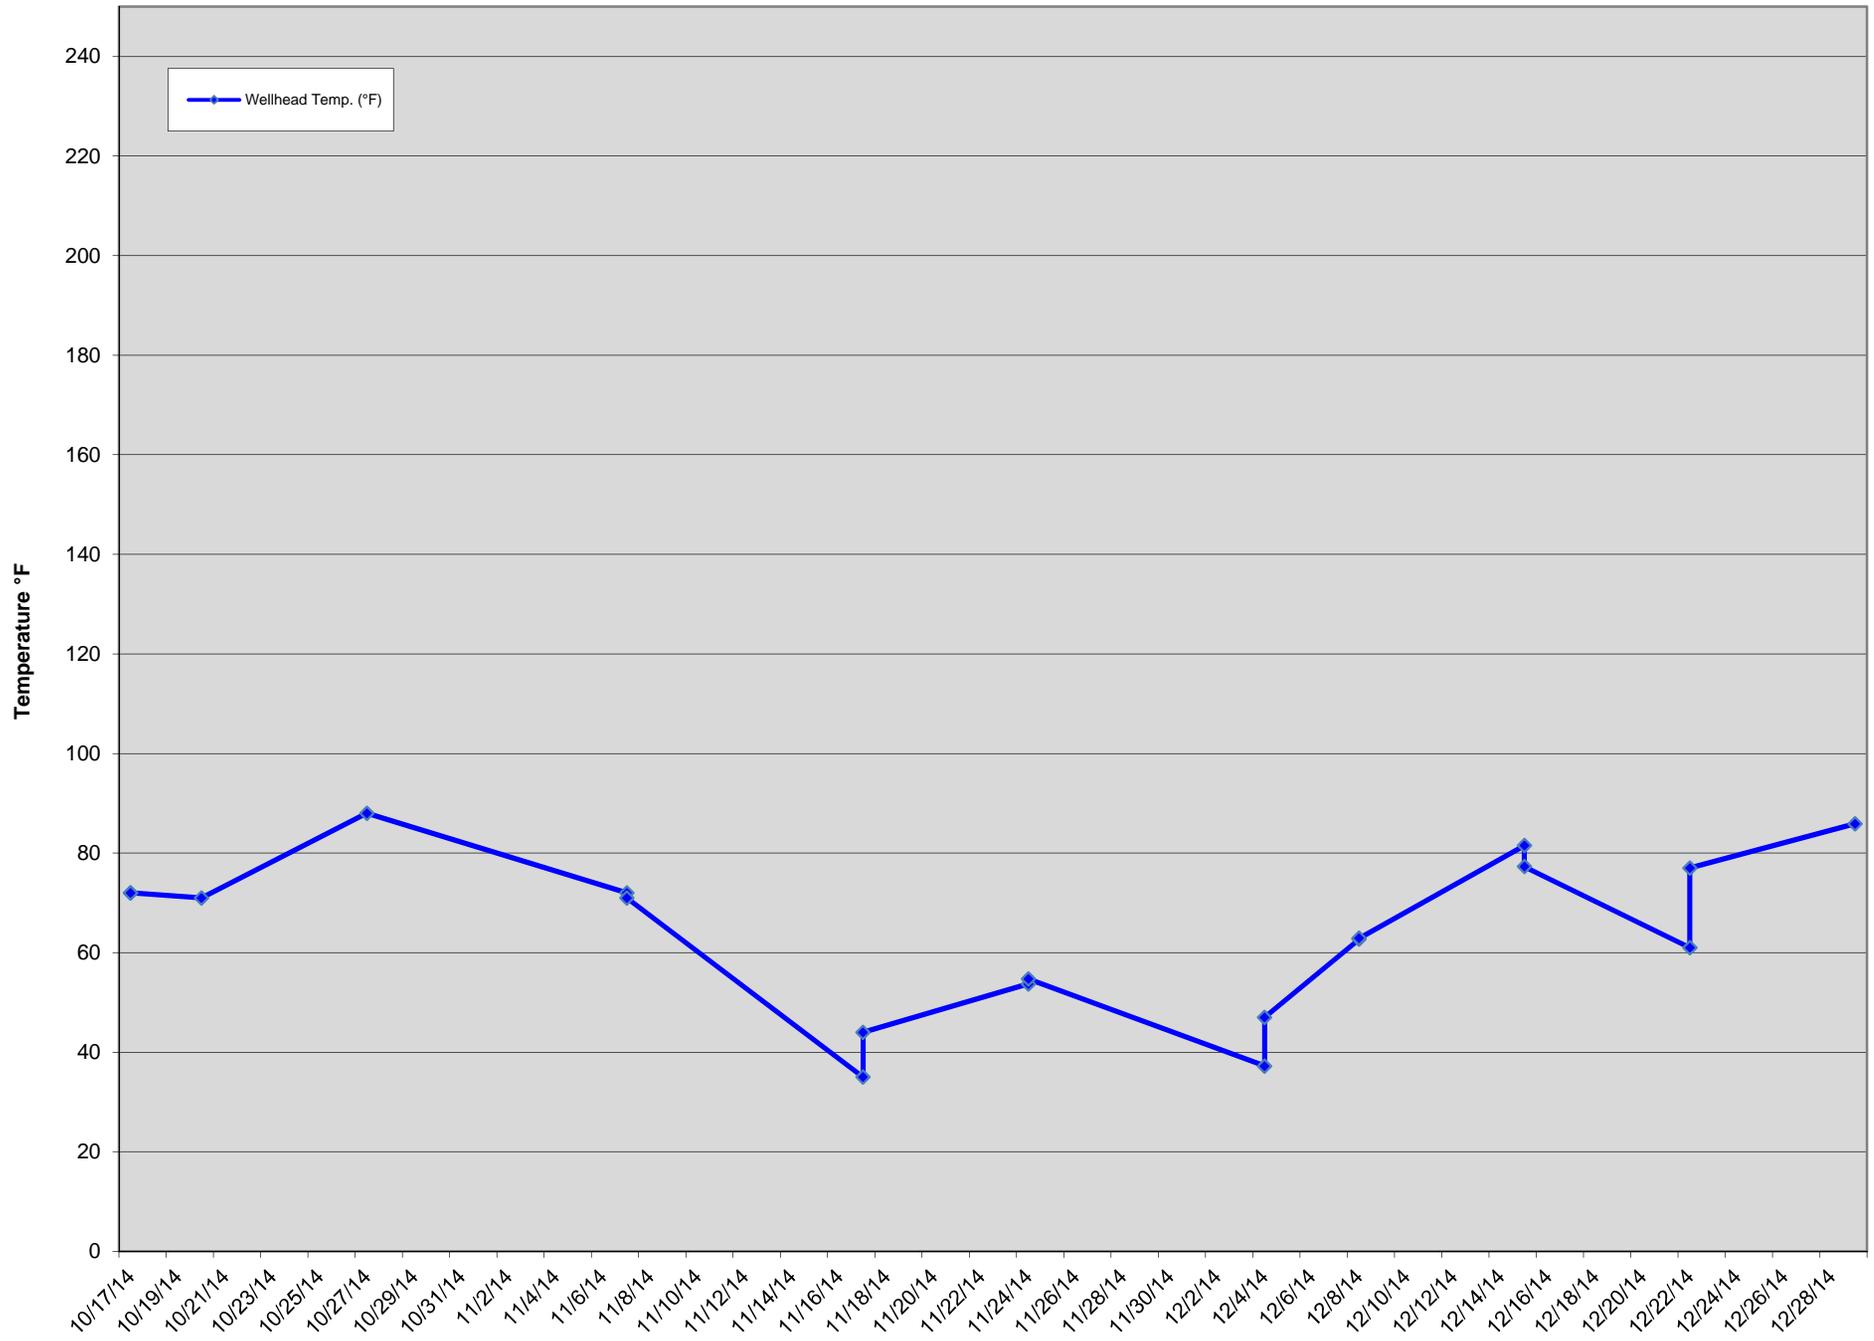
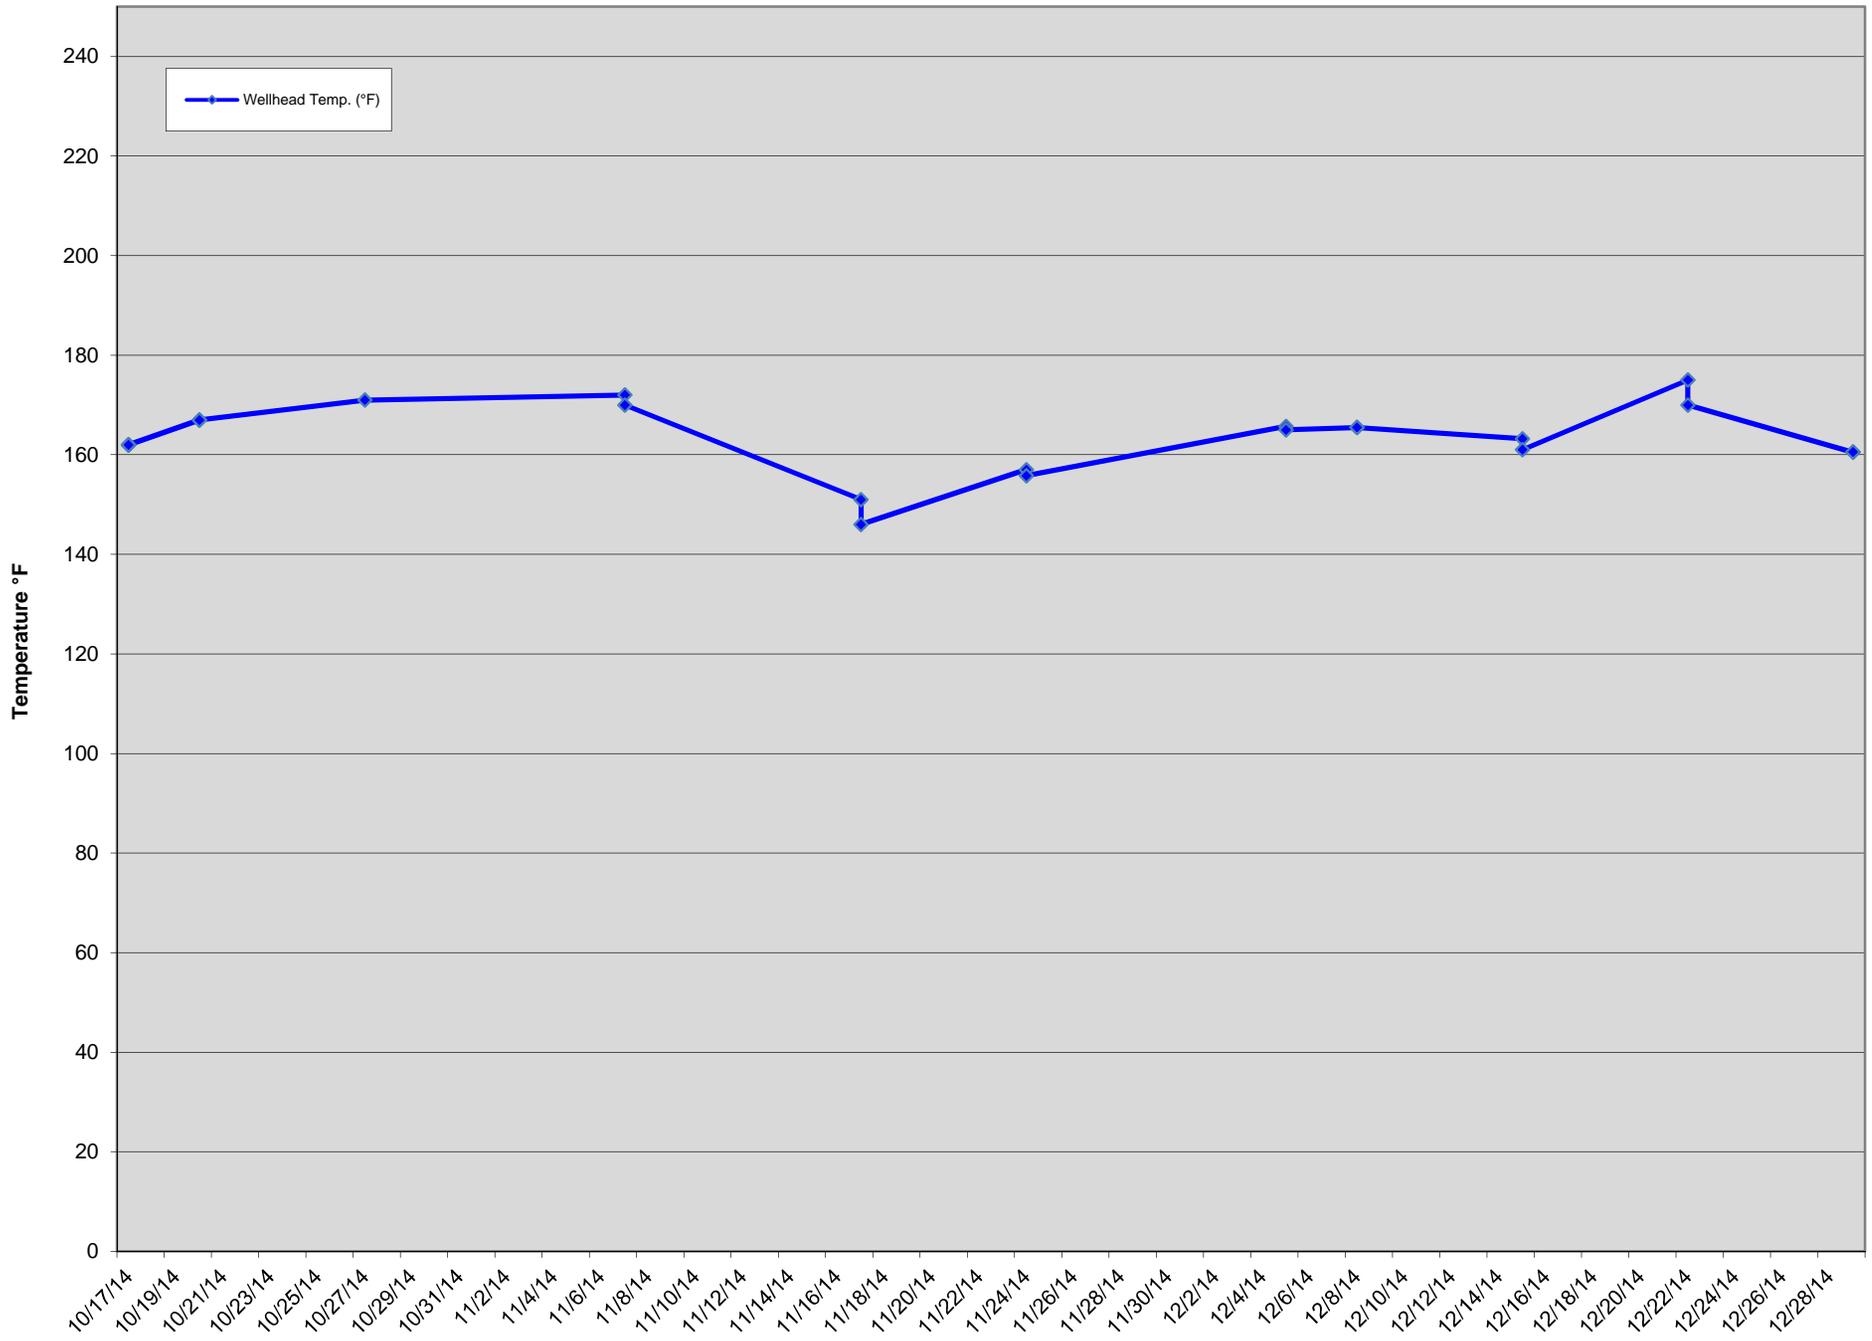
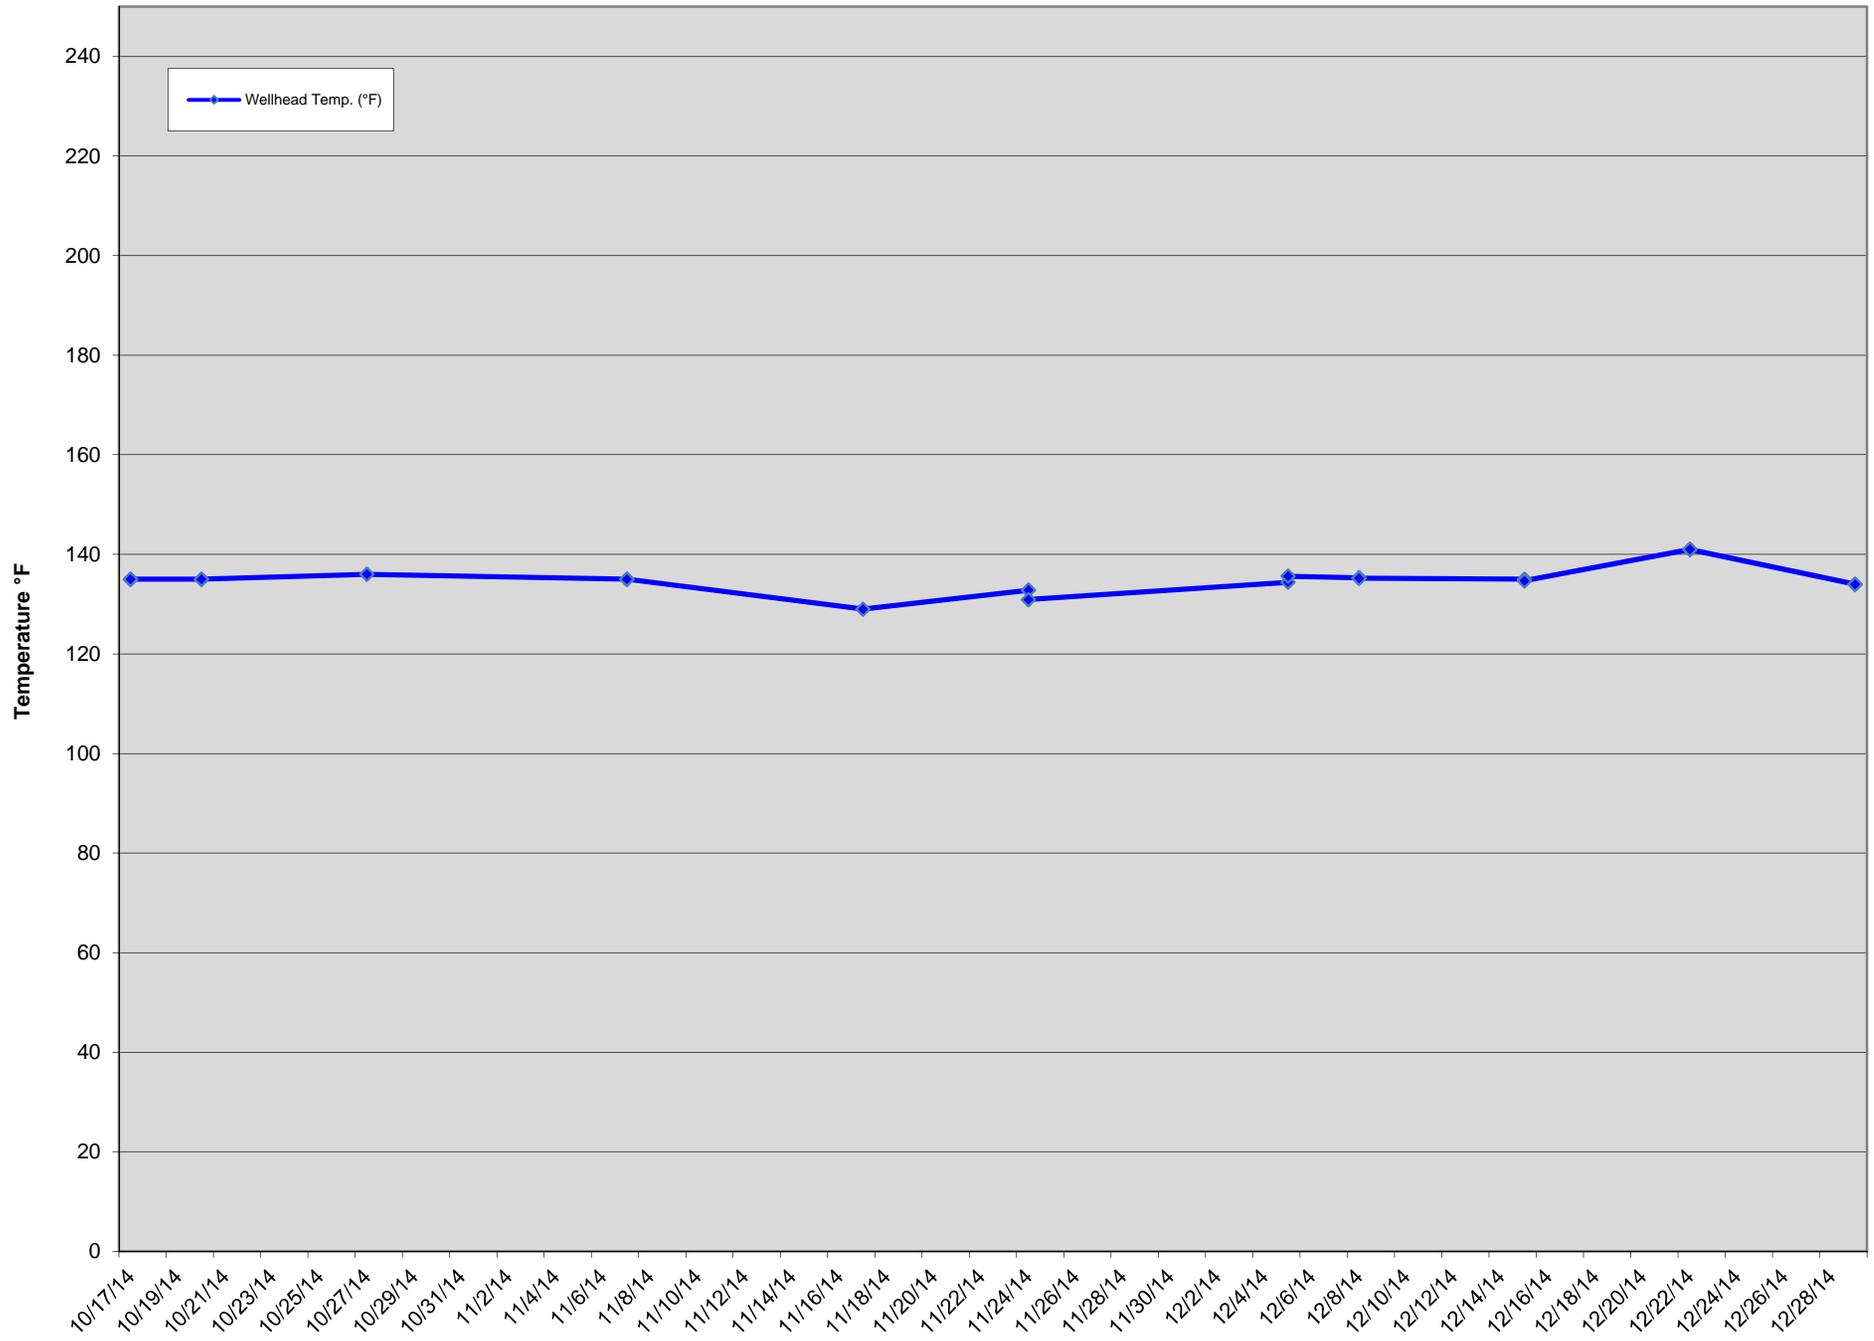
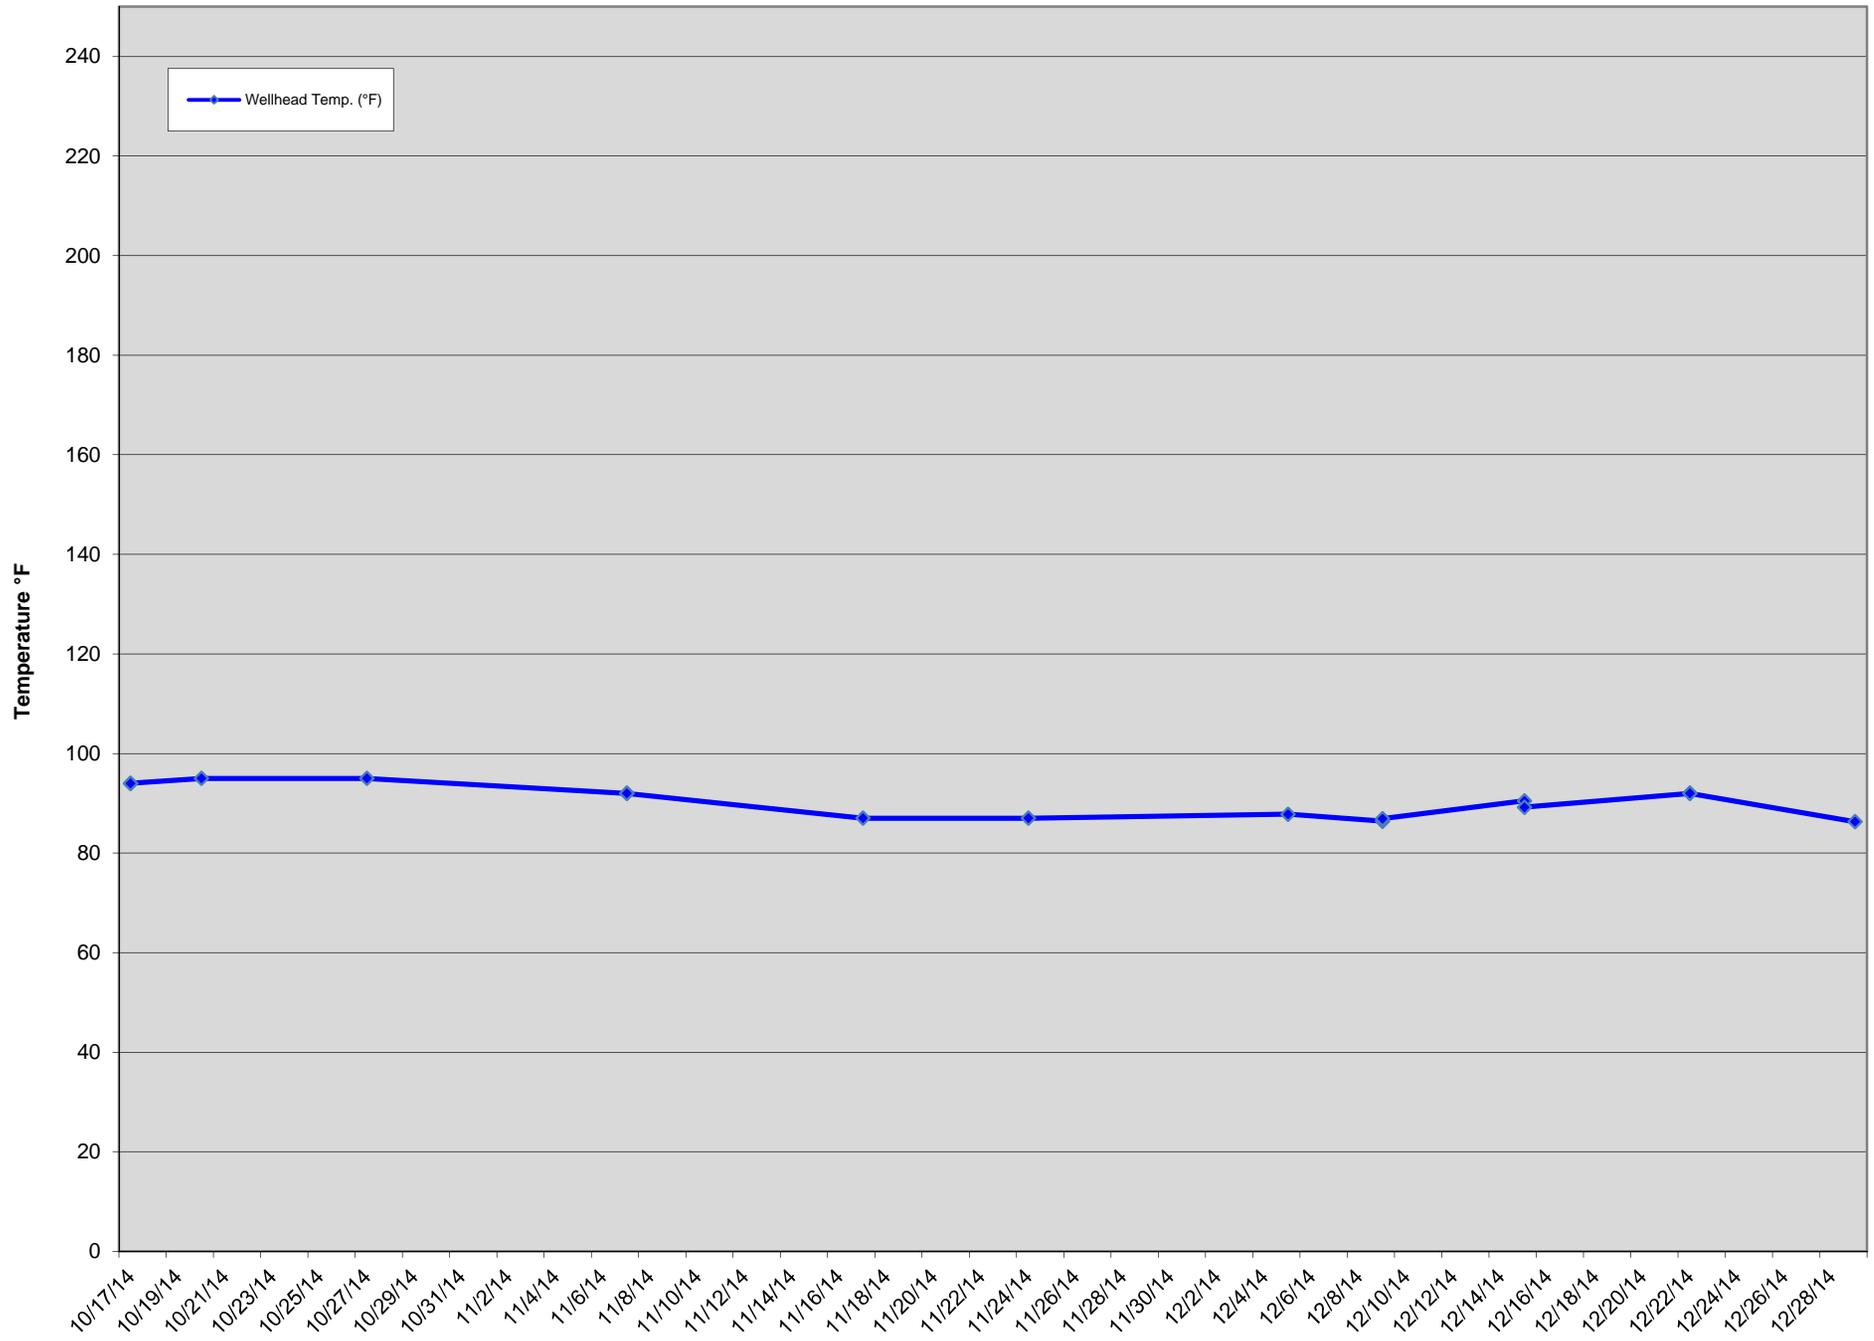
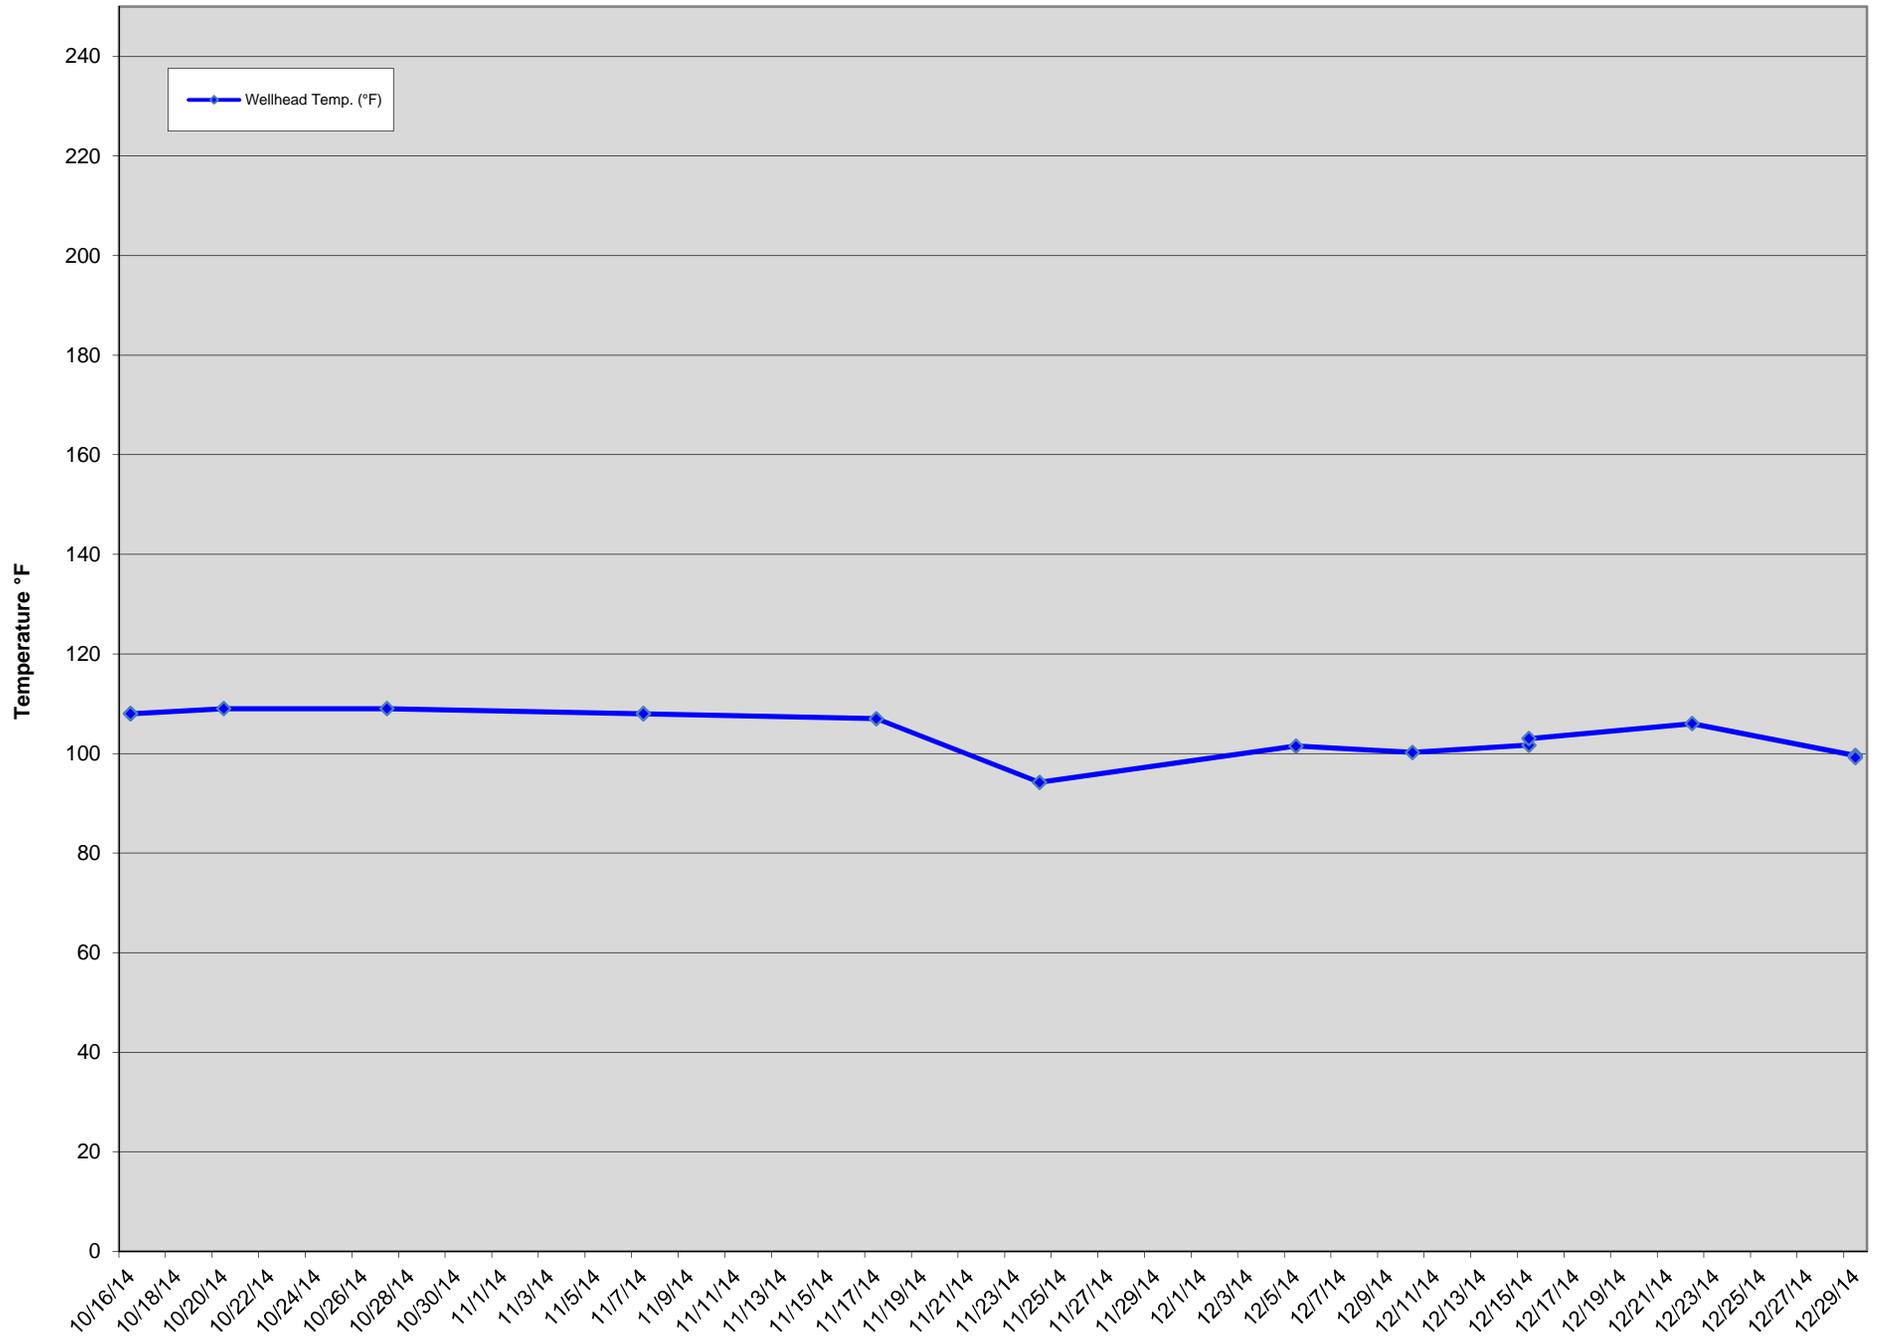
Weekly gas temperature data is being collected for select gas extraction wells (GEWs) located in the neck area of the landfill. These wells include GEW-08, -09, -10, -38, -39, -40, -41R, -43R, -53, -54, -55, -56R, -109, and -110. Over the past week all 14 wells were monitored and all well temperatures were consistent in comparison to prior weeks, with the exception of GEW-110, which experienced an increase in temperature from previous ambient conditions, due to effective liquids pumping and exposure of well casing perforations. This trend is expected to continue in future weeks to temperatures near adjacent TMPs.
