Figure 3-5
TCE Concentrations in Groundwater
 Phase I Sitewide Soil Vapor Investigation Report
 221 Sunset Drive, Camdenton, MO

FIGURE 4-1
Cross-Section Transects
 Phase I Sitewide Soil Vapor Investigation Report
 221 Sunset Drive, Camdenton, MO

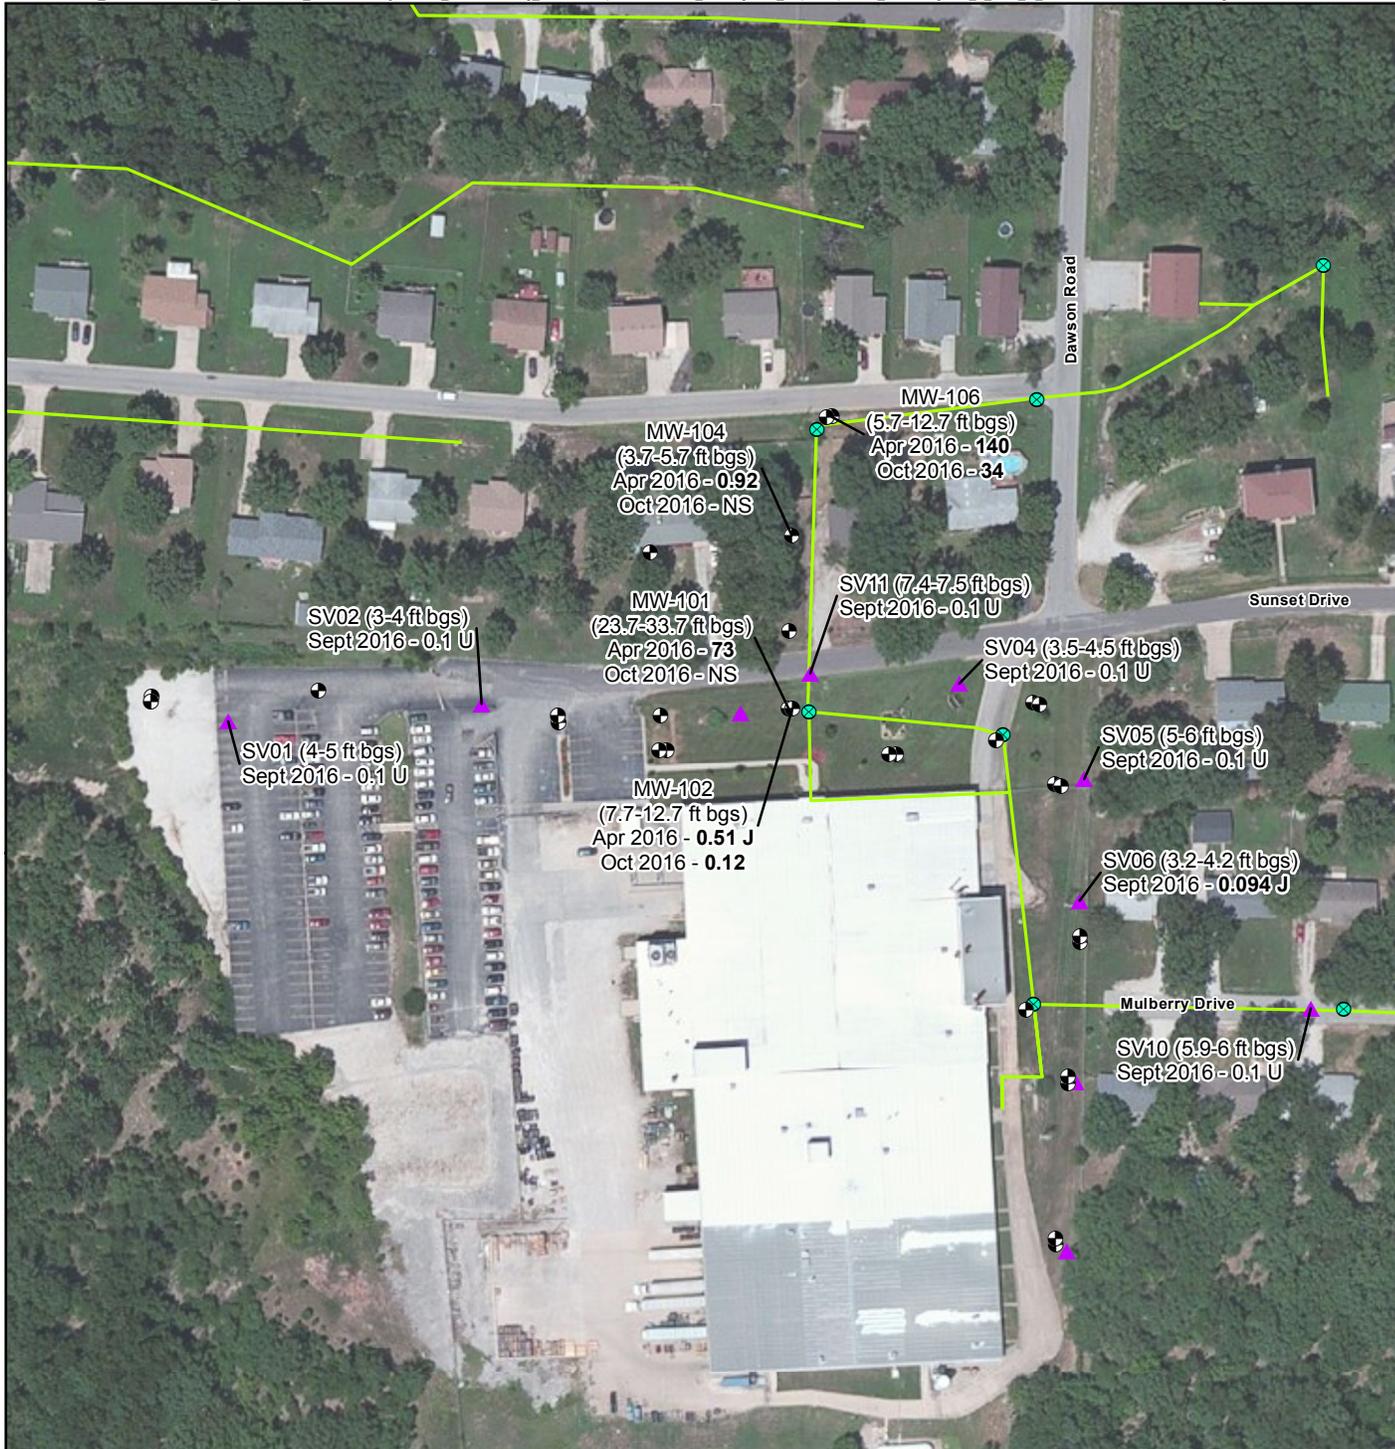
1. Results are presented in micrograms per liter ($\mu\text{g/L}$).
2. **Bold result indicates that the chemical was detected at the value reported.**
3. ft bgs = feet below ground surface
4. NS = not sample, groundwater not present
5. J = The analyte was positively identified; the associated numerical value is the approximate concentration of the analyte in the sample.
6. TCE = trichloroethene
7. U = The analyte was analyzed for but was not detected above the reported sample quantitation limit.

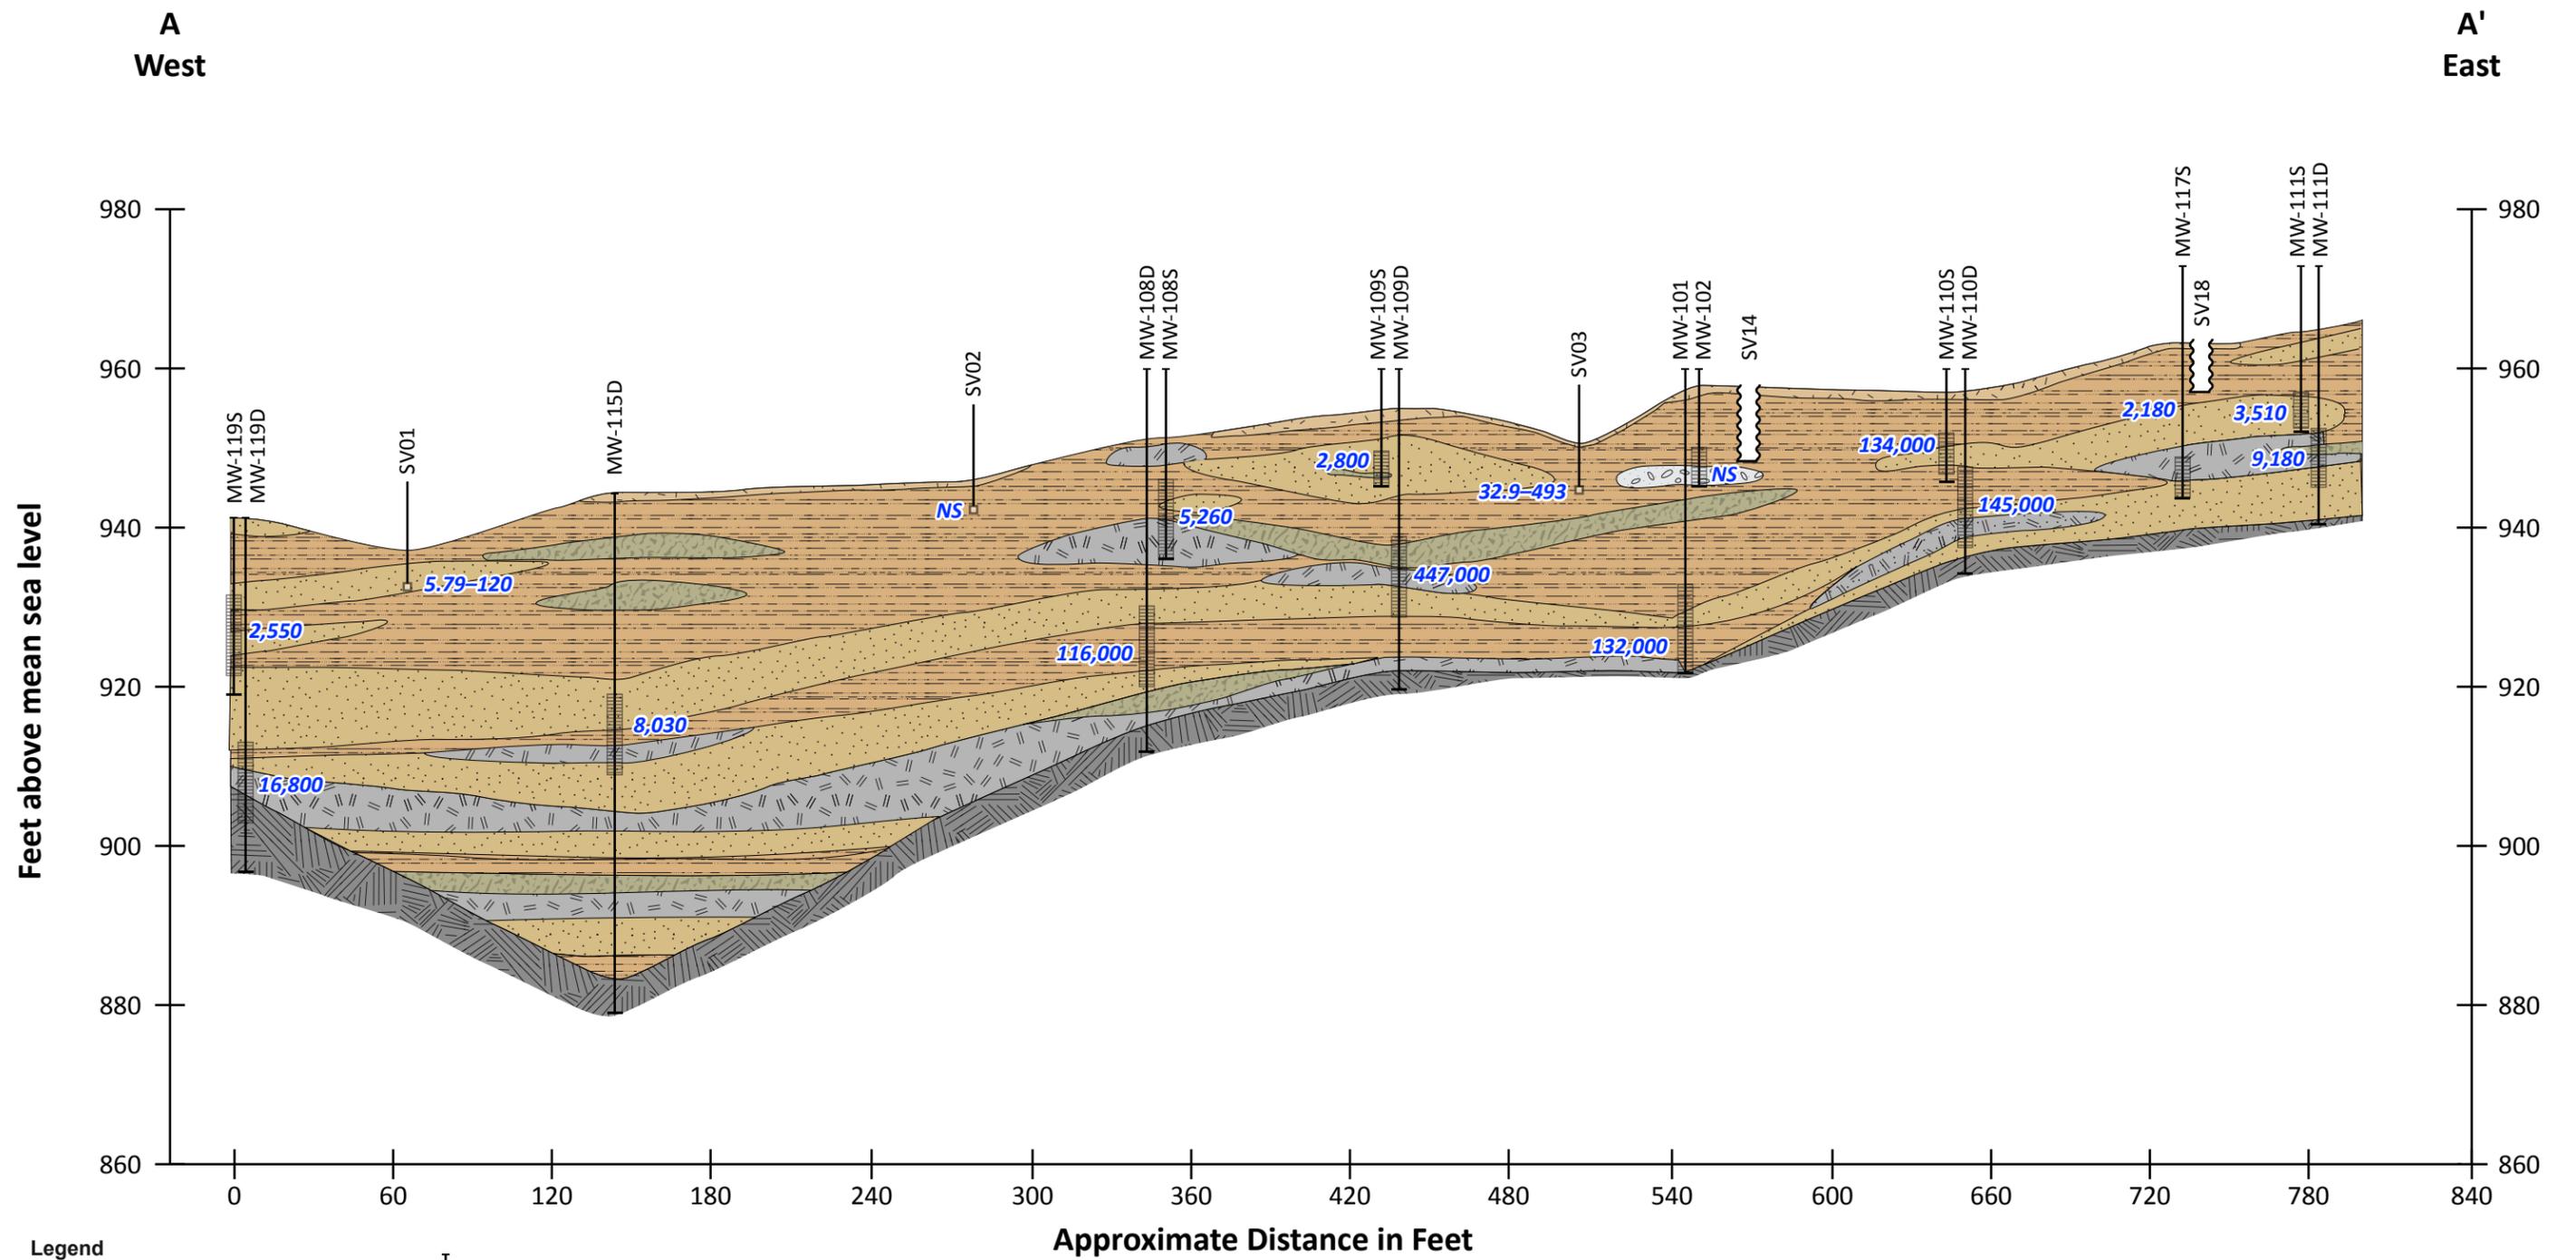
Cross-section transect depicting generalized/simplified representations of subsurface geologic conditions beneath the site.

Figure 4-2
Cross Section A-A'
 Phase I Sitewide Soil Vapor Investigation Report
 221 Sunset Drive
 Camdenton, Missouri

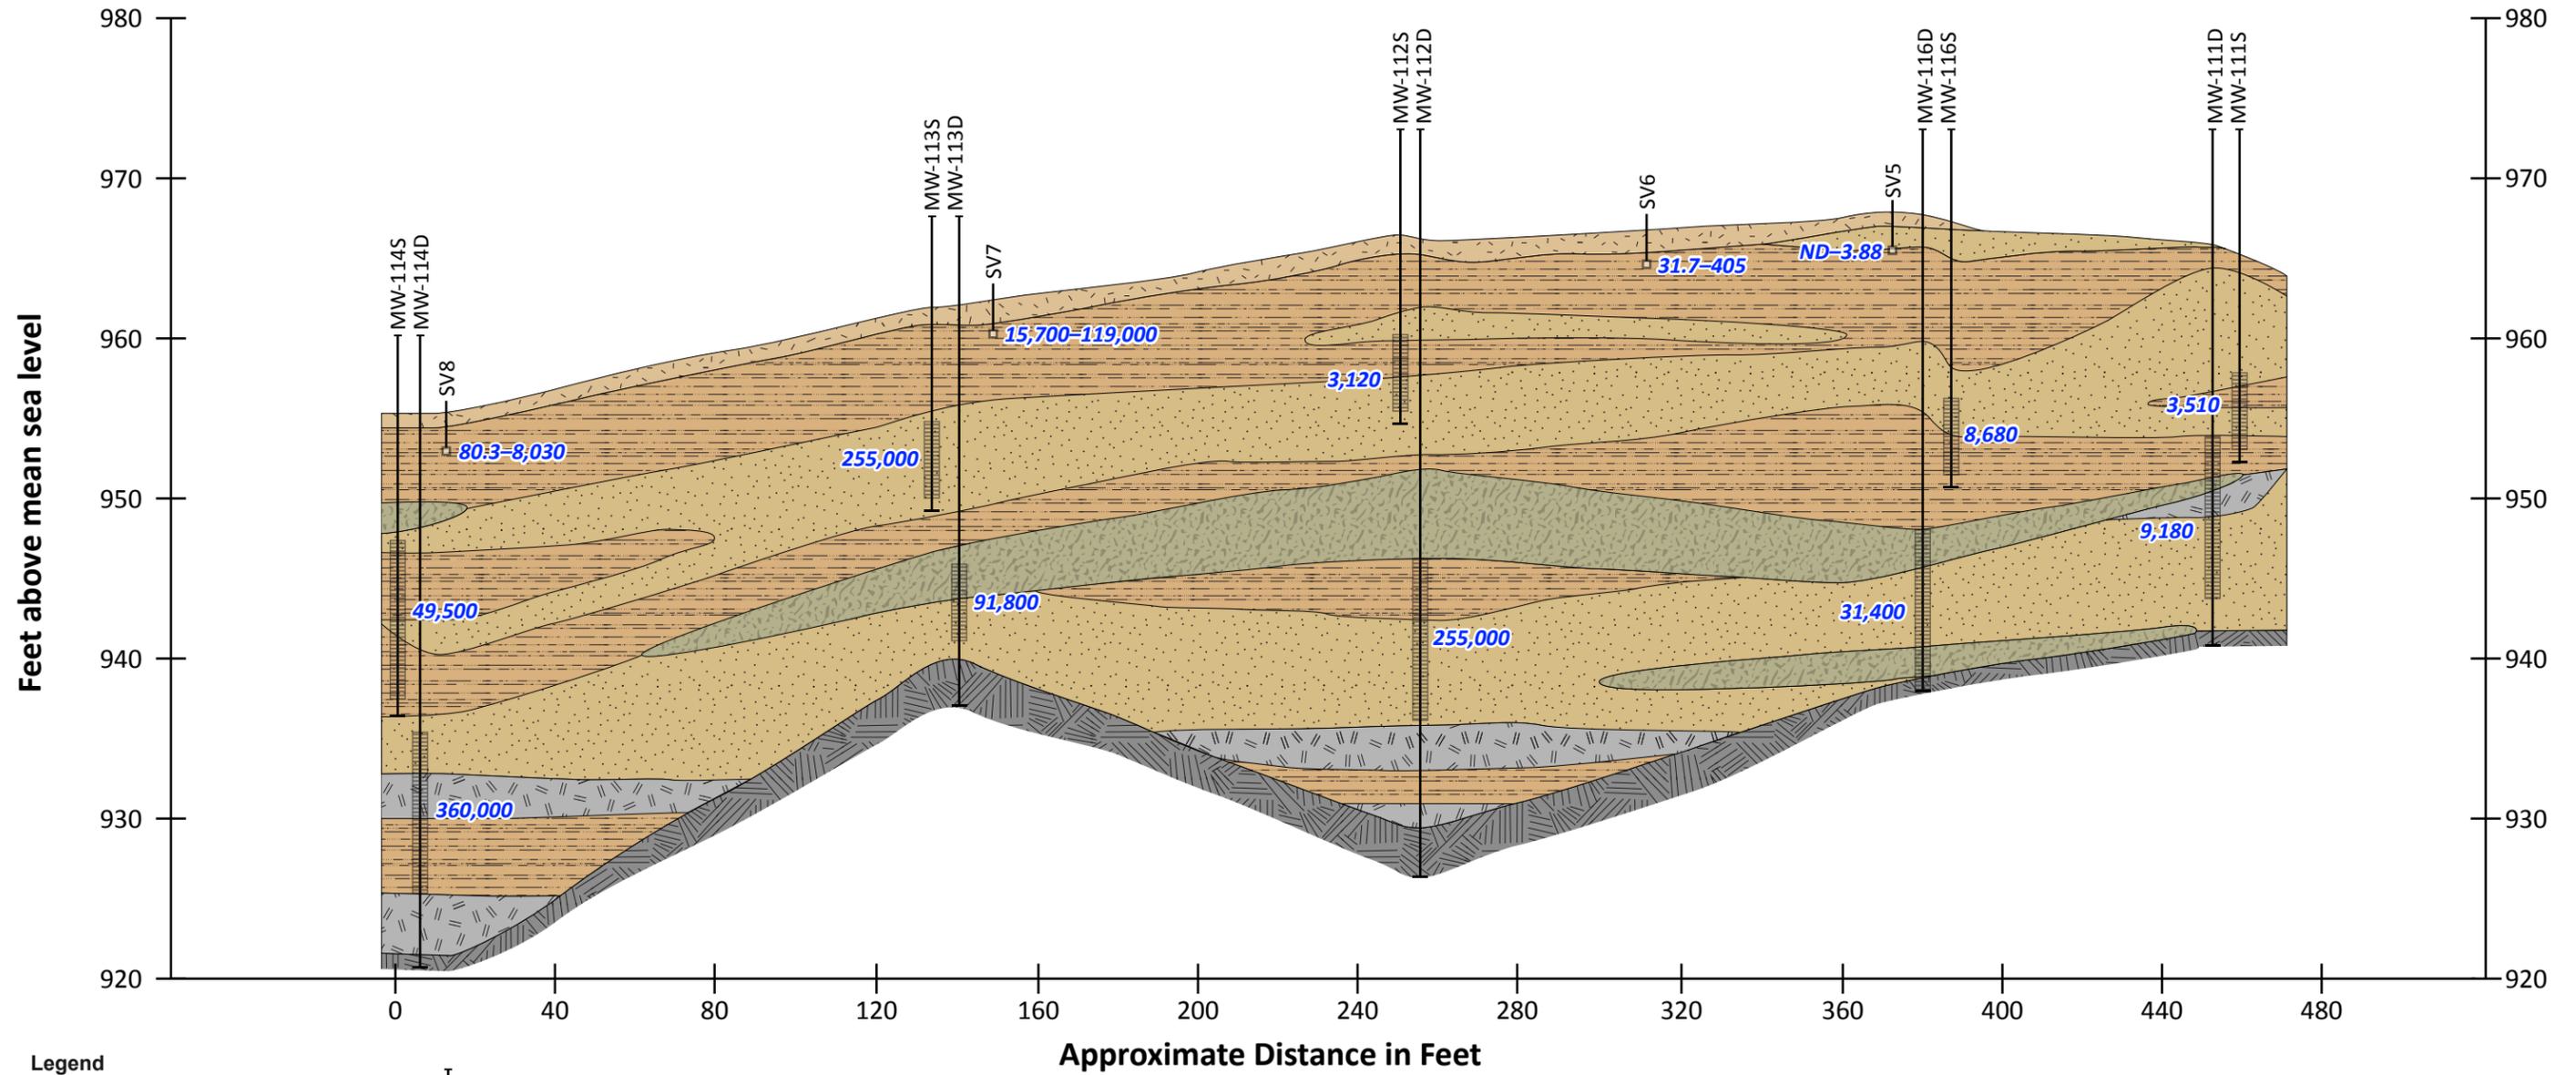
Cross-section transect depicting generalized/simplified representations of subsurface geologic conditions beneath the site.

Figure 4-3
Cross Section B-B'
 Phase I Sitewide Soil Vapor Investigation Report
 221 Sunset Drive
 Camdenton, Missouri

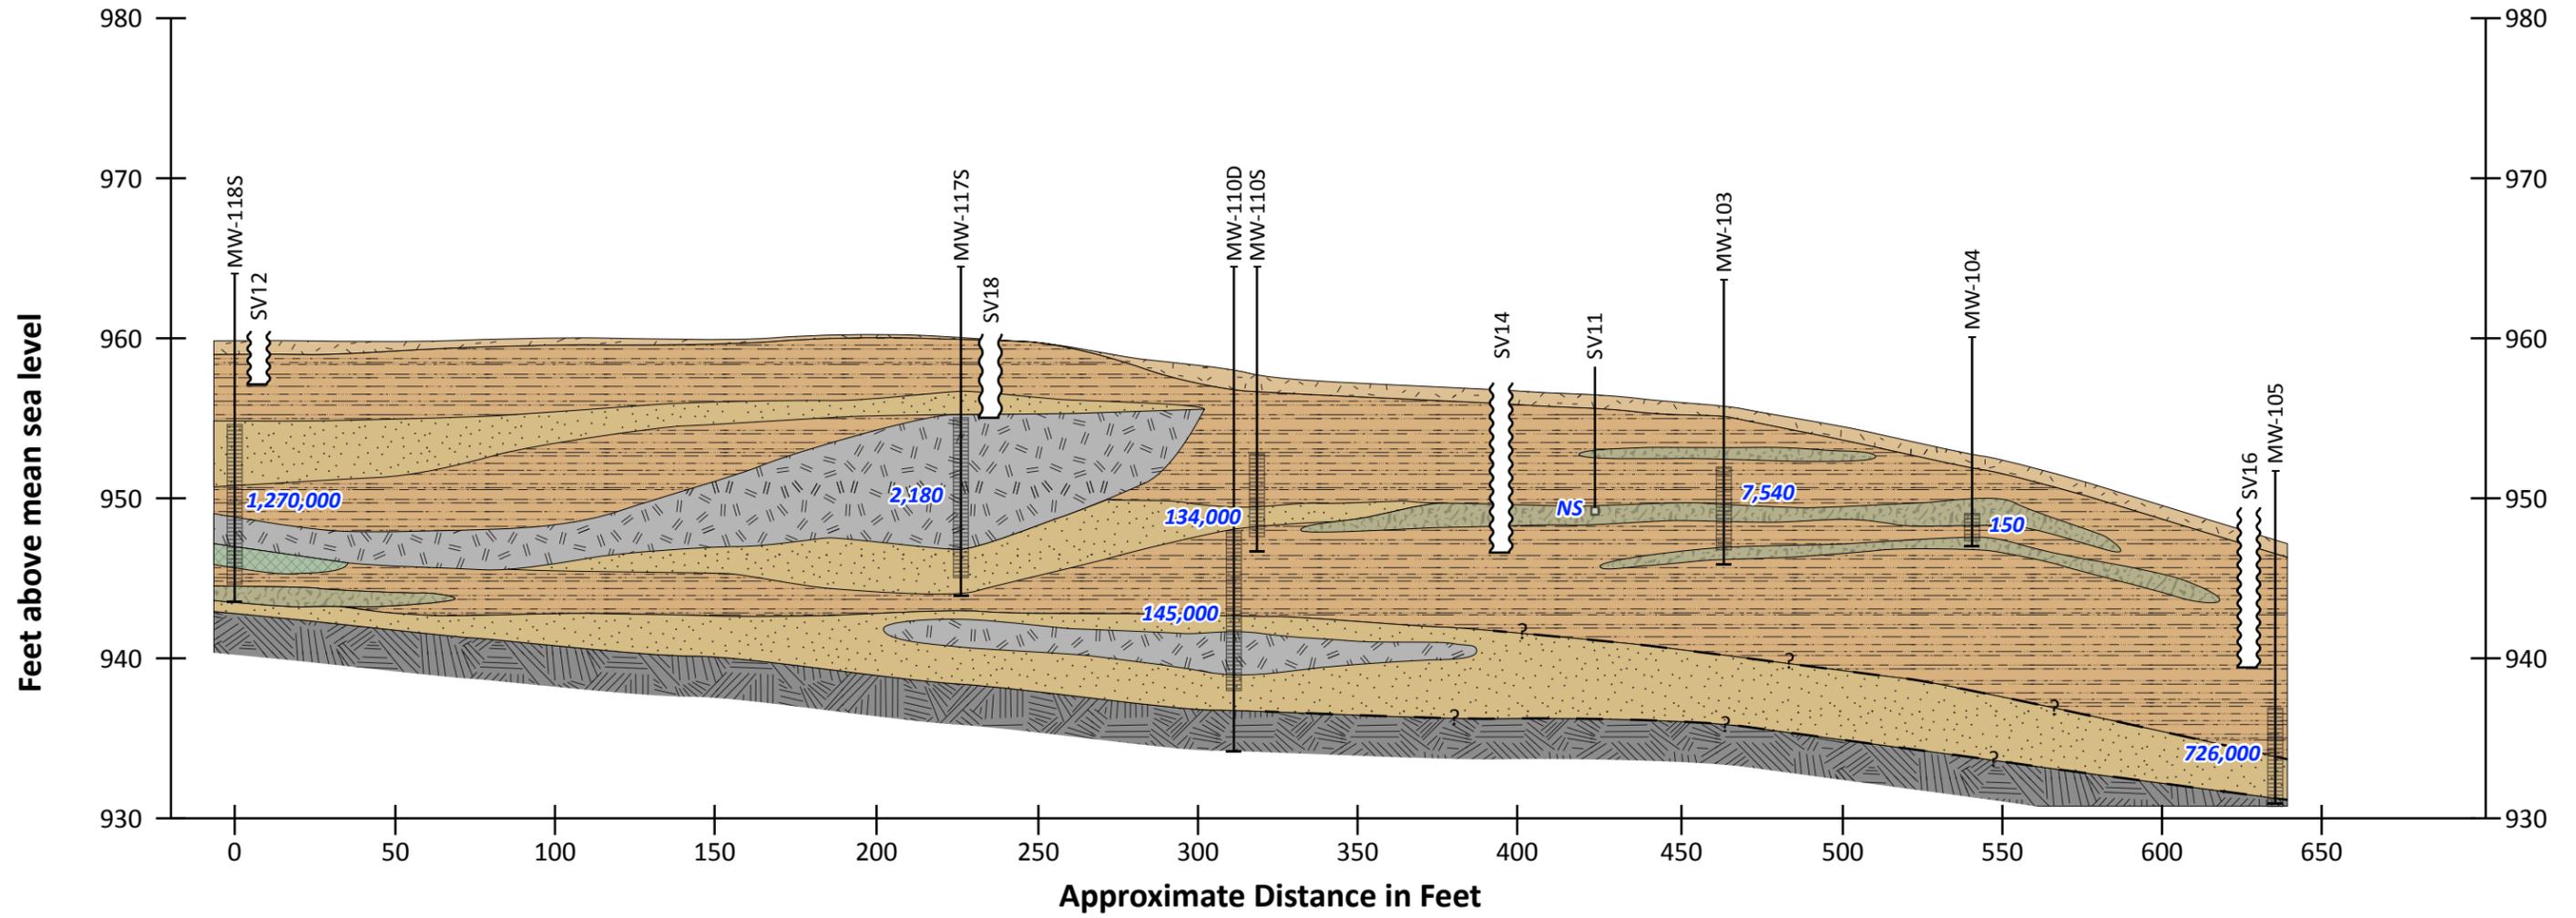
Cross-section transect depicting generalized/simplified representations of subsurface geologic conditions beneath the site.

Figure 4-4
Cross Section C-C'
 Phase I Sitewide Soil Vapor Investigation Report
 221 Sunset Drive
 Camdenton, Missouri
