**Missouri Department of Natural Resources
Water Protection Program**

Total Maximum Daily Load (TMDL)

Tributary to Pond Creek
(now correctly identified as Pond Creek)

Washington County, Missouri

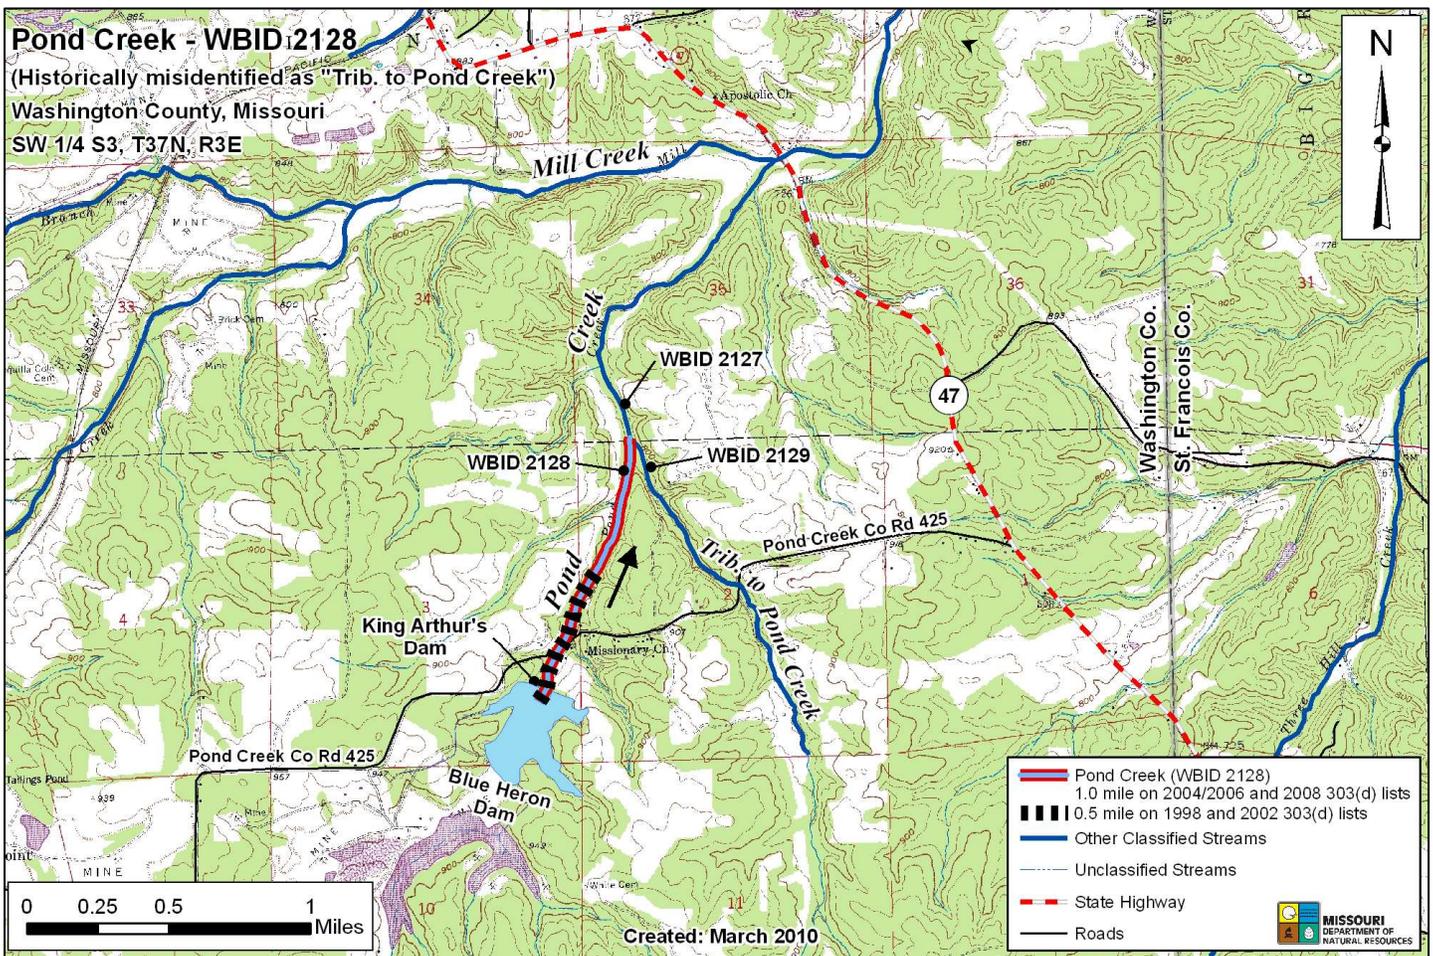
Figure 1. Pond Creek (WBID 2128) and Tributary to Pond Creek (WBID 2129) as seen on the USGS "Mineral Point" 7.5-minute topographic quadrangle map. (Note that the names of WBID 2128 and 2129 have been historically reversed in Missouri 303(d) lists and Water Quality Standards. Also, King Arthur's Dam, and the lake it impounds, has been superimposed on this figure's topographic map base because the 1982 photo revision of that map neglected to portray their existence, although the dam was constructed in 1980.)

⁶ Although King Arthur’s Dam, constructed in 1980, is easily identified on aerial photographs, it has yet to be portrayed on the USGS topographic maps and GIS layers, and was manually added to Figure 1.

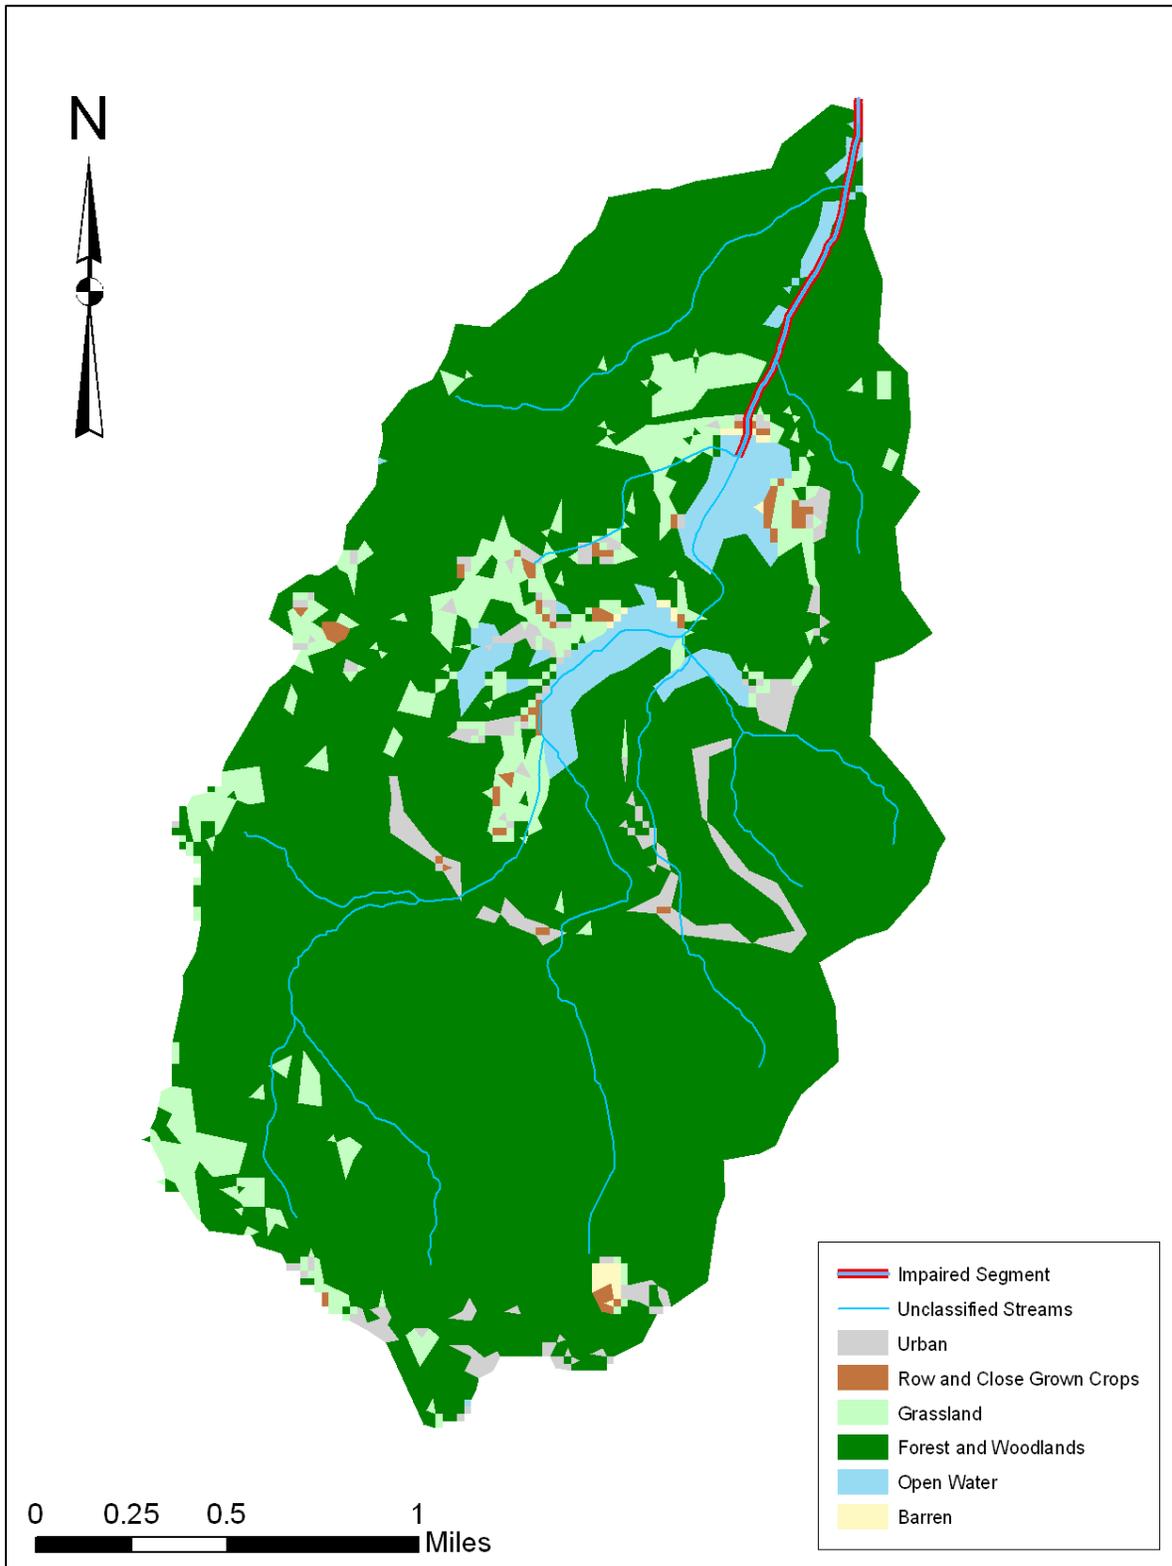
Figure 2. Map of Land Use in the Upper Pond Creek (WBID 2128) Watershed

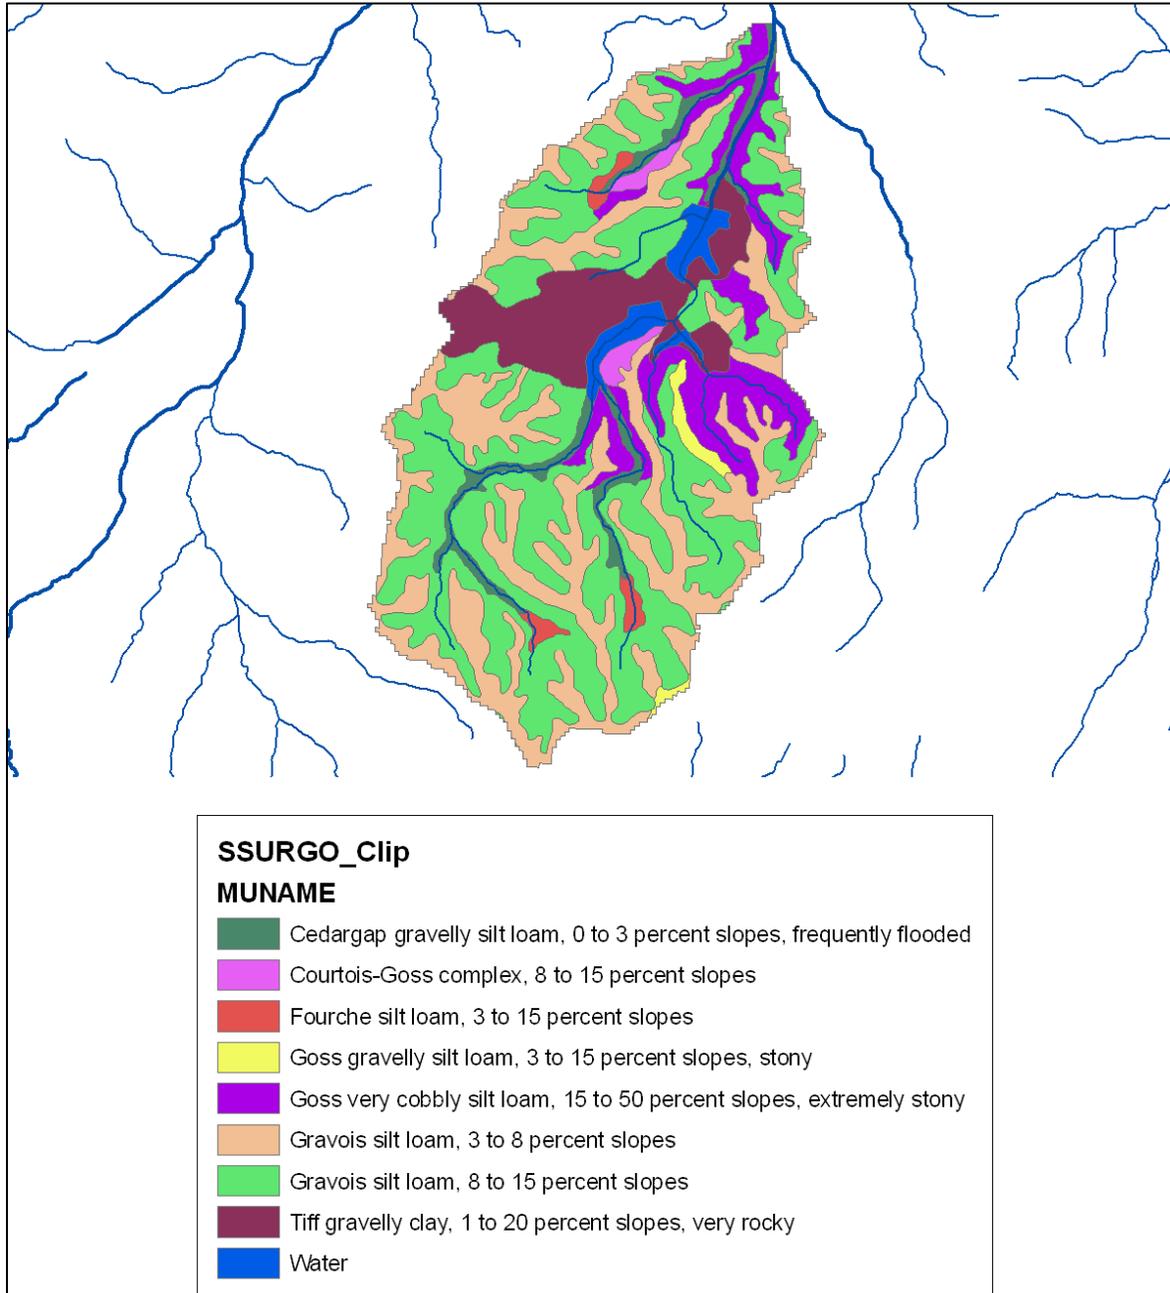
Figure 3a. Map of Soils in the Upper Pond Creek (WBID 2128) Watershed (NRCS 2007)

A map illustrating the soil types in the Pond Creek watershed can be found in Figure 3a. The headwaters of Pond Creek incise the Tiff soil series, which consists of very deep (over 60 inches), well-drained, moderately permeable soils that formed clayey residuum⁷ on uplands. These soils are on nearly level to moderately steep areas that have been truncated by mining operations with slopes ranging from 1 to 20 percent. The soil's taxonomic class is clayey-skeletal, kaolinitic, mesic Rhodic Paleudalfs. Typical pedon⁸ is tiff gravelly clay - on a convex escarpment of 13 percent slope in a mined area at an elevation of 710 feet (USDA NRCS 2005).

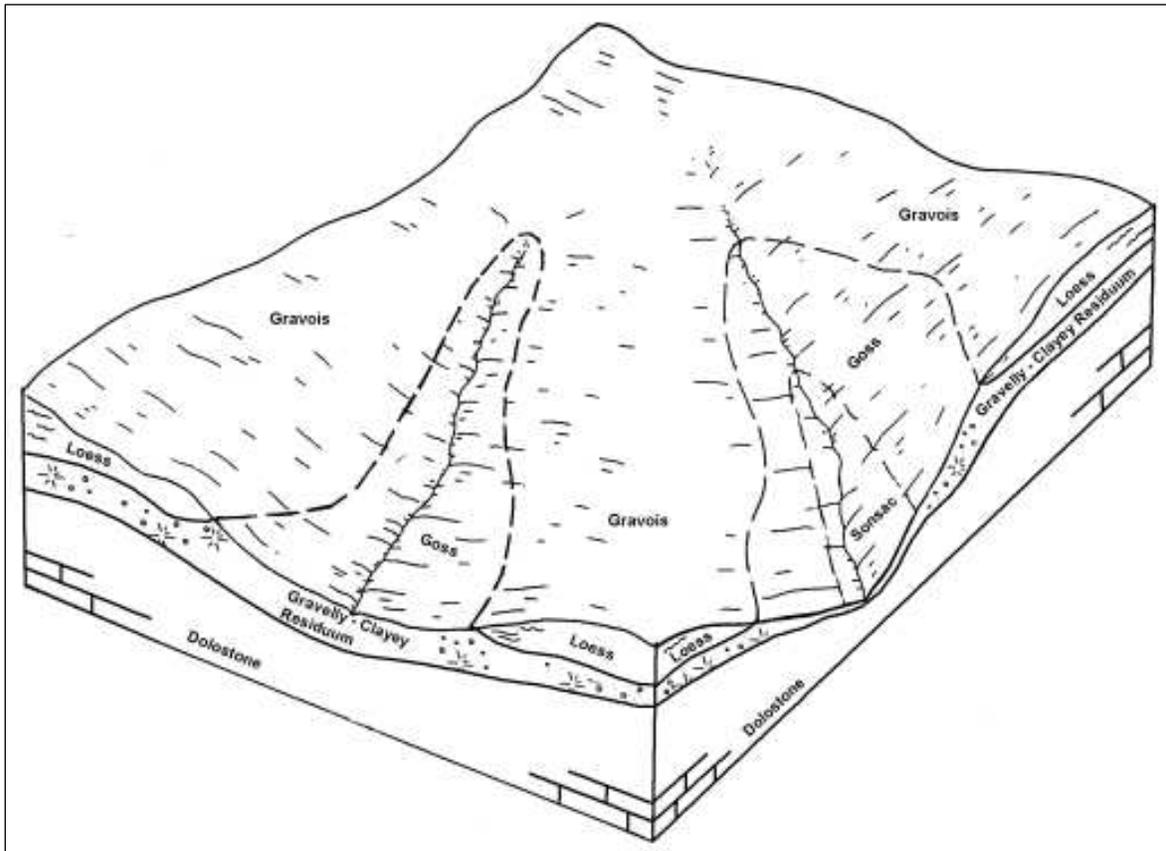
Figure 3b. Typical pattern of soils and parent material in the Goss-Gravois association (Figure 10 from USDA NRCS 2005).

The relationship of the Tiff soil series (labeled "gravelly-clayey residuum") and the overlying Gravois-Goss complex can be found in Figure 3b. Where exposed, the Tiff soil series and the barite-rich clay materials found in barite tailings areas are similar in appearance and composition. For this reason it is often difficult to distinguish between historic abandoned barite mine areas and more recently disturbed Tiff soils. Therefore, for the purposes of the Pond Creek TMDL the materials classified as "mine tailings" and "tiff gravelly clay" will be considered similar materials.

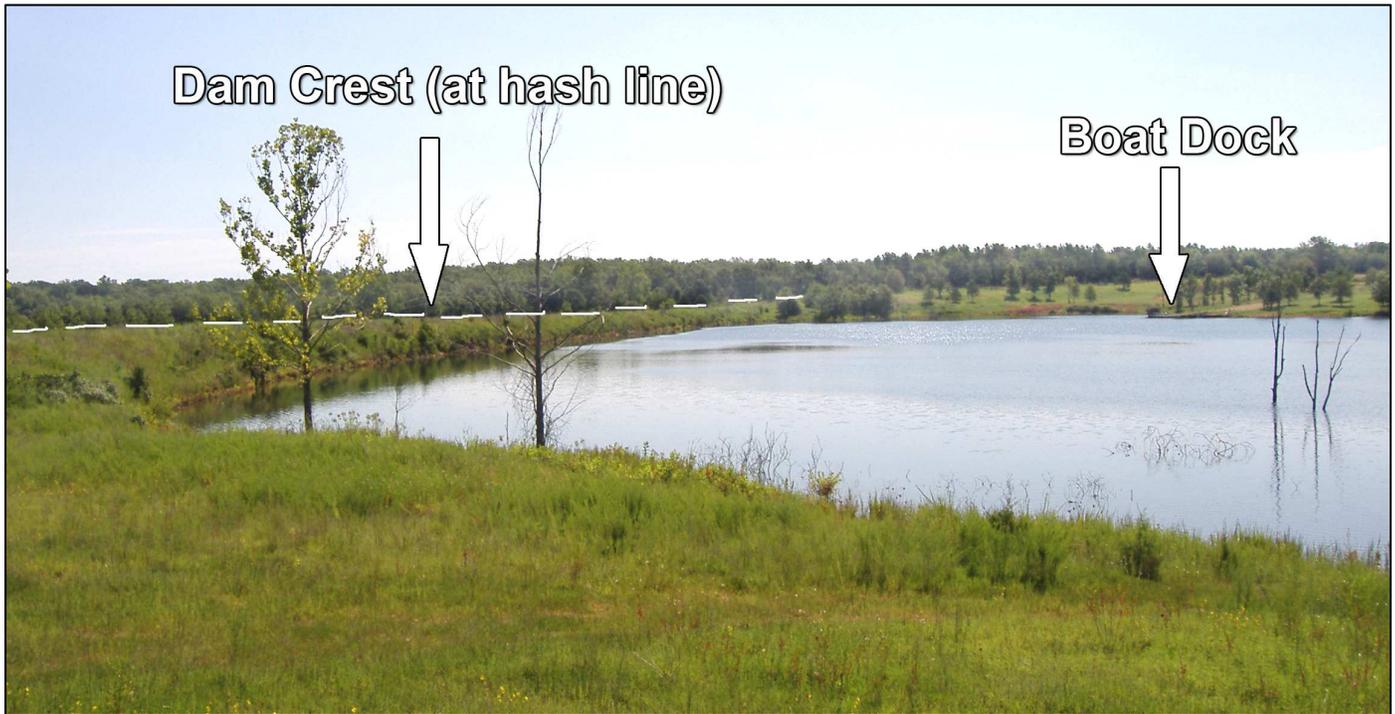
Figure 4. King Arthur's Dam, looking east (See hash marks drawn along dam crest). The current landowner's private residence is off the photo to the right of the boat dock (Photo taken Aug. 2008).

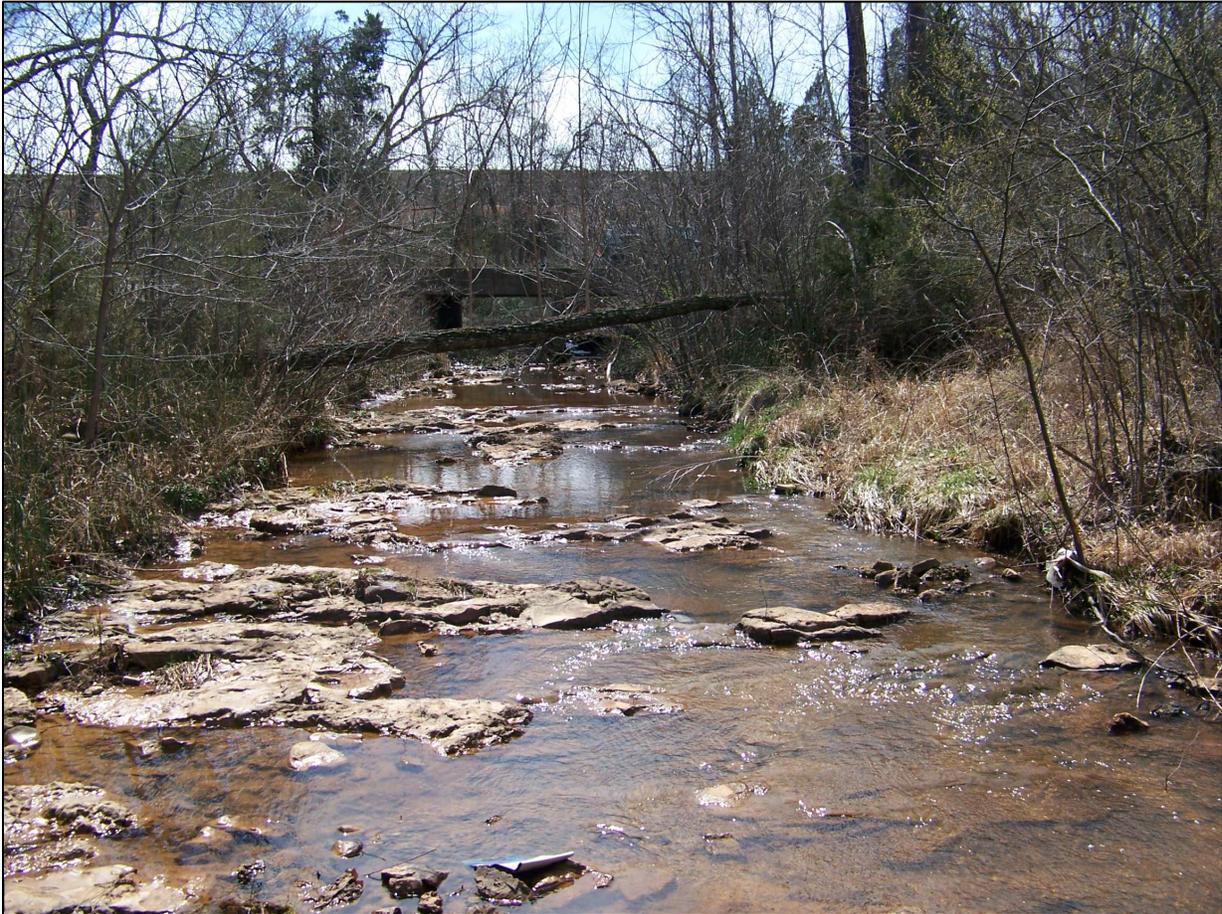
Figure 5. Pond Creek (WBID 2128) near sampling Site #2, looking upstream (south) at Pond Creek Road bridge and on to King Arthur's Dam (along horizon). Note bedrock on creek bottom (Photo taken March 2009).

It is important to note that Pond Creek Site #2 (on the impaired segment) was observed to be a small, predominantly bedrock-dominant stream segment with a shallow coating of fine sediment (See Figure 5). It was proposed in the department study that bedrock does not provide ideal habitat for macroinvertebrates and may have contributed to the appearance of an impairment.

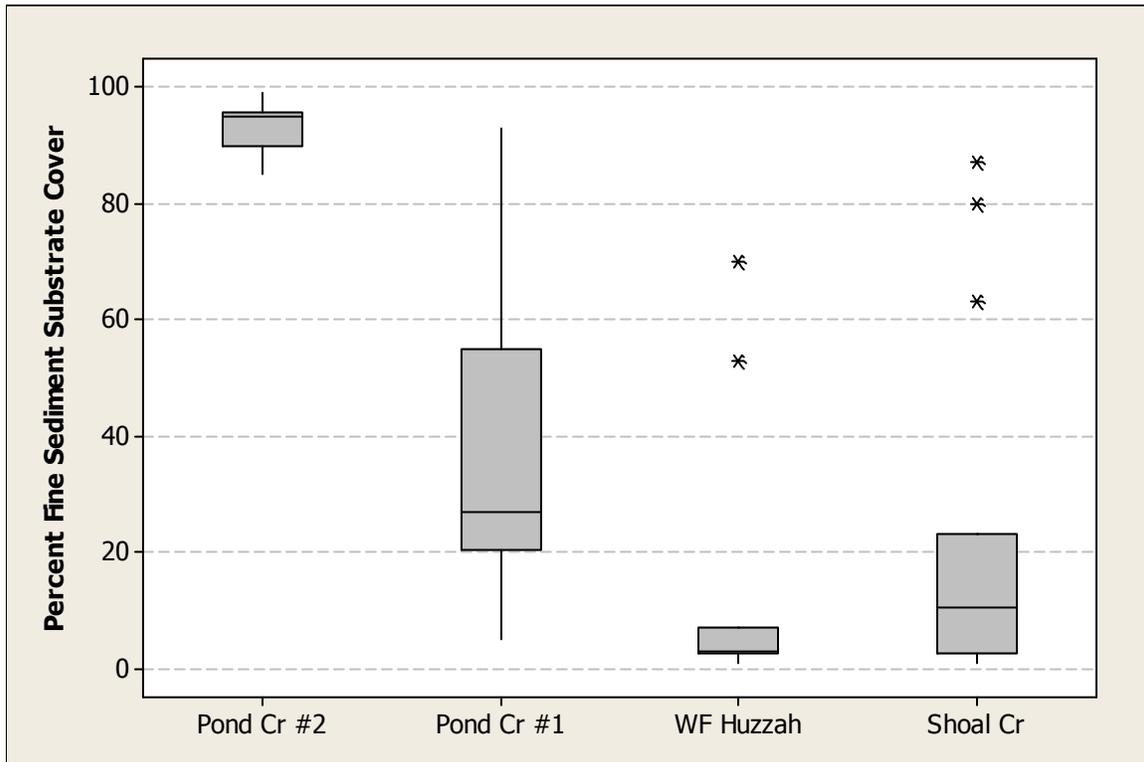
Figure 6. Boxplots of fine sediment observations in Pond Creek and control streams. (Boxes indicate 25th, 50th and 75th percentiles, lines extend to 0th and 100th percentiles, and “*” indicate outliers.)

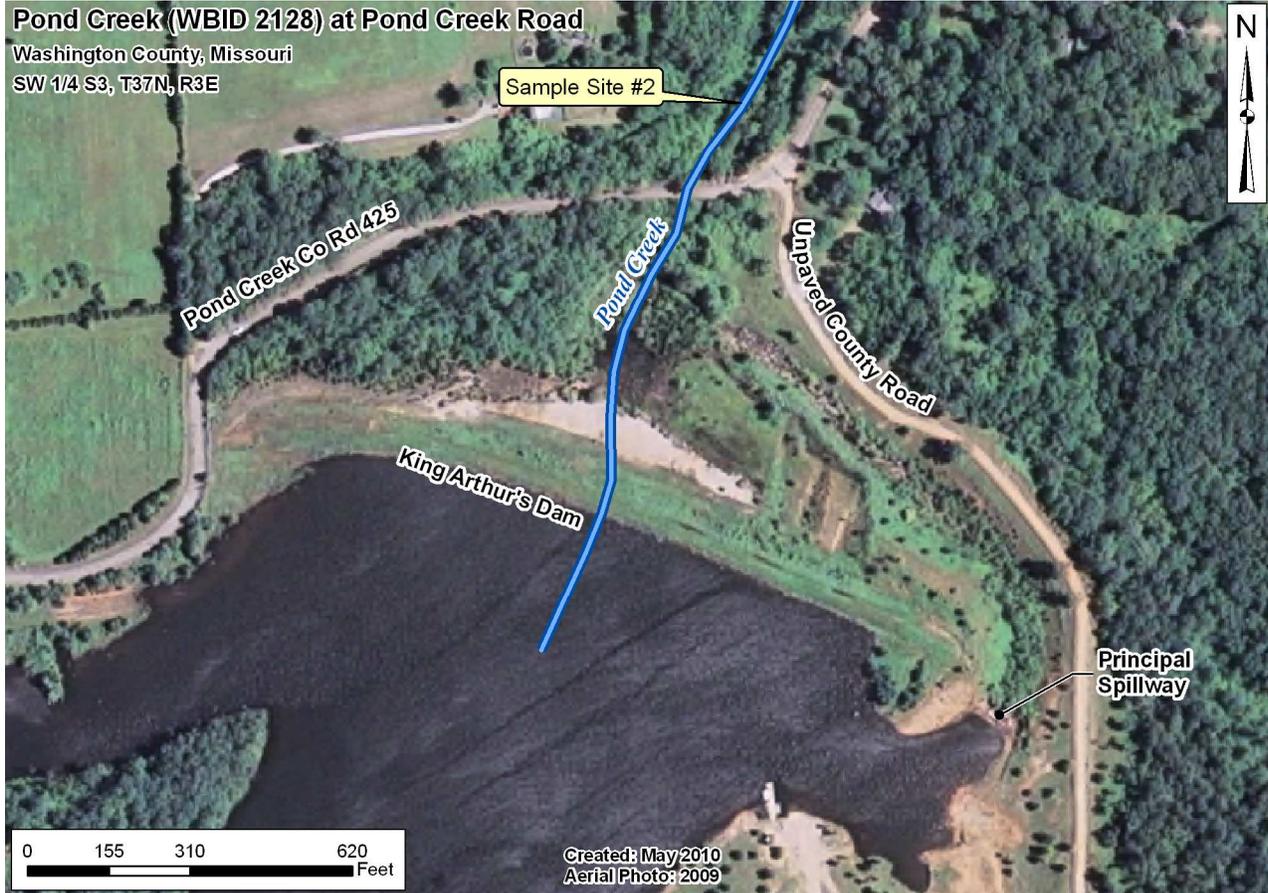
Figure 7. 2009 aerial photo illustrating Pond Creek (WBID 2128), and King Arthur's Dam and it's principal spillway, in relation to county roads.

The downstream face of King Arthur's Dam consists of an upper, heavily-vegetated slope below the crest (See Figures 7 and 8), followed by a flat "bench" approximately 10 to 15 feet wide (See Figures 8 and 9), followed by a second lower slope (See Figures 7 and 9) leading down to the dam's base (i.e., toe; See Figure 10). The crest (See Figure 4), and slope immediately below it, may have been built up with soil during the 2003 spillway modification, or at some point previously, as suggested by the dense vegetation in this area.

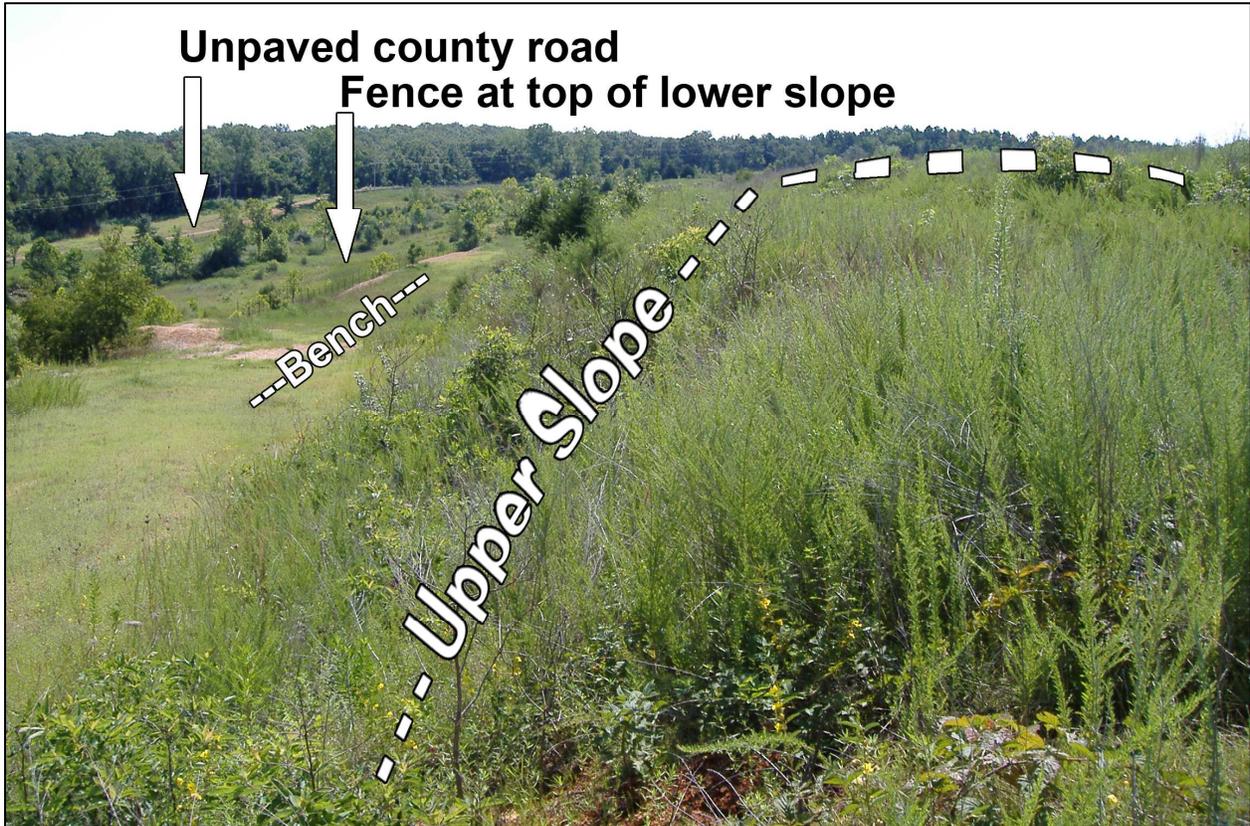
Figure 8. The heavily vegetated upper slope of the downstream face of King Arthur's Dam, looking southeast. Note relatively flat "bench" downhill from the upper slope and the fence in center of bench marking the top of the lower slope (Photo taken Aug. 2008).

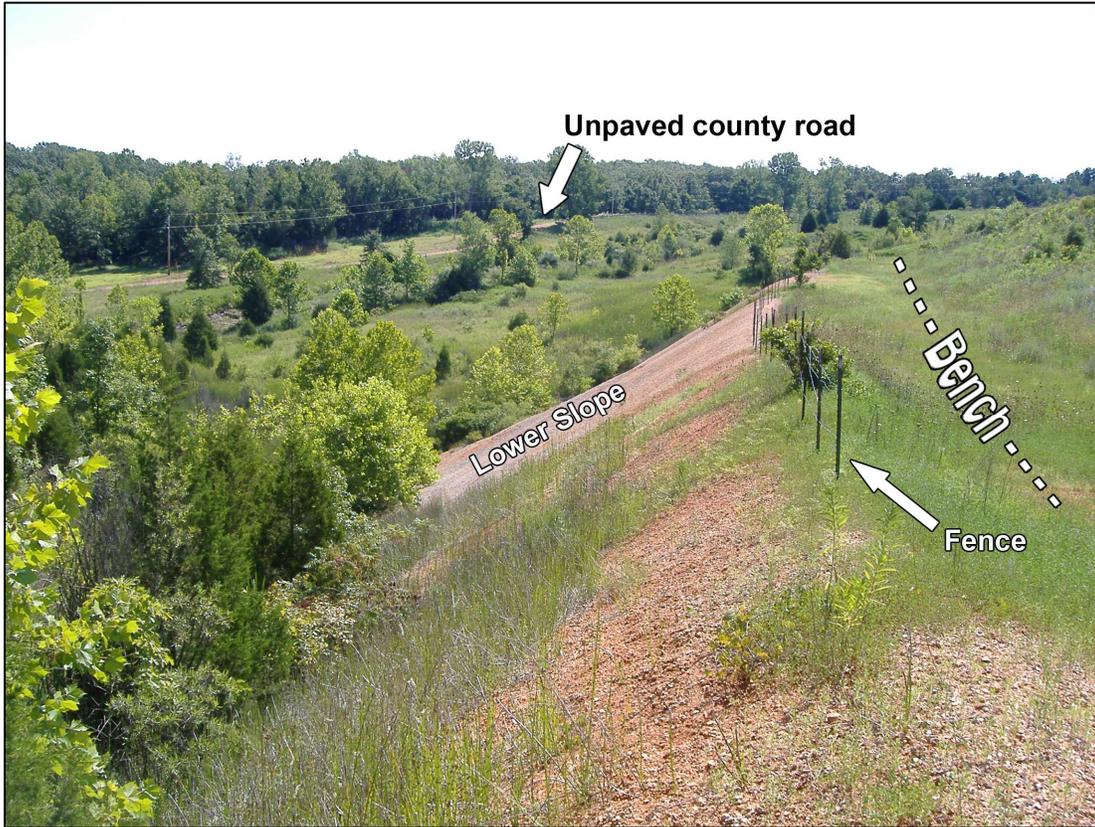
Figure 9. King Arthur's Dam looking southeast at the "level bench" (on right) separating the upper dam face slope from the lower dam face slope (center). Note the fence at the top of the slope, and the unpaved county road running along the tree line east of the dam
(Photo taken Aug. 2008).

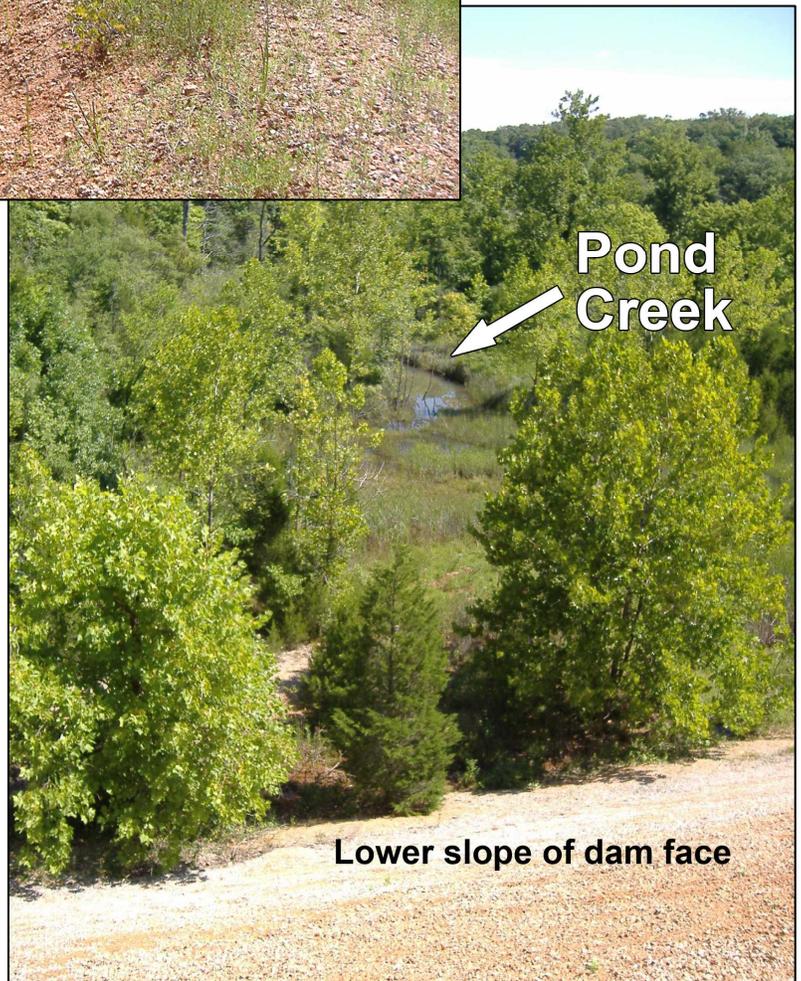
Figure 10 (to right). Looking downstream, past the toe of the dam, at Pond Creek (Photo taken by the fence at top of the lower slope (See Figure 8); Aug. 2008).

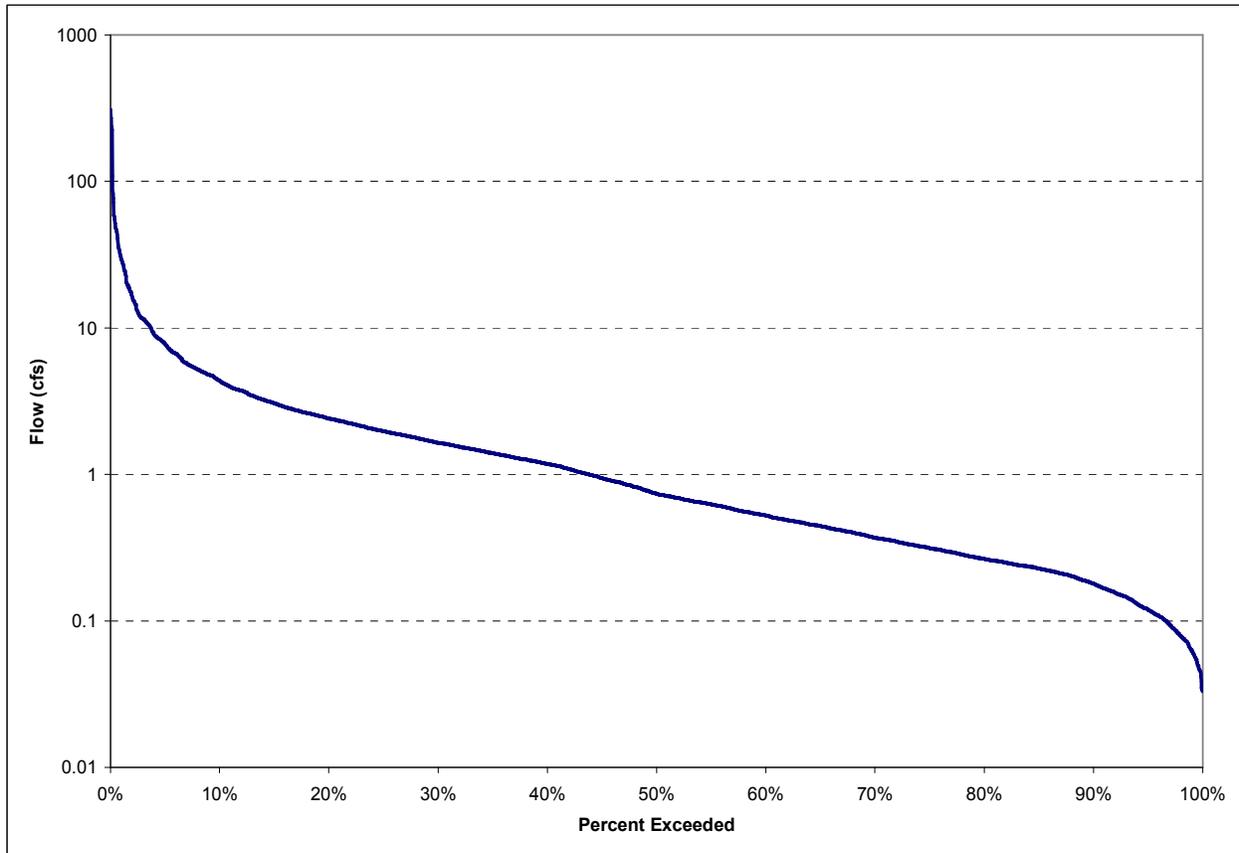
Figure 11. An estimated flow duration curve for Pond Creek.

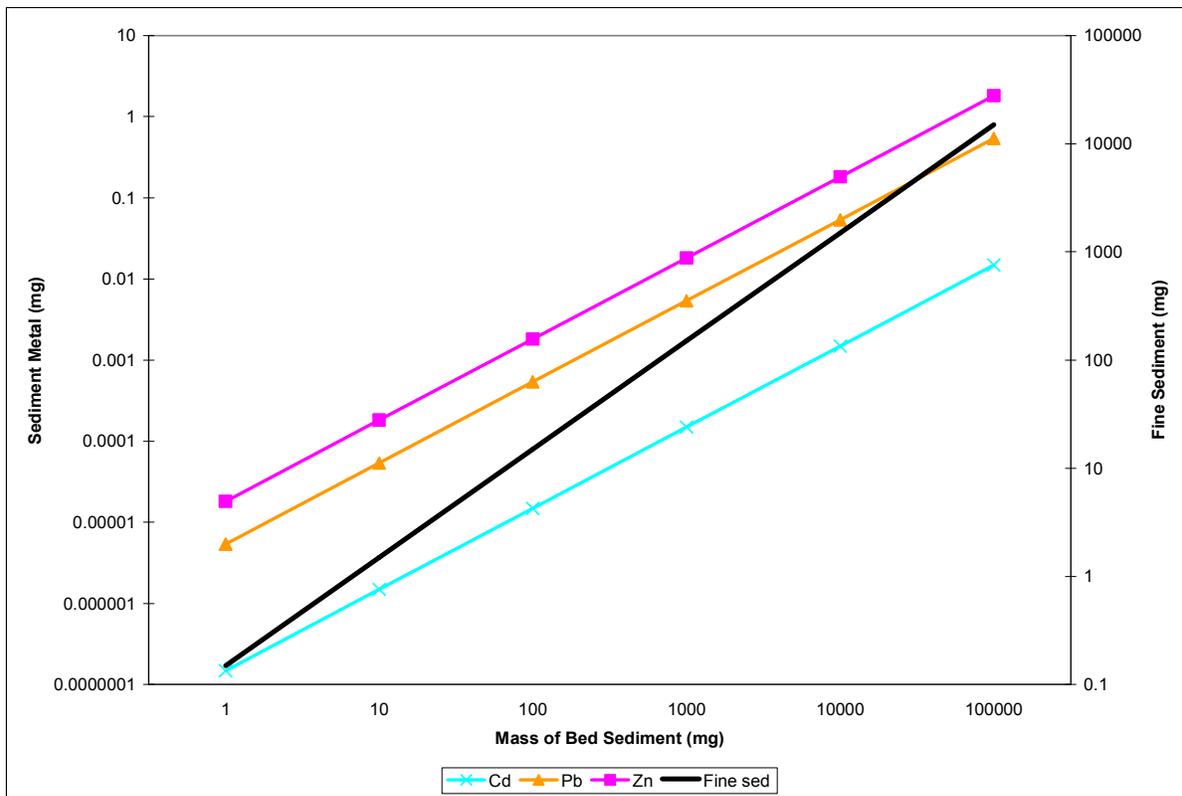
Figure 12. TMDL for bed sediment: cadmium, lead, zinc and fine sediment.

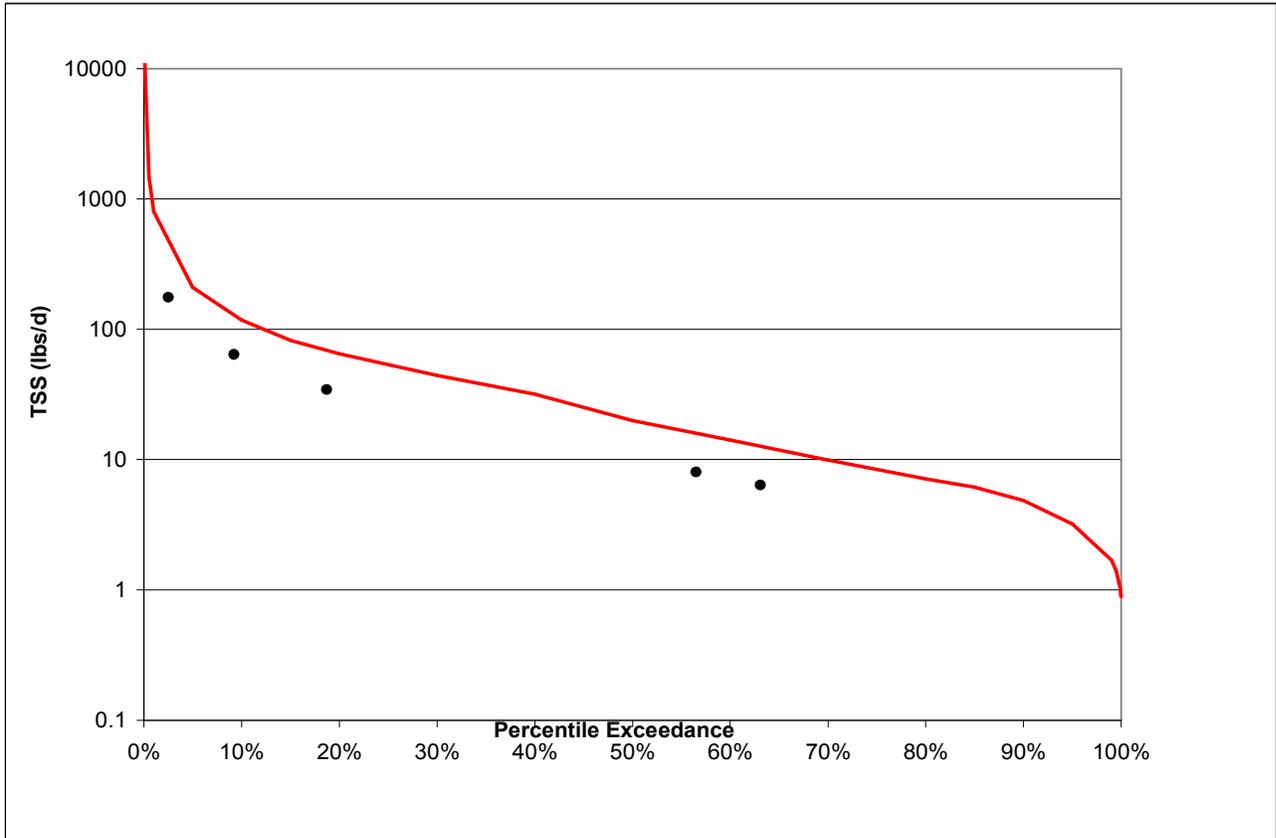
Figure 13. Load duration curve for inorganic sediment in Pond Creek.

The wasteload allocations for dissolved cadmium, lead and zinc and inorganic sediment must be achieved at the outlets to each segment. As seen in Figures 13 through 16, wasteload allocation increases with increasing flow. The wasteload allocation for bedded sediment and metals in sediment must be met at any point in each segment.

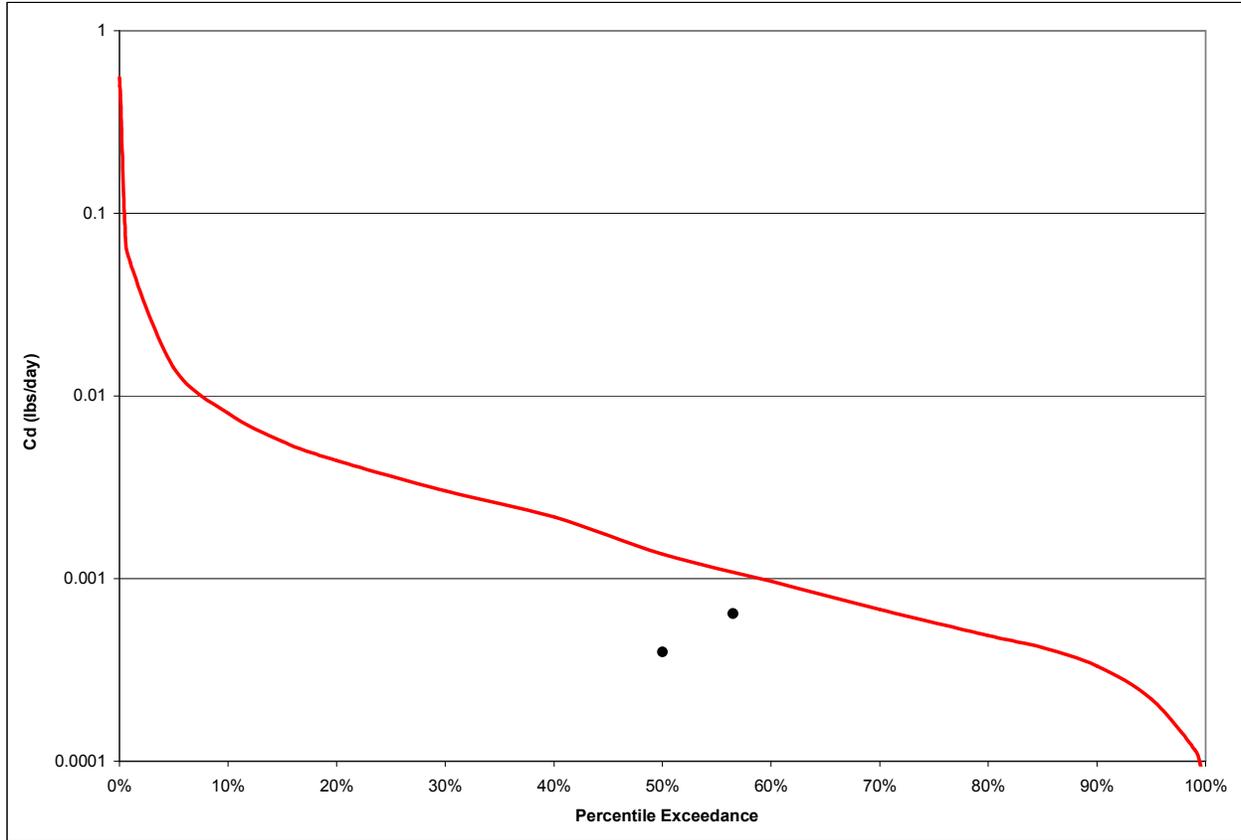
Figure 14. Load duration curve for dissolved cadmium in Pond Creek.

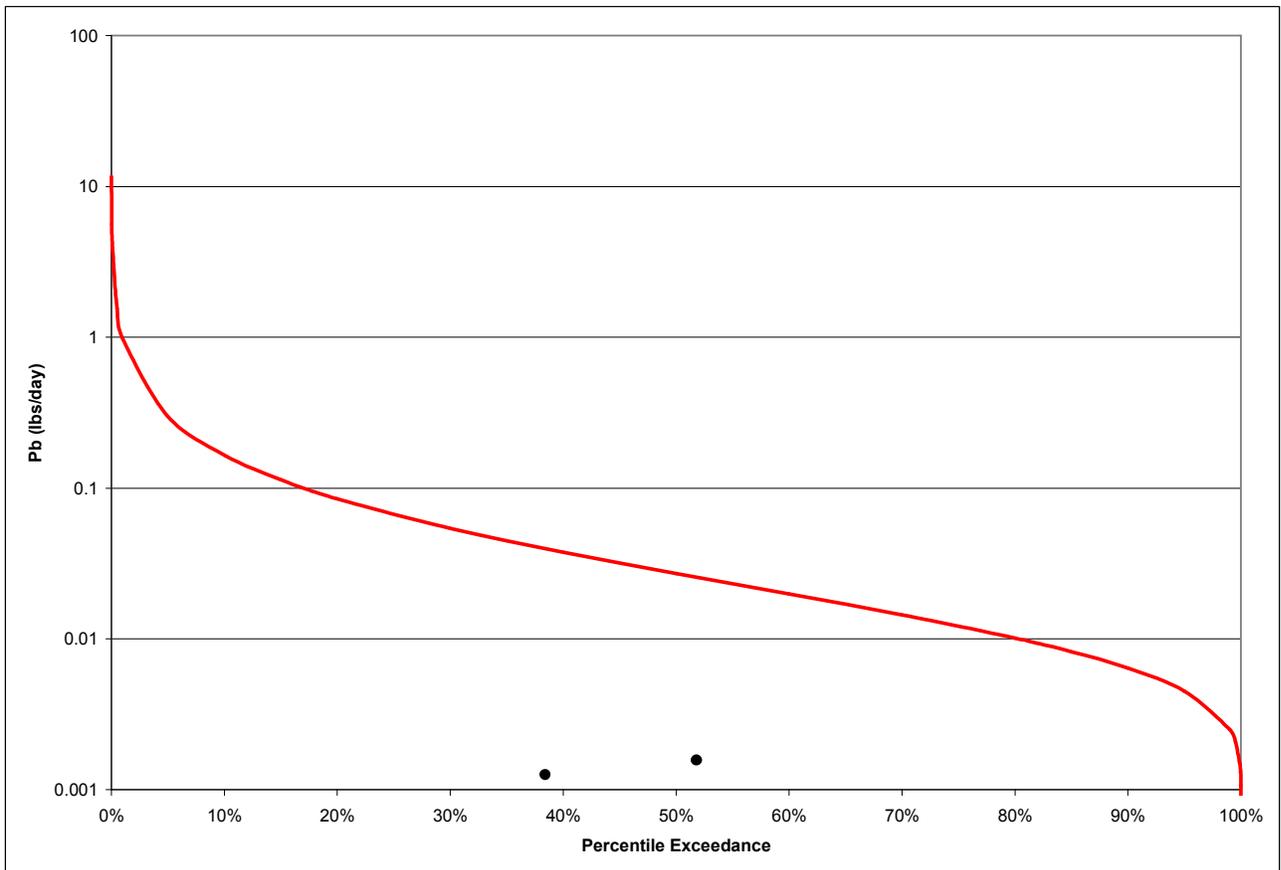
Figure 15. Load duration curve for dissolved lead in Pond Creek.

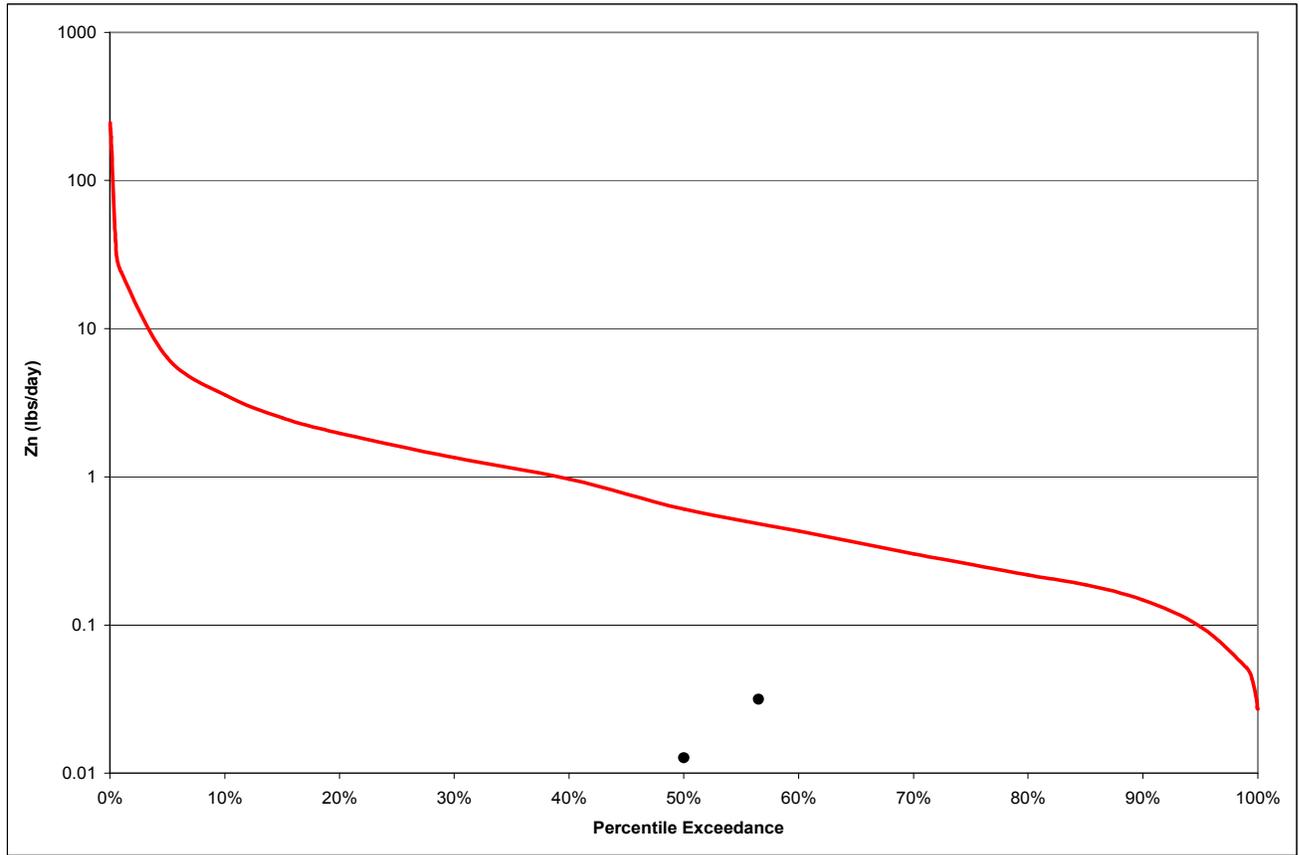
Figure 16. Load duration curve for dissolved zinc in Pond Creek.

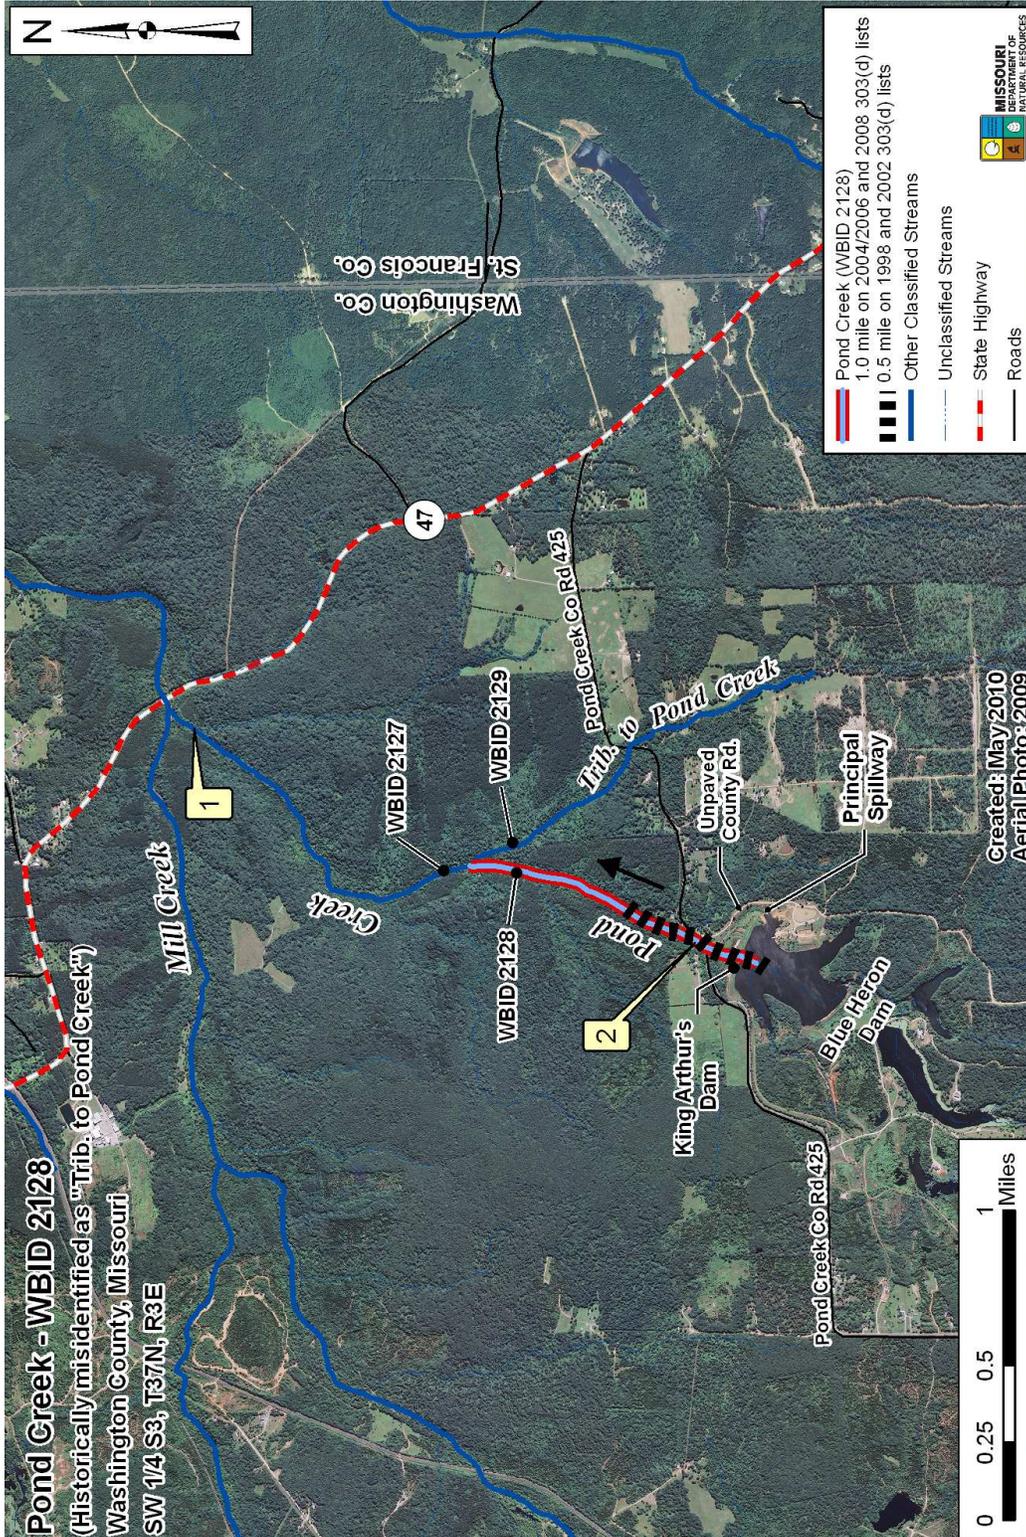
A-1: Aerial Photograph-based Map of Pond Creek (Both Segments) Sampling Sites
