**Missouri Department of Natural Resources
Water Protection Program**

Total Maximum Daily Load (TMDL)

Tributary to Pond Creek
(now correctly identified as Pond Creek)

Washington County, Missouri

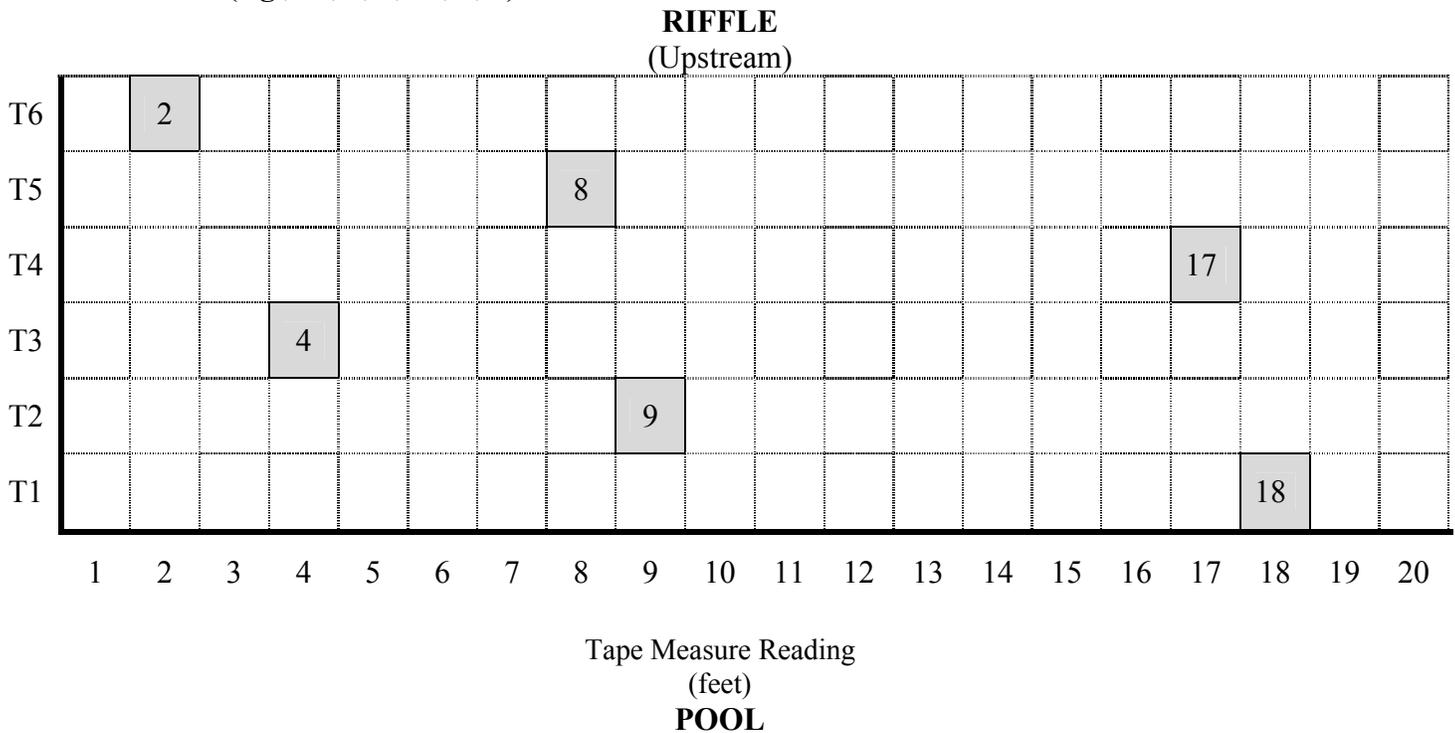
Figure B-1. Virtual grid of transects (T) and quadrats (in gray, numbered) for estimating percent fine sediment. Example: stream 20’ wide; quadrat placement based on random numbers (e.g., 18, 9, 4, 17, 8, 2).

Once a suitable area was identified, a virtual grid was constructed (Figure B-1). A 100’ tape measure anchored across the stream became the downstream transverse edge of a virtual grid of

six contiguous transects. Each transect was 12” deep and as wide as the useable grid and was identified by holding a retractable tape measure perpendicular to the 100’ tape. The useable grid width included the width of the stream with relatively laminar flow that excluded eddies, vegetation, and large obstructions. Random numbers, equating to one foot increments, were drawn to determine where the quadrat was placed along each transect. The quadrat was placed within the transect, with the downstream edge contacting the downstream transect edge. Two observers estimated/recorded the percent of fine sediment within the quadrat. The estimates were accepted and recorded if the two observations were within a ten percent margin of error or rejected and repeated until the margin of error was reached. Another random number was drawn and the quadrat was randomly placed in the next transect upstream where the next observation was made. This continued until fine sediment was estimated in each of the six quadrats (one per transect) and the results are summarized in Table B-1.

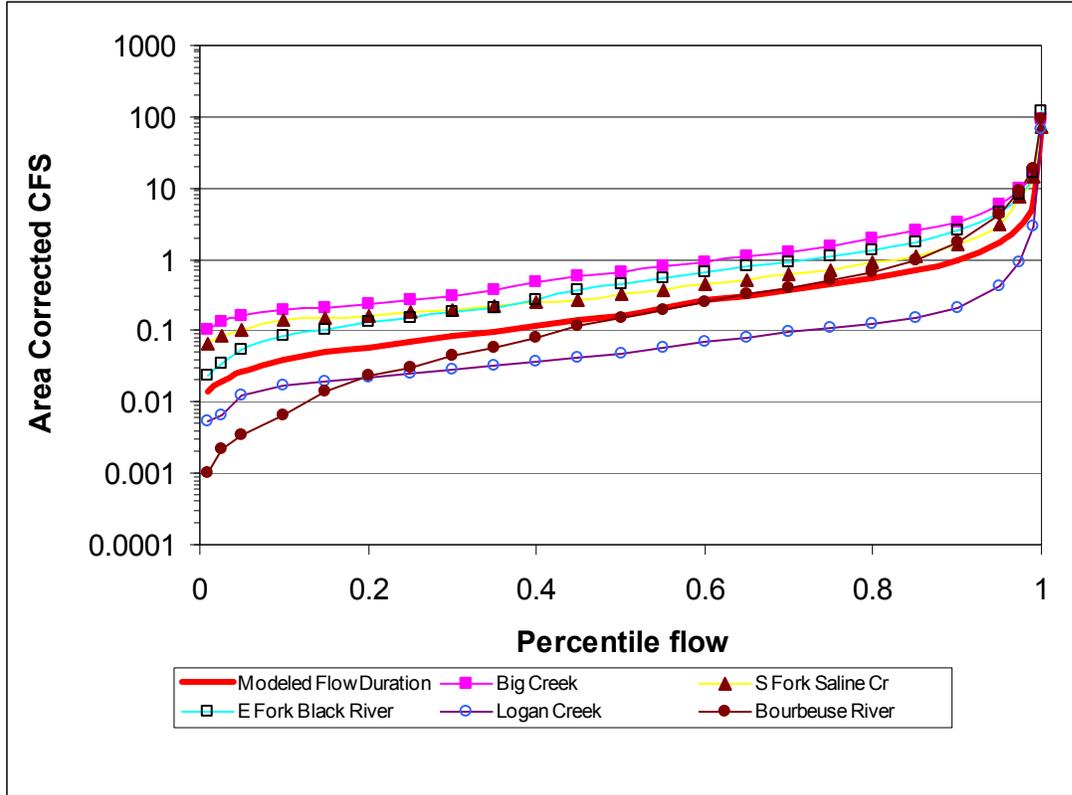
Figure C-1: Modeled and Reference Flow Duration Curves

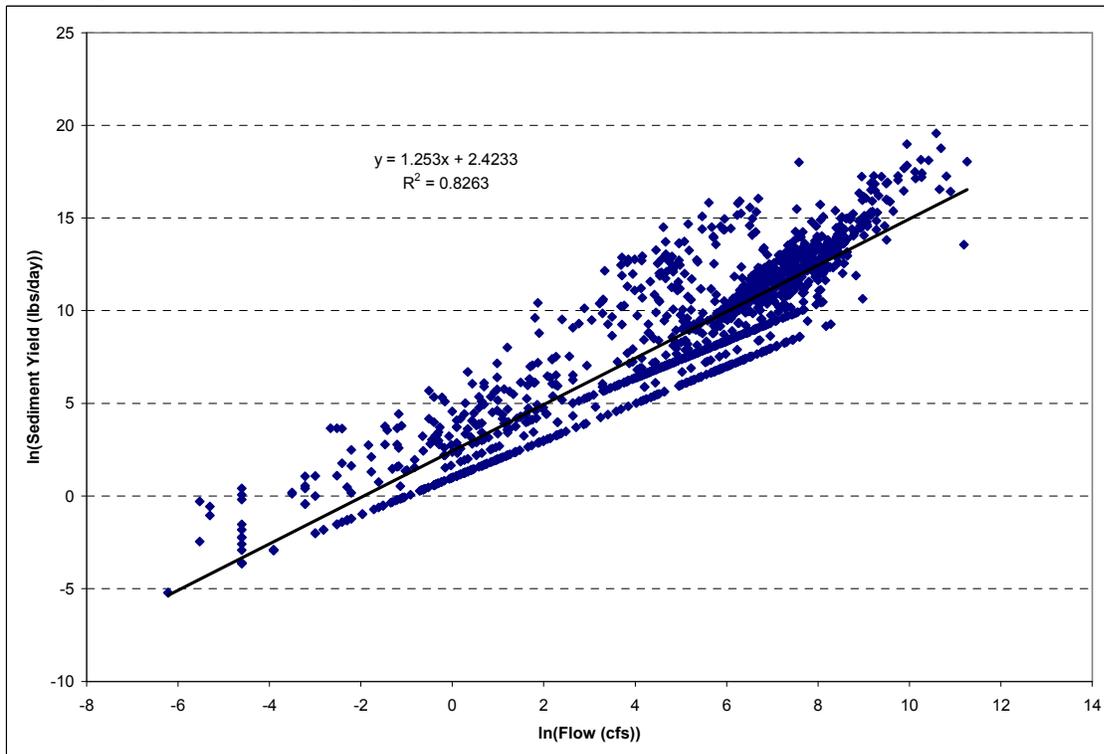
Figure C-2: Sediment yield as a function of instantaneous flow in Ozark/Meramec EDU.

The next step is to determine the target range for inorganic sediment. All data points within the EDU that include sediment concentrations concurrent with flow are compiled. The distribution of sediment is recalculated so that the median value of the adjusted distribution is equal to the 25th percentile of the original distribution while the minimum values remain constant. From the adjusted range, the load is calculated $[(mg/L) * (cfs) * 5.395 = lbs/day]$ and log transformed. A regression calculation is performed against the log of the instantaneous flow. Results are found in Figure C-2:

$$\text{Sediment yield (lbs/day)} = \exp(1.2538 * \ln(\text{flow}) + 2.4233)$$
