Total Maximum Daily Load Information Sheet

Bynum Creek

Water Body Segment at a Glance:

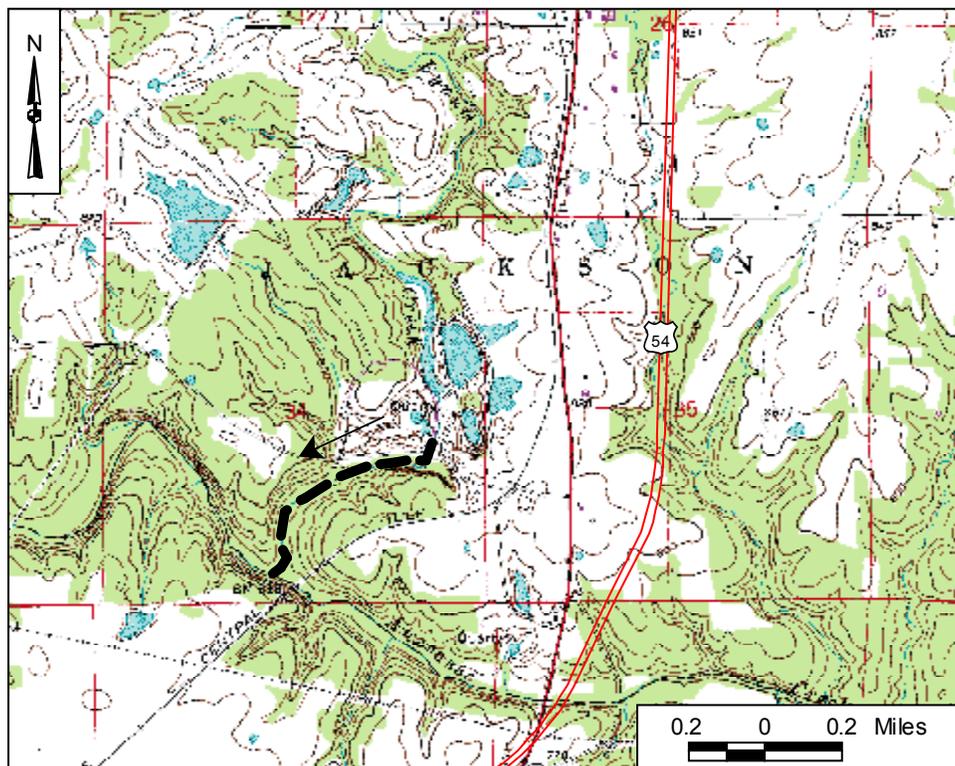
Bynum Creek in Callaway County, Missouri

--- Impaired Segment ← Direction of Flow
