Total Maximum Daily Load Information Sheet

Whetstone Creek and East Whetstone Creek Water Body ID: 1504 and 3964¹

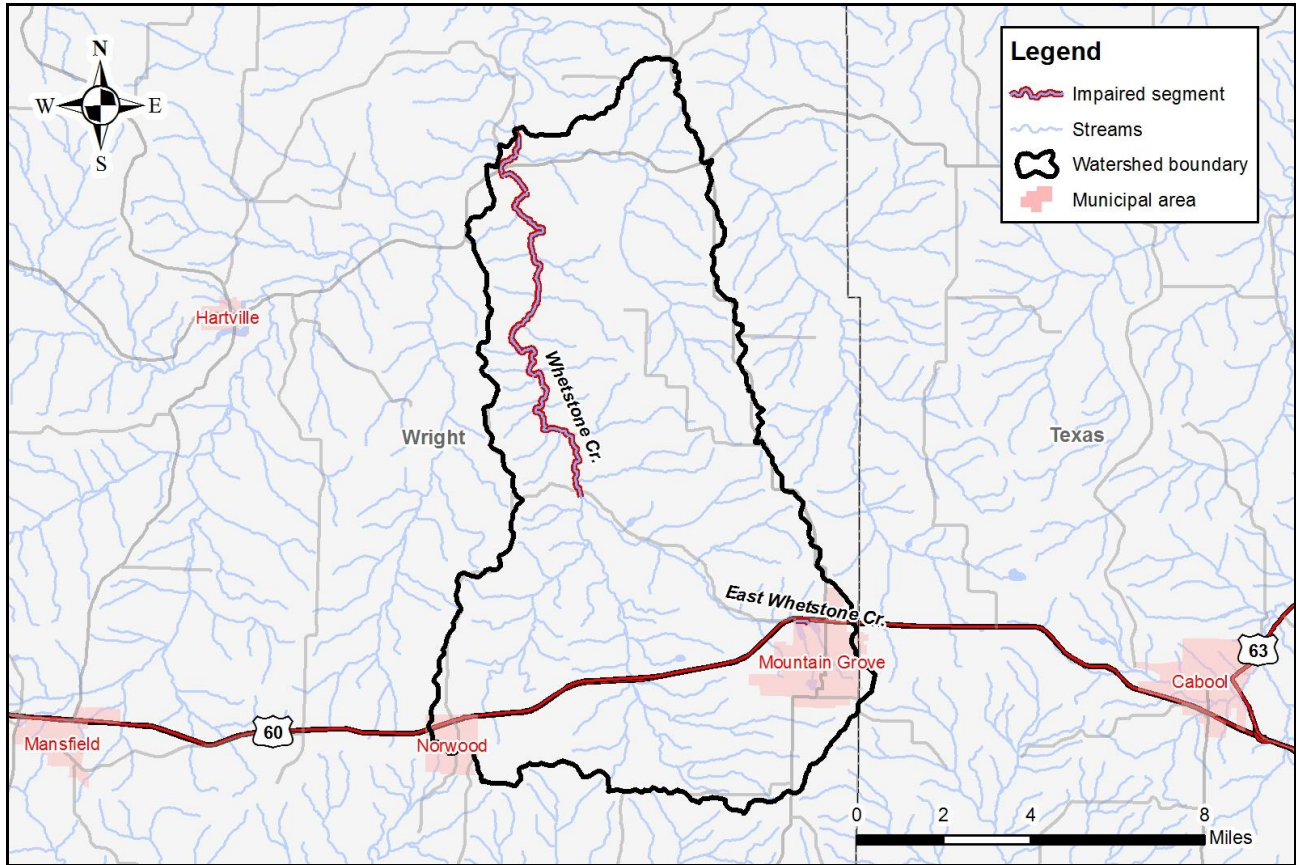
Map of the Whetstone Creek watershed
