Use Attainability Analysis

WBID 0319 Wilkerson Creek

Field Data Sheets for Recreational Use Stream Surveys

Wilkerson Creek (C) #0319 Clay County

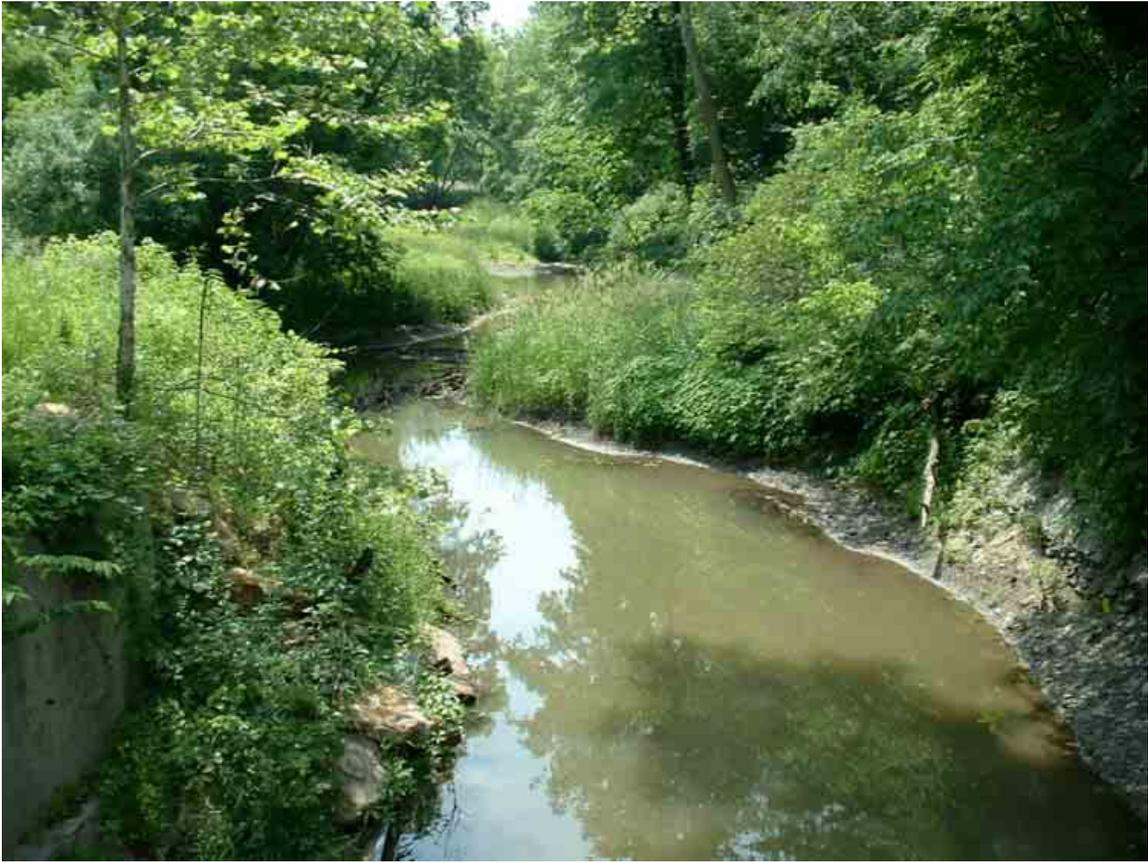
0319_01_US

<input checked="" type="checkbox"/> Riffle	Width (ft): <u>10</u>	Length (ft): <u>15</u>	Avg. Depth (ft): <u>0.1</u>	Max. Depth (ft): <u>0.3</u>
<input type="checkbox"/> Run	Width (ft):	Length (ft):	Avg. Depth (ft):	Max. Depth (ft):
<input checked="" type="checkbox"/> Pool	Width (ft): <u>20</u>	Length (ft): <u>50</u>	Avg. Depth (ft): <u>1</u>	Max. Depth (ft): <u>2.5</u>
<input type="checkbox"/> Flow Present?	<input checked="" type="checkbox"/> Yes <input type="checkbox"/> No	Estimated (ft ³ /sec): <u>1-3 cfs</u>

<u>10</u> % Cobble	<u>20</u> % Gravel	<u>30</u> % Sand	<u>50</u> % Silt	% Mud/Clay	% Bedrock
--------------------	--------------------	------------------	------------------	------------	-----------

NONE NOTED. Slight ALGAL bloom in pools.

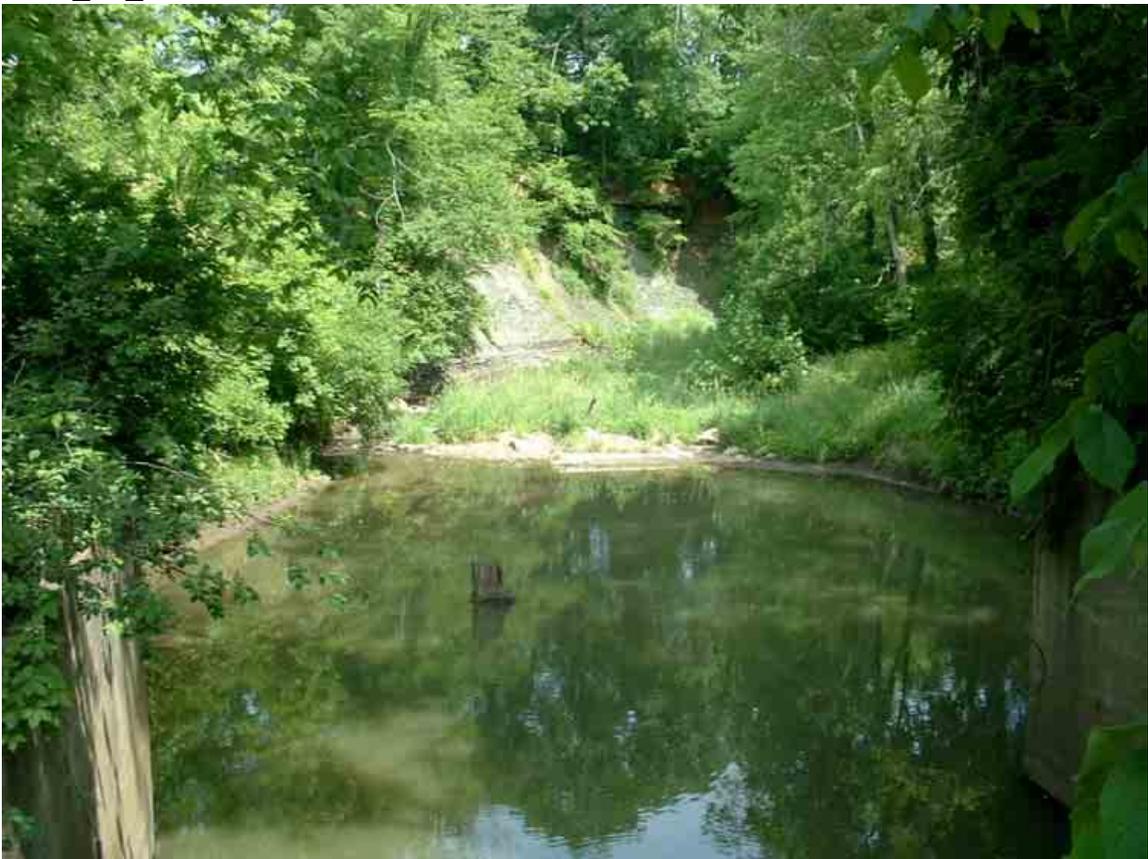
0319_01_DS

<input checked="" type="checkbox"/> Riffle	Width (ft): <u>15</u>	Length (ft): <u>20</u>	Avg. Depth (ft): <u>0.1</u>	Max. Depth (ft): <u>0.2</u>
<input type="checkbox"/> Run	Width (ft):	Length (ft):	Avg. Depth (ft):	Max. Depth (ft):
<input checked="" type="checkbox"/> Pool	Width (ft): <u>10</u>	Length (ft): <u>100</u>	Avg. Depth (ft): <u>0.5</u>	Max. Depth (ft): <u>>1.0</u>
<input type="checkbox"/> Flow Present?	<input checked="" type="checkbox"/> Yes <input type="checkbox"/> No	Estimated (ft ³ /sec): <u>1-3 cfs</u>

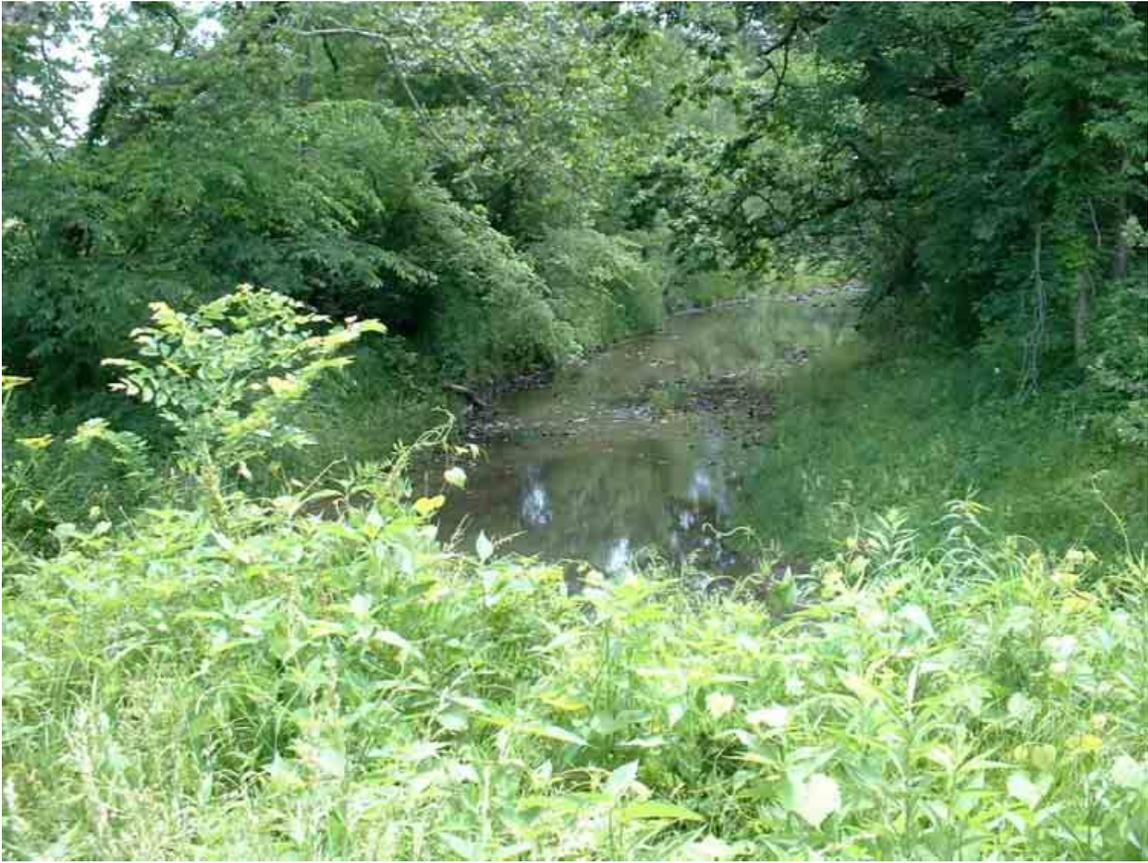
0319_02_US

Missouri WBID #: 0319-02	Site Location Description:	
Site GPS Coordinates: 15 0365910 4356934	VIRGINIA AVE / NE 144 th ST RR	
Date & Time: 5/31/05 11:50 hrs	Facility Name:	
Personnel: RD	Permit Number:	
Current Weather Conditions: PC	Weather Conditions for Past 7 days: CLEAR - PC	
Photo Ids: Upstream: 100-0004	Downstream: 100-0005	Other:

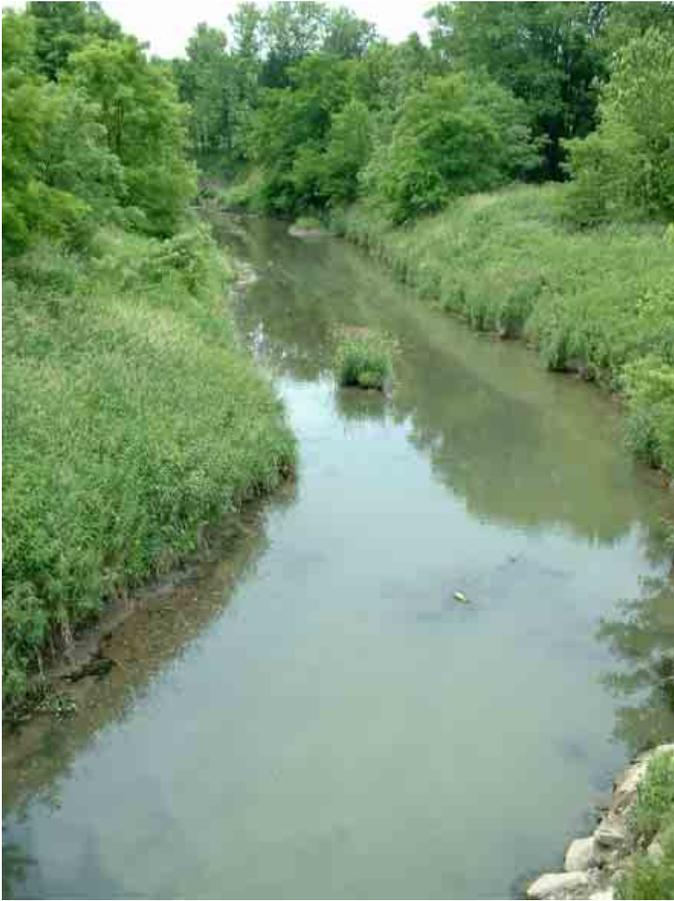
0319_03_US

<input type="checkbox"/> Riffle	Width (ft):	Length (ft):	Avg. Depth (ft):	Max. Depth (ft):
<input type="checkbox"/> Run	Width (ft):	Length (ft):	Avg. Depth (ft):	Max. Depth (ft):
<input checked="" type="checkbox"/> Pool	Width (ft): <u>30</u>	Length (ft): <u>300</u>	Avg. Depth (ft): <u>0.5</u>	Max. Depth (ft): <u>2.0</u>
<input checked="" type="checkbox"/> Flow	Present?	<input type="checkbox"/> Yes <input checked="" type="checkbox"/> No	Estimated (ft ³ /sec):

Algae <u>30%</u> Clonal s/w - <u>50%</u> Filamentous - <u>20%</u>

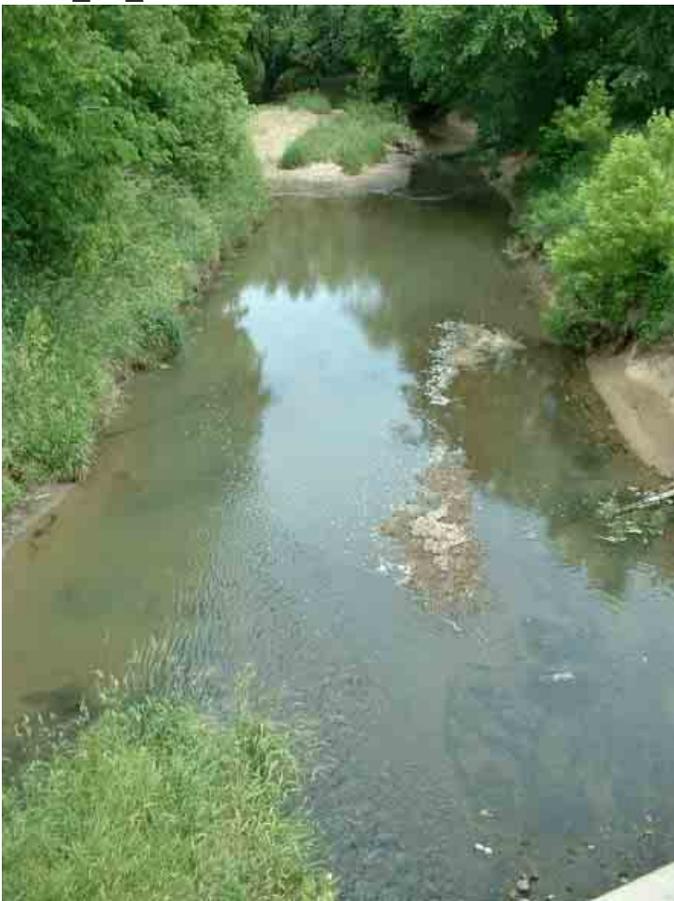
0319_03_DS

<input checked="" type="checkbox"/> Riffle	Width (ft): <u>5</u>	Length (ft): <u>30</u>	Avg. Depth (ft): <u>0.1</u>	Max. Depth (ft): <u>0.2</u>
<input type="checkbox"/> Run	Width (ft):	Length (ft):	Avg. Depth (ft):	Max. Depth (ft):
<input checked="" type="checkbox"/> Pool	Width (ft): <u>45</u>	Length (ft): <u>90</u>	Avg. Depth (ft): <u>0.5</u>	Max. Depth (ft): <u>1.0</u>
<input checked="" type="checkbox"/> Flow	Present?	<input checked="" type="checkbox"/> Yes <input type="checkbox"/> No	Estimated (ft ³ /sec): <u>5-10 cfs</u>

<u>20</u> % Cobble	<u>40</u> % Gravel	<u>30</u> % Sand	<u>10</u> % Silt	% Mud/Clay	% Bedrock
--------------------	--------------------	------------------	------------------	------------	-----------

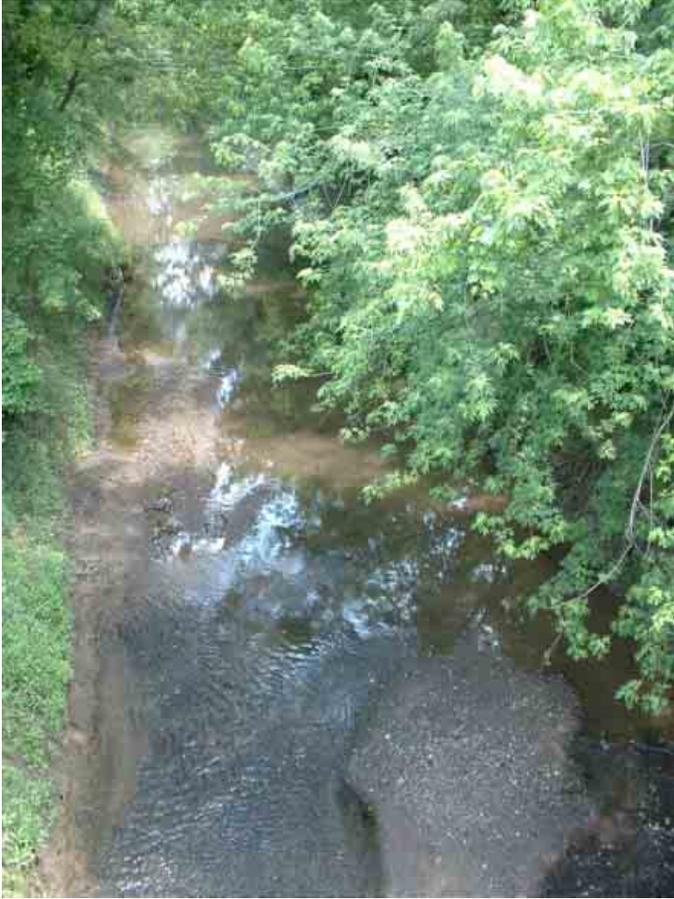
0319_04_US

<input checked="" type="checkbox"/> Riffle	Width (ft): <u>10</u>	Length (ft): <u>15</u>	Avg. Depth (ft): <u>< 0.1</u>	Max. Depth (ft): <u>0.1</u>
<input type="checkbox"/> Run	Width (ft):	Length (ft):	Avg. Depth (ft):	Max. Depth (ft):
<input checked="" type="checkbox"/> Pool	Width (ft): <u>25</u>	Length (ft): <u>100</u>	Avg. Depth (ft): <u>0.1</u>	Max. Depth (ft): <u>0.3</u>
<input checked="" type="checkbox"/> Flow Present?	<input checked="" type="checkbox"/> Yes	<input type="checkbox"/> No	Estimated (ft ³ /sec): <u>1-3 cfs</u>

Estimations on pool edges 10% of stream width

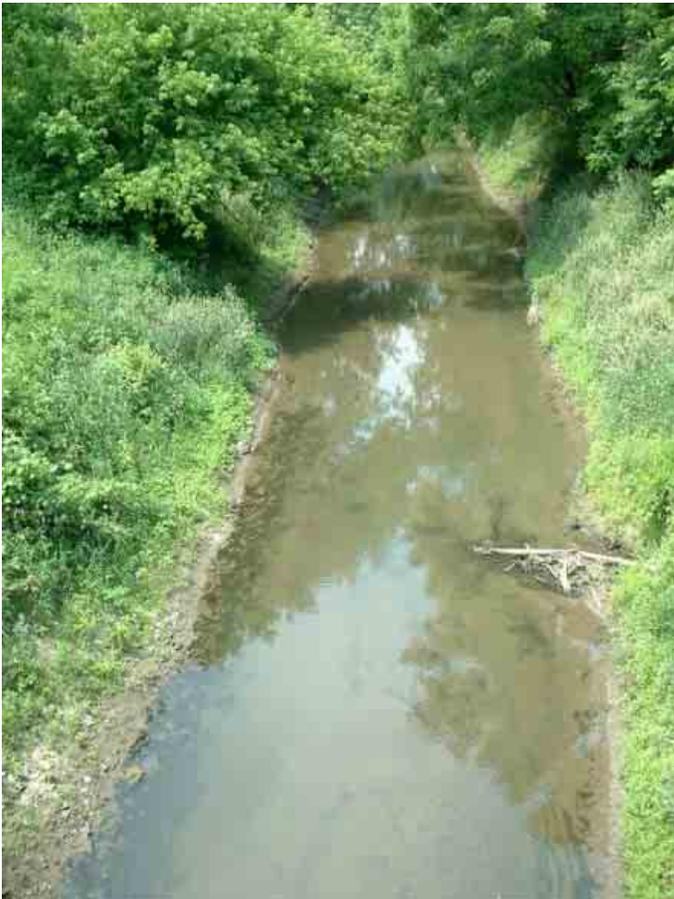
0319_04_DS

<input type="checkbox"/> Riffle	Width (ft):	Length (ft):	Avg. Depth (ft):	Max. Depth (ft):
<input type="checkbox"/> Run	Width (ft):	Length (ft):	Avg. Depth (ft):	Max. Depth (ft):
<input checked="" type="checkbox"/> Pool	Width (ft): <u>25</u>	Length (ft): <u>150+</u>	Avg. Depth (ft): <u>0.2</u>	Max. Depth (ft): <u>0.5</u>
<input checked="" type="checkbox"/> Flow Present?	<input checked="" type="checkbox"/> Yes	<input type="checkbox"/> No	Estimated (ft ³ /sec): <u>1-3 cfs</u>

% Cobble	<u>20</u>	% Gravel	<u>60</u>	% Sand	<u>20</u>	% Silt		% Mud/Clay		% Bedrock
----------	-----------	----------	-----------	--------	-----------	--------	--	------------	--	-----------
