Use Attainability Analysis

WBID 0519 Shoal Creek Ditch

Submitted by
SES, Inc.

To
Missouri Department of Natural Resources
Water Protection Program

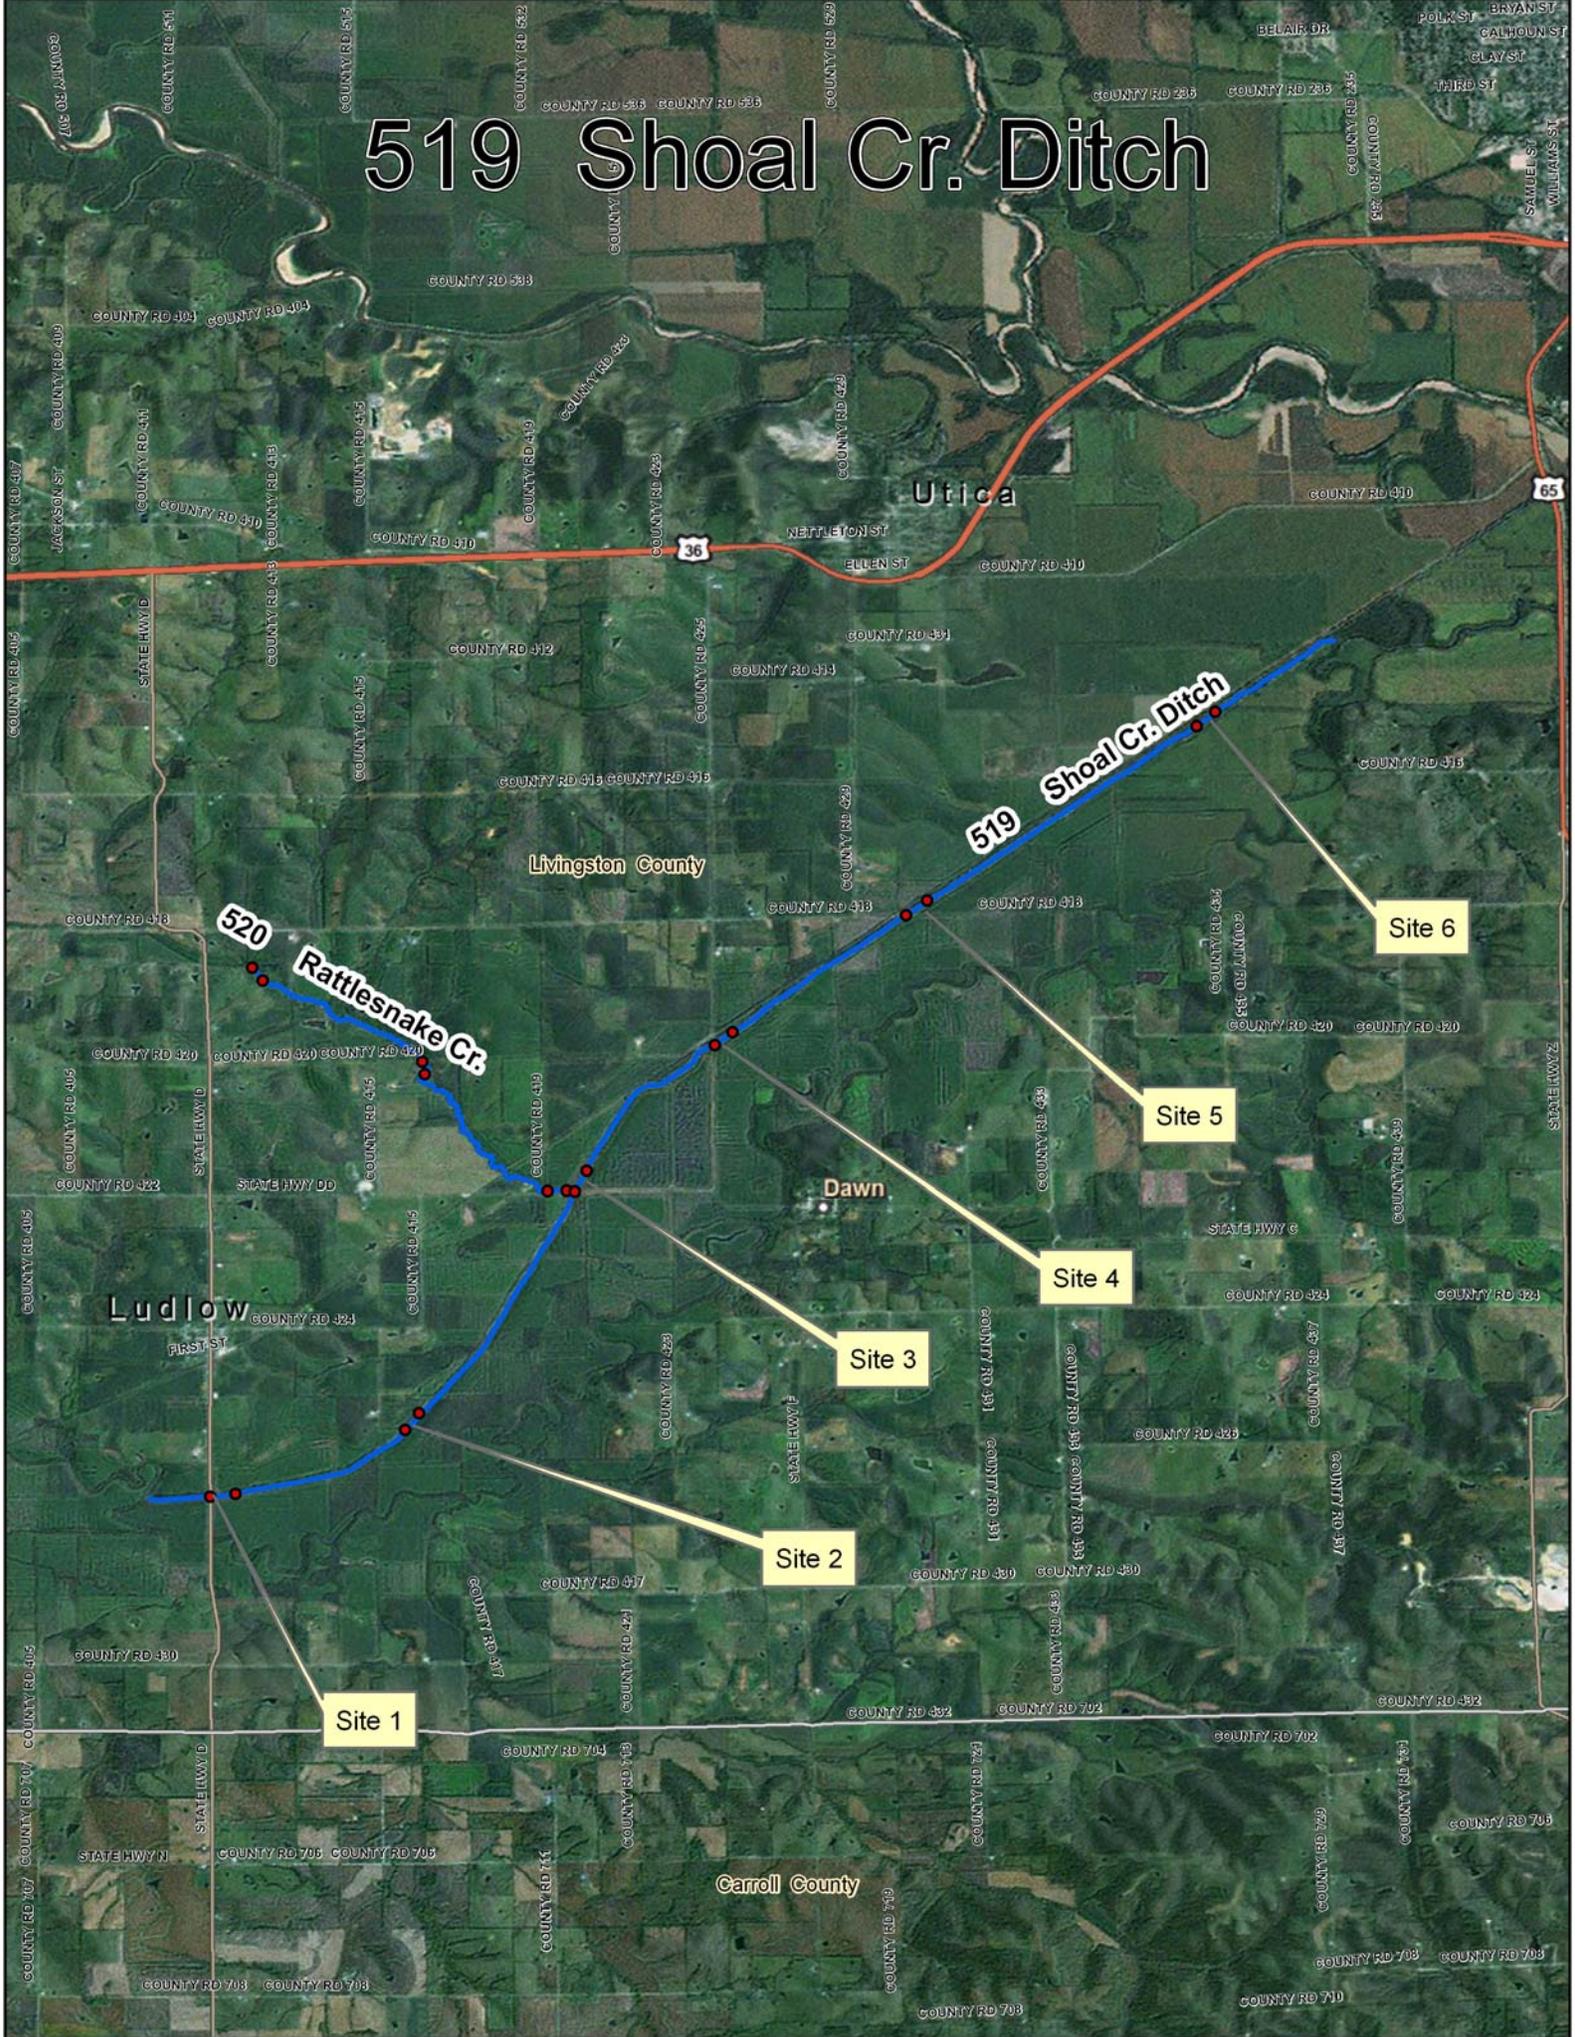
519 Shoal Cr. Ditch

Site 1

Site 2

Site 3

Site 4

Site 5

Site 6

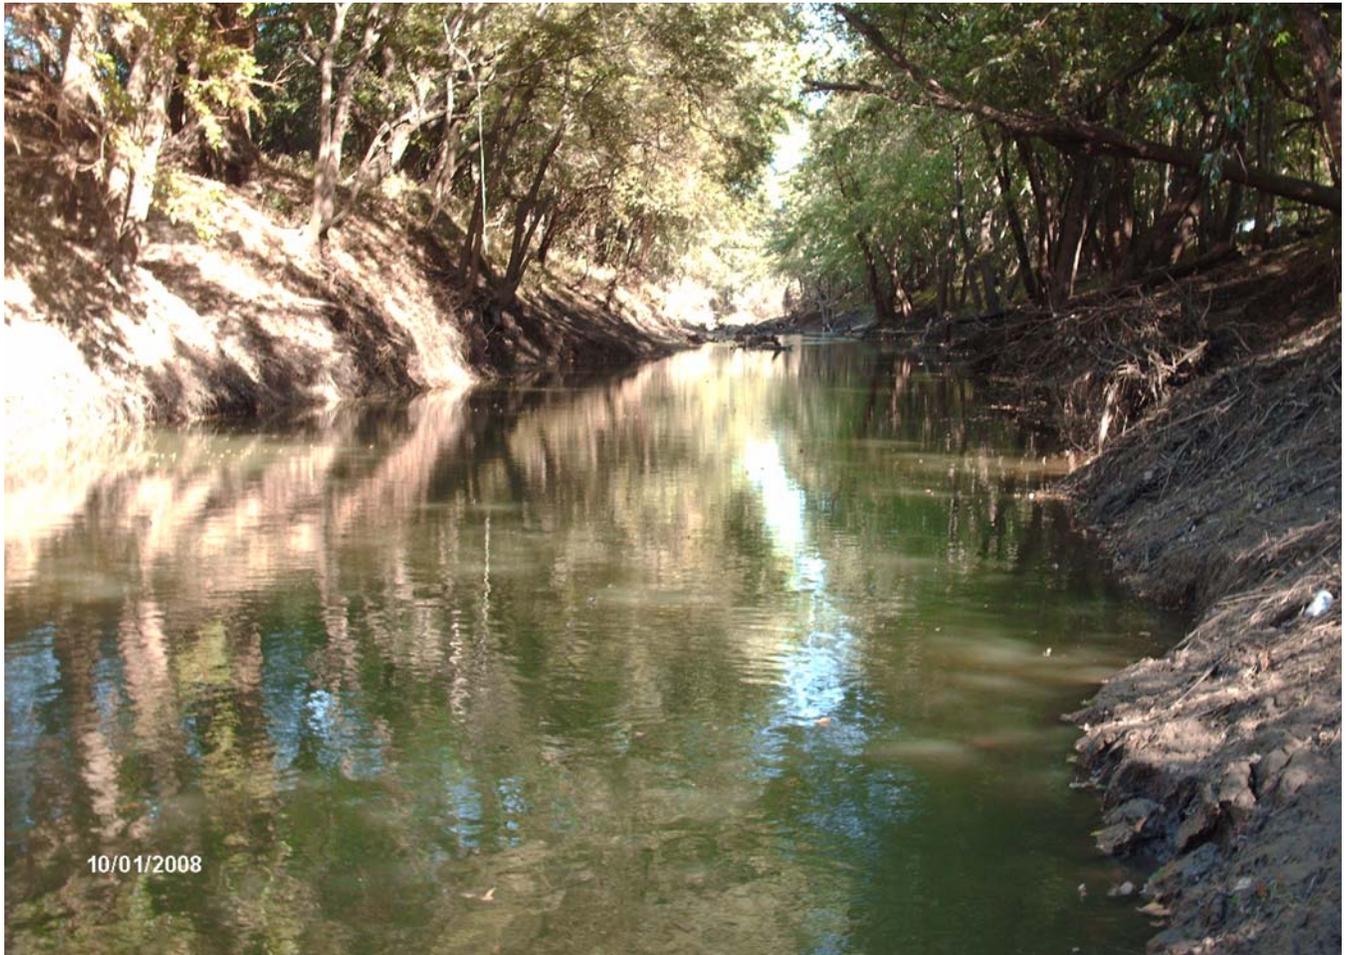
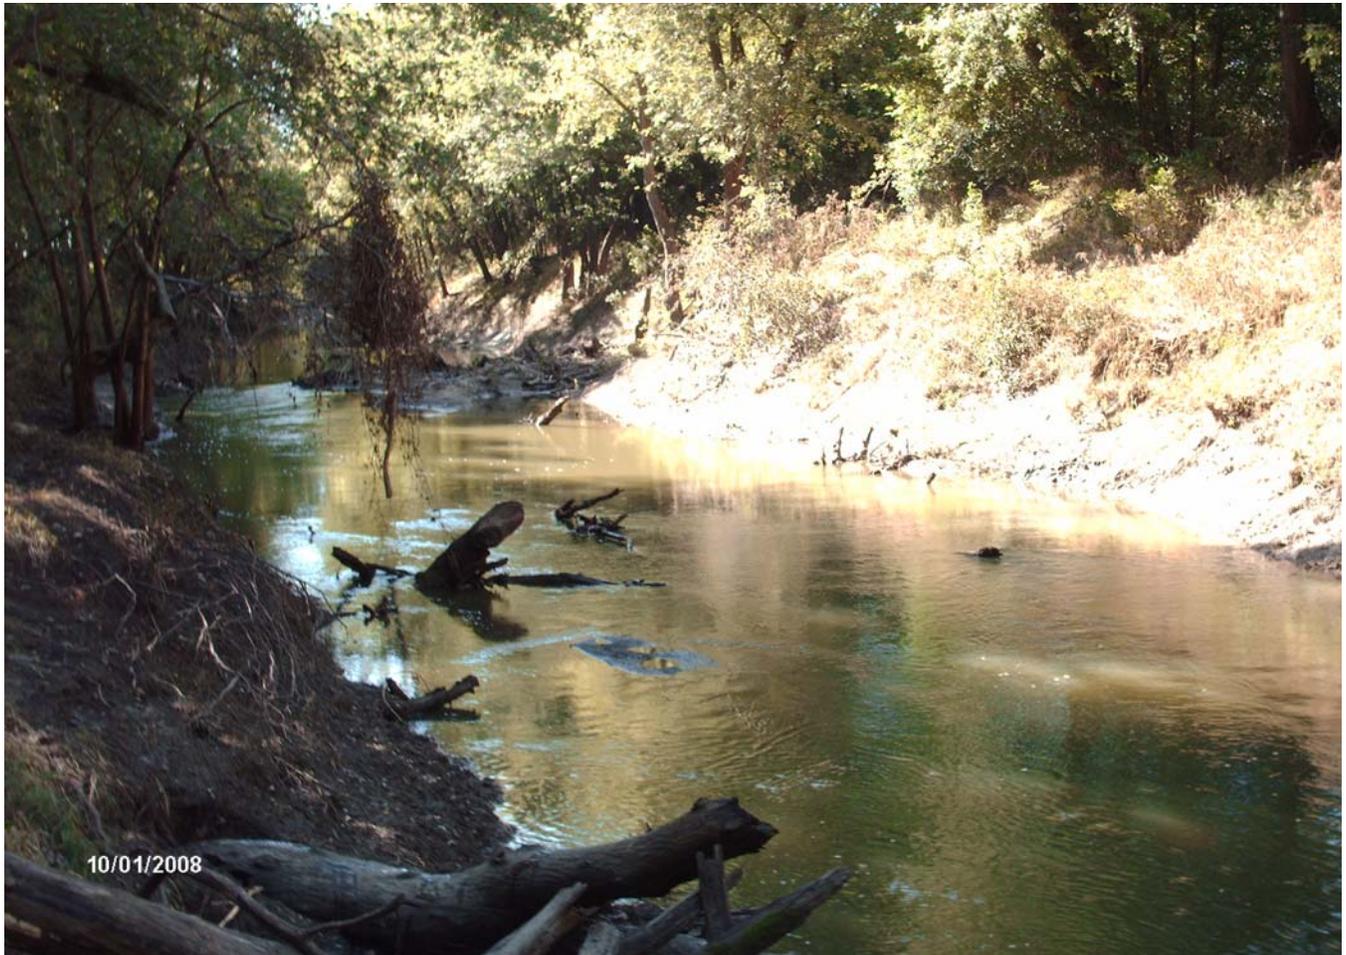
Site # 1

| Date & Time: 10/1/08 15:10 | Location Description (e.g., road crossing): Hwy D |

| Photo ID# | Photo Purpose | Photo ID# | Photo Purpose | Photo ID# | Photo Purpose |
|---|---|---|---|---|---|
| 38 | Downstream | 39 | Upstream | | |

| % Cobble | % Gravel | 60% Sand | % Silt | 40% Mud/Clay | % Bedrock |

| Color: | <input type="checkbox"/> Clear | <input checked="" type="checkbox"/> Green | <input type="checkbox"/> Gray | <input type="checkbox"/> Milky | <input type="checkbox"/> Other: |

| Stream Name: <u>Shoal Cr. Ditch</u> Waterbody ID: <u>519</u> Site #: <u>1</u> Estimated Channel Incision: <u>5</u> (m) (height between low bank width and water) GPS Location - Easting (UTM X), Northing (UTM Y), Horizontal Accuracy Estimate (EPE / PDOP / FOM) 01 UTM X: <u>0439738</u> UTM Y: <u>4387689</u> +/- <u>3</u> (meters) 11 UTM X: <u>0439968</u> UTM Y: <u>4387722</u> +/- <u>6</u> (meters) Average Stream Width: <u>9</u> (meters) Length of Survey Segment: <u>180</u> (meters) (To determine Length of Reach) (20x average stream width) Field Staff: <u>Bryan Deimeke and Gilisa Gould</u> | <h4 style="text-align: center; margin: 0;">Dissolved Oxygen</h4> Date: <u>10/1/2008</u> Time: <u>15:10</u> Dissolved Oxygen: <u>8.7</u> (mg/L) Dissolved Oxygen: _____ (% sat) Specific Cond: _____ (µS/cm) Water Temperature: <u>17.1</u> (°C) |

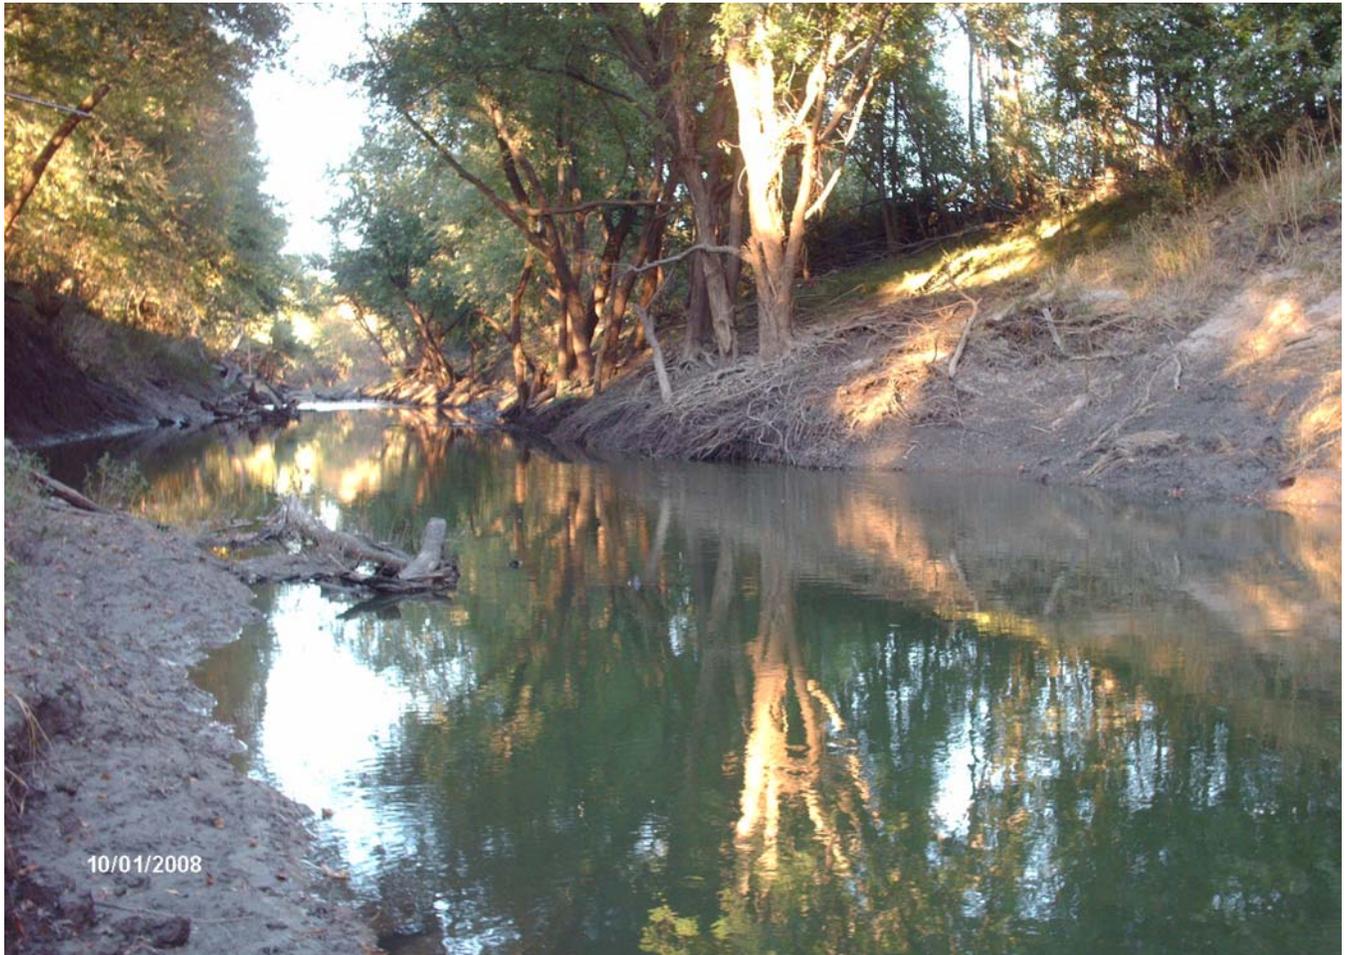
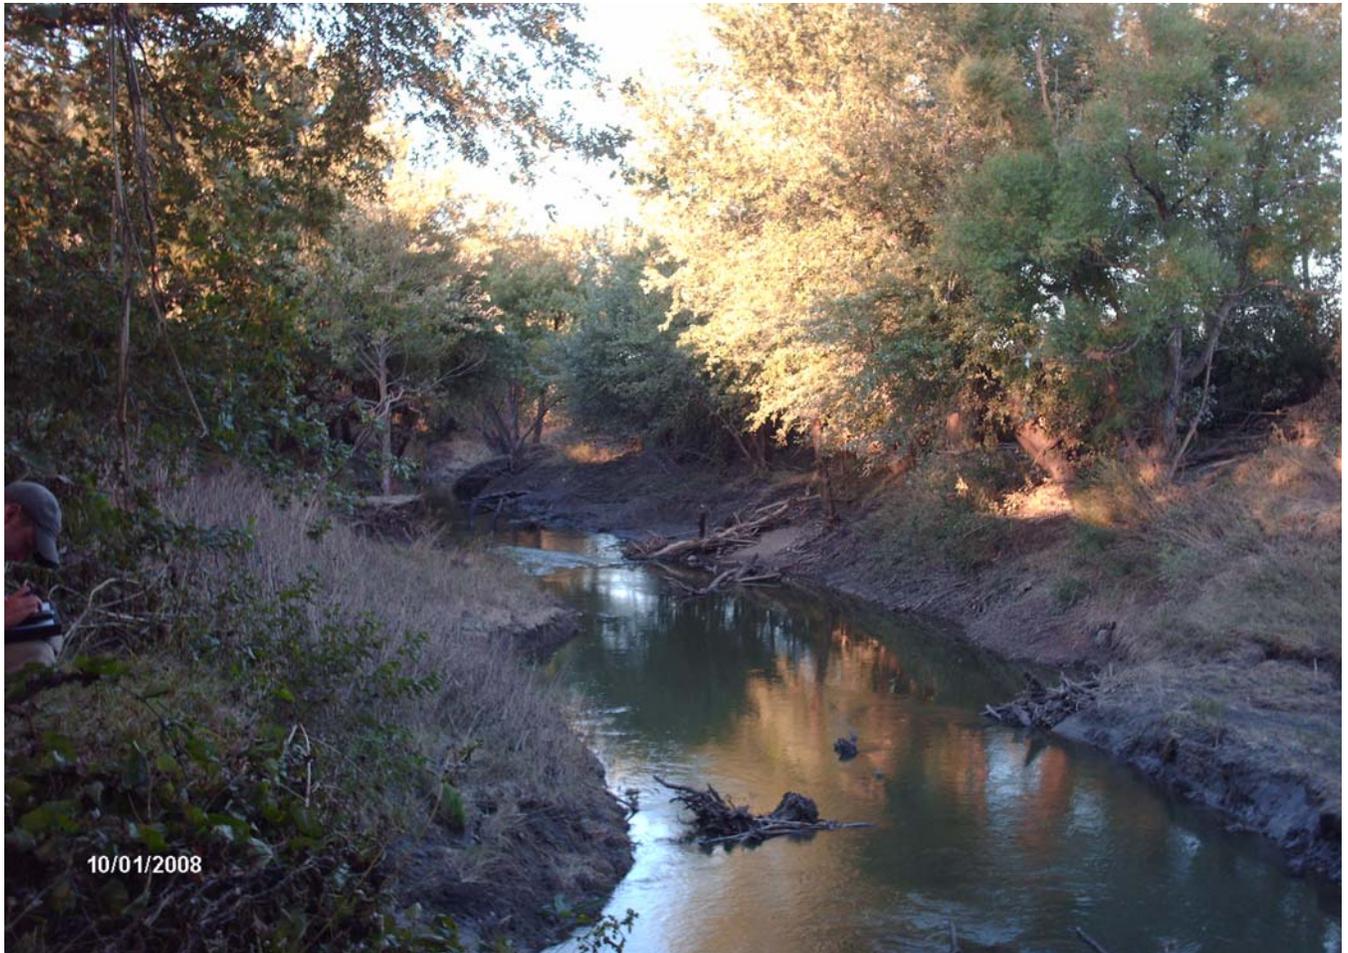
Site # 2

| Date & Time: 10/1/08 | Location Description (e.g., road crossing): South of CR 424 |

| Photo ID# | Photo Purpose | Photo ID# | Photo Purpose | Photo ID# | Photo Purpose |
|---|---|---|---|---|---|
| 44 | Downstream | 45 | Upstream | | |

| % Cobble | % Gravel | 60% Sand | 10% Silt | 30% Mud/Clay | % Bedrock |

| Color: | <input type="checkbox"/> Clear | <input checked="" type="checkbox"/> Green | <input type="checkbox"/> Gray | <input type="checkbox"/> Milky | <input type="checkbox"/> Other: |

| Stream Name: <u>Shoal Cr. Ditch</u> Waterbody ID: <u>519</u> Site #: <u>2</u> Estimated Channel Incision: <u>6</u> (m) (height between low bank width and water) GPS Location - Easting (UTM X), Northing (UTM Y), Horizontal Accuracy Estimate (EPE / PDOP / FOM) 01 UTM X: <u>0441560</u> UTM Y: <u>4388486</u> +/- <u>4</u> (meters) 11 UTM X: <u>0441689</u> UTM Y: <u>4388688</u> +/- <u>6</u> (meters) Average Stream Width: <u>8</u> (meters) Length of Survey Segment: <u>160</u> (meters) (To determine Length of Reach) (20x average stream width) Field Staff: <u>Bryan Deimeke and Gilisa Gould</u> | Dissolved Oxygen Date: <u>10/1/2008</u> Time: <u>17:55</u> Dissolved Oxygen: <u>9.6</u> (mg/L) Dissolved Oxygen: _____ (% sat) Specific Cond: _____ (µS/cm) Water Temperature: <u>16.9</u> (°C) |
