Use Attainability Analysis

WBID 2063 Little Bourbeuse River

Missouri Department of Natural Resources Staff

Field Data Sheets for Recreational Use Stream Surveys

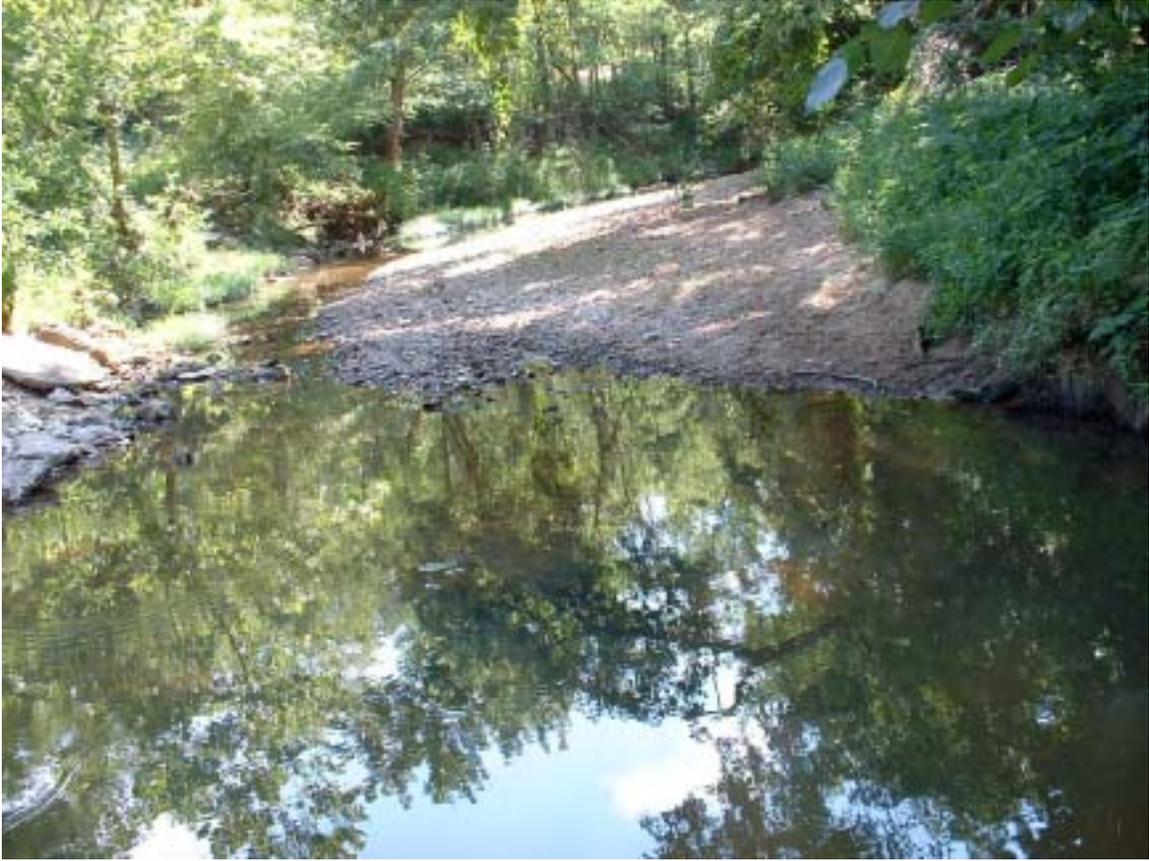
2063_001_US

Upstream View Physical Dimensions:

| <input checked="" type="checkbox"/> Pool | Width (ft): <u>12</u> | Length (ft): <u>15</u> | Avg. Depth (ft): 2 <u>1.5</u> | Max. Depth (ft): <u>2.5</u> |
| <input type="checkbox"/> Flow Present? | <input type="checkbox"/> Yes | <input checked="" type="checkbox"/> No | Estimated (ft ³ /sec): | |

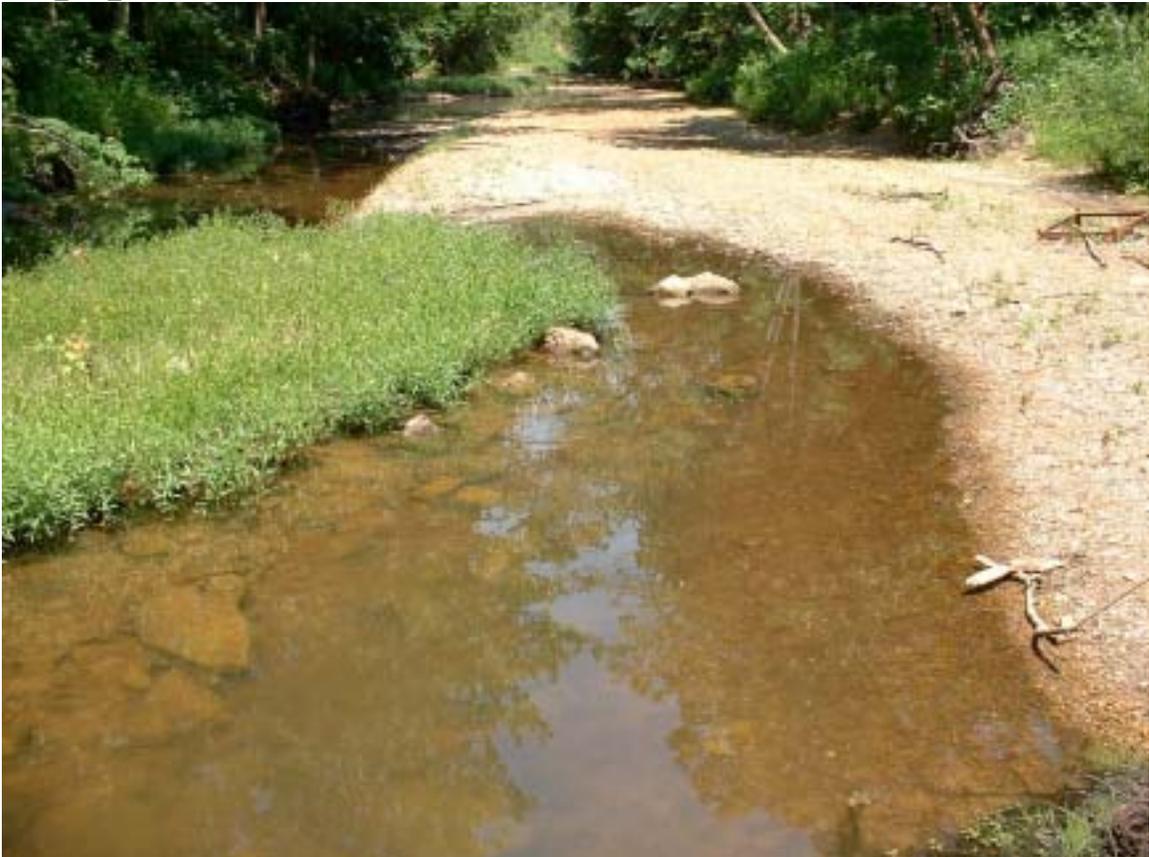
2063_001_DS

Downstream View Physical Dimensions:

| <input checked="" type="checkbox"/> Pool | Width (ft): <u>22</u> | Length (ft): <u>12</u> | Avg. Depth (ft): <u>2.5</u> | Max. Depth (ft): <u>4</u> |
| <input type="checkbox"/> Flow Present? | <input type="checkbox"/> Yes | <input checked="" type="checkbox"/> No | Estimated (ft ³ /sec): | |

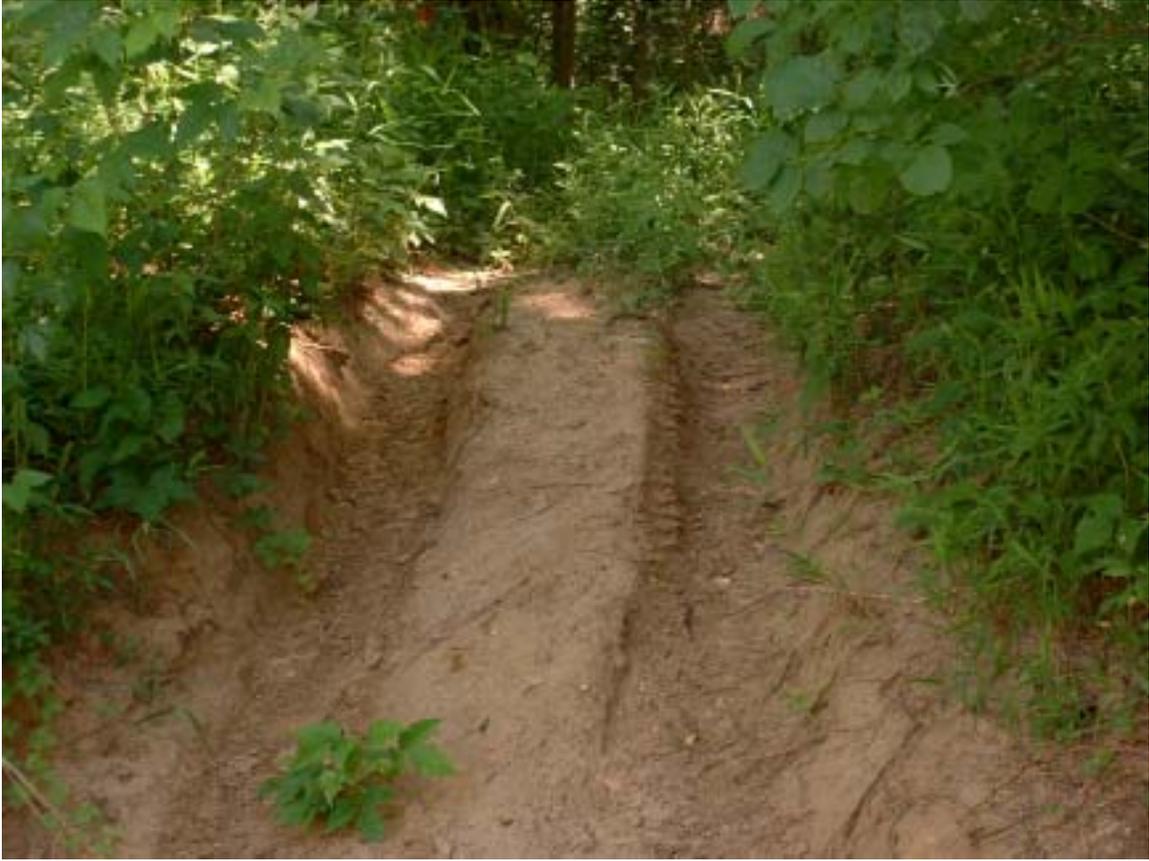
2063_001_ATV Tracks

| Photo Ids: Upstream: 06 Downstream: 05 Other: 07 - ATV Tracks | |

| <input type="checkbox"/> Roads | <input checked="" type="checkbox"/> Foot paths (prints) | <input type="checkbox"/> Dock/platform | <input type="checkbox"/> Livestock Watering | <input checked="" type="checkbox"/> RV / ATV Tracks |

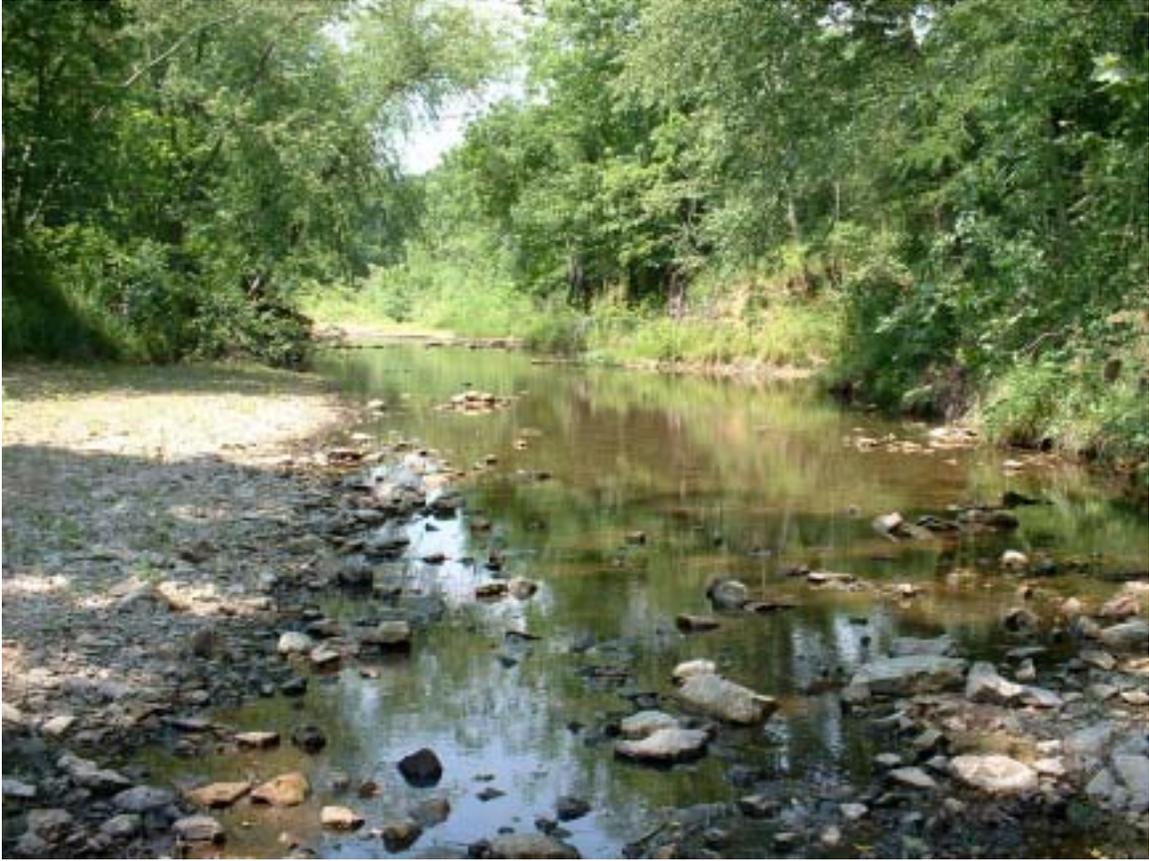
2063_002_US

Upstream View Physical Dimensions:

| <input checked="" type="checkbox"/> Pool | Width (ft): <u>20</u> | Length (ft): <u>200</u> | Avg. Depth (ft): <u>0.75</u> | Max. Depth (ft): <u>1.5</u> |
| <input type="checkbox"/> Flow Present? | <input checked="" type="checkbox"/> Yes <input type="checkbox"/> No | Estimated (ft ³ /sec): | | |

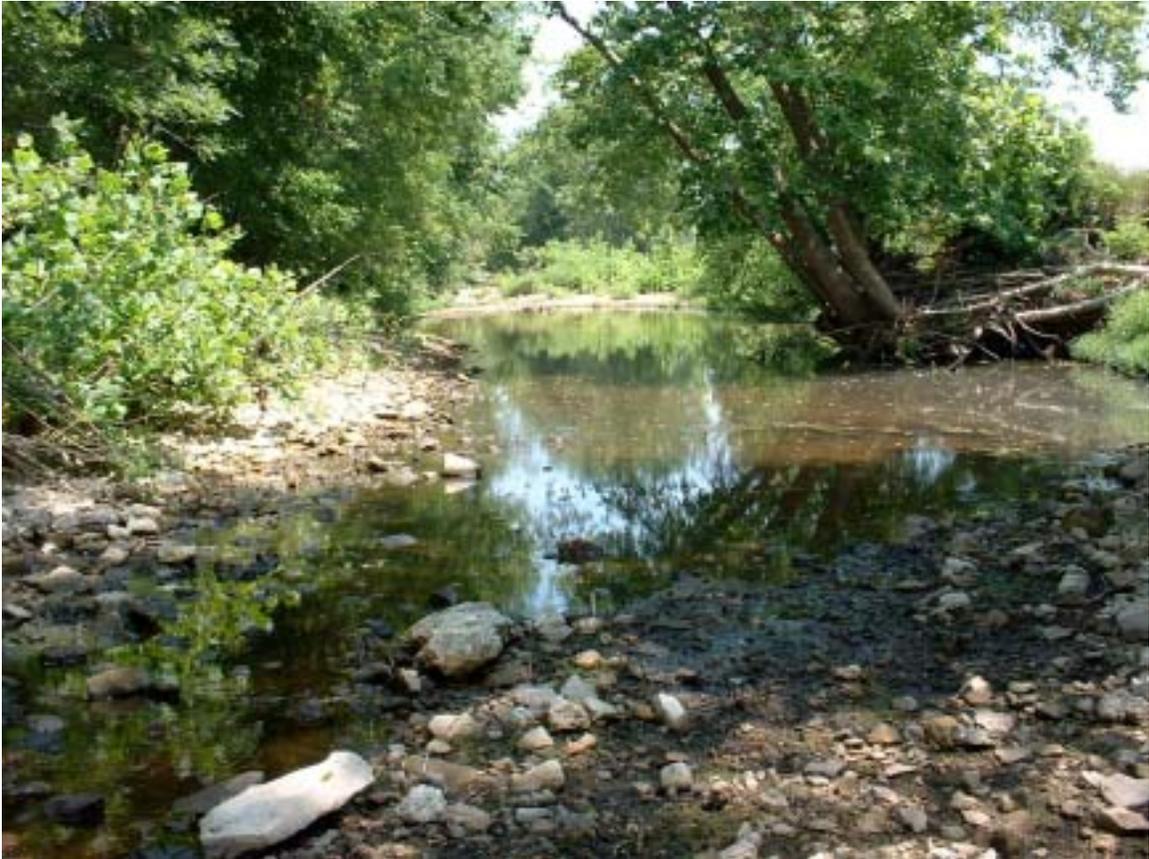
2063_002_DS

Downstream View Physical Dimensions:

| <input checked="" type="checkbox"/> Pool | Width (ft): <u>30</u> | Length (ft): <u>180</u> | Avg. Depth (ft): <u>2.0</u> | Max. Depth (ft): <u>3.0</u> |
| <input type="checkbox"/> Flow Present? | <input checked="" type="checkbox"/> Yes <input type="checkbox"/> No | Estimated (ft ³ /sec): | | |
