National Register of Historic Places Registration Form

historic name Downtown Cole Camp

other names/site number Central Cole Camp Historic District [preferred]

**Central Cole Camp Historic District
Benton County, Missouri**

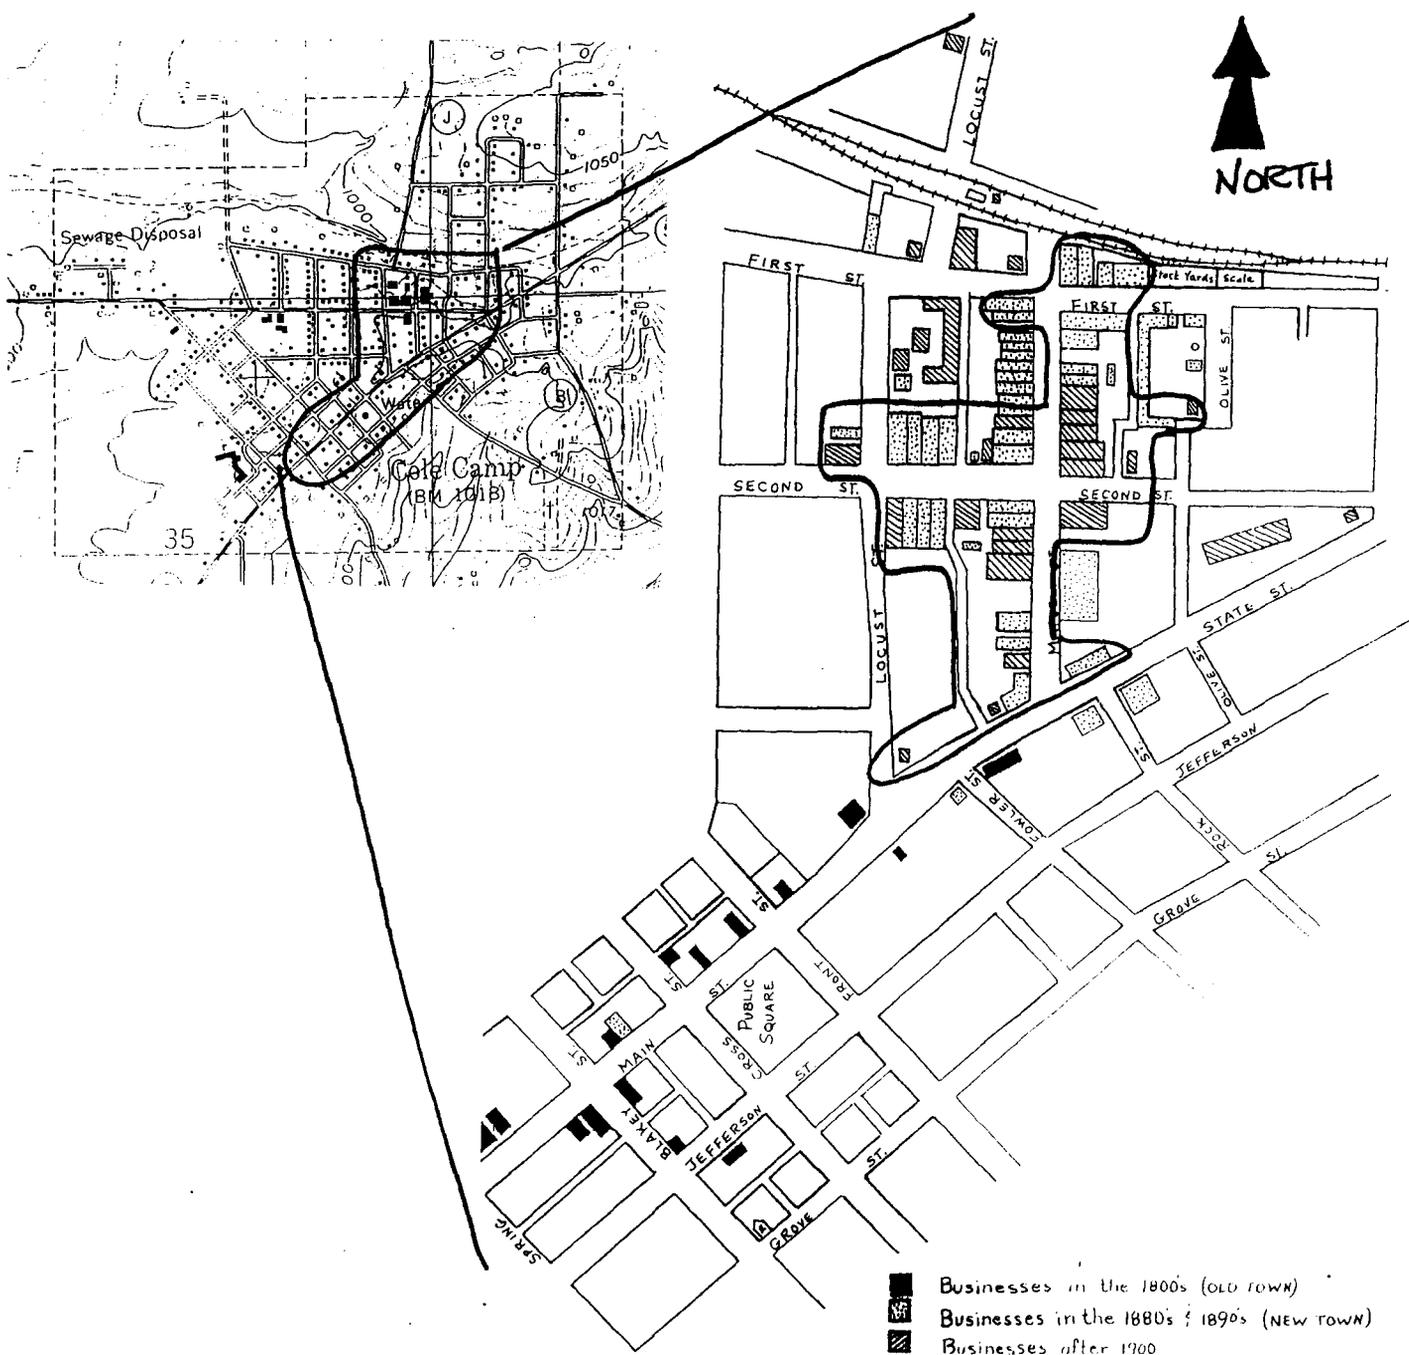
Figure One. Historic business locations and current historic district boundaries. Base map from Cole Camp Area Historical Society. Cole Camp Area History: 1839-1976. Shawnee Mission, KS: Kes-Print, Inc, 1976.

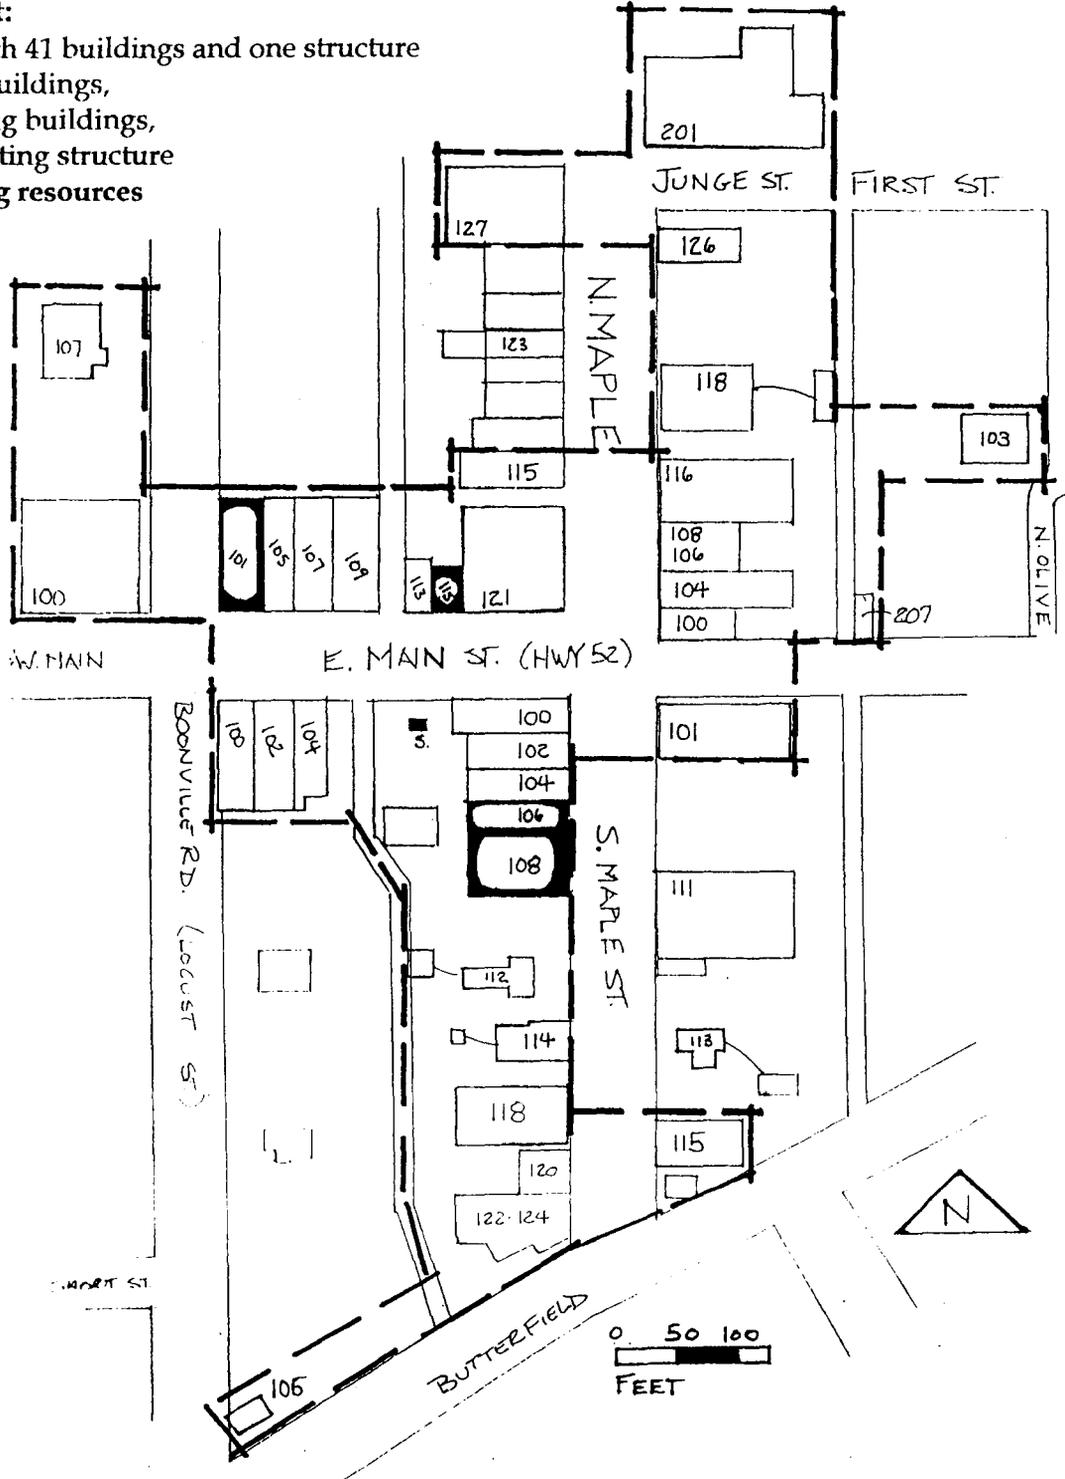
Resource Count:

- 38 Properties, with 41 buildings and one structure
 - 37 contributing buildings,
 - 4 non-contributing buildings,
 - one non-contributing structure
- Non-contributing resources are darkened.

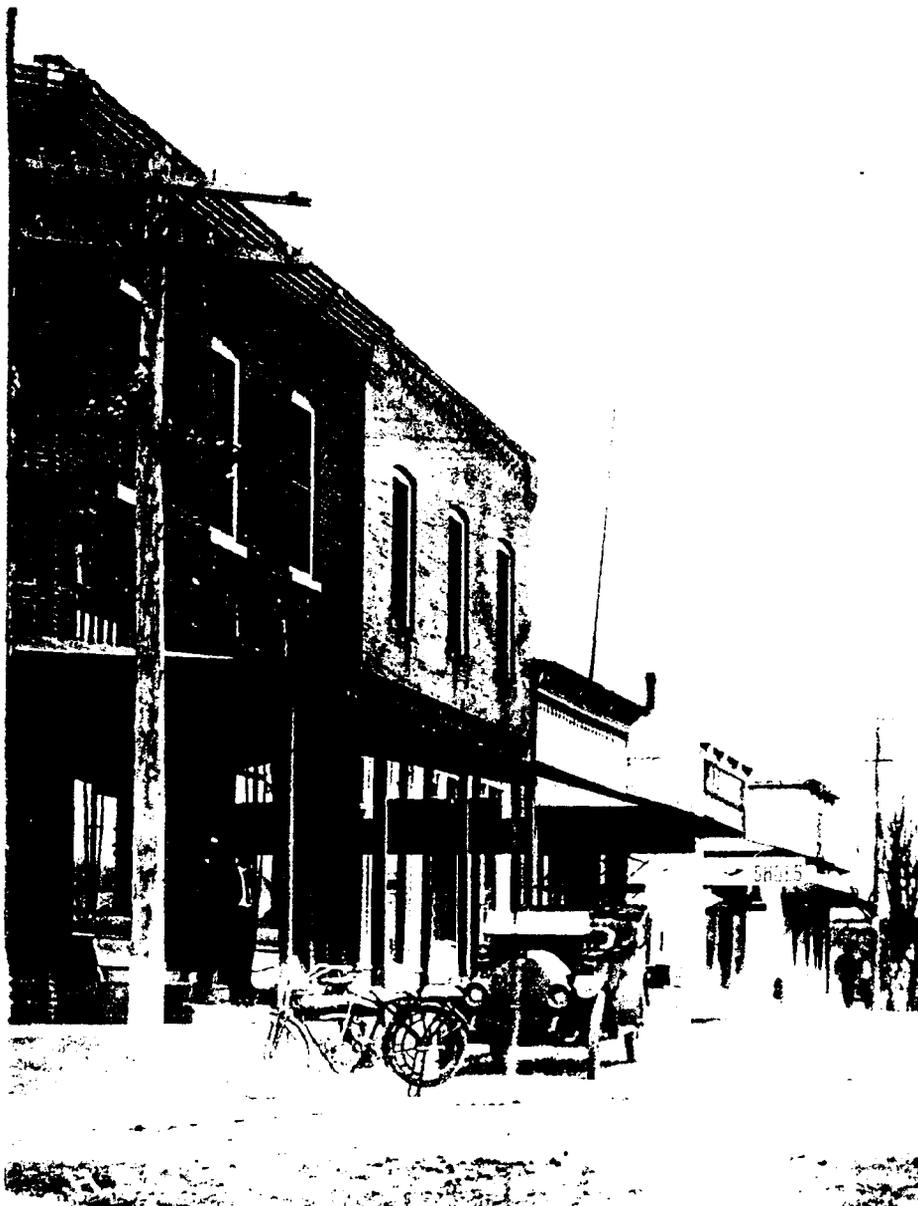
Figure Three. Historic photo of Maple Street, looking north from Butterfield.

Photo taken between 1905-1913, courtesy of Bob Owens, Cole Camp, MO.

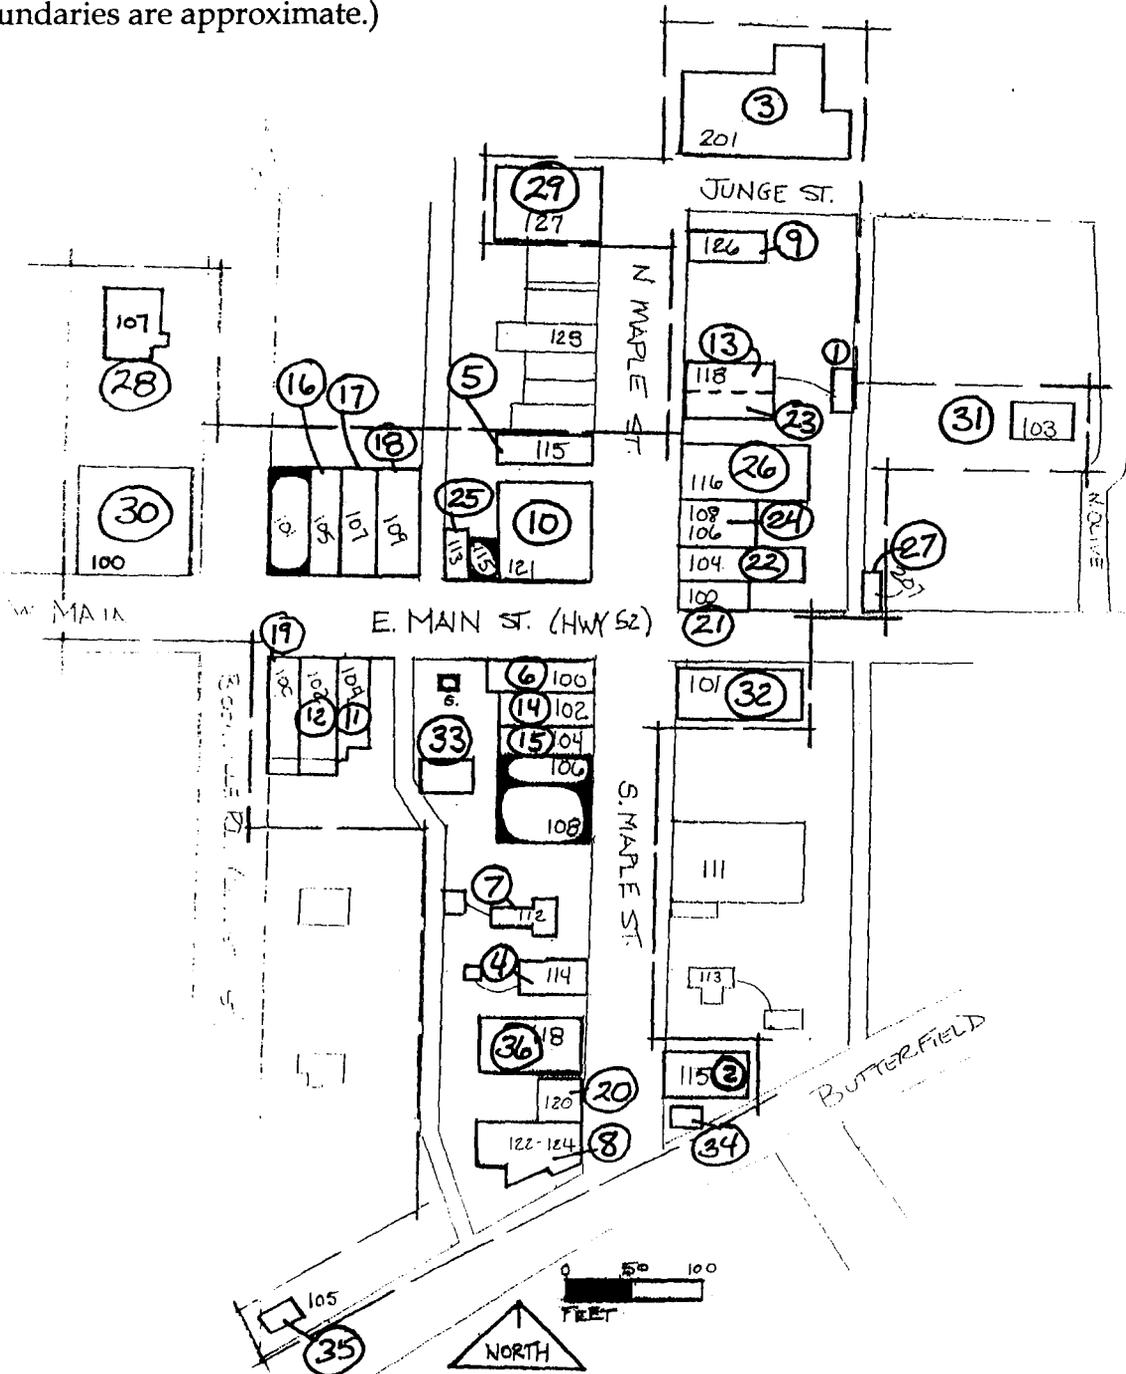
Figure Four. District Properties, numbered by date of construction, oldest to newest. See Section 7 and the following appendix for more information.
(District Boundaries are approximate.)

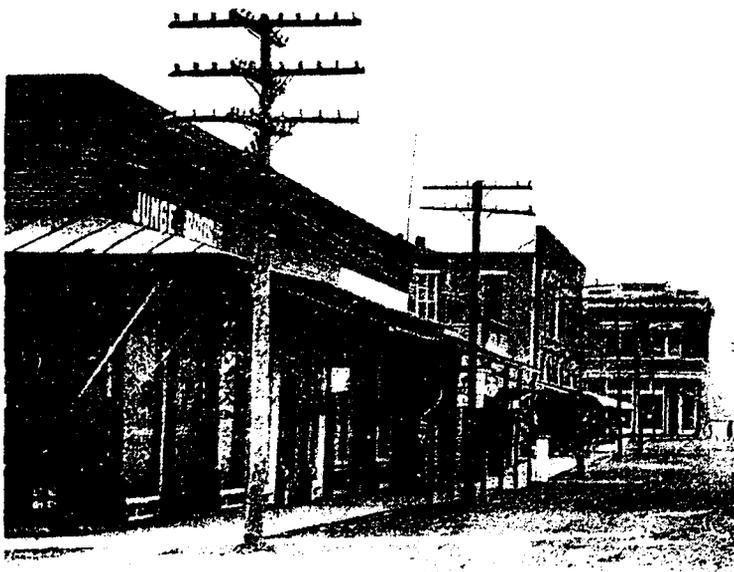
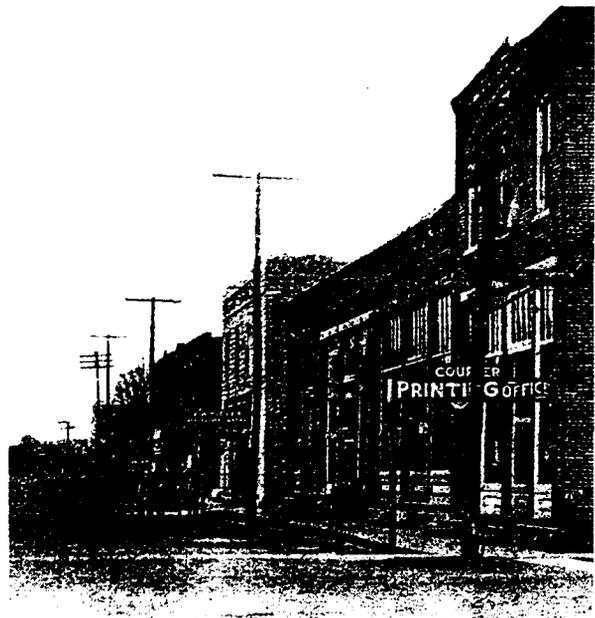
Right: South side of the street.

Left: North Side of the street, with the Farmers Bank at the end of the block.

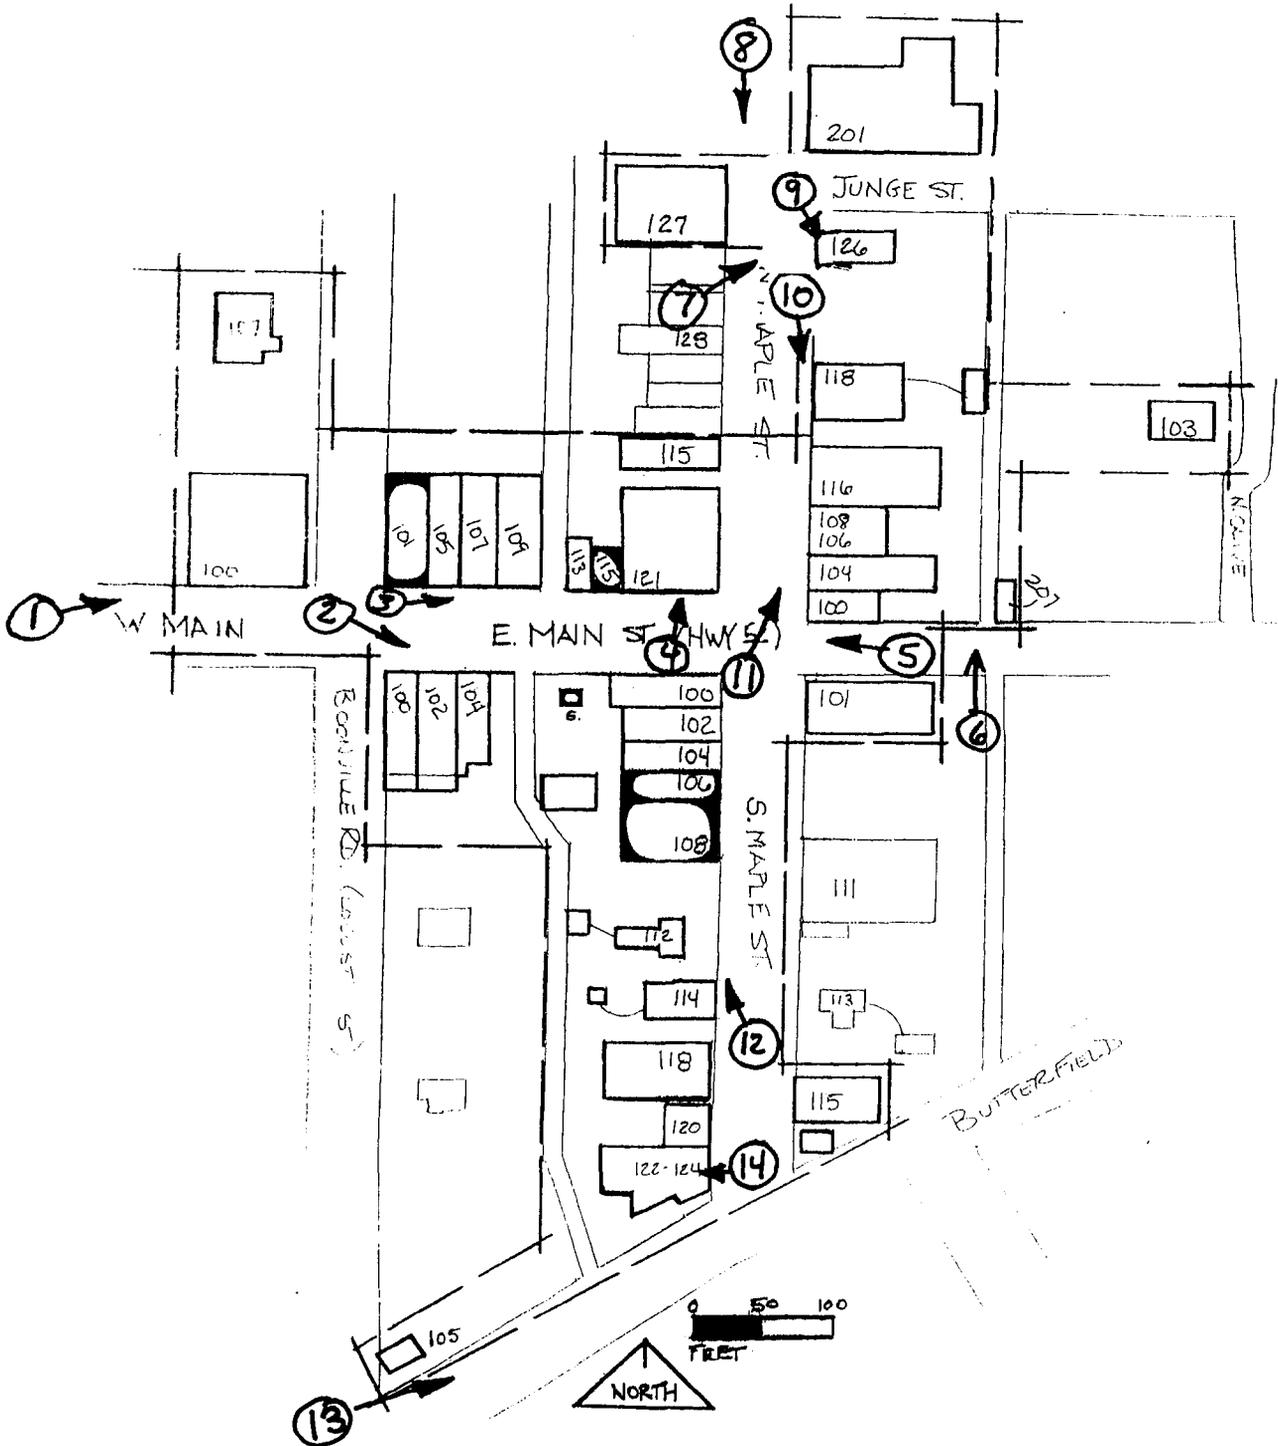
Photo Key.
(District Boundaries are approximate.)
