National Register of Historic Places
Inventory—Nomination Form

historic Shobe-Morrison House

7. Description

8. Significance

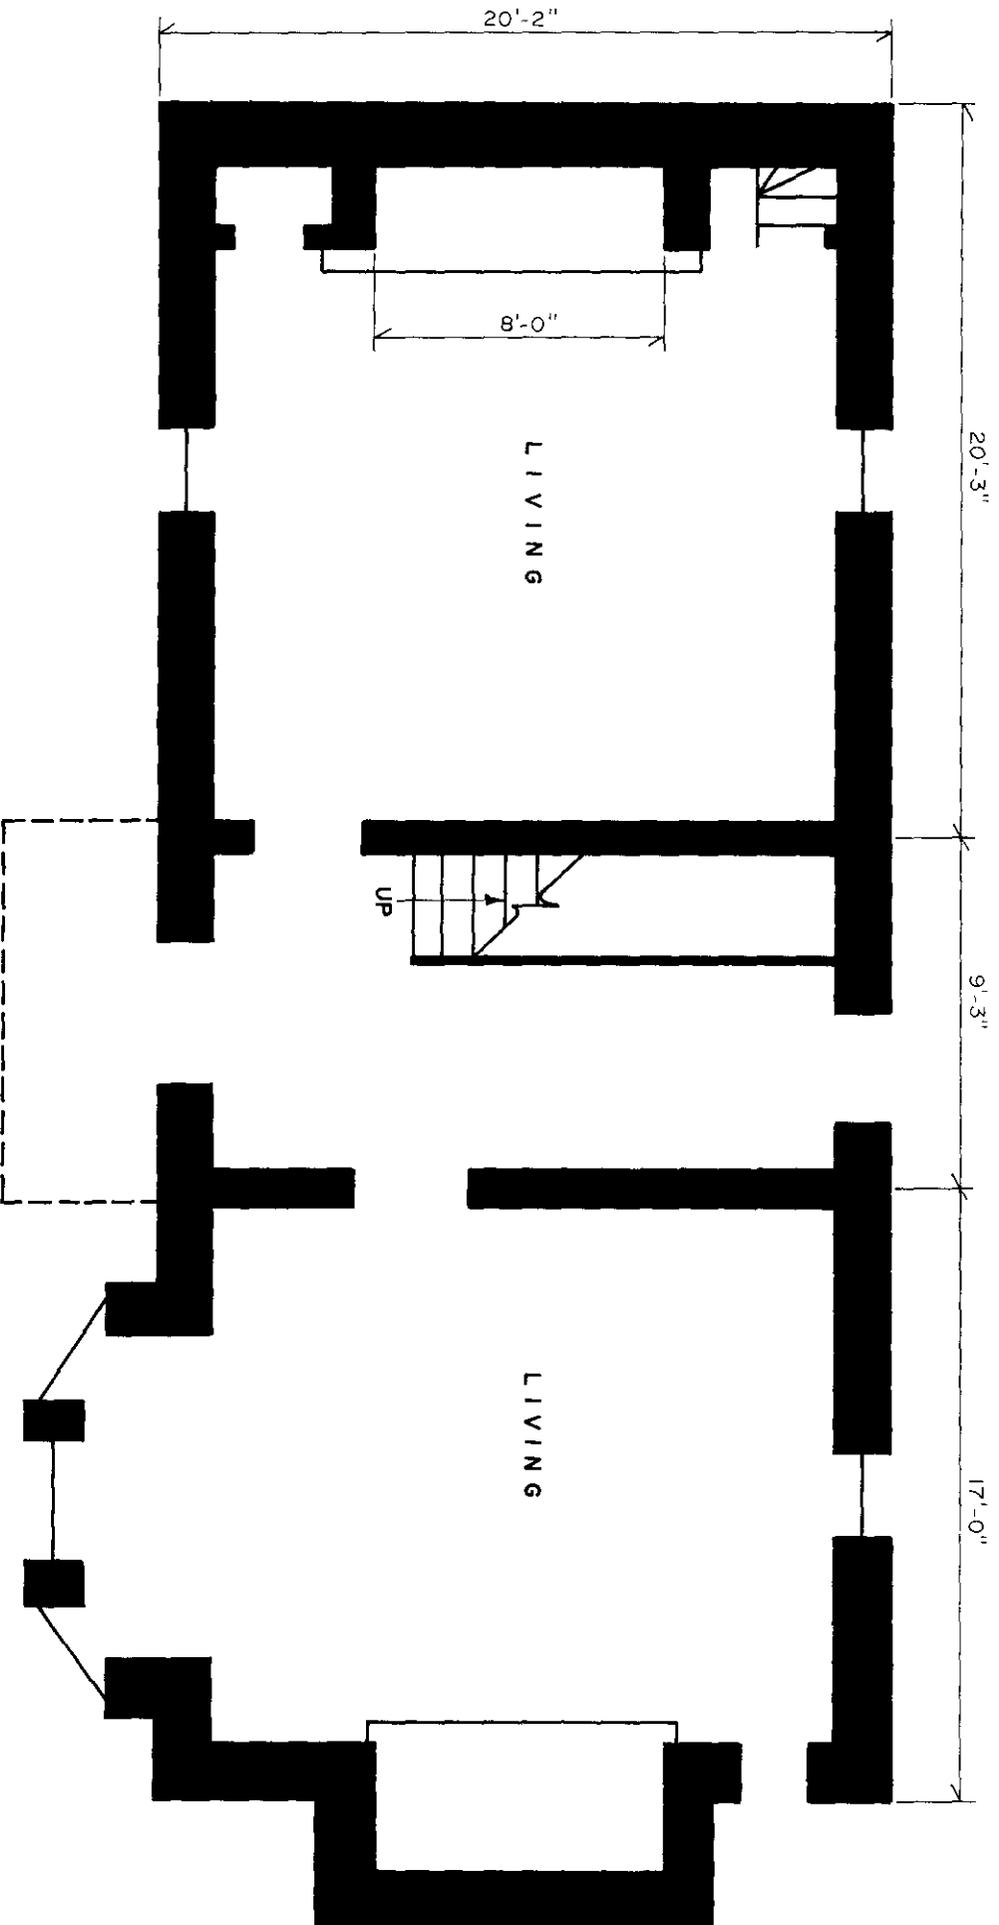
FIRST FLOOR PLAN
SHOBE - MORRISON HOUSE
MORRISON, GASCONADE COUNTY, MISSOURI

CIRCA 1828

NOT TO SCALE

Evidence that the hall and western portion were built at the same time can be seen in the logs across the rear which measure, on the second floor rear 27' per single log. Entering the first floor hall from the front one sees a staircase to the center left with a door to the left into the eastern section and a door to the right into the western parlor. Opposite the front entrance is a rear exit door. All doors are original with hardware intact. The first floor parlor walls retain a lath and plaster finish. A bay window to the front was probably added later. The fireplace on the gable-end is exterior compared to its counterpart on the eastern section which is interior. In 1917 an earthquake shook the structure and the chimney stack was destroyed. It was then covered over. During renovation, the stack and fireplace were rebuilt with local stone. To the left of the fireplace is an exterior door. This door was evidently used to gain access to a weaving building which was located about 5' from the west wall. This cabin has been removed. The door itself is unusual in that it angles up from left to right. On the door itself it is obvious that a piece was added to the top to accommodate this angle. Observation of the door from the outside shows that the door support structure sunk at some point. We can imagine that during the earthquake this happened and that to accommodate this occurrence, a piece was added to the door.

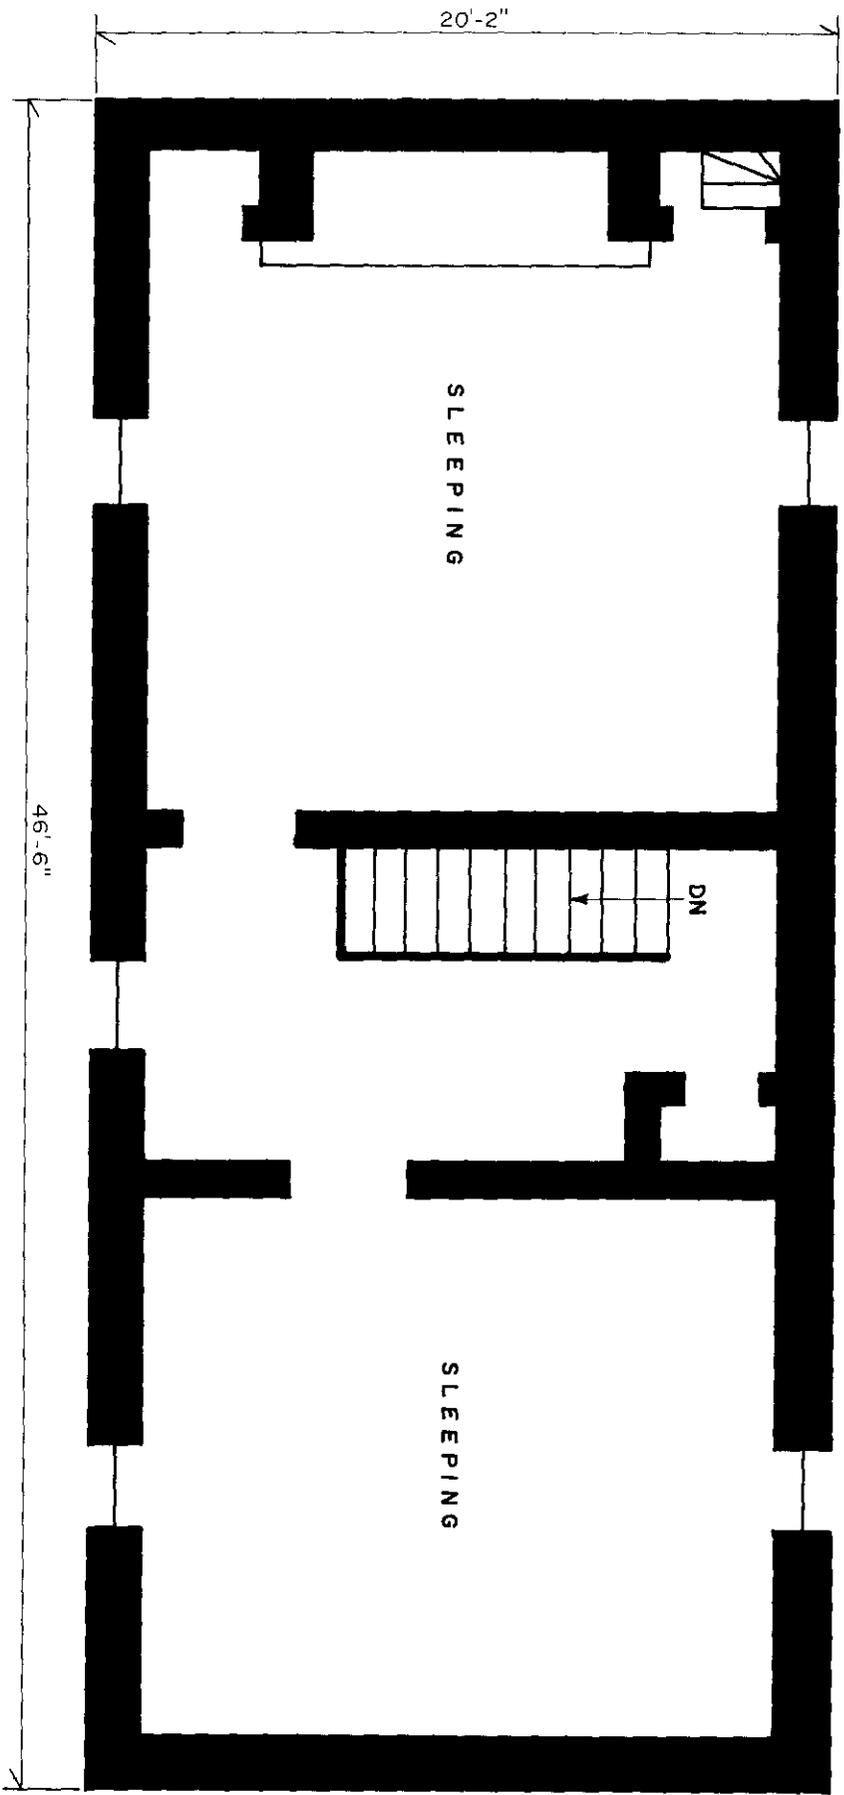
**SECOND FLOOR PLAN
SHOBE-MORRISON HOUSE
MORRISON, GASCONADE COUNTY, MISSOURI**

CIRCA 1828

The second floor of the western section is gained by the center staircase. In the second floor hall area a window to the north and a staircase to the south leading to the attic are found. A partition, not in the original design separates the sleeping area. In this sleeping area the Lion's Club has set up a small display of artifacts found around the house. The attic is interesting in that the original roof supports, complete with pins and roof supports, are in evidence. The roof was originally covered with wood shingling but has been replaced by a metal one. A tongue and groove floor covers this area.

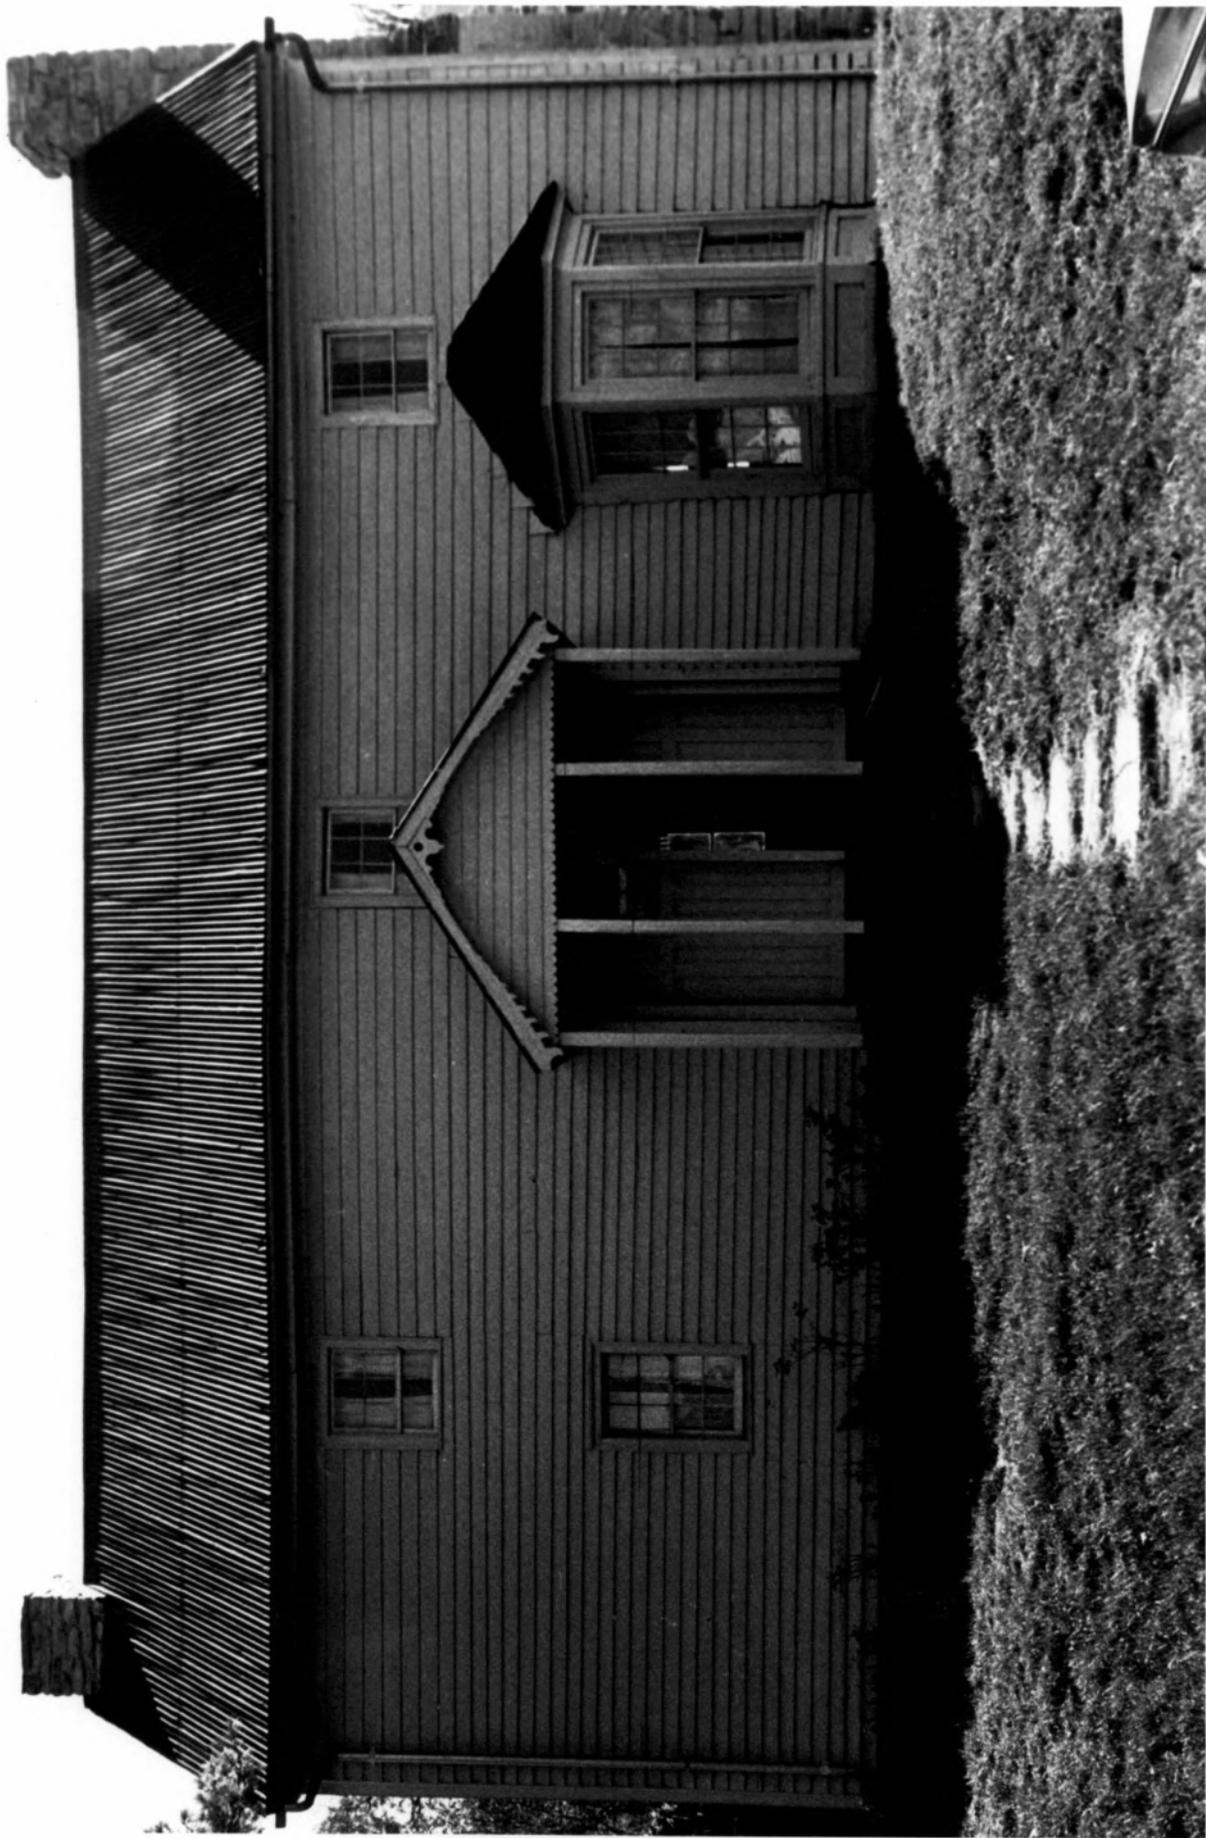
#1 of 9

View from North, the primary facade.

The exterior still demonstrates the original weatherboarding which is a uniform thickness of approximately one inch. Some sections have been replaced due to decay but most of the original boards remain. Alterations to the front include the addition of guttering and a porch with carpenter gothic decorations. To the rear a porch has been added, as has guttering and an entrance to the cellar. Other buildings on the property have disappeared with exception to a log structure some 80' south of the house. This building was decayed to the point where it is dangerous and will probably be removed in the near future. It was said to have been the old slave quarters.

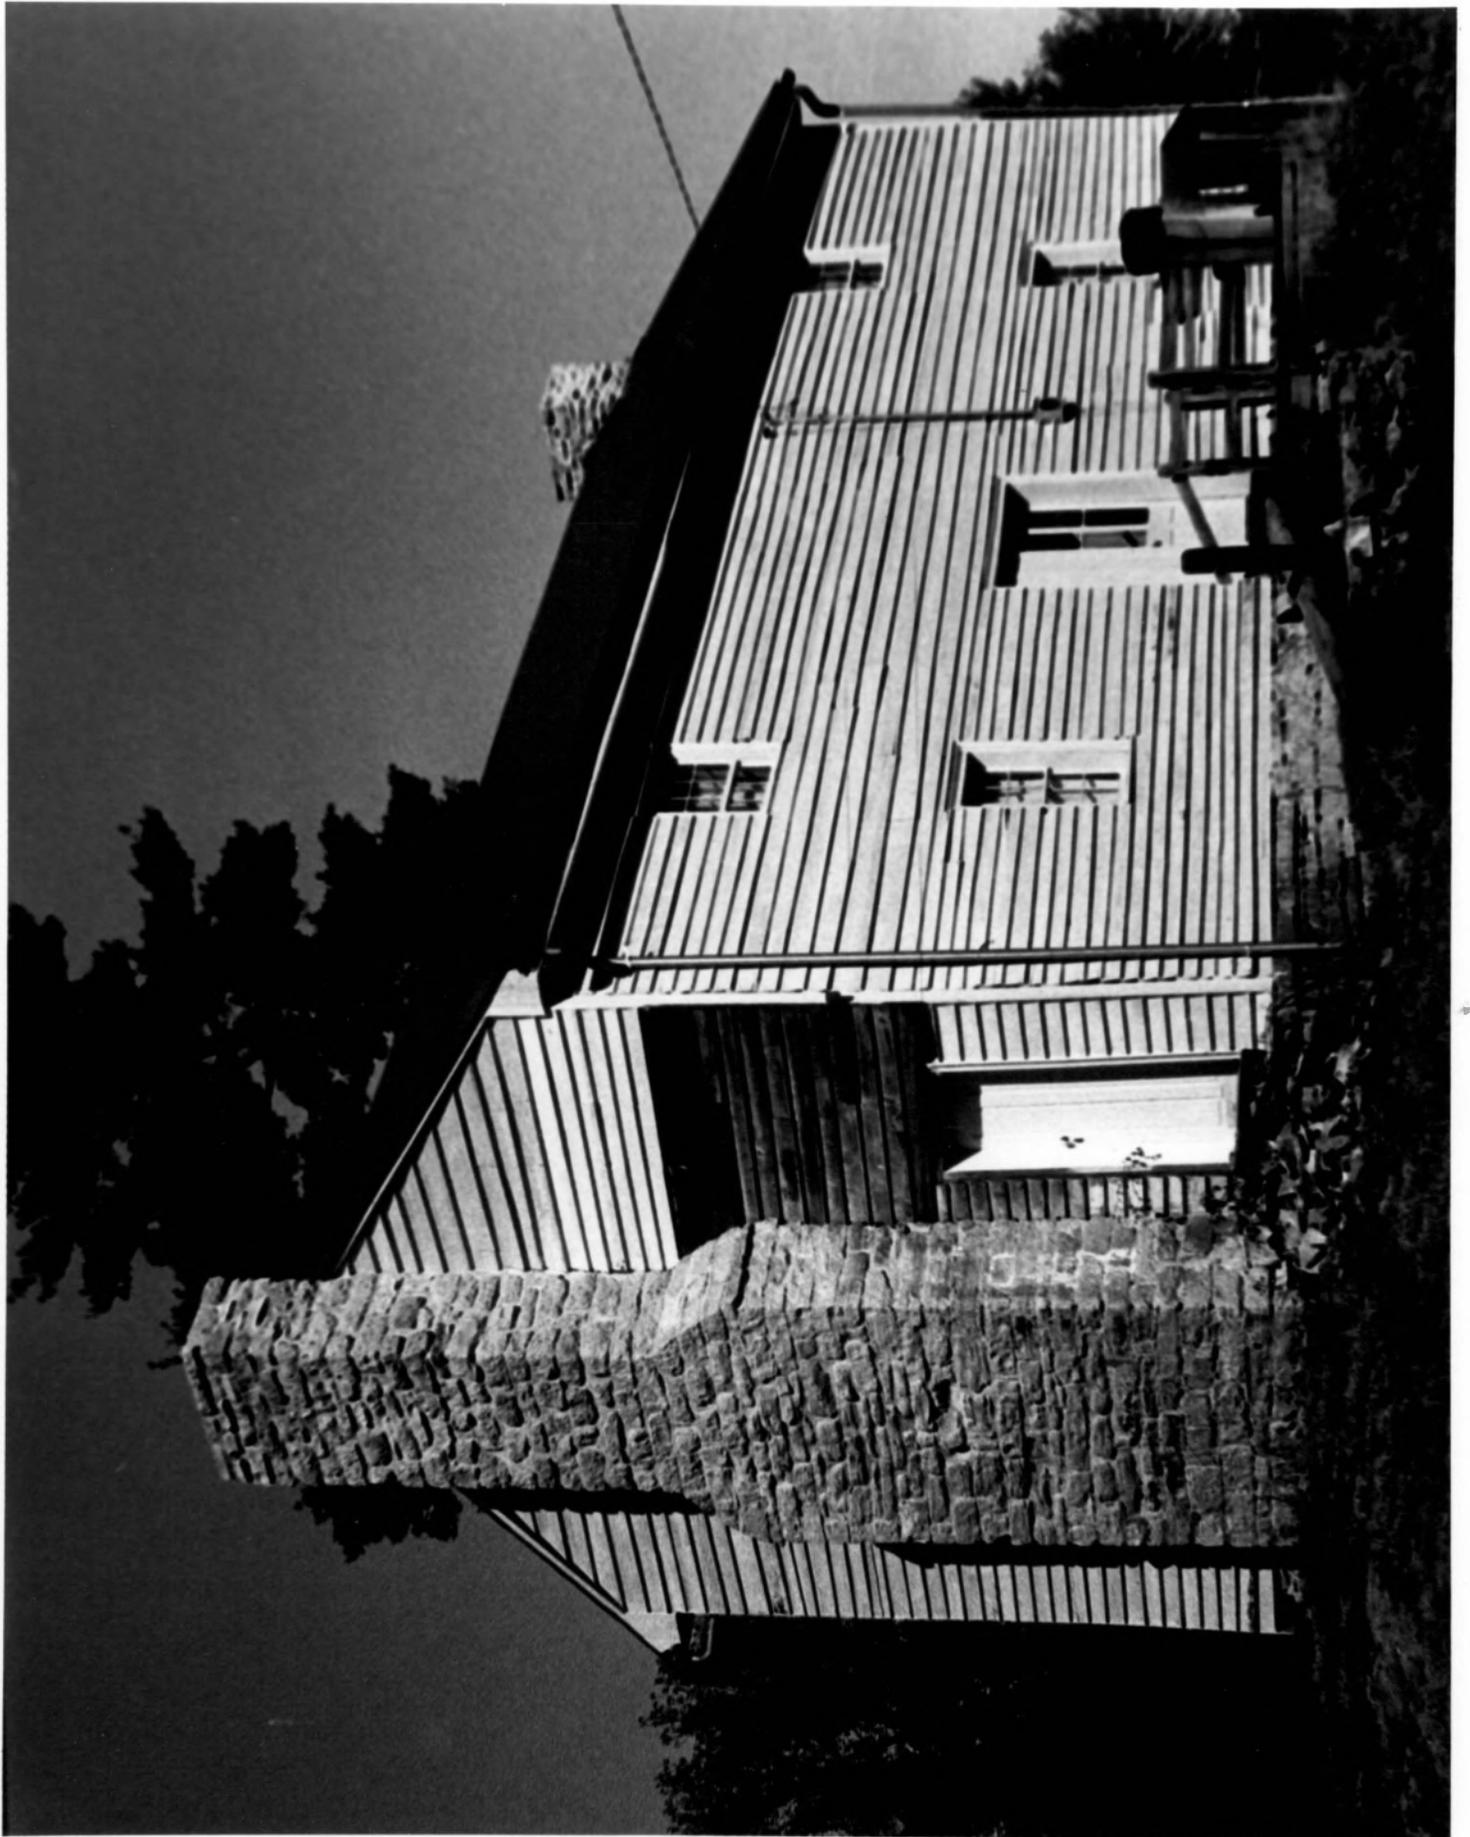
#2 of 9

View from Southwest

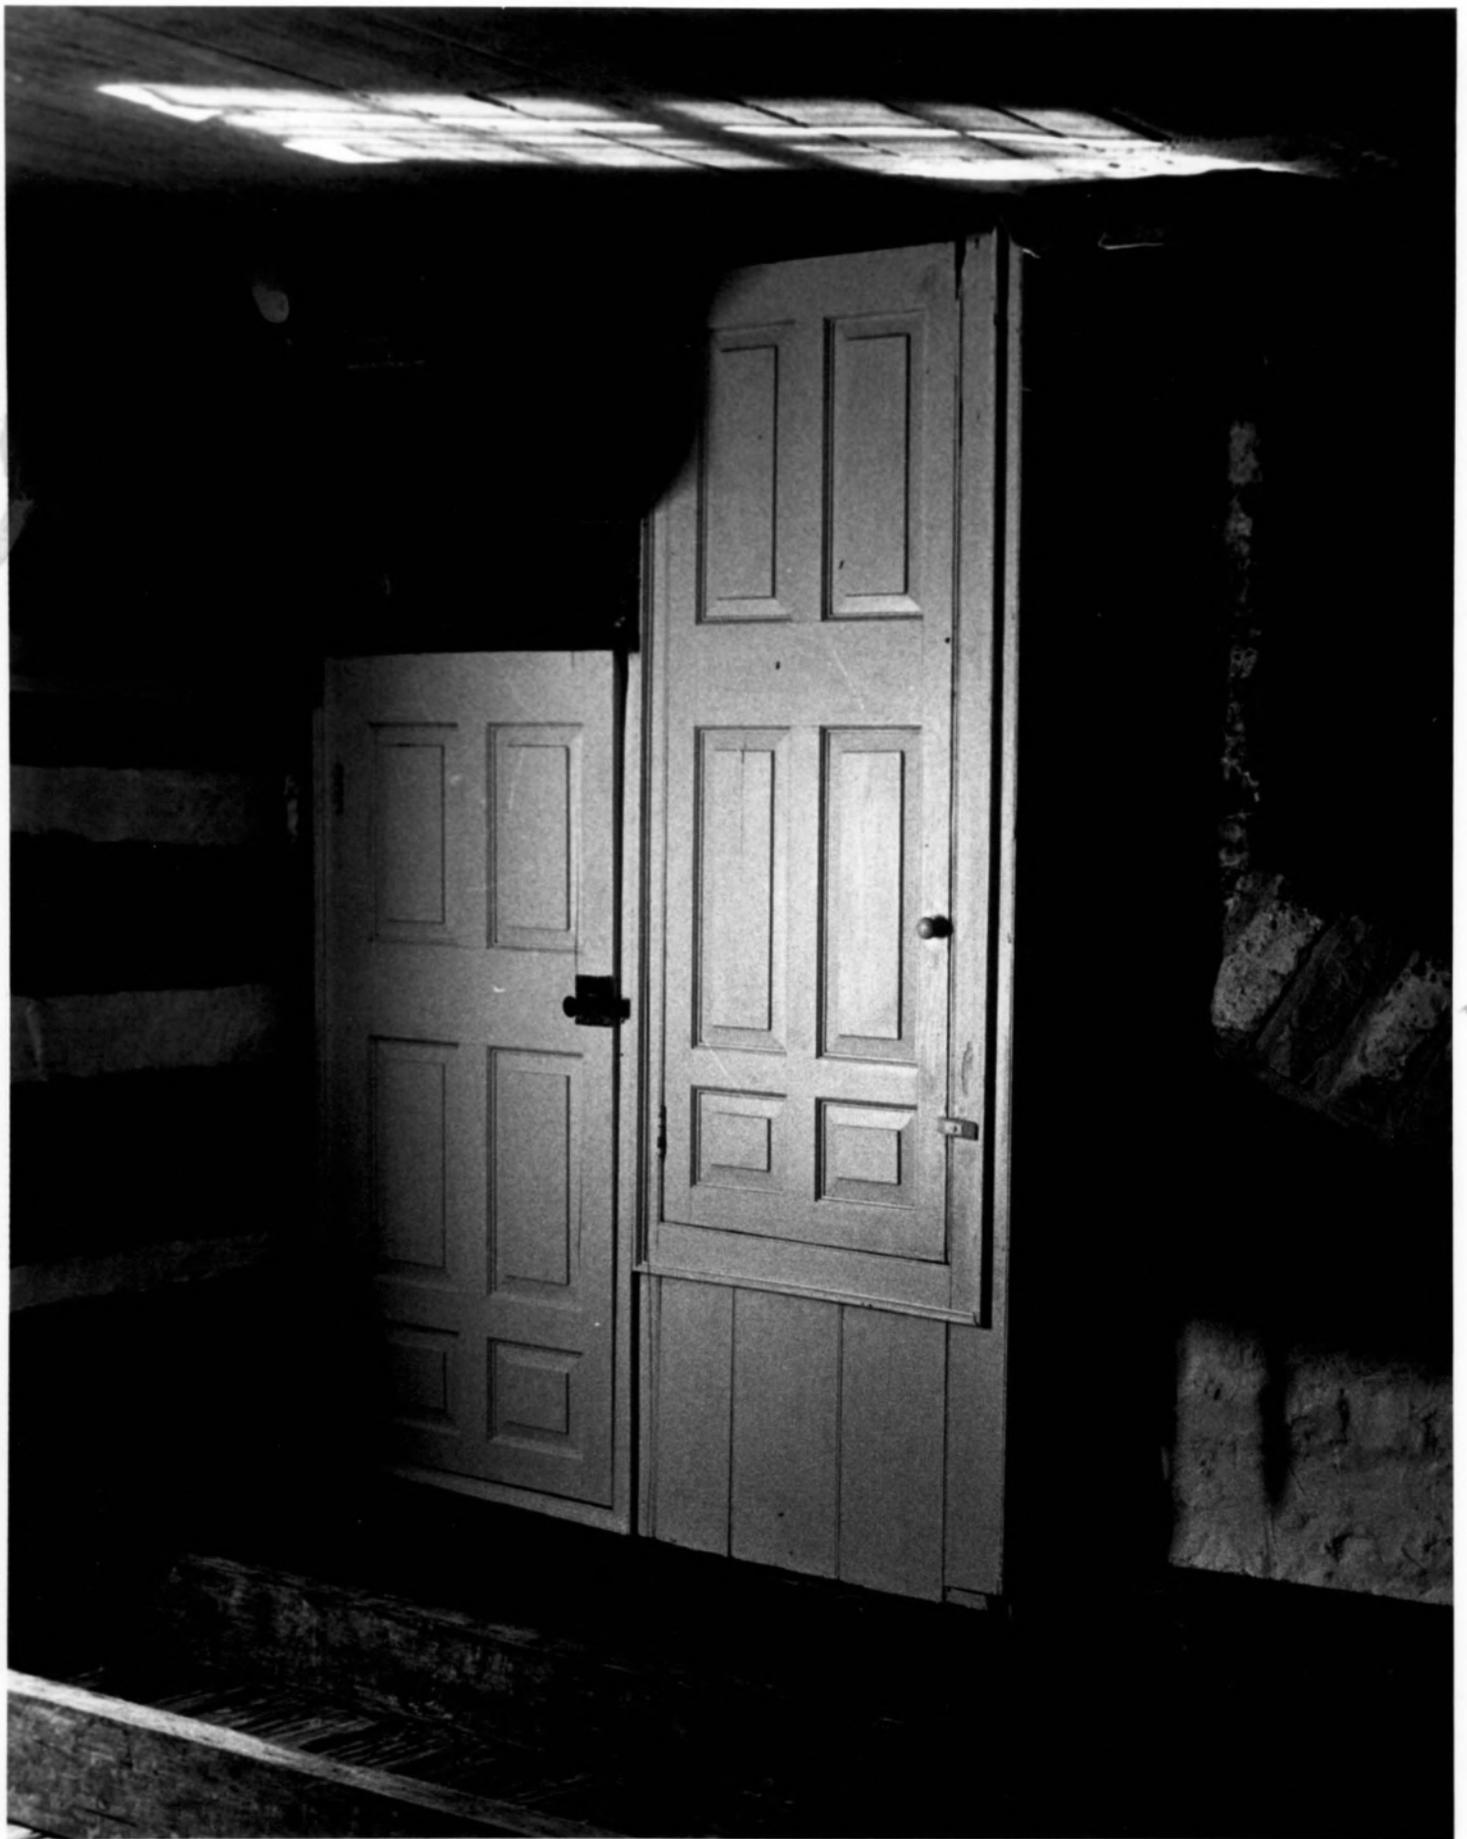
#3 of 9

View from the west; parlor-dining room
showing closet & staircase to second
floor.

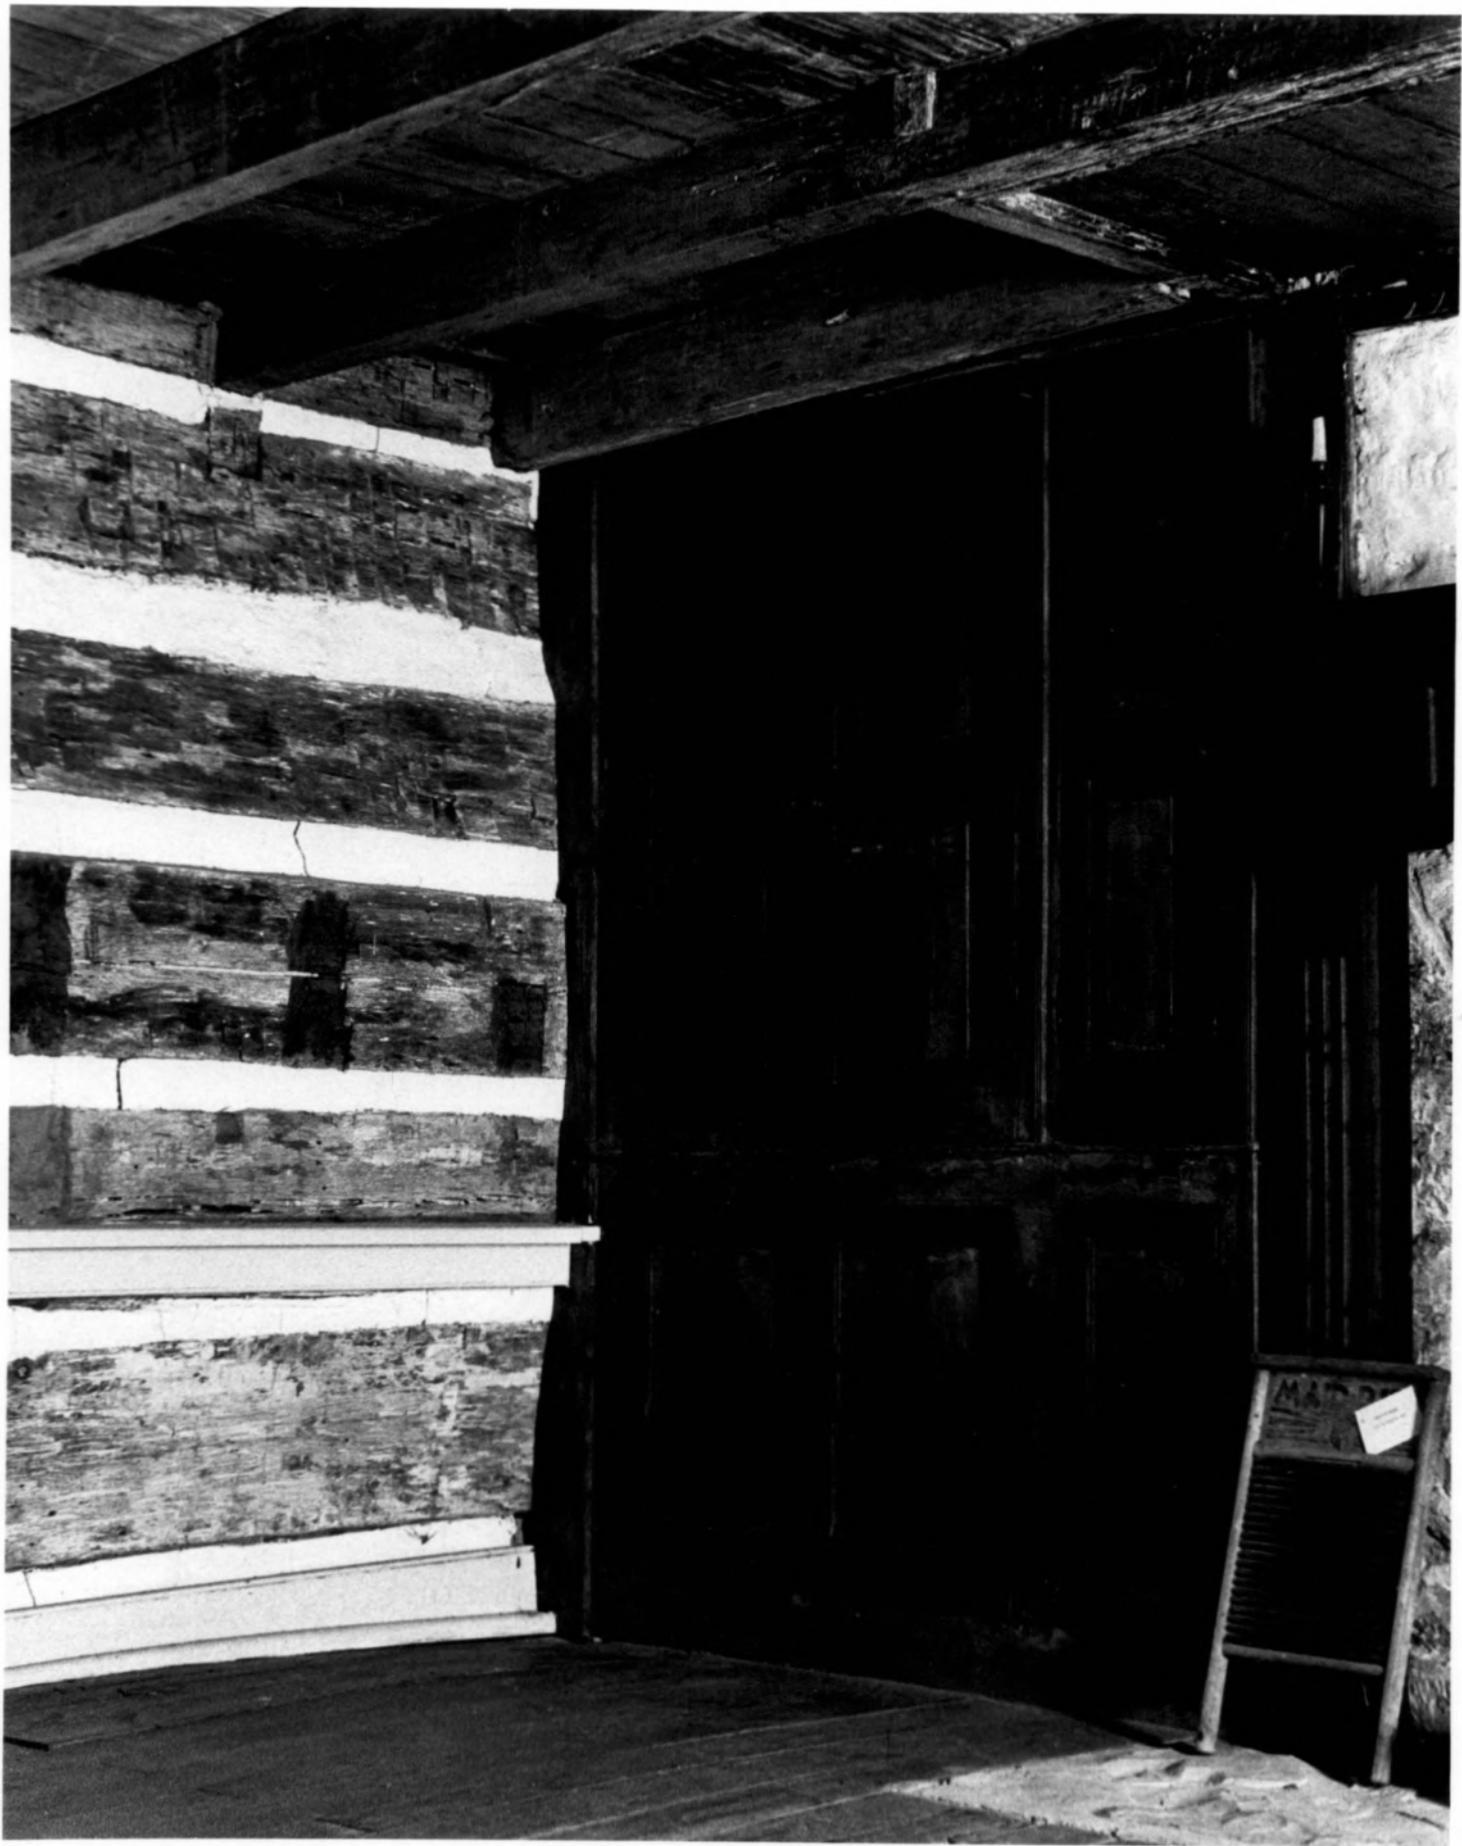
#4 of 9

View from the west; showing six door,
floor to ceiling storage cabinet

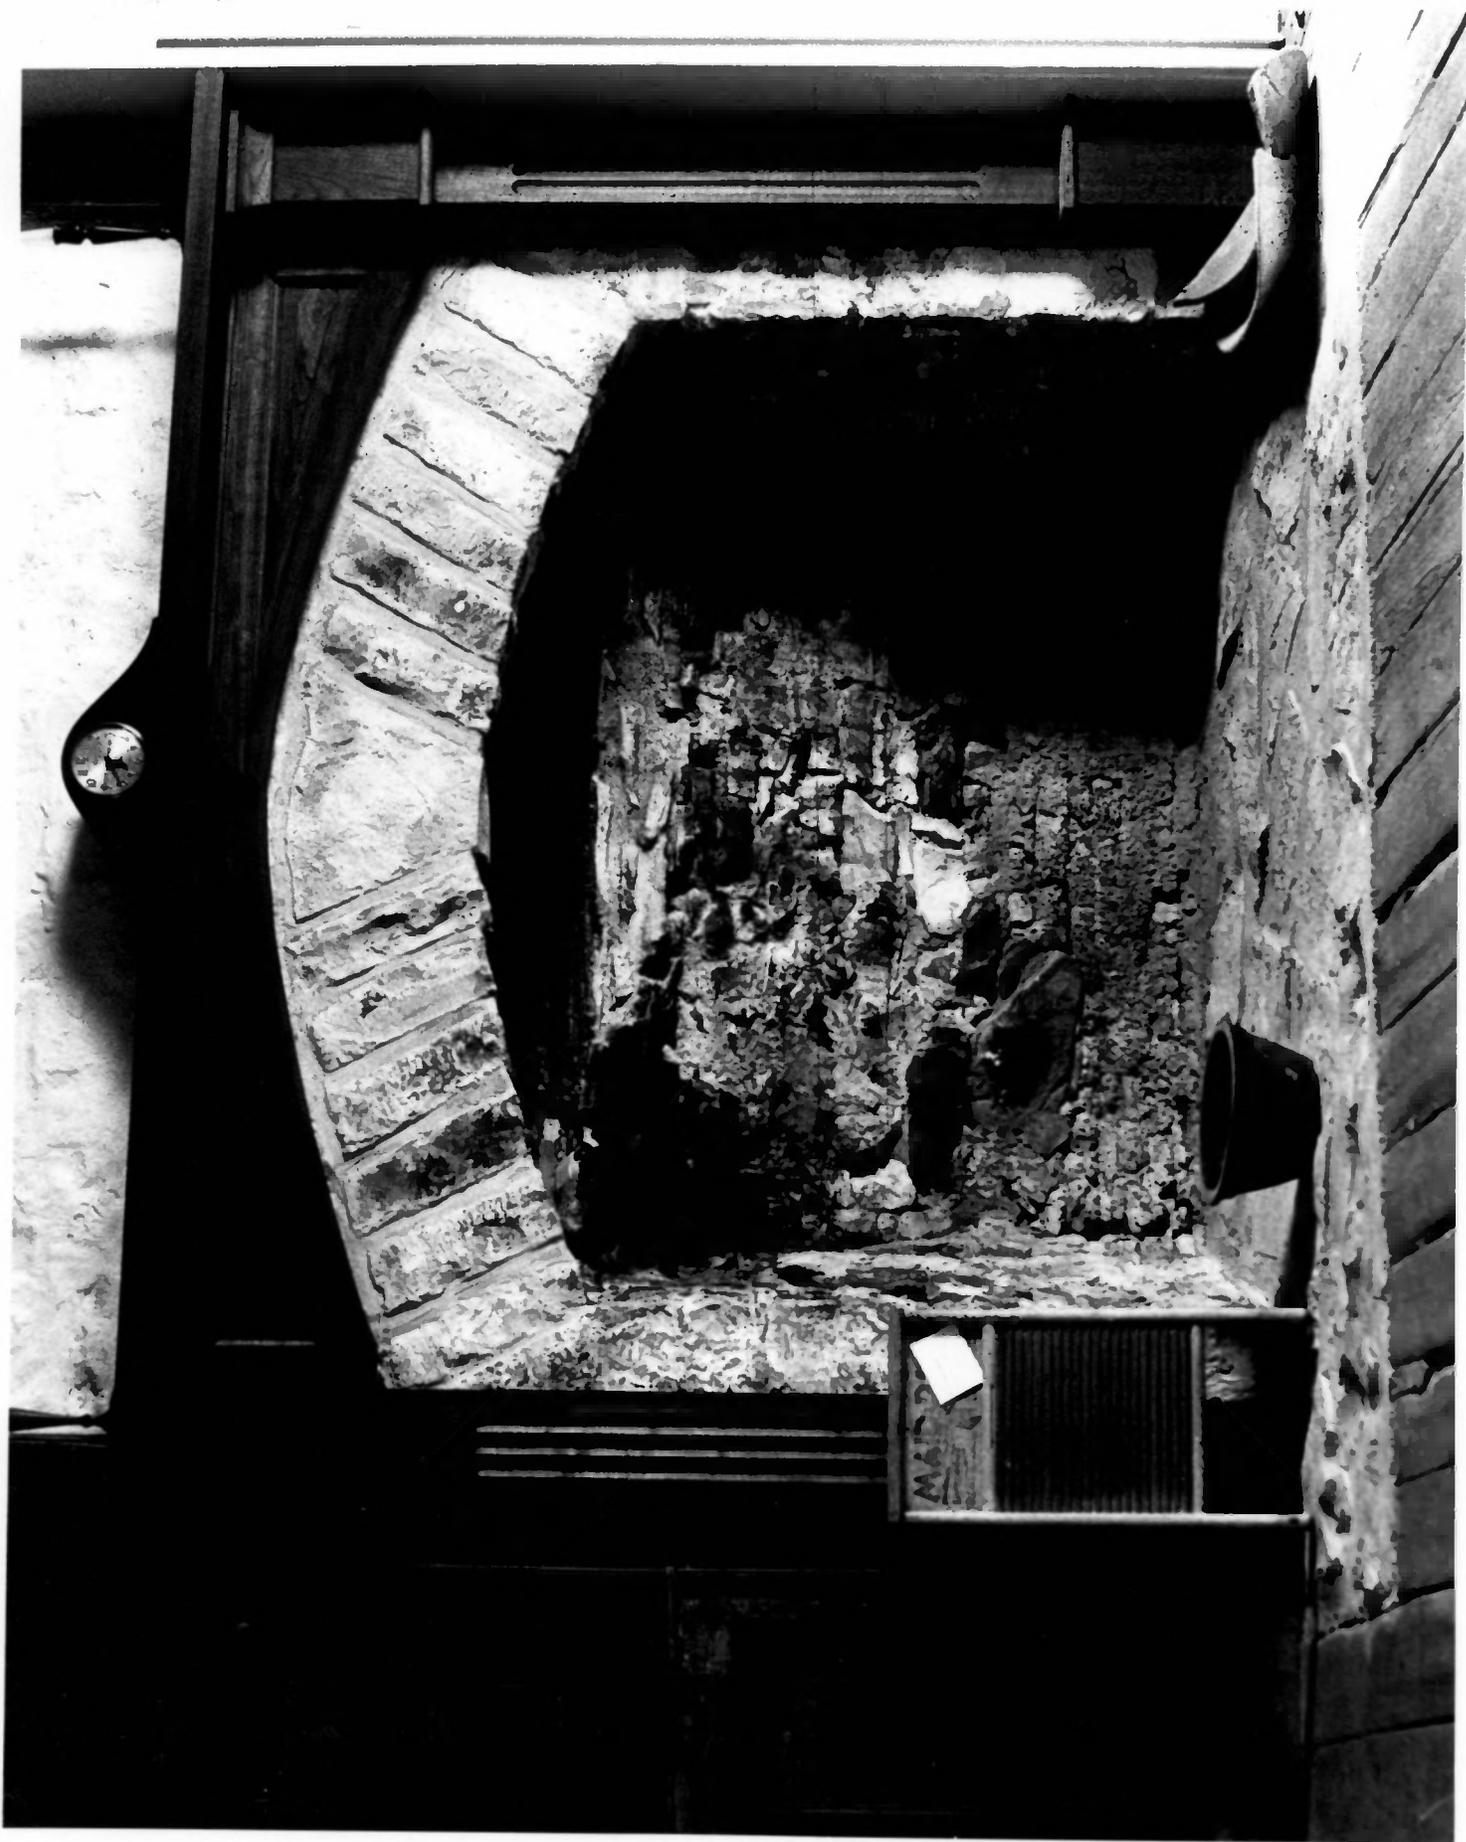
#5 of 9

view from the west; showing fireplace and
mantle in parlor-dining room.

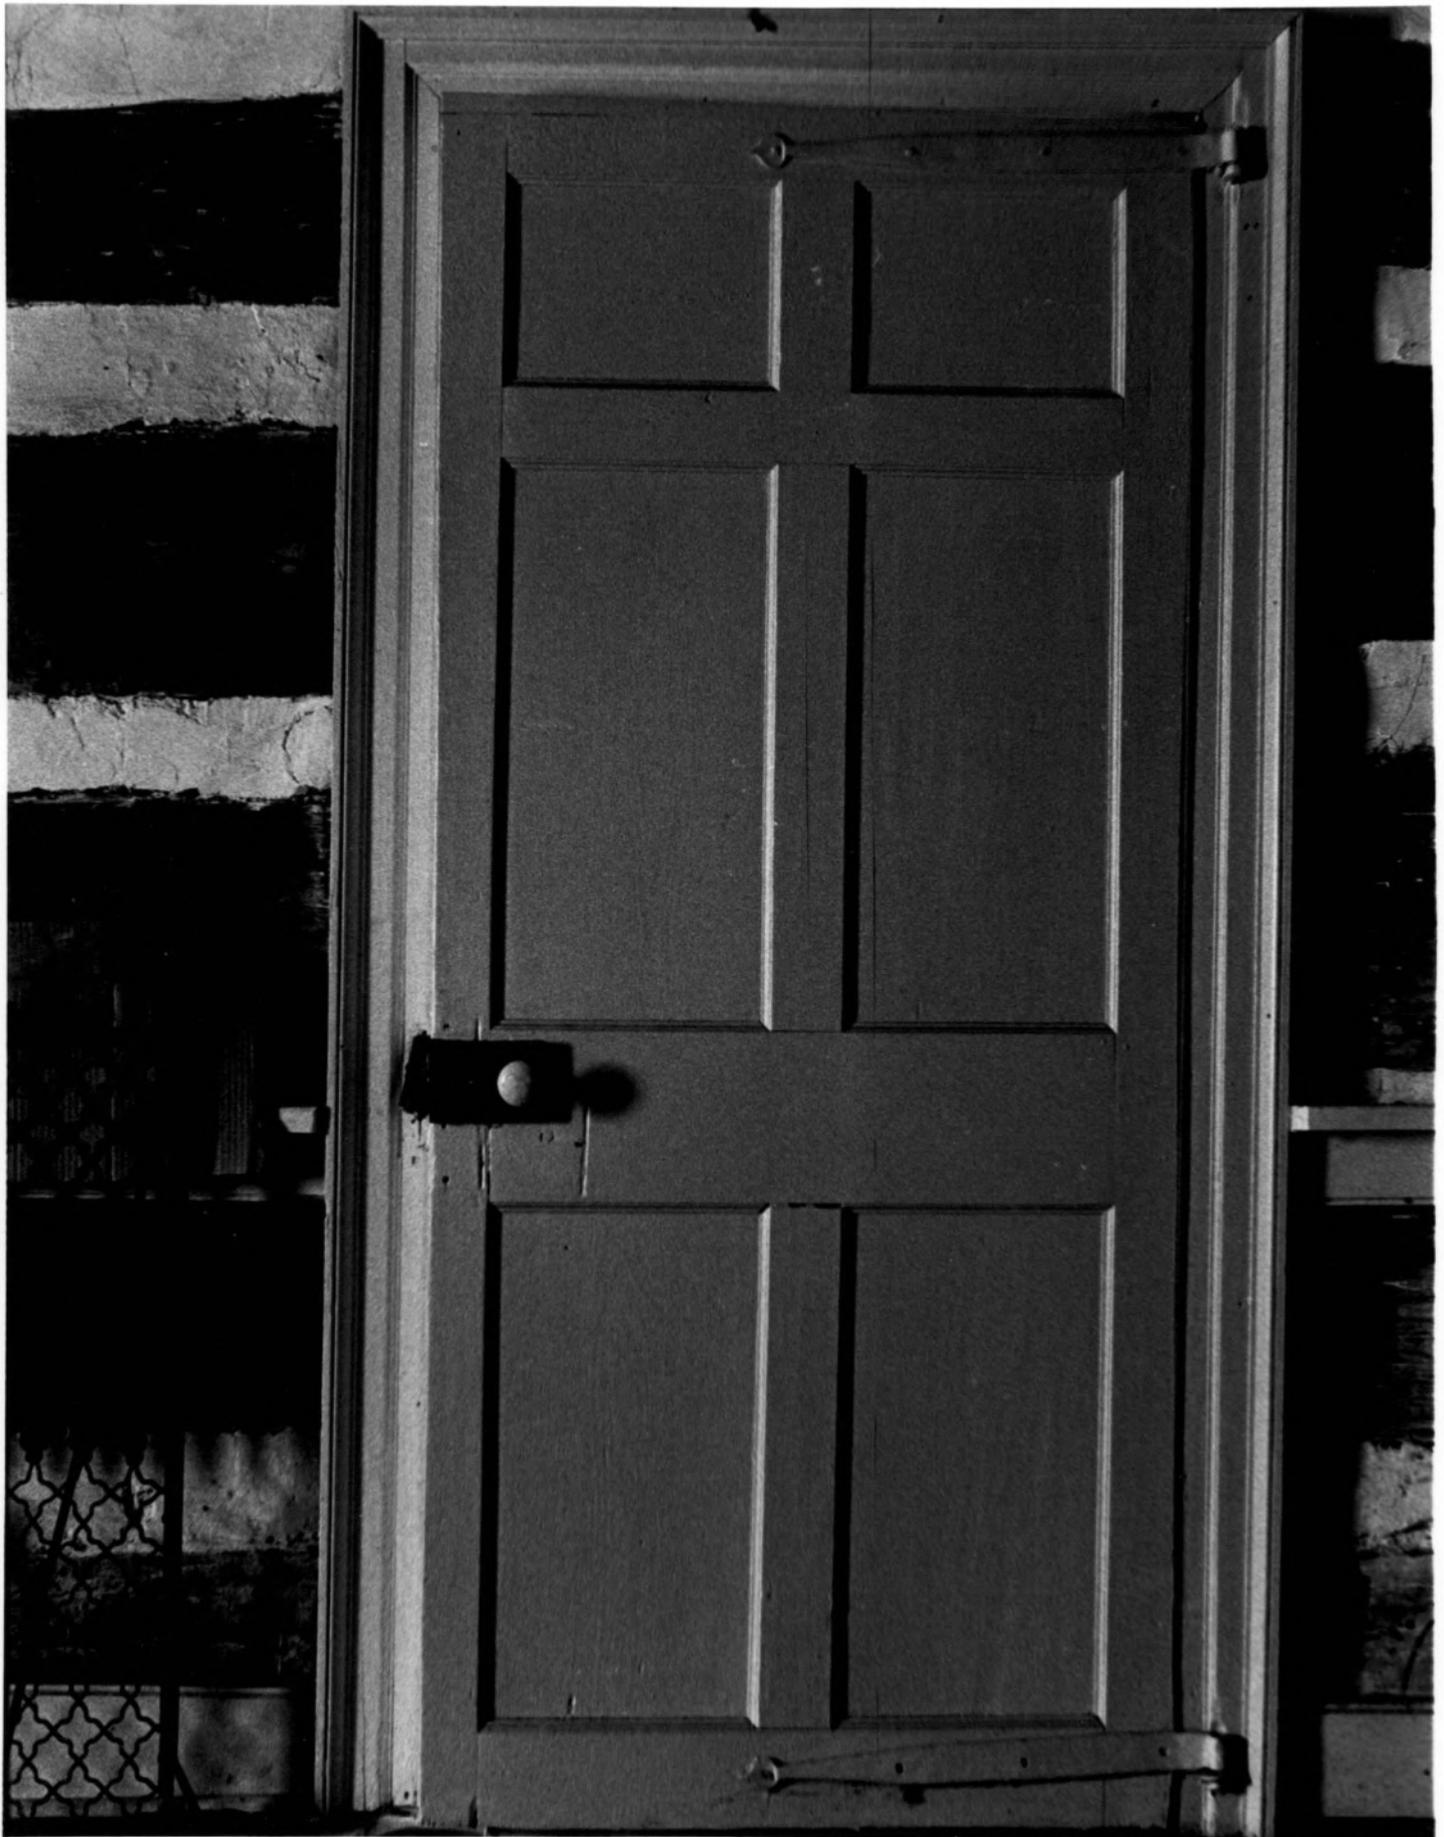
#6 of 9

view from the east showing door to
central hall from parlor-dining room.

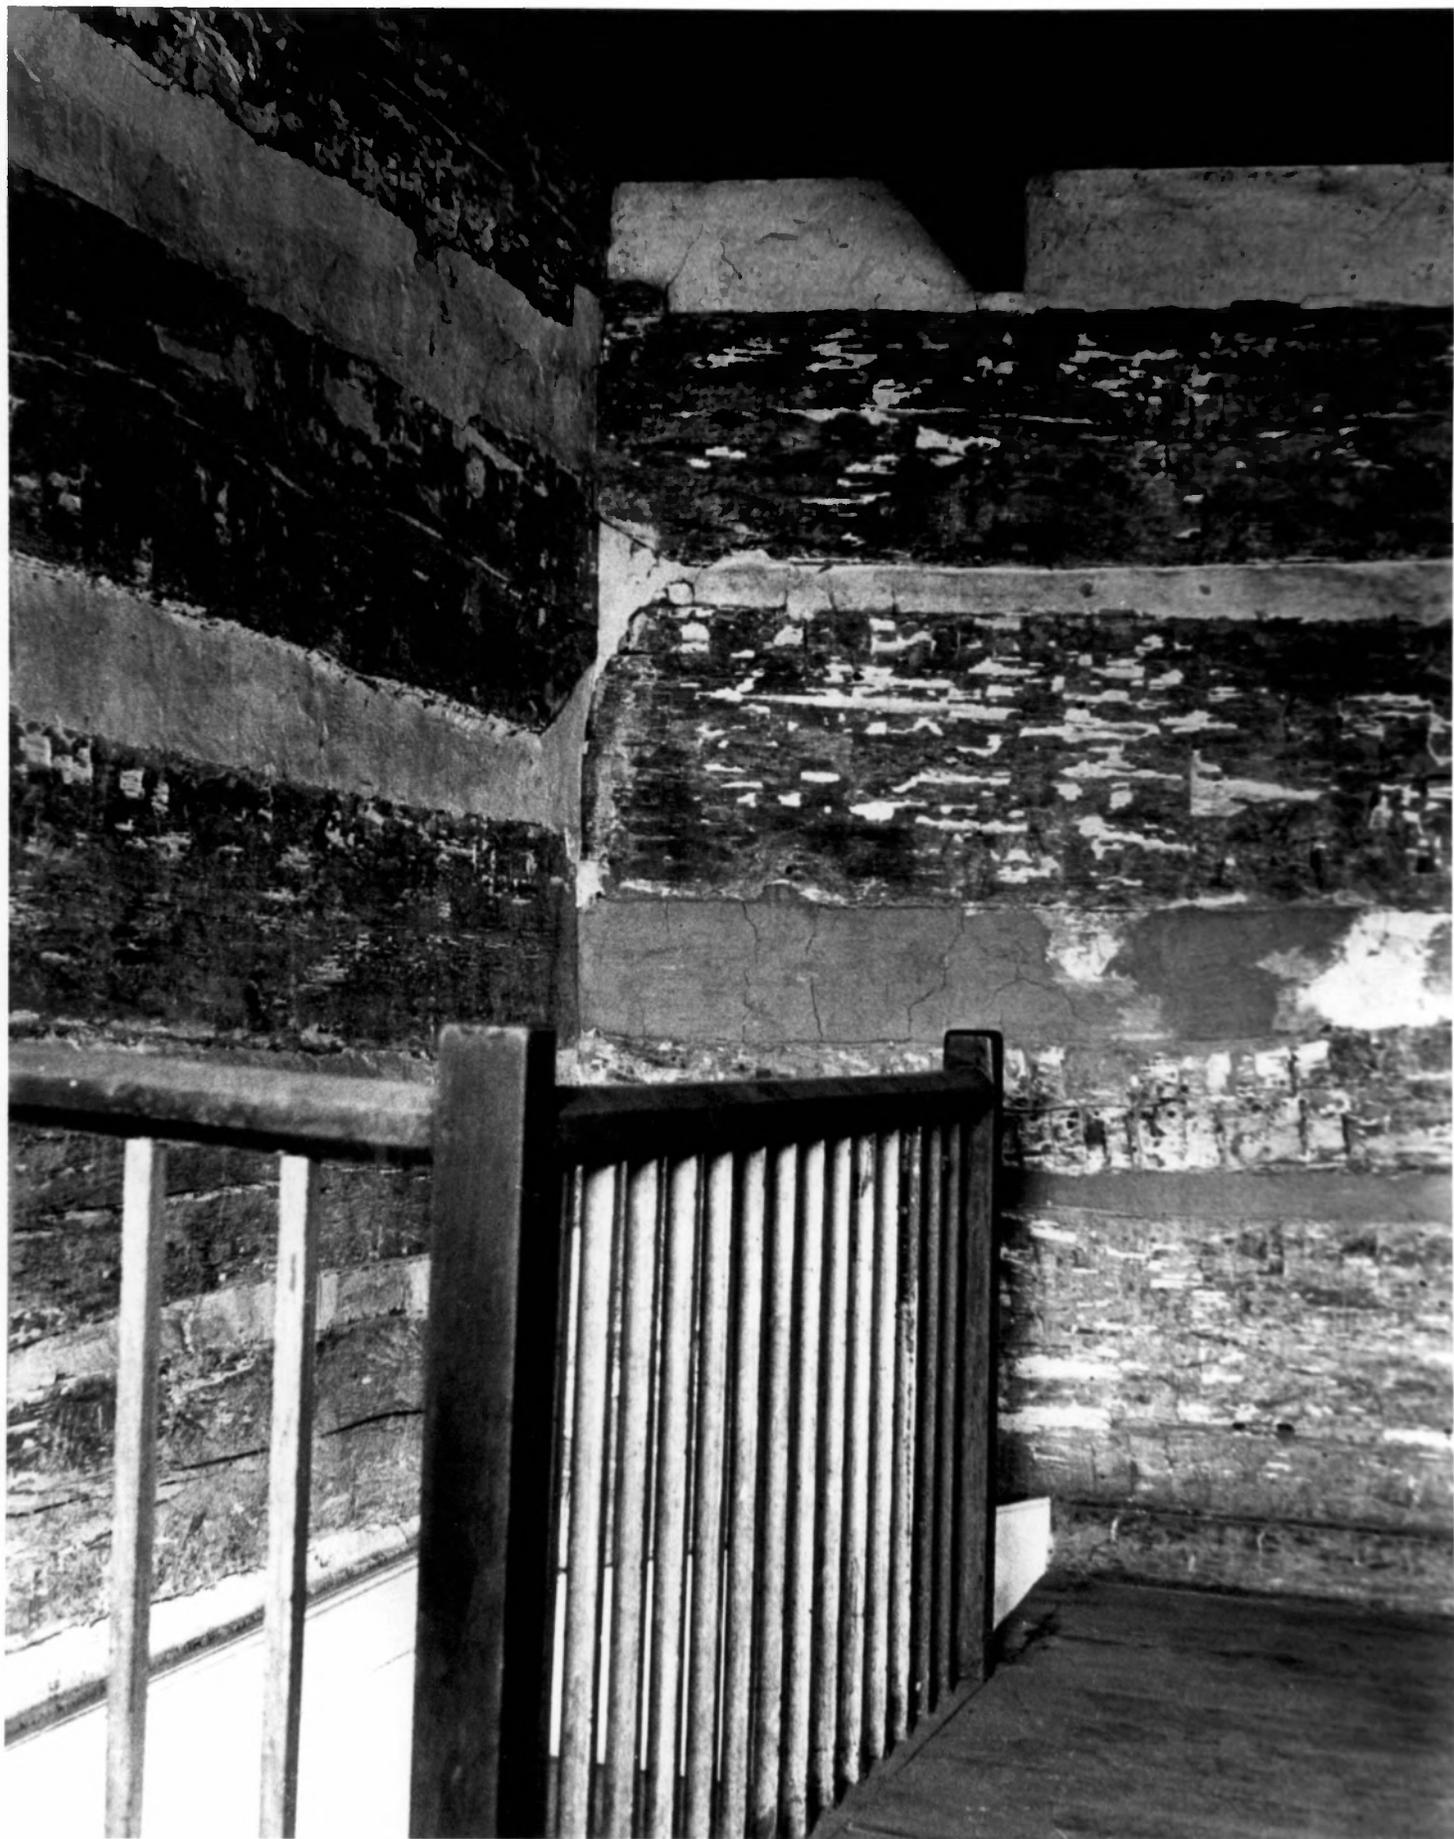
#7 of 9

view from the north showing second
floor stairwell to the central hall
