National Register of Historic Places
Inventory—Nomination Form

historic Shobe-Morrison House

7. Description

8. Significance

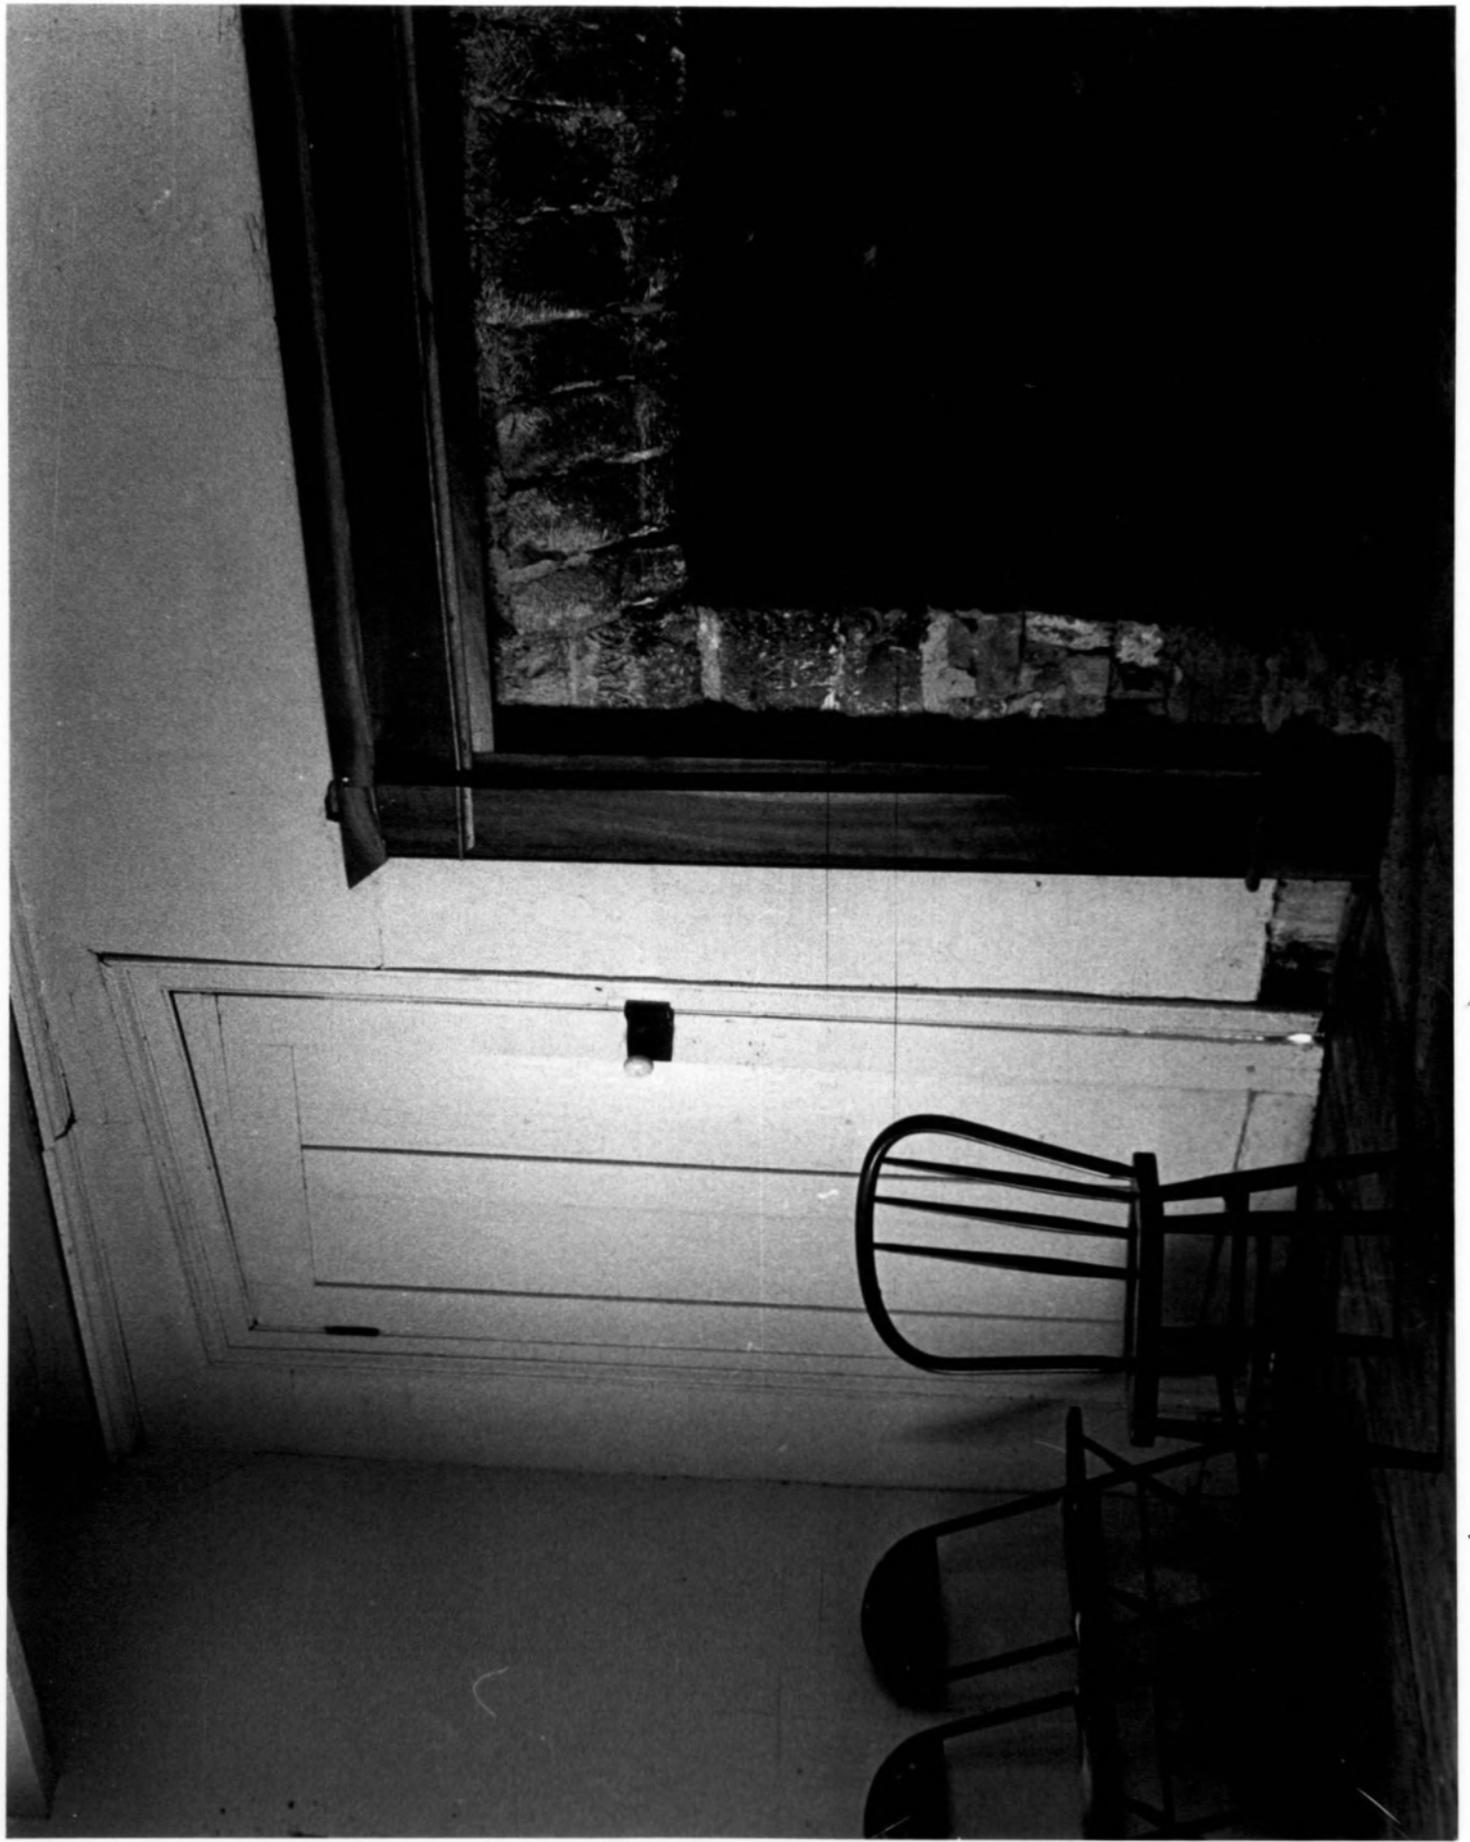
#8 of 9

view from the northeast showing fire-
place, mantel and exterior door in
Western parlor.

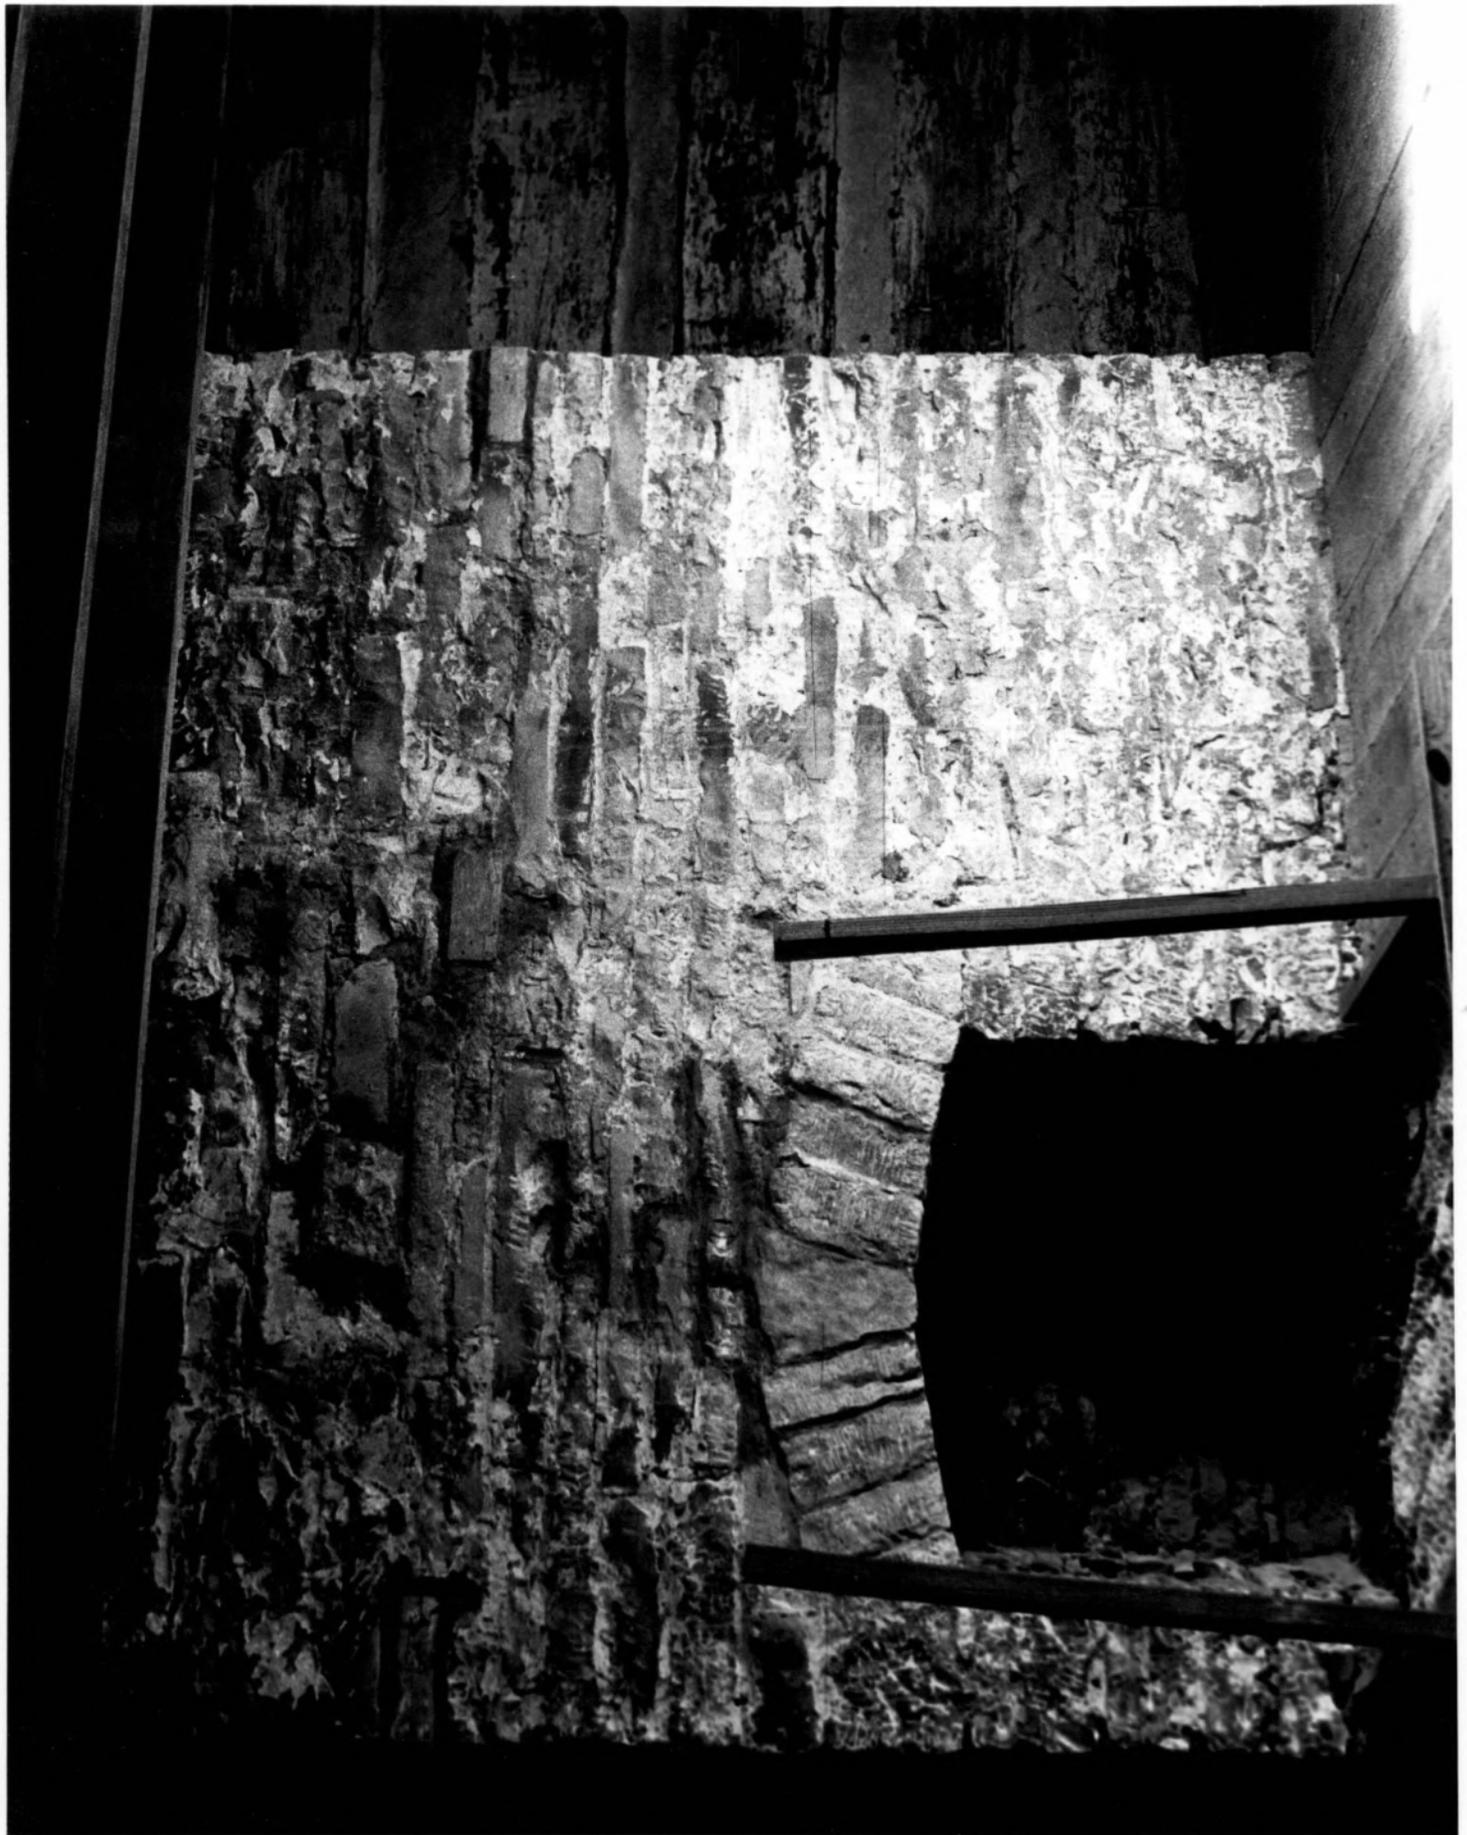
#9 of 9

view from the west showing fireplace
Eastern second floor bedroom.

The second floor of the eastern section reveals a large sleeping quarters with stone fireplace. Some renovation has been done on the fireplace but it is largely intact. A closet to the left of the fireplace has been removed. The log walls in this room and the support beams were white-washed but have been stripped. Two windows, still intact, are six panes each. The original floor remains in this area. Renovation work is progressing on the fireplace and sandbox.
