HISTORIC SOUTHSIDE COMMERCIAL AREA

MISSOURI HISTORIC PROPERTY INVENTORY FORM

REFERENCE NUMBER CO AS003-001		A. HISTORIC NAME					
B. COUNTY 054 Cole		C. OTHER NAME(S)					
D. ADDRESS 102 East Ashley Street			E. CITY Jefferson City		F. VICINITY <input type="checkbox"/>	G. RESTRICTED	H. ACREAGE

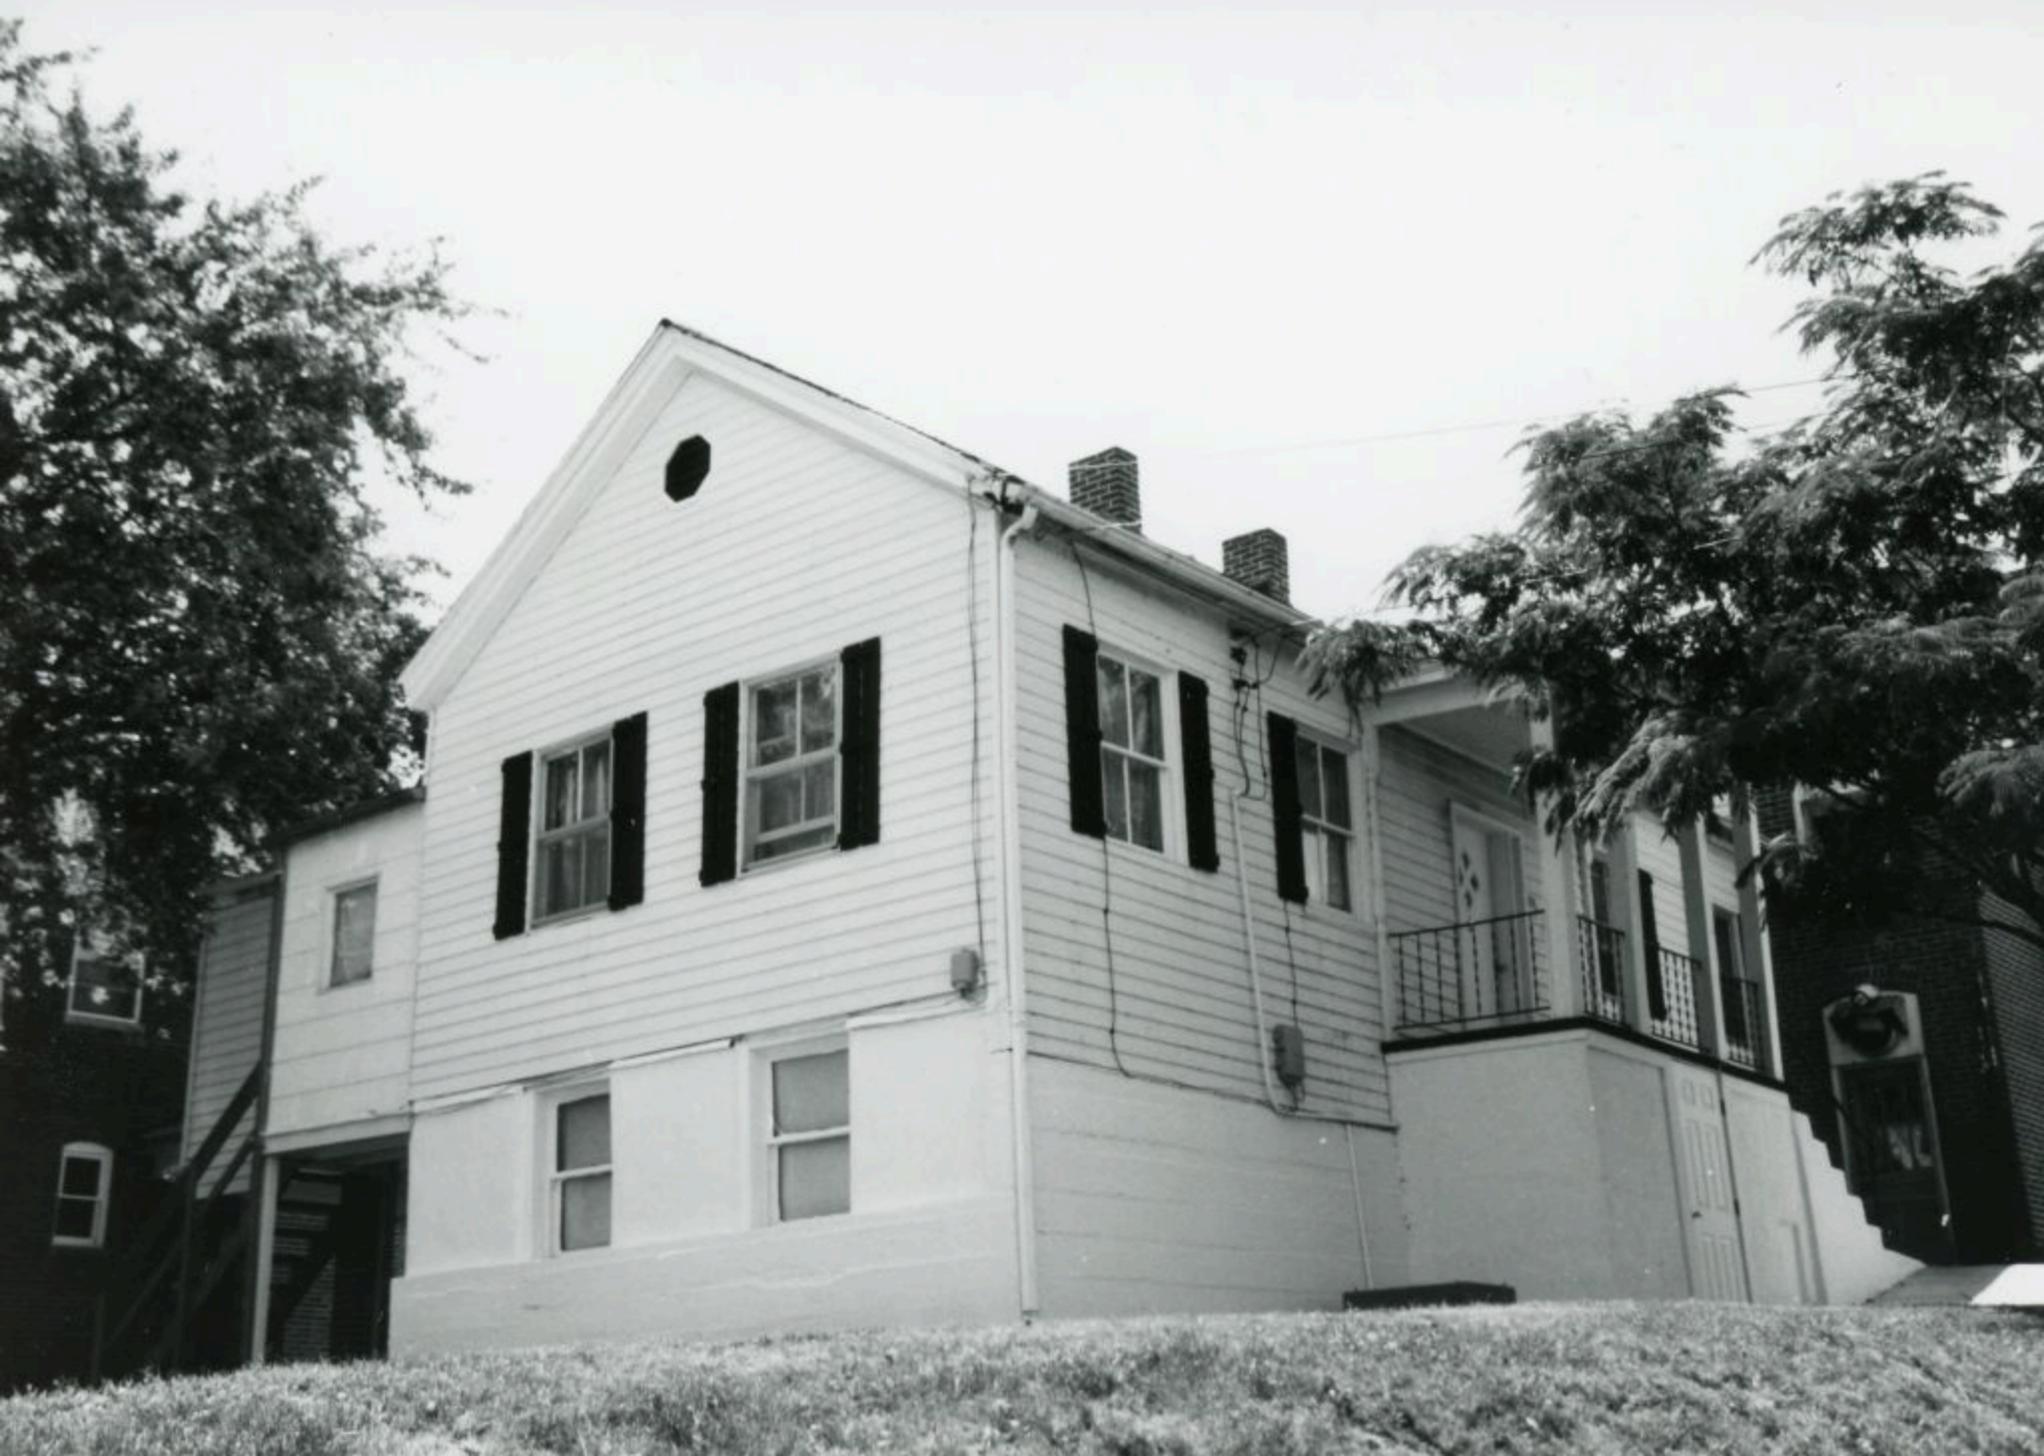
1 story on high basement. central passage/single pile type. irregular L-plan, 5 bay symmetrical facade. parged concrete over stone foundation, artificially sided (vinyl) walls. side gable (asphalt shingle) roof. blind raised basement exposed on east half; center gable roof portico set on high foundation with modern at-grade entry, portico with two turned wood pilasters and single scroll sawn side bracket attached to house, four modern wood posts and modern metal railing, west side concrete/parged steps; entry with modern door and sidelights, flanking 2/2 windows with modern slat blinds in end bays, narrow overhanging wood boxed eaves and two center brick ridge chimneys. windows as 2/2, 1/1 double hung some with modern slat blinds. west elevation attached to 801 Jefferson Street. east elevation as gable end; raised basement with two modern 1/1 windows, 1st-story with two 2/2 windows with blinds, gable with modern hexagonal vent. original L-plan rear to west with gable end wing with brick interior end ridge chimney, paired 2/2 to west and very small modern window to east (infills original opening), exposed stone basement with 2-light and clapboard infilled openings, small hyphen connection to 801 Jefferson with 1/1 window; east half with frame addition raised on brick and wood piers, small recessed enclosed porch on corner with south facing wood stairs.

The 1908 Sanborn Map does not cover this area. The 1923 and 1939 maps are similar; they show the L-plan dwelling with center portico and attached to 801 Jefferson (stores).

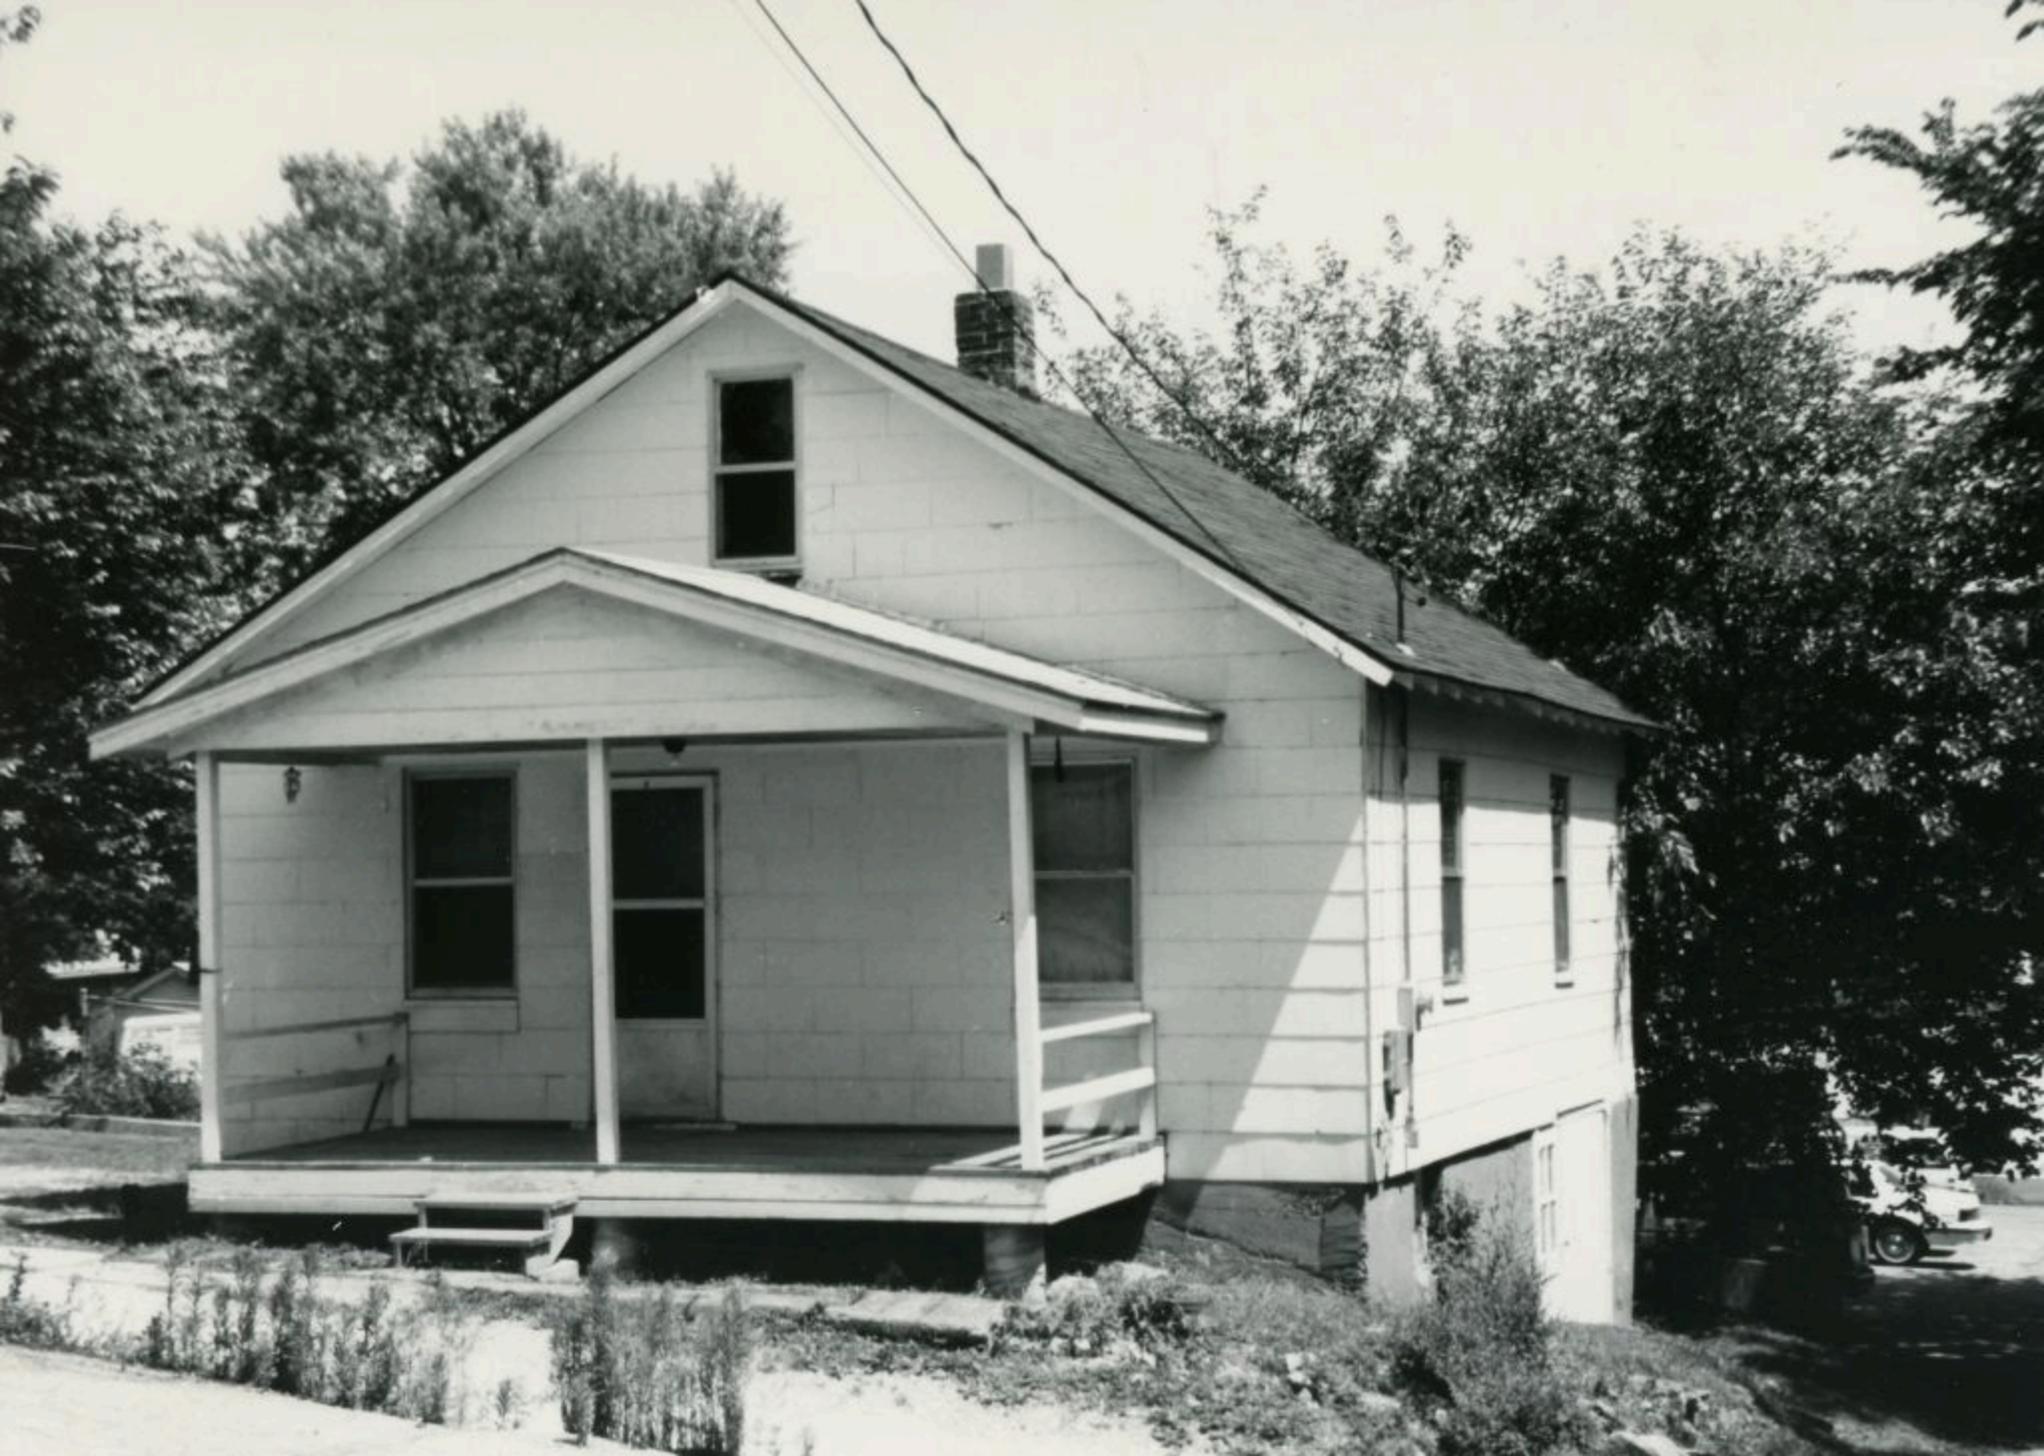
1-1/2 stories. open gable type. rectangular plan. poured concrete foundation, asbestos shingle sided walls. gable (asphalt shingle) roof. three-quarter width gable roof porch with three modern thin posts and modern horizontal wood railing on sides only, wood deck and steps; off-center (to north) door with flanking 1/1 windows; 1/1 in gable, wide overhanging eaves, center ridge chimney. windows as 1/1 double hung. north elevation with infilled opening to west (wood and air-conditioner), paired 1/1 to east, overhanging open eaves with exposed rafter tails. south elevation with two 1/1 windows, exposed basement with at-grade door and infilled garage opening. rear with raised shed roof enclosed (bead board and asbestos shingle siding, 1/1 and casement windows) porch with modern platform and steps on northeast corner, boarded opening in house gable.

The 1908 Sanborn Map does not cover this area. This building does not appear on the 1923 map. The 1939 map shows the dwelling (#110-1/2) with a garage in the basement and front and rear porches.

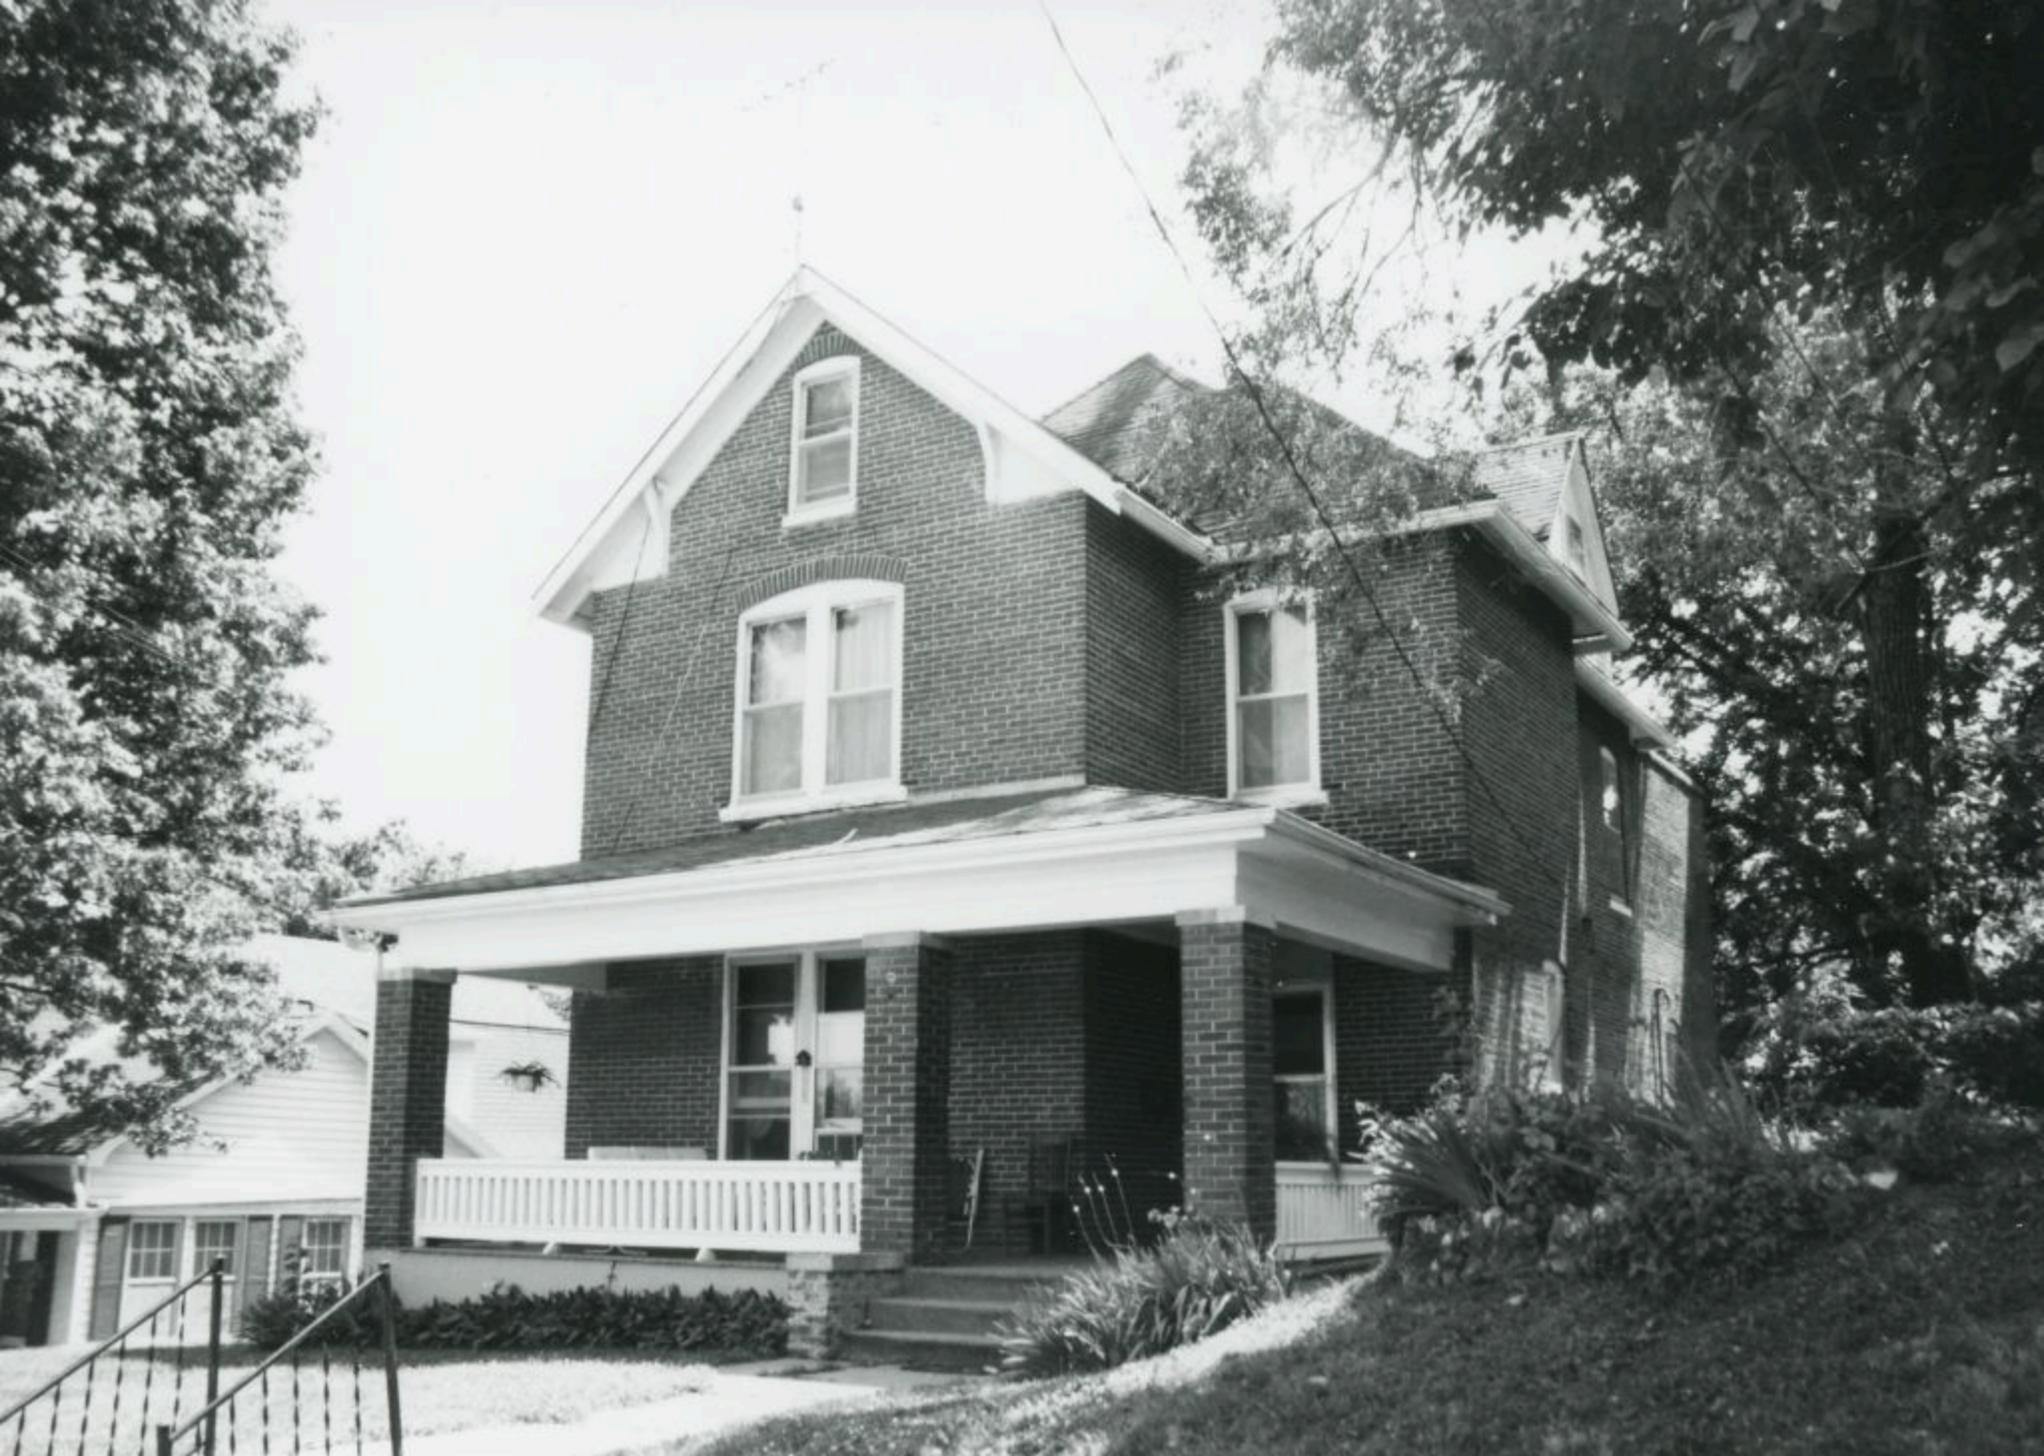
2-1/2 stories. Queen Anne influence. L-plan, 2 bay asymmetrical facade. Limestone foundation, brick walls. Hip & gable (asphalt shingle) roof. Left/east bay as lower projecting gable roof pavilion with paired 1/1 windows on 1st & 2nd stories; gable with single 1/1, rake boards & plain cornice with flat return ending at angled brackets. Right/west re-entrant bay with entry; 1/1 window above. Early 20th-century full-facade L-plan hip roof porch wraps around recessed right/west section with 3 brick piers with concrete caps, raised wood slat open rail & raised wood deck, plain entablature. 1/1 double hung windows with incised heads on facade, soldier segmental arches & stone lug sills; side elevations with double rowlock segmental arches. East elevation with interior end chimney, small 1-story square brick bay toward rear with single windows on front/north & side/east; second story rear of this elevation is clapboard (the east end of a second story rear sleeping porch). Recessed wing off west side with blind 2nd-story toward rear; west gable roof dormer with wood shingles & small 1/1. 1-story rear porch; clapboard section above is sleeping porch.

The 1908 Sanborn Map does not show this block. Shown on the 1923 Sanborn Map (as 118) with a wrap-around or L-shaped porch, as is extant. Southeast corner wing attached at rear. No outbuildings. Same on 1939 Sanborn Map.

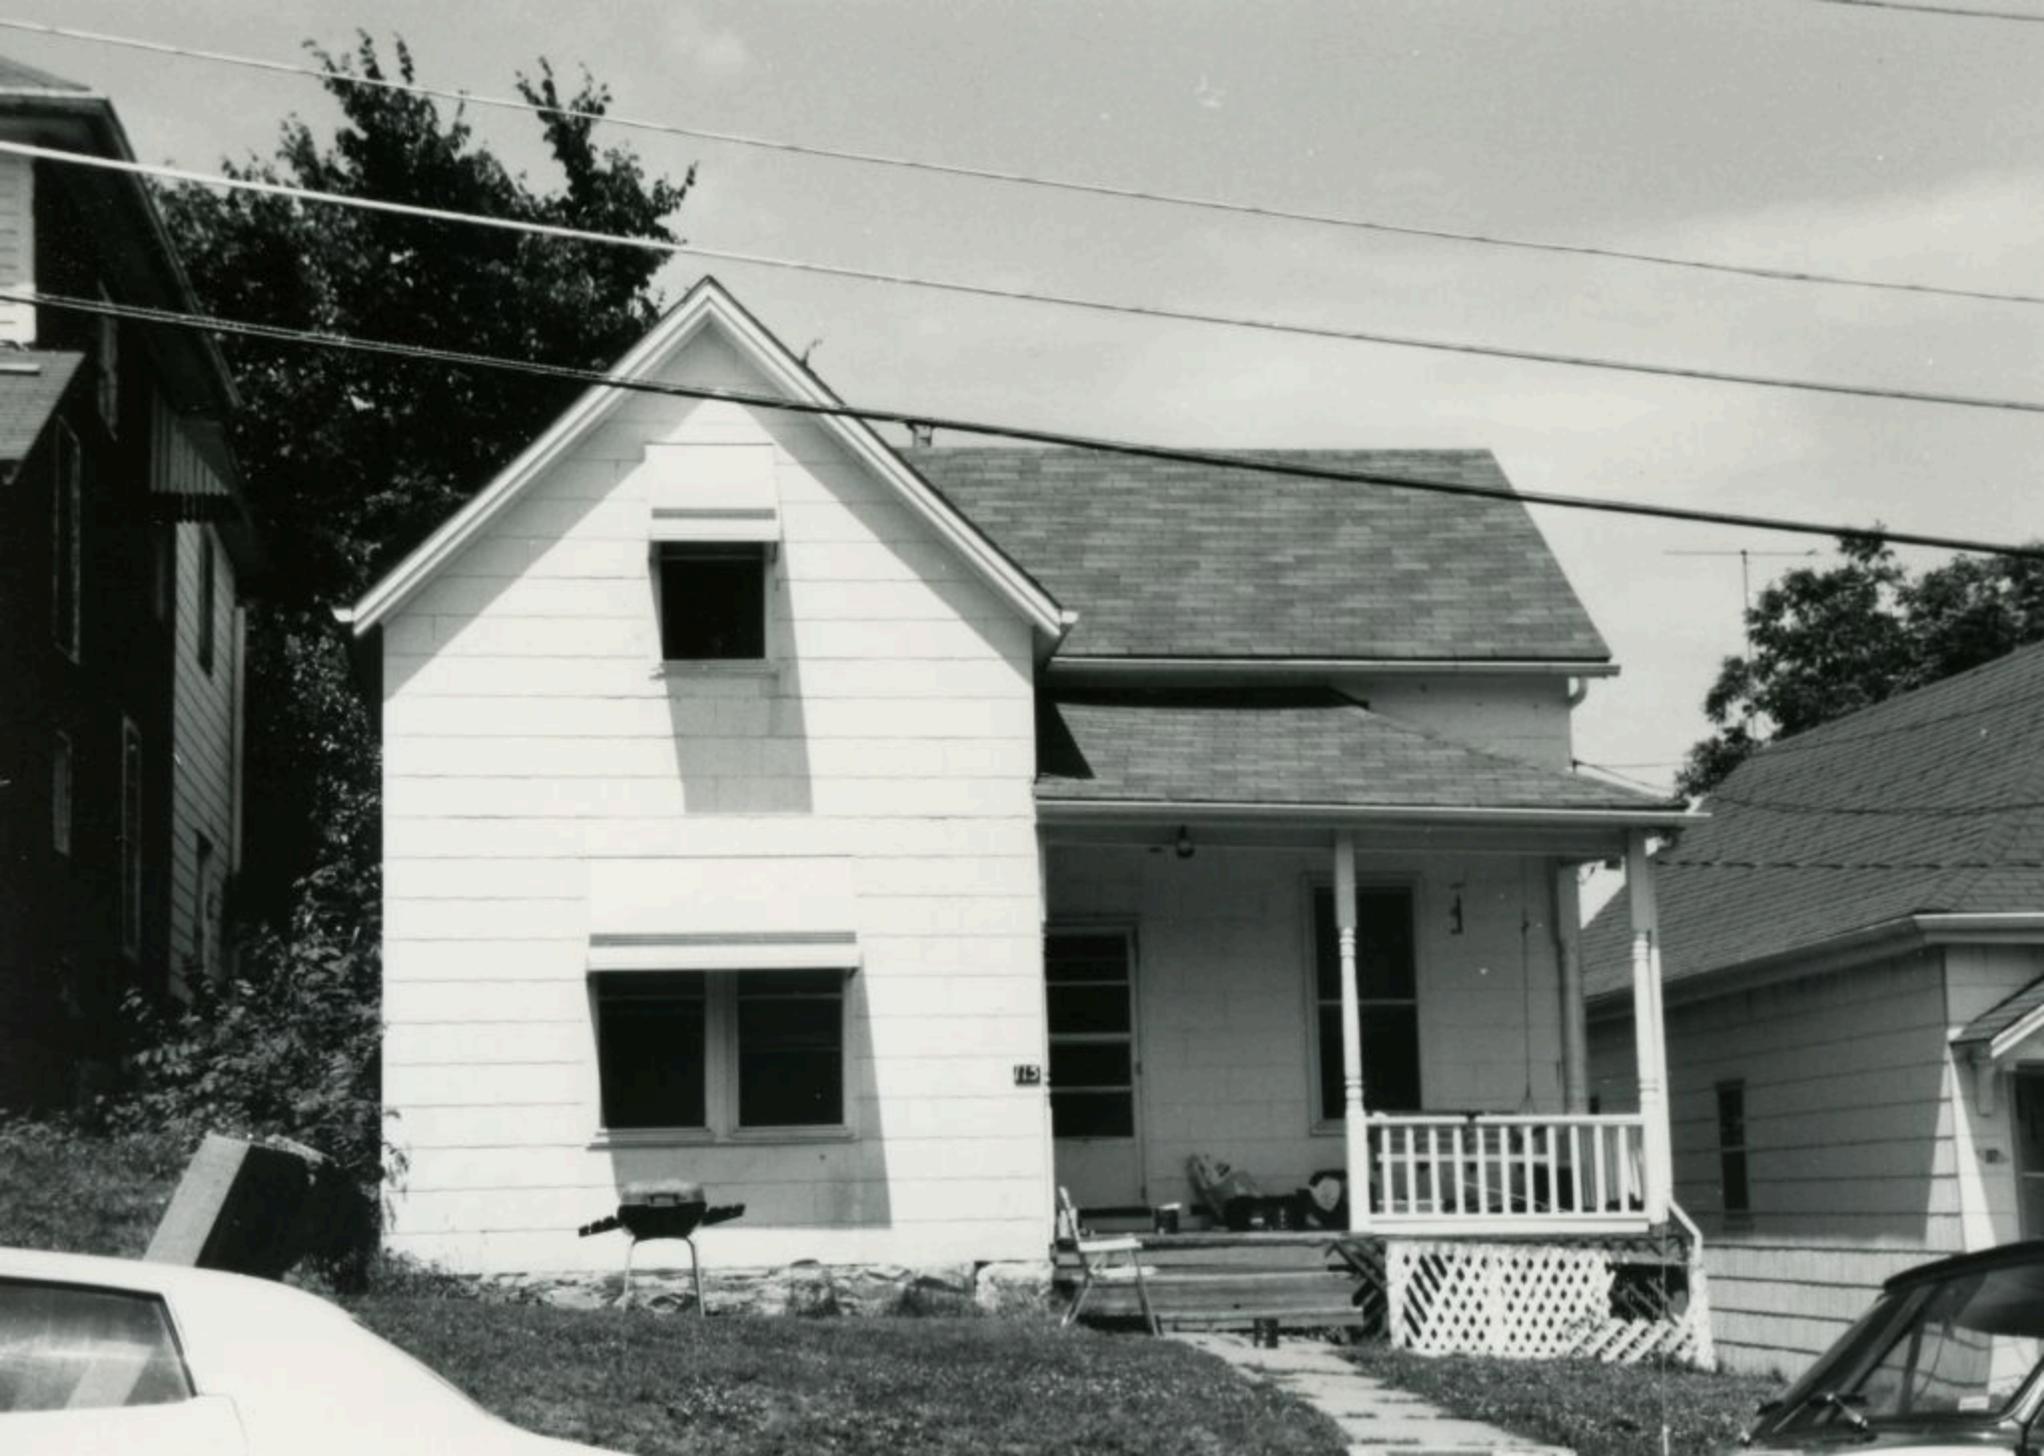
1-1/2 stories. gabled ell type. L-plan, 2 bay asymmetrical facade. rubble stone foundation, asbestos shingle sided walls. cross gable (asphalt shingle) roof. quarter hip roof porch in east bay re-entrant corner with two turned wood posts and two pilasters, wood slat railing, wood deck and steps, narrow frieze; modern door in corner facing south with window to east. west bay as projecting gable roof pavilion with center paired 1/1 windows, window in upper story, both with modern metal awnings, narrow overhanging boxed eaves. windows as 1/1 double hung. east elevation gable end with exposed basement with entry, 1/1 window per story. west elevation with two windows.

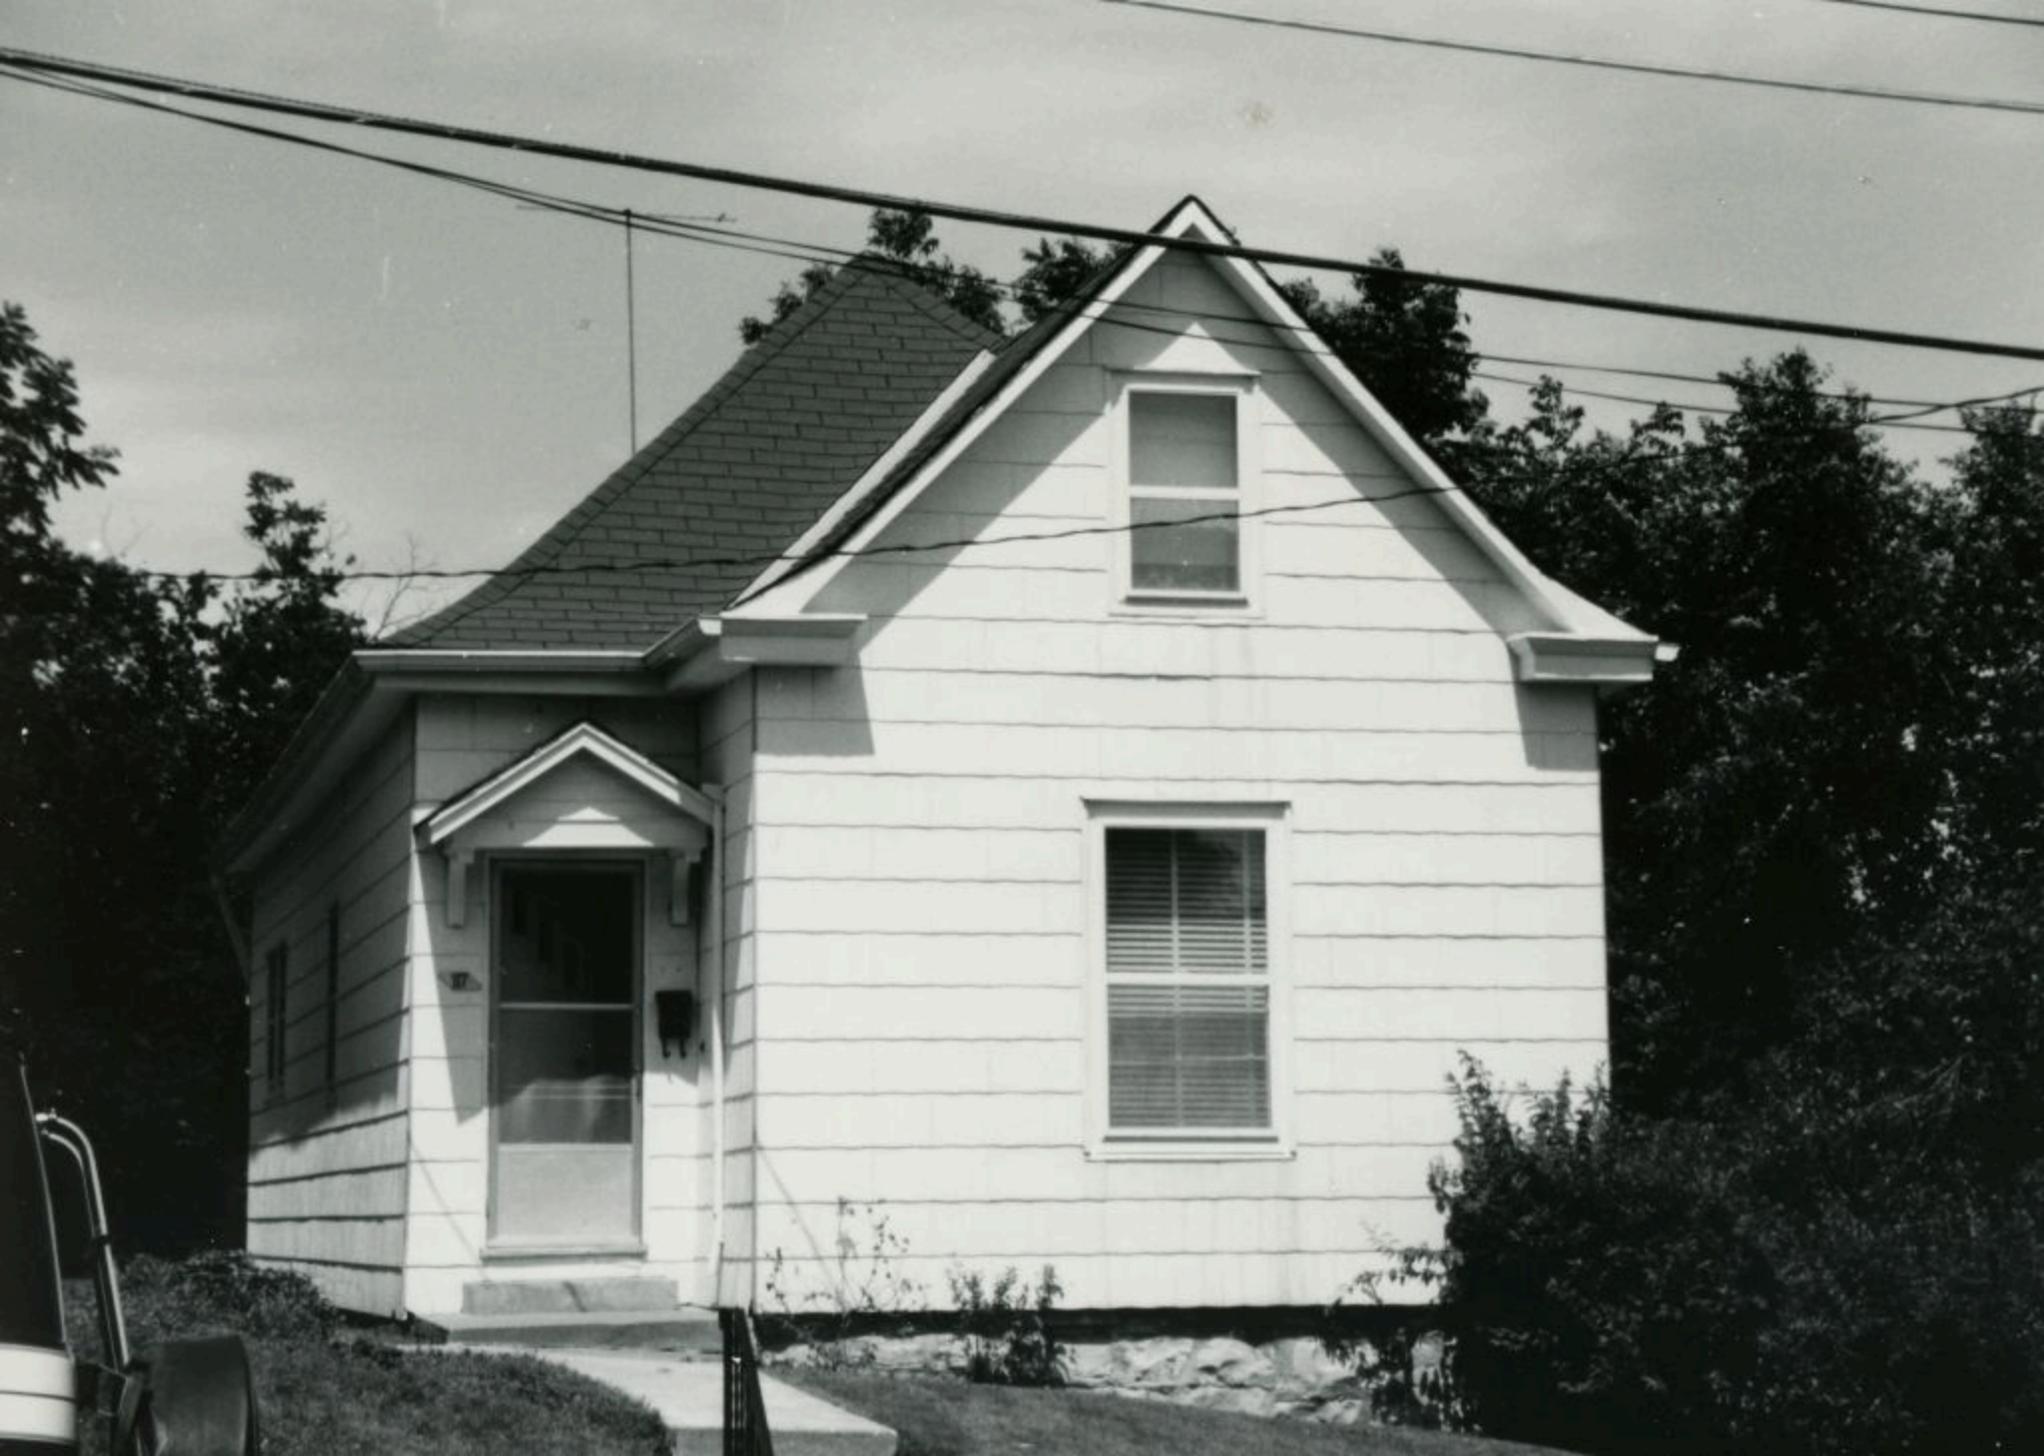
REFERENCE NUMBER	A. HISTORIC NAME	B. COUNTY	C. ADDRESS
		051/Cole	117 East Ashley Street
<p>Photograph Negative Roll: 4 Frame: 36</p>			
<p><u>2.X. Further Description</u></p>			
<p>1-1/2 stories. composite type (gable on hip cottage). L-plan, 2 bay asymmetrical facade. rubble stone foundation, asbestos shingle sided walls. hip and gable (asphalt shingle) roof. east bay as lower projecting gable roof pavilion with center 1/1 window and 1/1 in gable, narrow overhanging boxed eaves with cornice returns, slight bell cast to roof; narrow west bay with modern door with gable hood on small curved brackets, concrete stoop and step. windows as 1/1 double hung with wood surrounds and drip caps. west elevation with small central 1/1, small paired 1/1 to north. east elevation with three 1/1 symmetrically placed windows, exposed basement.</p>			
<p><u>2.Y. Description of Environment and Outbuildings</u></p>

<p>Set on rise, ground slopes down to east, lower level parking lot to east behind high concrete retaining wall No outbuildings</p>			
<p><u>T. Significance</u></p>			
<p>1908 <i>City Directory</i>: #121: Louis & Hortence Schneider, fireman with MoPac 1915 <i>City Directory</i>: #121: Ernest Alsbaugh 1925 <i>City Directory</i>: #121: John T. & Edith Saar, engineer 1935 <i>City Directory</i>: #121: James G. & Mary Johnson, furniture repair for Milo Walz</p>			
<p>The 1908 Sanborn Map shows this 1-1/2 story dwelling with west corner porch and addressed as #121. The 1923 and 1939 maps are similar.</p>

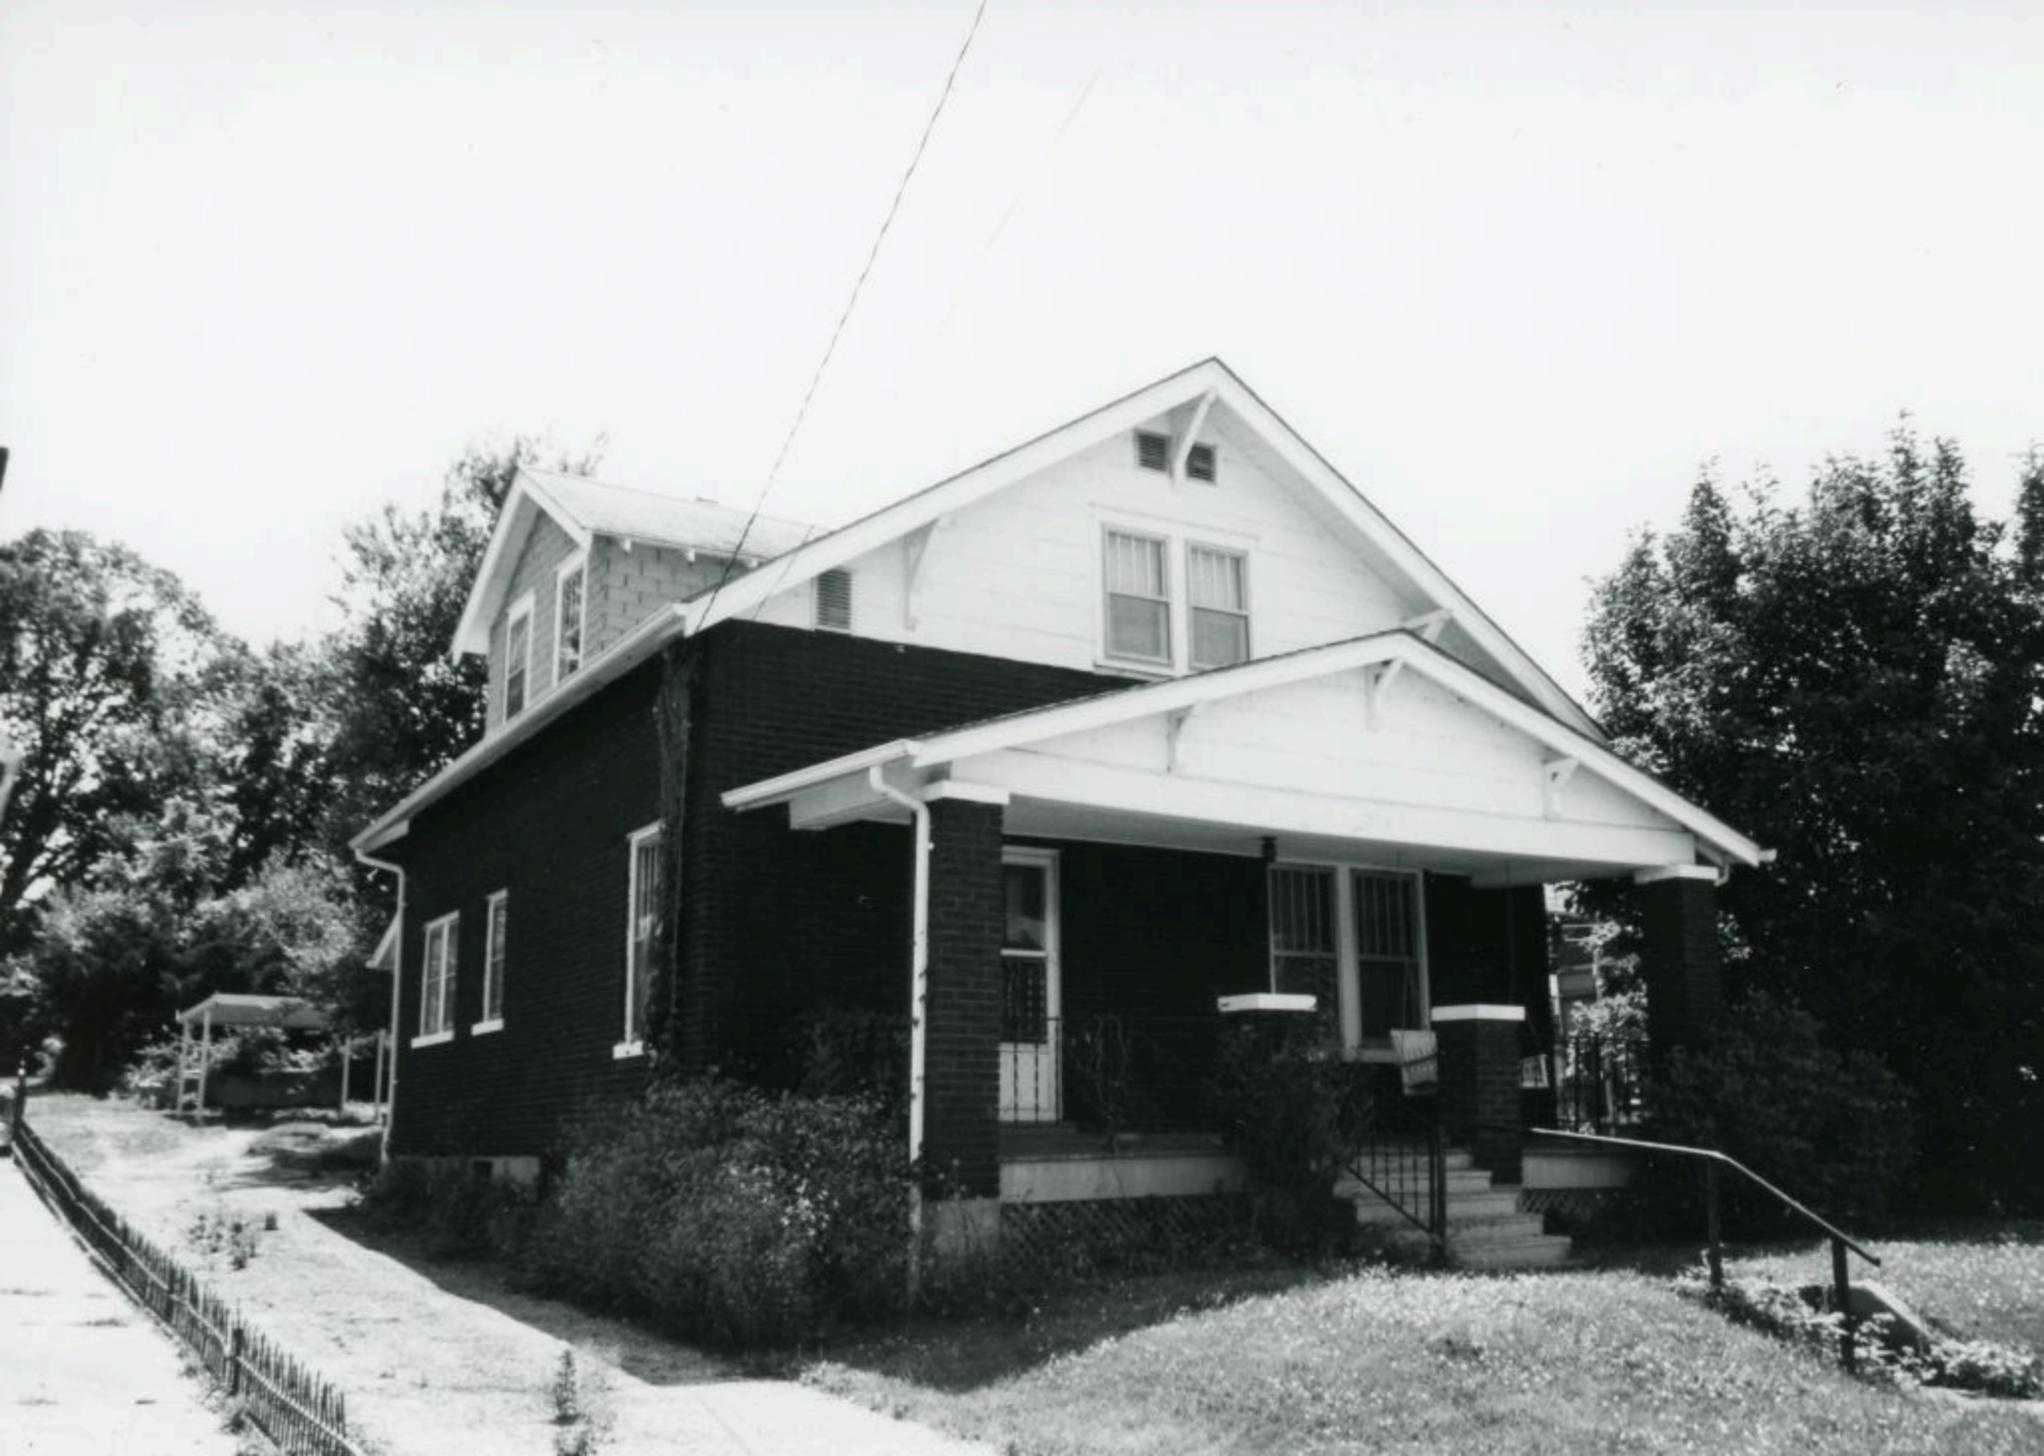
1-1/2 stories. Open Gable vernacular type. Rectangular plan, 2 bay facade. Poured concrete foundation, brick (wire-cut) walls. Gable (asphalt shingle) roof. Left/east 3-light oak door & right/west 5-vertical/1 paired windows; full-width gable roof porch with brick corner piers & center entry bay pedestals with concrete (painted) caps, modern metal railing, raised wood deck with lattice below, asbestos shingled gable with plain frieze & 3 braces. Asbestos shingled house gable with paired 4-vertical/1 windows, overhanging eaves with 3 braces, vents flank apex brace & in lower left & right corners. 4-vertical/1 double hung windows with painted concrete sills. East elevation with 3 asymmetrical bays: far south bay with small window pair, middle bay with single small window & right/north end bay with regular window; center asbestos shingled gable roof dormer with 2 windows, overhanging open eaves with exposed rafter tails. Rear shed roof porch recessed from left/east elevation. Two bay west elevation with left/north single window & right/south window pair; similar gable roof dormer.

Not shown on 1923 Sanborn Map. Appears on the 1939 Sanborn Map. Shared corner lot with 200, now gone and replaced with modern gas station. House shown with full-facade front porch and rear porch. Rear lot garage at side alley.
