HISTORIC SOUTHSIDE COMMERCIAL AREA

MISSOURI HISTORIC PROPERTY INVENTORY FORM

REFERENCE NUMBER CO AS003-001		A. HISTORIC NAME					
B. COUNTY 054 Cole		C. OTHER NAME(S)					
D. ADDRESS 102 East Ashley Street			E. CITY Jefferson City		F. VICINITY <input type="checkbox"/>	G. RESTRICTED	H. ACREAGE

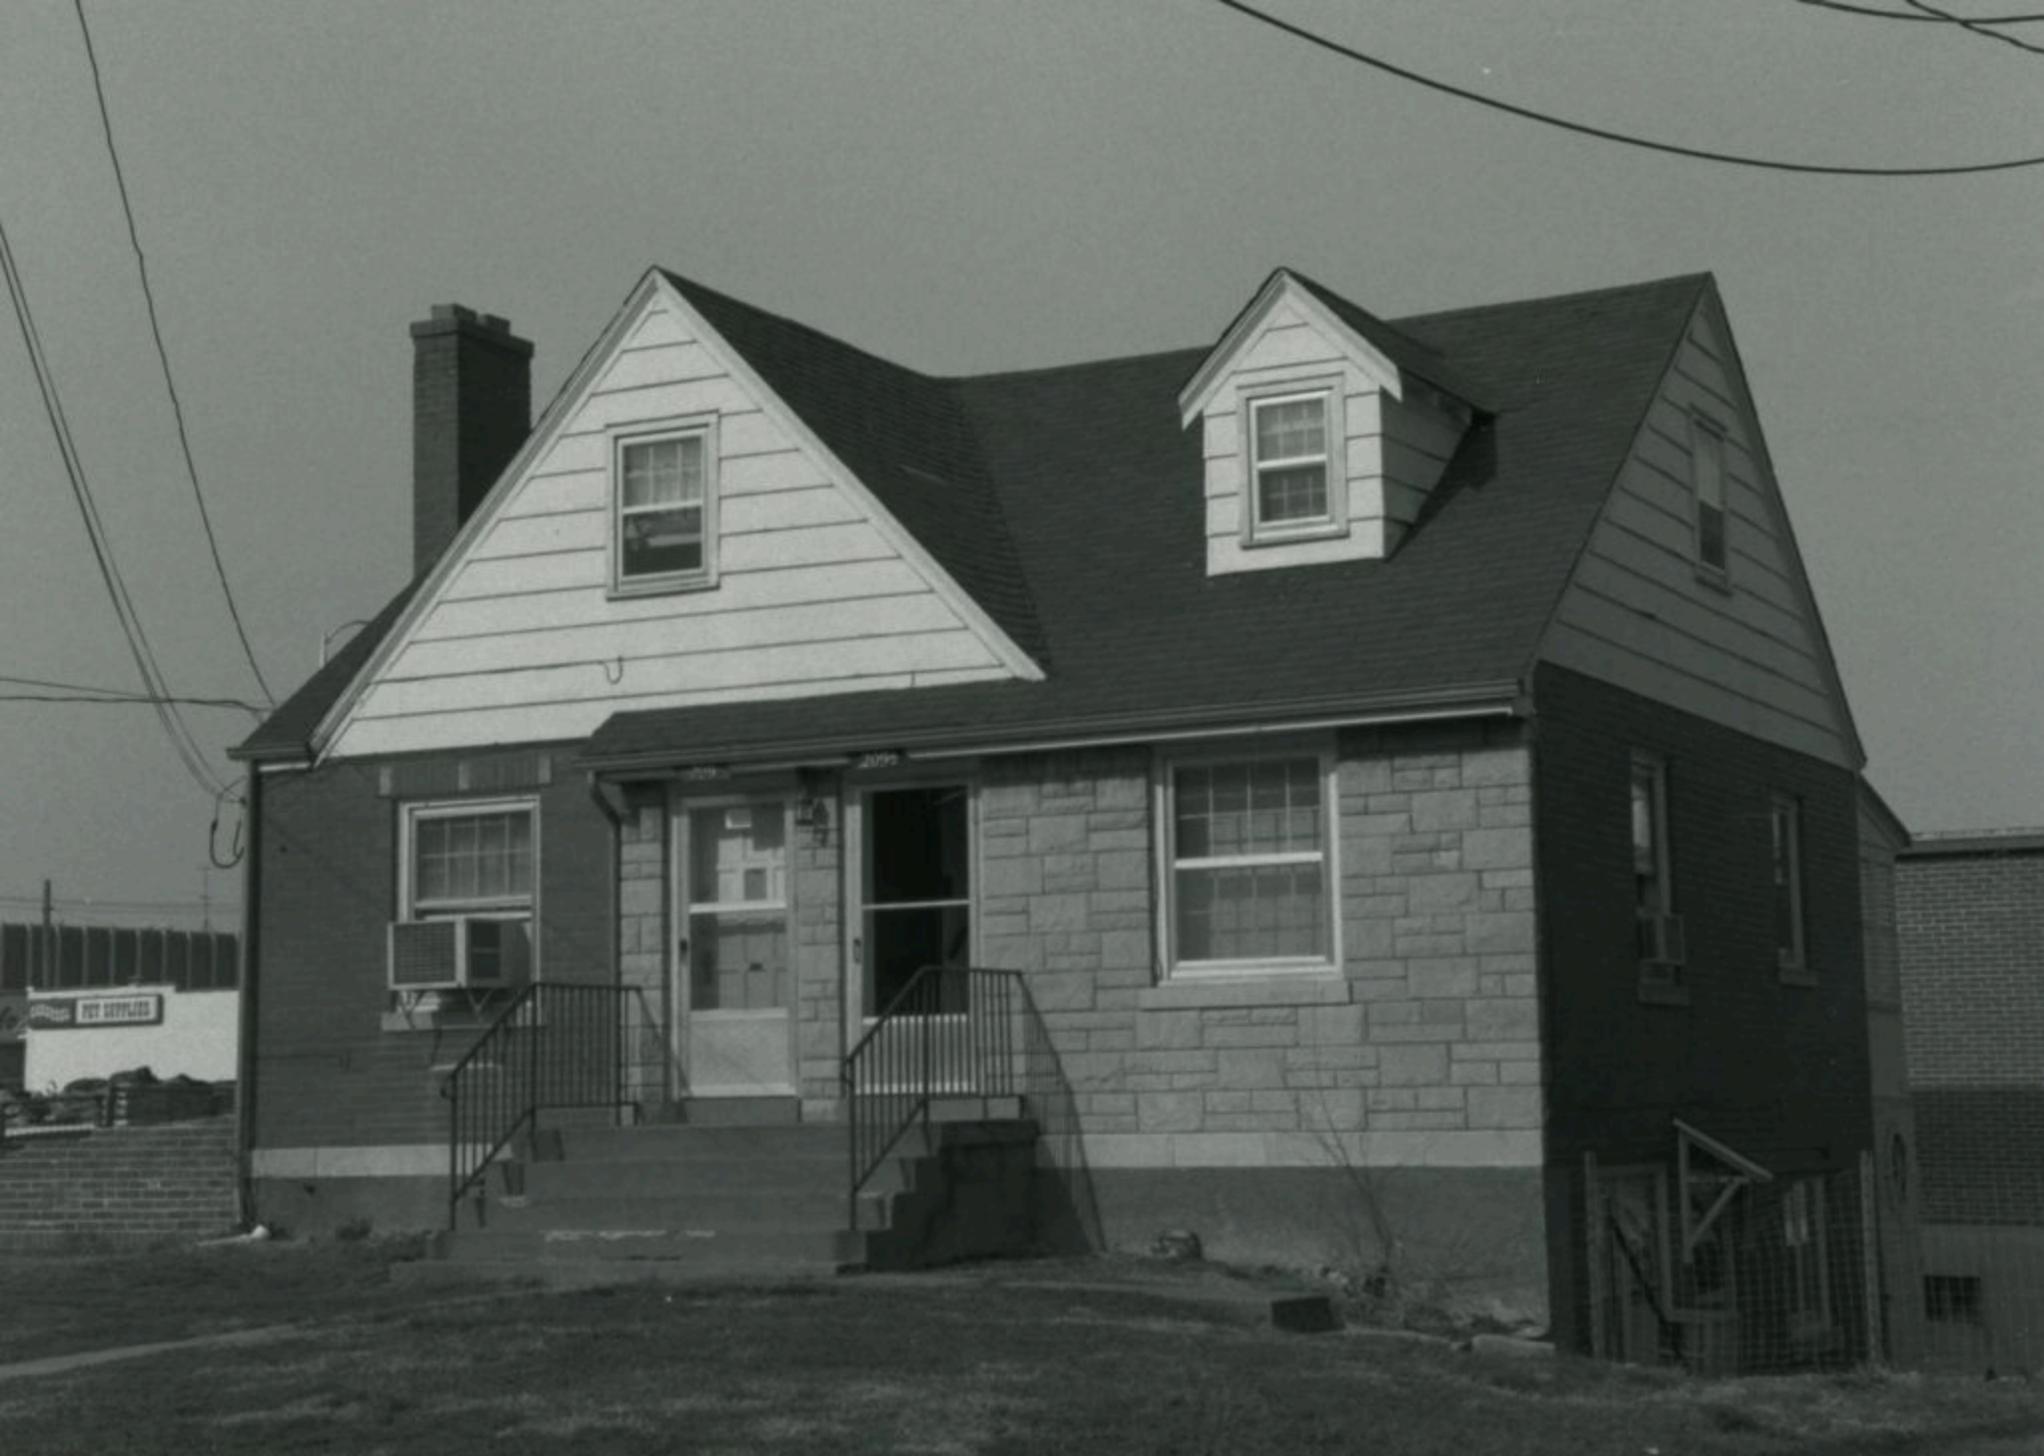
1-1/2 stories. Cape Cod Cottage. Rectangular plan, 3 bay asymmetrical facade. Concrete foundation with tooled limestone watertable; brick walls (west two thirds of facade with random ashlar cladding). Gable (asphalt shingle) roof. Central poured concrete steps with metal railings to paired multiple panel doors slightly protected by projecting eave, flanking 8/8 windows, west window with soldier flat arch with center & end "keystones"; weatherboard gable wall dormer at west end with smaller 6/6 window, gable dormer with 6/6 to east. Windows as 6/6, 8/8 double hung with concrete or limestone sills. East elevation with at-grade door with shed hood & flanking paired windows in basement level; 1st-story with 2 windows, weatherboard gable with single window. Shed roof rear porch enclosed with windows; shed roof asbestos shingle dormer with exposed rafter tails. West elevation with exterior end chimney.

Not shown on the 1939 Sanborn Map. No city directory listings.

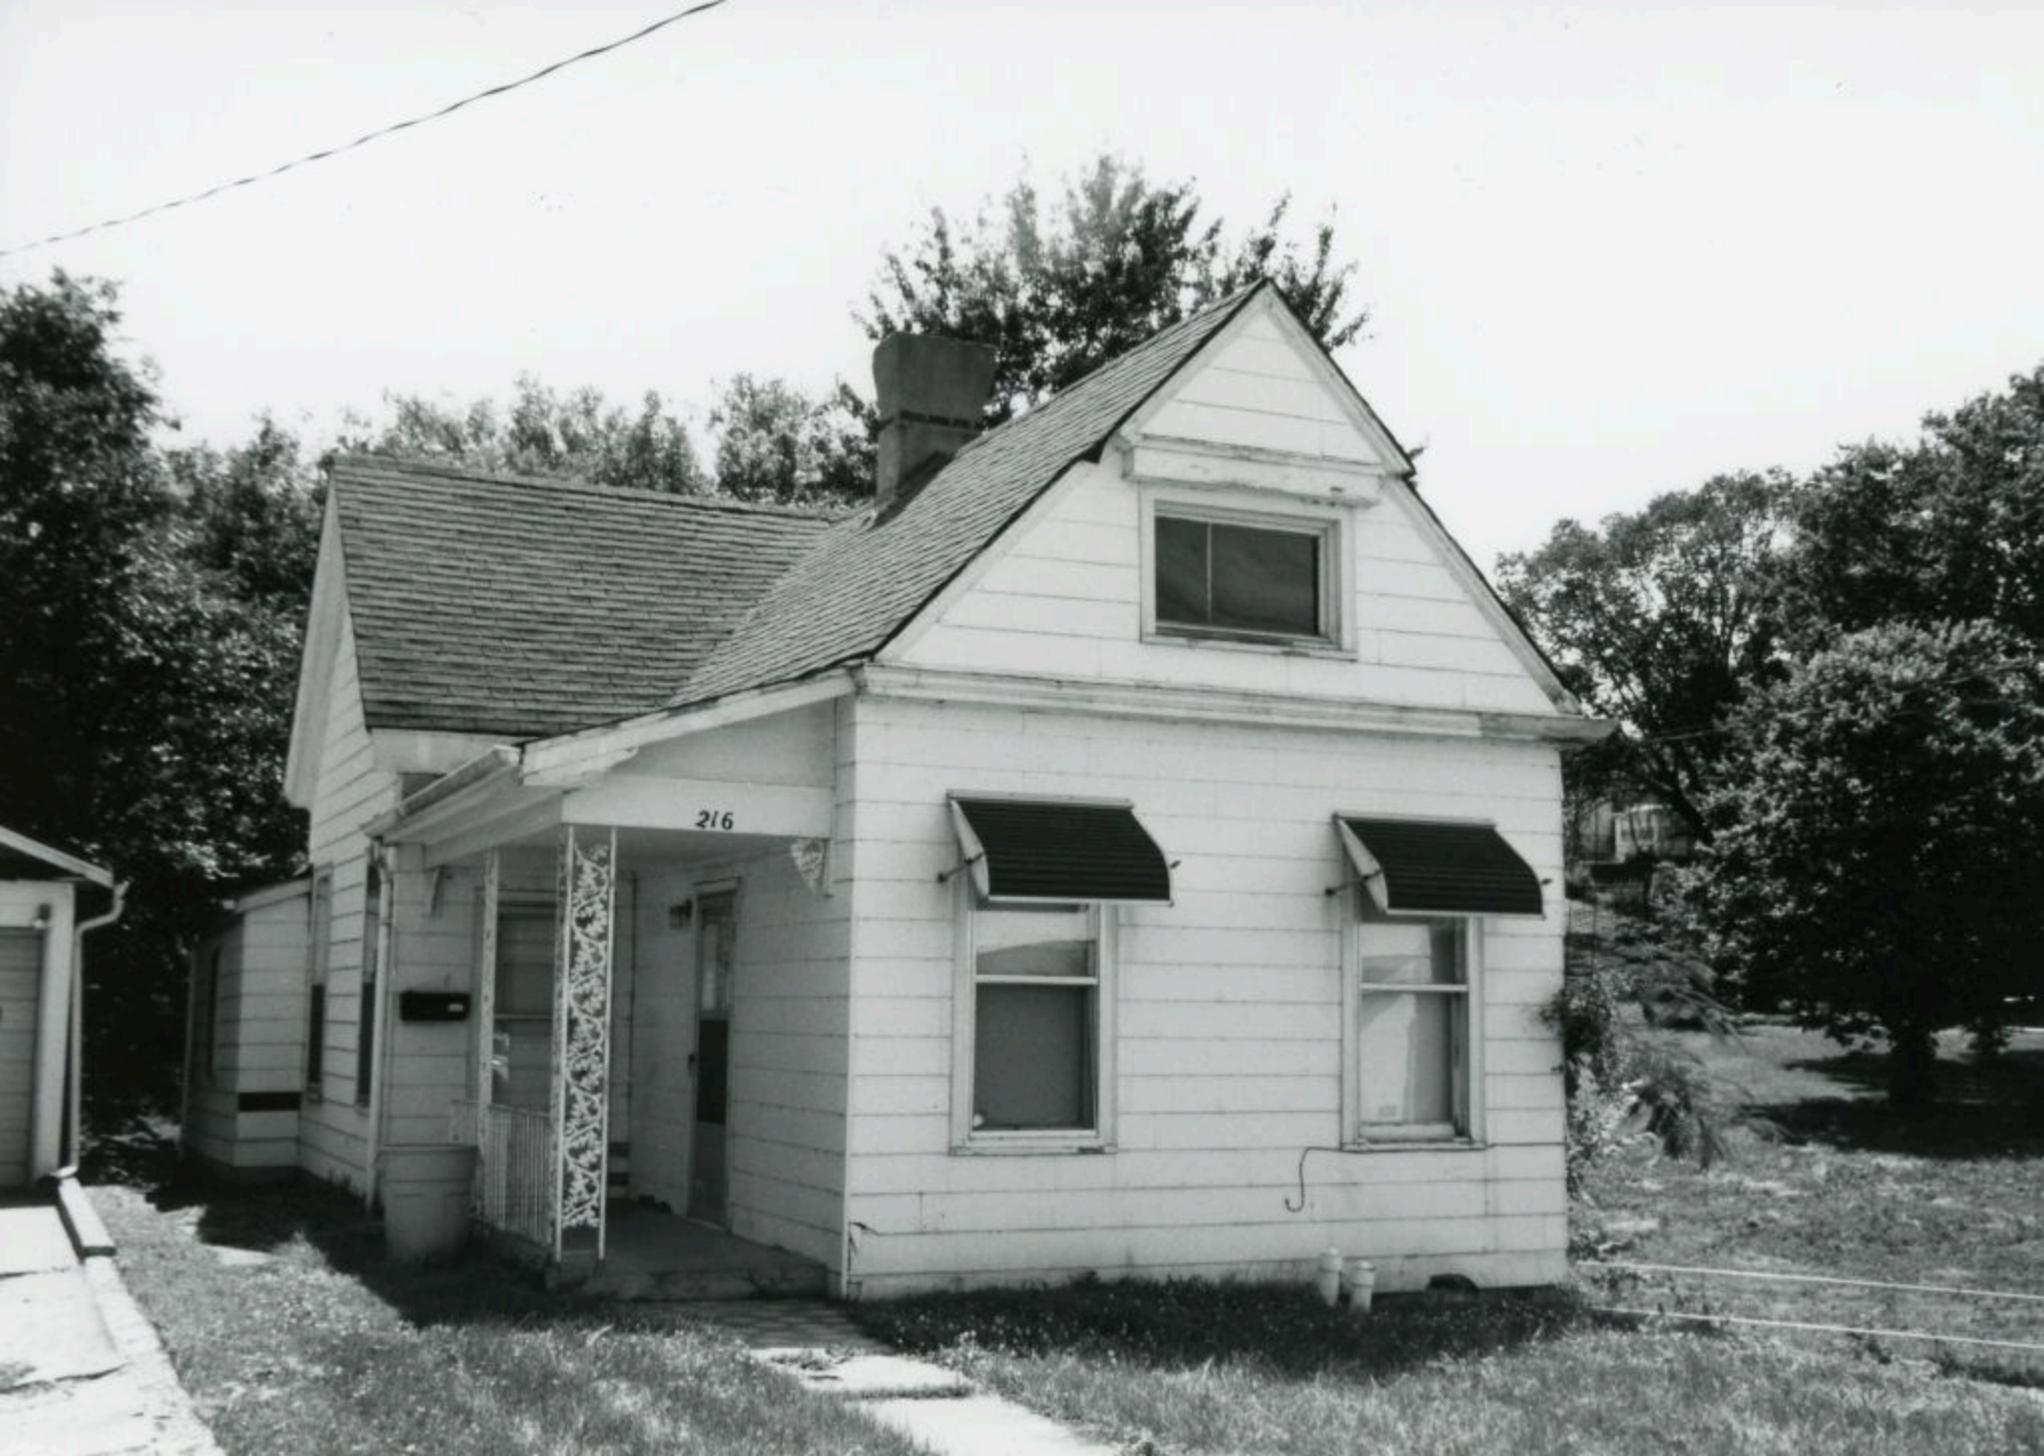
1-1/2 stories. Gabled Ell type. L-plan, 2 bay asymmetrical facade. Limestone foundation, wide artificially sided walls. Gable (asphalt shingle) roof. Left/east re-entrant angle with corner entries (large 1-light/panel doors) facing north & east; shed roof re-entrant angle porch with low poured concrete deck, c. 1940s iron post & railing, curved side soffit piece. Right/west side gable pavilion (added) with two 1/1 windows on 1st story with metal awnings; gable with rectangular replacement fixed sash, full cornice return & overhanging gable apex; parged ridge chimney. Windows as 1/1, 4/4 & 2/2 double hung. East elevation with left/east side gable pavilion with two 1/1 windows, blind gable; shed roof wing on rear projects slightly to east. Lower hip roof wing rear; added later.

Wear's Creek to west. Railroad-tie retaining wall, shallow rear lot before Wears Creek.
No outbuildings.

Appears on the 1923 Sanborn Map with an L-shaped porch extending from the front reentrant angle across the east side gable. Shared lot with 222. A third dwelling was at the rear lot. Rear alley. The 1939 Sanborn Map shows the lot having been subdivided; no outbuildings.

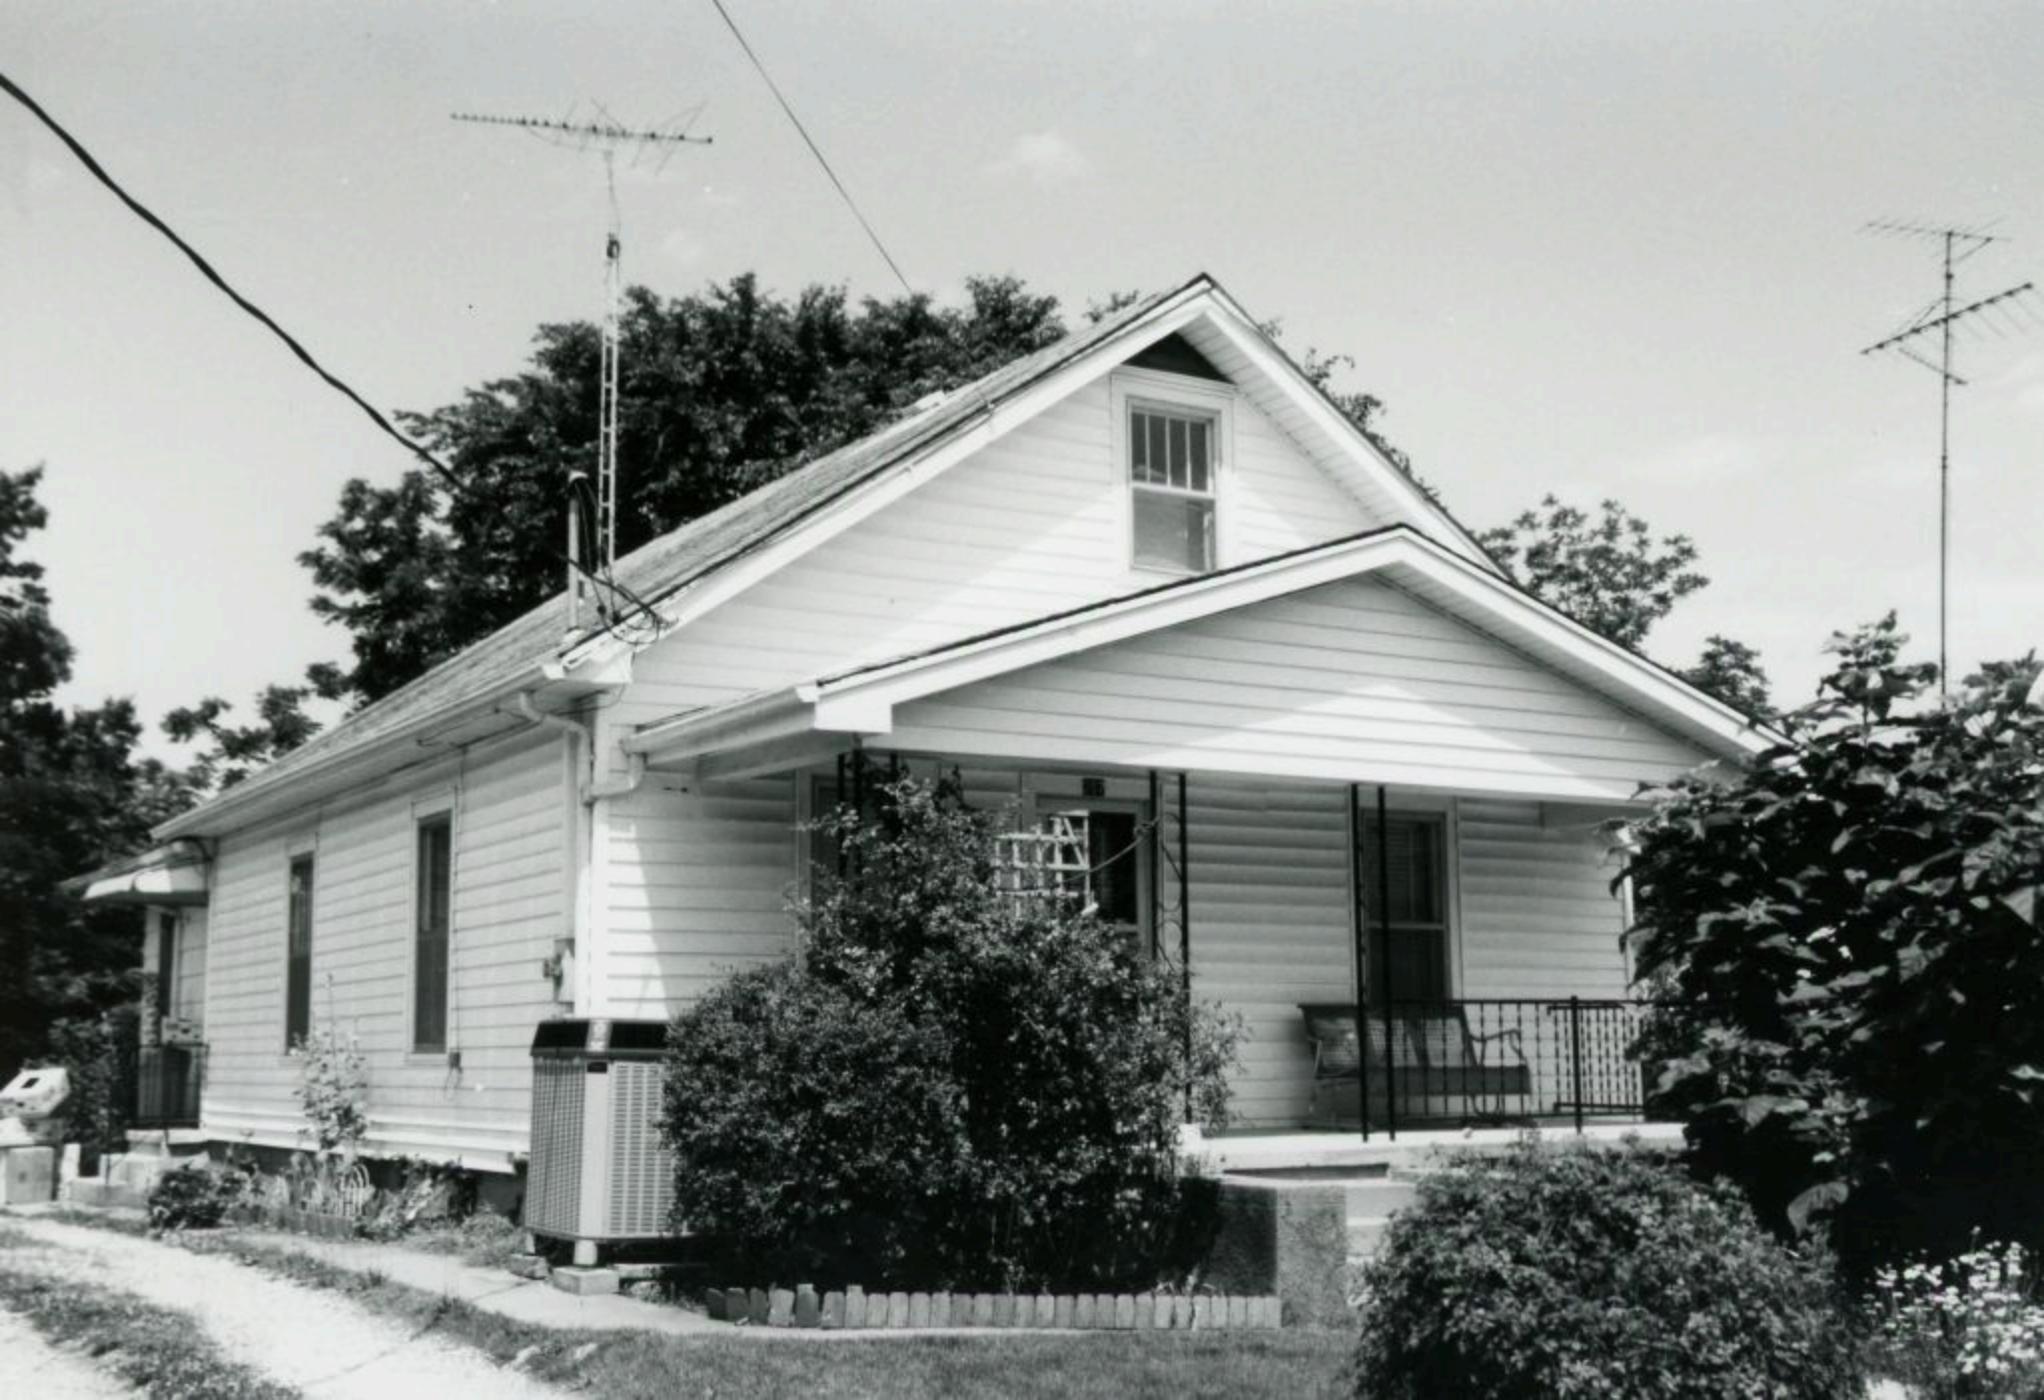
This area does not appear on the 1908 Sanborn Map. The 1923 map shows this area as vacant and a different structure to the north is addressed as #213. This house appears on the 1939 map addressed as #213 with front and rear porches and a garage in the basement. It appears the block was renumbered after 1939.

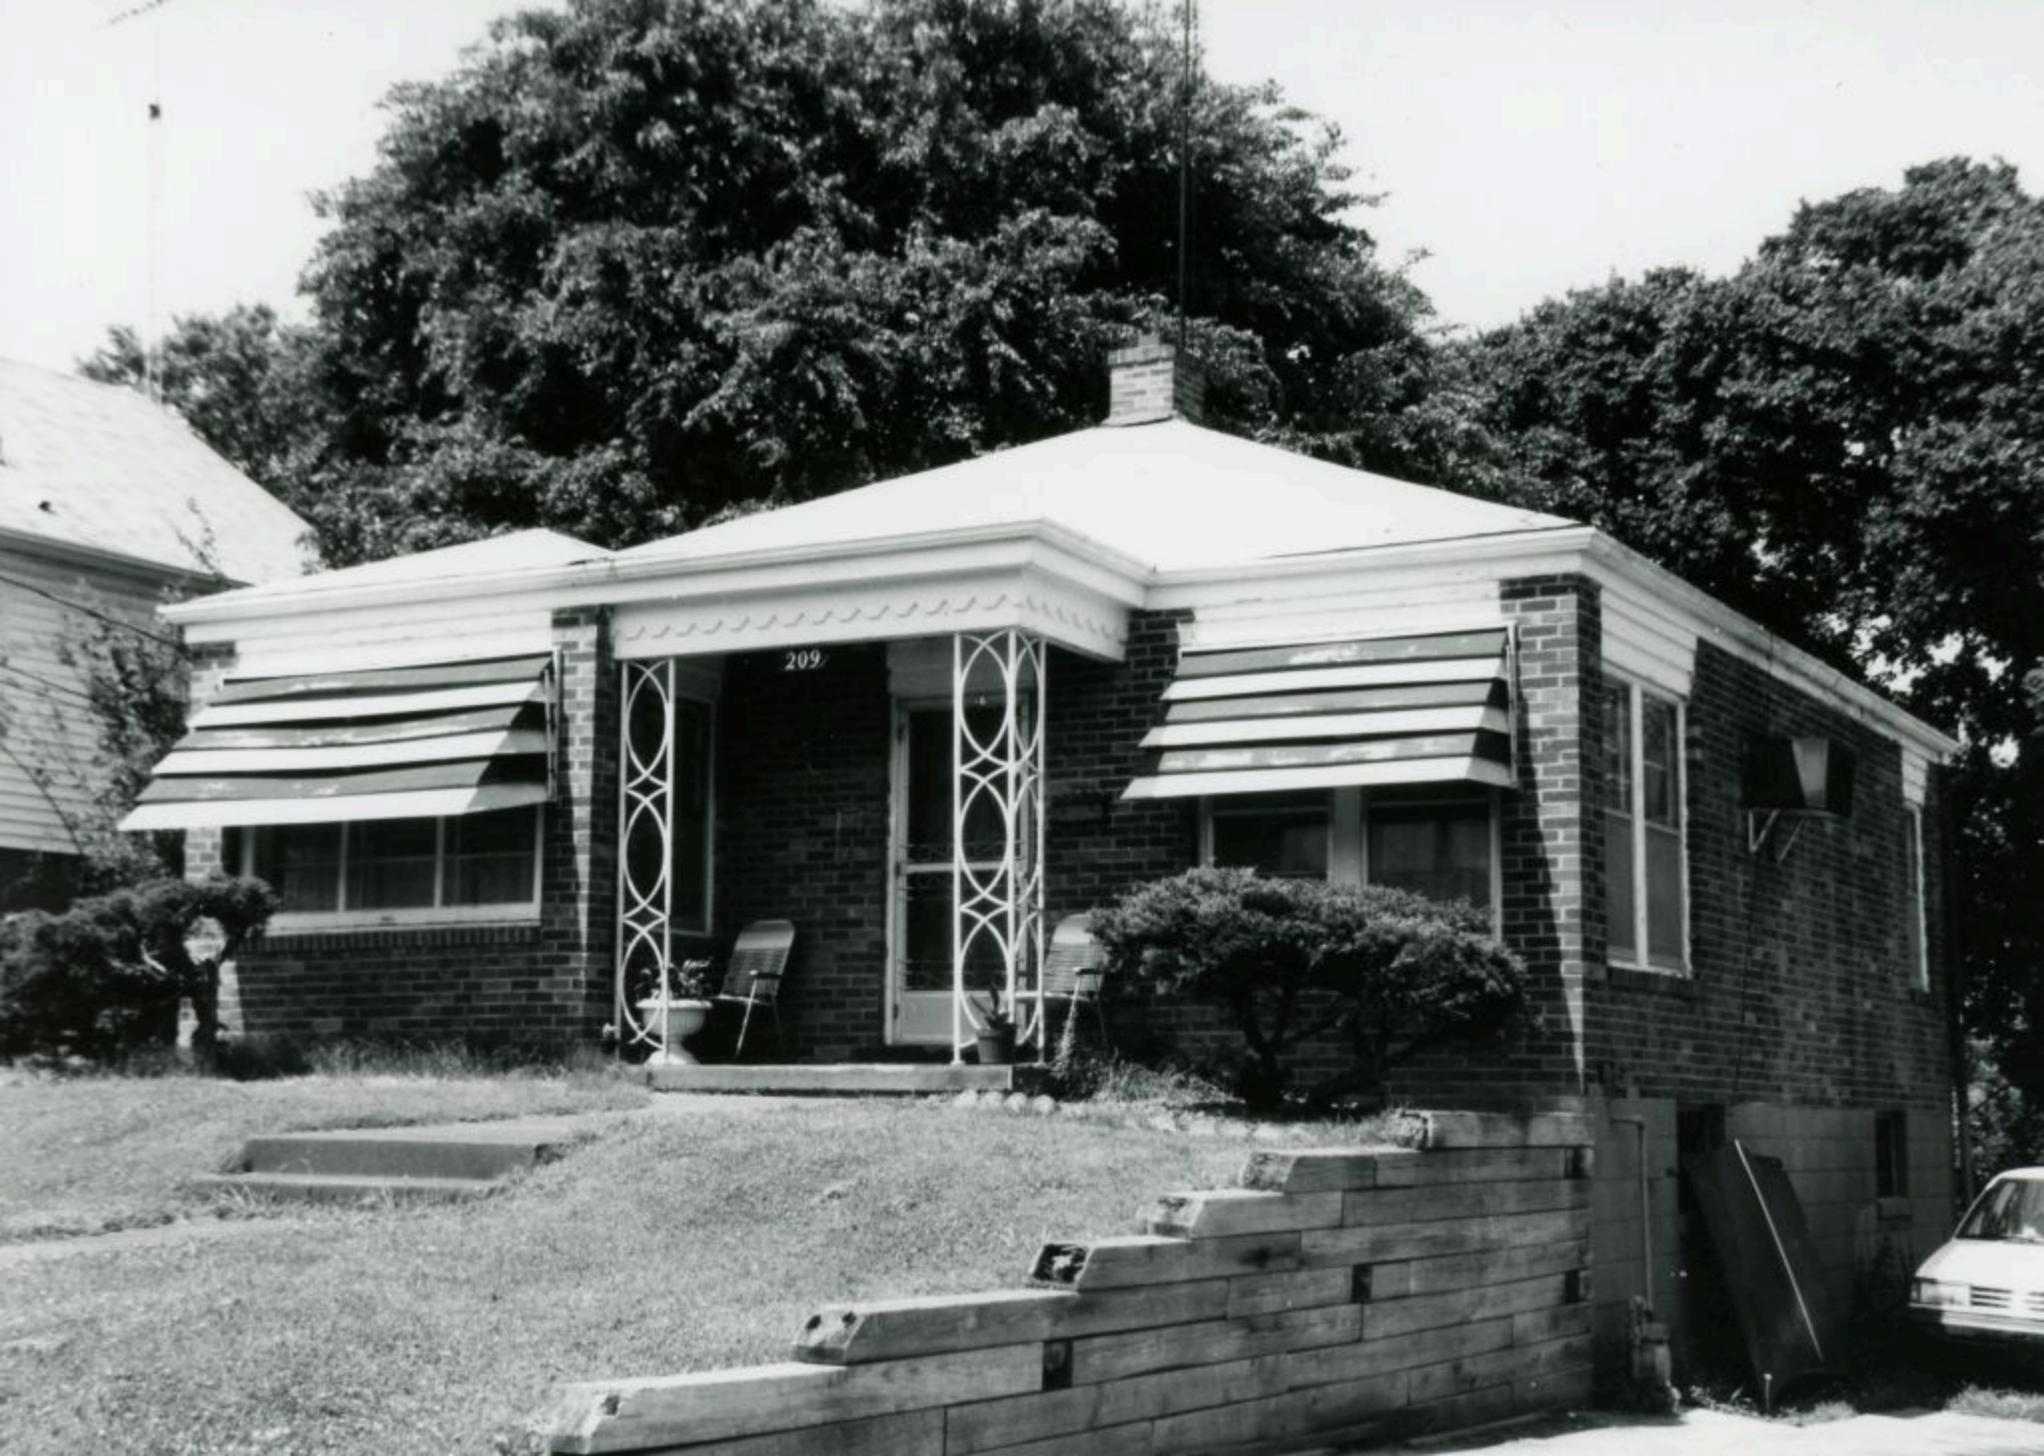
209

1 story. moderne style influence. slight L-plan, asymmetrical facade. concrete block foundation, brick (wire cut, mottled colored) walls. hip (asphalt shingle) roof. projecting lower hip roof pavilion to west with triple windows, clapboard over windows to eave line; small flat roof porch in re-entrant corner with two historic metal posts, low concrete deck, wide wood frieze with applied scalloped decoration, original door with single long vertical light, clapboard in transom area; paired window to east; apex chimney. windows as 2-horizontal/2-horizontal double hung with header sills and historic metal retractable awnings, clapboard over windows to eave line. east elevation with exposed basement with two openings, paired corner windows to south, small window to rear. west elevation with central door with gable hood on braces, high window to south, window to rear.

This area does not appear on the 1908 Sanborn Map. This house does not appear on the 1923 or 1939 maps. It also appears that the block was renumbered after 1939.

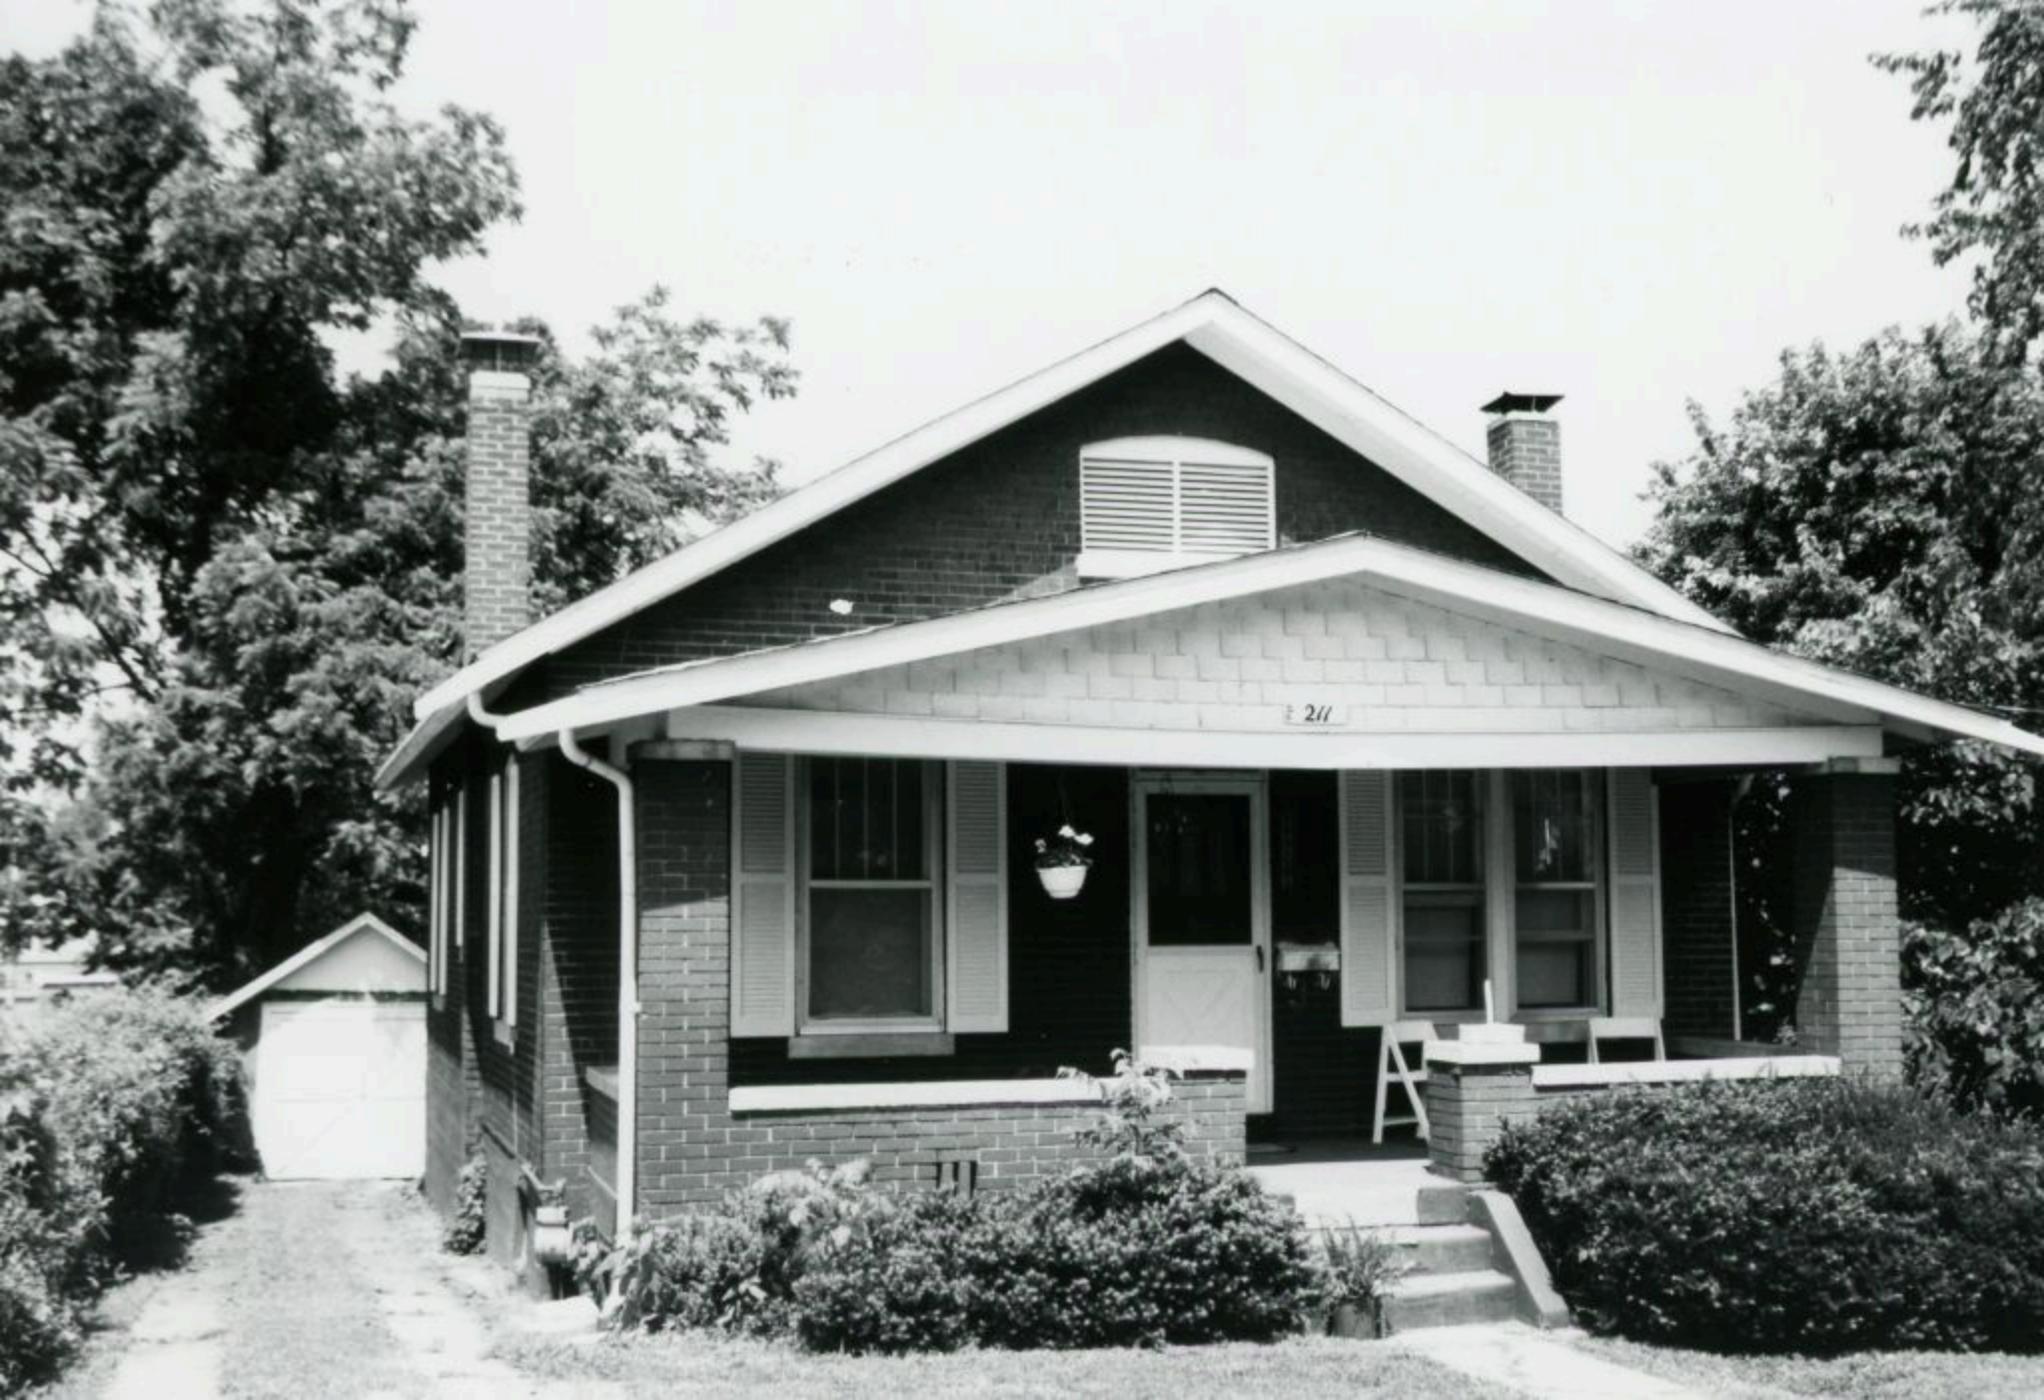
1 story. Rectangular plan. Three bay asymmetrical facade. Poured concrete foundation; brick walls. Gable front (asphalt shingle) roof. Multi-vertical light/1 double hung sash with double rowlock segmental brick arches and concrete lug sills. Left/west bay with single 4 vertical/1 double hung sash. Entrance in middle with modern storm/screen door. Right bay with narrower paired 3 vertical/1 double hung sash. Nearly full-facade low-pitched gable roof porch with raised concrete deck (clad with artificial turf), brick solid rail, brick end posts; entrance bay framed with brick pedestals. Concrete caps, plain cornice, asphalt shingle painted white in gable. Attic fenestration now with double side-by-side vent. East elevation with four bays; second bay from north with exterior end chimney. West elevation also four bays with exterior end chimney in third bay from north.

Appears as "217" on 1939 Sanborn Map; does not appear on the 1923 Sanborn Map. Garage shown. Also a large garage at the rear lot labeled "810 1-1/2" Monroe, but mostly on this lot.

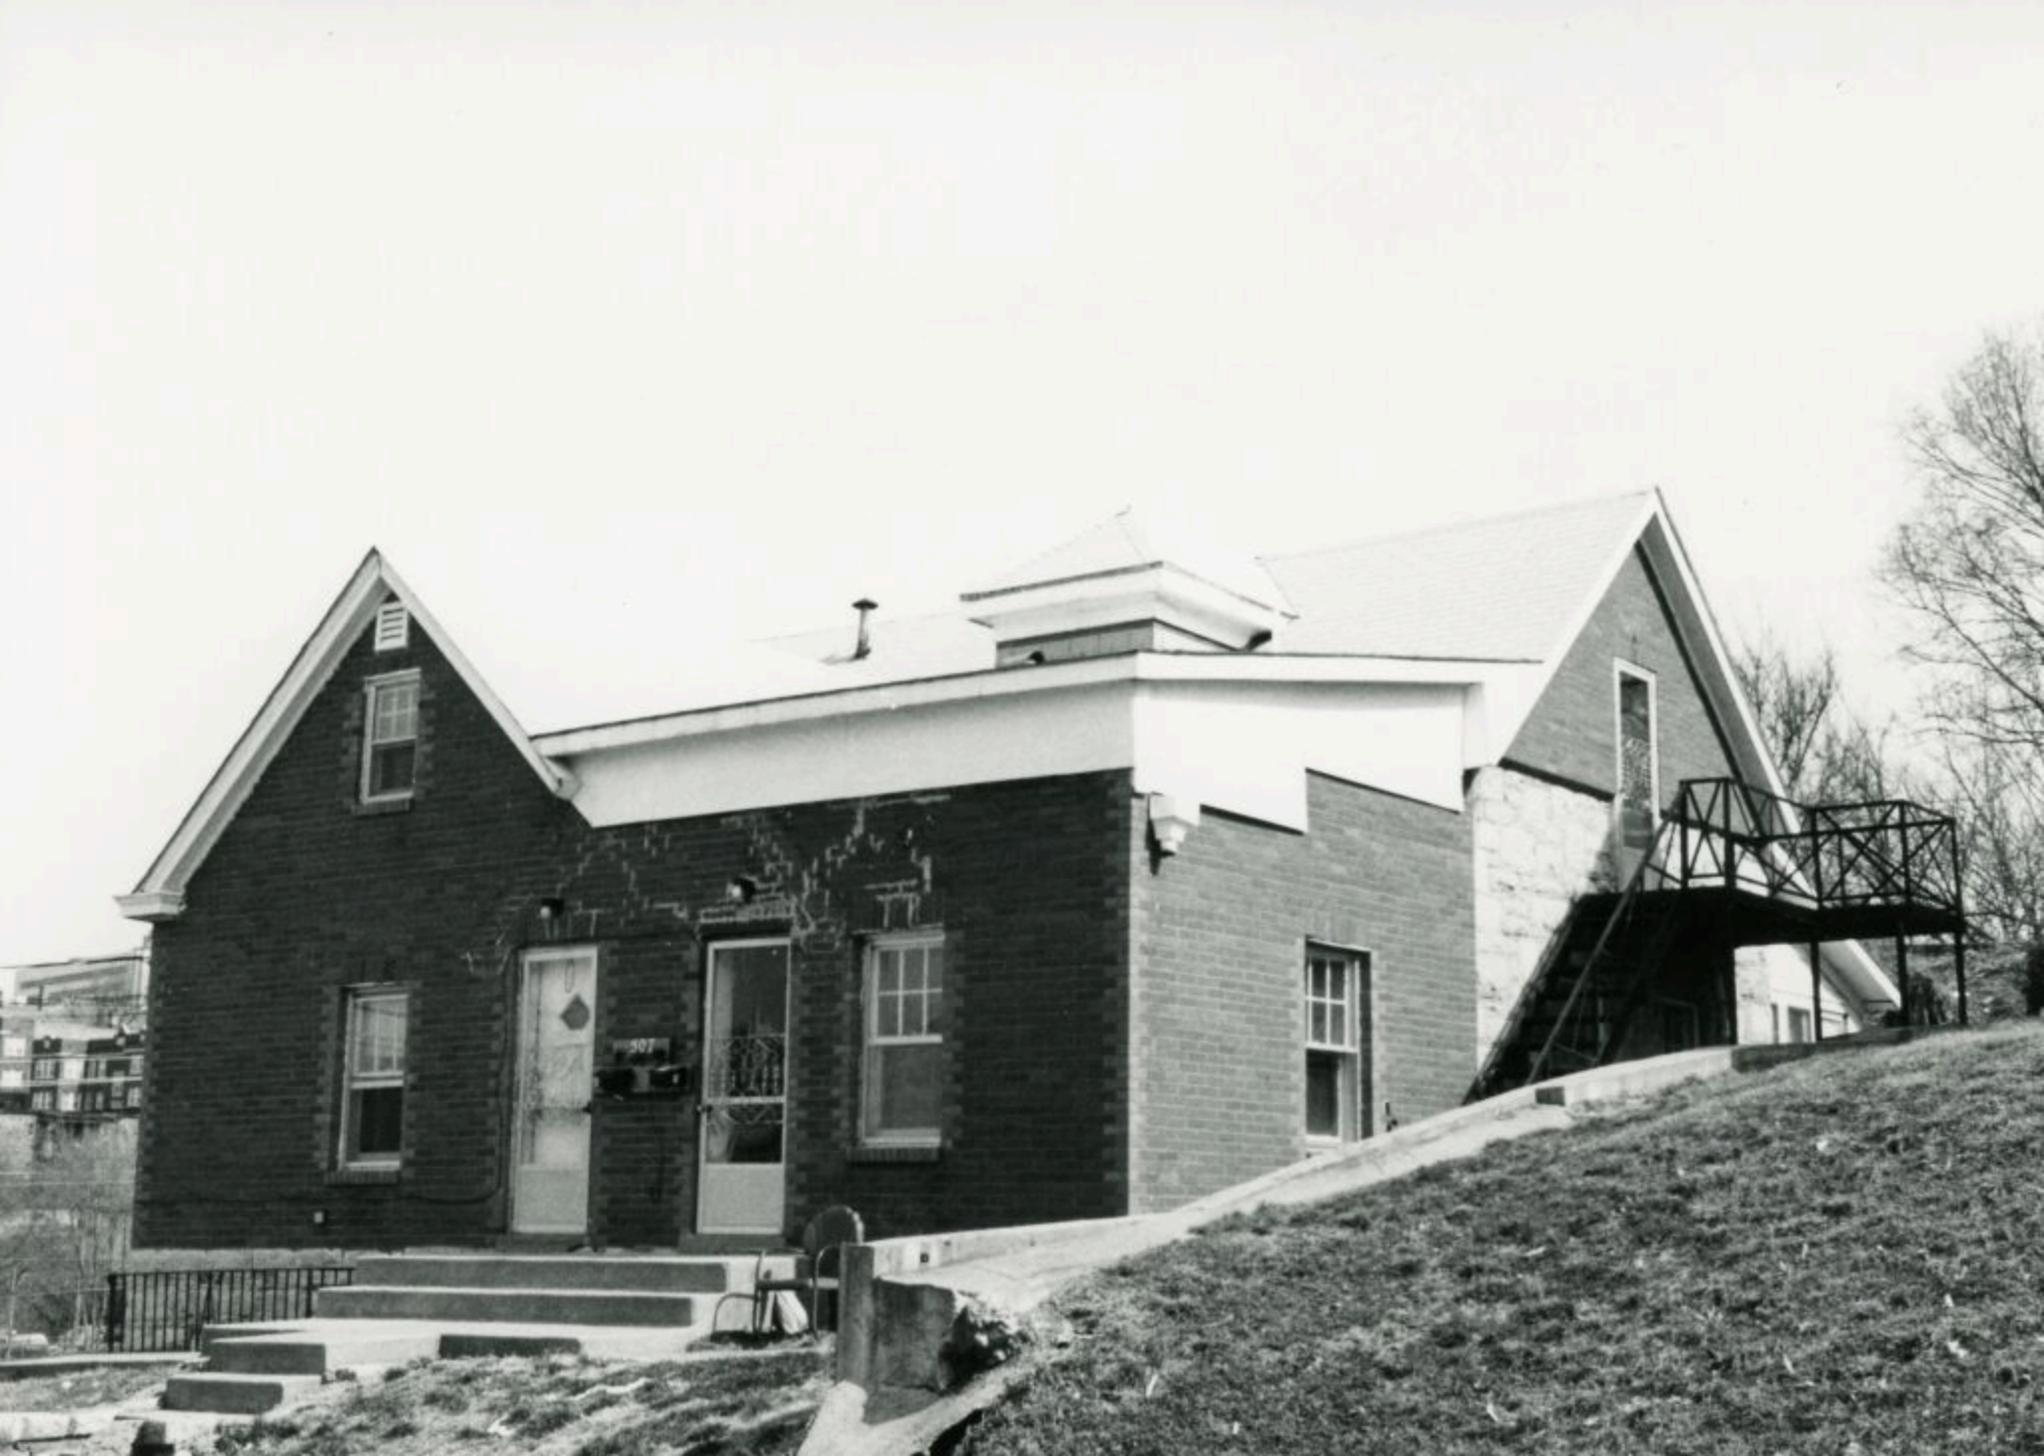
1-1/2 stories. no style or vernacular type. rectangular plan, asymmetrical facade. stone foundation, brick and stone (random rubble) walls. cross gable and shed (asphalt shingle) roofs. appears to have been originally a stone structure with added brick section with contrasting colored brick "quoins" at corners and around window and door openings. west elevation with cross gable section to north, shed roof section to south with very wide wood boards in frieze area; two central modern doors with wide concrete stoop and steps, ghost of gable roof porch, 6/1 window at south end and smaller 6/1 window centered below gable, gable with 6/1 window. south elevation with 1-1/2 story side gable roof stone section with brick end gables between modern brick facade and 1-story frame shed roof rear wing; 6/1 window in modern brick section, brick gable of stone portion with added modern entry with exterior metal stairs and platform; blind hip roof dormer on west slope of stone section side gable roof. shed roof wing across rear, three hip roof dormers.

This building is labeled apartments on the 1939 Sanborn Map; the front brick section is depicted.

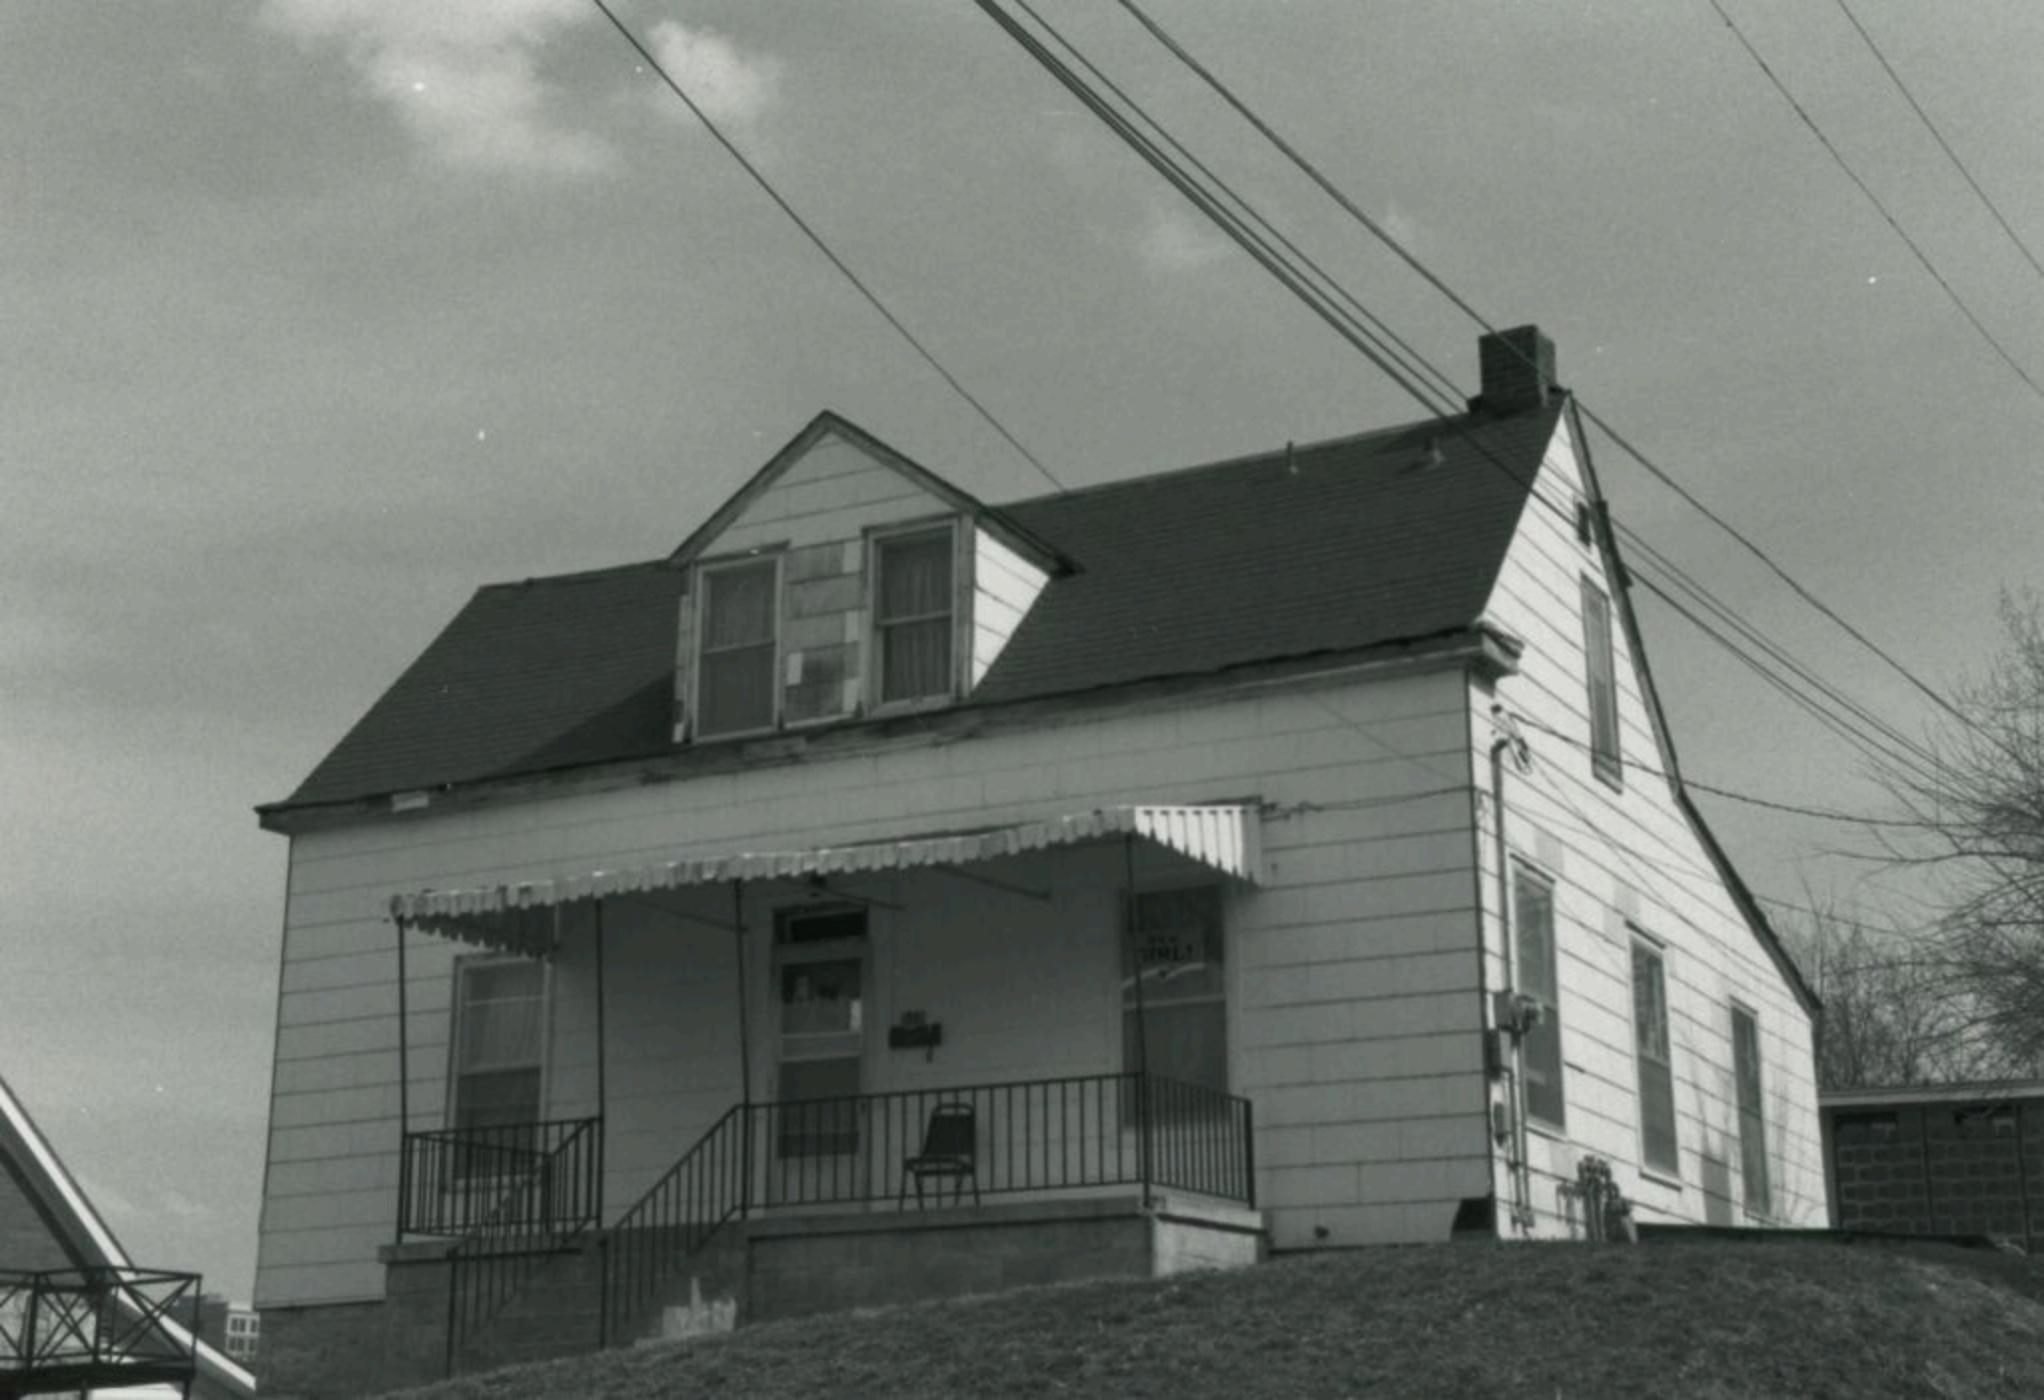
1-1/2 stories. Hall and Parlor vernacular type. Rectangular plan. Three bay, slightly asymmetrical facade. Limestone foundation; asbestos shingle walls. Side gable (asphalt shingle) roof with small cornice returns on side elevations. Central 3/4 modern porch with concrete block foundation, poured concrete deck, and modern iron balustrade; tiny poles support aluminum awning. Facade with modern replacement door off-center to left with transom. Single windows in end bays. Central gable roof dormer nearly at roof eave; two windows, not paired. South elevation with interior end chimney cropped. Two first story windows; upper story window off-center toward rear with vent above. Cellar (bulkhead) door on south near alley. Lower one story shed roof wing rear.

Area not shown on the 1908 Sanborn Map. Shown on the 1923 Sanborn Map with a lower one story rear wing, as is extant. Entrance porch shown on the 1939 Sanborn, but the porch may well have existed earlier; the 1923 Sanborn Map was inconsistent about showing porches.
