HISTORIC SOUTHSIDE COMMERCIAL AREA

MISSOURI HISTORIC PROPERTY INVENTORY FORM

REFERENCE NUMBER CO AS003-001		A. HISTORIC NAME					
B. COUNTY 054 Cole		C. OTHER NAME(S)					
D. ADDRESS 102 East Ashley Street			E. CITY Jefferson City		F. VICINITY <input type="checkbox"/>	G. RESTRICTED	H. ACREAGE

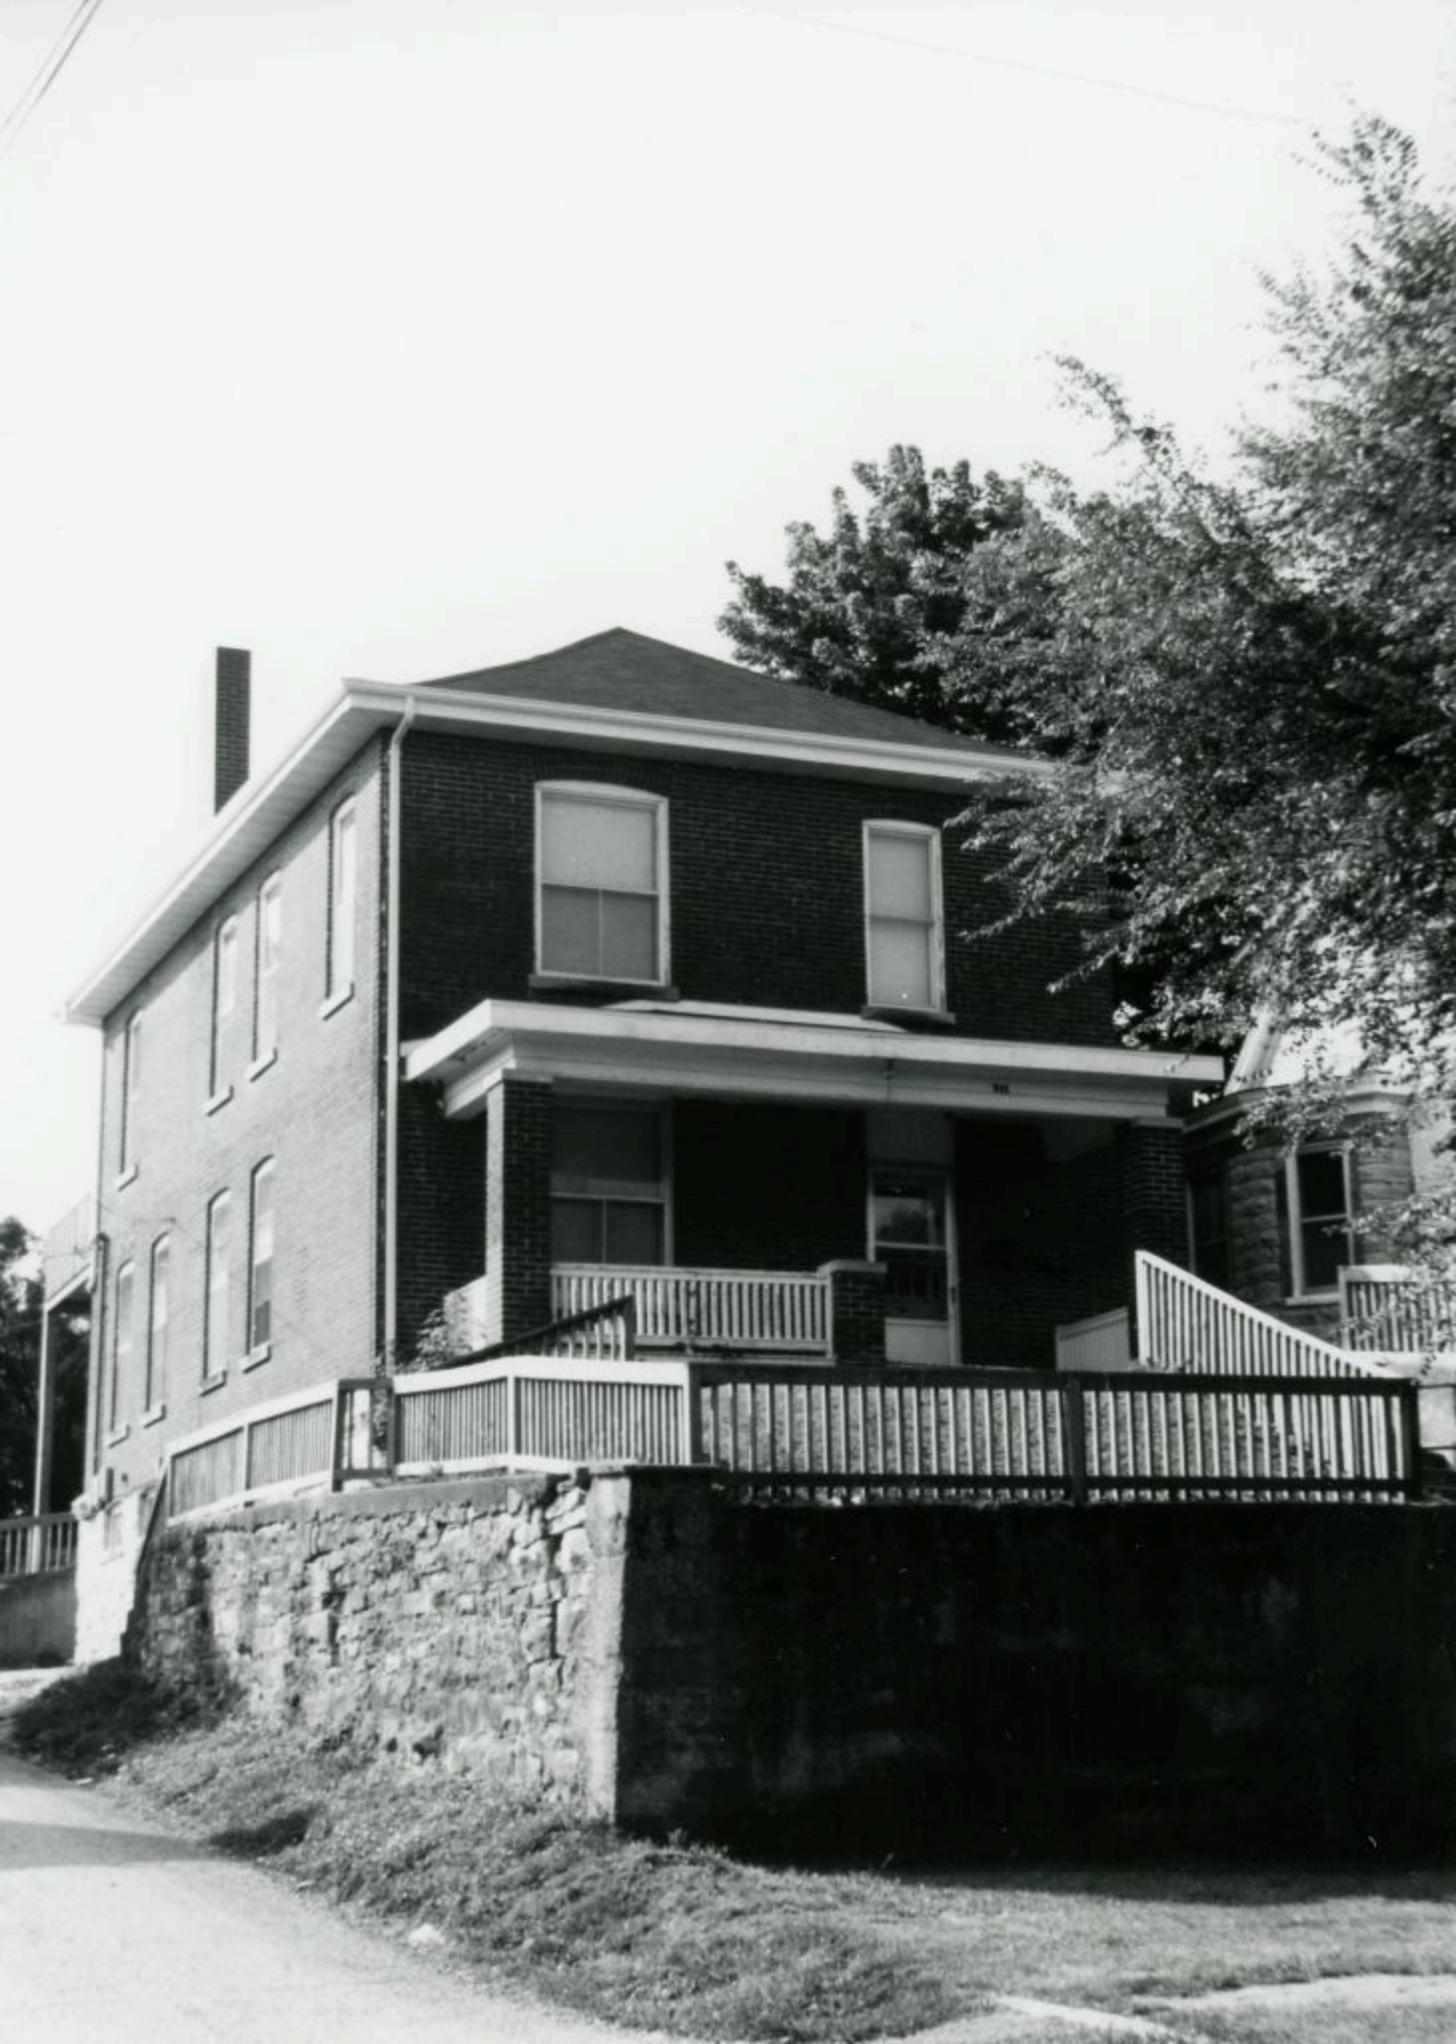
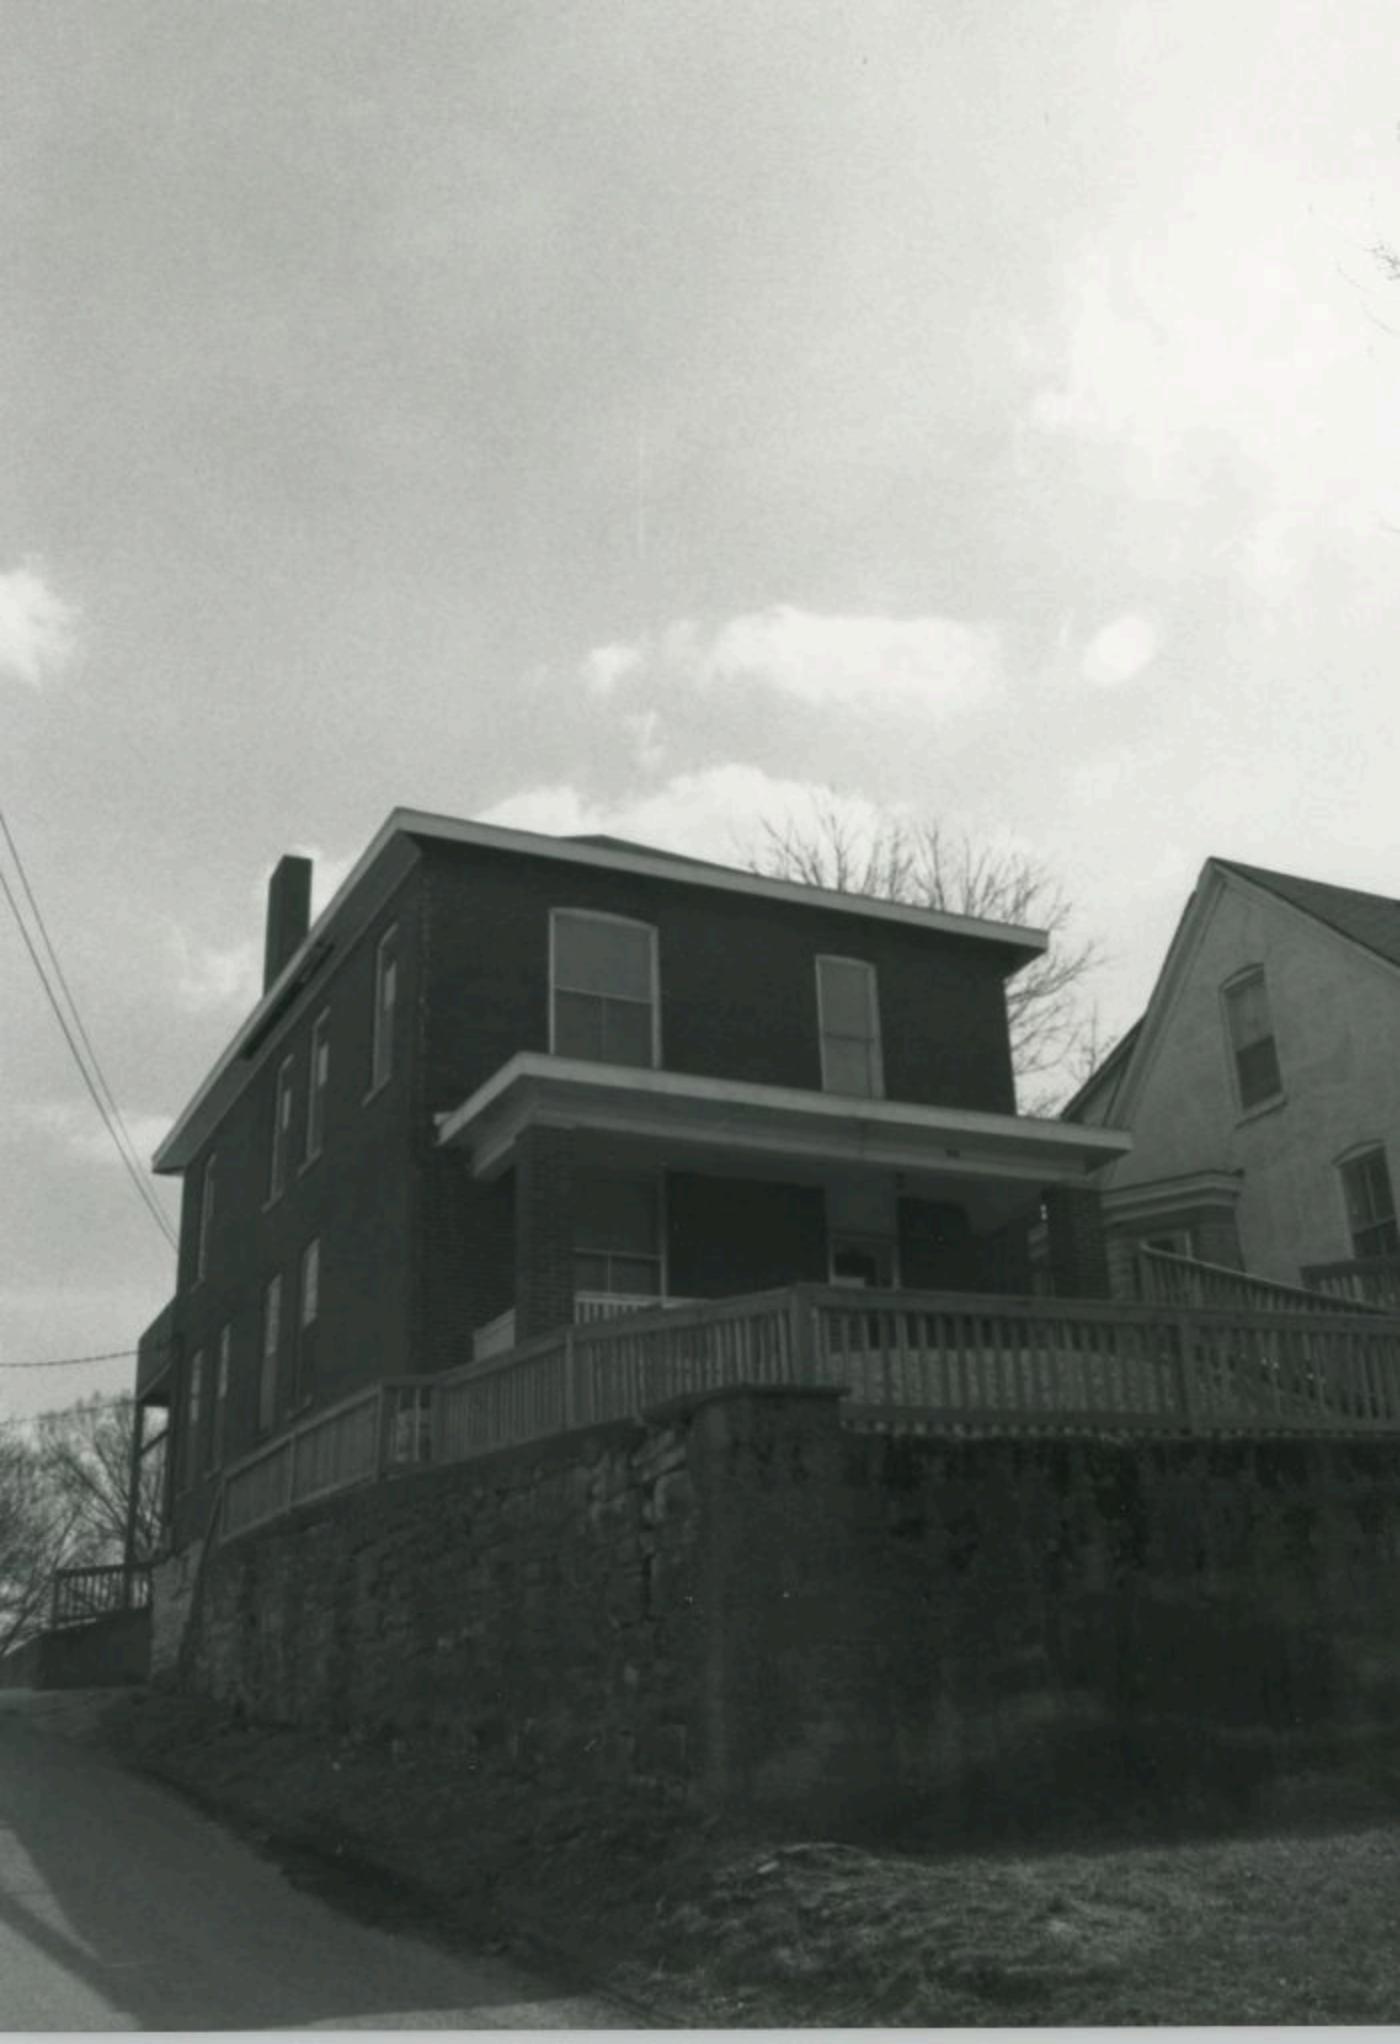
2 stories. American Four Square vernacular. rectangular plan, 2 bay symmetrical facade. random stone foundation, brick walls. hip (asphalt shingle) roof. full-width porch with two corner brick piers and stair pedestal, wood railing and wide frieze; 1-light entry with blocked transom in south bay with large 1/1 window in north bay; 2nd story with two 1/1 windows; wood overhanging boxed eaves being covered with artificial siding. windows as 1/1 double hung with stone sills and double rowlock segmental arched openings. south elevation with entry and exterior wood stairs. north elevation with exposed basement with at-grade entry, center interior end chimney, variously placed windows. rear with large 2-story modern wood deck with stairs on south side; off-center entries on each story.

This section of Broadway is not shown on the 1908 Sanborn Map. This dwelling appears on the 1923 and 1939 maps with a 1-story front porch and a 2-story rear porch.

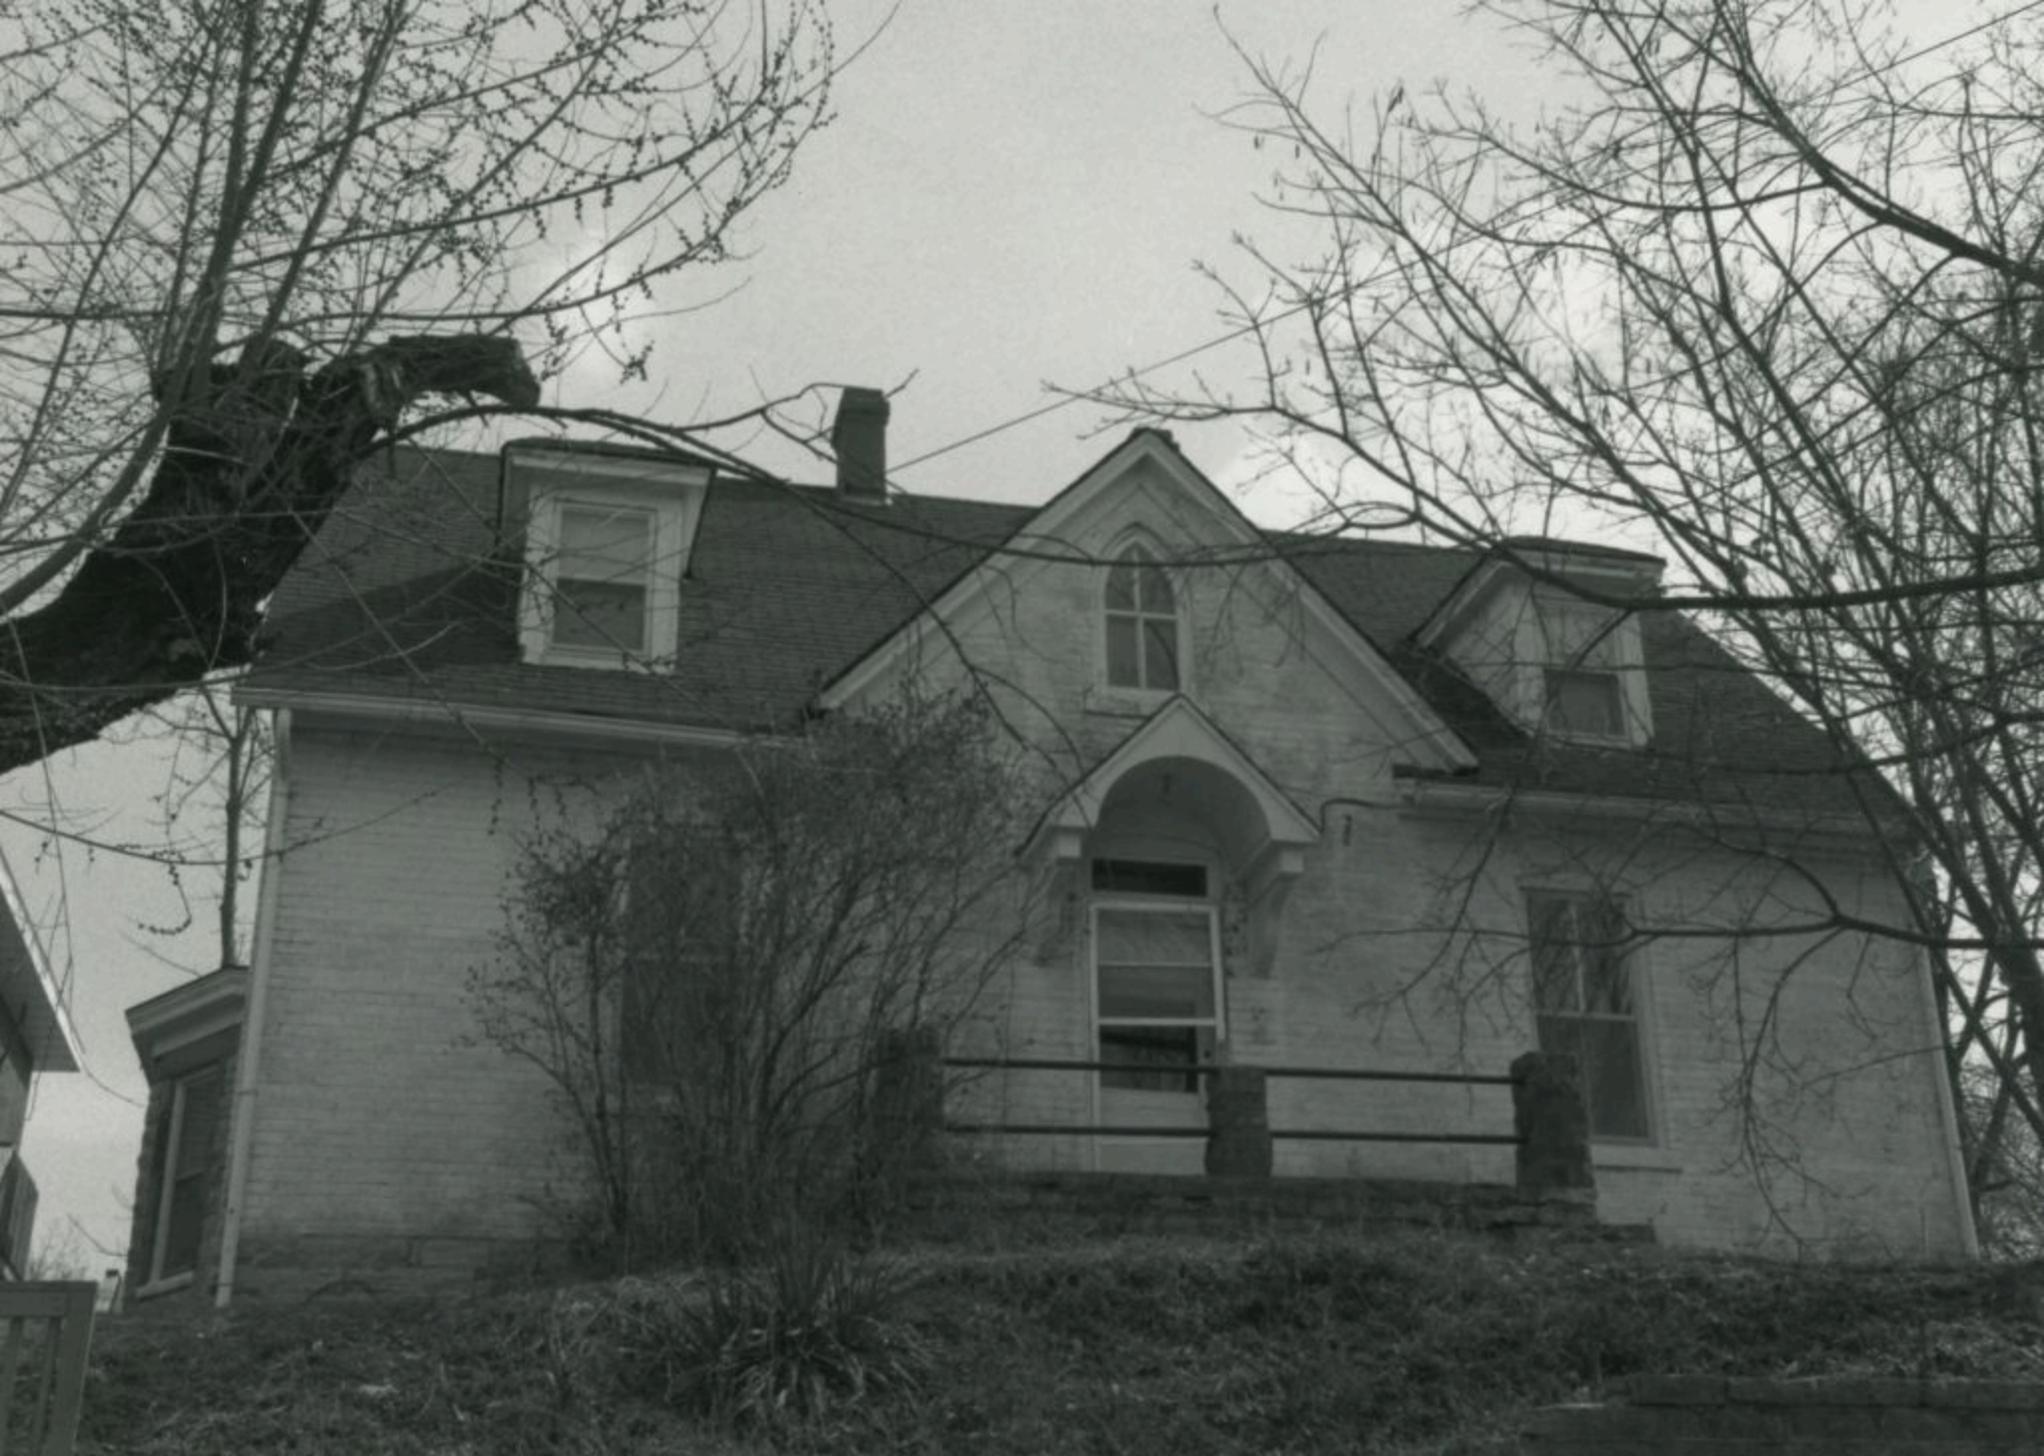
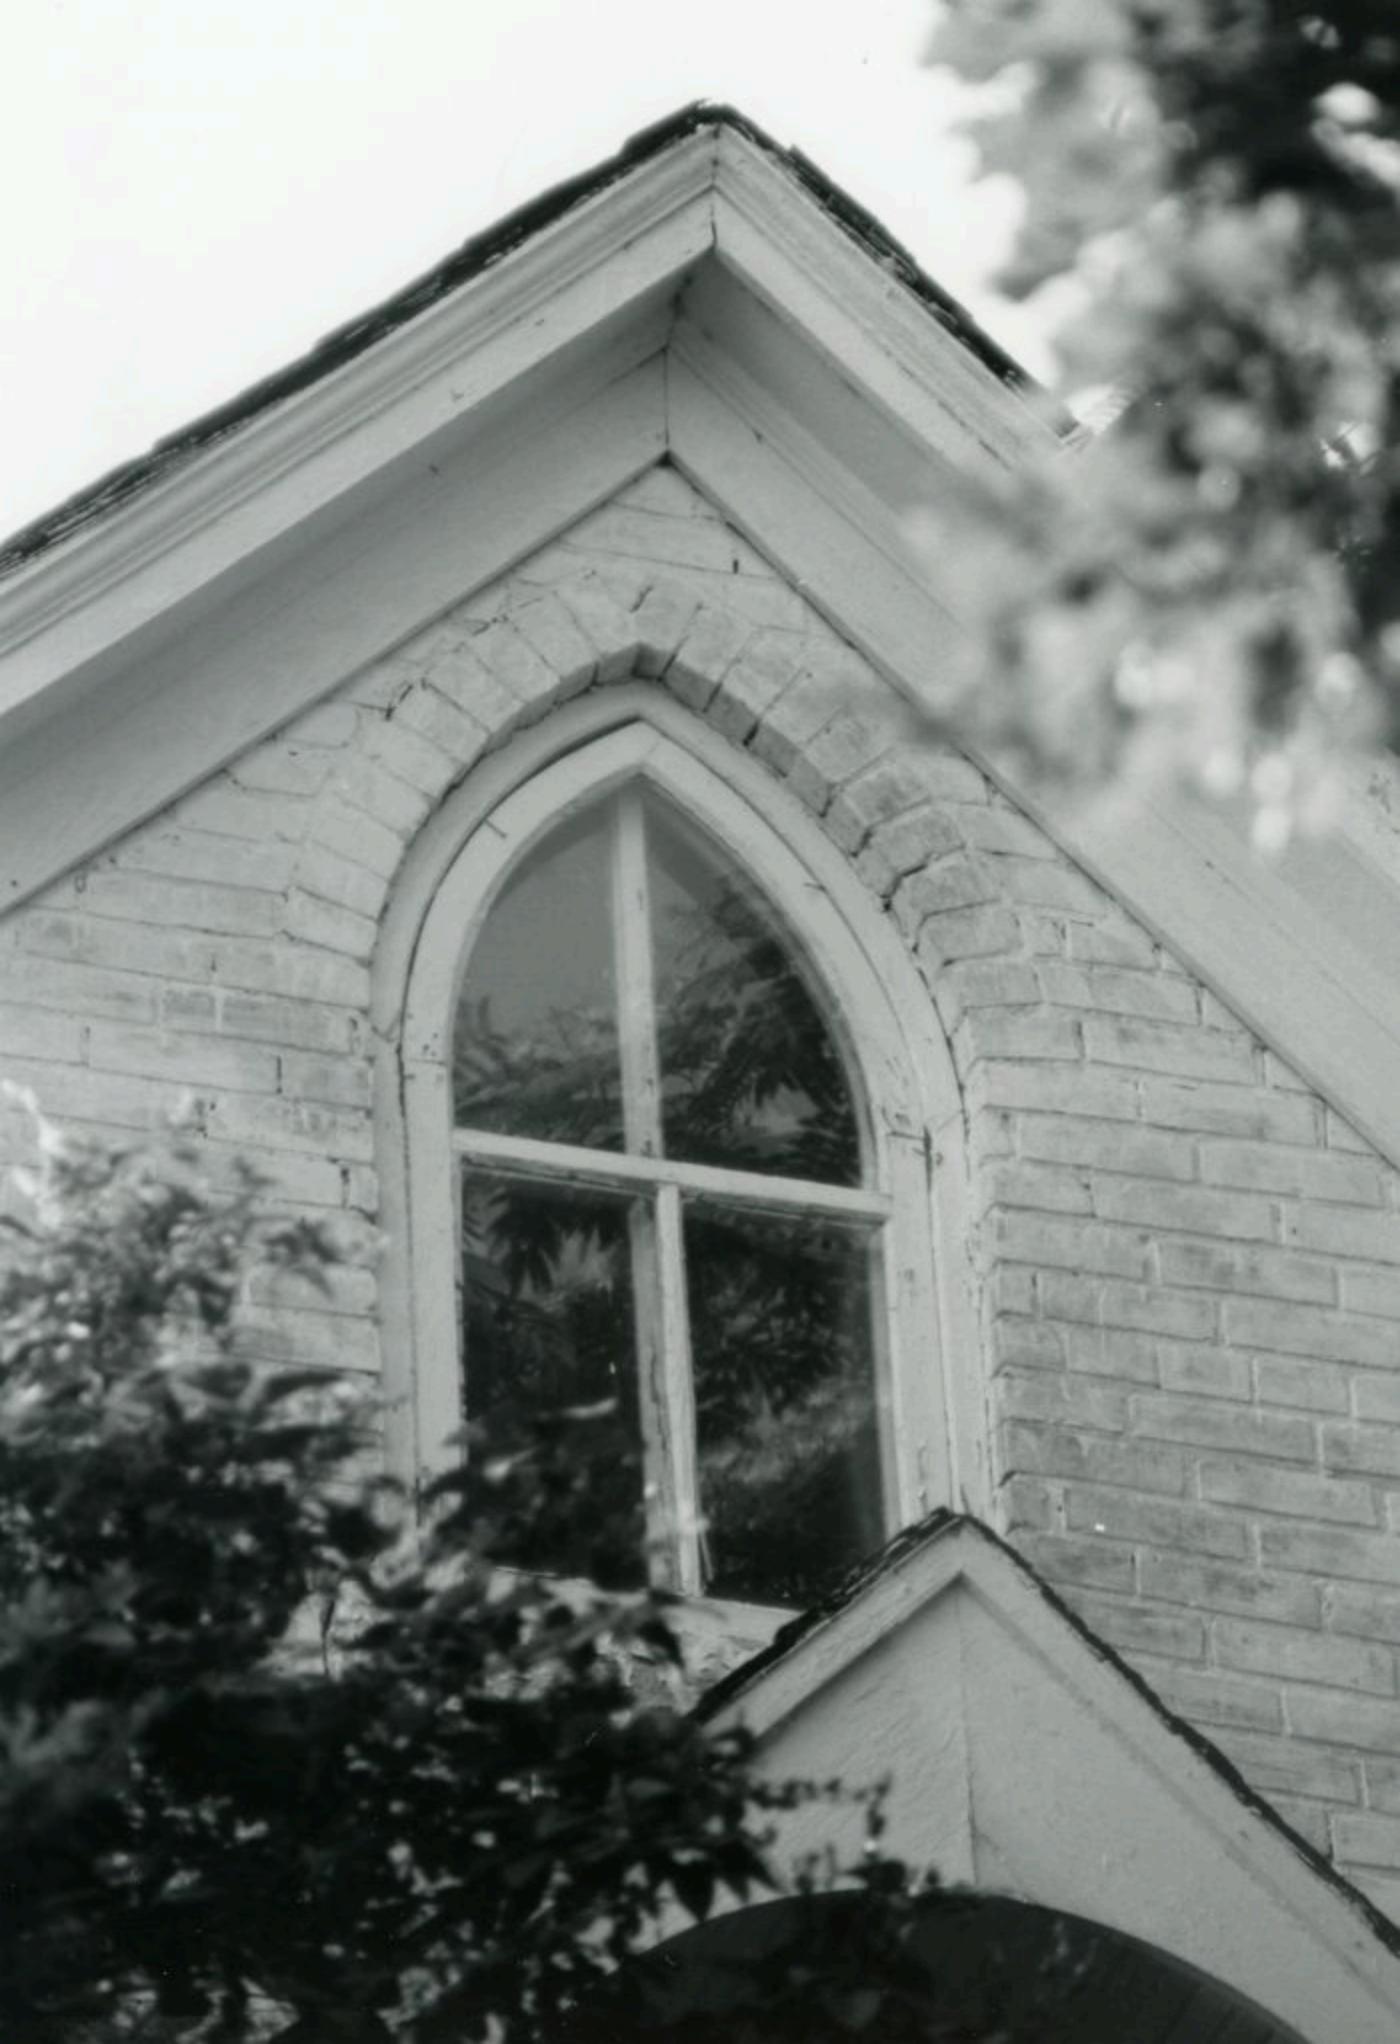
1-1/2 stories. Gothic Revival influence. Rectangular plan. Three bay symmetrical facade. Limestone foundation; brick (painted white) walls. Side gable (asphalt shingle) roof. 2/2 double hung sash with stone lug sills; plain window heads. Extended raised limestone stoop with three pedestals and a double iron open rail. Central door with extensive panels, medallions, single light and drip mold form (or ledge-like feature) on the door itself; two-light transom. Door with early 20th century steep gable hood with round arched open bed with curved braces. 2/2 double hung sash on either side with tooled stone voussoir segmental arches with keystones and shoulders. Two central ridge chimneys, corbeled; partially concrete parged. Central gable wall dormer with main roof eaves as returns; pointed arch 2 vertical/2 vertical with header arch. Tie rod ends visible on dormer. Early 20th century hip roof dormers off-set from original fenestration on first story; single 1/1 windows in each. Rock-faced limestone semi-hexagonal flat roof one story bay north. South elevation with upper story door added; exterior wood staircase into former sash location as evidenced by soldier course segmental brick arch.

The 1908 Sanborn does not show this section of the block. The house appears on the 1923 Sanborn Map with a central porch; rear wing fitted in ell around the house's northeast corner. Full rear elevation porch on the 1939 Sanborn Map.

Recommended for potential local landmark status. This central hall vernacular house type shows fine craftsmanship through its facade window treatment (stone voussoir arches with keystones and shoulders), north elevation bay, and brickwork. Its Gothic Revival influence is not found elsewhere in the neighborhood. The house ranks favorably with 707 and 714 Washington, and is among the earliest houses remaining in the Southside.

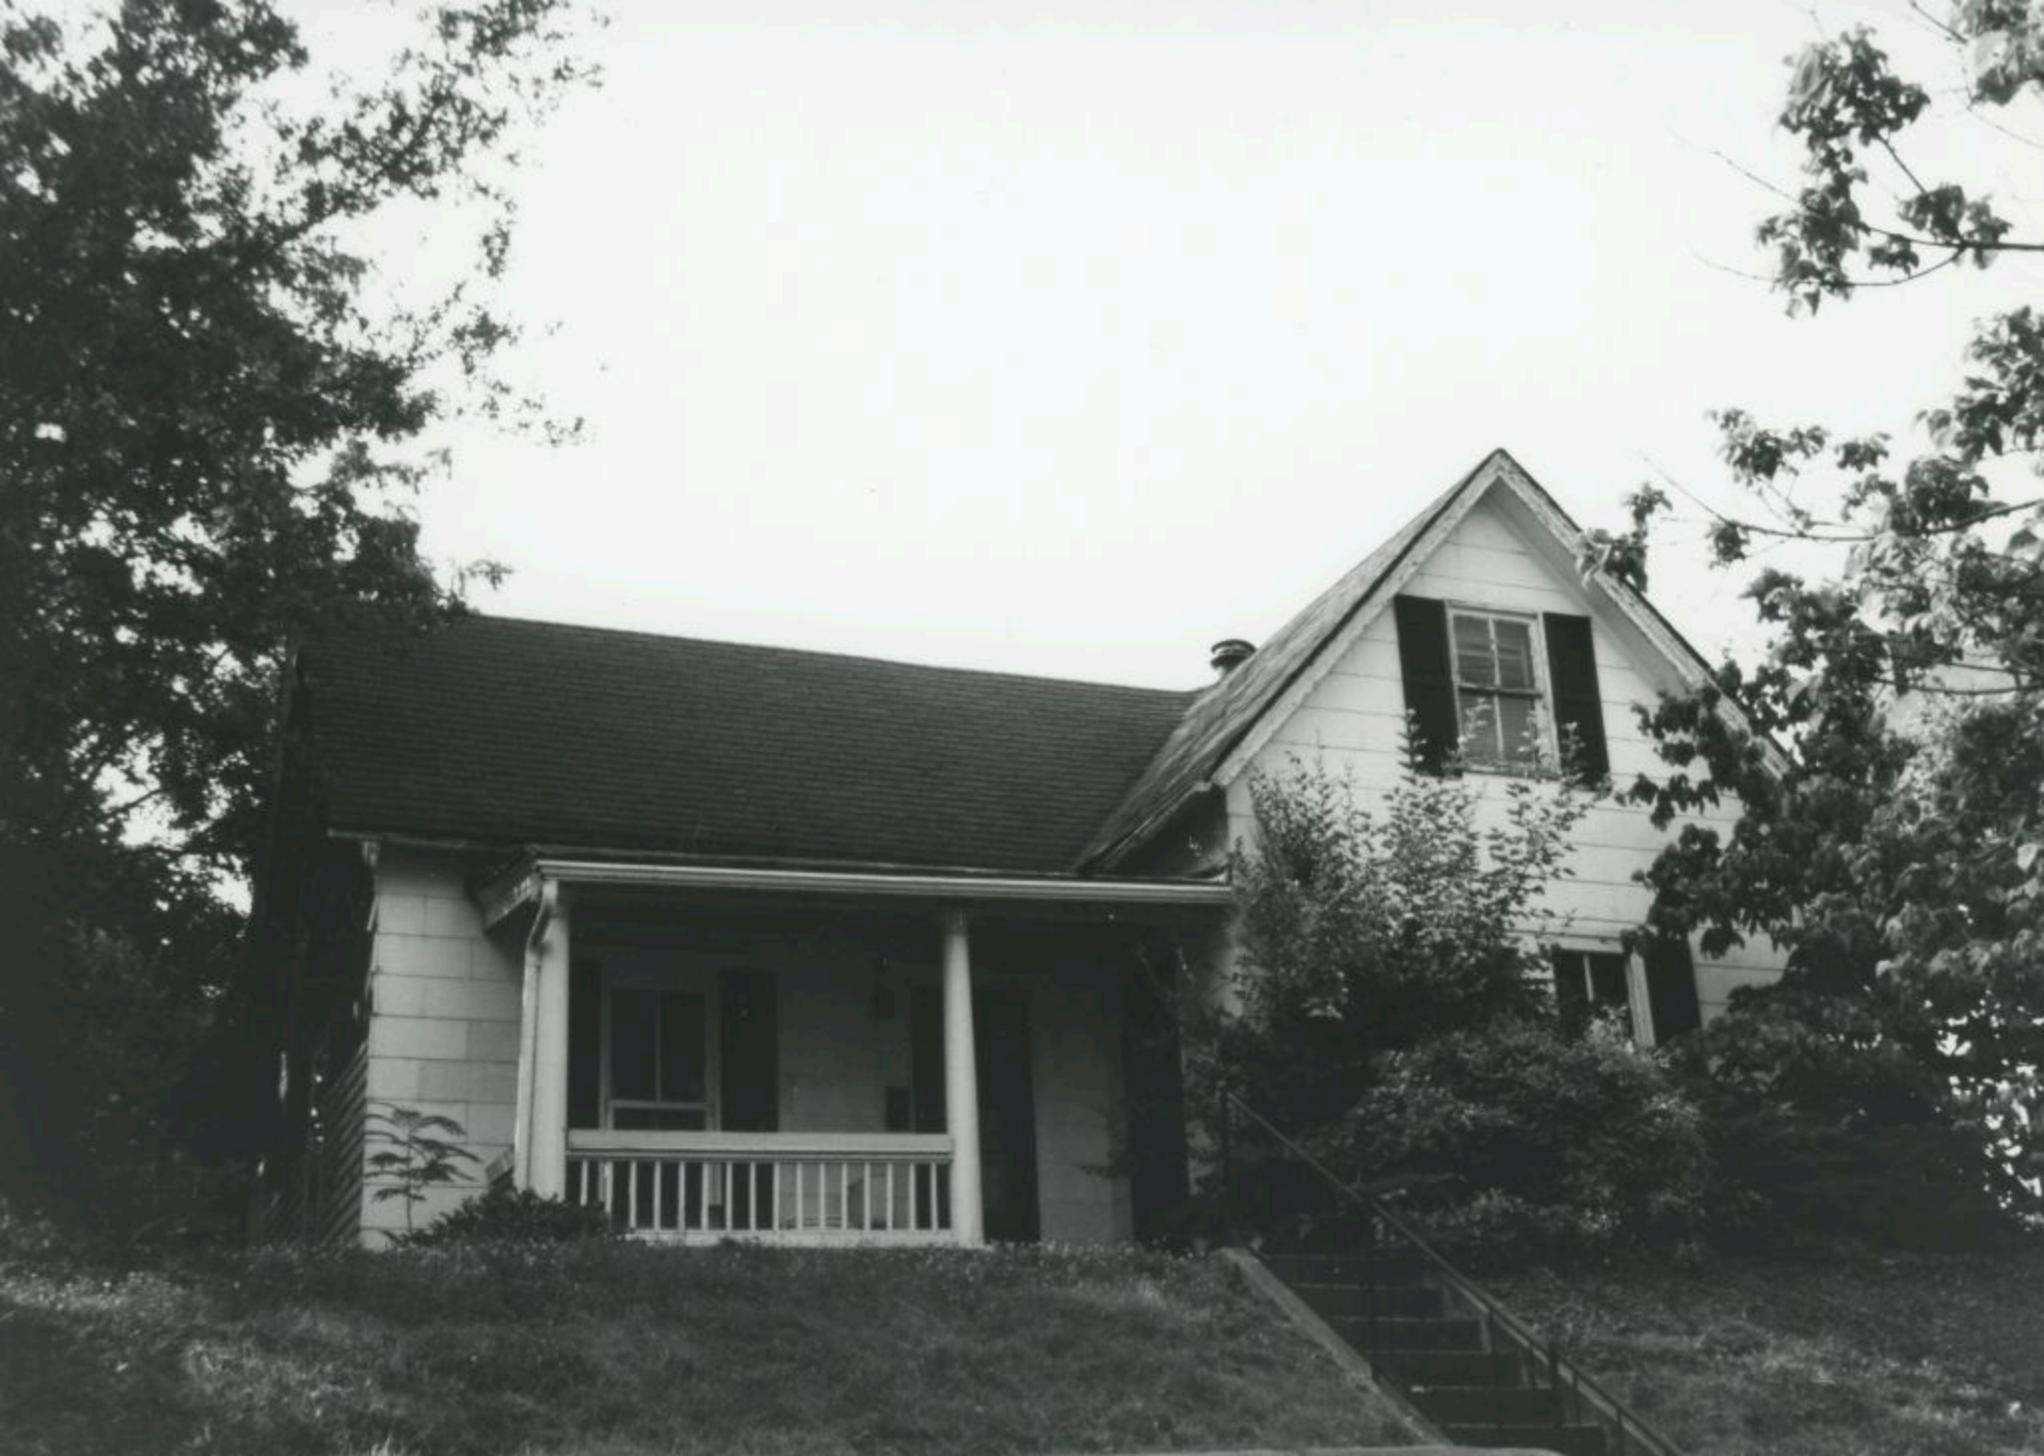
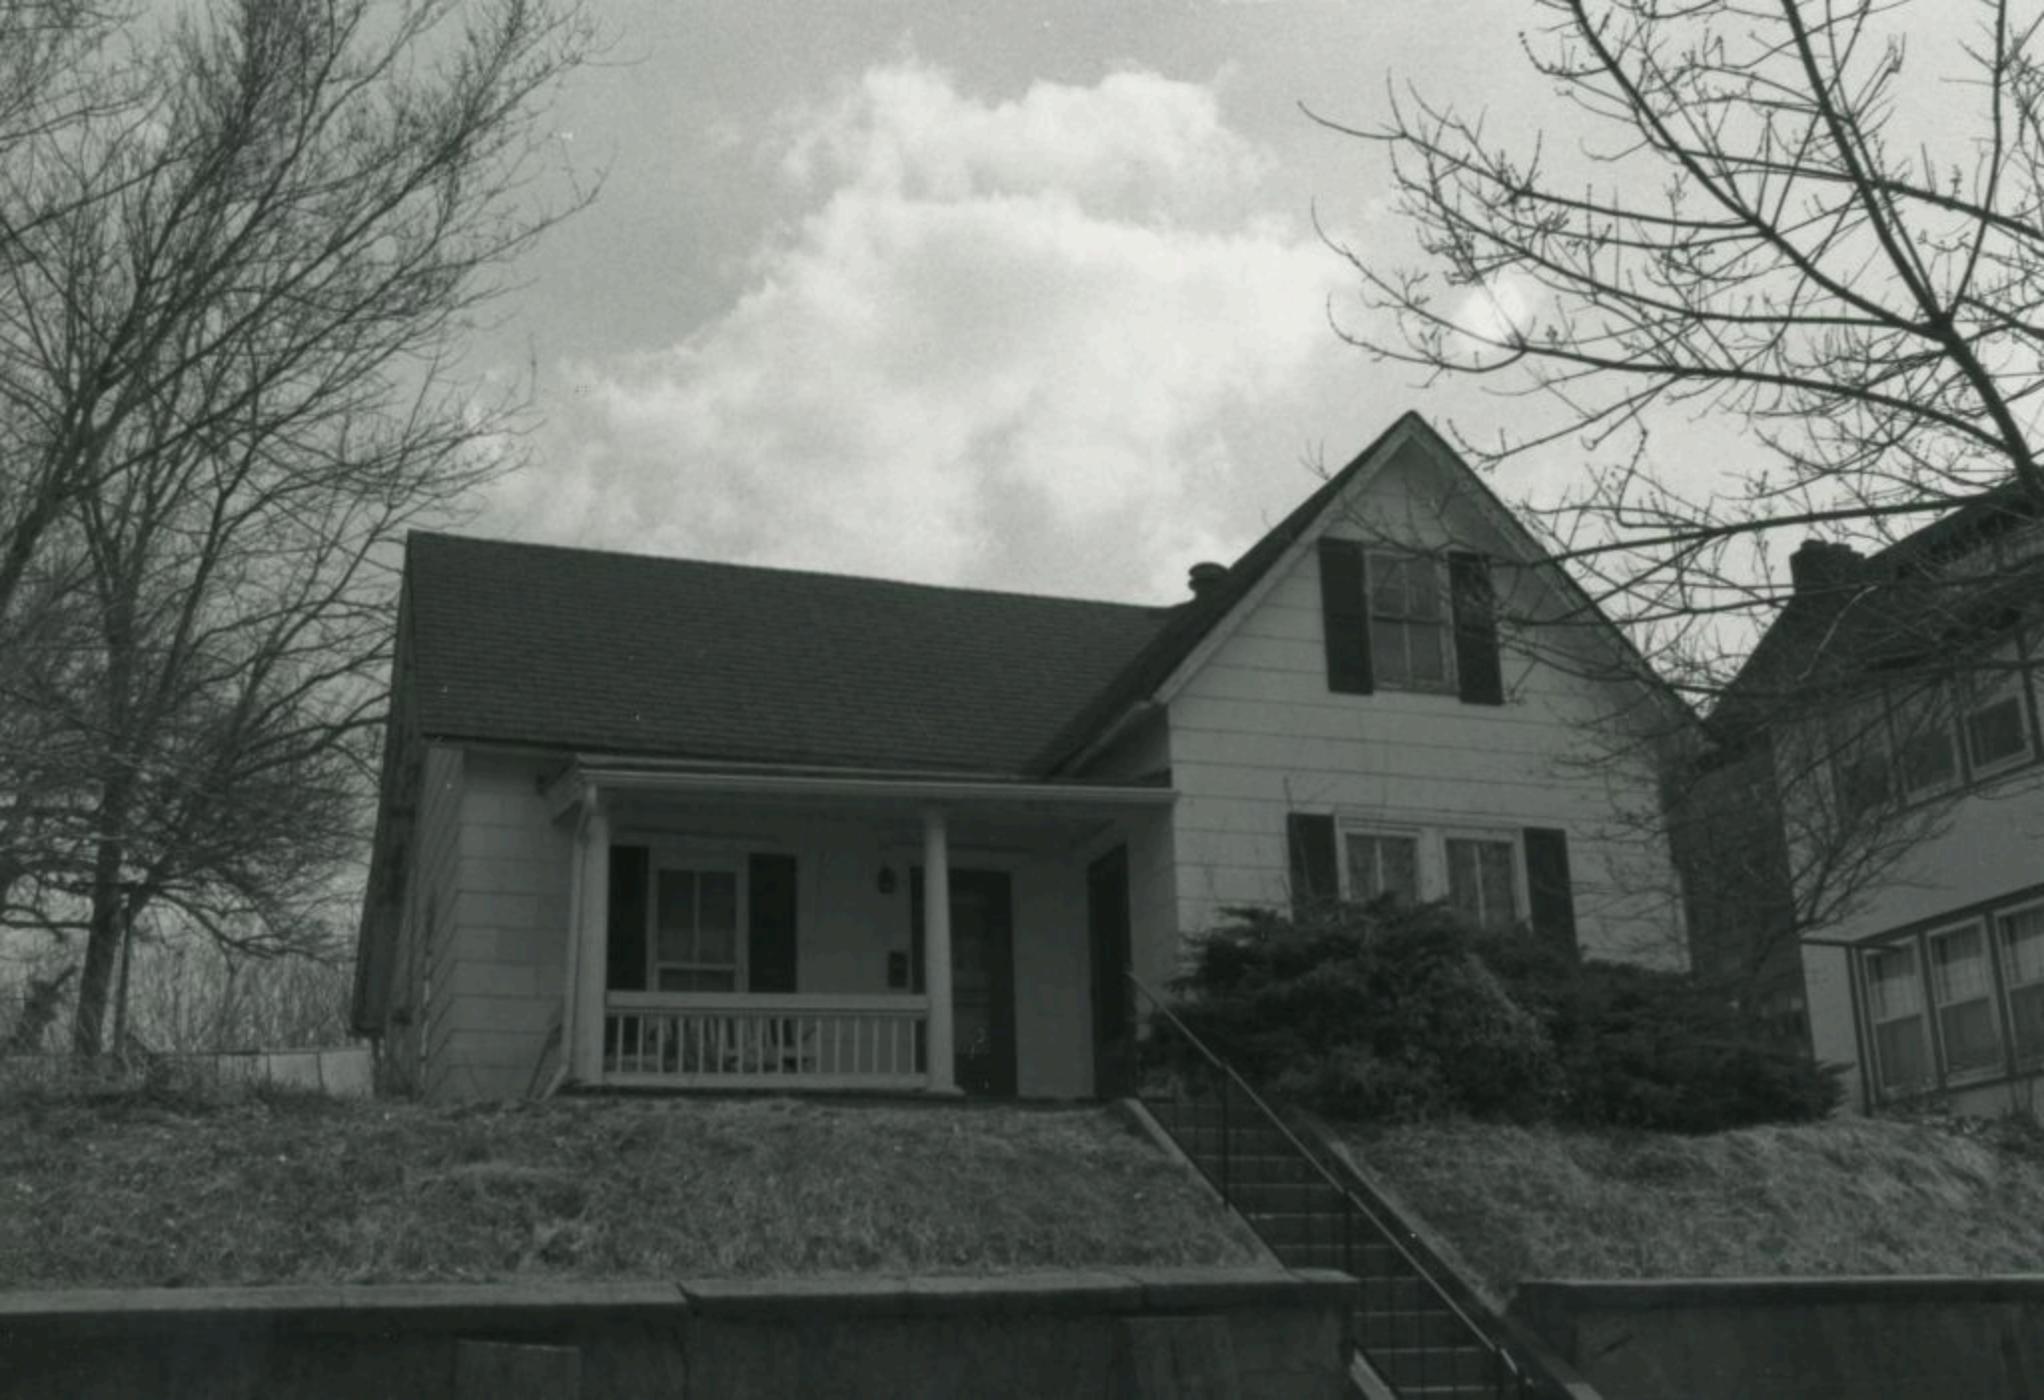
1-1/2 stories. Gabled Ell type. L-plan, 2 bay asymmetrical facade. random stone foundation, composition shingle sided walls. cross gable (asphalt shingle) roof. shed roof porch in north re-entrant corner/bay with two Doric columns with open wood railing; two corner entries, single 2/2 with historic louvered blinds to north. south bay as projecting gable roof pavilion with paired 2/2 on 1st story windows and single 2/2 window in gable, both with historic louvered blinds, overhanging boxed eaves. windows as 2/2 double hung with simple wood surrounds and drip caps, historic louvered blinds. north elevation with lower shed roof wing on rear. south elevation with two 2/2 windows, shed roof wing on rear, stove chimney on south slope. rear with shed roof wing, 2/2 windows, 2/2 in cross gable.

The 1908 Sanborn Map does not show this section of Broadway. The 1923 map shows an L-plan dwelling with a north corner porch and rear wing. The 1939 map is similar with the garage shown.

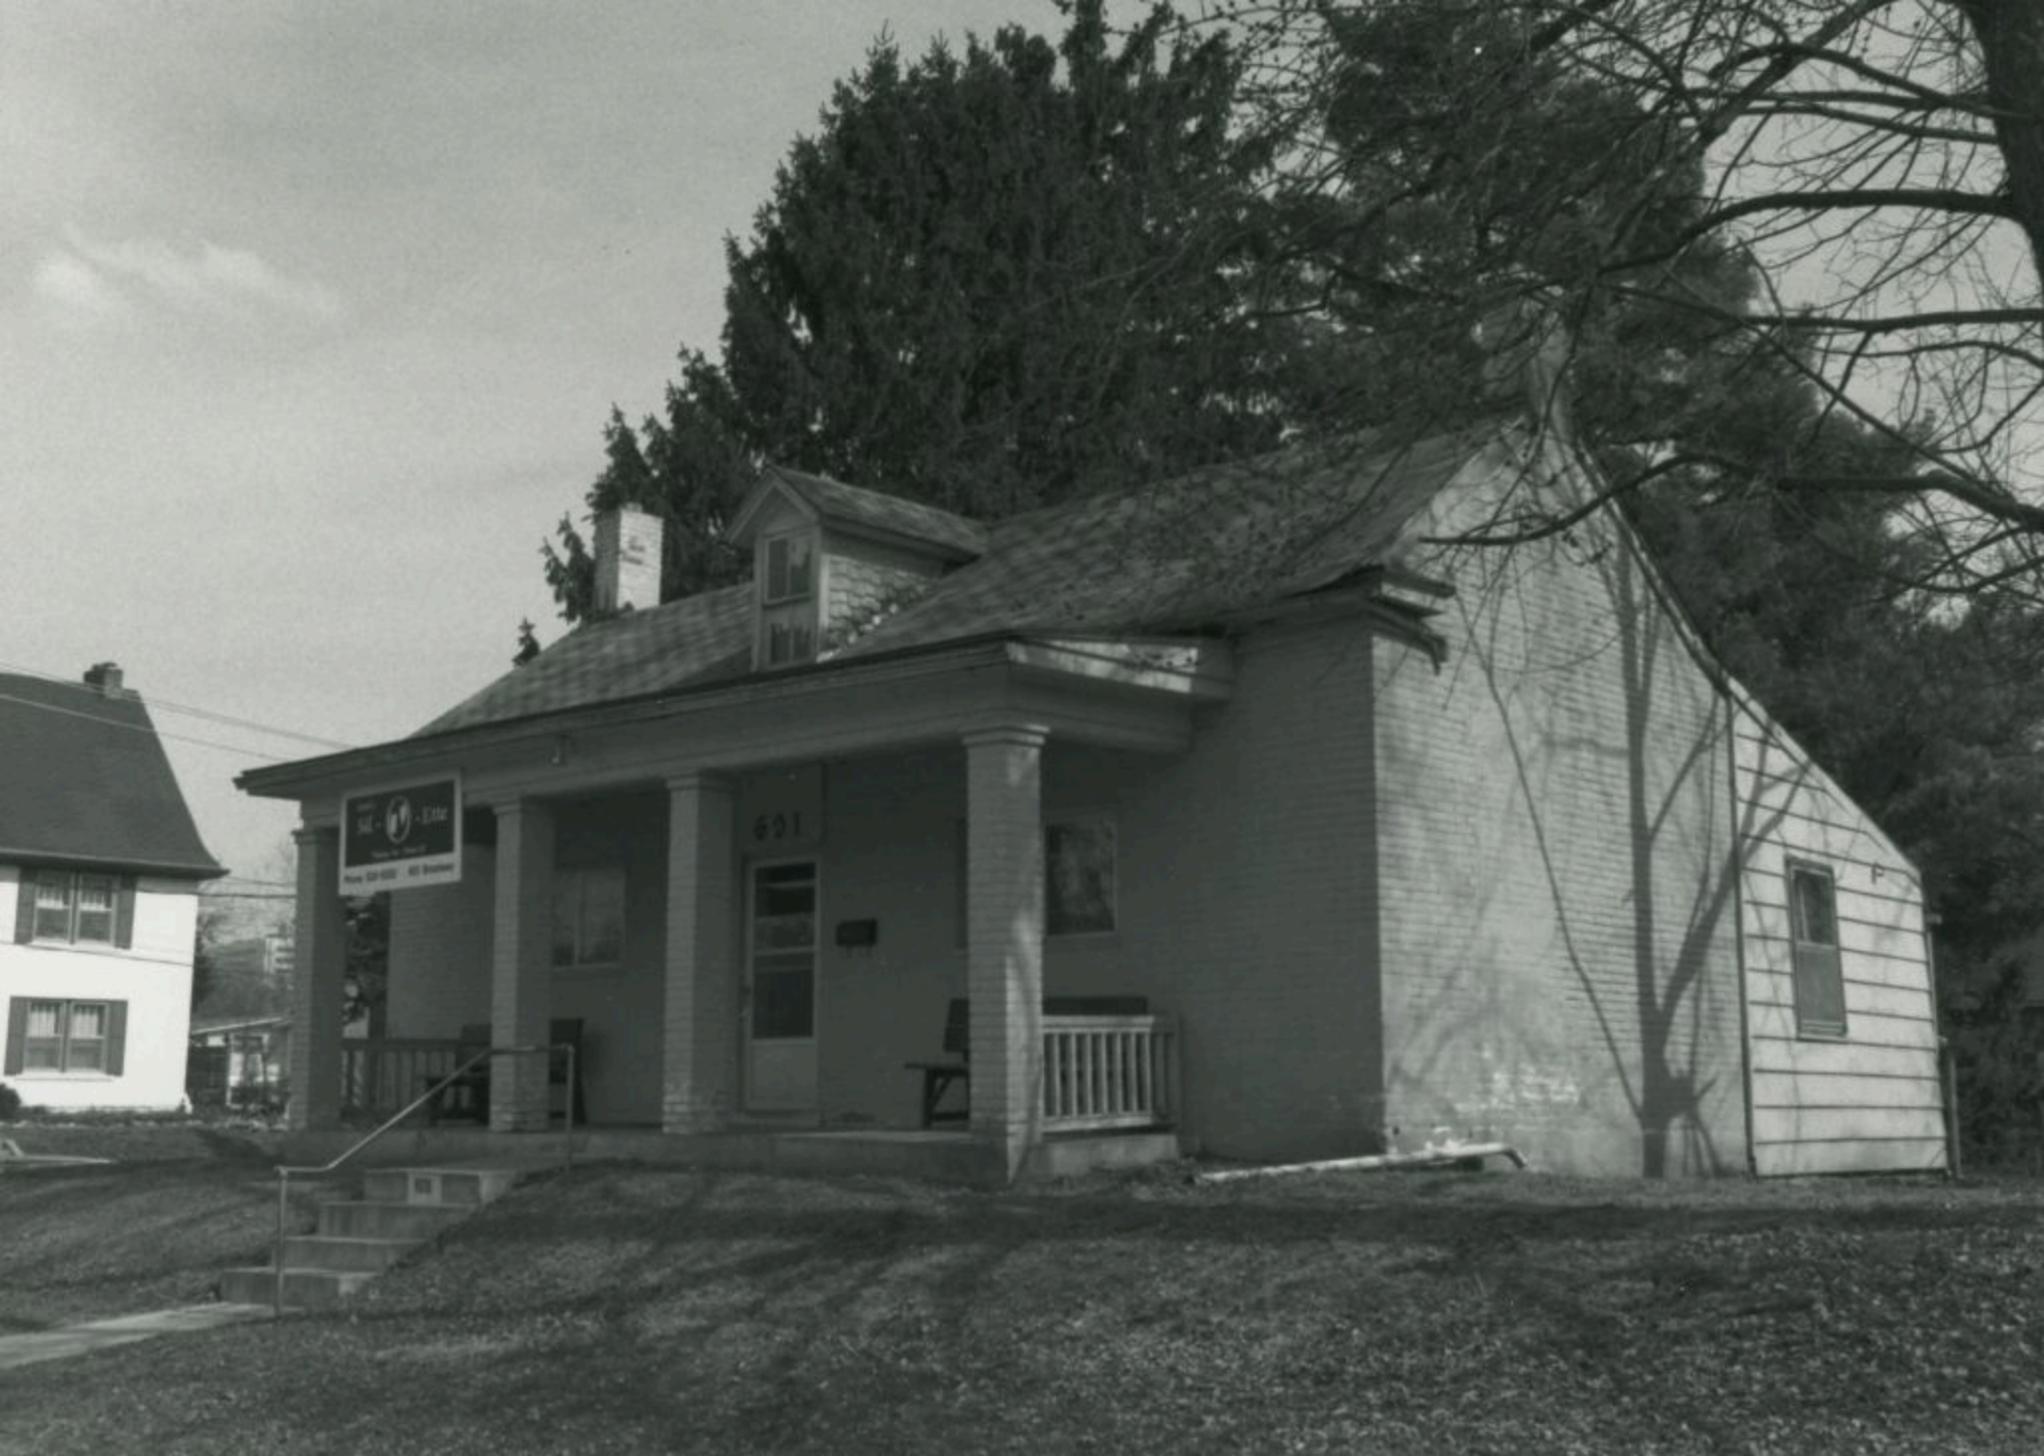
1 story with attic. Central Passage single pile vernacular type, altered. Rectangular plan. Three bay symmetrical facade. Parged foundation; brick walls (painted yellow); artificially sided wing; wood shingle dormer walls. Side gable (asphalt shingle) roof. Broad, 3/4 central shed roof porch c. 1920 with low poured concrete deck, brick posts, and side wood slat open rail; plain cornice. Central entrance with two-light paneled door; transom blocked. Infill replacement sash in end bays, with original openings not evident. Petite central gable roof dormer with 2/2 window occupying nearly all of the dormer's front. Interior end chimneys, both gable ends. Small shed frame rear wing at south end; one bay deep; single window faces south. South elevation fenestration in main house block with brick, flush with elevation plane. Converted to Ann's Sil-O-Ette hair salon.

Appears on the 1908 Sanborn Map, the first to show this block. Two part rear wing shown. Two one story outbuildings. The 1923 Sanborn Map shows the house also having a 226 West Elm Street address. A nearly full-facade porch is shown on the 1939 Sanborn Map, but the 1923 did not consistently show porches, so the porch could date to the early 1920s. A one story rear outbuilding is shown.
